NEW MEXICO
ENVIRONMENT DEPARTMENT

August 22, 2016

**RE: DISAPPROVAL
LETTER REPORT EVAPORATION POND 7 DIKE BREACH AND
SUMMARY REPORT EVAPORATION POND REPAIRS
WESTERN REFINING SOUTHWEST INC., GALLUP REFINERY
EPA ID # NMD000333211
HWB-WRG-15-006**

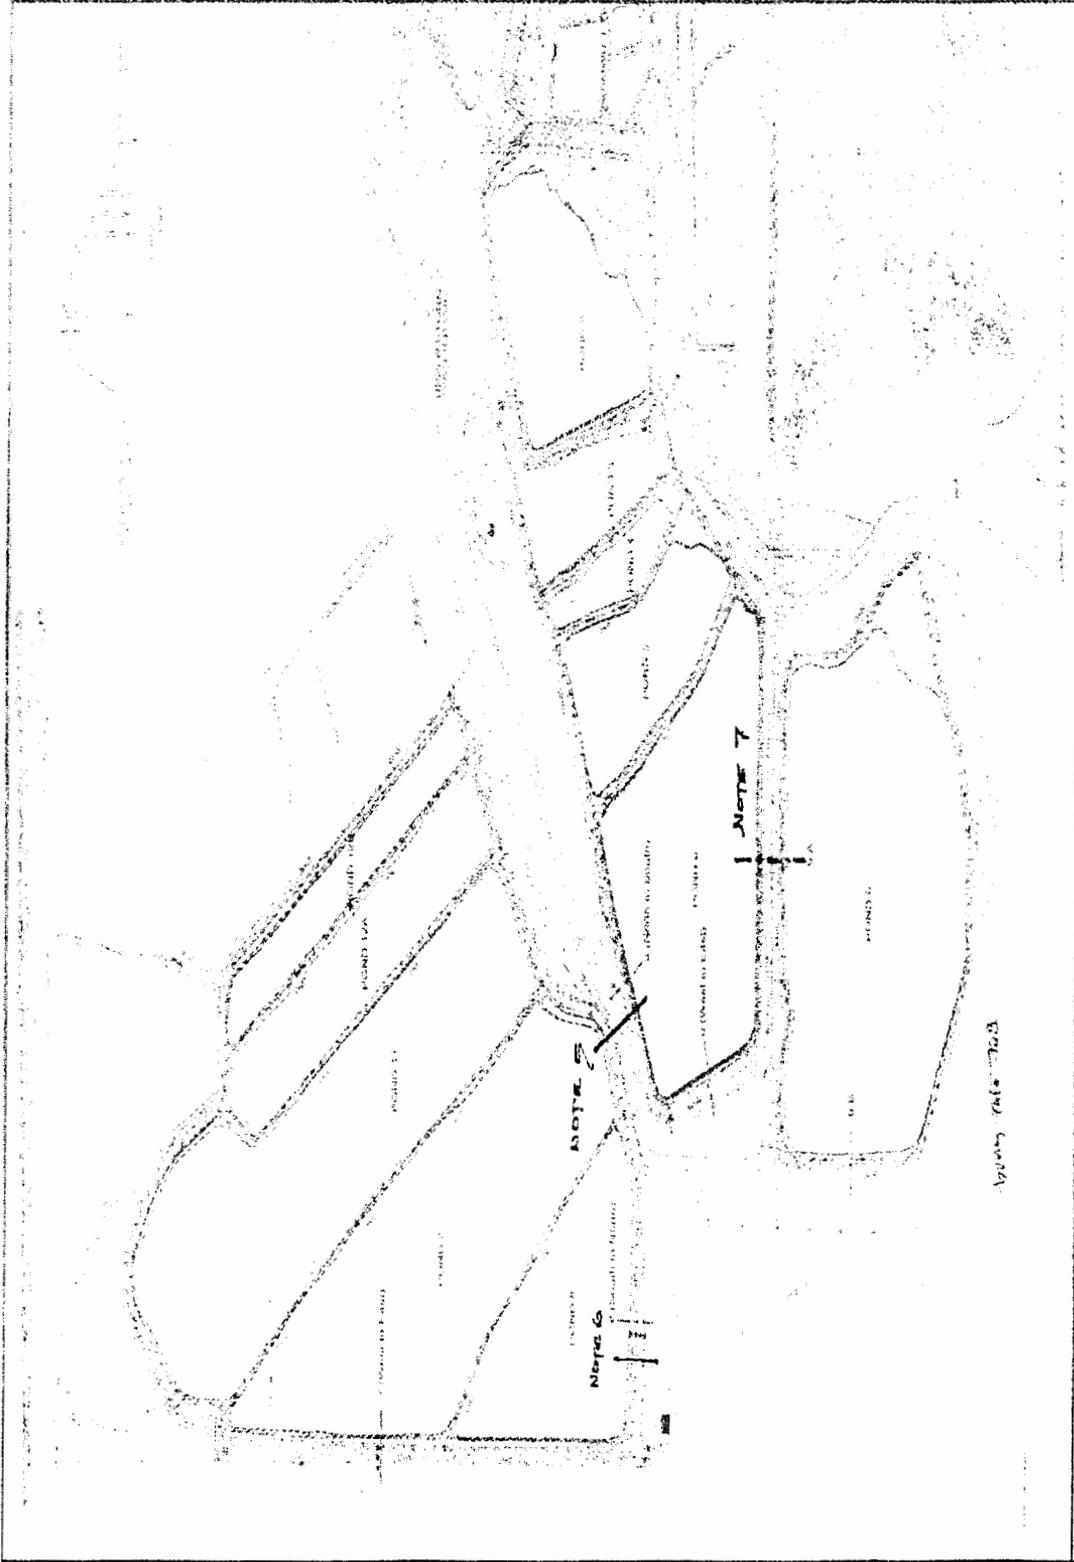
3. The Report does not explicitly state why the sections were cut where they were. Revise the Report to discuss the decision process. Additionally:
 - a) move Section 6 to the southwest and extending Section 6 into the bottom of Pond 7 to enable a stability analysis of the interior slopes of Ponds 6 and 7, including a surcharge loading (as appropriate). [See Annotated Drawing 6a, note 5];

- b) move Section 8 slightly to the west to capture the low point of the pond, corresponding to what appears to be the tallest and most appropriate embankment section for the analysis of stability. [See Annotated Drawing 6a, note 6]; and

- c) extend Section 9A directly north into the Pond 6 bottom, so the stability analysis is performed of the interior slopes of Ponds 6 and 9, with the inclusion of surcharge loads, as appropriate. [See Annotated Drawing 6a, note 7]
