State of New Mexico
ENVIRONMENT DEPARTMENT

Hazardous Waste Bureau

**RE: DISAPPROVAL
SANITARY LAGOON INVESTIGATION
REVISED INTERIM MEASURES REPORT HYDROCARBON SEEP AREA
WESTERN REFINING SOUTHWEST INC., GALLUP REFINERY
EPA ID # NMD000333211
HWB-WRG-15-002**

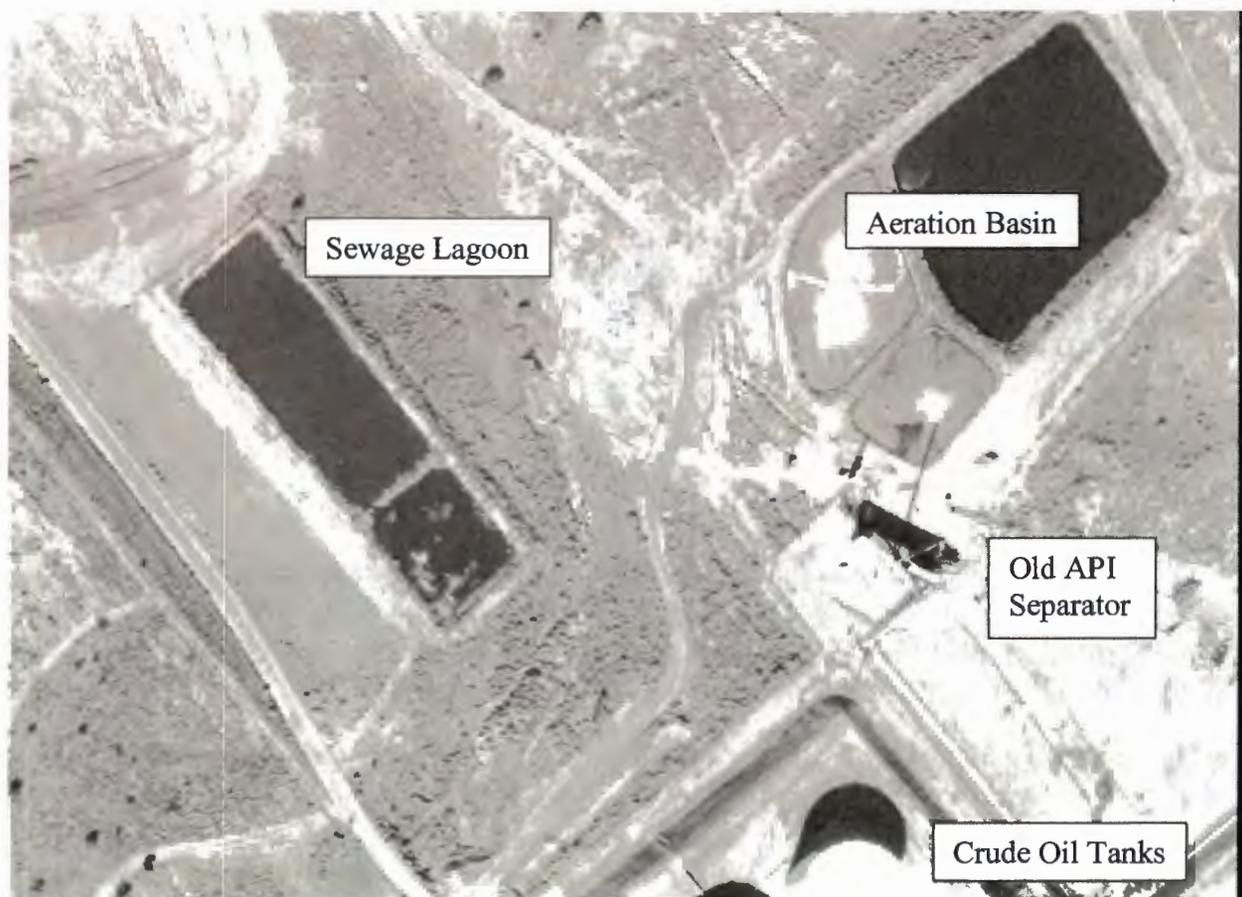
The sewage lagoon is a two-cell lagoon that was installed when the facility opened in 1957. The two cells are separated by an earthen berm. In the past (see aerial photo from 1994 below) both cells of the lagoon were used to store wastewater. Currently, one cell is dry and used for storage and the other half holds raw sewage and other discharge.
