Mixed Waste Landfill Alternative Cover Construction Quality Assurance Report January 2010

Mixed Waste Landfill Alternative Cover Construction Quality Assurance Report

URS

JANUARY 2010

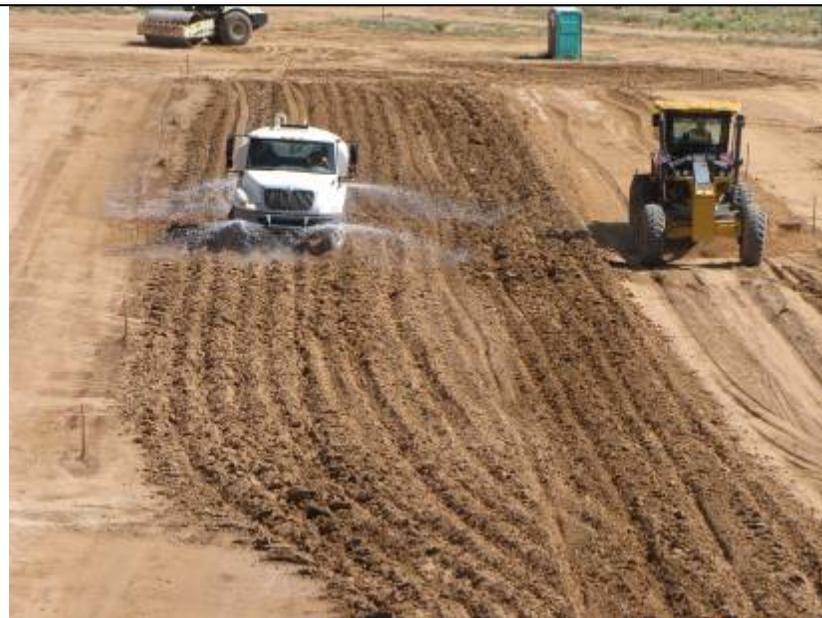
Date: 07/07/09 Time: 1604
Photo Taken by: J. Schermerhorn
Description: Adding water to increase the moisture to Lift 5 soil (grid blocks 1 and 2) after area ripped with grader scarifier shanks to a depth of ~6 inches after initial field compaction tests failed for moisture content
Facing: South
