RE: Follow-Up on Spill of JP-4

ENVIRONMENTAL SPILL CONTROL, INC.

SITE SURVEY

SOIL ANALYSIS REPORT

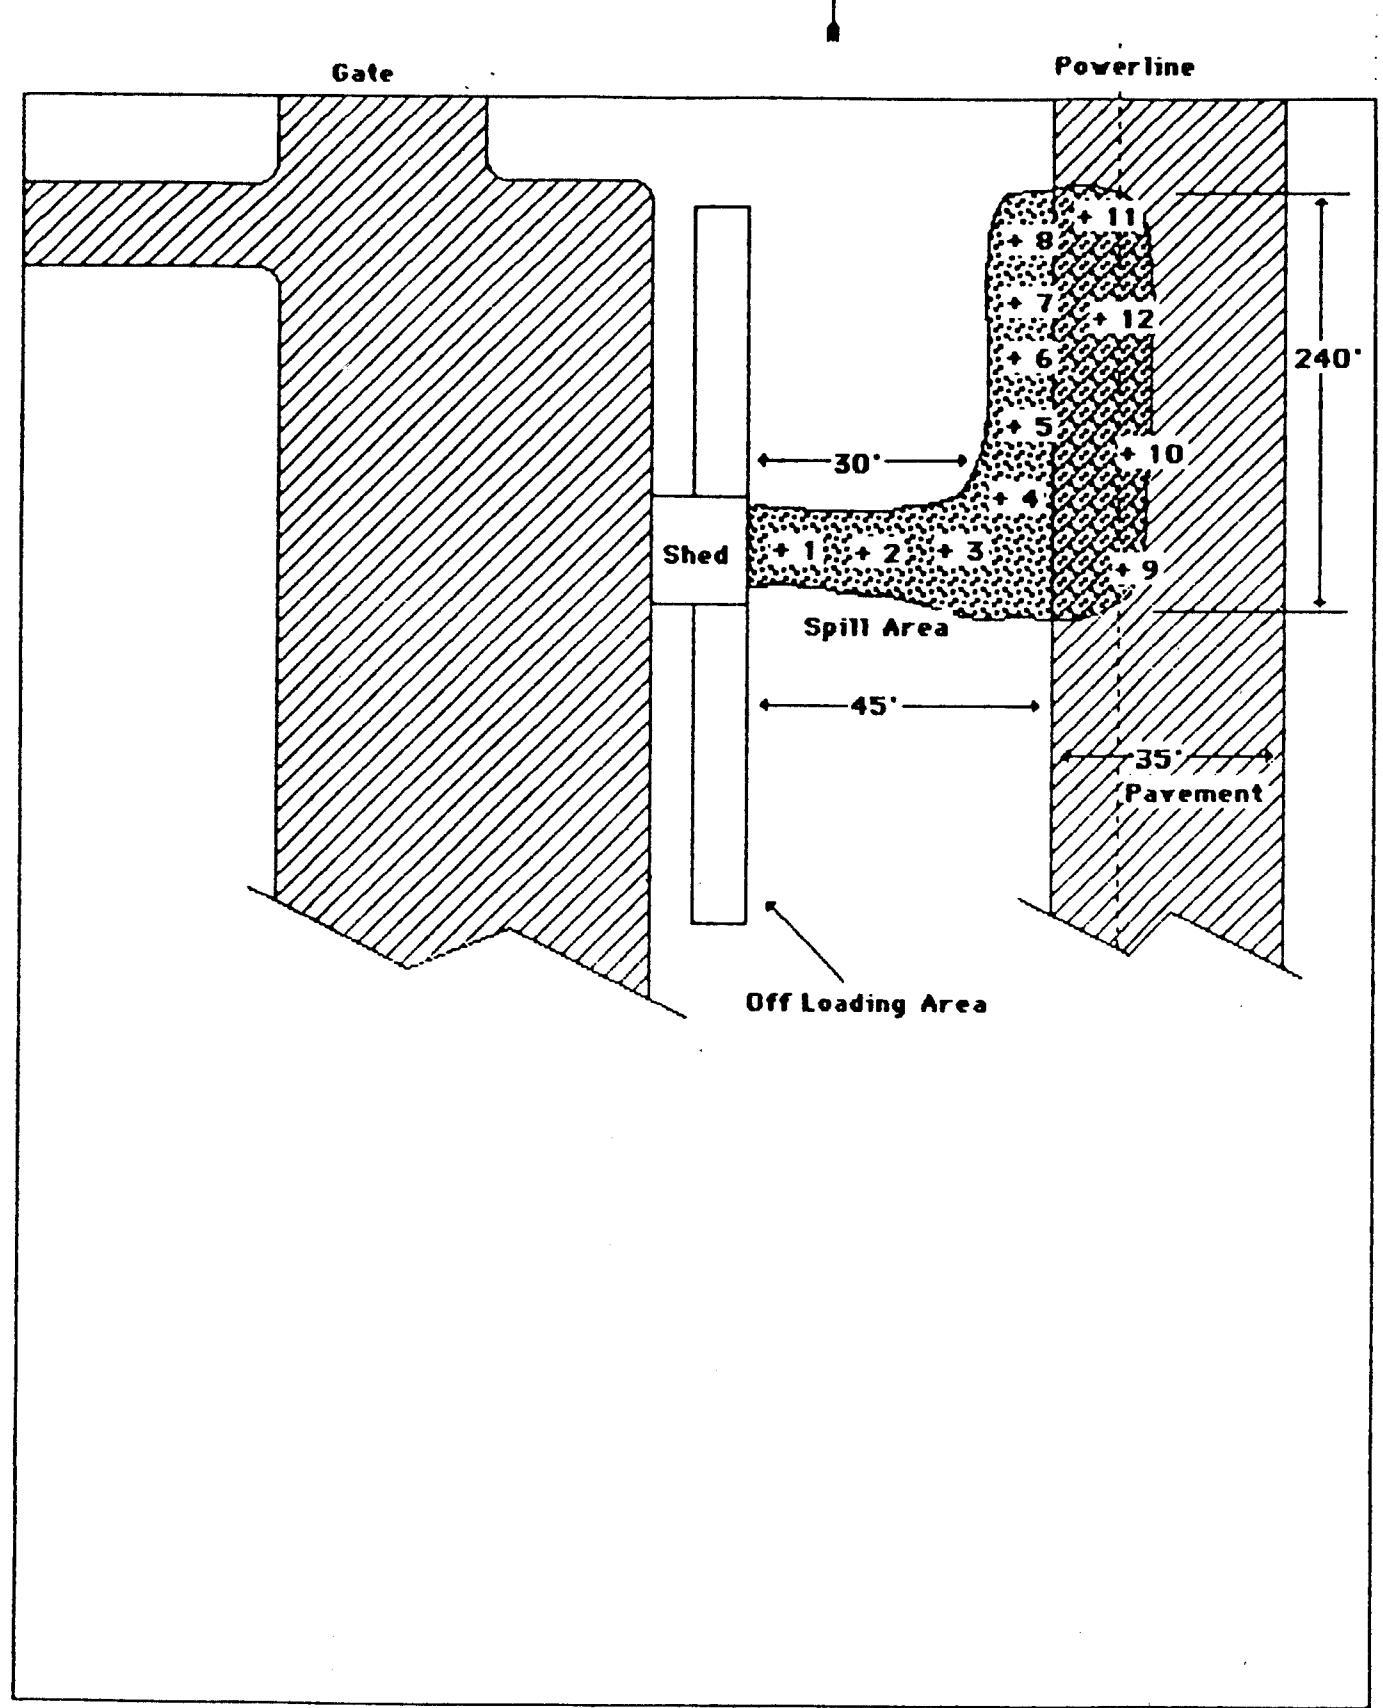
COMMENTS: TPH contamination at start of clean up was in the 3000 ppm to 4000 ppm range as shown in sample # 1. Samples # 1 and #2 were samples taken at beginning of clean up. Samples # 3 - # 8 were samples taken after clean up was finished. Samples # 9, 10, and 11 were samples of native soil just under the base course or road material. Sample # 12 was a sample of the road material and sample # 13 was a background sample taken at the bottom of base course north of spill area.
