#58846

*Fracture Characterization of the
Bandelier Tuff in OU-1098 (TA-2 and TA-41)*

Kenneth H. Wohletz

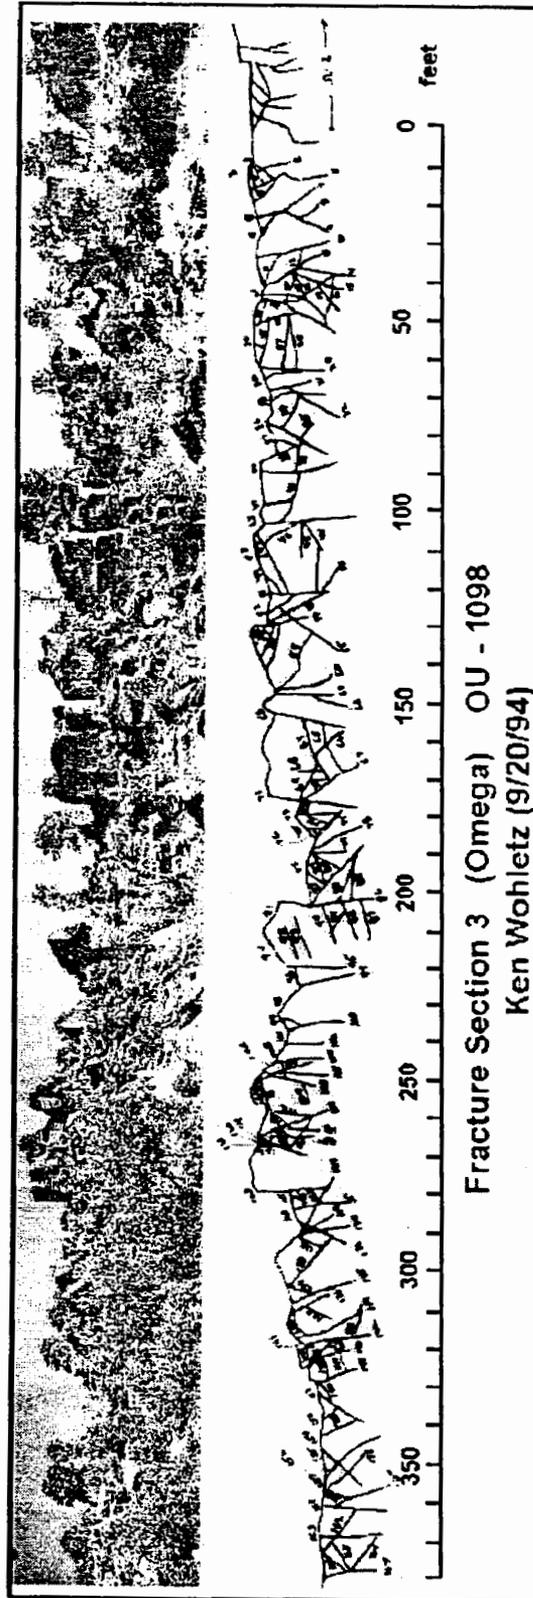
Figure 3. An example fracture photomosaic map (map 3) adjacent to Omega Site (TA-2-1). Each documented fracture has a number for its identification in the fracture data base.

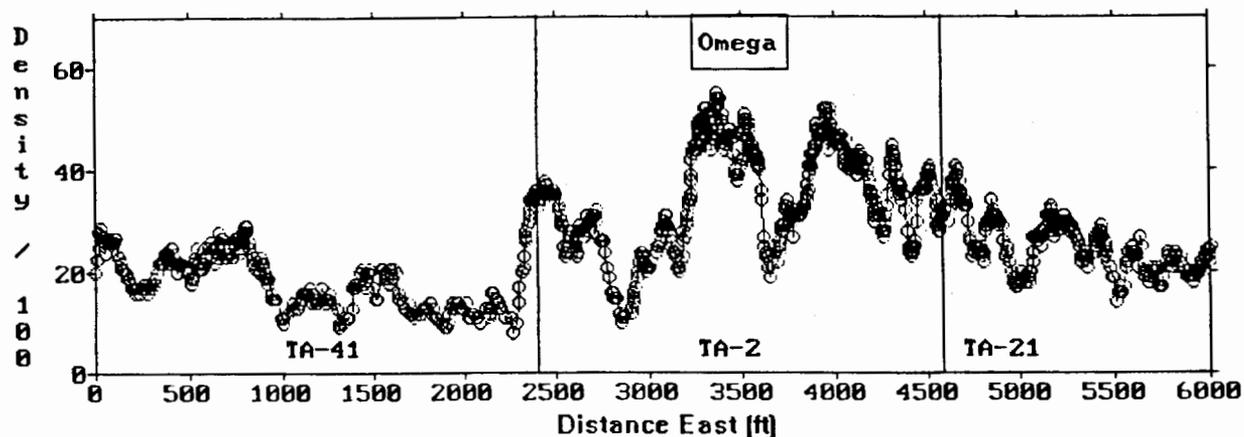
Fracture Density. Linear fracture density is portrayed in Figure 4 as the number of fractures within a 100-foot interval centered on each fracture for the section starting west of building TA-41-4 and extending 6013 feet down Los Alamos Canyon. From Table 1, fracture density increases from a western background value of 22 fractures per 100-foot interval to over 40 within the GMFZ and then declining to about 30 east of GMFZ. The densities of NW and NE fractures are virtually the same. From previous studies, background fracture densities in the Bandelier Tuff are about 20 fractures per 100-foot interval (Vaniman and Wohletz, 1990; Wohletz, 1995). The value of 30 fractures per 100-foot interval east of the GMFZ likely shows the influence of another fault zone existing near Material Disposal Area V (MDA-V) in TA-21 (~7000 feet east; Wohletz, 1995). Figure 4 shows the prominent rise in fracture density within TA-2 near Omega Site, reaching maximum values between 50 and 60 fractures per 100-foot interval. At 2500 feet another peak in fracture density is apparent. Figure 5 is an enlargement of Figure 4 over the area adjacent to Omega Site building TA-2-1, which likely constitutes a western branch of the Guaje Mountain Fault; the eastern branch exists about 400 feet east of TA-2-1.

Figure 4. Fracture density shows the number of fractures per 100-foot interval centered on each fracture along the traverse of approximately 6000 feet. Note the increase in density from about 3200 to 4200 feet (adjacent to Omega Site), which is the signature of the Guaje Mountain Fault Zone.

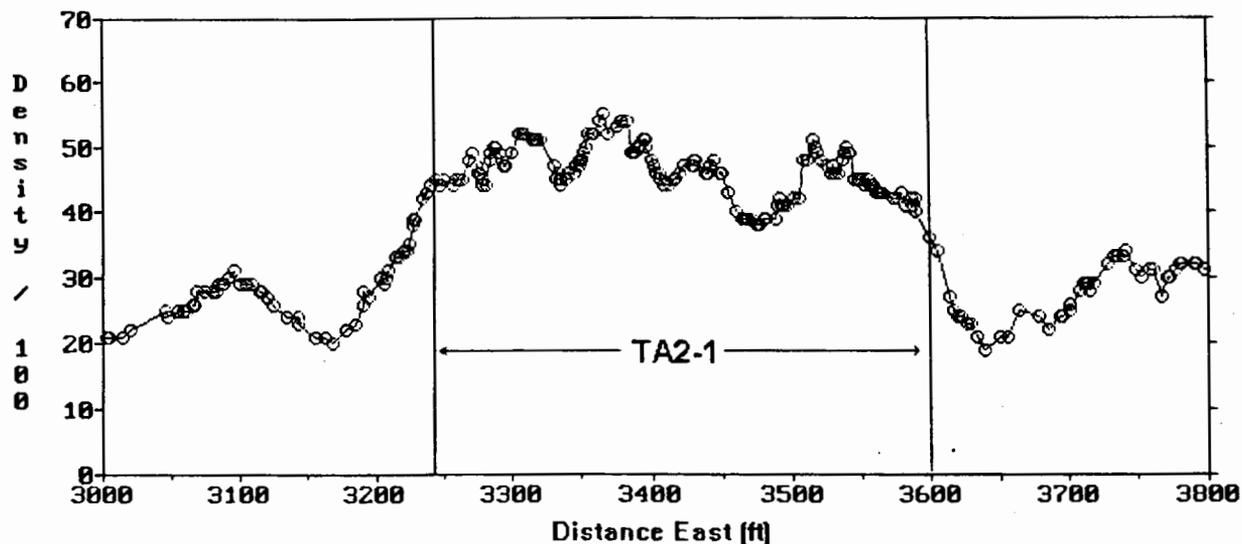
Figure 5. Detail of fracture density from 3000 to 3800 feet along the fracture traverse in the region of building TA-2-1 (Omega West reactor).

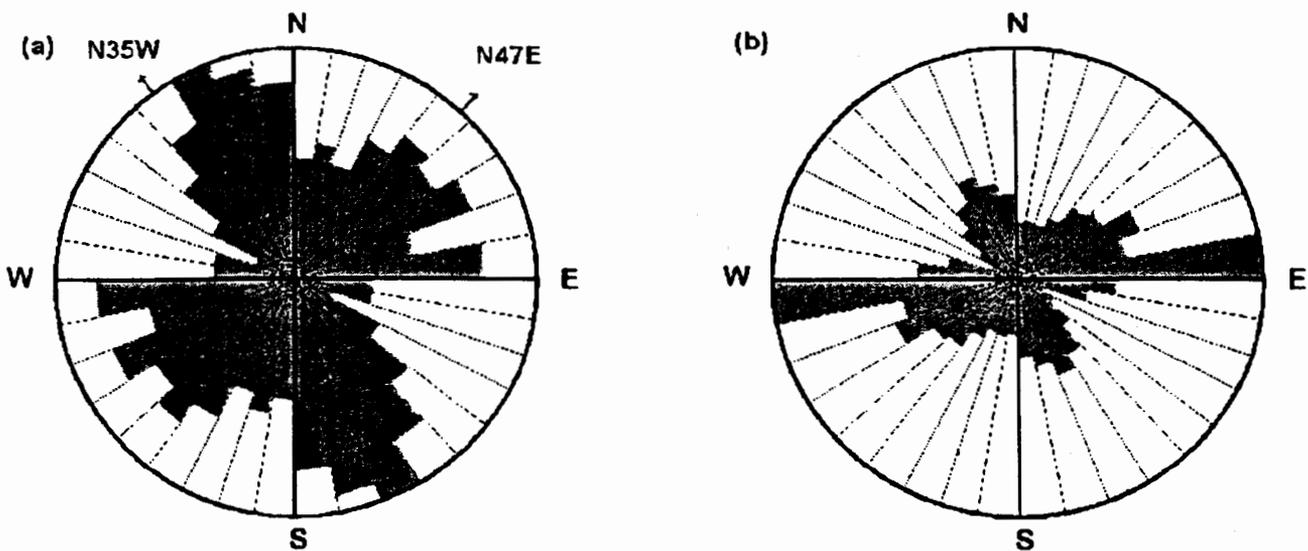
Fracture Strike. Plotted in a rose diagram (Fig. 6a), fracture strikes show two groupings with mean strikes at N35W and N47E, supporting the conjugate joint-set assumption for distribution of the fractures. As mentioned above, measurement of fractures along a nearly E-W line precludes unbiased representation of fractures nearly parallel to that trend. A compensation algorithm can be defined based on the assumption that the observed fracture abundance is inversely proportional to the cosine of the angle between the fractures and the perpendicular to the line of observation. This algorithm is modified to take into account that the fracture traverse is not a straight line and represents about 20 degrees of variability (canyon wall reentrants allow measurement of some of the fractures striking parallel to the canyon); hence, the maximum compensation will not be infinity but about a factor of 3 [$1/(\cos 70^\circ)$]. Figure 6b is a rose diagram depicting this compensation, which defines a hypothetical but dominant E-W grouping (note that rose diagram depicts E-W trend in bin adjacent to E-W line). The angle between mean strikes is 82° (NW and NE sets) and between 43° (EW and NE sets) and 55° (EW and NW sets).

Figure 6. (a) Rose diagram showing the frequency of measured fracture strikes with conjugate set mean values at N35W and N47E. (b) Compensated rose diagram showing hypothetical frequencies of fractures nearly paralleling the fracture traverse.

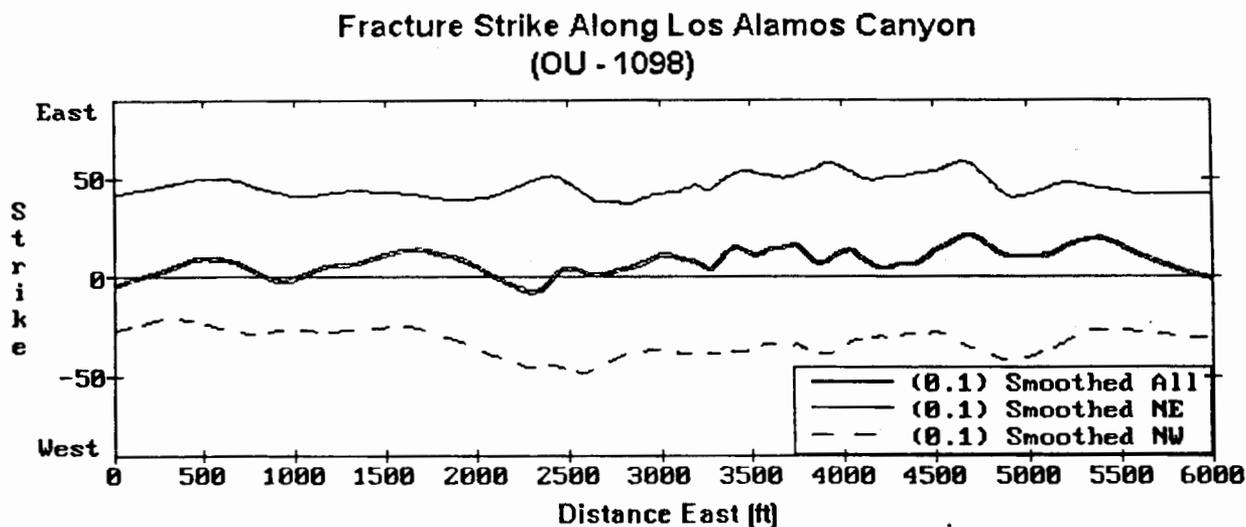
Figure 7. Fracture strikes shown as 150 point (0.1) LOWESS (Locally Weighted Regression Scatter Plot Smoothing) curves for all fractures, NE trending fractures (positive values), and NW trending fractures (negative values).

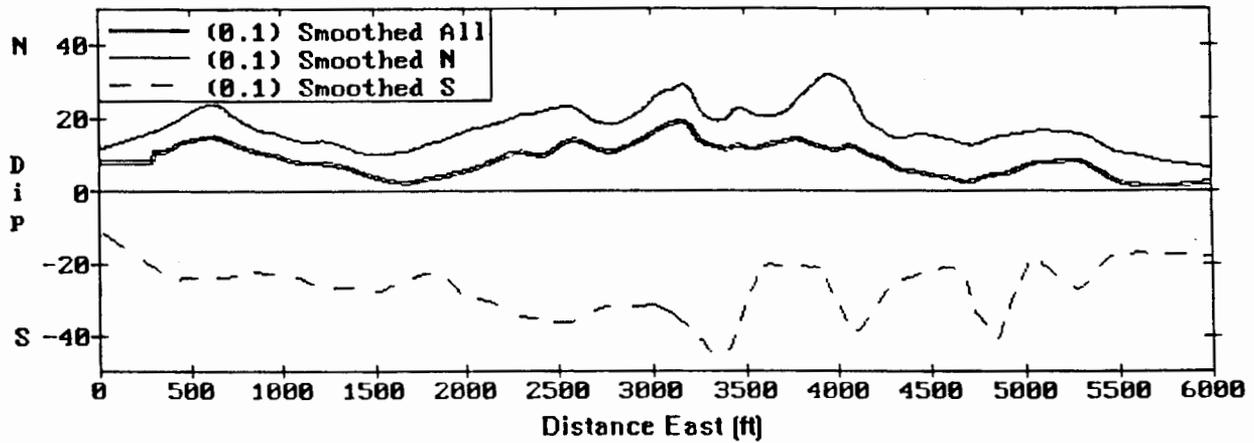
Fracture Dip. Fractures generally dip steeply (Table 3), with mean values near 80 (from horizontal) to the north, attesting that northerly dipping fractures are more abundant than southerly dipping ones. While northerly dipping fractures are steeper than southerly dipping ones for the NW fracture set, they show the same verticality for the NE fracture set (Table 3). The mean dip changes little from background values to those in the GMFZ; however, Figure 8 shows a marked decrease in dip (increase from vertical) for fractures in the regions of high fracture density at ~3400 and ~4100 feet in the GMFZ where the average angle between southerly and northerly dips approaches 70 from a background average of ~35 .

Figure 8. LOWESS (0.1) smoothed curves of fracture dips relative to vertical (0) where southerly dips are shown as negative values. Because there are more north dipping fractures than south dipping ones, the smoothed average of all data shows northerly dipping tendencies.

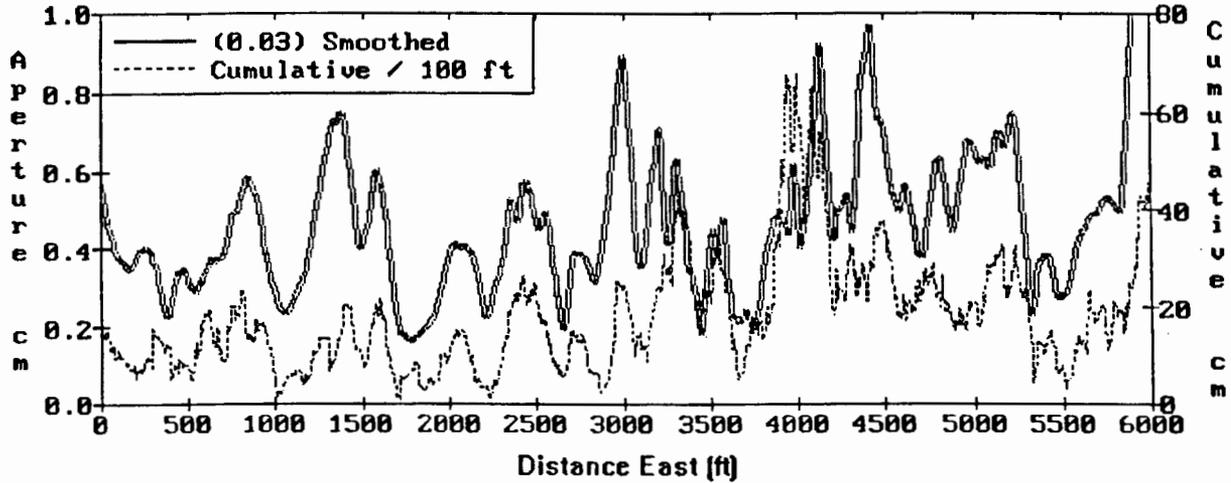
Fracture Aperture. The mean fracture aperture is 0.7 cm (Table 4). This value represents the average opening along the sinuous fractures that in places may be nearly closed and other places open. In unit 2, fracture filling materials were not observed; however, they become abundant in the upper part of unit 3, near the mesa top. In general, the fractures show widest apertures in unit 2 and decrease above and below it, generally being closed in unit 1 where because the tuffs are less competent, fractures are difficult to trace. The mean aperture of fractures slightly increases going east into the GMFZ as shown by Figure 9 and reaches a high value of 1.0 cm at the east of the traverse. Figure 9 also depicts the cumulative aperture over 100-foot intervals centered on each fracture. From background values of about 20 cm of cumulative aperture over 100-foot intervals, values reach about 70 cm of cumulative aperture over the GMFZ. Figure 10 shows the variation of fracture aperture with dip. From this plot, one can see a general increase in fracture aperture as dip goes from 0 (horizontal) to 90 degrees (vertical).

Figure 9. LOWESS (0.03; 45 point) smoothed curve of fracture apertures and the curve for cumulative fracture aperture per 100-foot interval centered on each fracture. The cumulative curve shows peak values in the region of the GMFZ.

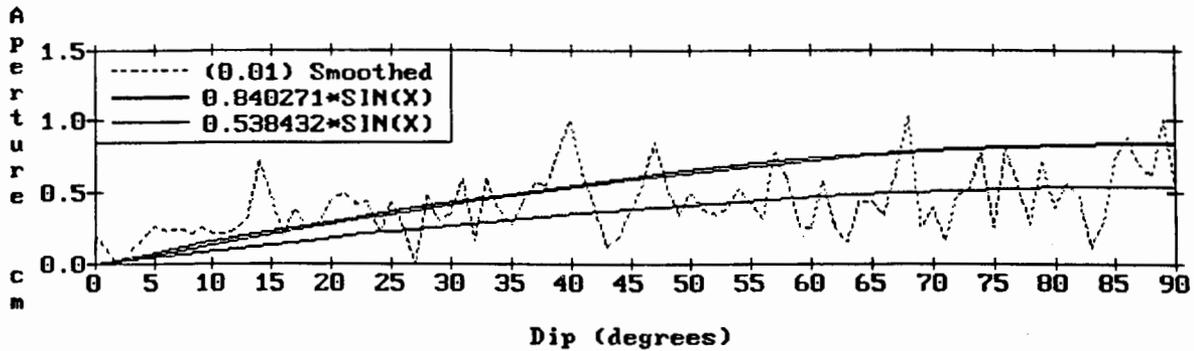
Figure 10. LOWESS (0.01) smoothed curve (dotted) of fracture apertures as a function of dip. Sine curves are shown for a best fit of all aperture data (double) and best fit of smooth data (single). This plot shows that there is a general observed increase in fracture aperture with increasing fracture dip, such that horizontal fractures generally show little or no aperture while vertical ones generally show apertures of about 0.8 cm.

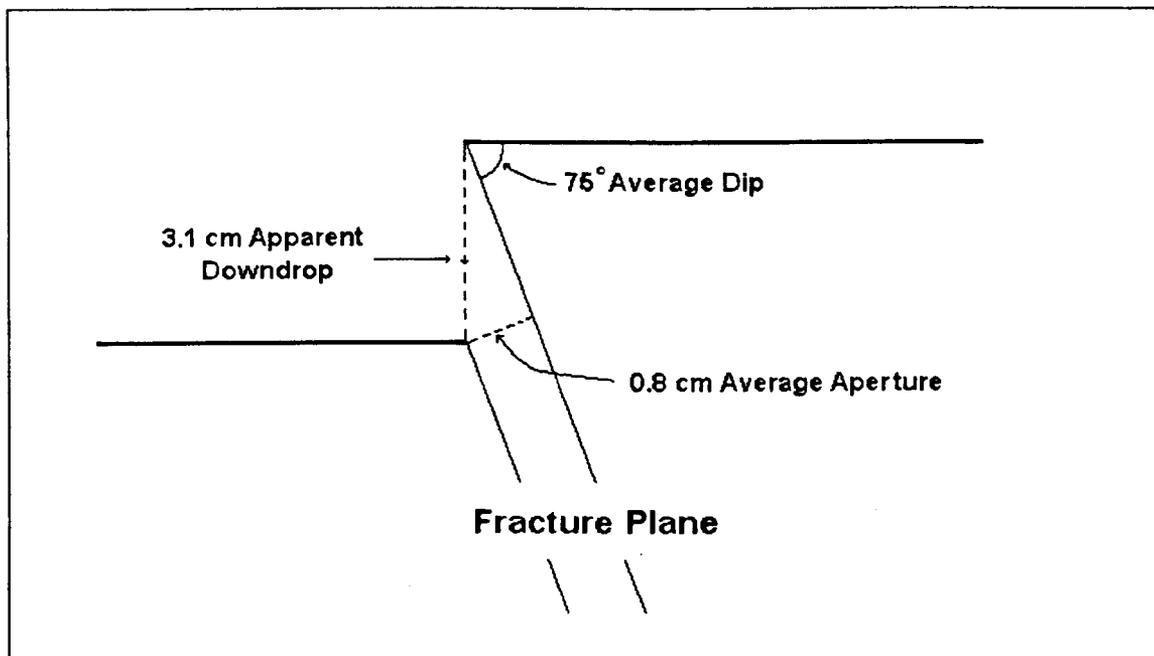
Figure 11. Schematic illustration of average fracture geometry, showing one possible geometric configuration that explains fracture aperture by downdrop of tuff block on the left relative to the one on the right.

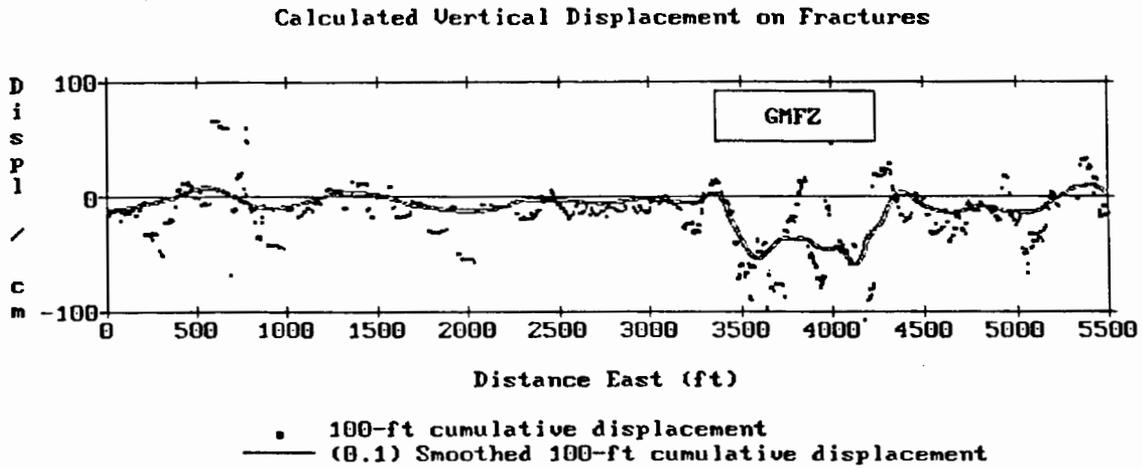
Figure 12. Fracture aperture per 100-foot interval (interval centered on each fracture) and LOWESS (0.1) smoothed curve of these data calculated as shown in Figure 11. Note the negative (down to the west) signature over the GMFZ between 3200 and 4200 feet.

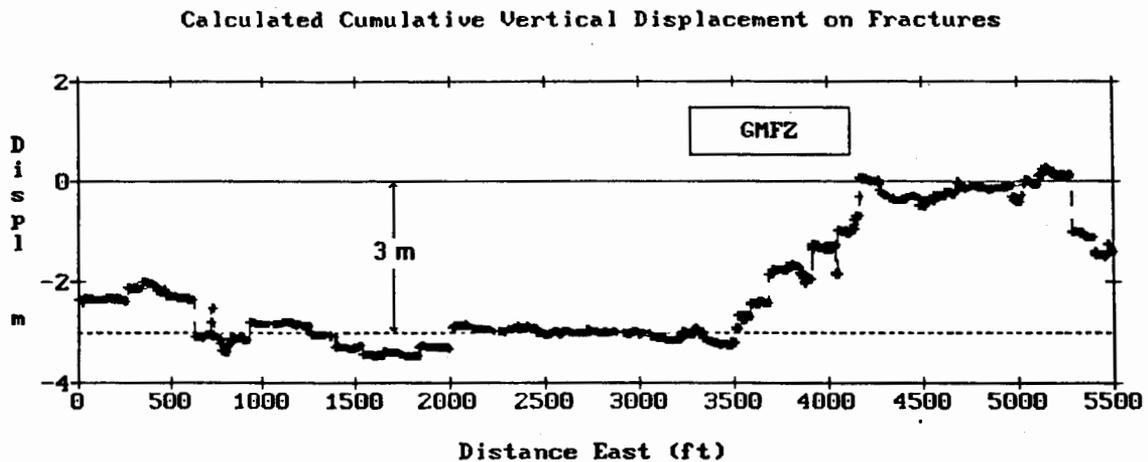
If in fact tectonic displacement has been accommodated by the 409 documented fractures over the GMFZ (3200 to 4200 feet) by incremental, vertical displacement on each fracture, then with summation of these displacements one can test the model of Gardner and House (1987) that shows downdrop on the west side of this fault zone. Because most fractures do not show measurable evidence of incremental displacement, an alternative method is proposed here, a method based on the assumption that fracture apertures have developed by vertical displacement along initially closed cooling joints. Figure 11 illustrates this method, showing how a vertical displacement along a fracture produces a fracture aperture where the apparent downdrop equals the aperture divided by the cosine of the dip. This method also requires the assumption that vertical fractures produce no aperture, which is incorrect considering observed data (Fig. 10); however, if vertical fractures were included in this method, then an infinite vertical displacement would arise, which is obviously incorrect. Furthermore, cooling contraction of the tuff may have produced fracture apertures, but I note that many localities in the Bandelier Tuff show cooling joints having no aperture. Keeping in mind the above assumptions, an application of this method (Figs. 12 and 13) does show an apparent cumulative downdrop of approximately 3 m (10 ft) to west has been accommodated by fractures in this zone. In support of this calculation, Vaniman and Wohletz (1990) calculated ~2 m of vertical displacement on the GMFZ where it crosses East Jemez Road to the south of Los Alamos Canyon. In addition this former study noted an inflection of the Los Alamos Canyon stream gradient of about 20 feet over the GMFZ, which is a common geomorphic feature of fault displacement.

Figure 13. Cumulative fracture vertical displacement calculated as shown in Figure 11. Note the apparent westward downdrop over the GMFZ. Approximately 4m of apparent displacement occurs between 3500 and 4200 feet, where cumulative offset is taken from an arbitrary zero level east of the GMFZ.
