To/MS: Carl Newton, ESS-1, MS E525
From/MS: William C. Francis, CST-18, MS E525 *W.C.F.*
Phone/FAX: 7-6080/5-4632
Symbol: ER-WCF-96-17
Date: November 27, 1996

**MATERIAL DISPOSALS AREA (MDA) U. RESEARCH ON OIL FROM THE
PRECIPITRON TO THE PITS.**

**The Decommissioning of TA-21-153,
A ²²⁷Ac Contaminated Old Filter Building**

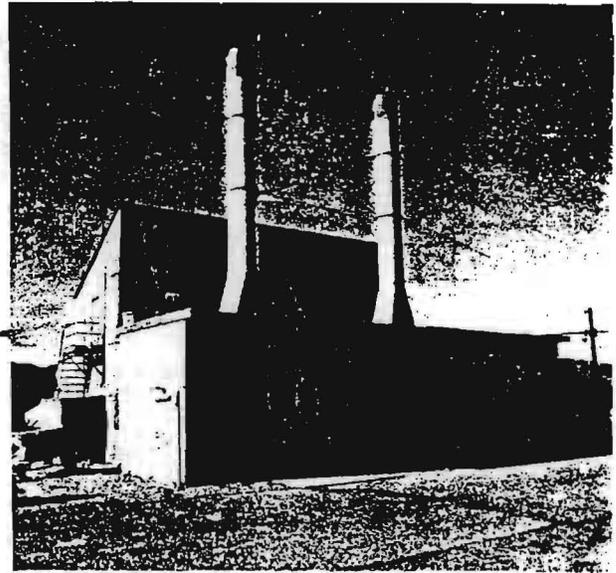
Fig. 2.
East elevation, Structure TA-21-153.

- a. a two-story frame and masonry building (Figs. 2 and 3) with 200 m² of ground floor area and 84 m² of second story floor area;
- b. 42 lineal meters of metal duct (Fig. 4);
- c. transitional plenums, filter housings with electromatic filters, (Fig. 5); and
- d. two blowers and two stacks.

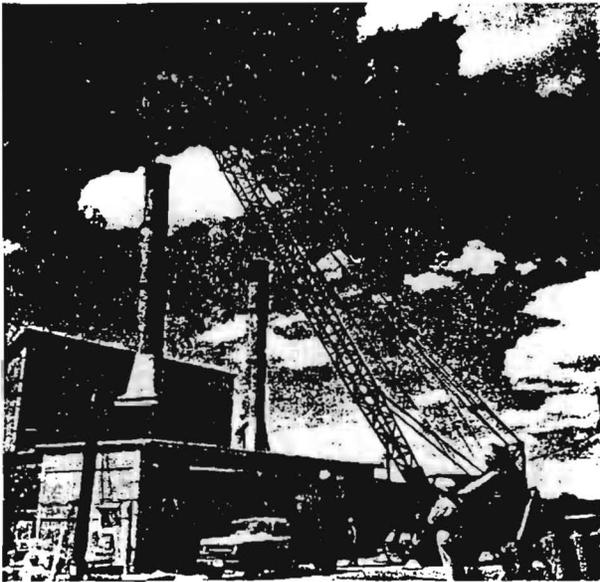
and 10). Only 0.3 dis/s/cm^2 of alpha activity was detected inside the blowers and stacks.

Fig. 9.
Removal of stack.

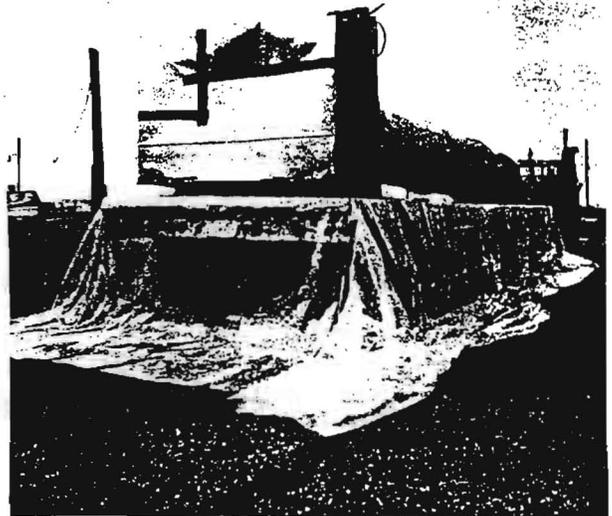
Fig. 10.
Packaging of stack.
