SUBJECT: DISCHARGE PERMIT DP-857 QUARTERLY REPORT, SECOND QUARTER 2013, TA-46 SANITARY WASTEWATER SYSTEMS PLANT

Discharge Permit DP-857 Quarterly Report
2nd Quarter, 2013

Monthly inspection photographs of the
SERF evaporation basins

SERF Evaporation Basins

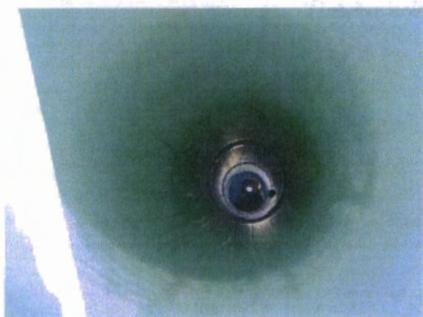
Port 1 Total column: 194"
Water column 123"

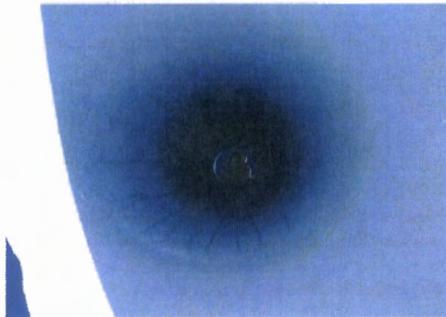
Port 2 Total column: 191"
Water column 121"

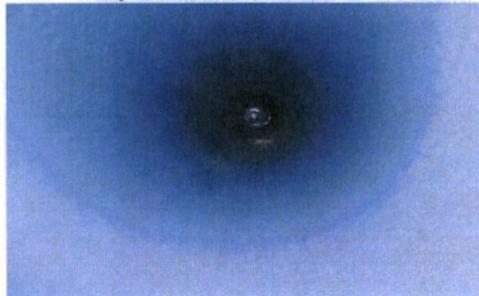
Port 2 Dry

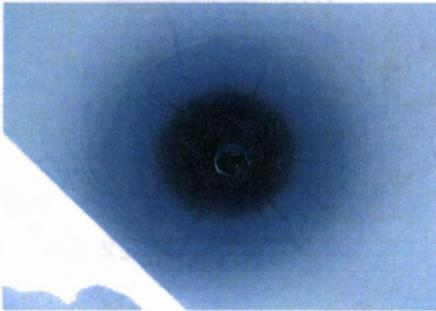
Port 1 Total column: 195"
Water column 111.5"

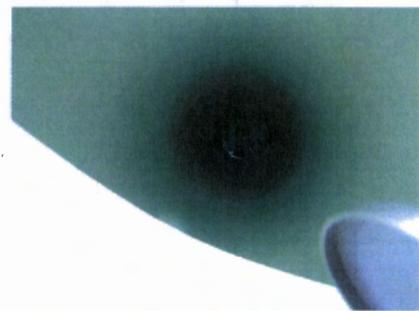
Port 2 Total column: 191"
Water column 109.5"

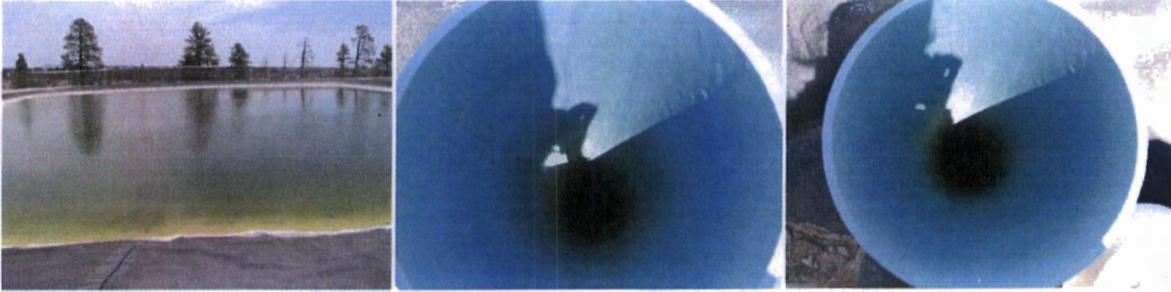
Northwest Basin

Both inspection ports were dry. The basin level has visible dropped. Water color was a blue green, and visibility through the water was about 5 feet and the bottom of the basin could be seen.

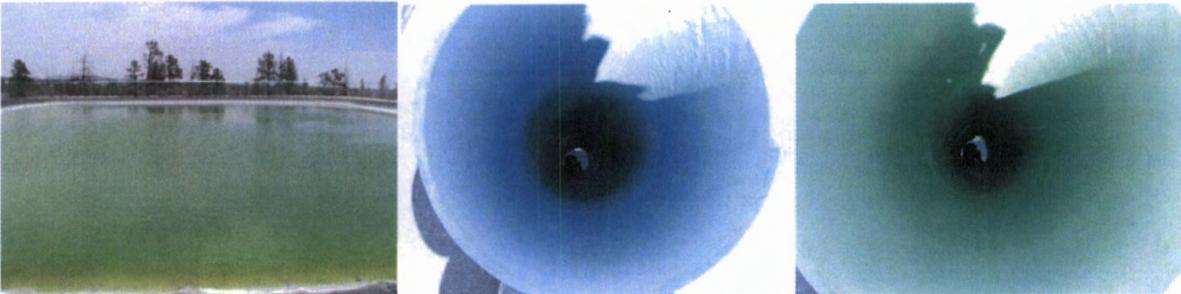
Northeast Basin

Both Inspection ports contained water. The number one port (to the West) contained 104" of water, while the number 2 port contained 103" of water. The basin color was a bright blue green and visibility of this basin was less than 1 foot.

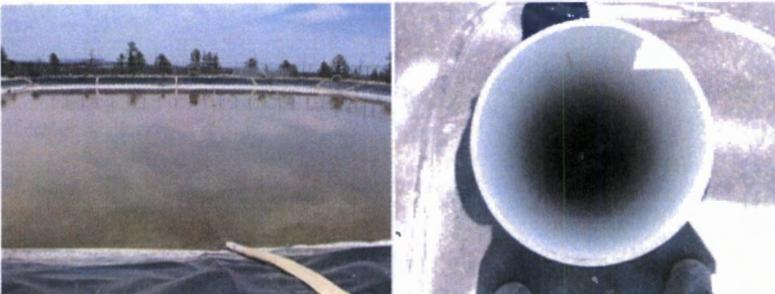
Southwest Basin

Both inspection ports were dry. The basin level was at about the inlet height. The color of the water was a reddish brown color and visibility was about 4 feet. The bottom of the basin was visible.
