RE: Nickel Contamination at the Sandia National Laboratories Mixed Waste Landfill. Citizen Action request that 1) fines and RCRA compliant groundwater monitoring be immediately implemented and that 2) RCRA compliant groundwater monitoring wells be installed at the MWL.

Nickel Contamination in the Regional Aquifer From Nickel Wastes Buried in the Sandia Mixed Waste Landfill, Version January 23, 2007
by Robert H. Gilkeson, Registered Geologist rhgilkeson@aol.com

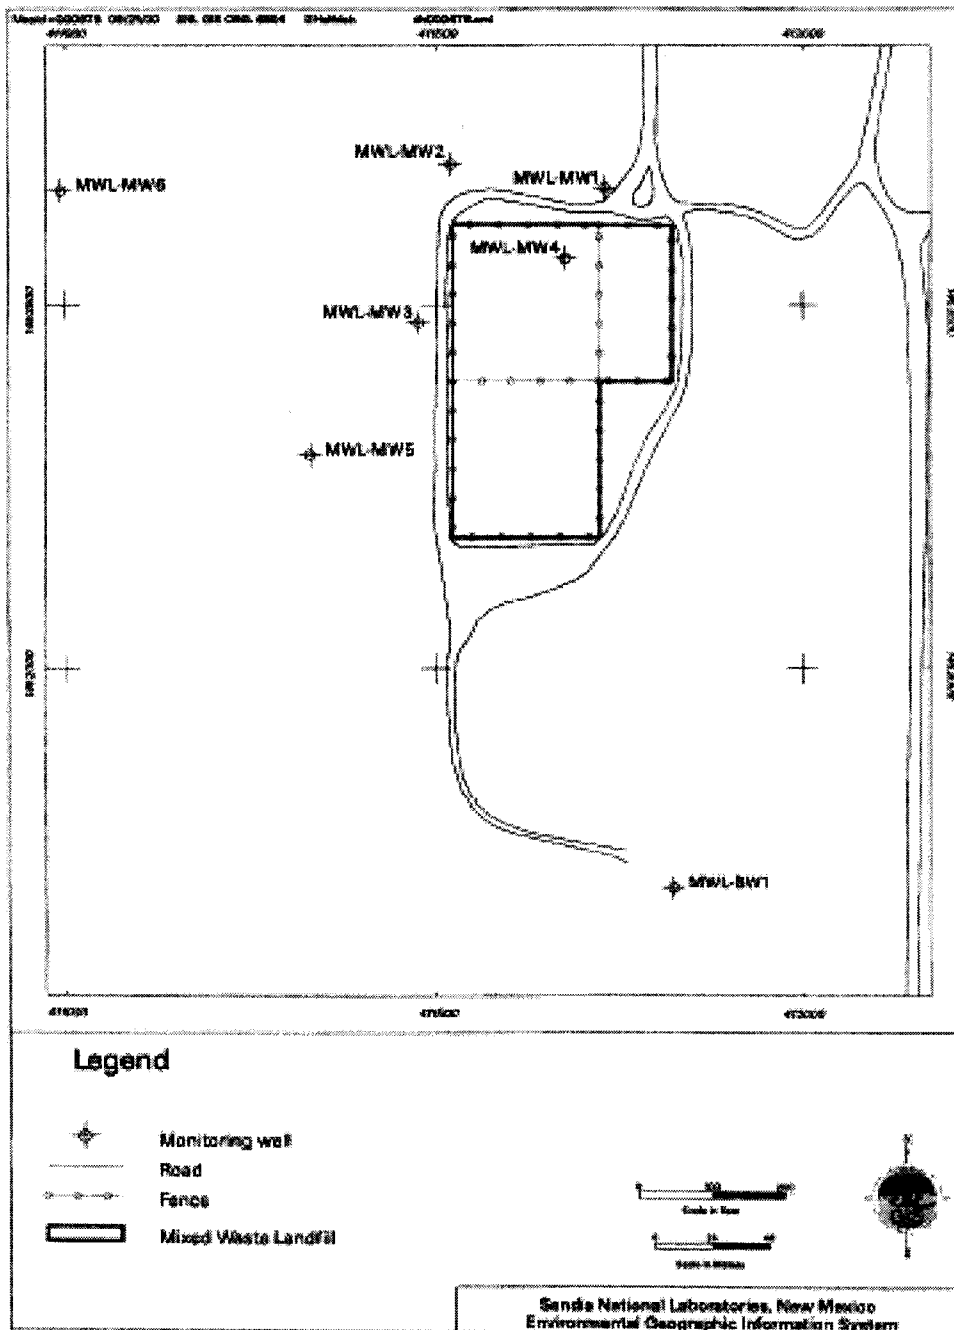
Figure 1. Monitoring Wells at the Mixed Waste Landfill.

The nickel contamination measured in water samples produced from well MW1 are summarized below in Table 1. The location of well MW1 is shown on Figure 1. The Moats report does not acknowledge that nickel wastes were disposed of in the MWL. Page 4 of the Moats report describes the contaminants measured in boreholes drilled below the MWL as follows:
