**From:** Maestas, Ricardo, NMENV  
**Sent:** Wednesday, August 13, 2014 10:03 AM  
**To:** Allen, Pam, NMENV  
**Subject:** FW: Public Disclosure that Dampers leaked....

**From:** Kliphuis, Trais, NMENV  
**Sent:** Wednesday, April 16, 2014 10:37 AM  
**To:** Maestas, Ricardo, NMENV; Smith, Coleman, NMENV; Holmes, Steve, NMENV  
**Cc:** Kieling, John, NMENV  
**Subject:** Public Disclosure that Dampers leaked....

**What happened at WIPP in February 2014**

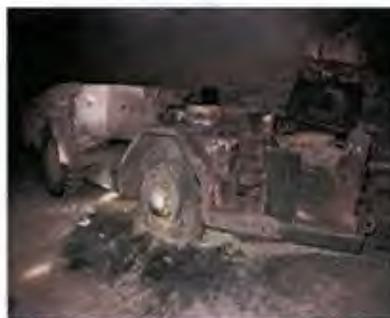
Salt hauling truck after the fire

Two isolated events took place at WIPP in February. On February 5, a salt haul truck caught fire. Workers were evacuated and the underground portion of WIPP was shut down. Several workers were treated for smoke inhalation, but no injuries occurred.

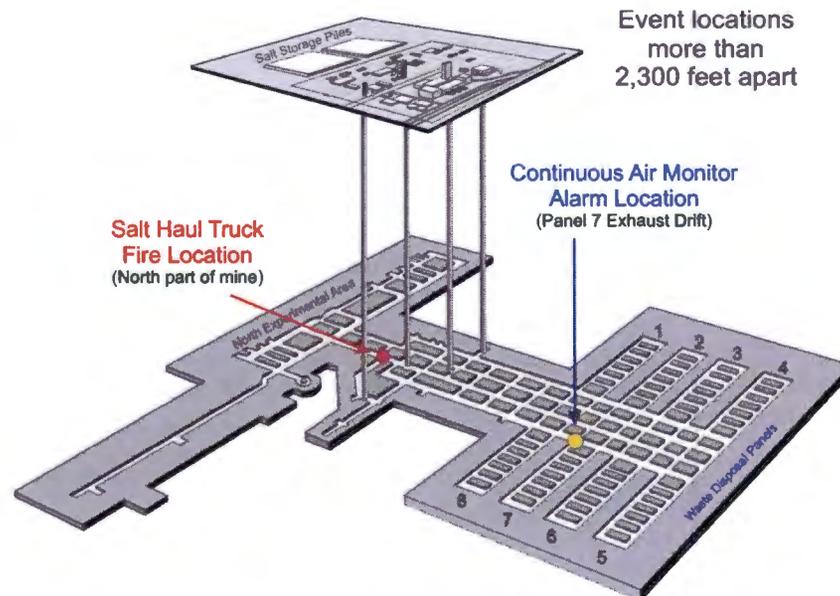
When the CAM alarmed, two dampers were automatically closed in the exhaust duct that redirected the exhaust through high efficiency particulate air (HEPA) filters that removes radioactive particles.

It is believed that a small amount of radioactivity leaked by the exhaust-duct dampers, through the unfiltered exhaust ducts and escaped aboveground. The exhaust duct dampers are large "butterfly" valves that are designed to close and cut off the air flow through the exhausters. However, the valves do not fully seal the exhaust ducts and still allowed a small amount of unfiltered air to escape.

The dampers have since been sealed with high-density expanding foam insulation. Remote monitors lowered down the Air Intake Shaft and Salt Shaft into the underground repository have not detected airborne radioactivity. Plans and preparations are being made for a manned entry into the underground repository.
