Commitment for Resolution of

API Separator Storm Water Issues

Giant Industries, Inc. - Ciniza Refinery

March 28, 2006

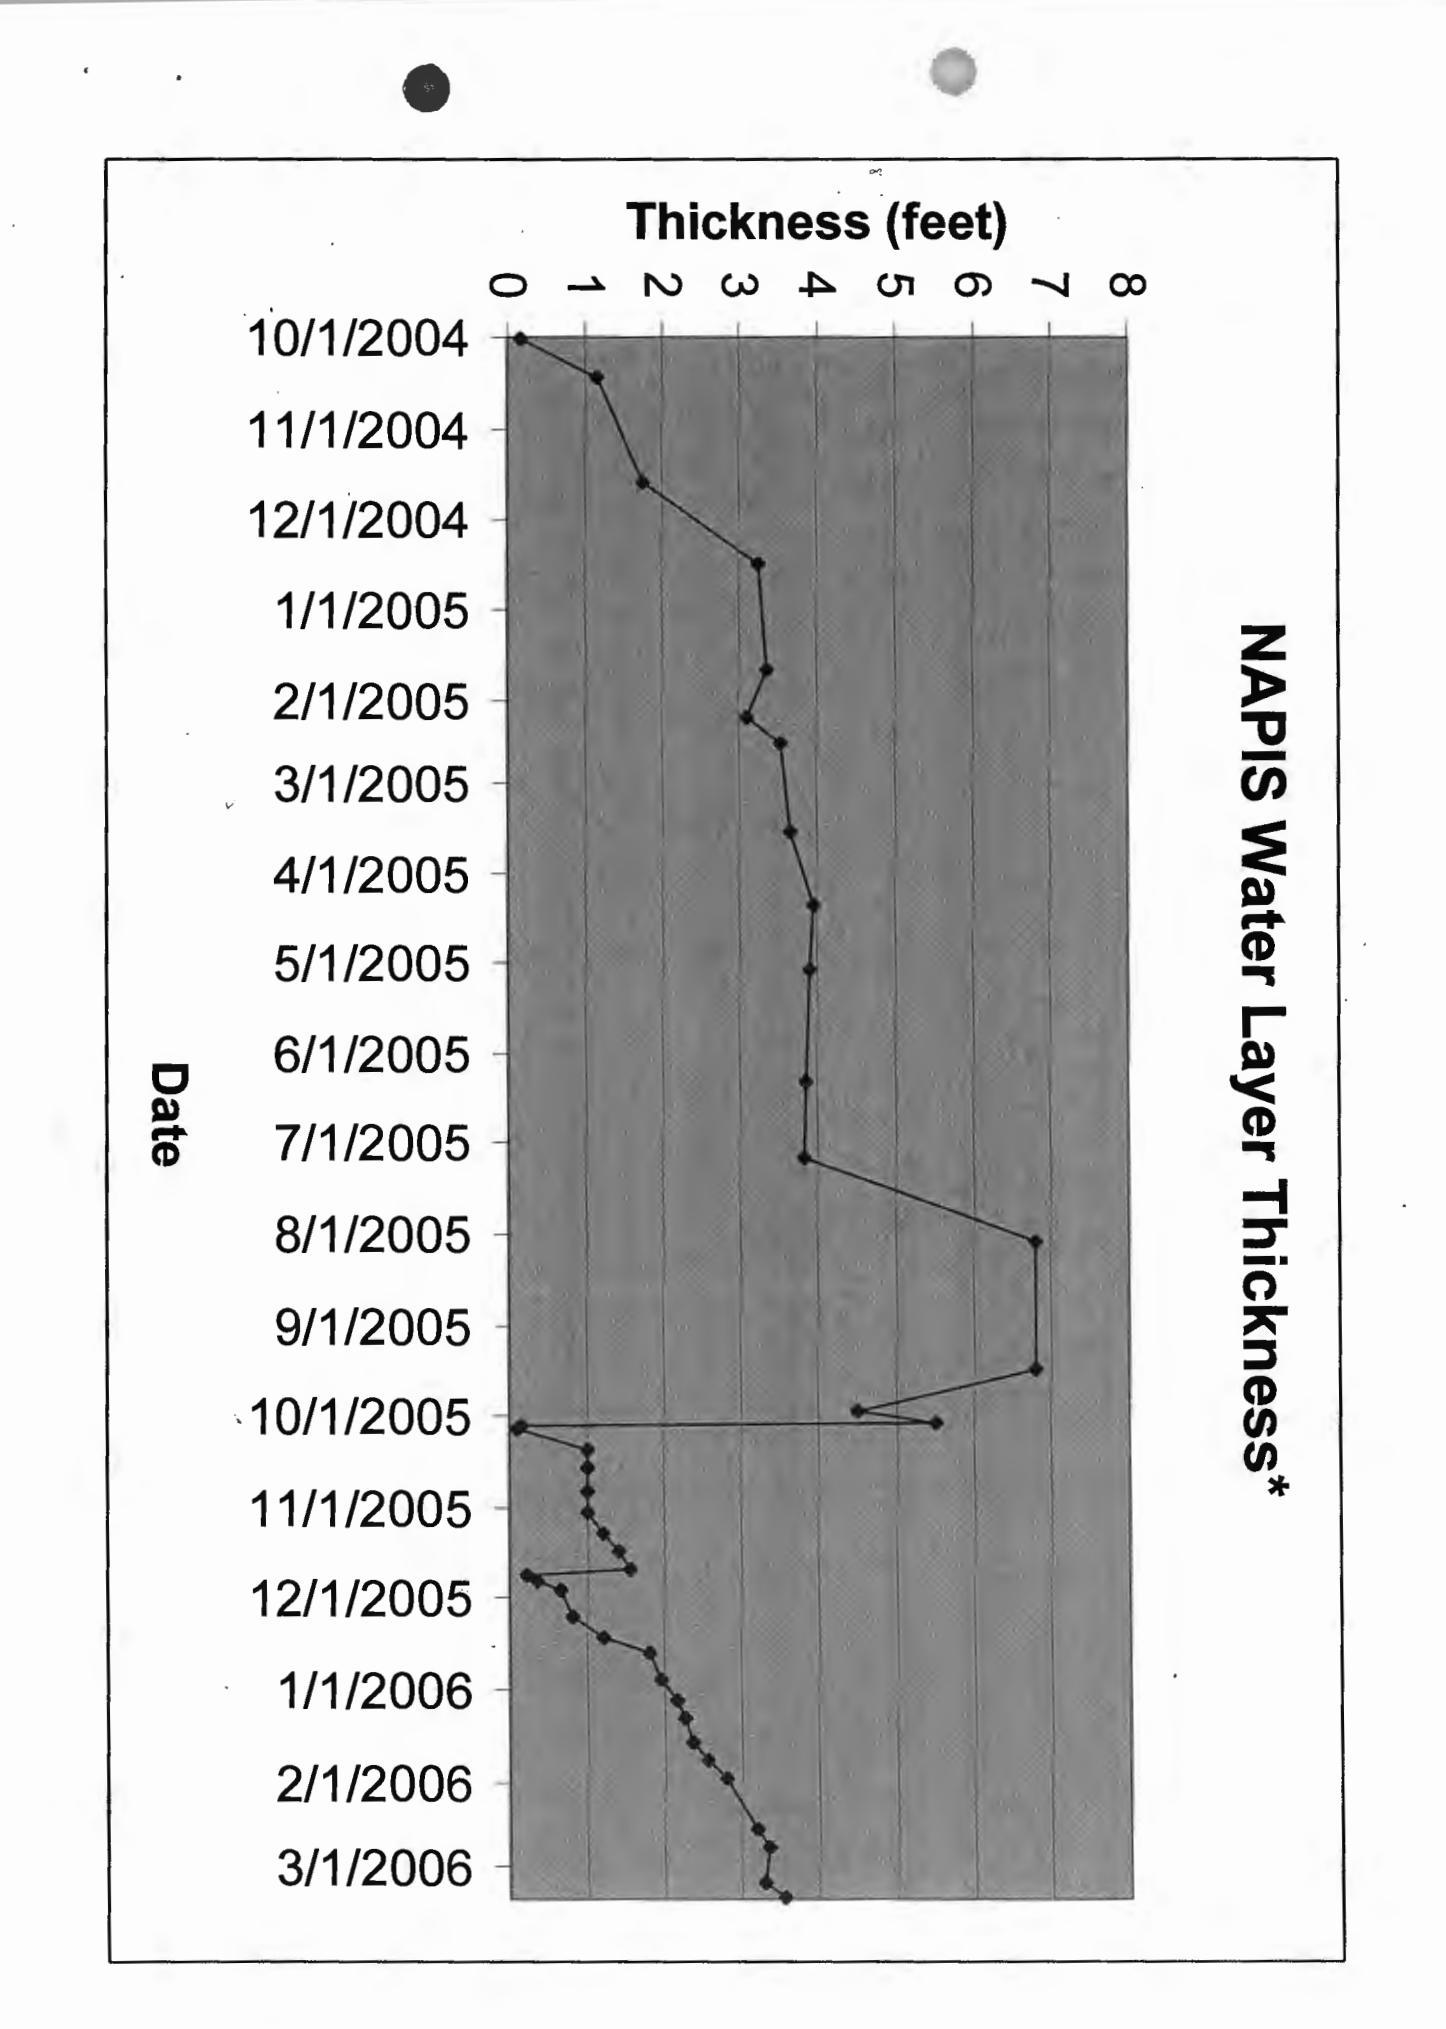
SECONDARY CONTAINMENT INSPECTIONS NEW OIL WATER SEPARATOR

NEW OIL WATER SEPARATOR													
			SEC	ONDAR	Y CONTA	INMEN	IT INSPE	CTION	S				
		STAR	RT DEPTH T	O BOTTOM	OF SECON	DARY CO	NTAINMENT	EQUALS	13.25 FE	ET			
DATE	WATER LAYER THICKNESS (FEET)	COMMENTS	BENZENE (ug/L)	TOLUENE (ug/L)	ETHYL BENZENE (ug/L)	MTBE (ug/L)	XYLENES, TOTAL (ug/L)						
10/1/2004	*	* See attache	d inspection	report date	d 10/14/05			•					
10/14/2004	0.17												
11/18/2004	1.15	1											
12/16/2004	1.75	1											
1/21/2005	3.25										*		
2/15/2005	3.35	SAMPLED	1.1	0.9	0.62		5.7	1					
3/17/2005	3.53												
4/11/2005	3.65	1											
5/3/2005	3.95	1											
6/10/2005	3.9	1											
7/6/2005	3.85												
8/3/2005	3.825									•			
9/15/2005	6.8	SAMPLED	150	130	ND	1000	58]					
9/29/2005	6.8							-					
10/3/2005	4.5	Today mainte	nance vacu	umed out so	ome water fro	m here, K	Cerry said abo	ut 5 barrel	s.				
10/4/2005	5.5												
10/5/2005	0.15	This was just vacuumed out now. Water taken out about 10 barrels. Continuous pumping of below grade tank.

10/12/2005	0.1												
10/18/2005		Air driven pur	np removing	all water be	ut one inch or	n the botto	om while repa	irs are bei	ng made :	to separa	tor.		
10/26/2005		Air driven pur	mp removing	all water b	ut one inch or	n the botto	om while repa	irs are bei	ng made '	to separa	tor.		
11/2/2005	1]											
11/9/2005	1]											
11/15/2005	1.2												
11/21/2005	1.4]											
11/23/2005	1.55	After measuri	After measuring, all water was pumped out.										
11/25/2005	0.22												
11/28/2005	0.35												
12/7/2005	0.65												
12/14/2005	0.8												
12/19/2005	1.2												
12/28/2005	1.8												
1/4/2006	1.95												
1/10/2006	2,15												
1/18/2006	2.25								•				
1/24/2006	2.35												
1/30/2006	2.55												
2/6/2005	2.8												
2/16/2006	3.1												
2/22/2006	3.2												
3/6/2006	3.35												
3/11/2006	3.3												
3/16/2006	3.55
