SITE ST-26 (SWMU 48A)
CORRECTIVE MEASURE IMPLEMENTATION (CMI)
SITE CLOSURE REPORT ADDENDUM
CANNON AIR FORCE BASE, NEW MEXICO

AFCEE Contract No. FA8903-04-D-8679 Task Order No. 0079
Project No. CZQZ20077926L

May 2010

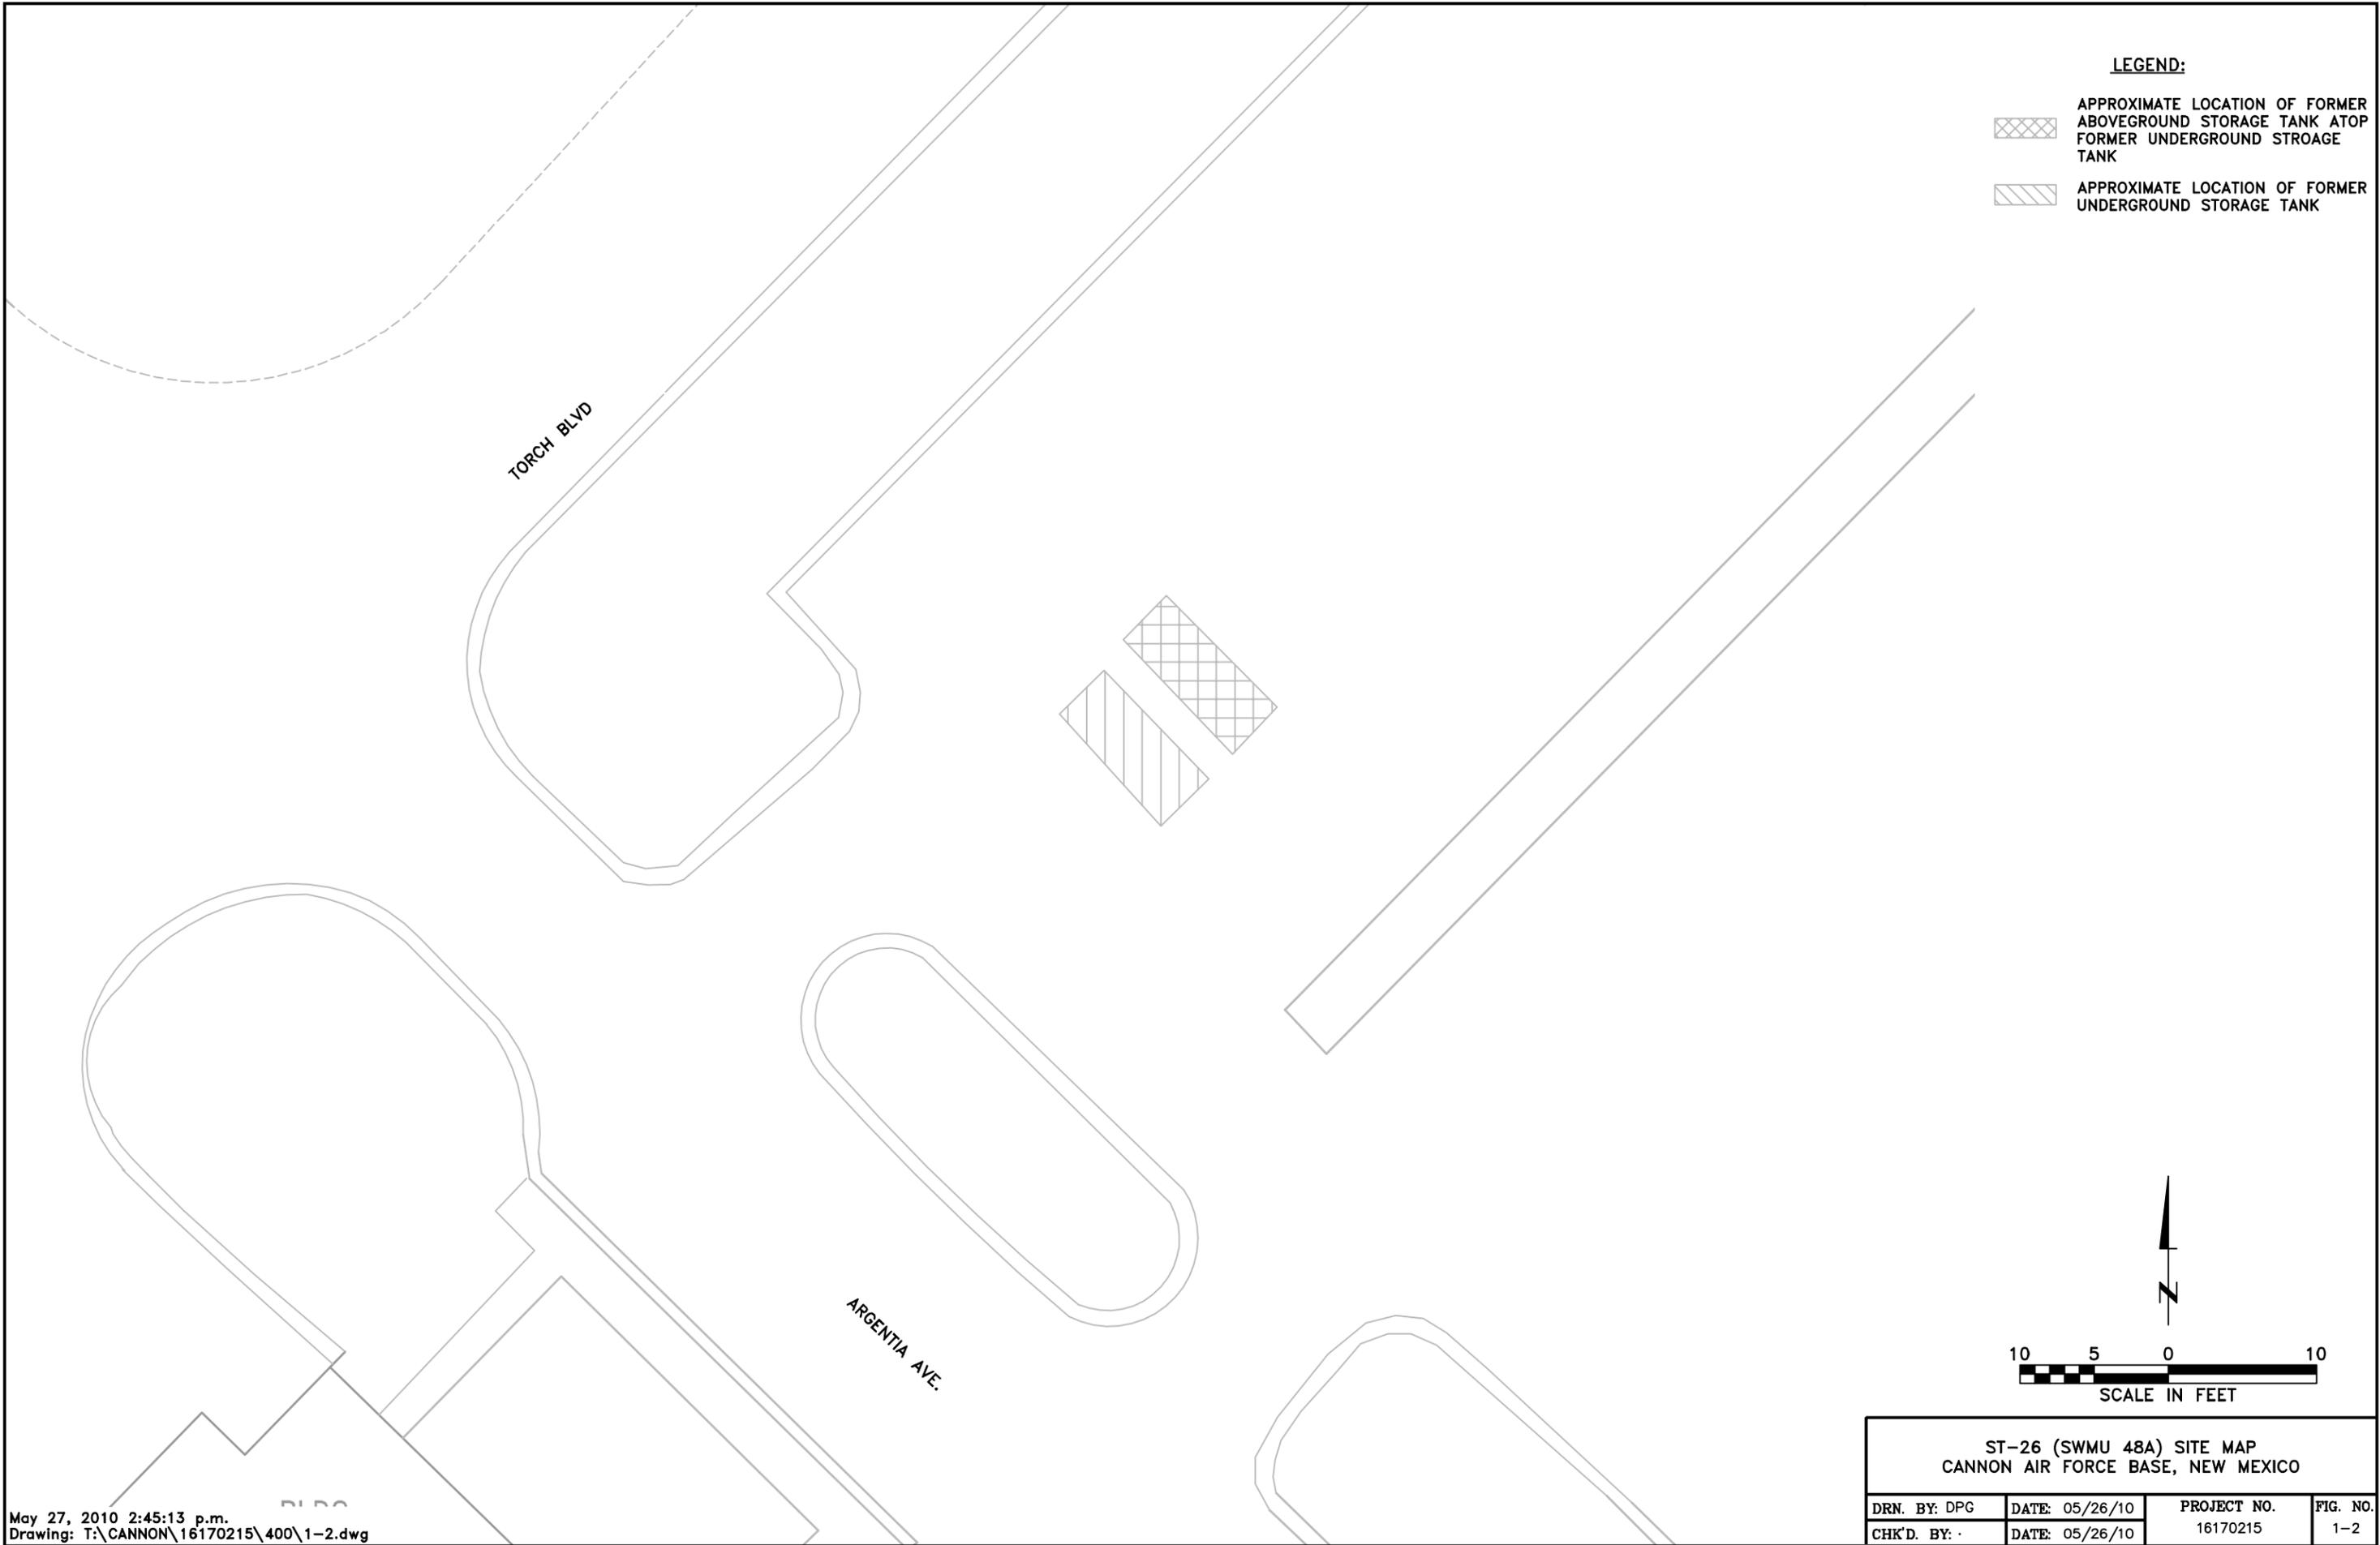
ST-26 (SWMU 48A) SITE MAP CANNON AIR FORCE BASE, NEW MEXICO			
DRN. BY: DPG	DATE: 05/26/10	PROJECT NO. 16170215	FIG. NO. 1-2
CHK'D. BY: .	DATE: 05/26/10

APPROXIMATE LOCATION OF FORMER UNDERGROUND STORAGE TANK

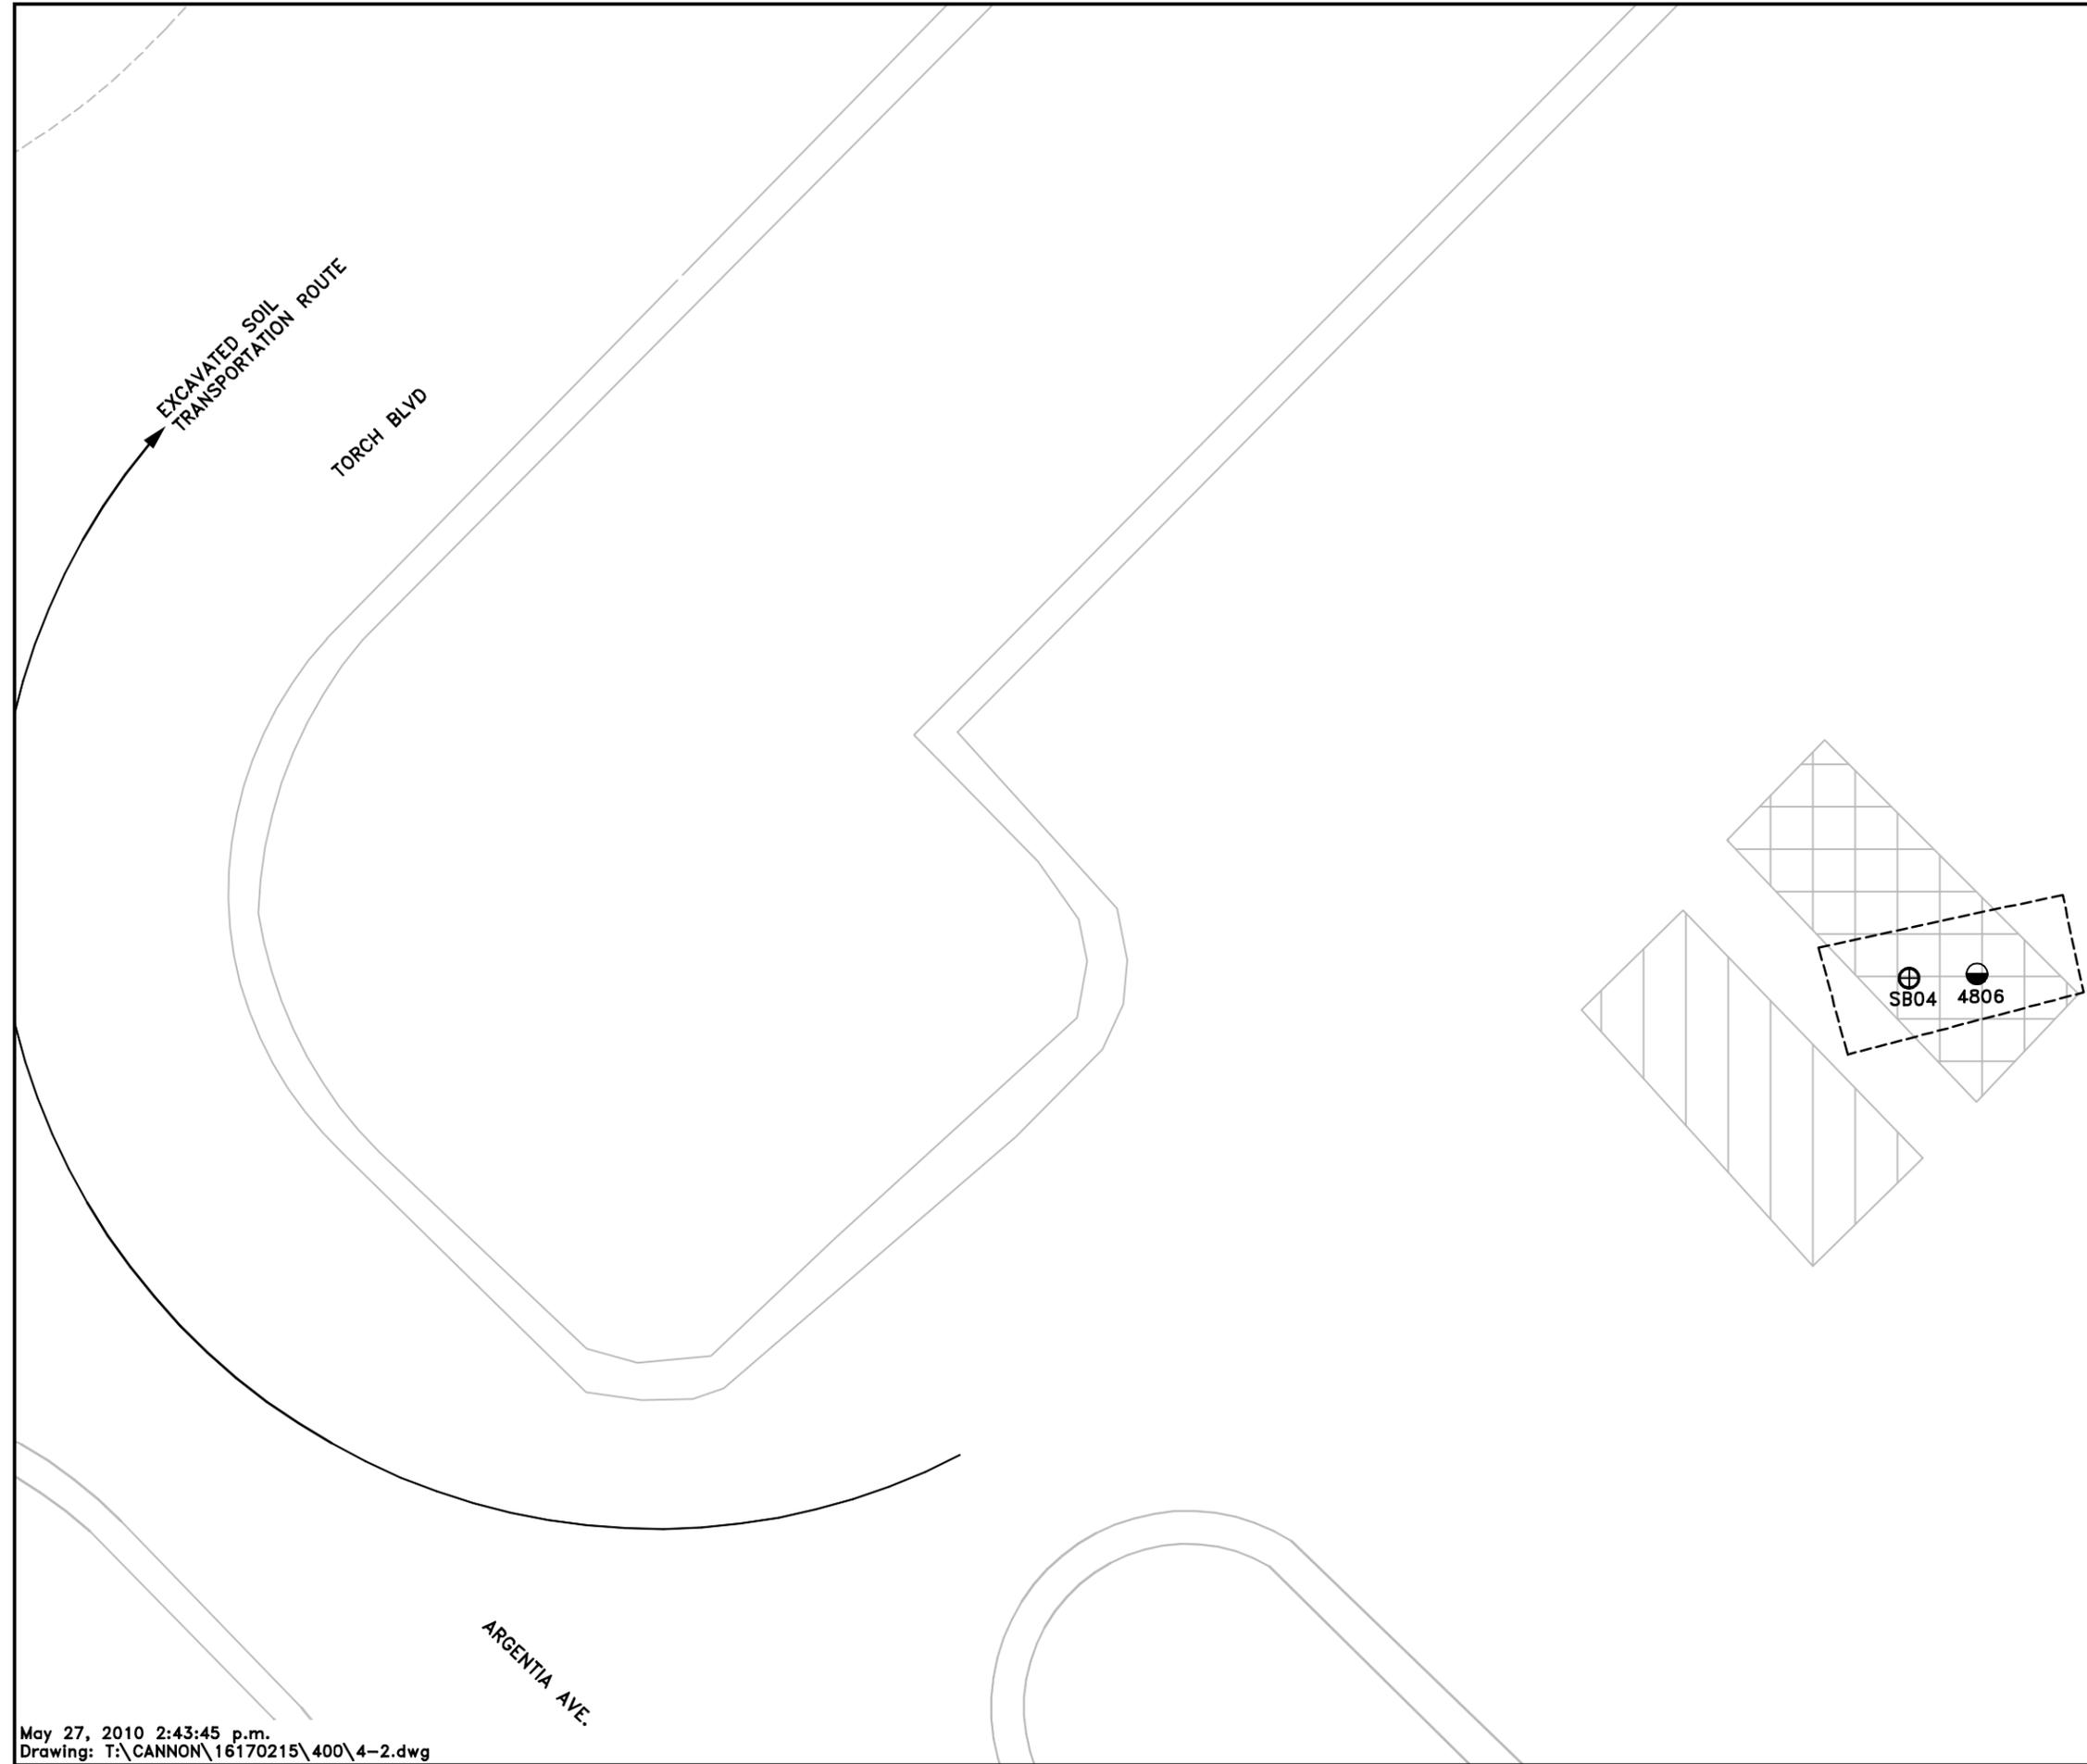
ST-26 (SWMU 48A) EXCAVATION MAP CANNON AIR FORCE BASE, NEW MEXICO			
DRN. BY: DPG	DATE: 04/30/10	PROJECT NO. 16170215	FIG. NO. 4-2
CHK'D. BY: .	DATE: 04/30/10

----- FINAL EXCAVATION LIMITS

Once the overburden was removed, the excavation of TPH-impacted soil commenced at the southeast end to the excavation. The excavated TPH-impacted soil was directly loaded into a belly dump truck on the north side of the excavation. Once the belly dump truck was full the additional TPH-impacted soil was stockpiled on the north side of the excavation and covered with 10-mil thick poly for dust control. Excavation depths were based on historical analytical results from the 1994 soil boring 4806, visible inspections for staining, observations of soil odors, and PID readings. Soil was excavated to 12 feet beyond the first 7 feet of the excavation. The initial excavation dimensions were 4 feet by 7 feet by 19 feet. The excavated soil had no visible petroleum staining, and PID readings of zero. Slight petroleum odors were noted in the 8-to-11 foot and 11-to-14 foot samples collected for soil characterization (i.e., staining, odor and PID readings). Based on the odors the excavation was expanded to the final dimensions of 6 feet by 14 feet by 19.9 feet and confirmatory samples were collected.

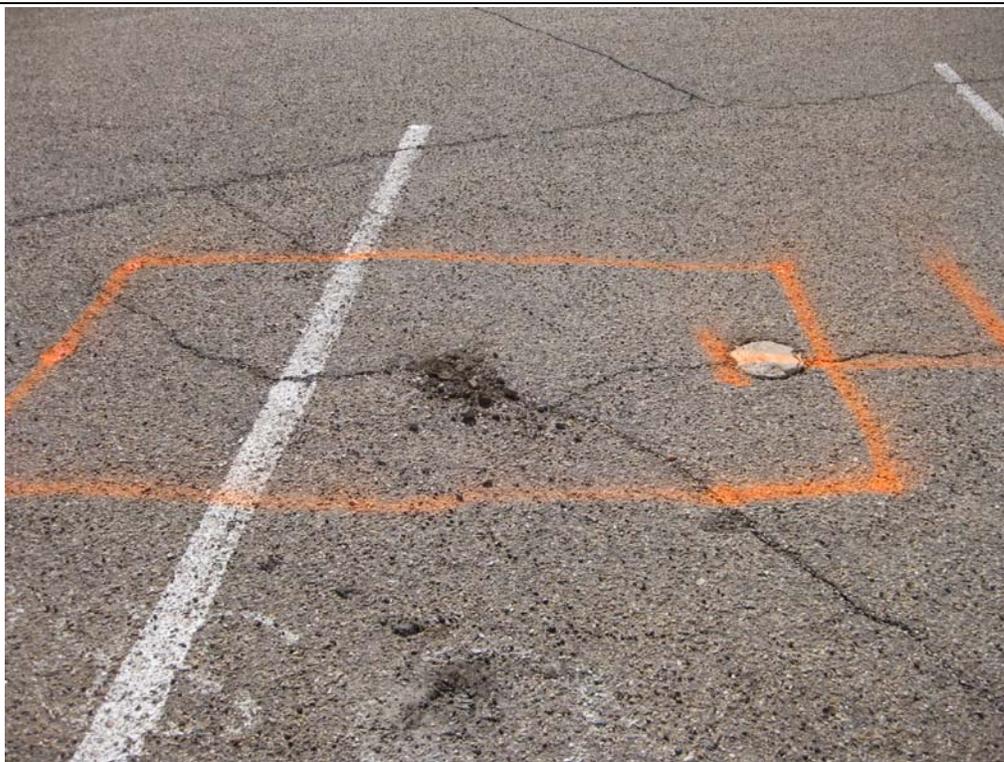
Initial excavation limits around 1994 soil boring 4806.

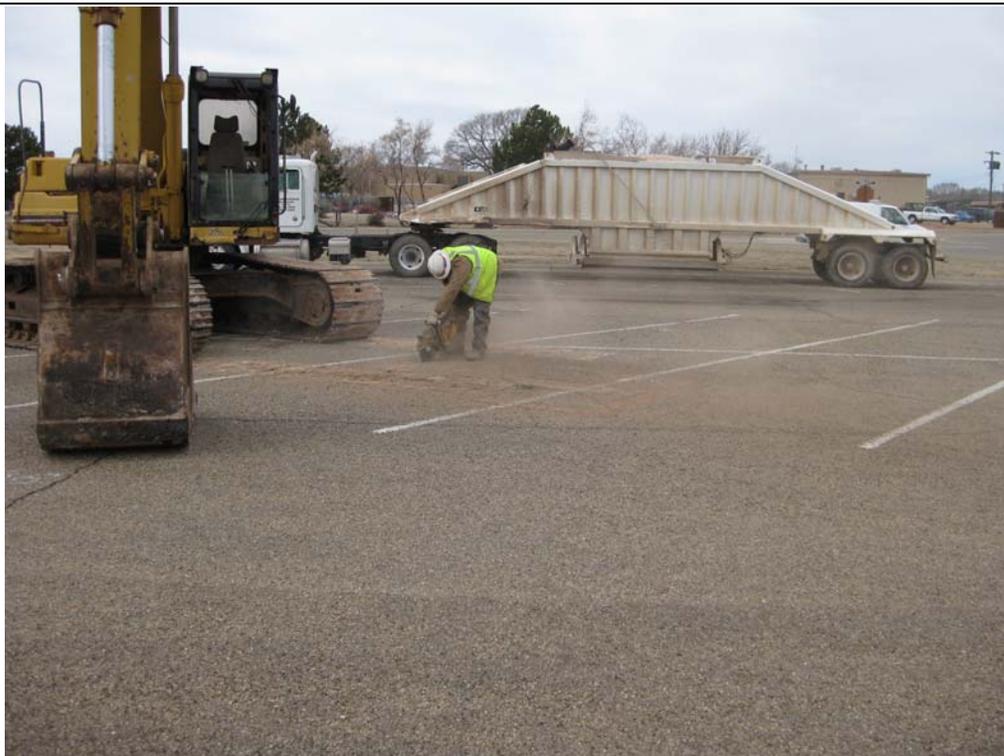
Photo No. 02

Cutting asphalt parking lot cap to establish excavation limits and to remove asphalt.

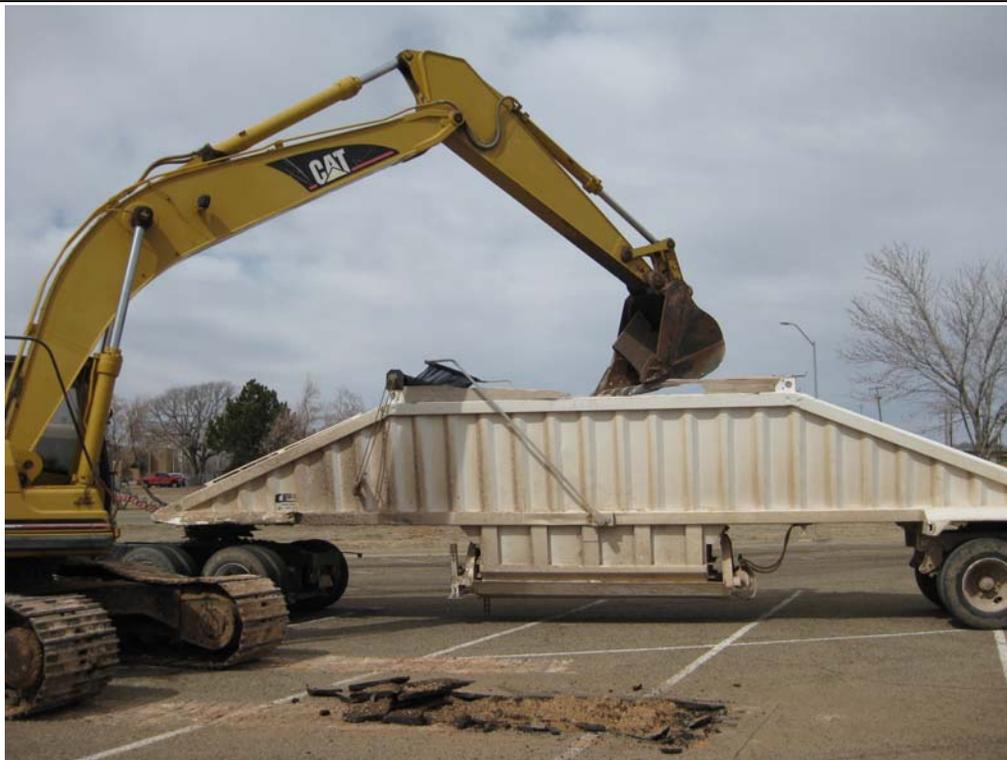
Starting excavation and loading asphalt into transportation vehicle.

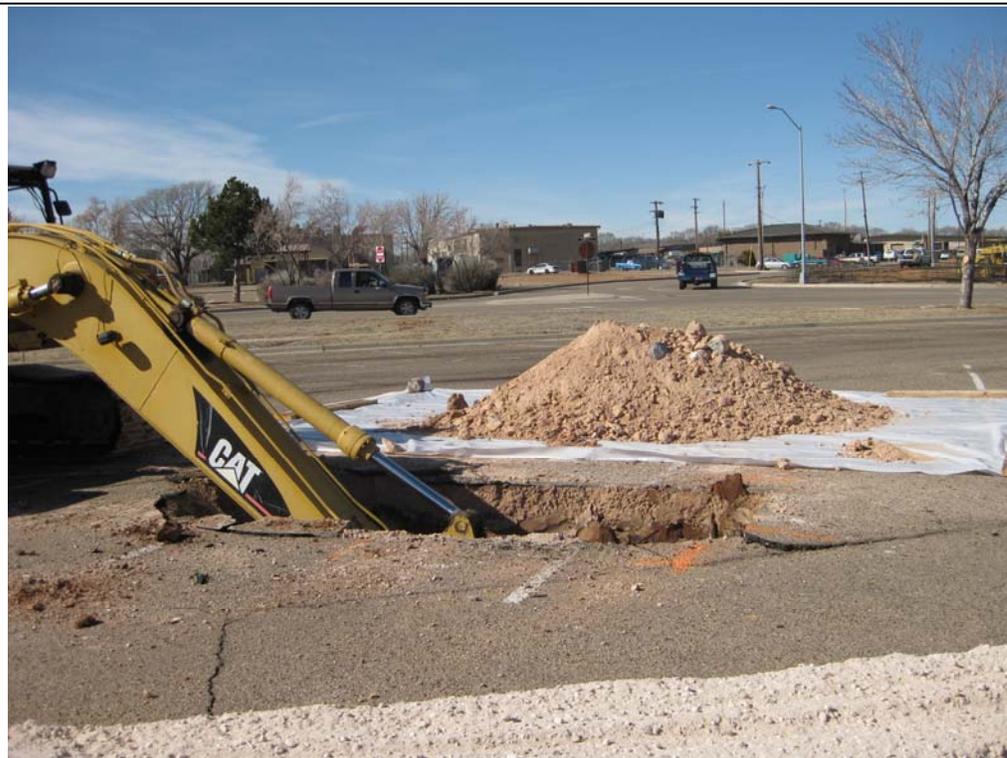
Photo No. 04 Date: 24-Feb-10

Excavating TPH-impacted soil.

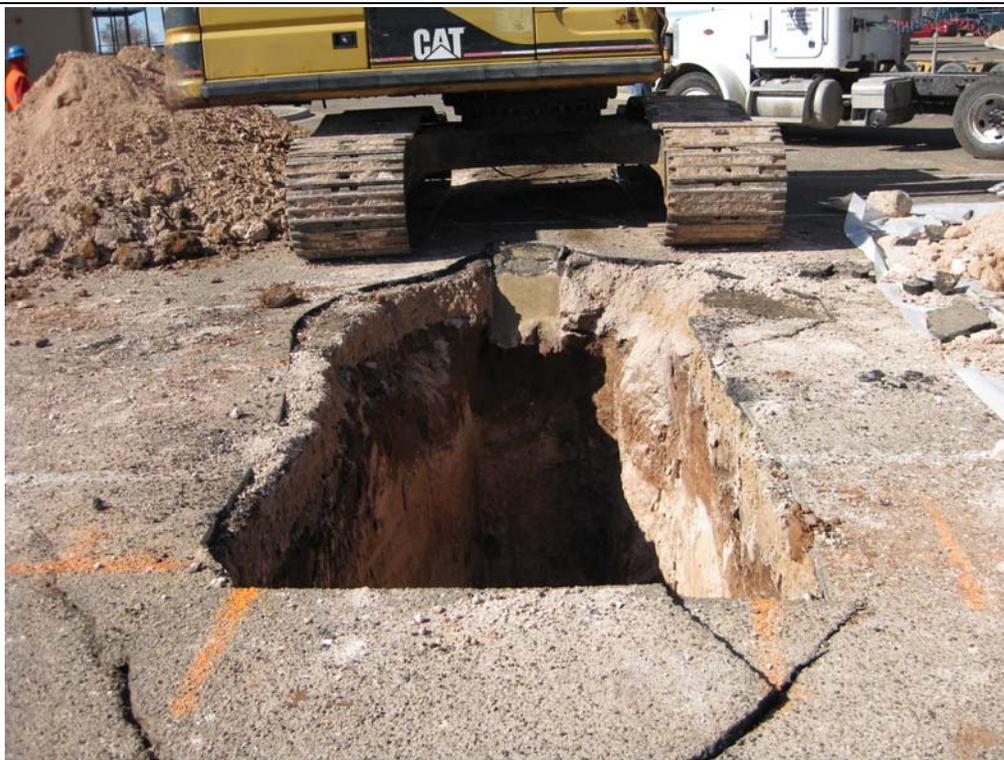
Final excavation limits.

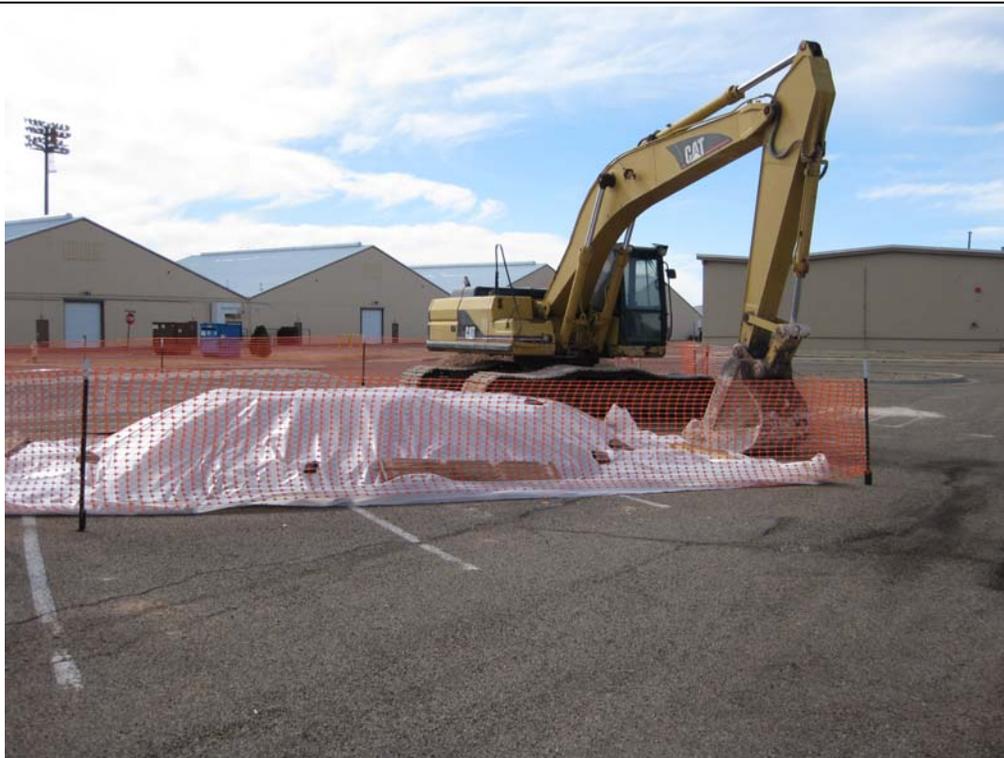
Photo No. 06 Date: 25-Feb-10

Secure excavation area with covered TPH-impacted stockpile.

Dust control measures were implemented during excavation, handling, segregation, loading, and transportation activities at Site ST-26 (SWMU 48A). Dust control was accomplished by covering the stockpile with 10-mil polyethylene sheeting to eliminate the potential for dust emissions and wind dispersion. The stockpile was covered at the completion of the stockpiling activities. In addition, all loads into and out of Site ST-26 (SWM 48A) were covered in accordance with DOT regulations. No visible airborne dust was observed, so no further dust controls were necessary.

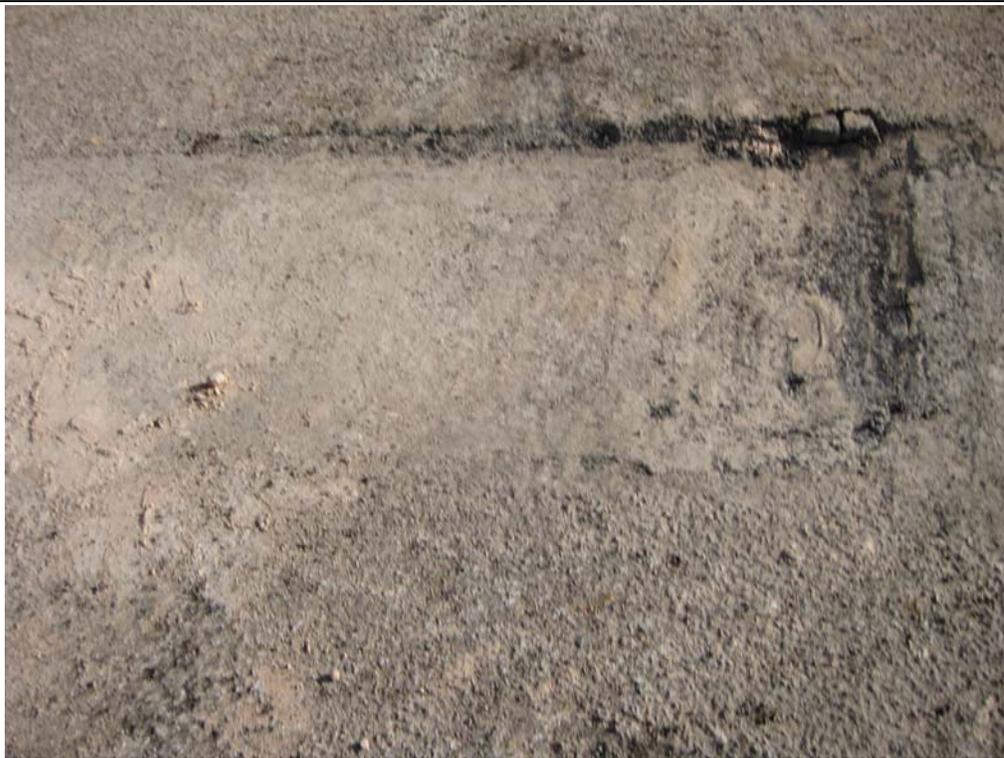
Damaged asphalt from track hoe that required repair.

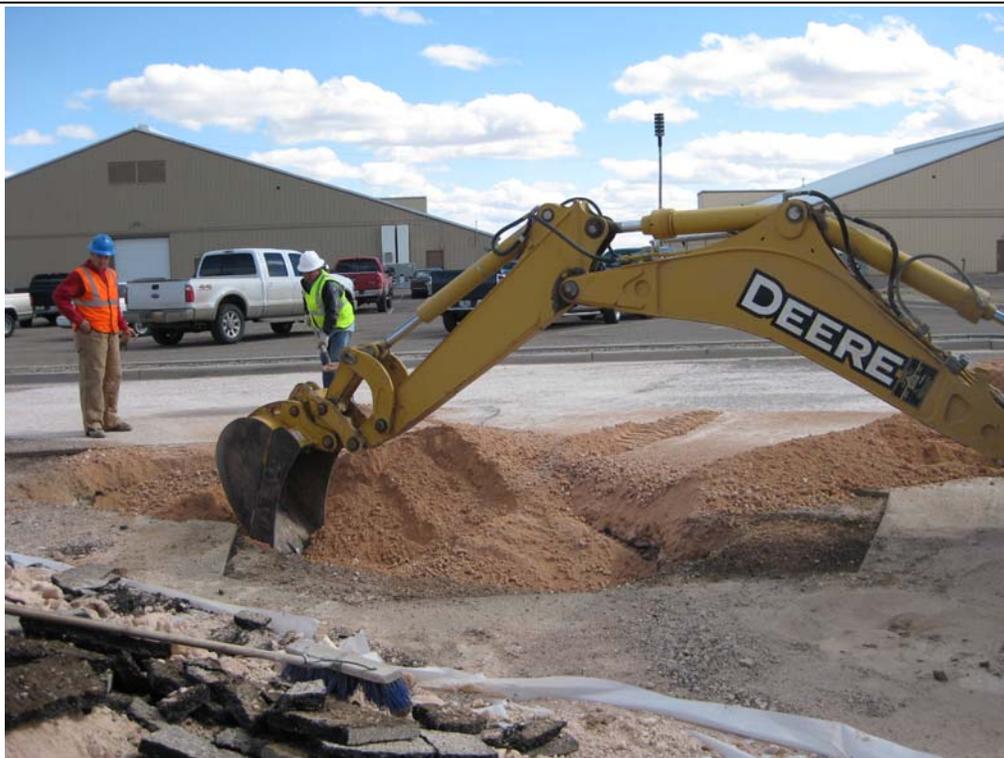
Photo No. 08	Date: 26-Feb-10
---------------------	---------------------------

Diamondback Disposal Services Inc. (Excavation Subcontractor) backfilling excavation.

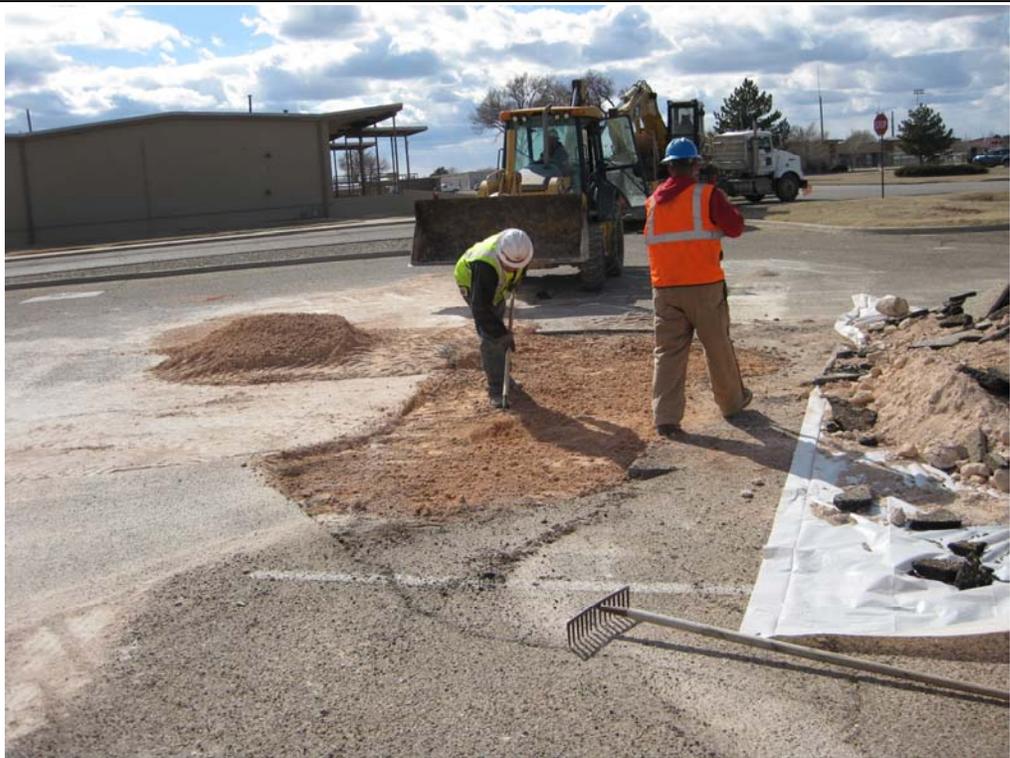
Photo No. 09	Date: 26-Feb-10
Description: Diamondback Disposal Services Inc. preparing final subgrade.

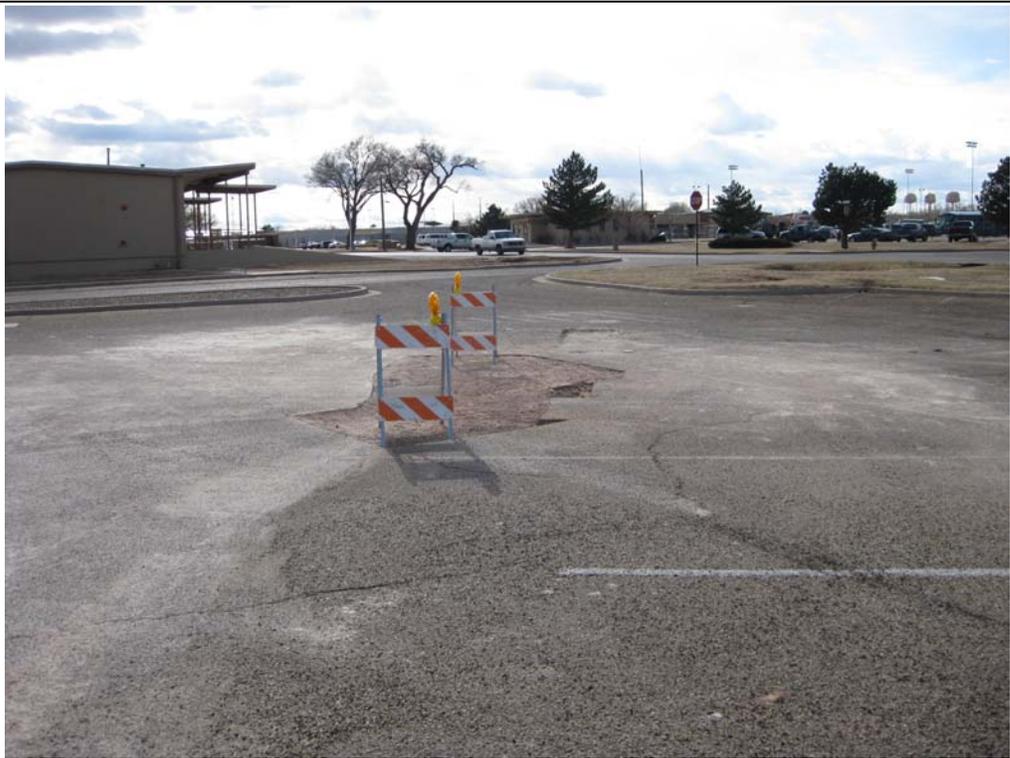
Photo No. 10	Date: 26-Feb-10
Description: Final grade after backfill and compaction is complete, site clean up completed and ready for asphalt site restoration.

The final subgrade of Site ST-26 (SWMU 48A) was graded and compacted to a uniform depth of two inches for asphalt site restoration. Prior to demobilization activities, URS and Diamondback completed a site walkover to identify heavy equipment disturbance that required corrective action and to cleanup of any backfill material that dropped from the trucks. Heavy equipment disturbances were repaired as part of the asphalt restoration. URS and Diamondback removed all equipment and leftover construction materials from Site ST-26 (SWMU 48A) during time of demobilization, with the exception of the track hoe owned by Diamondback. The asphalt restoration was unable to be completed prior to demobilization due to cold weather. The barricades were left in place until the asphalt restoration was completed on March 10, 2010. The asphalt restoration was subcontracted to K. Barnett and Sons Inc. of Clovis, New Mexico by Diamondback. As of May 2010, parking stall striping has not been completed for the asphalt restoration because K. Barnett and Sons Inc. is not licensed to complete the striping. Diamondback has contracted a second subcontractor approved by Cannon AFB to complete the asphalt striping, which will be completed in June, 2010.

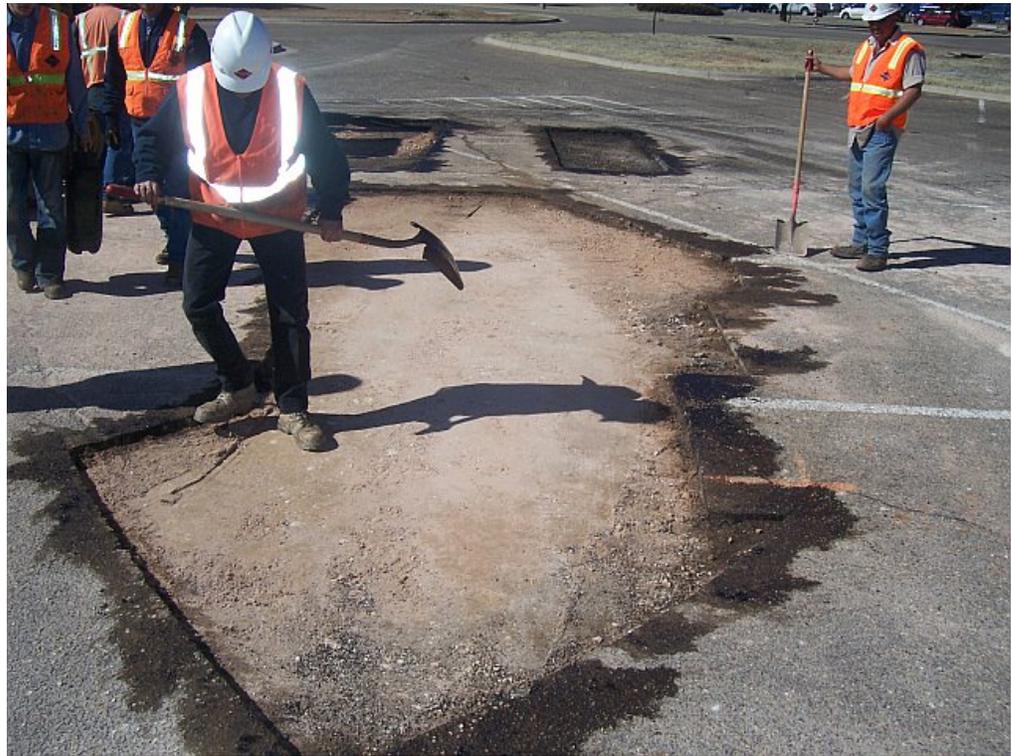
Site preparation for asphalt restoration being completed by Diamondback subcontractor K. Barnett & Sons Inc.

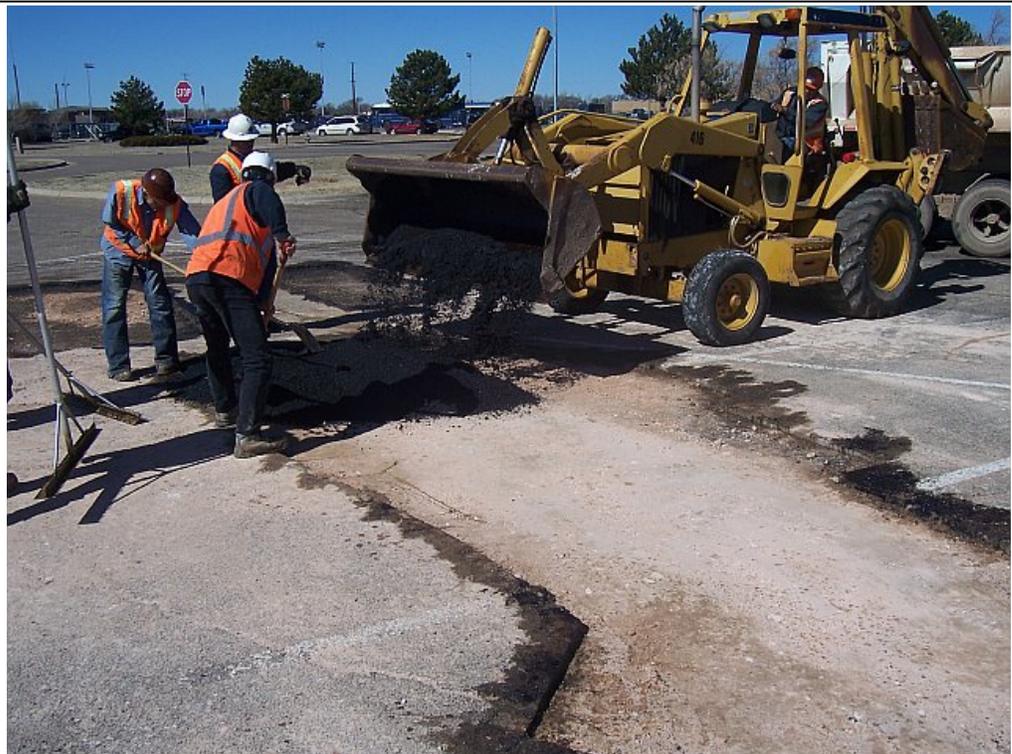
Photo
No. 12

Asphalt restoration being completed by K. Barnett and Sons Inc.

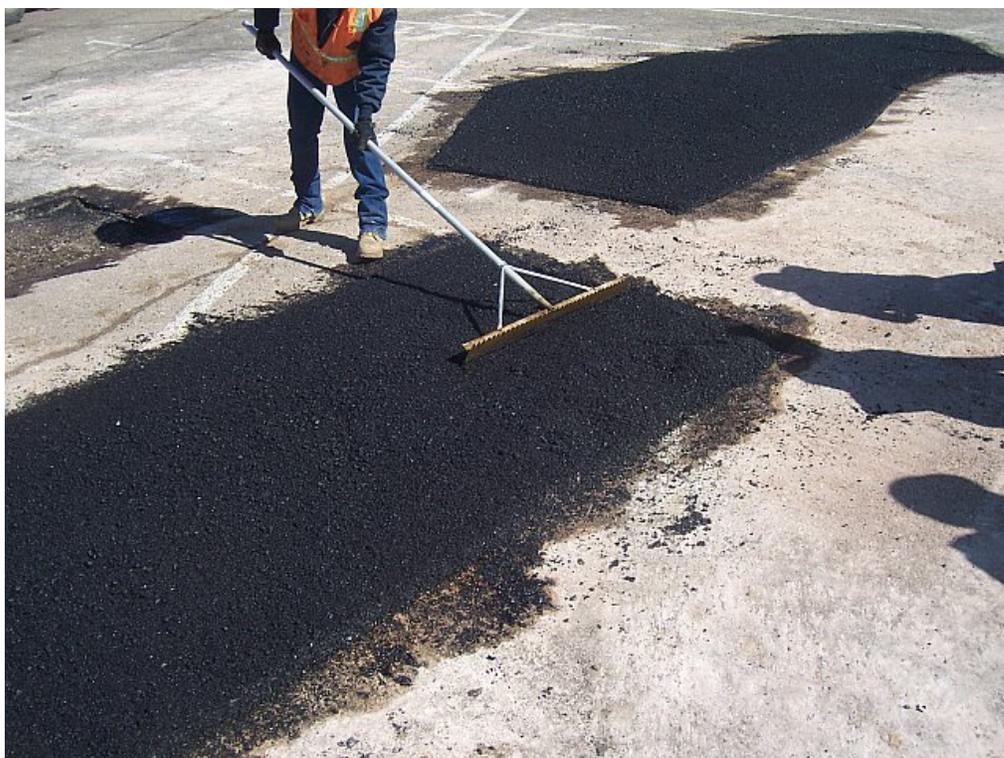
Leveling of asphalt
and preparing for roll
compaction.

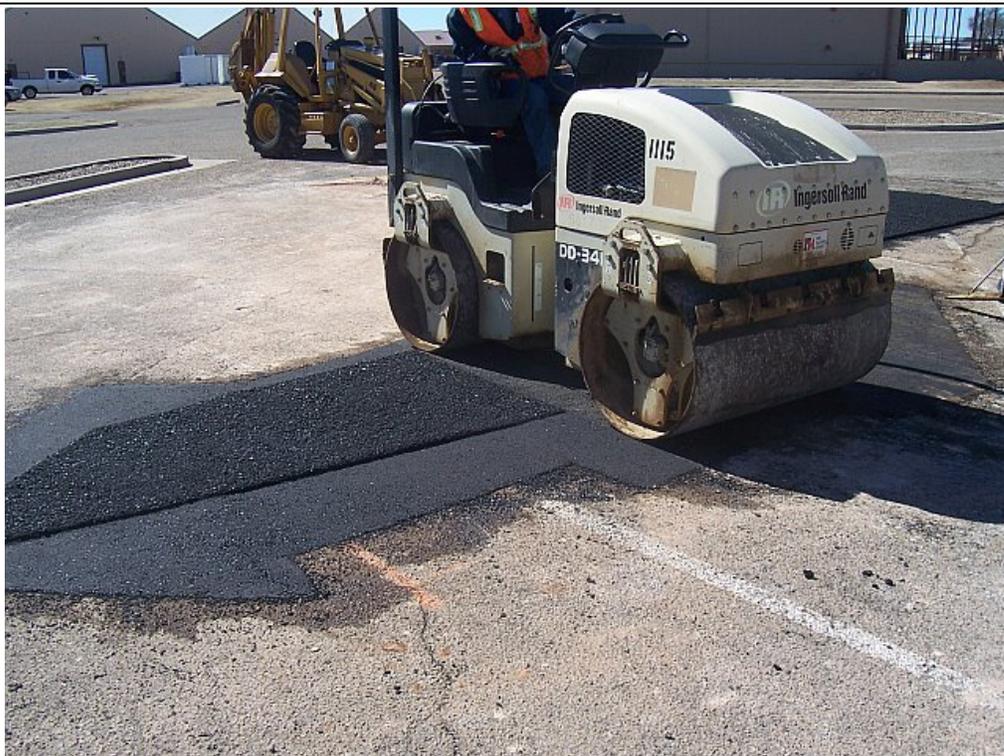
Photo
No. 14

Asphalt compaction.

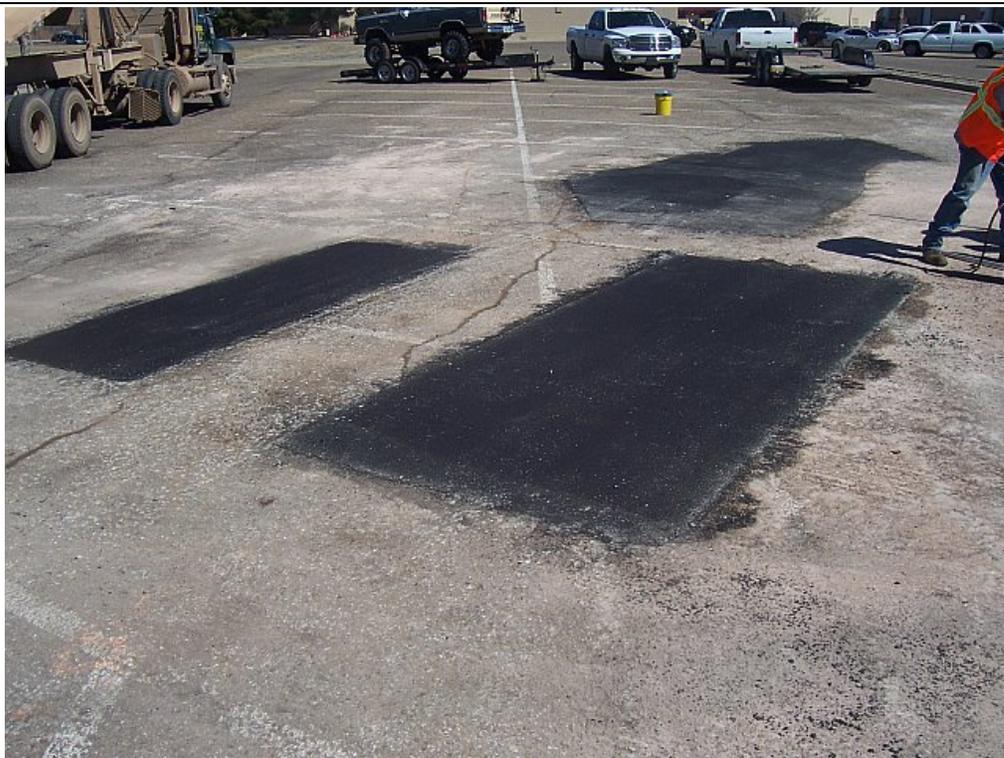
Completed asphalt
site restoration.

Note: Stripping is
scheduled for June
2010.

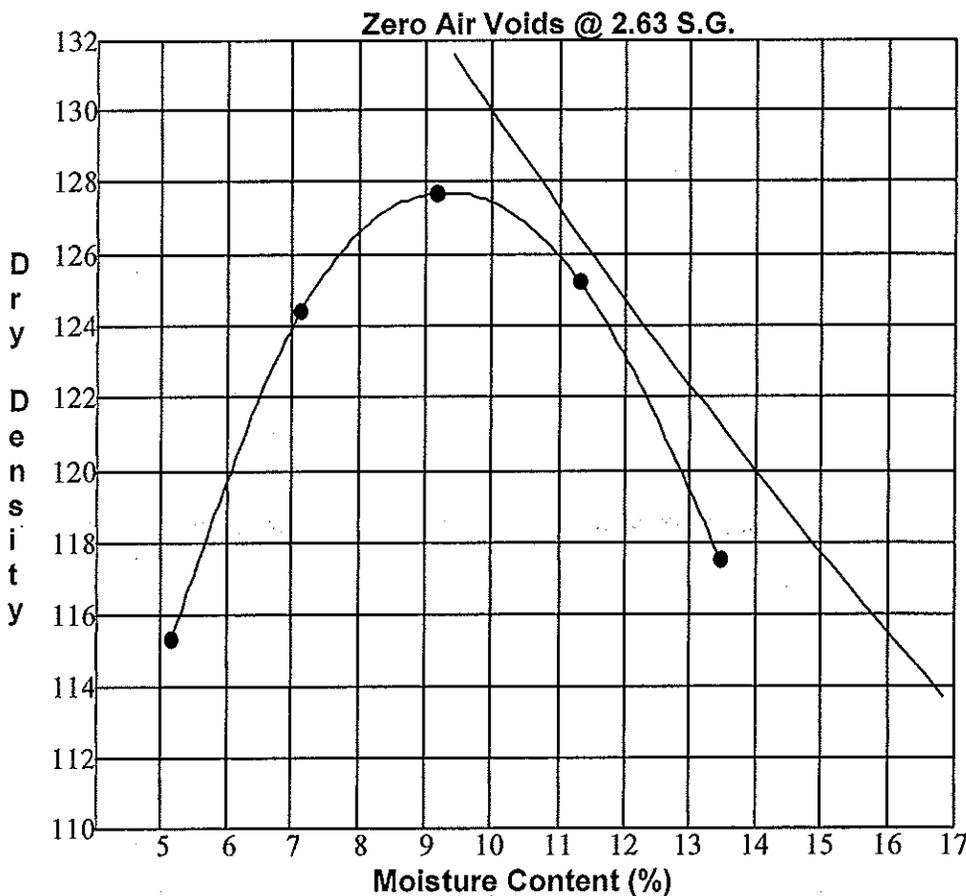
Max. Dry Density (pcf): 127.7
Optimum Moisture (%): 9.3

Moisture Content (%)	Dry Density (pcf)	Wet Density (pcf)
5.2	115.3	121.2
7.1	124.5	133.3
9.2	127.7	139.4
11.3	125.2	139.4
13.5	117.5	133.3

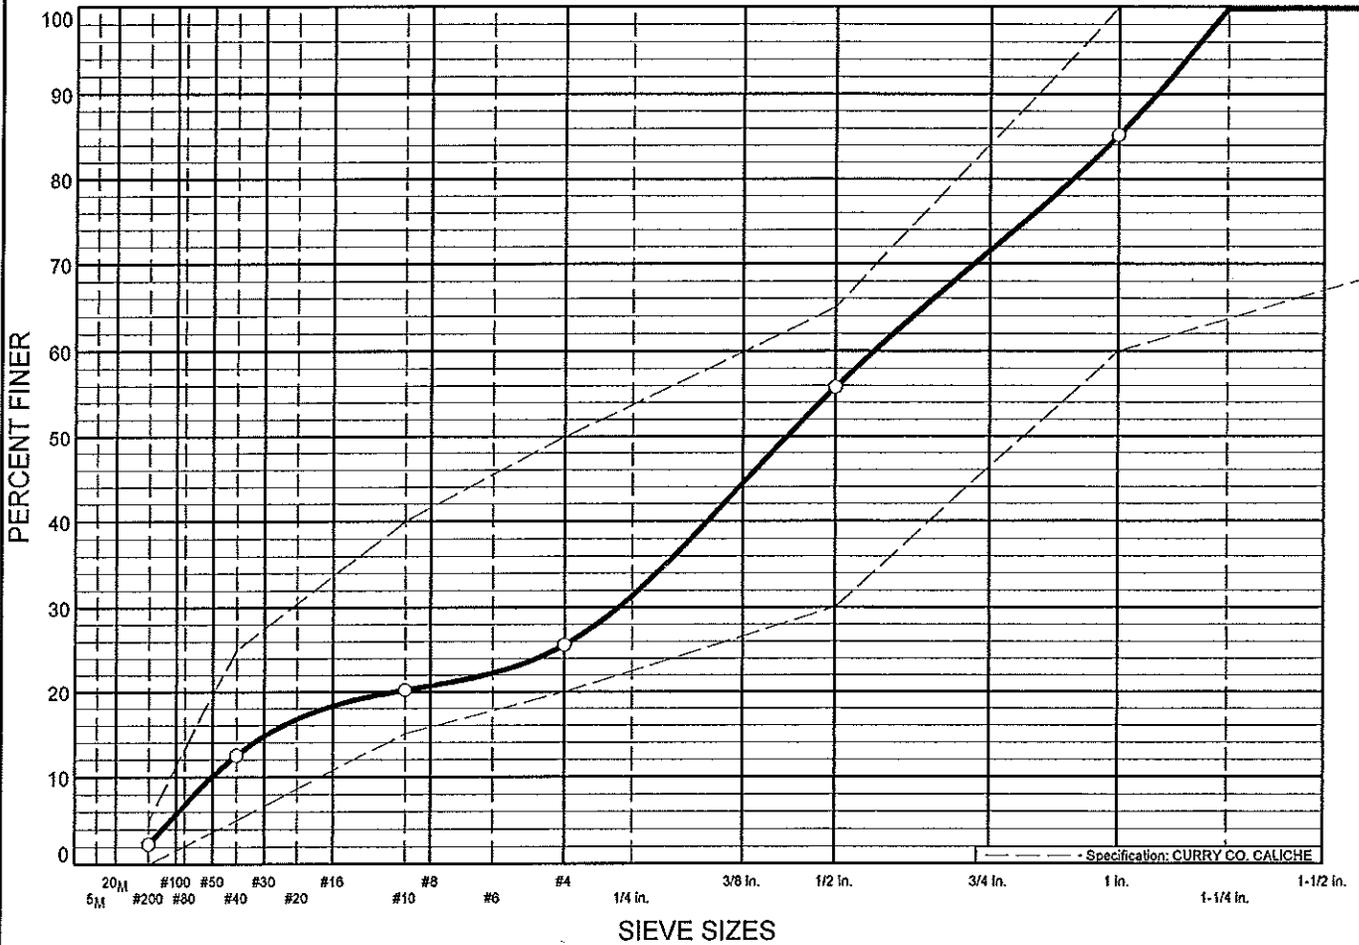
CLAY SILT	% SAND	% GRAVEL
2.3	23.3	74.3

SIEVE SIZE	PERCENT FINER	SPEC.* PERCENT	PASS? (X=NO)
1 1/2 in.	100.0	100.0 - 100.0	
1 in.	85.2	60.0 - 100.0	
1/2 in.	55.8	30.0 - 65	
#4	25.6	20.0 - 50.0	
#10	20.2	15.0 - 40.0	
#40	12.5	5.0 - 25.0	
#200	2.3	0.0 - 5.0
