HWB PHOTO SHEET

Facility: IEC Electronics

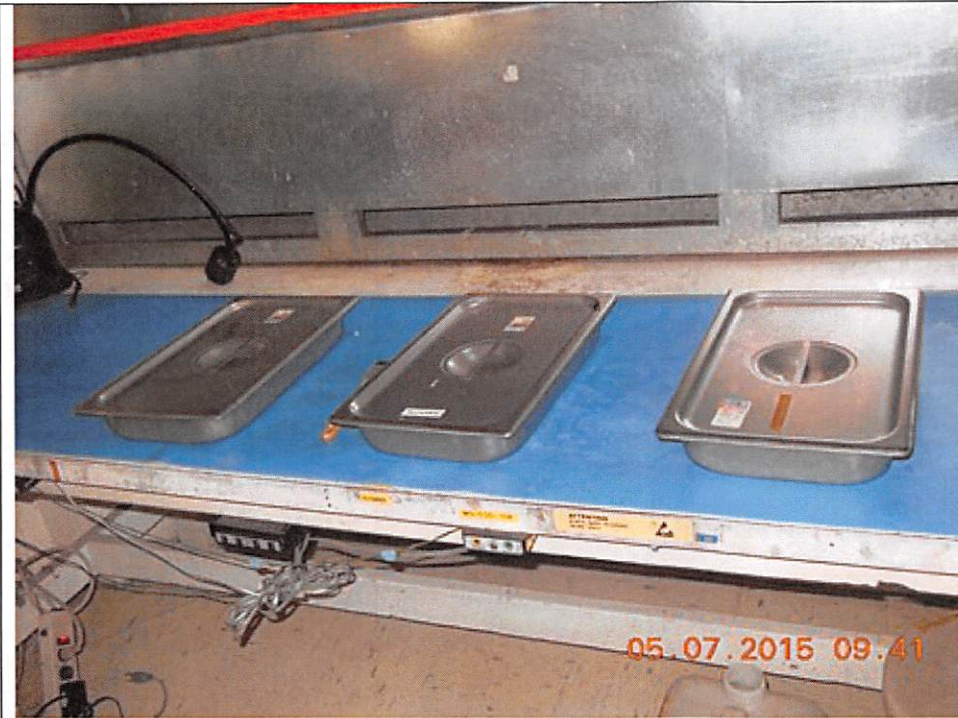
Photo #: 0833

Location: Hand Washing Area.

Description: Circuit boards are hand washed in the trays with IPA and rinsed with DI water. The spent IPA is placed into two red 5-gallon cans.

Violation(s): None.

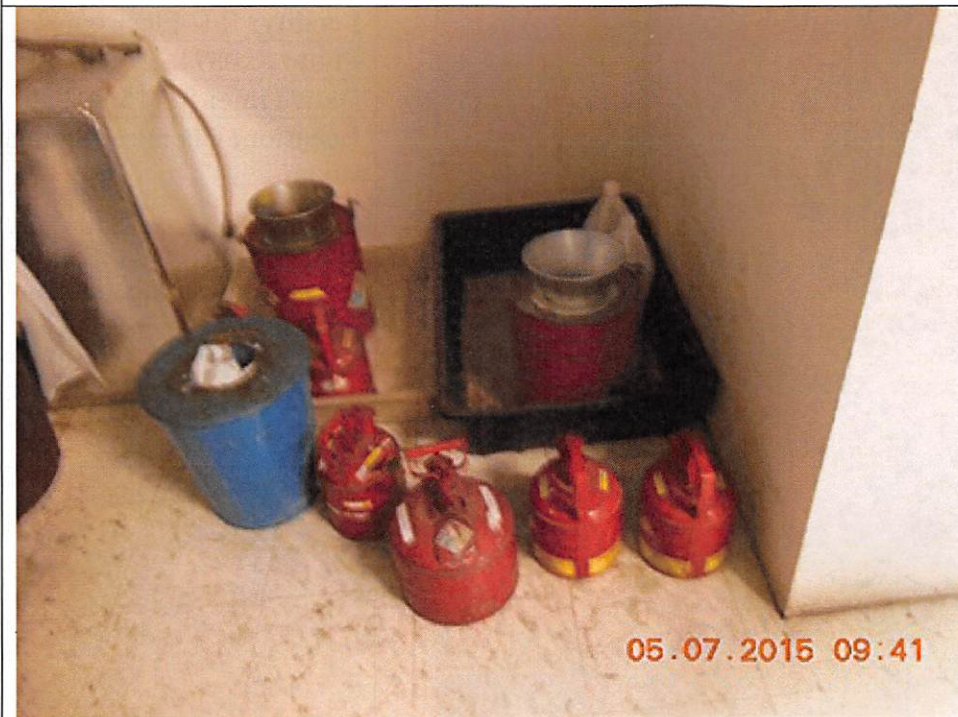
Photo #: 0840

Location: Hand Washing Area

Description: Two red metal buckets with mesh tops need to be kept closed and labeled.

Violation(s): Failure to label an SAA with the words Hazardous Waste and failure to keep containers closed. 40 CFR 262.34(a)(3) and 262.34(d) referring to 265.173(a).

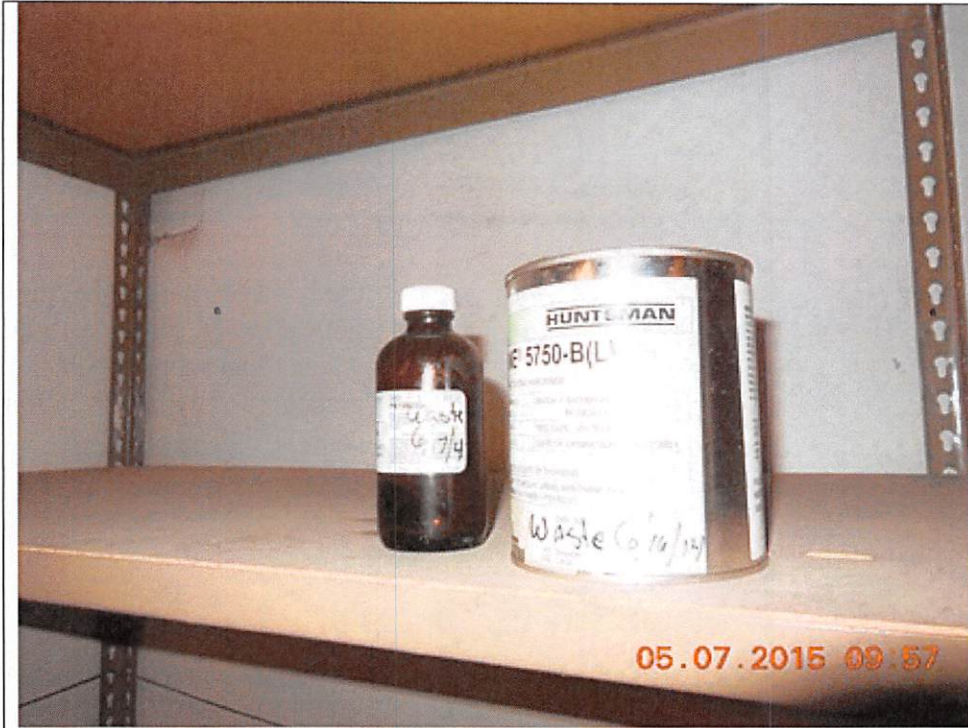
Photo #: 0866

Location: Second shelf from top in the less-than-180 day storage area.

Description: Two hazardous waste containers were stored greater than 180 days in the storage area.

Violation(s): Failure to dispose of hazardous waste within 180 days of the start of accumulation. 40 CFR 262.34(d).

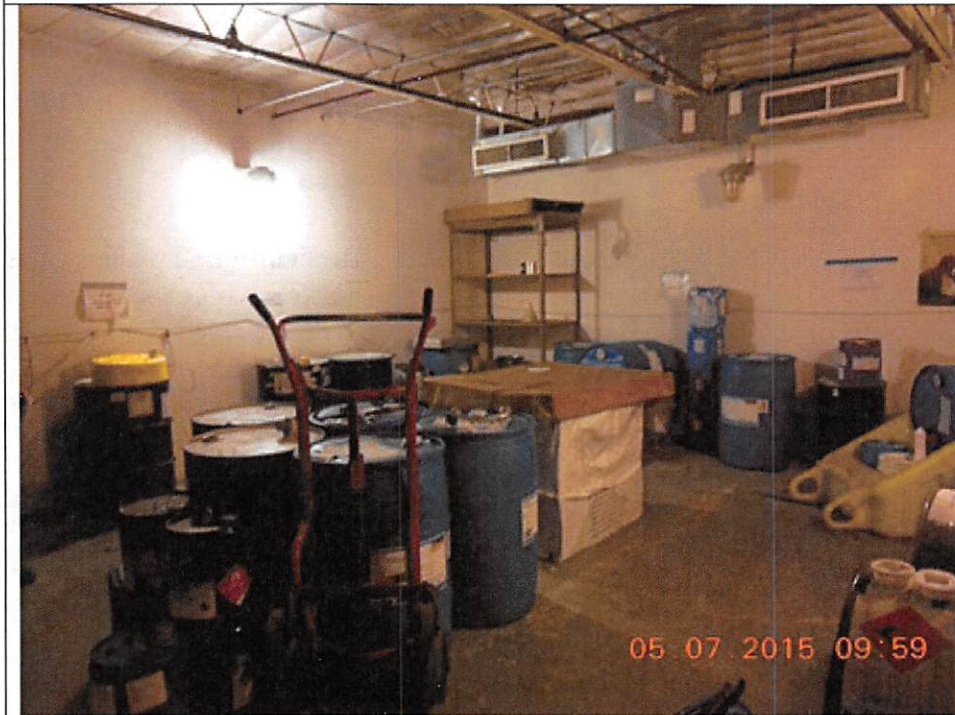
Photo #: 0871

Location: Chemical Storage Room.

Description: area photo of the 180 day storage area on the left side.

Violation(s): None.

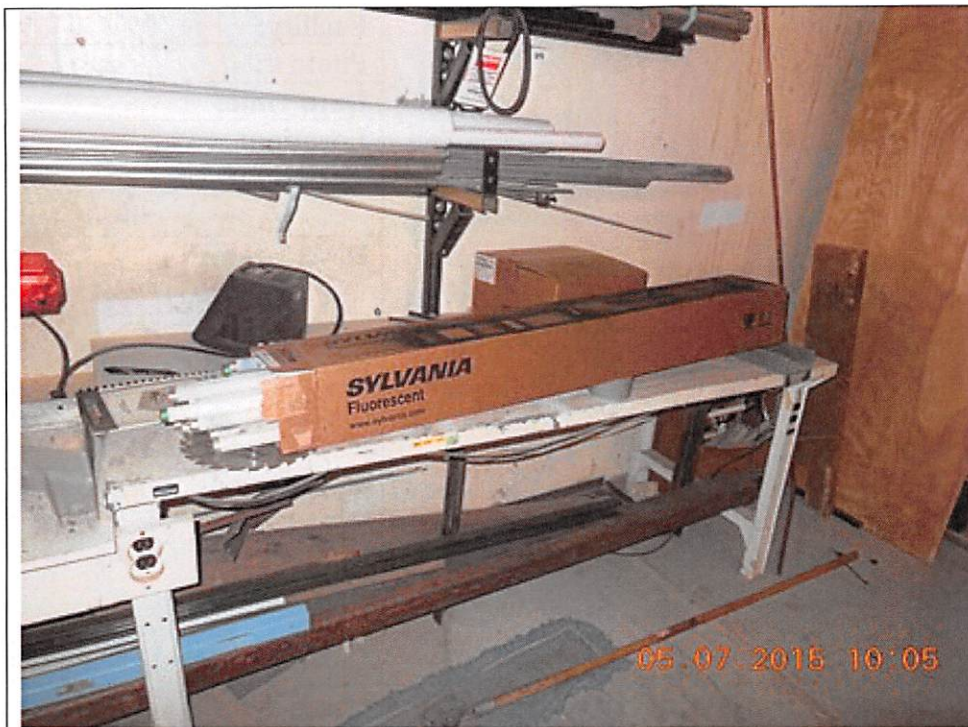
Facility: IEC Electronics
Photo #: 0878
Date/Time: 5/7/15 10:05am
Location: Warehouse

Description: One box of spent fluorescent lamps needs to be closed, labeled and marked with an ASD.

Violation(s): 40 CFR 273.13(d)(1), 40 CFR 273.14(e) and 40 CFR 273.15(c)(2).

Description: Spent lamps pictured in photo #0878 placed in new box with Velcro fasteners and labeled and marked with an ASD.

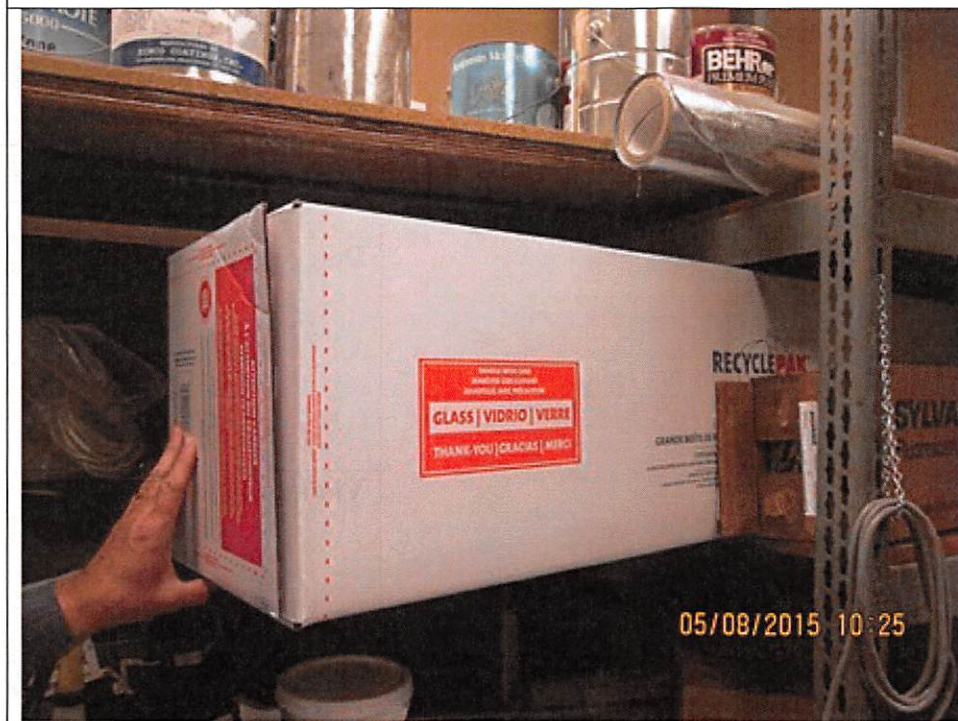
Facility: IEC Electronics
Photo #: 1192
Date/Time: 5/8/15 10:25am
Location: Warehouse

Violation(s): None.
