Interim Corrective Measure Completion Report
for SWMU ST-66, Trestle Facility (ST-66)

Final Draft - July 1997

Prepared By
JACOBS ENGINEERING GROUP INC.
2155 LOUISIANA BLVD. NE, SUITE 10,000
ALBUQUERQUE, NEW MEXICO 87110

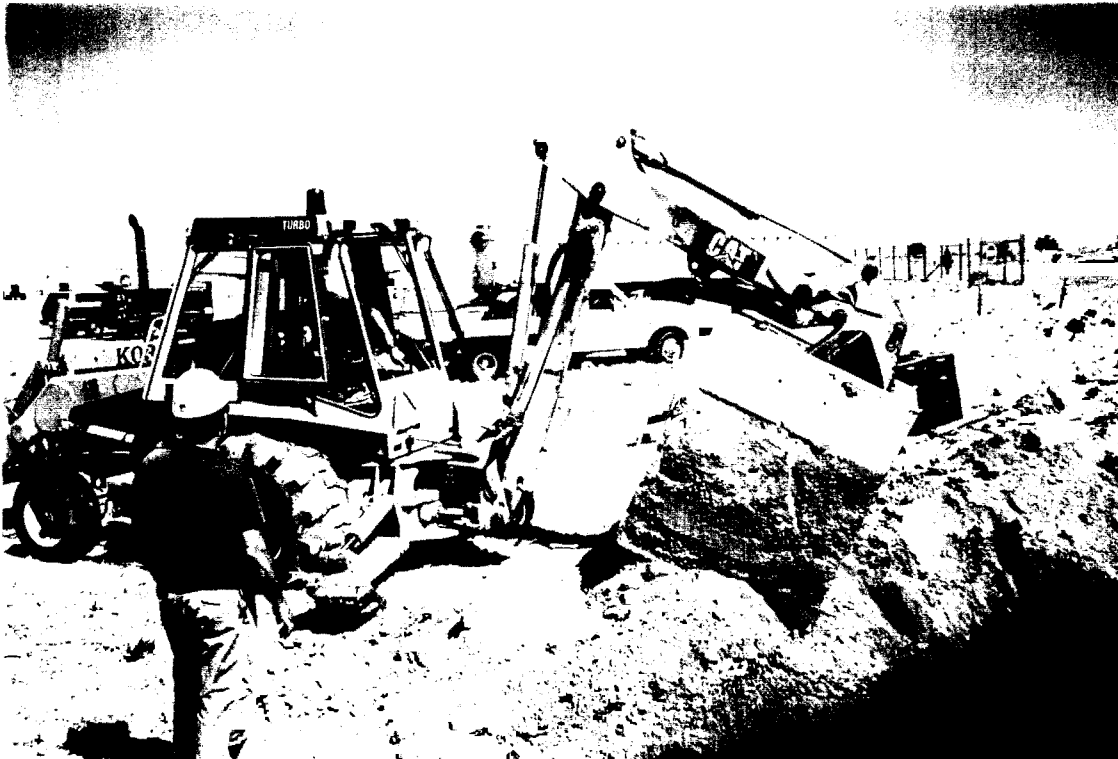
Figure 3-1. Photo Showing OWS Removal

The piping between the vehicle pit and the OWS was removed and then the remaining piping from the OWS to the drainage ditch was removed. The OWS was removed in one piece and then broken into smaller pieces using a hydraulic hammer attached to the backhoe as shown in Figures 3-1 and 3-2.

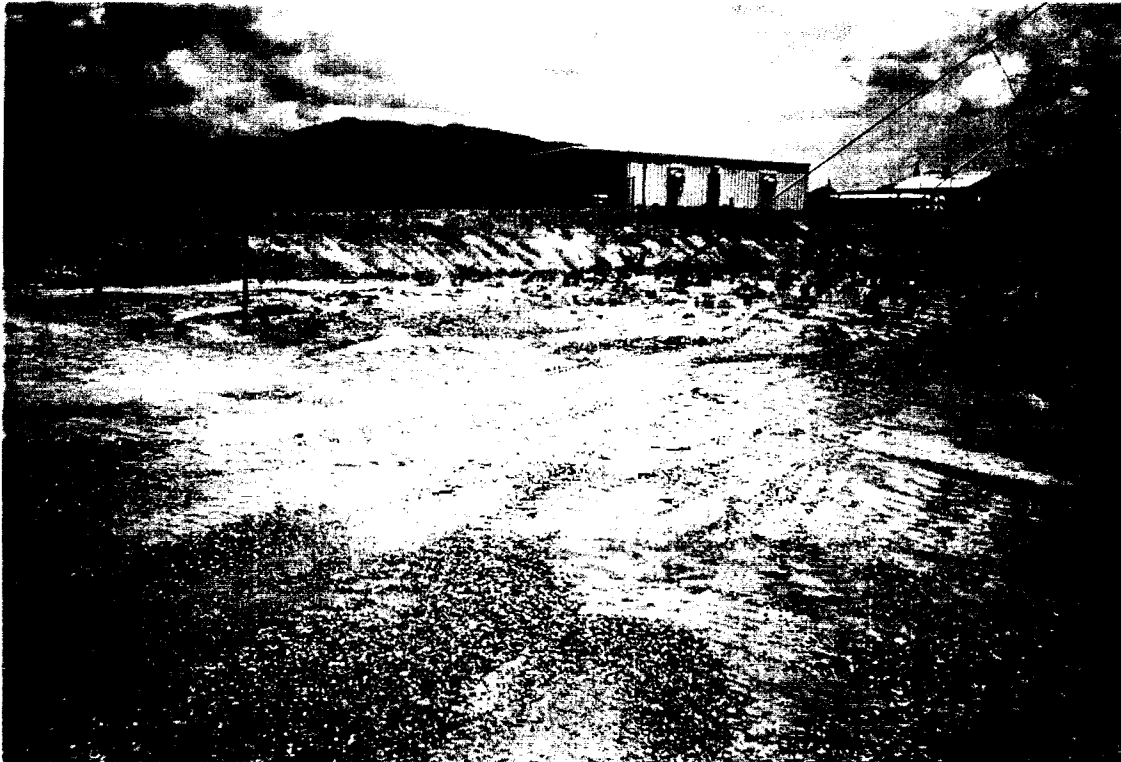
Figure 3-3. Photo Showing Final Site Condition

Once all the construction debris was removed, several cubic yards of clean fill were used as backfill material. The site was compacted using existing equipment and regraded to the original contours. Final site conditions are shown in Figure 3-3.

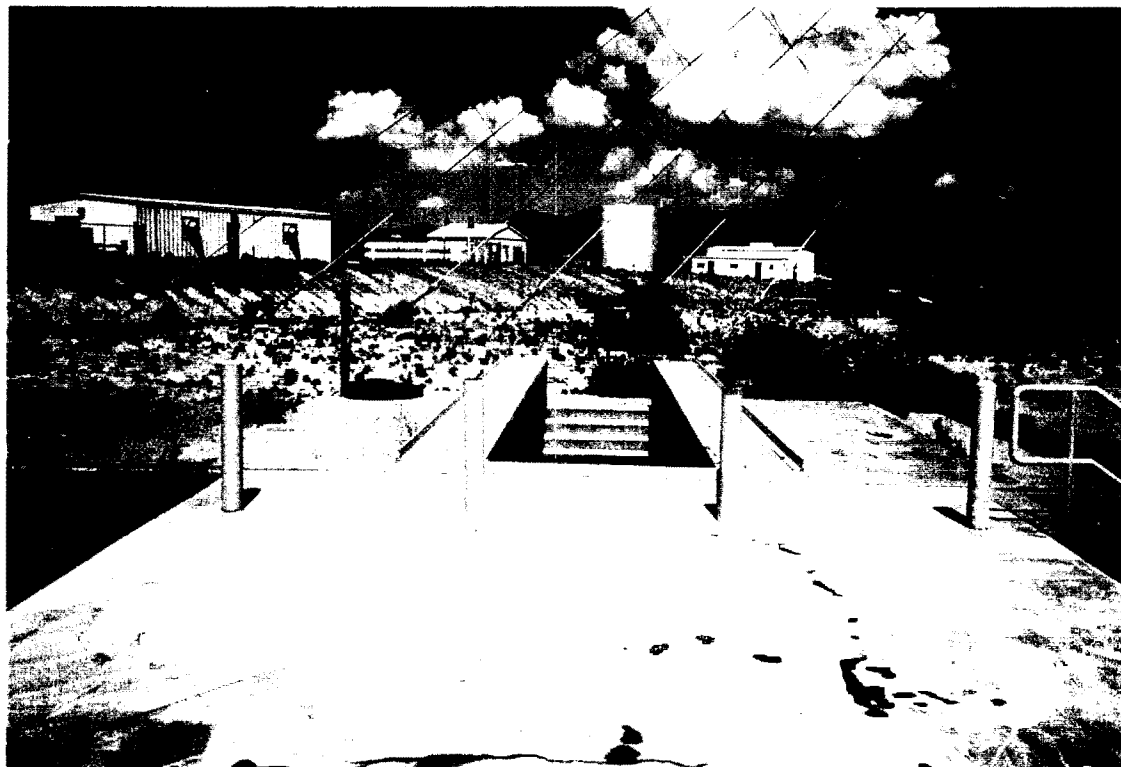
Figures 3-4. Photo Showing Vehicle Pit Protective Posts

Removable posts were installed on the vehicle pit ramp by using a concrete core to cut two 5 1/2-inch diameter holes in the 10-inch-thick concrete slab. The removable protective posts were installed and placed in the core holes and painted to match the existing posts, as shown in Figure 3-4.
