DEPARTMENT OF THE AIR FORCE
AIR FORCE CIVIL ENGINEER CENTER
JOINT BASE SAN ANTONIO LACKLAND TEXAS

This letter serves as the Corrective Action Report for the golf course pond vegetation clearing coolant leak associated with the Bulk Fuels Facility Spill, Solid Waste Management Unit ST-106/SS-111, Kirtland Air Force Base (AFB), New Mexico. This report is submitted pursuant to 20.6.2.1203.A(6) NMAC, "Notification of Discharge-Removal". The two- to three-gallon leak of engine coolant (water and ethylene glycol) from a contractor's vehicle near the golf course ponds was originally reported to NMED via email on July 11, 2017, a few hours after the release was discovered.

Attachment 1 – Photographic Log

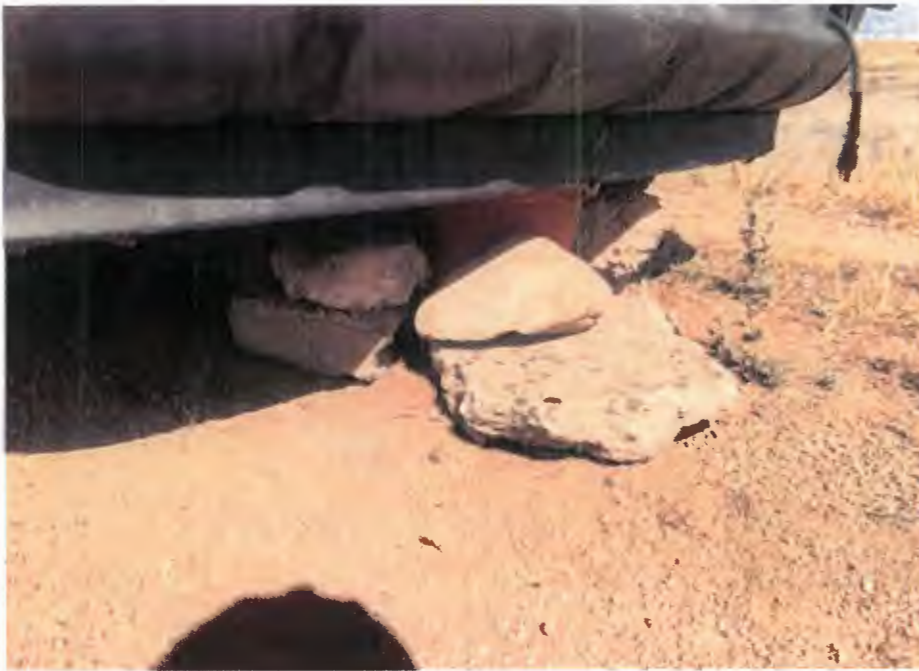
Location: Location 2
Description: Bucket Placed Under Truck to Capture Residual Coolant
Date: 12 July 2017

Direction: Northwest

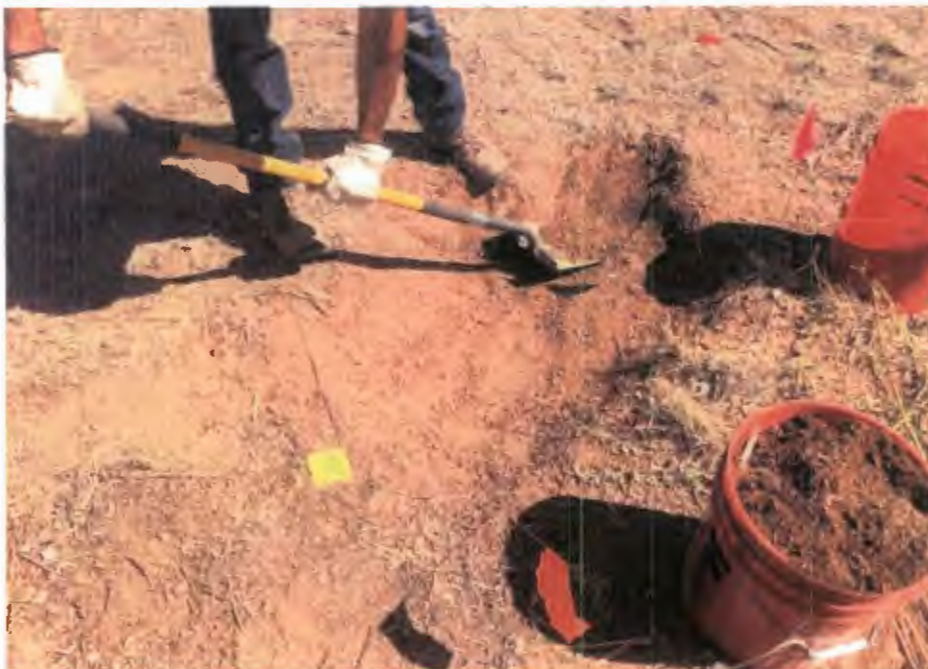
Location: Location 1
Description: Soil Removal
Date: 12 July 2017

Direction: Down

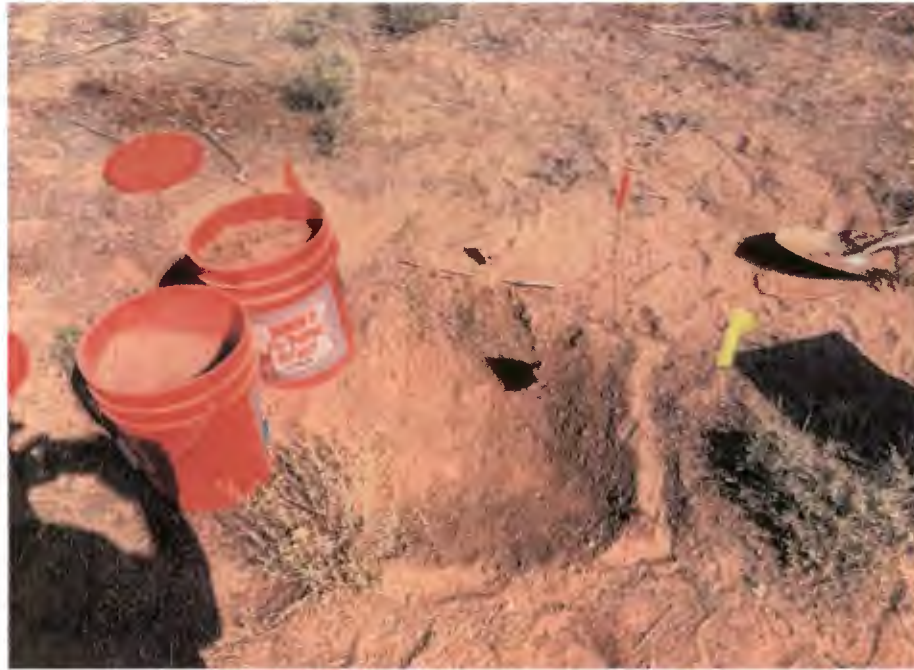
Location: Location 2
Description: Soil Removal
Date: 12 July 2017

Direction: Down

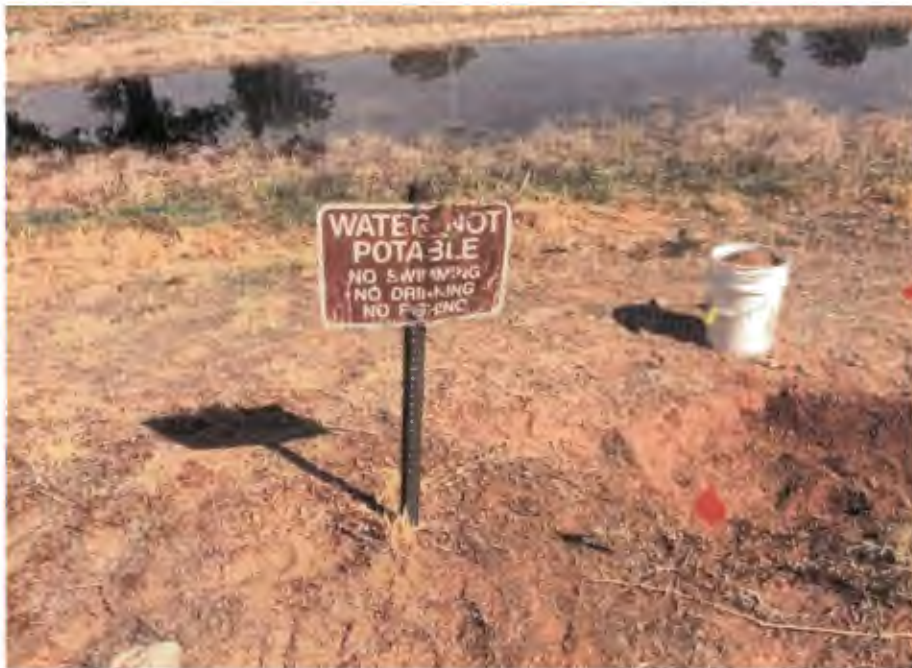
The leak occurred as a result of a punctured radiator when the contractor's vehicle hit a non-potable water sign near Pond #2 at the Tijeras Arroyo Golf Course, Kirtland AFB. The leak soaked into two locations, one near the sign (Location 1) and approximately 40 feet (ft) east of the sign (Location 2) where the truck was initially moved following the incident. Approximately two gallons were leaked at Location 1 and an additional 0.5 gallons at Location 2. Immediately upon discovery, a bucket was placed under the radiator to catch any dripping coolant and a total of approximately four gallons of wetted soil was removed from both locations. All wetted soil and captured coolant were transferred to five-gallon buckets, which are stored in EA's IDW yard pending waste disposal approval. On July 12, 2017 approximately 5.3 cubic feet of soil was excavated and removed from the surface release areas (Location 1: Excavated 1.2 ft x 3.5 ft by 8 inches in depth; Location 2 excavated 2 ft x 2.5 ft x 4 inches in depth). Soil was placed into a 55-gallon polyethylene drum. Photographs of the cleanup operations are provided as Attachment 1. Two confirmation samples (SP-01 and SP-02) were collected (one from each location) to be analyzed by EPA Method 8015 (for ethylene glycol specifically) following soil removal to ensure that the residual soil did not pose a risk to human health or the environment.

Location: Location 1
Description: Damaged Sign
Date: 12 July 2017

Direction: West

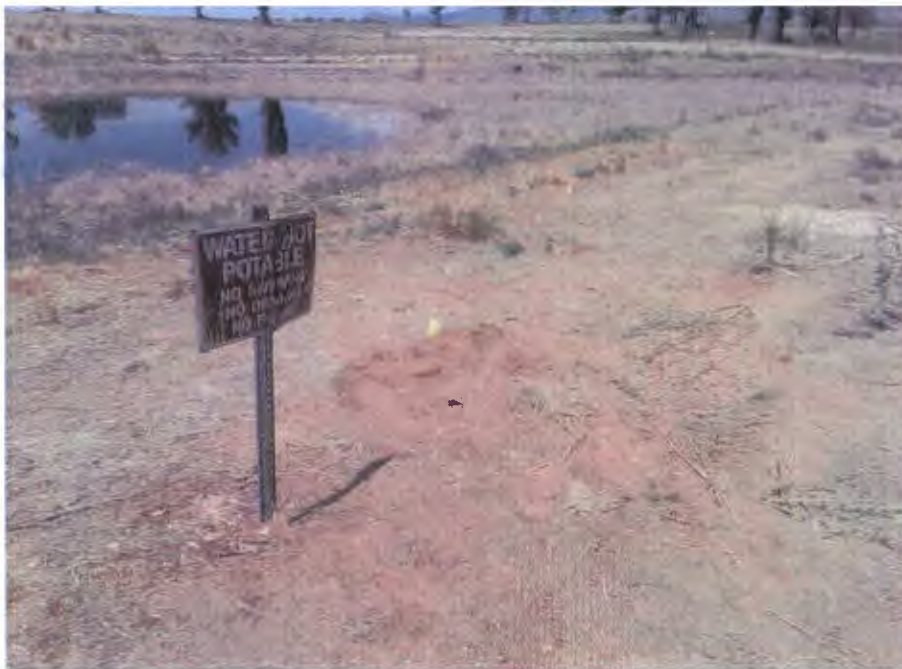
Location: Location 1
Description: Location 1 Post Soil Removal
Date: 12 July 2017

Direction: North

Both sample locations had low residual detections of ethylene glycol. Location 1 (SP-01) contained 12 milligrams per kilogram (mg/kg) and Location 2 contained an estimated concentration of 1.3 mg/kg (Table 1). Both samples contain residual ethylene glycol; below the EPA Regional Screening Levels (RSL) Protection of Groundwater, Risk-based Soil Screening Level (162 mg/kg) and the EPA RSL for Residential Use (13,500 mg/kg). The laboratory analytical report is provided as Attachment 2. Since the laboratory data confirm that the samples contained minimal coolant contamination, in such quantity as may with reasonable probability not to injure or be detrimental to human health, animal or plant life, or property, or unreasonably interfere with the public welfare or the use of property, Kirtland AFB is proposing no further corrective action.

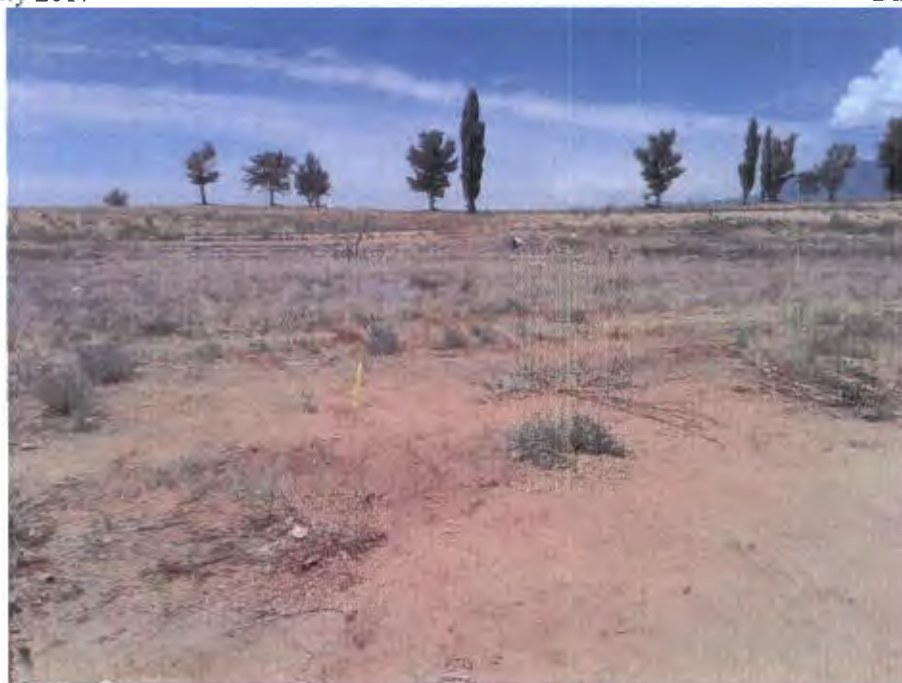
Location: Location 2
Description: Location 2 Post Soil Removal
Date: 12 July 2017

Direction: North
