DEPARTMENT OF THE AIR FORCE
377TH AIR BASE WING (AFGSC)

On 14 September 2017 at 0800, a spill of approximately 133 gallons of diesel fuel was discovered from a portable generator tank failure at the "Taxiway Pad 5" construction project on Kirtland Air Force Base (AFB). Ms. Melissa Clark, Environmental Management Chief at Kirtland AFB, completed the required oral report within 24 hours of the spill at 1438 on 14 September through a voicemail to Mr. Stephen Connolly at the New Mexico Environment Department.

Photo Documentation for Taxiway Pad 5 Construction Project – Diesel Spill – 14 September 2017

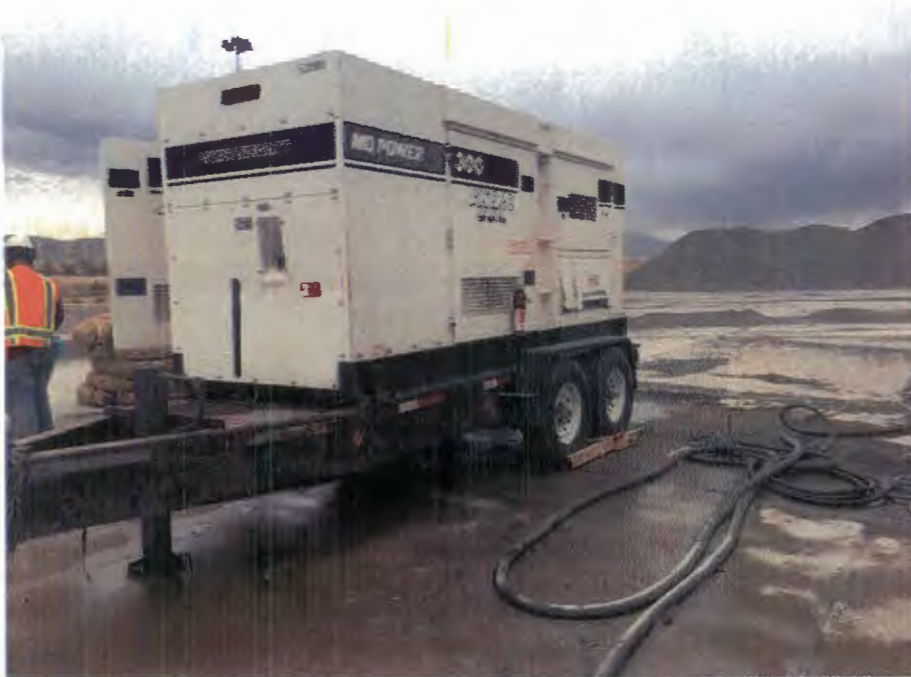
Portable diesel generator

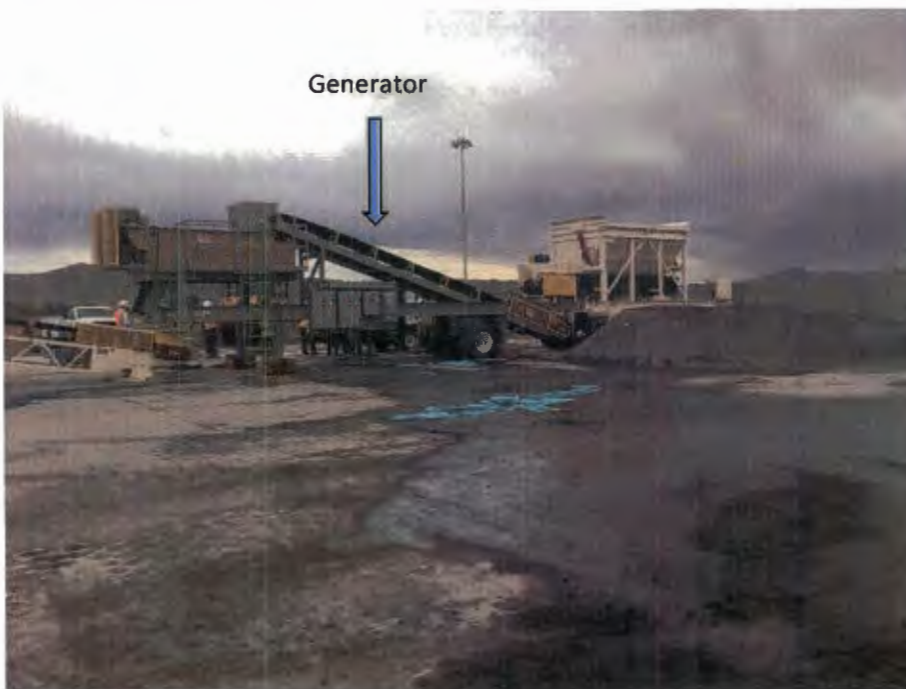
Generator

Spill looking east to generator

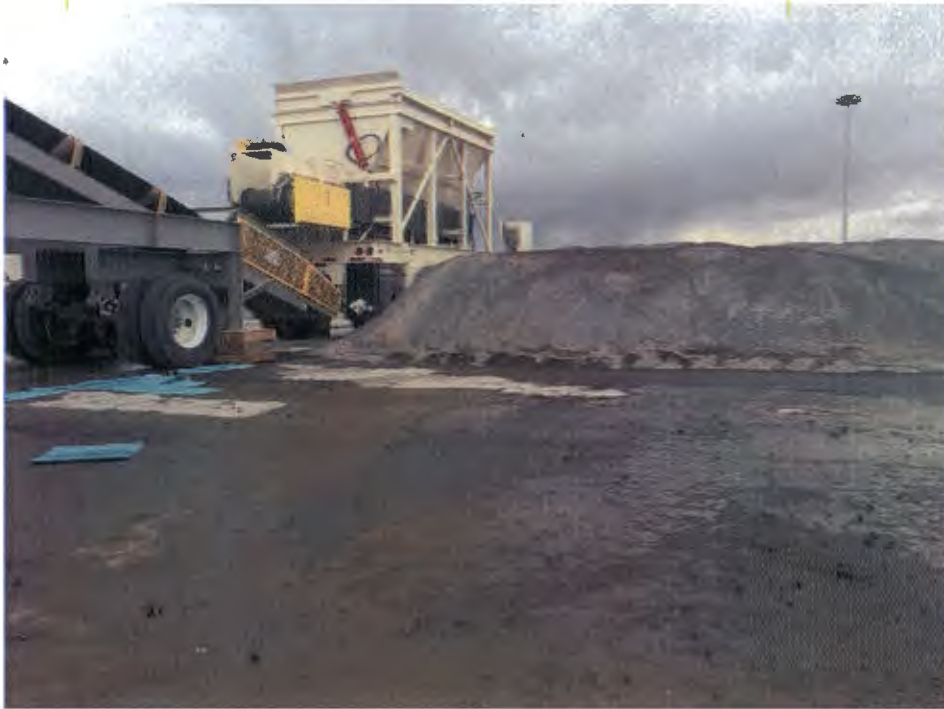
Spill looking east from generator

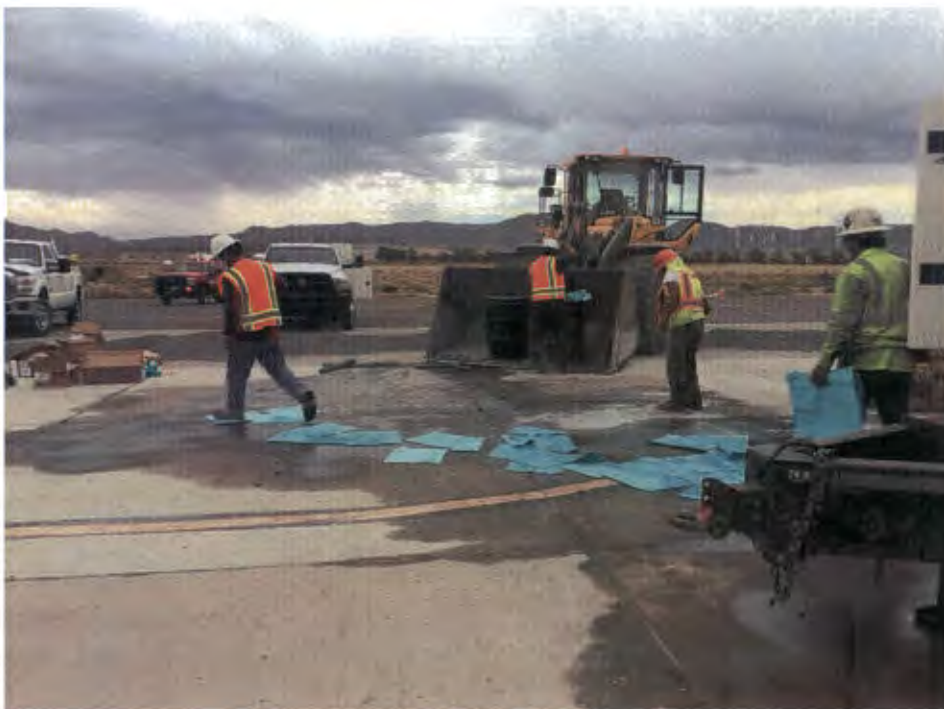
Spill looking west from generator

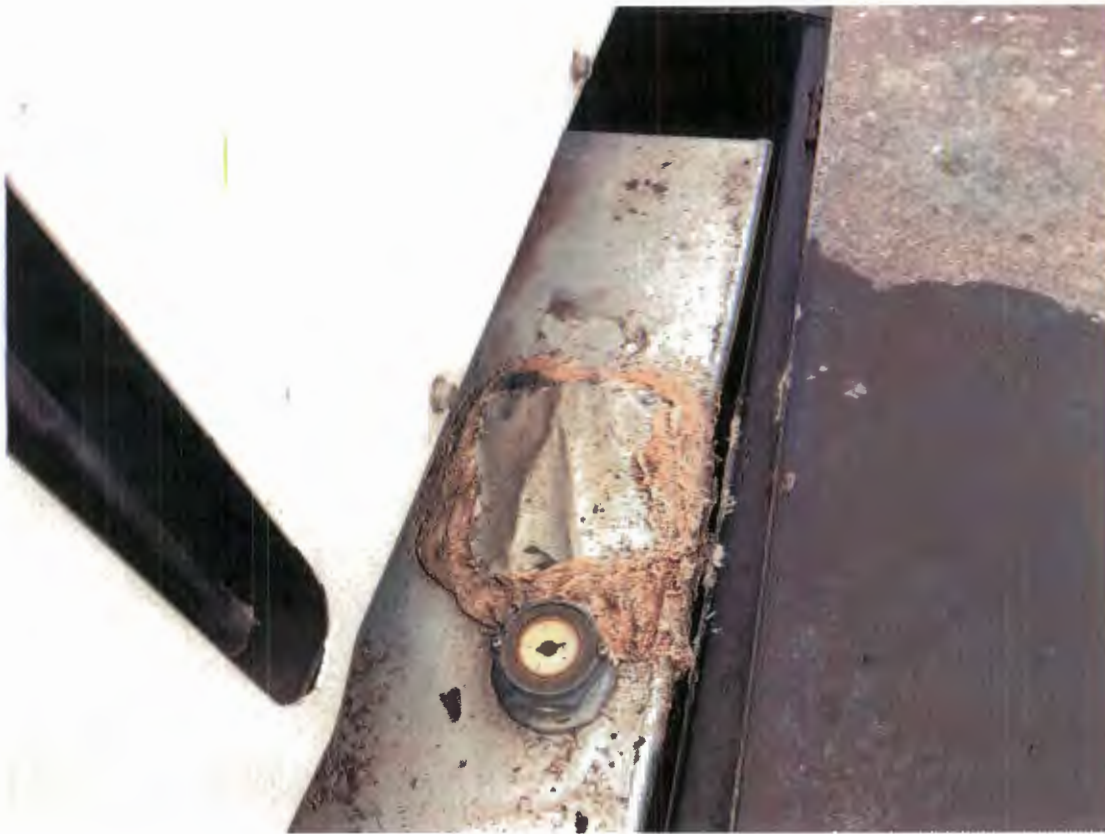
A description of the noncompliance and its cause: The morning of 14 September at 0800, the construction contractor Barlovento, LLC, noticed diesel fuel on Taxiway Pad 5. It was determined that approximately 133 gallons of diesel fuel spilled when a silicone repair on a portable diesel generator tank failed. The portable diesel generator was delivered to the site by Ahern Rentals on 13 September at 1530 with 200 gallons of diesel in the lower tank. At approximately 1830 on 13 September, the upper generator tank was refueled with 133 gallons of diesel by AUI, Inc., a subcontractor to Barlovento, LLC. AUI, Inc. states that there was no leak present during and immediately after refueling. The head pressure from the additional 133 gallons of fuel likely caused the tank repair on the topside of the lower tank to fail. The diesel fuel was released onto the concrete pad and did not reach soil or stormwater drains.

Silicone patch on
topside of lower
fuel tank

Barlovento, LLC is the prime contractor for the Taxiway Pad 5 project. Going forward, Barlovento, LLC will inspect all rental equipment containing fuel for defects prior to accepting delivery, prior to refueling, and during refueling. A safety stand-down meeting was led by personnel from Barlovento, LLC and attended by personnel from AUI, Inc. and Ahern Rentals on 15 September to discuss the spill response lessons learned and corrective actions. Kirtland AFB will ensure that all construction contractors have procedures in place to inspect fuel containing equipment as well as refueling activities.

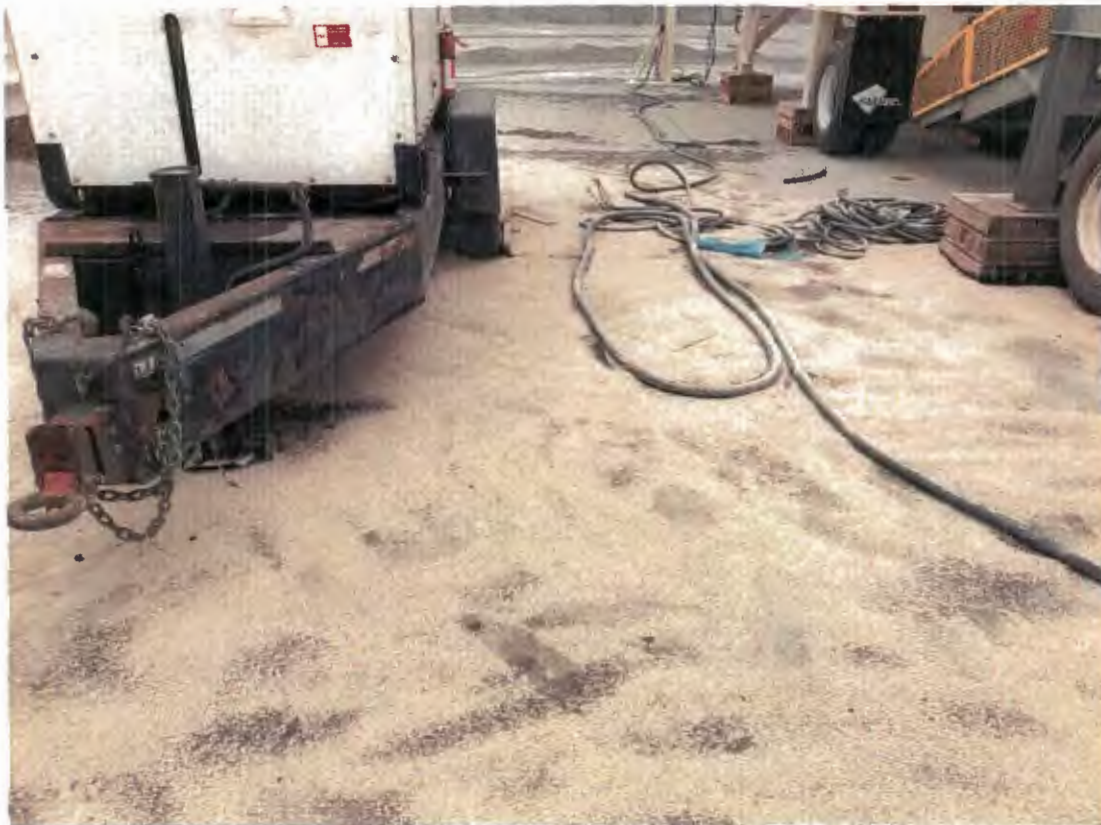
Spill cleanup in
progress

Southwest Abatement was hired to clean up the spill. Absorbent materials were used to clean the concrete pad and placed into 55-gallon drums for disposal. In total, eight 55-gallon drums were taken from the site for disposal at an approved site by Southwest Abatement. A small amount of raw construction material (aggregate) was impacted by the spill and was included in the eight drums that were removed for disposal.

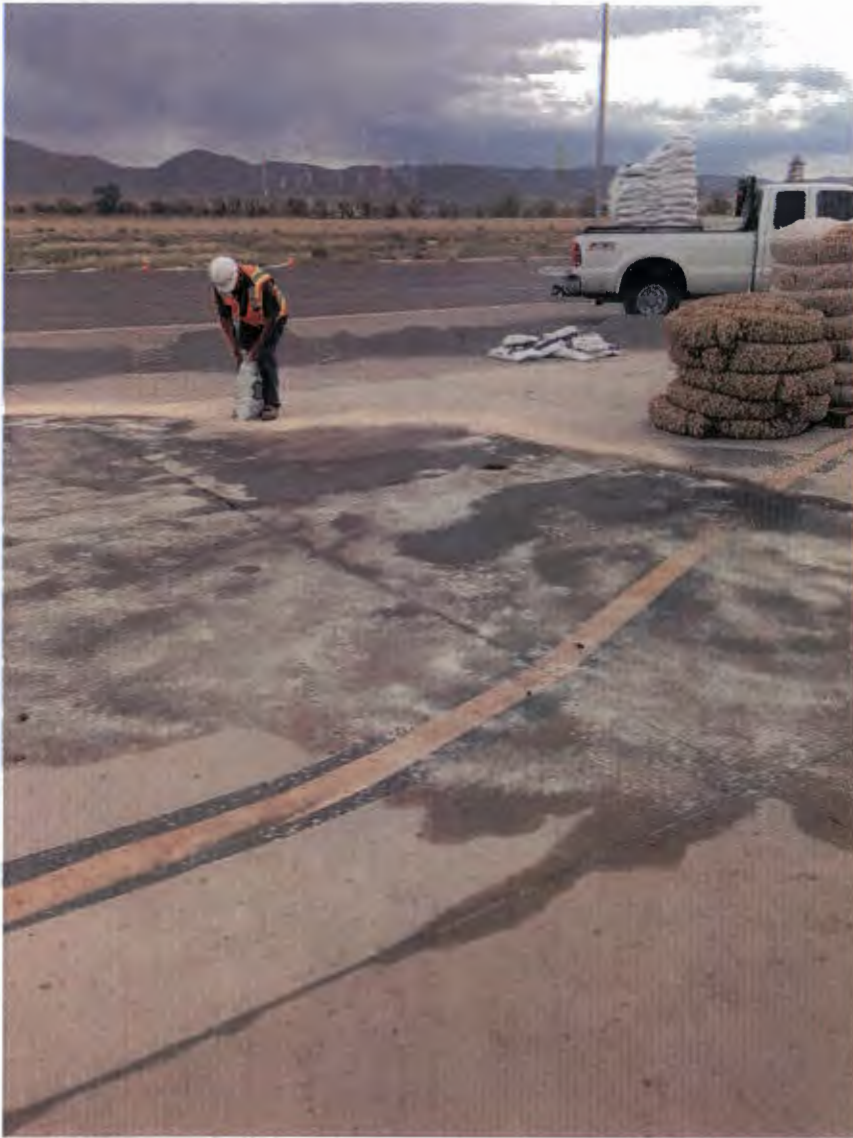
Spill cleanup in progress

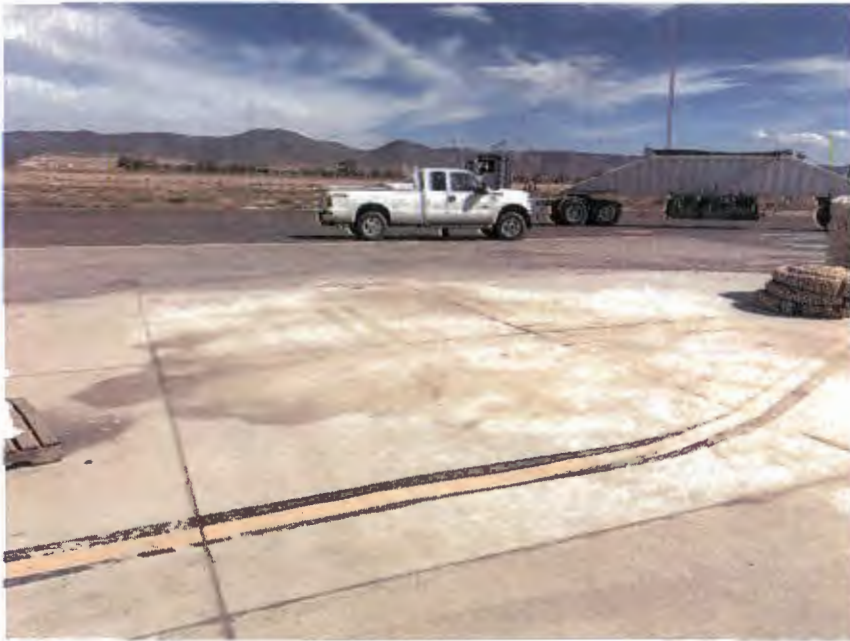
Clean up complete
14 September 2017
Photo Taken 14:59

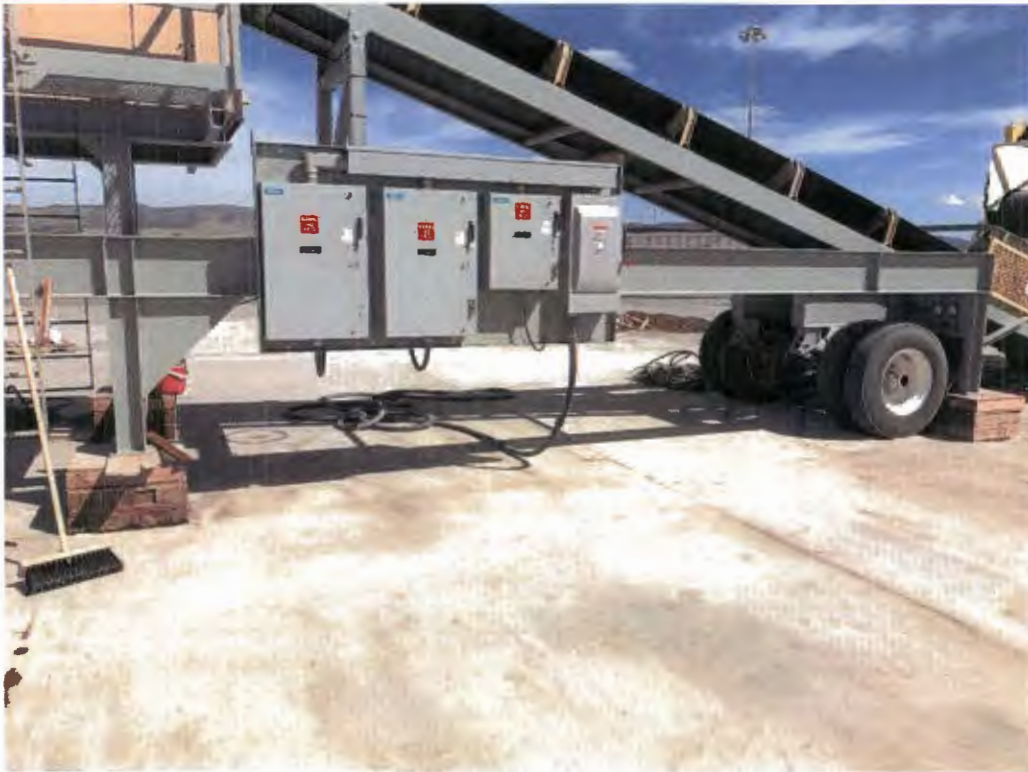
Clean up complete
14 September 2017
Photo Taken 14:58
