Objectives of BAER

WATERSHED ASSESSMENT

Cerro Grande Fire Burned Area Emergency Rehabilitation Environmental Compliance Considerations and Documentation

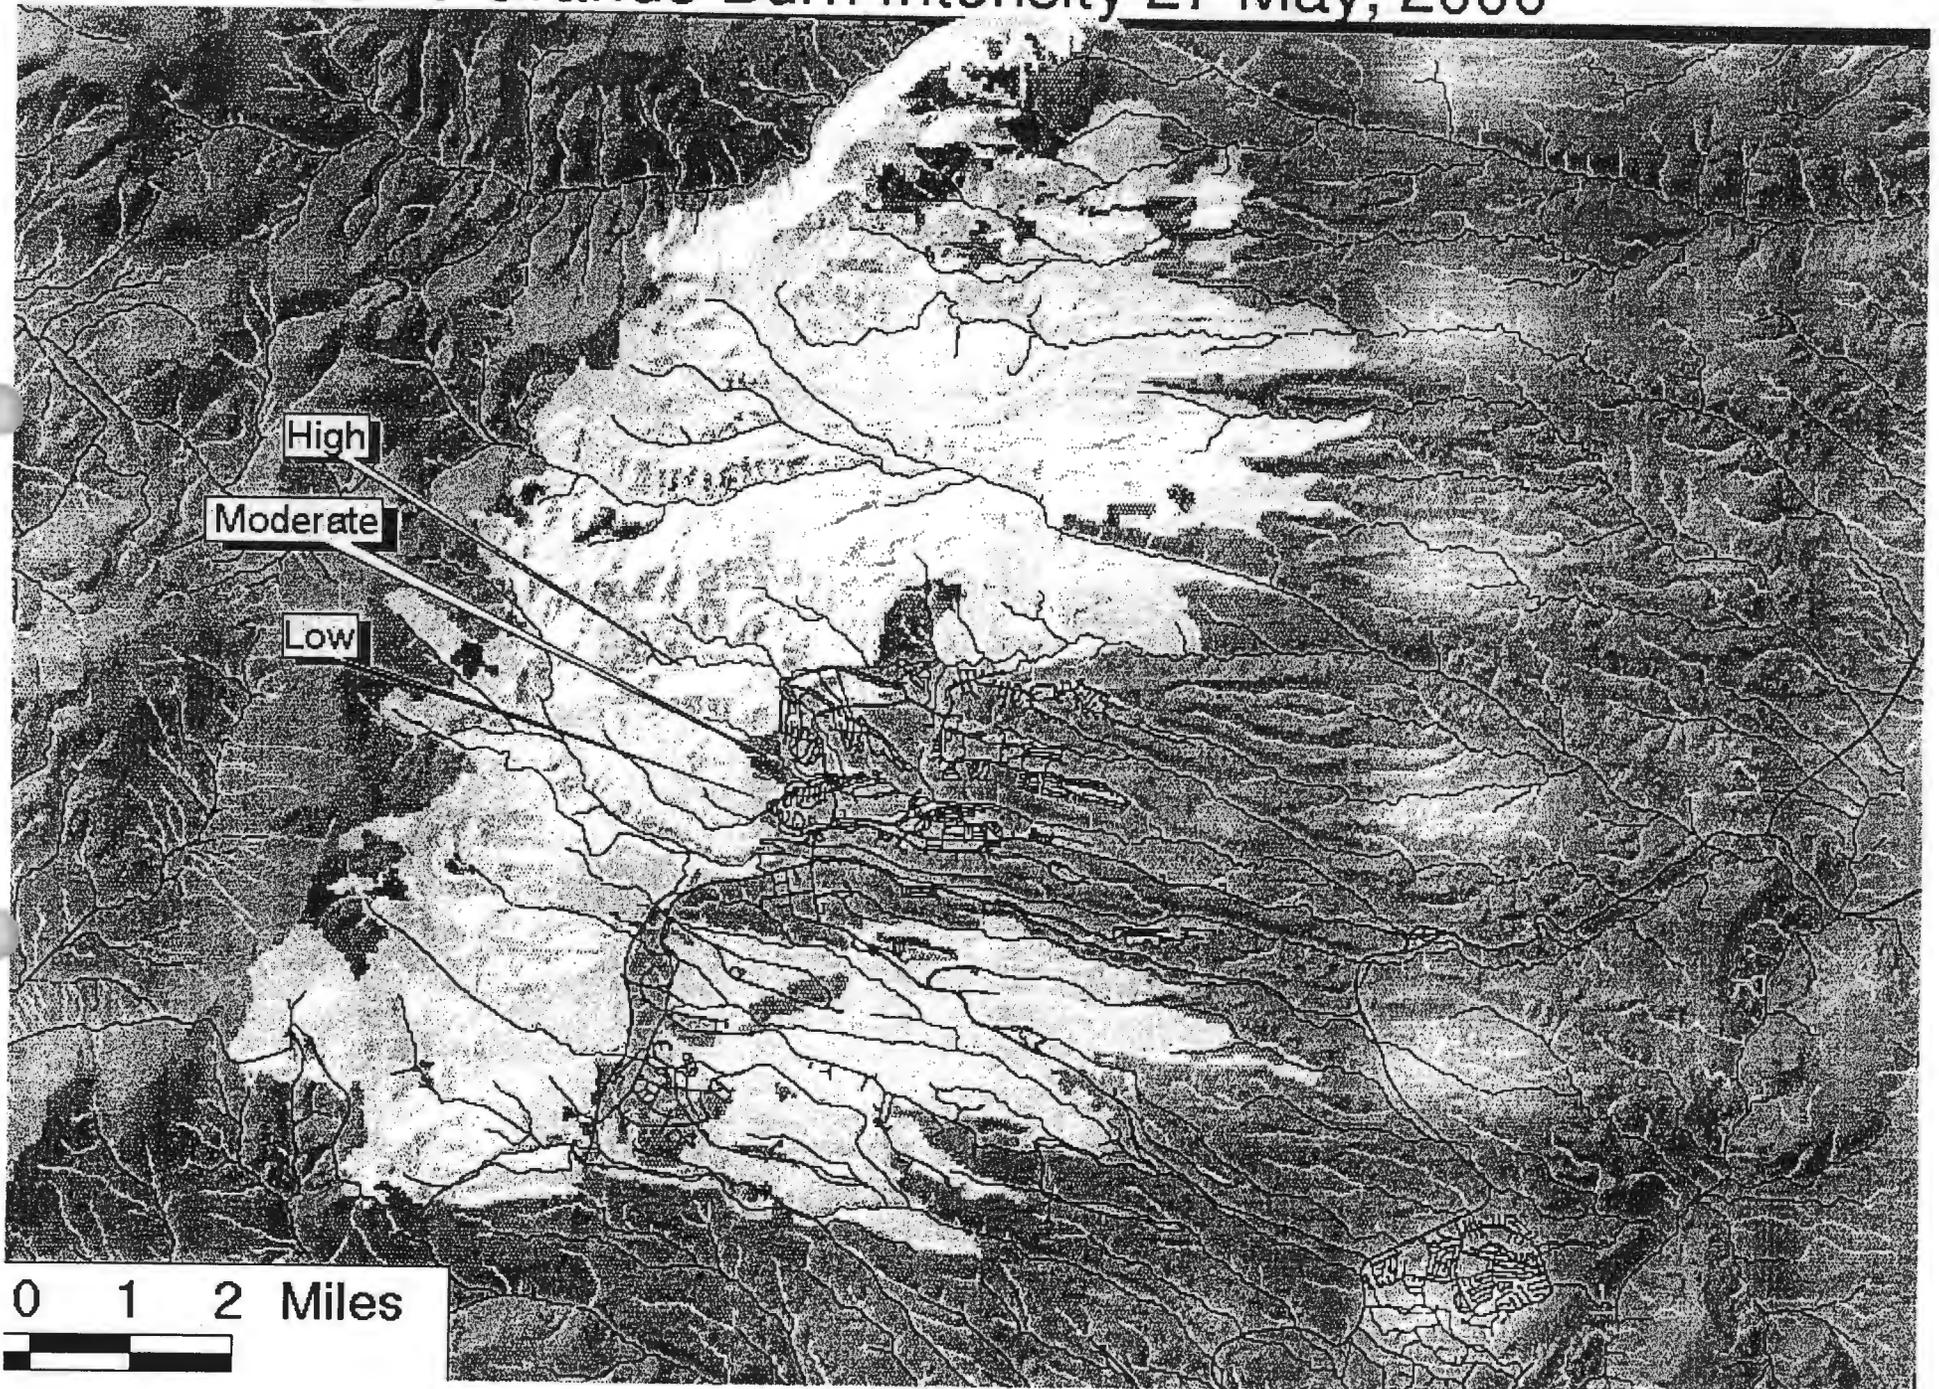
Cerro Grande Burn Intensity 27 May, 2000

GREATEST RISK IS IN WATERSHEDS WITH HIGH AMOUNTS OF HIGH AND MEDIUM BURN SEVERITY.

Burn Severity	Acres	Percent
High	14,511	34
Moderate	3,323	8
Low	25,035	58
Total	42,869	100

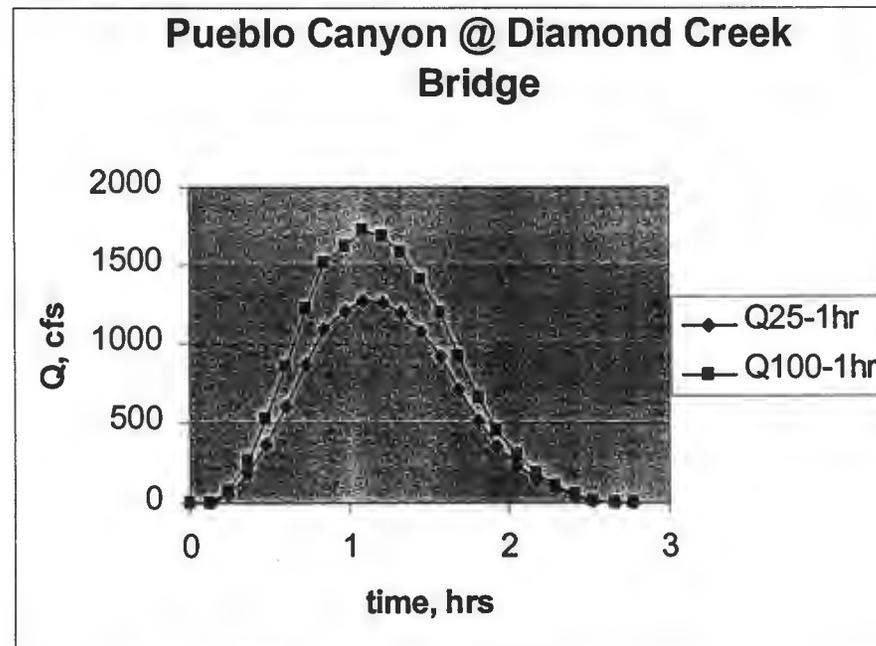
DIAMOND STREET FILL BRIDGE

- 25-YEAR, 1-HOUR EVENT UNBURNED = 9cfs
- 2-YEAR, 1-HOUR EVENT BURNED = 494cfs
- 25-YEAR, 1-HOUR EVENT BURNED = 1278cfs
- 100-YEAR, 1-HOUR EVENT BURNED = 1711cfs

- 30% REDUCTION OF RISK AT THE BRIDGE
- THE COUNTY IS WORKING TO REDUCE IMPACTS BY PUTTING A 6-FT CULVERT IN PLACE.
- EVACUATION PLANS BASED ON AN EARLY WARNING NETWORK WILL REDUCE MORE OF THE RISK

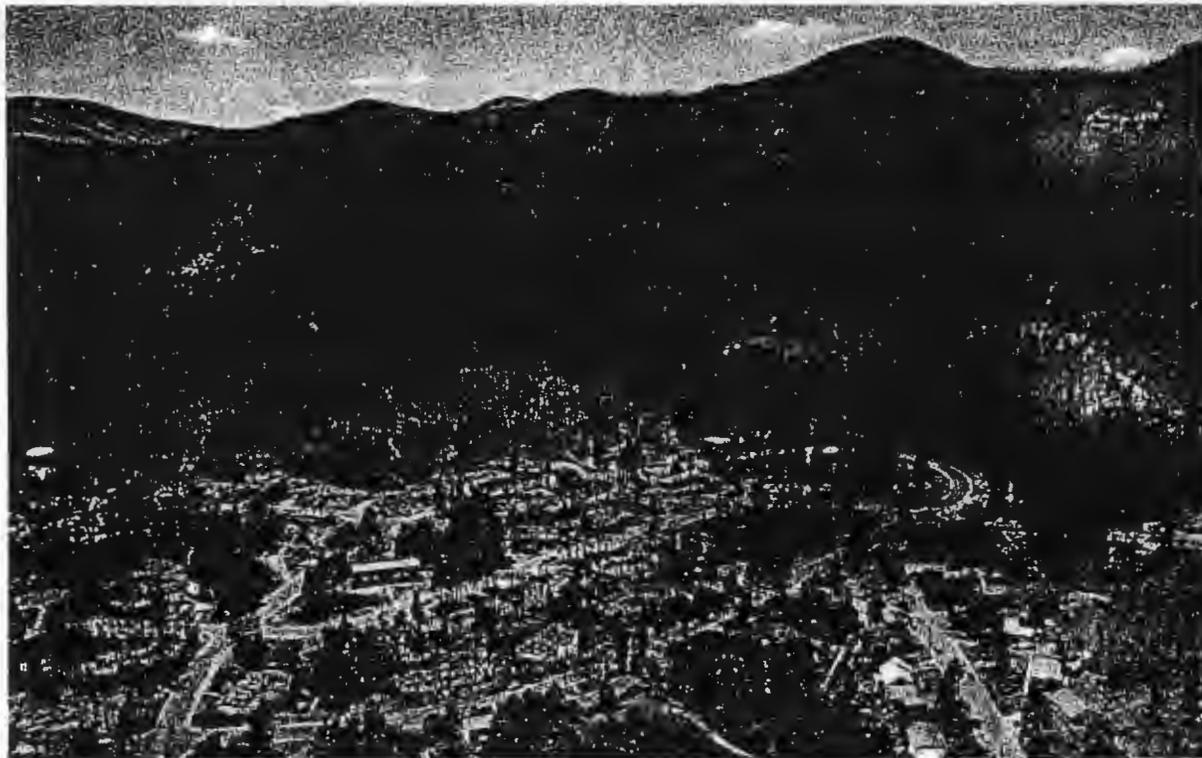
FINDINGS

- Post-fire landscape: mosaic of black and gray scattered patches of unburned vegetation pattern to persist in areas vegetative pattern to feature more non-conifer species

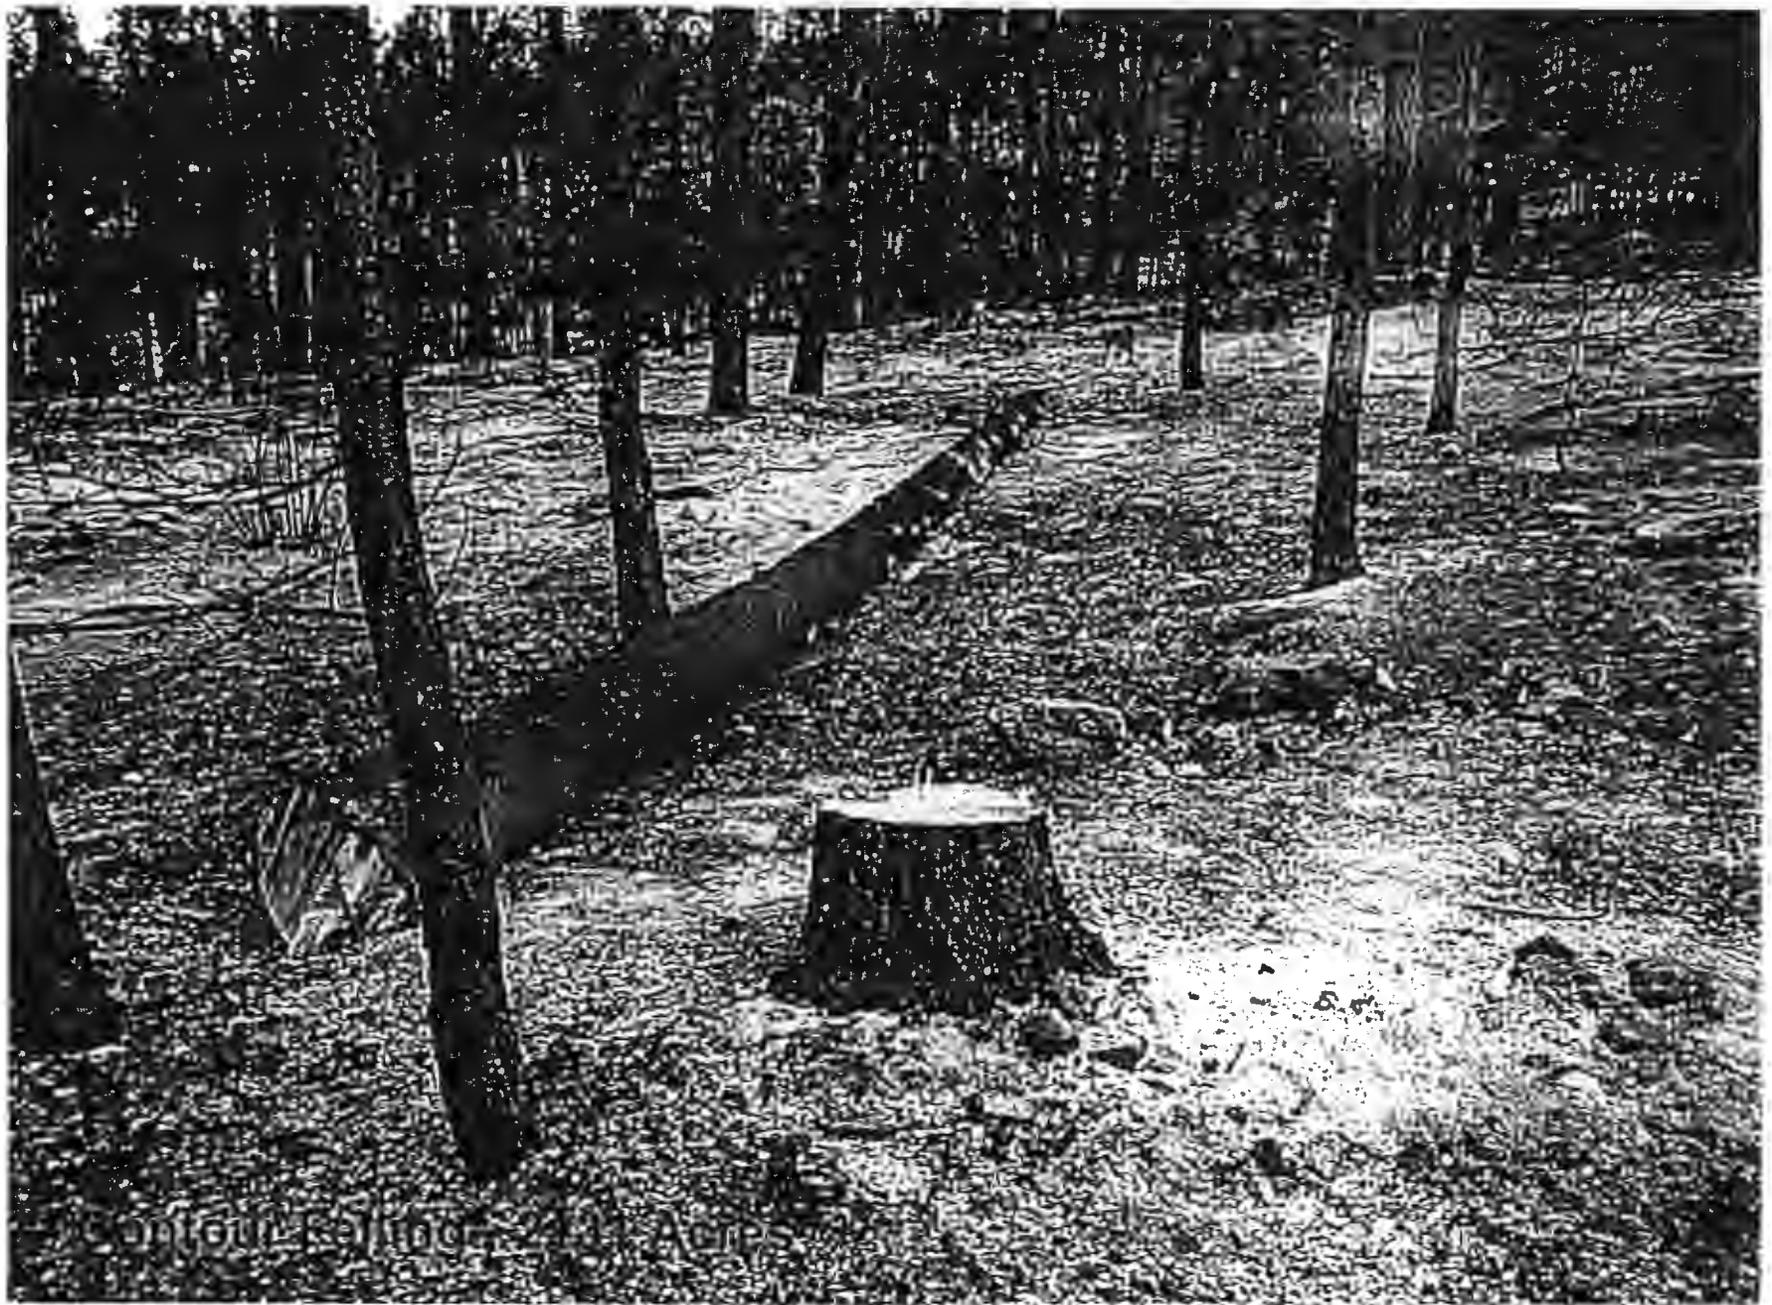
Contour terracing - 1941

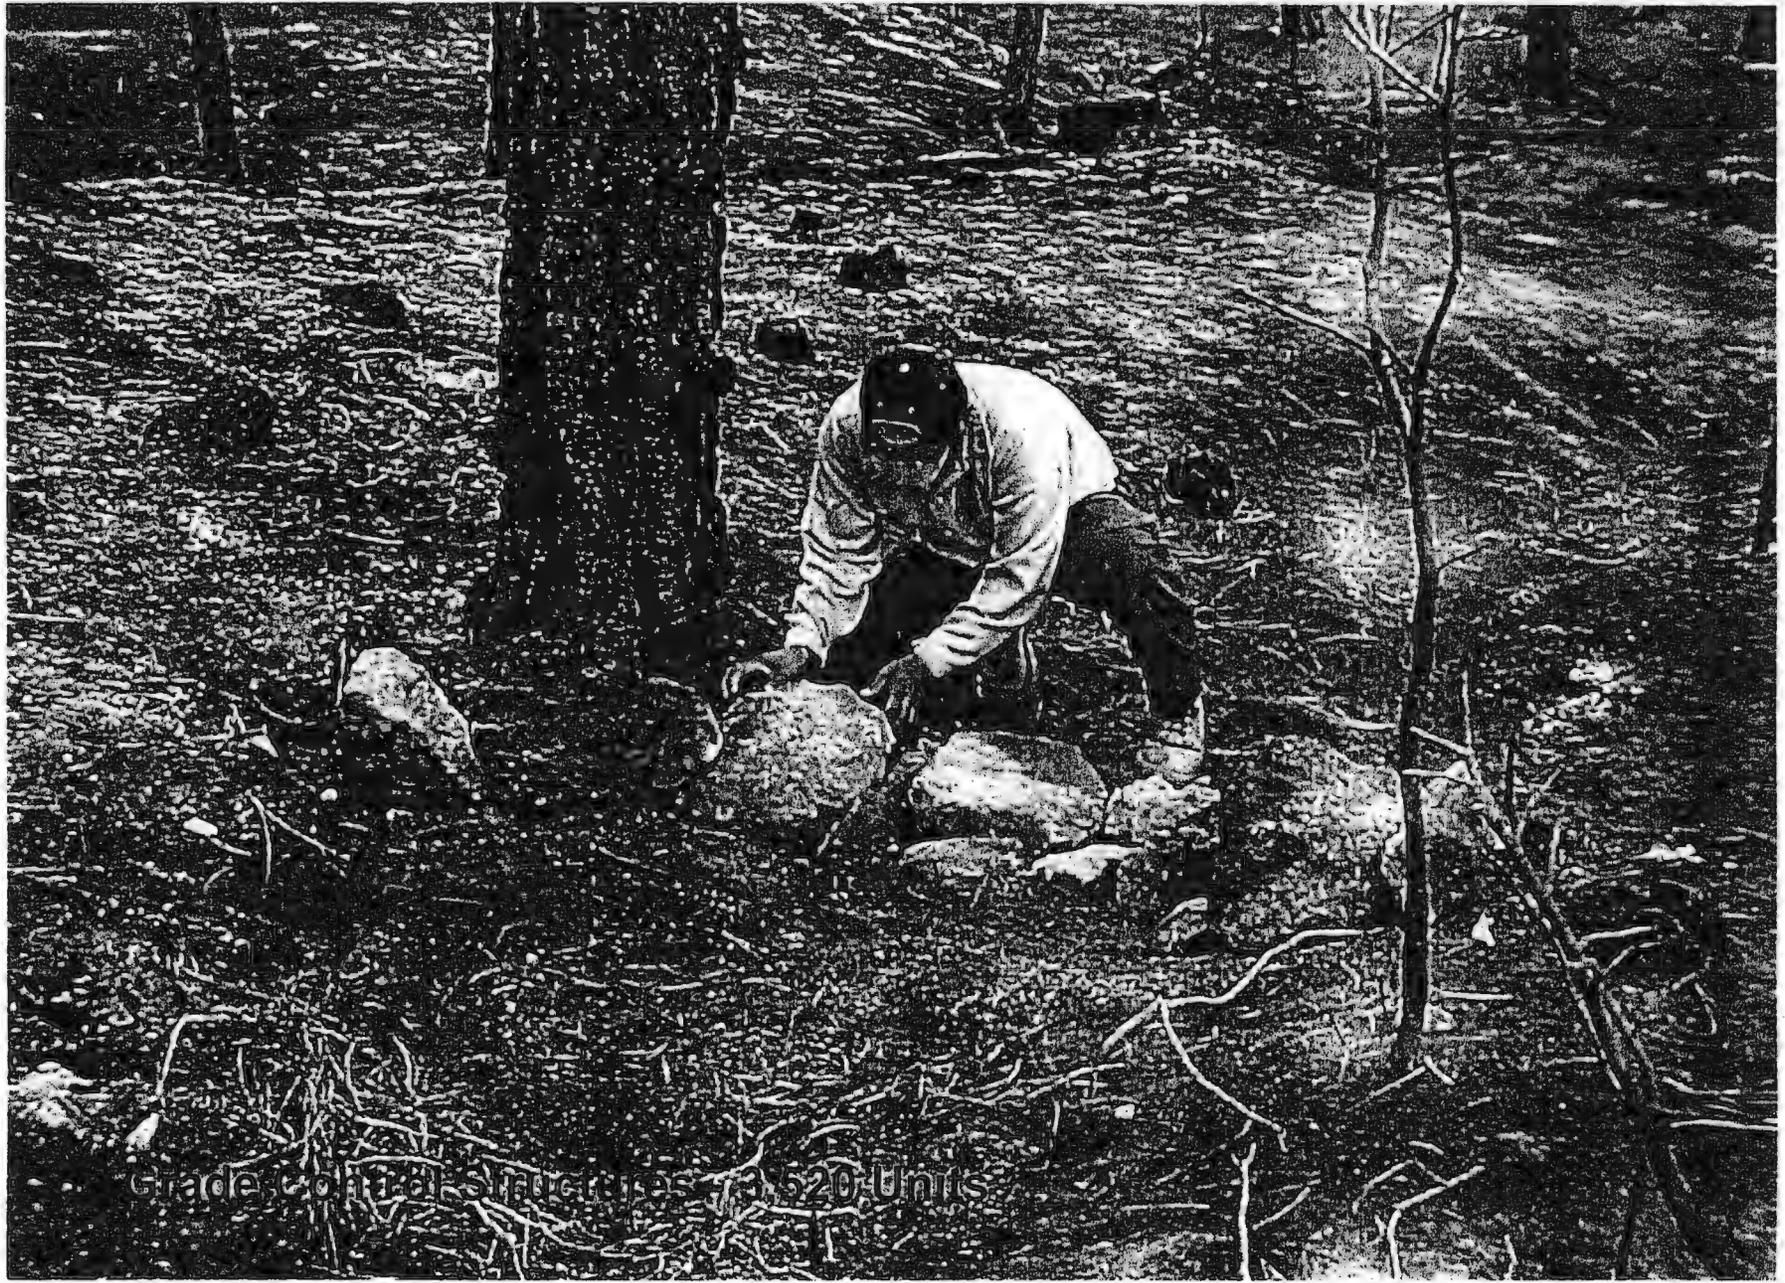
Grade Control Structures 1520 Units
