SUBJECT: NOTIFICATION OF MONITORING WELL ABANDONMENT, LOS ALAMOS NATIONAL LABORATORY

Project Completion Report

Well Plugging and Abandonment

Alluvial Monitoring Wells: PO-3B, PO-4A, PO-4B

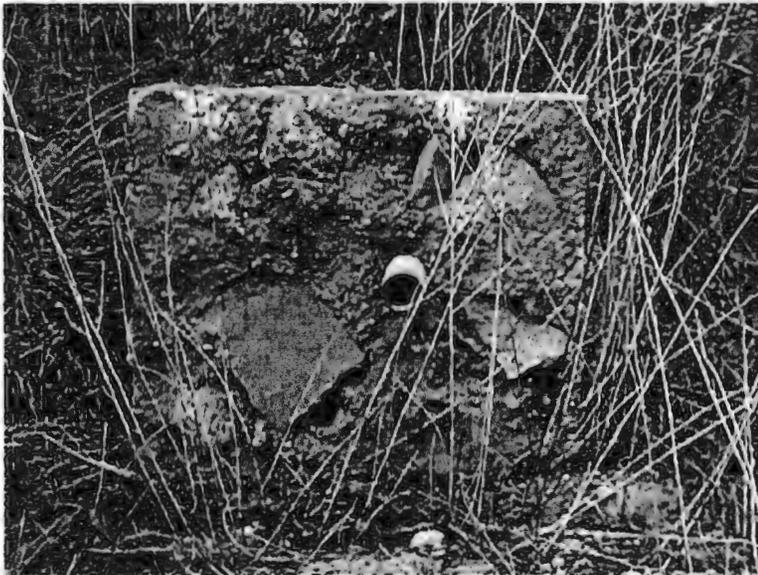
Photograph PO-3B-3
Wellhead removed with part of casing

Well PO-3B was installed in 1956 using a 5-inch diameter auger. The well consisted of 59 feet of 2-inch diameter plastic pipe including 10- feet of perforated well screen. The wellhead consisted of a concrete and rock block fitted with a lockable metal cap. The wellhead was removed in one piece (Photograph PO-3B-3). The well was overdrilled using an 8-inch auger bit. At a depth of approximately 25 feet, the auger penetrated and ripped the well casing. The overdrilling continued to a depth of 60 feet. Shards of the plastic well casing were visible in the drill cuttings (Photograph PO-3B-4) to a depth of 60 feet, confirming that the overdrilling stayed on top of the well throughout the entire depth. The well remained open after the overdrilling was complete. This was confirmed using the auger and, after the auger was removed from the hole, using a tape measure to confirm the depth of the hole. The hole was grouted (Photographs PO-3B-7 and 8) using a Portland cement and bentonite mixture as follows.

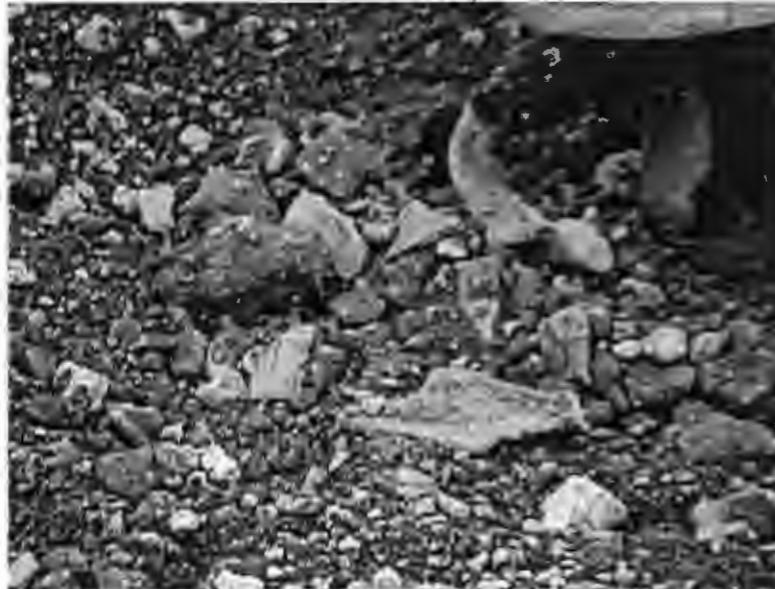
Photograph PO-3B-4
Shards of well casing in drill cuttings

- 1440 Cut through pipe at ~25'. Pipe pieces in the cuttings
- 1502 Pipe casing cuttings still coming out of hole Photo 4 (D1)
- 1515 Finished drilling to 60', pieces of casing coming up in cuttings begin to back anger out of hole. Start to run

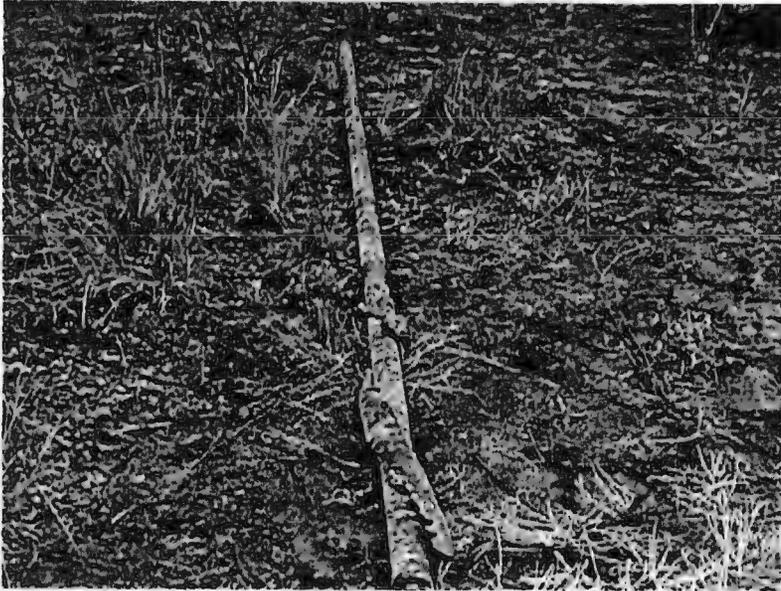
Photograph PO-3B-5
Well casing removed

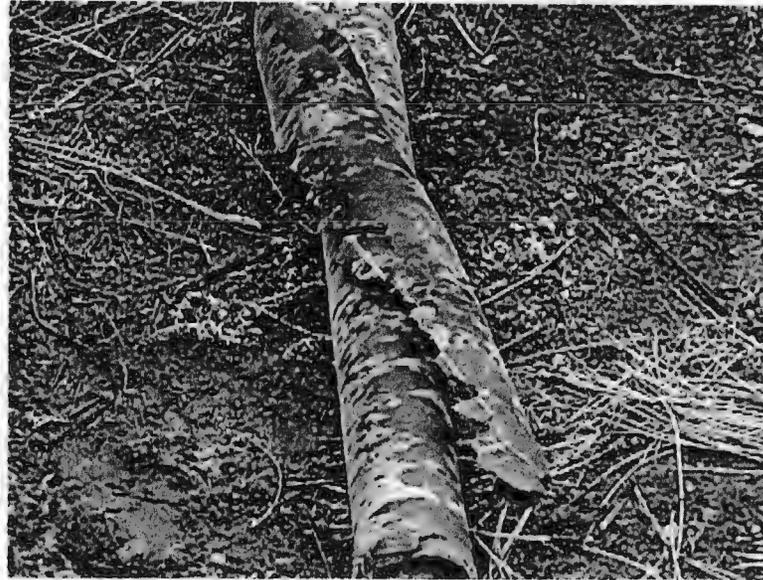
Photograph PO-3B-6
Well casing with portion ripped by auger bit

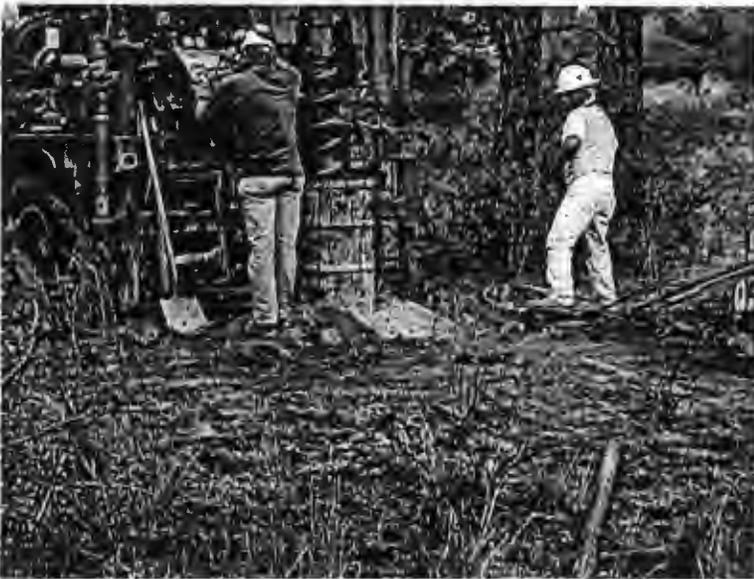
Photograph PO-3B-7
Mixing of grout batch with the rig

No. Of Batches	Batch Size	90# Bags Portland per Batch	# Bags of Bentonite Powder per Batch
4	50-55 gal	3	0.5
1	40-45 gal	2	0.3

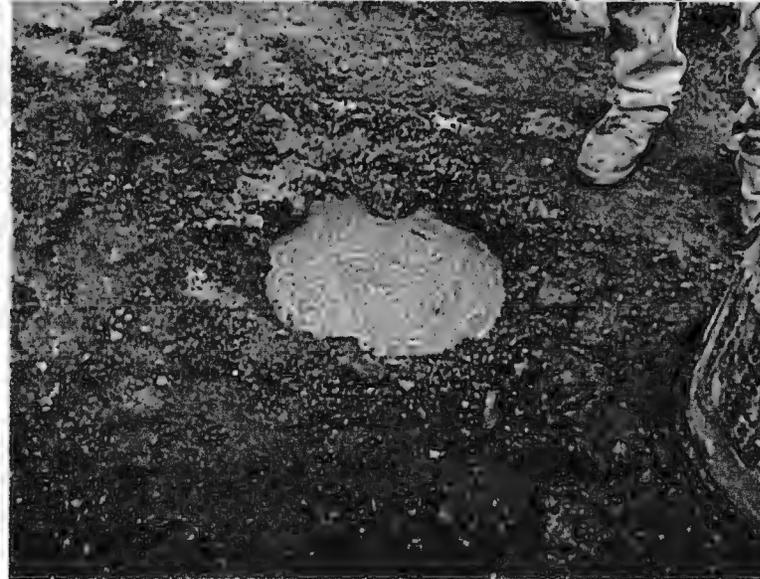
Photograph PO-3B-8
PO-3B filled with grout

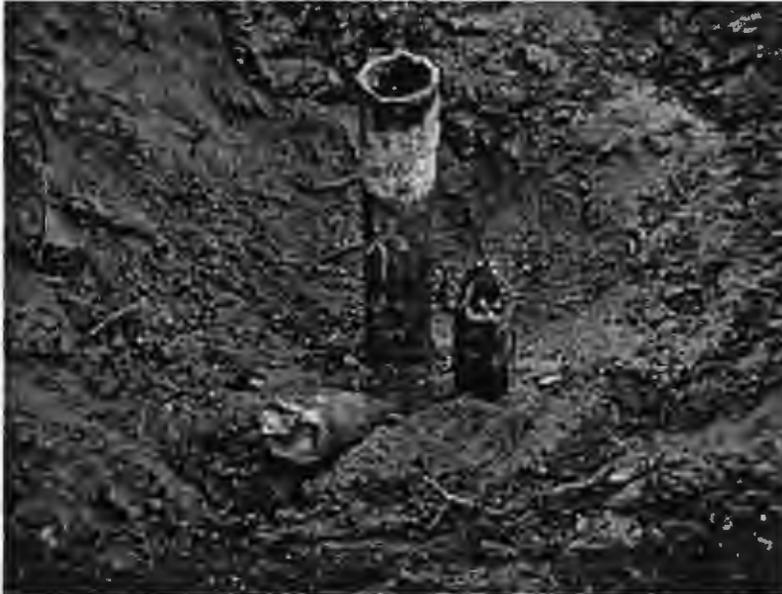
Photograph PO-4A-2
Well casing and two pieces of stove pipe after wellhead removal

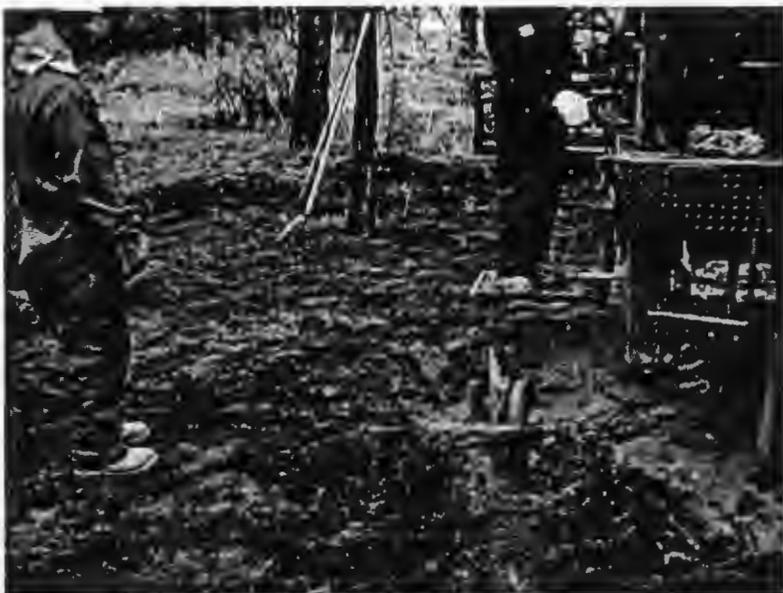
Photograph PO-4A-3
Setup at PO-4A after wellhead removal

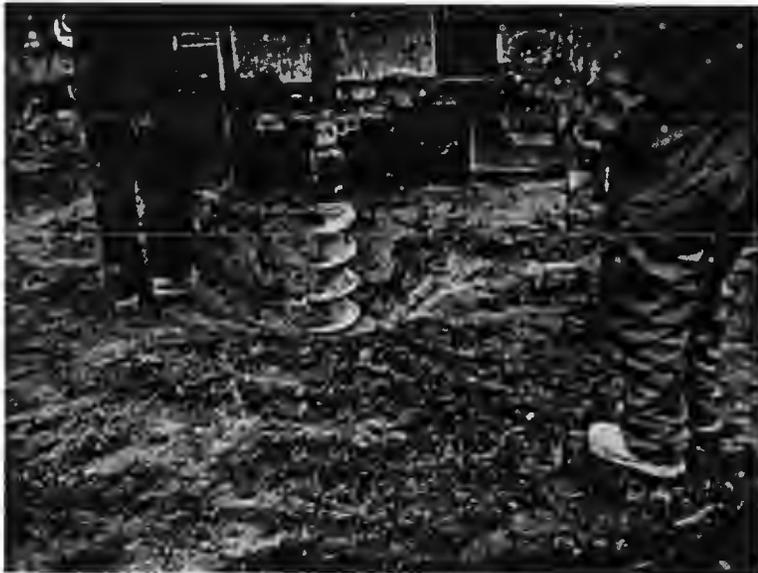
Photograph PO-4A-6
Overdrilling of PO-4A

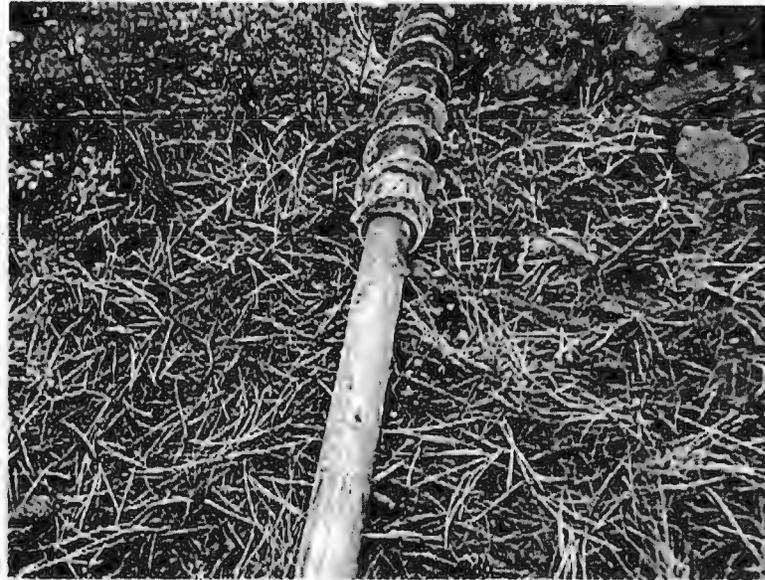
Photograph PO-4A-7
Bottom seven feet of well casing stuck inside of auger flight

1032 At 30' bring auger out, remaining 7' of casing is stuck in auger 02 photos 12 and 14

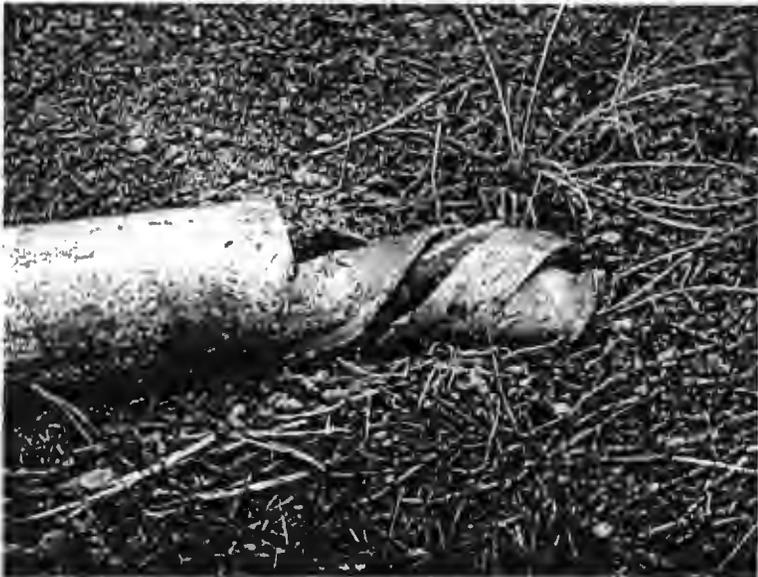
Photograph PO-4A-8
Top 14 feet of casing ripped due to auger torque

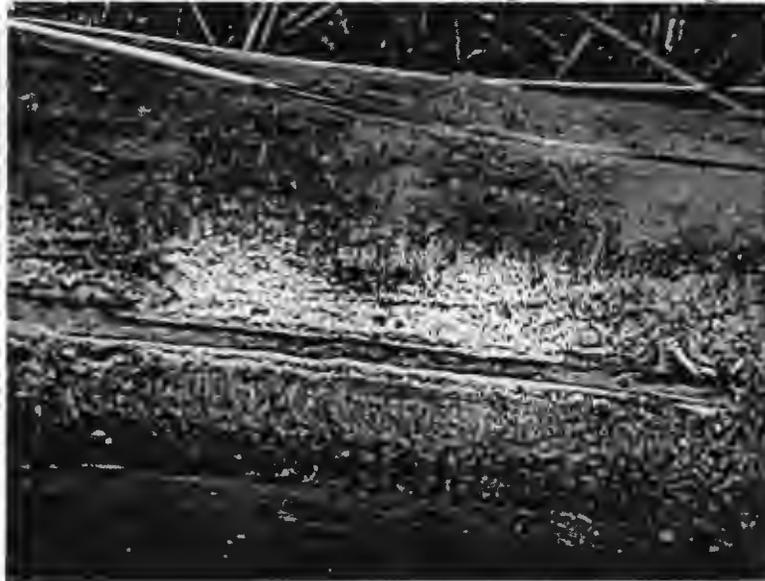
Photograph PO-4A-9
Vertical slots in well casing

Well PO-4A was installed in 1956 using a 5-inch diameter auger. The well consisted of 21 feet of 3-inch diameter galvanized pipe with vertical slots cut into the lower 9 feet of pipe (Photograph PO-4A-9). The wellhead consisted of a concrete and rock block fitted with a lockable metal cap. The wellhead was broken up with a sledgehammer and removed. Removal of the wellhead revealed three pipes protruding from the ground (Photographs PO-4A-2 and 3). Upon investigation, two of the pipes were pieces of sheet metal stovepipe, approximately 2-feet in length. The stovepipe was removed (Photograph PO-4A-5) to provide access to accomplish overdrilling of the well. An attempt was made to overdrill the well using an 8-inch auger bit. The bit encountered a coupling on the casing at a depth of about five feet that was larger than the inner diameter of the auger bit. The torque applied to the coupling caused the well casing to twist and rip at approximately 14 feet in depth (Photograph PO-4A-8). The auger was removed from the hole and the casing pulled using a pulley on the rig. It was decided that the hole would be overdrilled to a depth of 14 feet and the final seven feet of casing would be plugged in place. Upon overdrilling to 14 feet, it was determined that the casing remaining in the hole had entered the auger bit so the overdrilling was advanced to 25 feet, Upon removal of the auger, it was determined that the final seven feet of casing had lodged in one of the auger flights (Photograph PO-4A-7). The well remained open after the overdrilling was complete. This was confirmed using a tape measure to confirm the depth of the hole. The hole was grouted (Photographs PO-4A-10 and 11) using a Portland cement and bentonite mixture as follows.

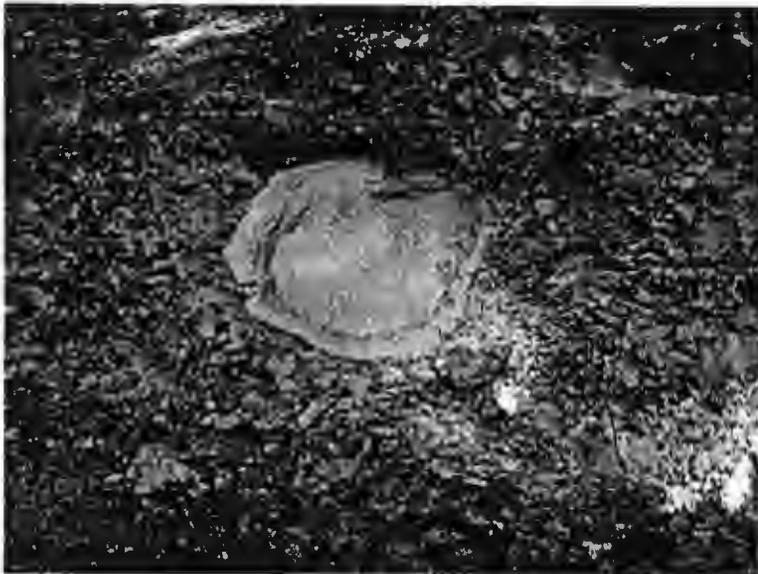
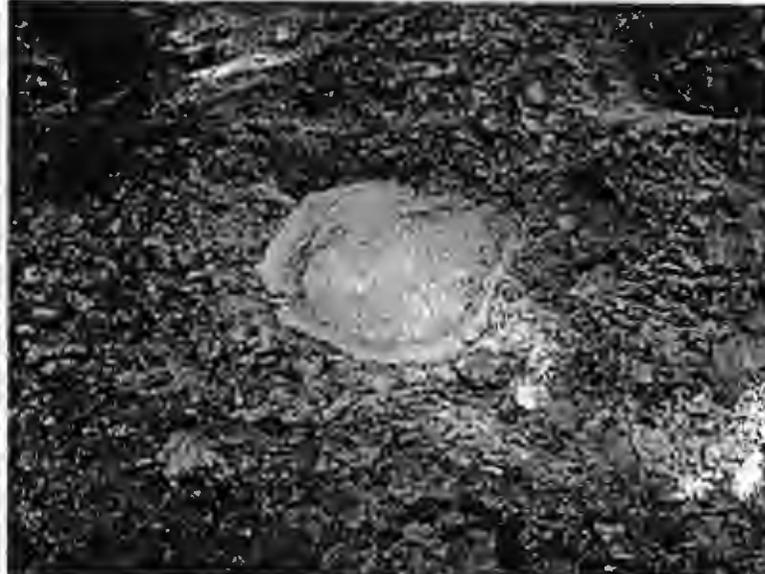
Photograph PO-4A-10
PO-4A Filled with grout

Photograph PO-4A-11
PO-4A Filled with grout

No. Of Batches	Batch Size	90# Bags Portland per Batch	# Bags of Bentonite Powder per Batch
2	50-55 gal	3	0.5

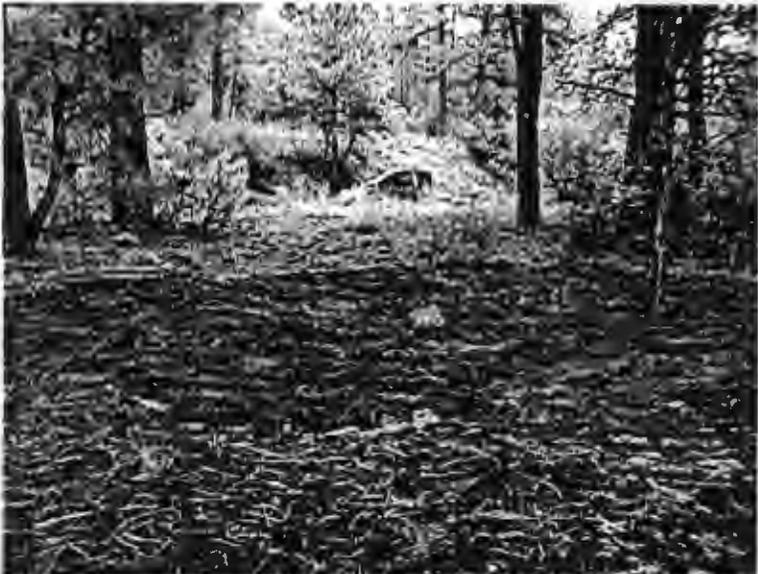
Photograph PO-4A-12
PO-4A site raked and recovered with duff after plugging

When grouting and cleanup was complete, the site was raked down and re-covered with existing duff (Photograph PO-4A-12). The casing was cut into sections using a gas-powered cut-off saw and removed from the site for recycling or disposal. The wellhead concrete was removed from the site for disposal.

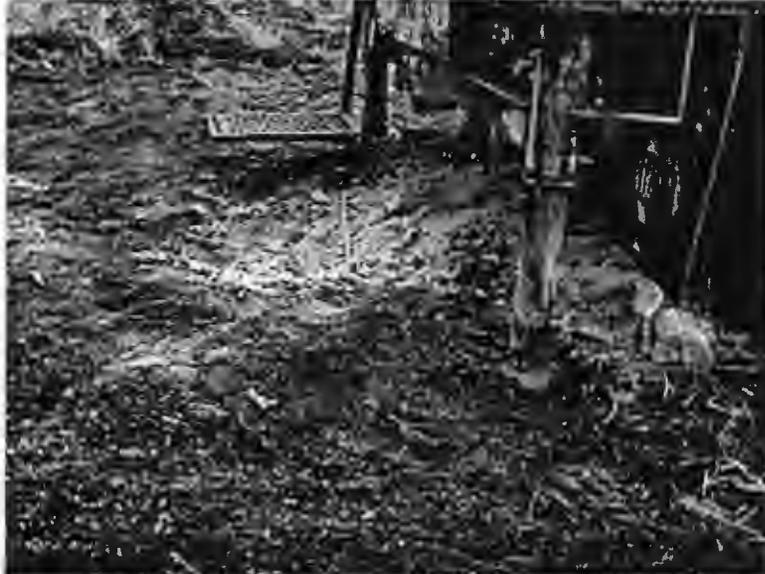
Photograph PO-4B-1
Setup at PO-4B' after wellhead removal

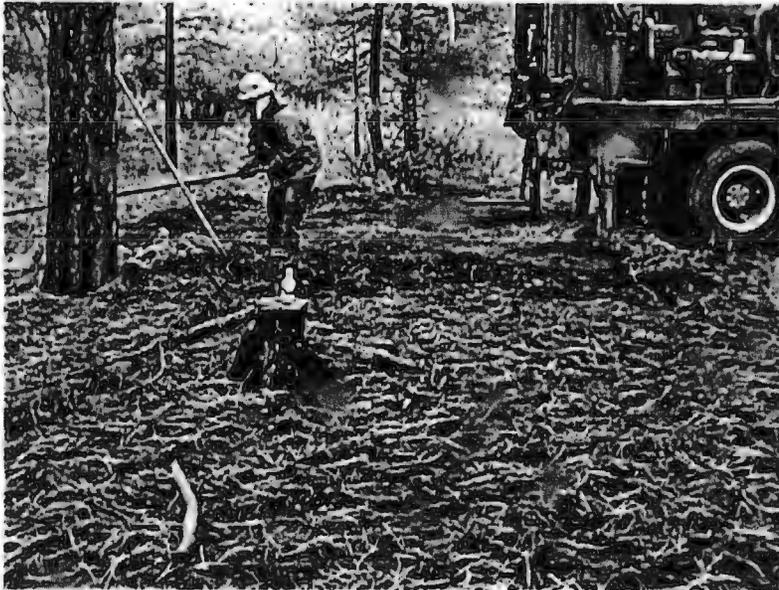
Photograph PO-4B-2
Removal of casing

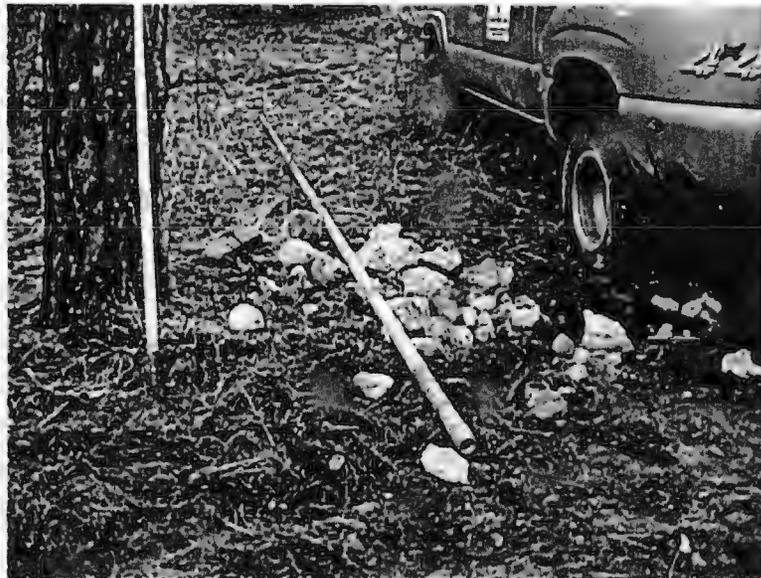
Photograph PO-4B-3
Casing removed and broken up wellhead

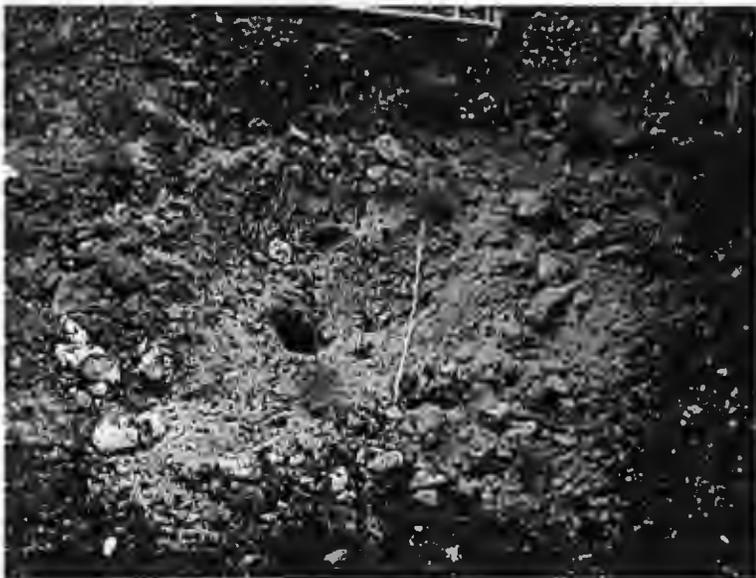
Photograph PO-4B-4
Overdrilled well

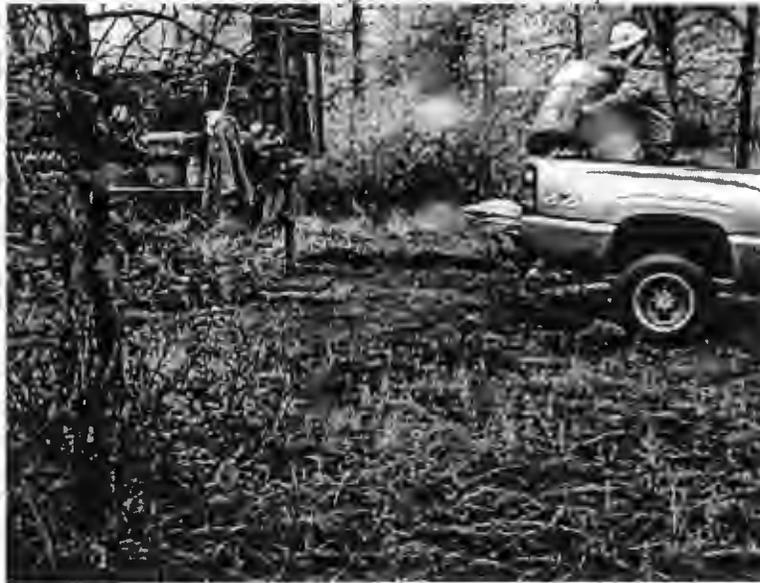
Photograph PO-4B-5
Setup for grouting at PO-4B

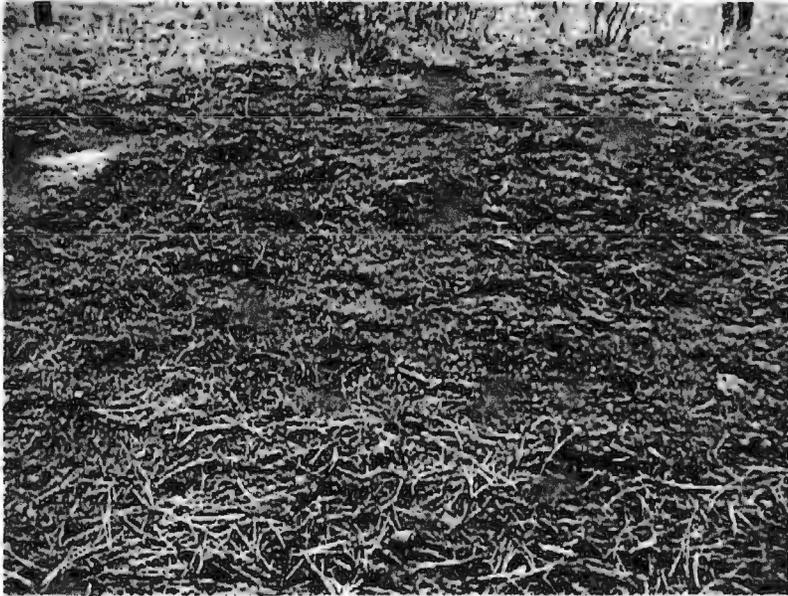
Photograph PO-4B-6
PO-4B after raking and covered with duff

Well PO-4B was installed in 1956 using a 5-inch diameter auger. The well consisted of 36 feet of 1.5-inch diameter galvanized pipe with a well point. The wellhead consisted of a concrete and rock block fitted with a lockable metal cap. An attempt was made to remove the well head in one piece but the well casing began to come out of the ground with the well head so it was broken apart using a sledge hammer (Photograph PO-4B-3). The well was overdrilled (Photograph PO-4B-4) using an 8-inch auger bit to a depth of 35 feet and the casing was removed (Photograph PO-4B-2). The well remained open after the overdrilling was complete. This was confirmed using the auger and, after the auger was removed from the hole, using a tape measure to confirm the depth of the hole. The hole was grouted (Photograph PO-4B-6) using a Portland cement and bentonite mixture as follows.

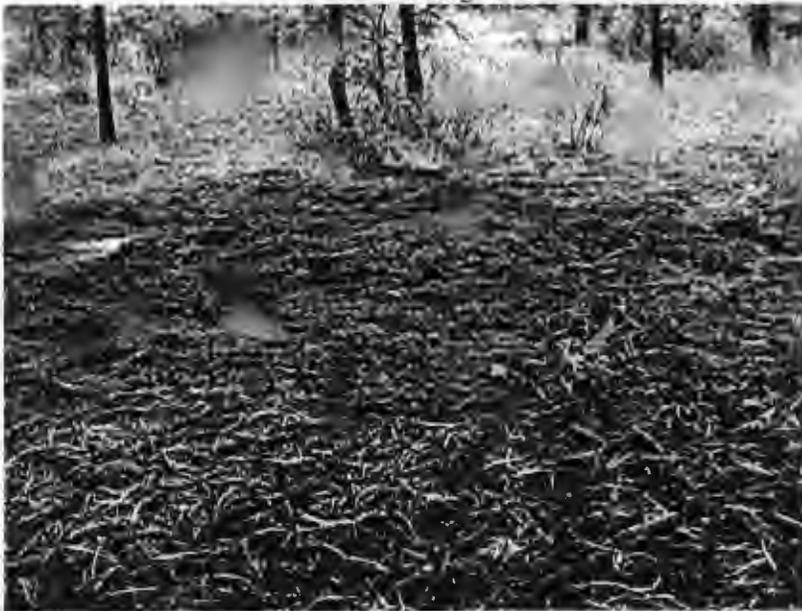
Photograph PO-4B-7
PO-4B after raking and covered with duff

When grouting and cleanup was complete, the site was raked down and re-covered with duff (Photographs PO-4B-7 and 8). The casing was cut into 8-foot sections with a gas powered cut-off saw and removed from the site for recycling or disposal. The wellhead concrete was removed from the site for disposal.
