LA-UR-01-66

*Title:* Sandia Wetland Evaluation

*Authors:* Kathryn Bennett, David Keller, and Rhonda Robinson

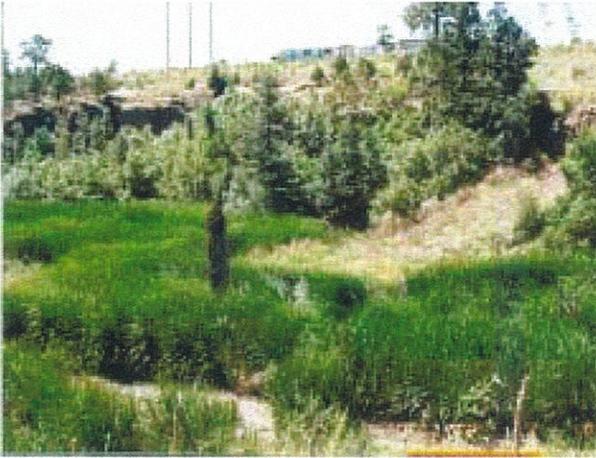
*Figure 2a: A 1990 photograph of upper Sandia wetland showing persistent vegetation that completely surrounds the snag (center of photo).*

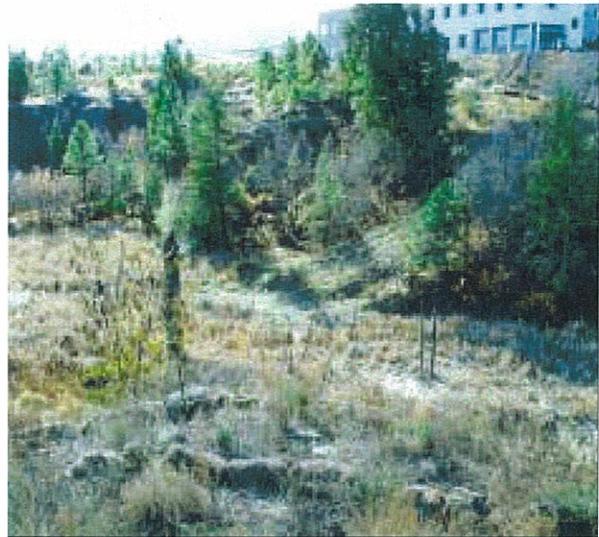
*Figure 2b: A 2000 photograph of upper Sandia wetland showing a change in wetland vegetation. Wetland vegetation no longer completely surrounds the snag (center of photo).*

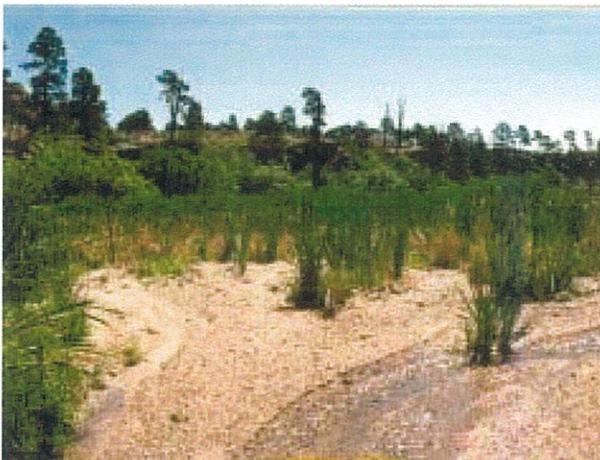
*Figure 3a: A 1990 photograph of upper Sandia wetland showing a broad, diffused stream channel with cattails.*

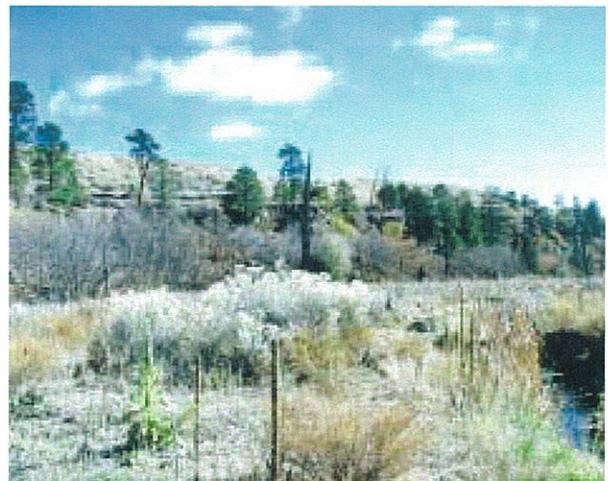
*Figure 3b: A 2000 photograph of upper Sandia wetland showing an incised channel with a change of vegetation type.*

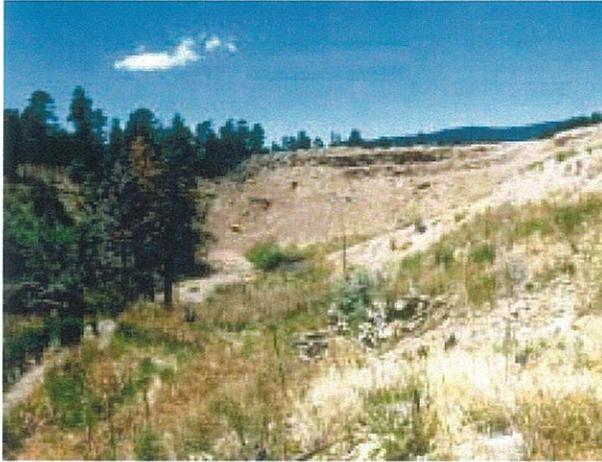
*Figure 4a: A 1990 photograph of upper Sandia wetland below the rubble landfill. Cattails can be seen adjacent to the stream channel.*

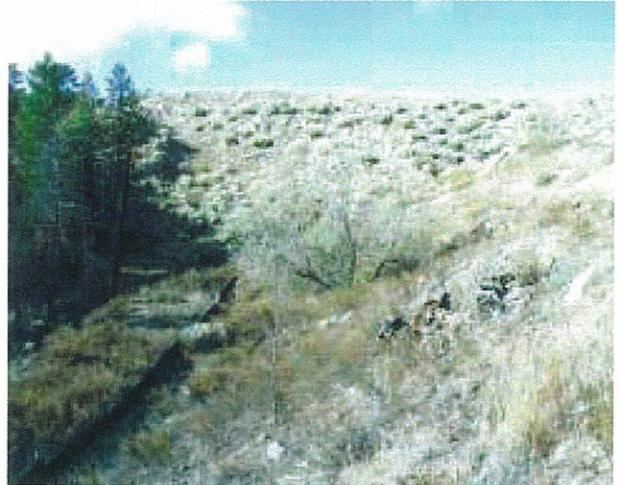
*Figure 4b: A 2000 photograph of upper Sandia wetland below the rubble landfill. Stream channel is incised and vegetation is dominated by false tarragon (*Artemisia dracunculoides*).*

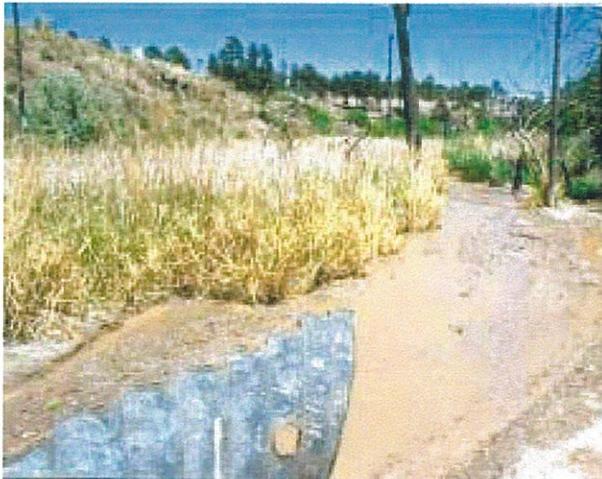
*Figure 5a: A 1990 photograph of upper Sandia wetland at the culvert by the rubble landfill showing a wide, diffused (braided) stream channel with cattails.*

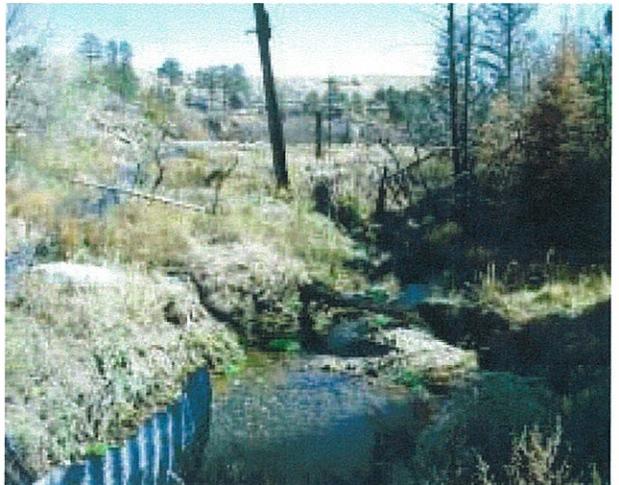
*Figure 5b: A 2000 photograph of upper Sandia wetland at the culvert showing an incised stream channel and increased sedimentation below the sediment fence.*

- control releases of discharge volumes,
- control sediment input (current best management practices [BMPs] need to be evaluated, revised/increased, and monitored),
- install a series of small check dams within the stream channel of the wetland (low-disturbance methods are recommended using material found on site),
- mitigate any areas of head cutting with head cut control structures (Zeedyk 1999) (use low-disturbance methods such as logs found

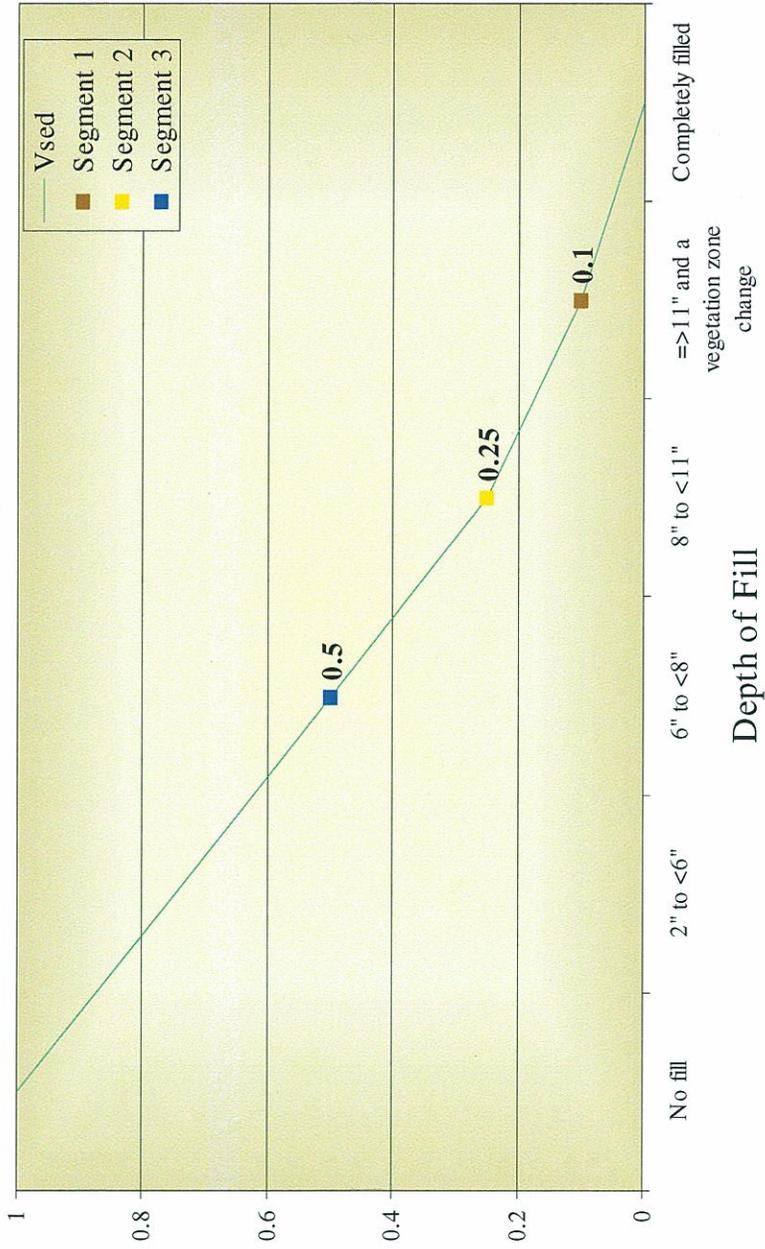
Figure 12. Sediment delivered to a wetland calculated for each segment of the Sandia wetland.

Determined by measuring sediment in the three different segments.
