LA-13892-MS

*Description of the Cerro Grande Fire
Laser-Altometry (LIDAR) Data Set*

*J. William Carey
Greg Cole*

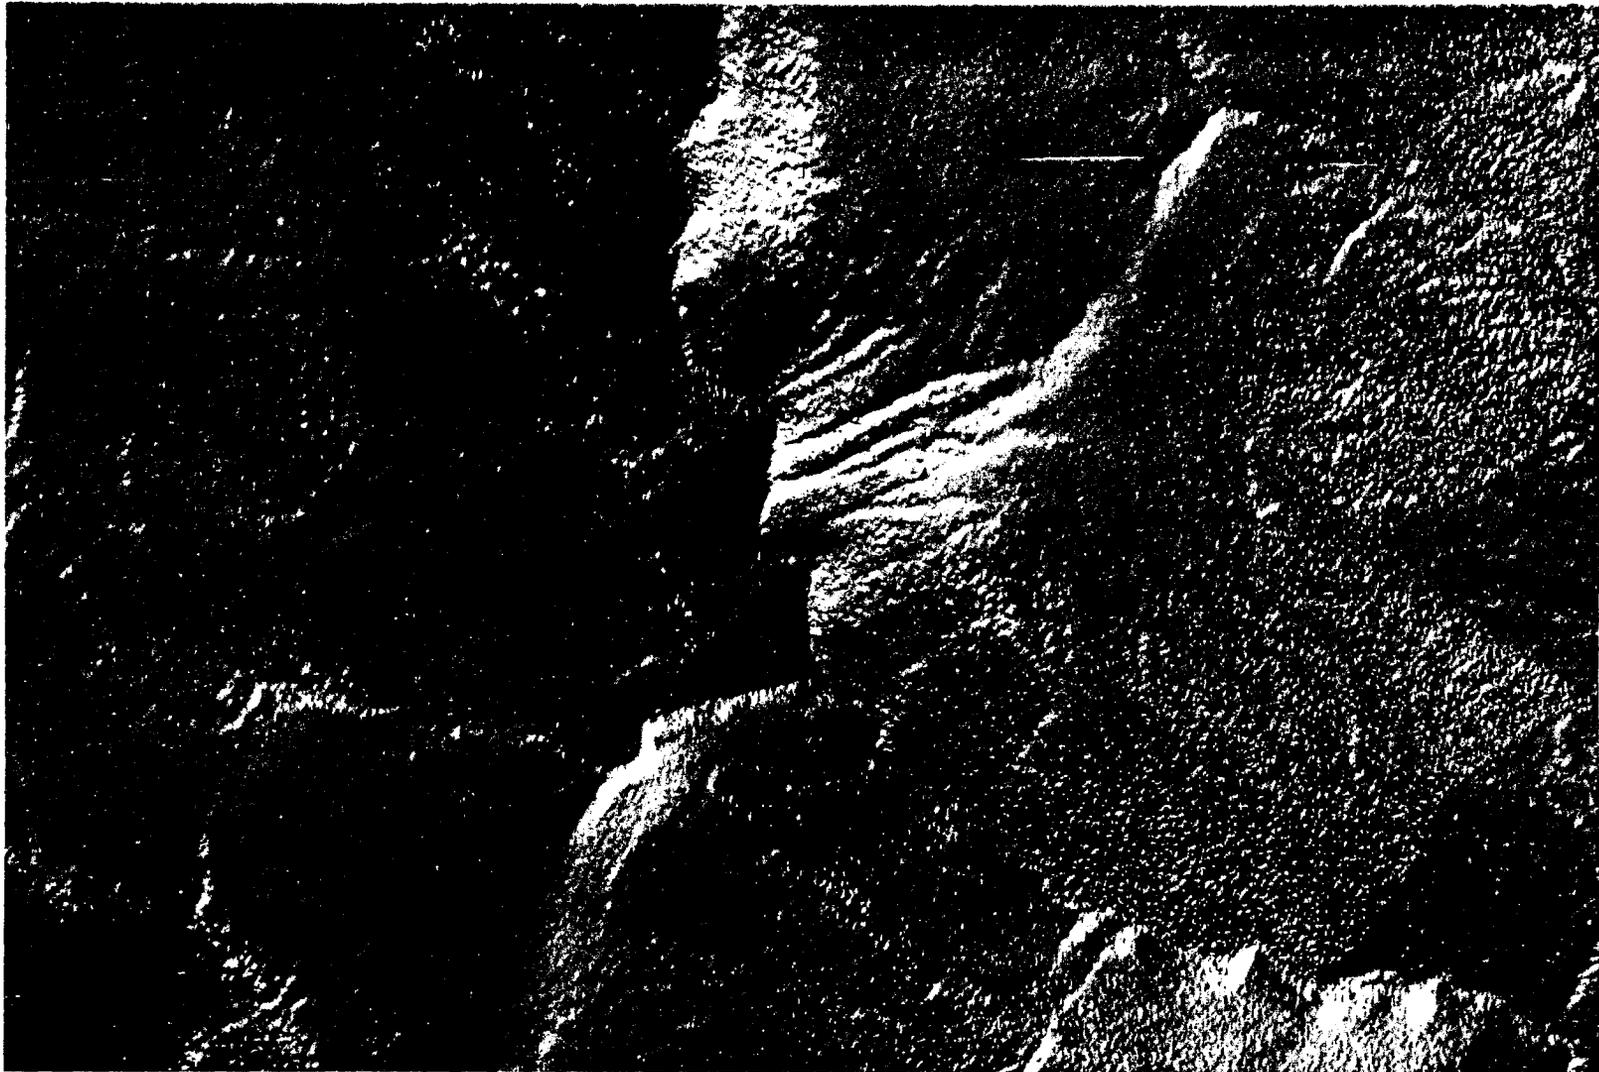
Figure 13. Shaded-relief image of one tile (778609) from the 1' ALSM DEM bare-earth data set. The image illustrates several artifacts including hashing (east side of image) and striping (top-central part of image).
