**Closure Certification Report for the TA-54, Area L Hazardous
Waste Treatment/Storage Tanks, Revision 0.0
LA-UR-06-6756**

Closure Certification Report for the TA-54, Area L Hazardous Waste Treatment/Storage Tanks

Revision 0.0

June 2003

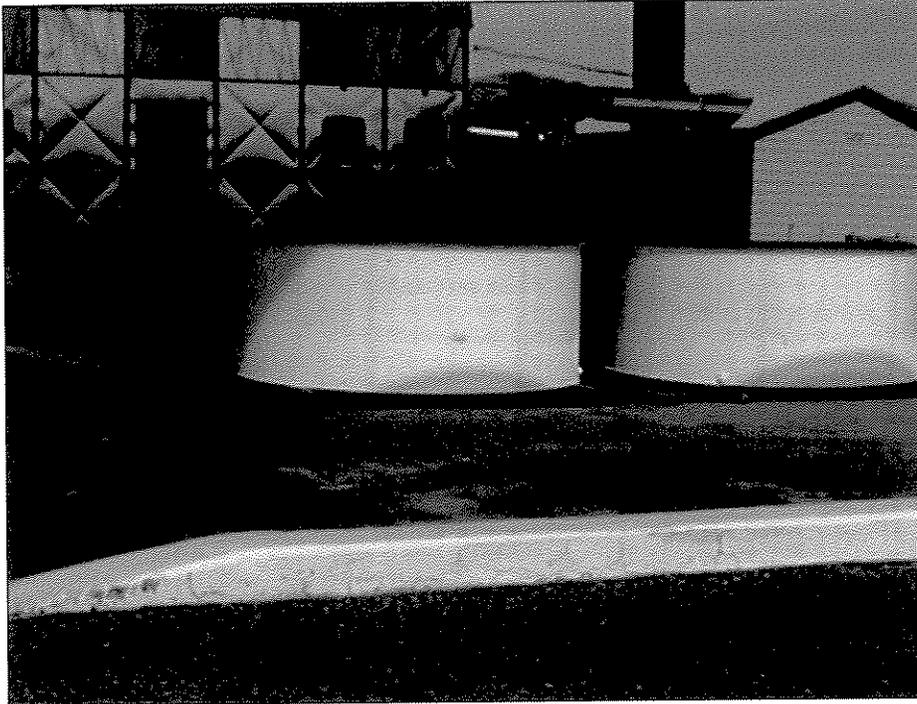
Figure 3. Photographs Documenting Closure Activities

View from southeast. Entrance to pad TA-54-35 on left. Tank 1 on left. Tank 2 on right. Tanks positioned on 4-inch by 4-inch wood beams. Covers removed.

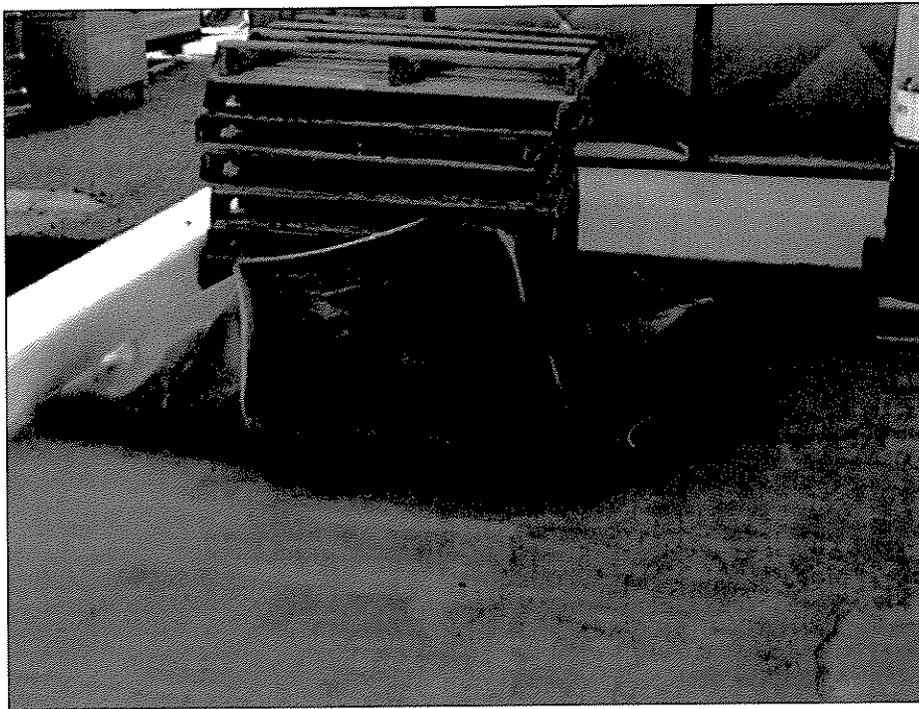
View from west. Containment pad TA-54-58 to west of pad TA-54-35. New, unused liners removed from Tank 1 and Tank 2.

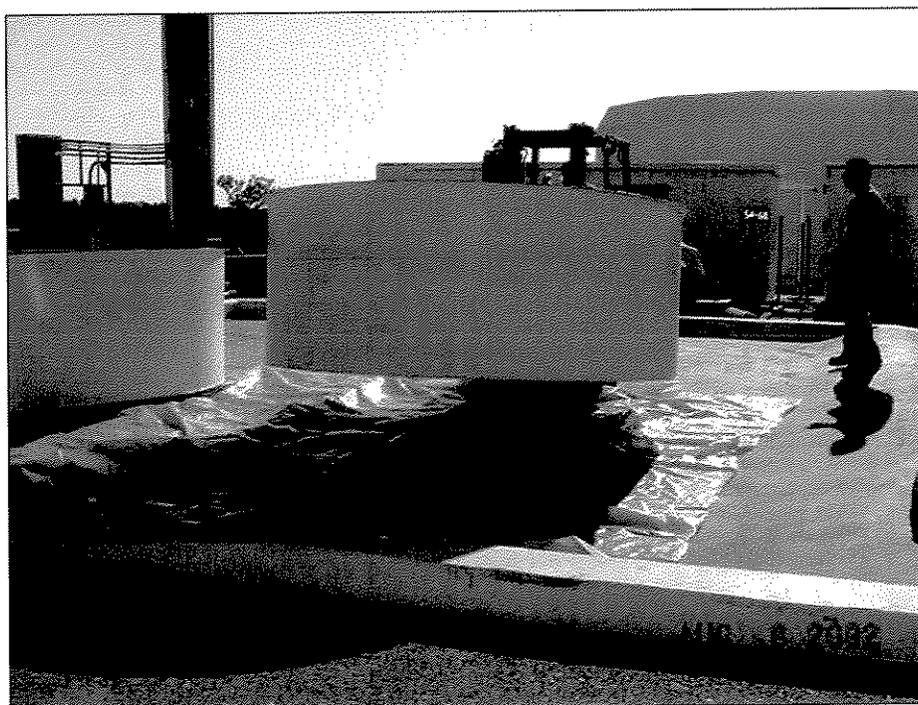
Figure 3. Photographs Documenting Closure Activities (Continued)

View from southwest. Additional supports and plastic sheet in place. Repositioning Tank 1 on supports.

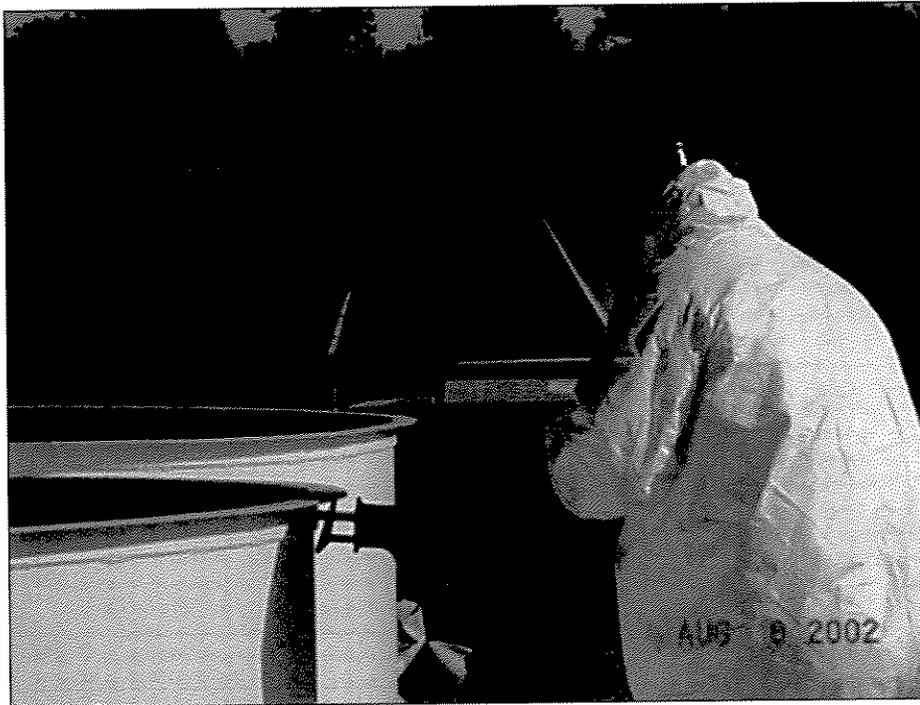
Figure 3. Photographs Documenting Closure Activities (Continued)

View from south. Close up of crew beginning to cut Tank 1 in half with reciprocating saw.

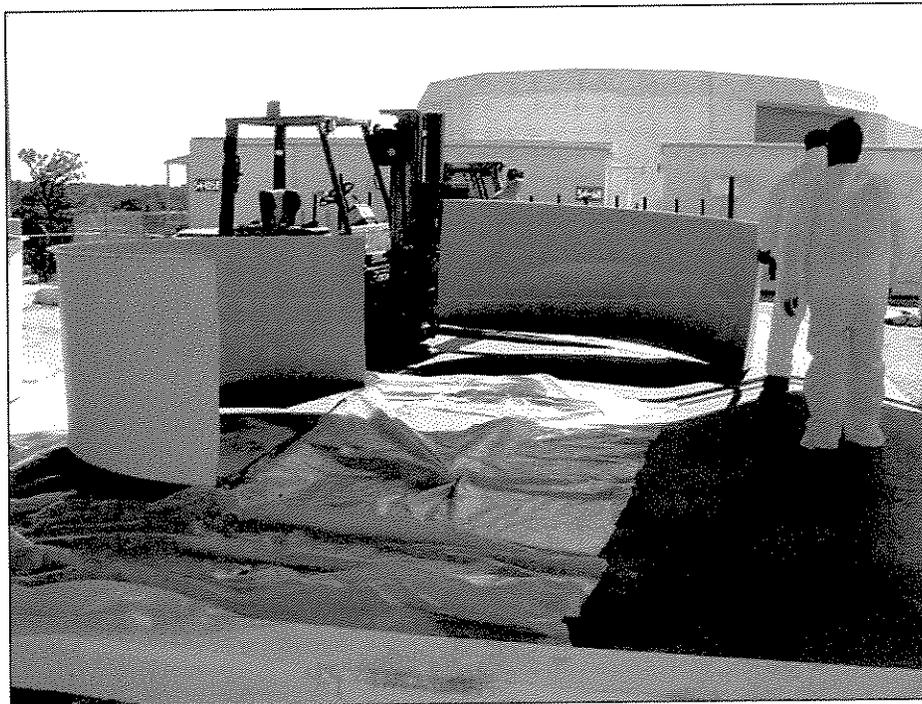
View from west. Tank 1 sections being removed from pad TA-54-35 with forklift.

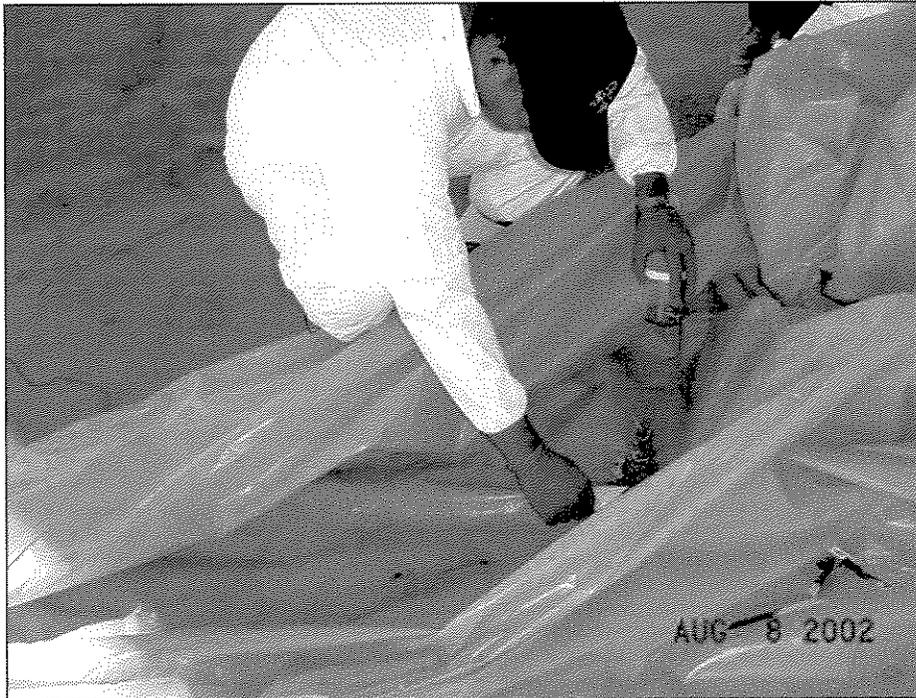
Figure 3. Photographs Documenting Closure Activities (Continued)

View from northeast. Tanks 2 cutting debris sample collection. Used saw blades on bottom right.

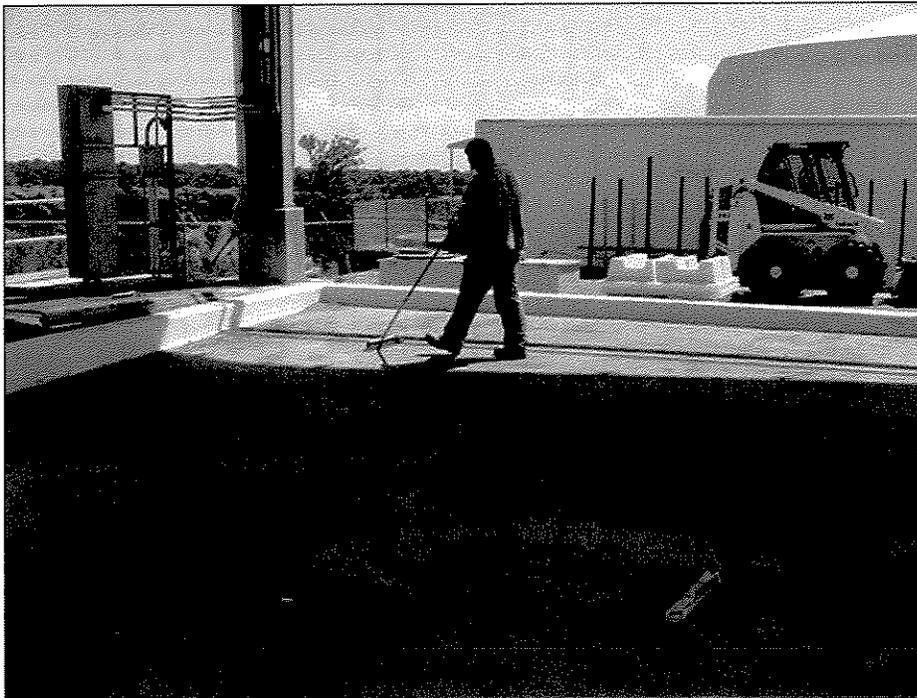
View from west. Crew sweeping Pad TA-54-35.

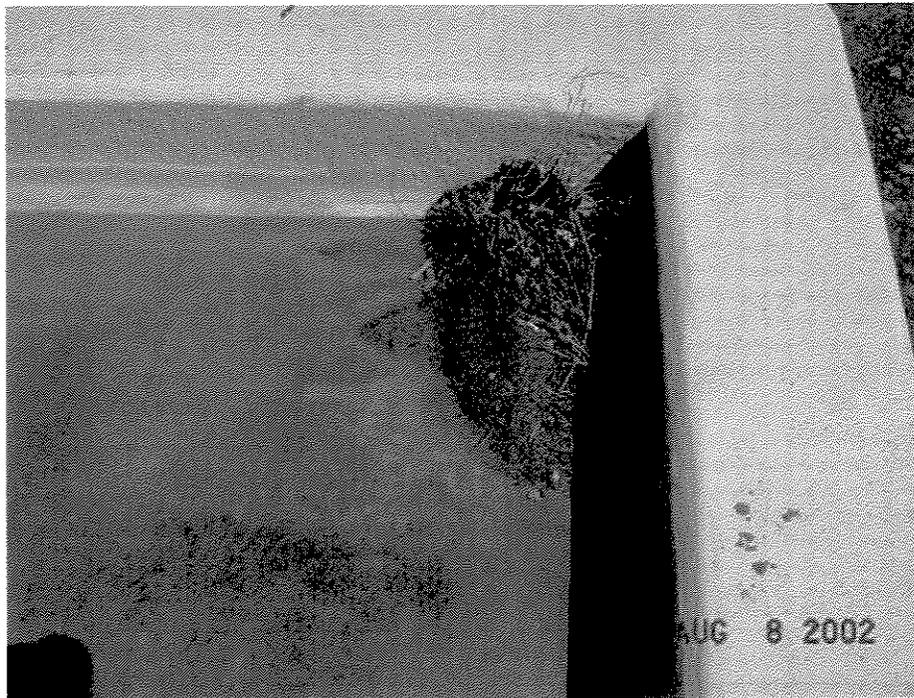
Figure 3. Photographs Documenting Closure Activities (Continued)

View from south. Northwest corner of Pad TA-54-35. Sweepings.

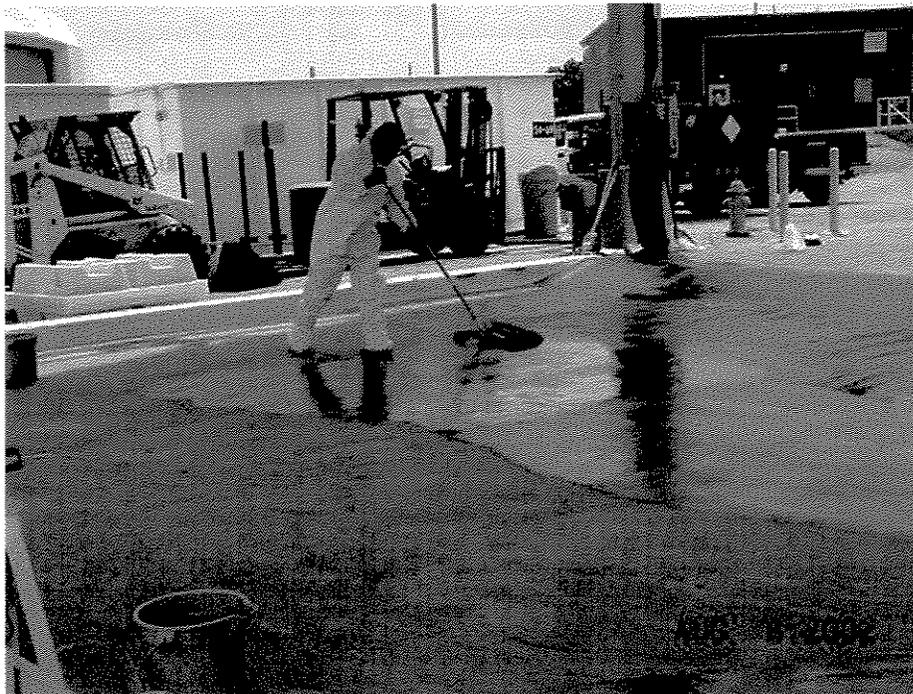
View from northwest. Crew decontaminating Pad TA-54-35. Sampler preparing sample labels for wash water samples.

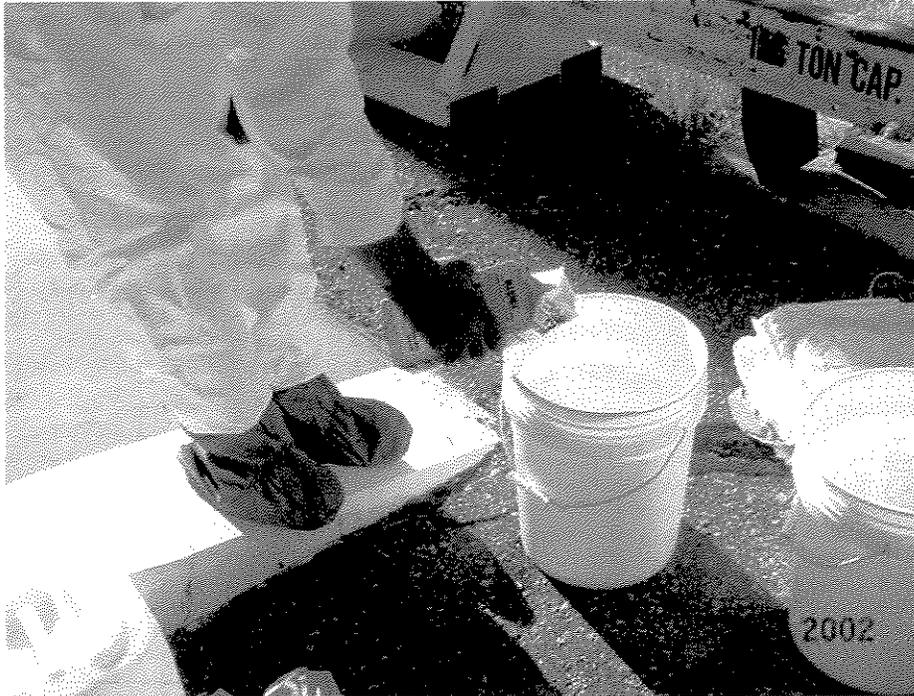
Figure 3. Photographs Documenting Closure Activities (Continued)

View from northeast. Pad TA-54-35 decontamination round 2. Mixing washwater solution of water and Alconox.

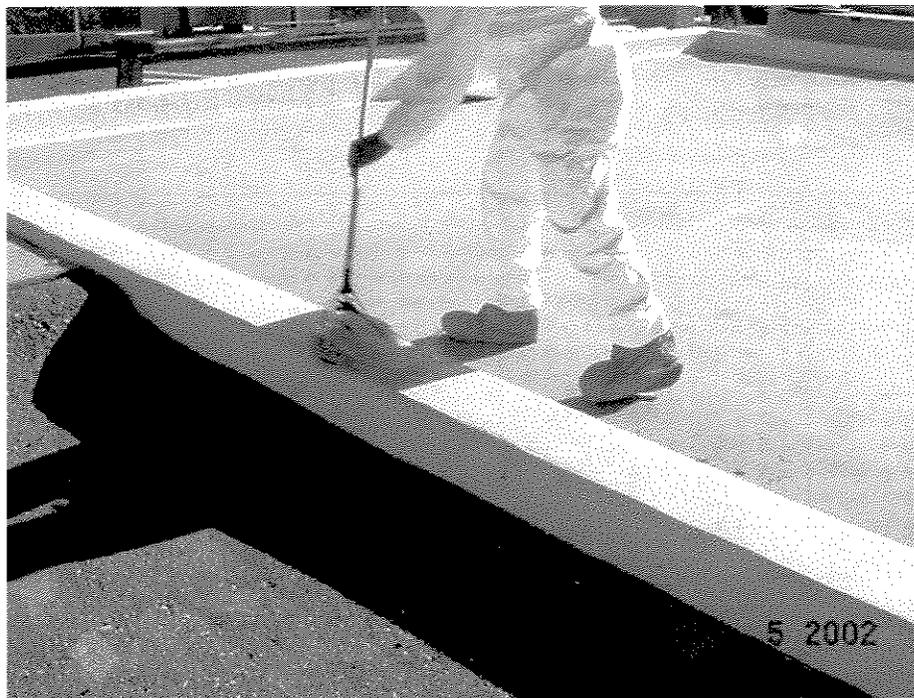
View from southwest. Pad TA-54-35 decontamination round 2. First wash down. Mopping berm.

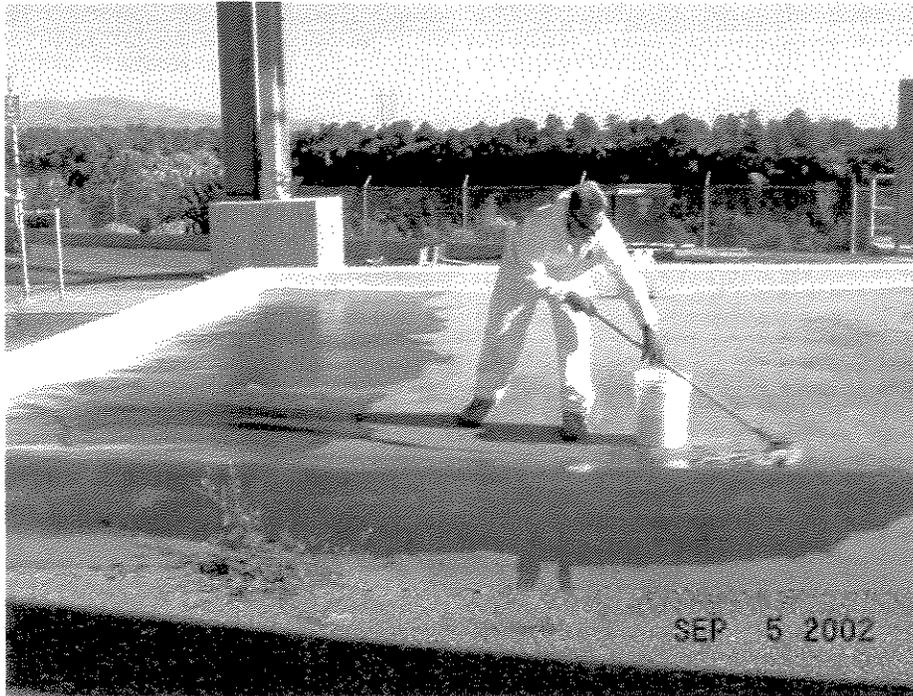
Figure 3. Photographs Documenting Closure Activities (Continued)

View from south. Pad TA-54-35 decontamination round 2. First wash down. Mopping pad.

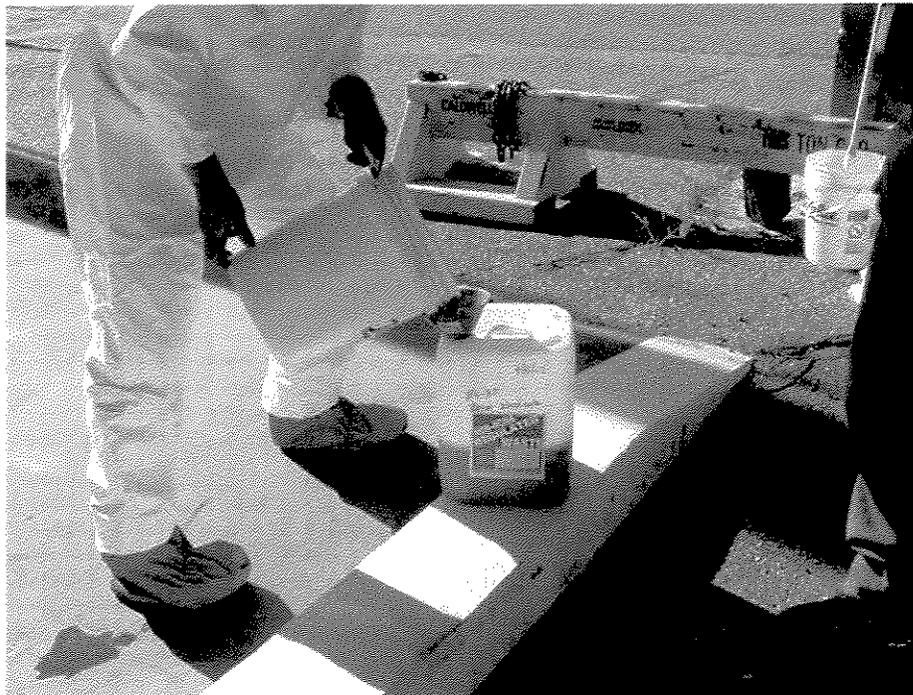
View from northwest. Pad TA-54-35 decontamination round 2. First wash down. Collecting used wash water in 5 gallon carboy (same carboy used for round 1 decontamination activities performed on 8/8/02).
