Site Discharge Pollution Prevention Plan

Los Alamos National Laboratory
NPDES Permit No. NM0030759, April 7, 2011

LA-UR 11-1554 • EP-DIR-PLAN-10006, R.0

Water Canyon & Cañon de Valle Watershed

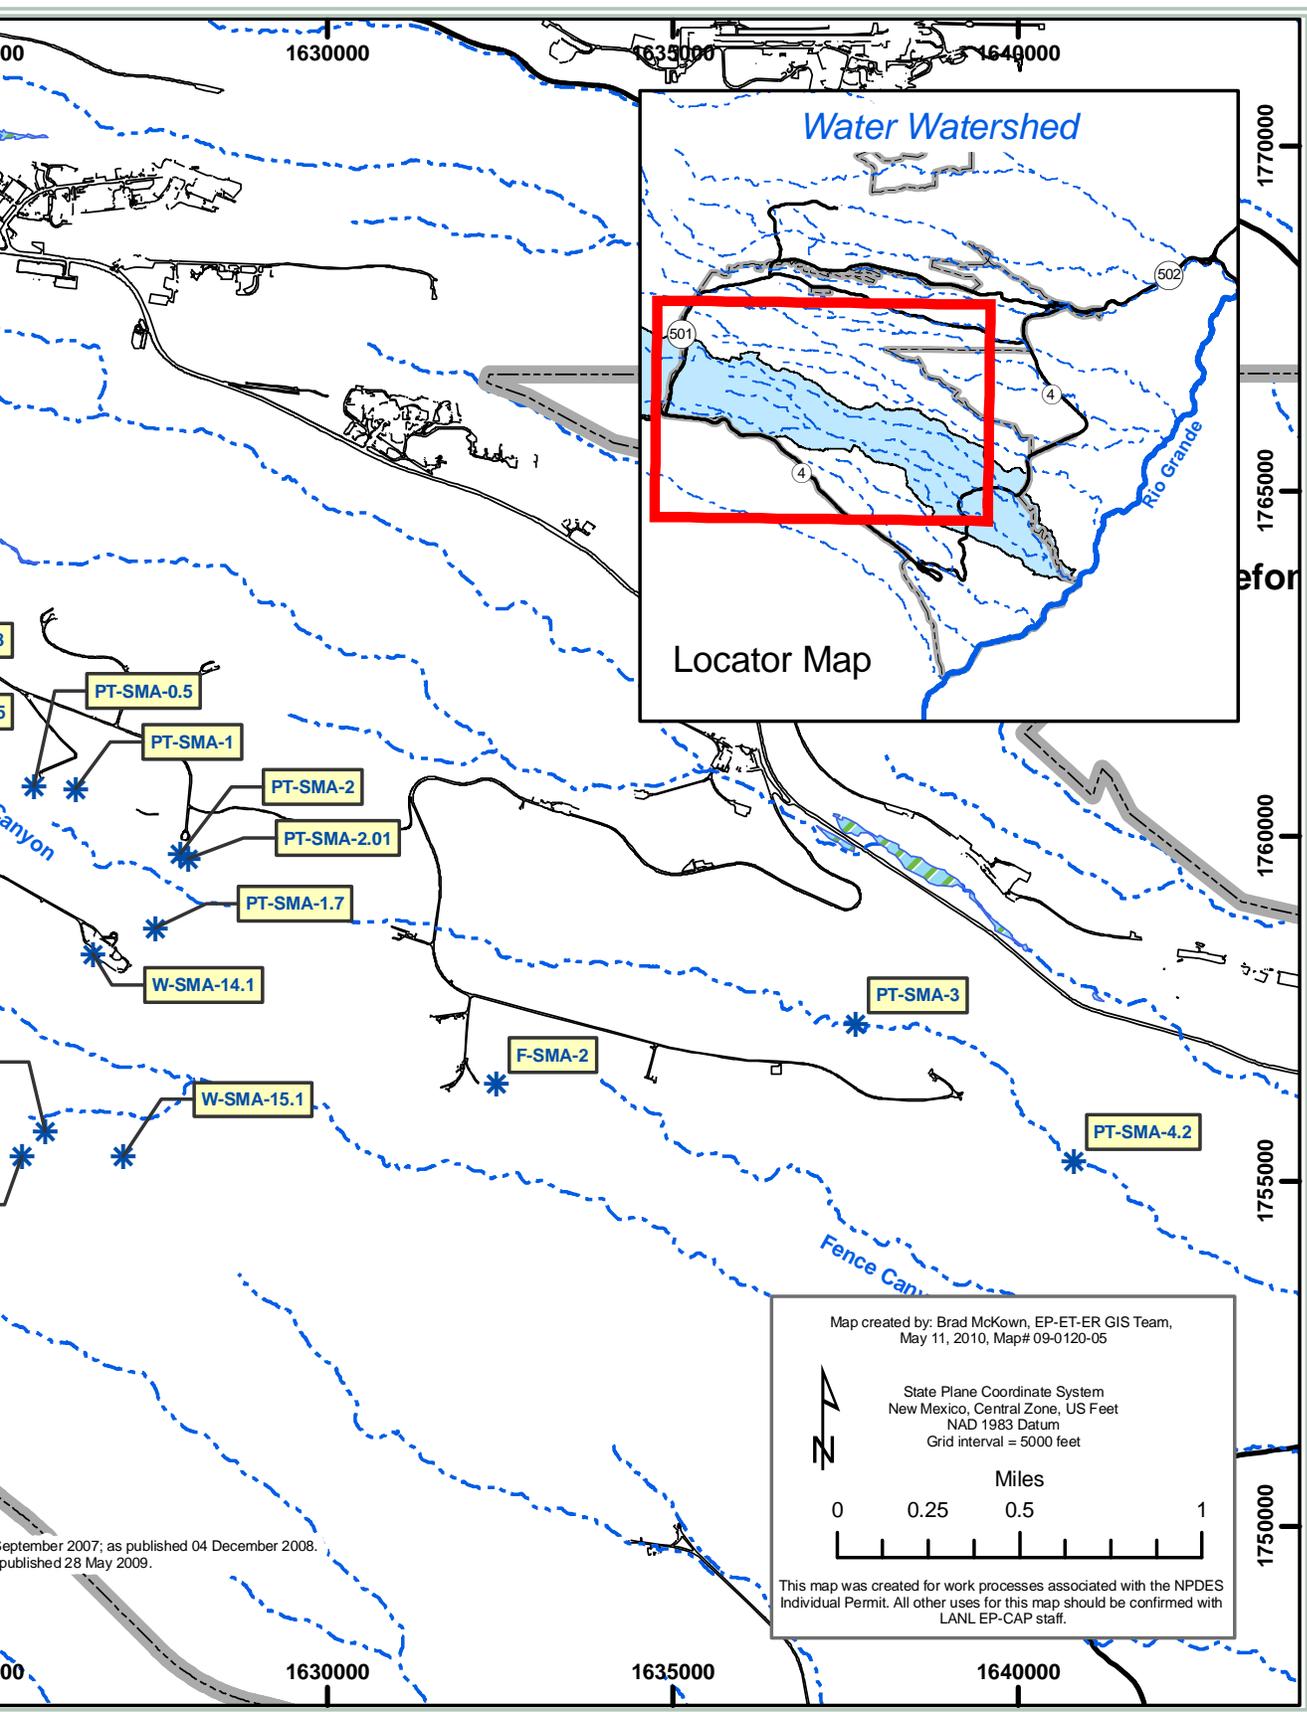
Map created by: Brad McKown, EP-ET-ER GIS Team,
 May 11, 2010, Map# 09-0120-05
