*Title:* FISCAL YEAR 2011 SITE-WIDE ENVIRONMENTAL  
IMPACT STATEMENT MITIGATION ACTION PLAN  
ANNUAL REPORT, REVISION 2  
MARCH 2, 2012

*Preparers:* SWEIS Project Office  
Jennifer E. Nisengard, Environmental Protection Division,  
Environmental Stewardship Group (ENV-ES)  
John S. Isaacson, Environmental Protection Division (ENV-DO)

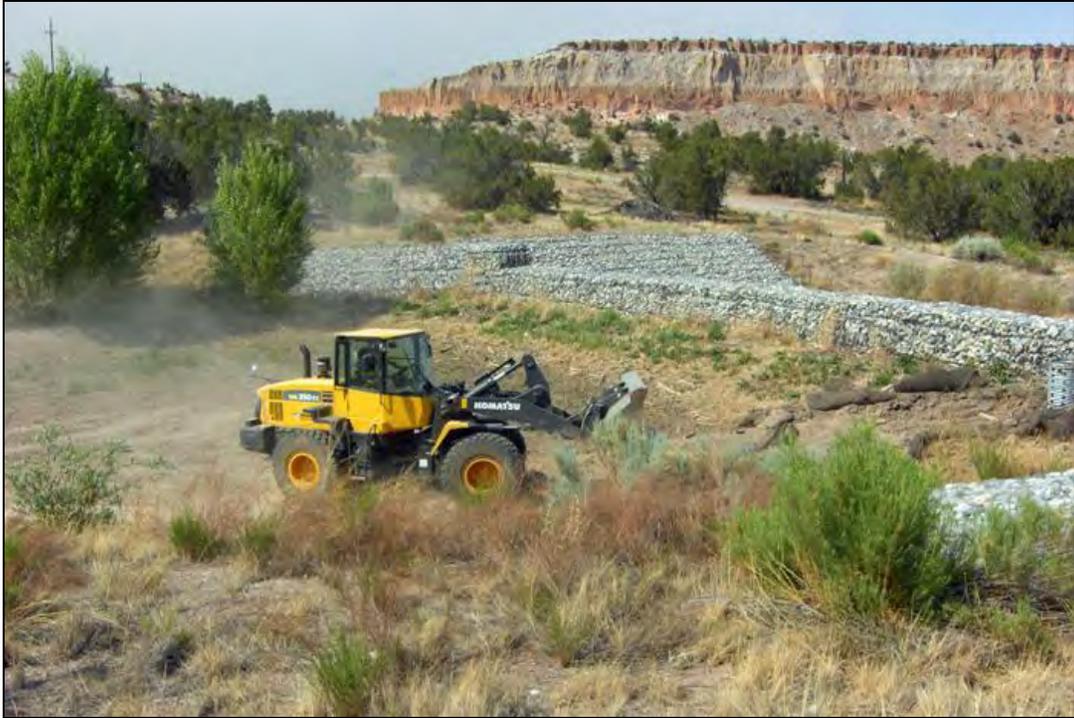
**Photograph 8. Crews using heavy machinery to remove sediment from the Los Alamos Canyon Weir to restore its storage capacity.**

The potential for large floods generated from burned areas was present even while the fire was still active. The Los Alamos watershed was one of the watersheds most affected by the Las Conchas fire. The Los Alamos Canyon low-head weir was installed near the downstream boundary of the Laboratory after the Cerro Grande fire to collect sediments mobilized by floodwaters and to reduce the transport of contaminated sediments off-site (DOE 2002).

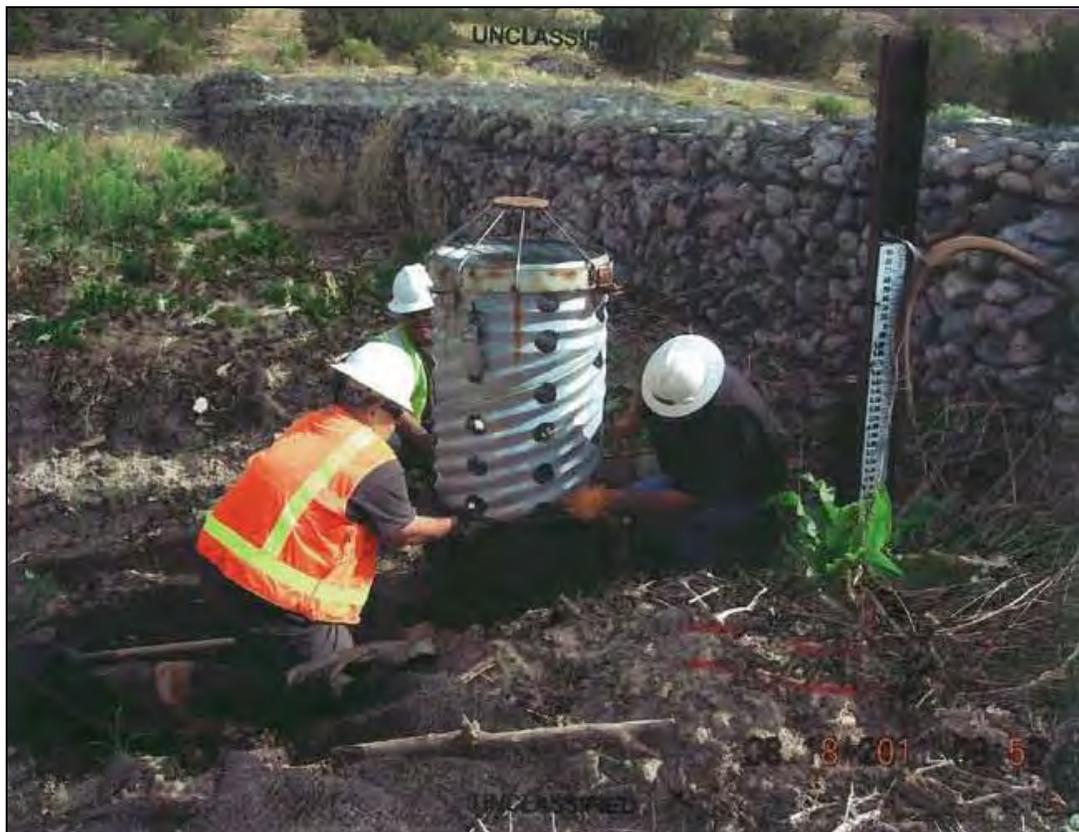
**Photograph 9. Crews expose discharge standpipe and wrap it with filter fabric.**

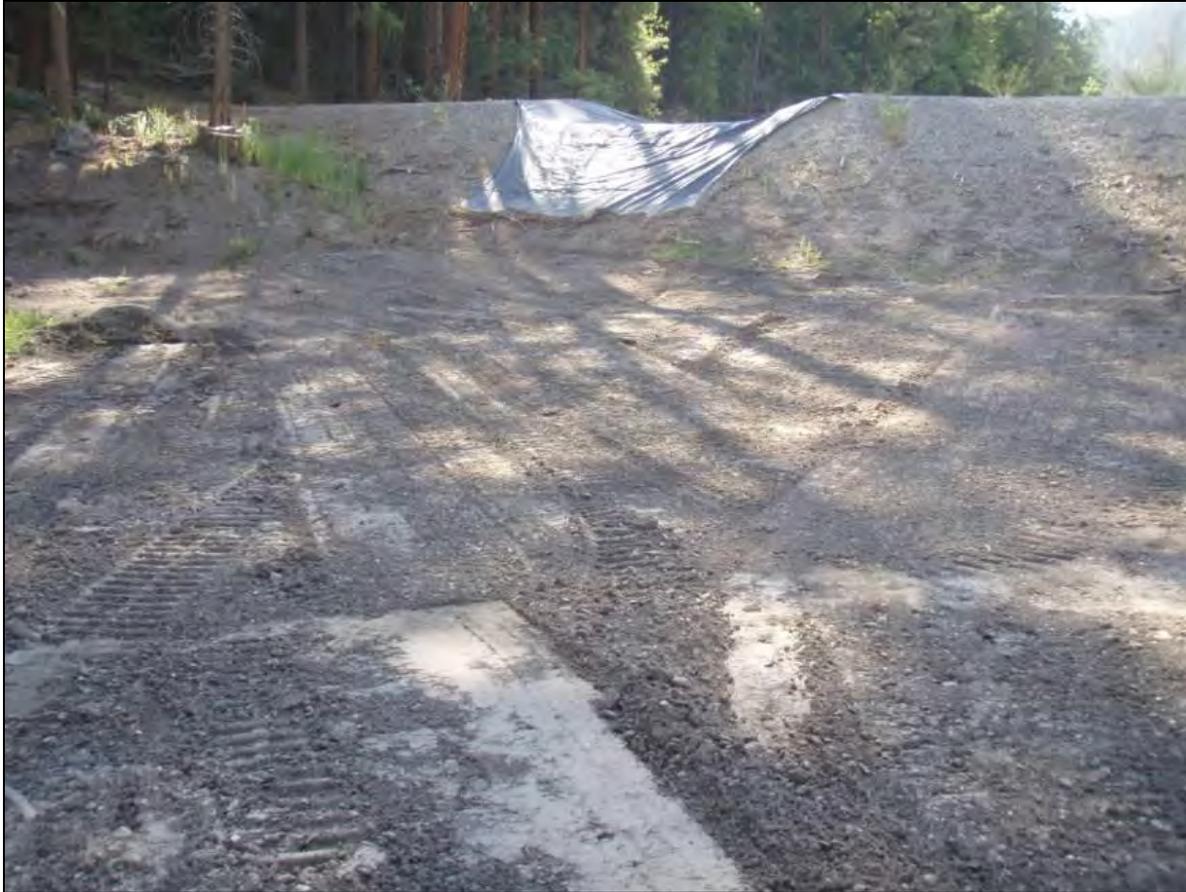
**Photograph 11. Los Alamos Canyon retention basin.**

In anticipation of increased sediment loads following rain events after the Las Conchas fire, sediments were removed from upper Los Alamos Canyon retention basins (Los Alamos Solid Waste Monitoring Unit (SWMU)-2, LA SMA-2) to restore their storage capacity. Crews removed and disposed of approximately 25–30 cubic yards of contaminated sediments. Sediment removal is a standard, on-going LANL activity; basins are maintained and cleaned regularly. However, the removal activity was accelerated in schedule to ensure that the maximum capacity of existing structures was available in case of post-fire flooding events (DOE 2002; DOE 2008; Photograph 11).

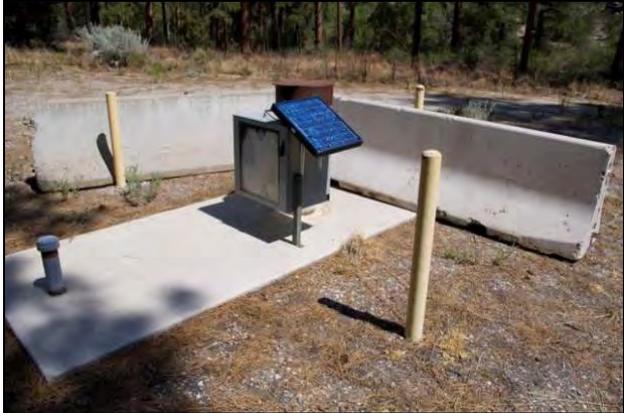
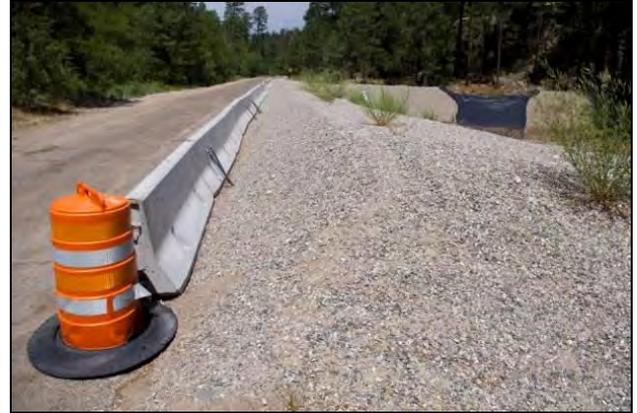
**Photographs 12 and 13. Armoring at groundwater wellhead (left) and armoring of a sediment collection system (right).**

LANS crews placed armoring (concrete barriers) around utility infrastructure, groundwater monitoring wells, and sediment collection systems in Los Alamos and Water Canyons as necessary, to protect these structures from potential floods and damage by floating debris (Photographs 12 and 13). Crews from Los Alamos County placed concrete barriers around the Los Alamos Ice Rink in order to protect it from the fire and associated flooding (DOE 2008; Photograph 14).

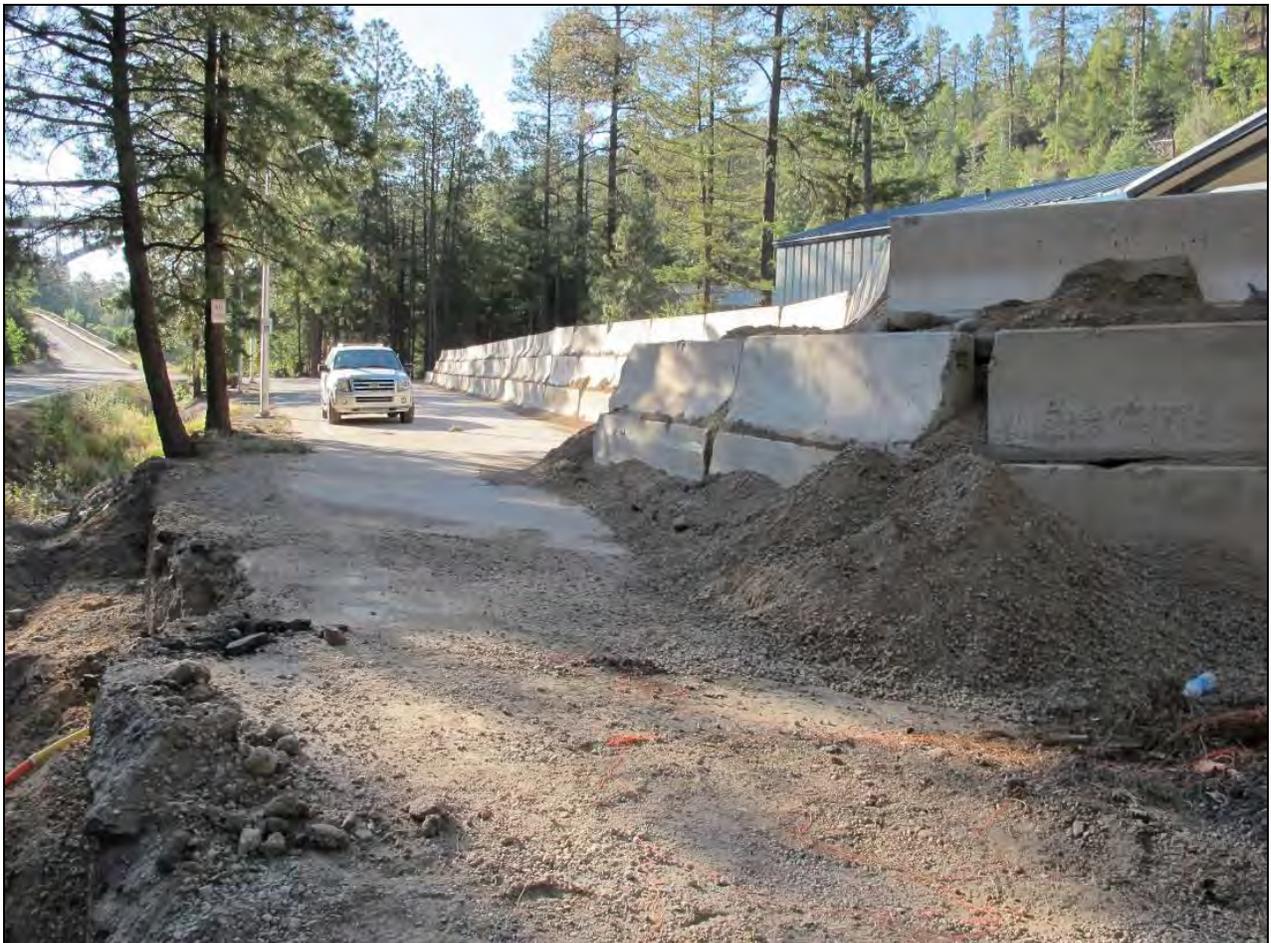
**Photograph 14. Armoring at the Los Alamos County Ice Rink.**

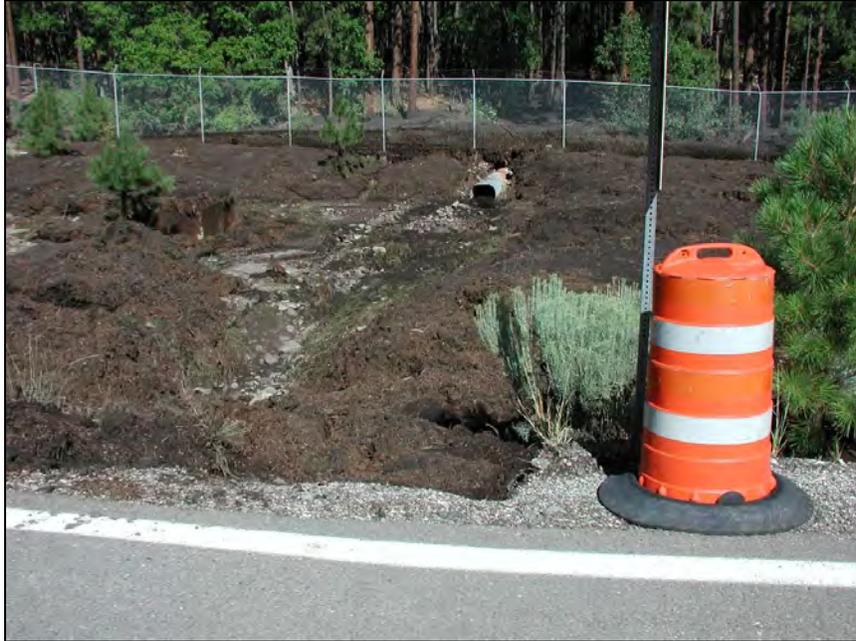
**Photograph 39. Cleaned out culvert along Anchor Ranch Road.**

As inspections of BMPs continue, erosion controls in Site Monitoring Areas (SMAs) are expected to need repair. As rain events persist, crews will continue to clean out culverts, as necessary, in Water Canyon, Pajarito Canyon, Cañon de Valle, and along NM 501 and Anchor Ranch Road (Photograph 39). Crews will repair roads damaged by flooding around LANL as necessary (Photograph 40).

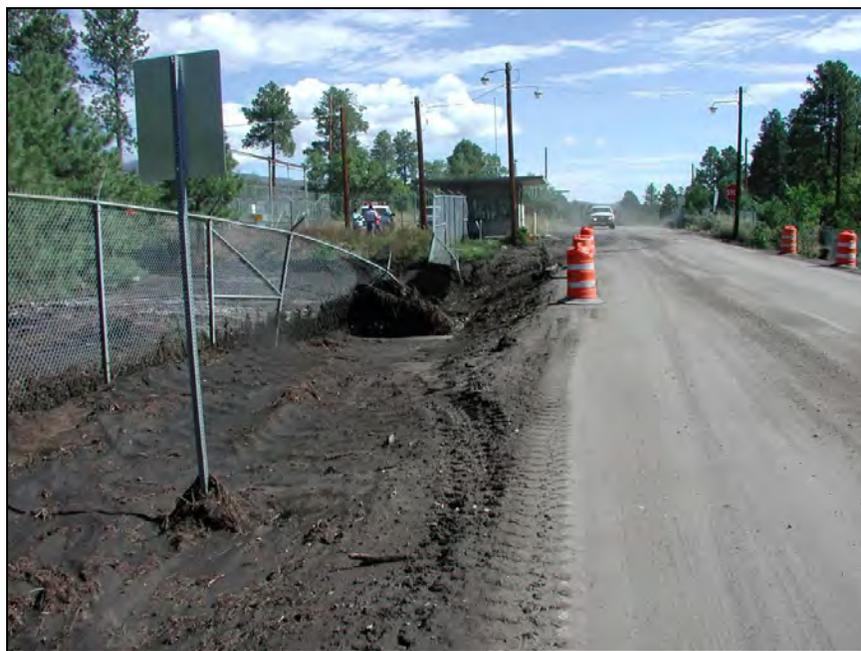
**Photograph 42. Security fence along Anchor Ranch Road damaged by flood event.**

LANS crews repaired a security fence at TA-16 damaged by post-Las Conchas fire flooding in August 2011. A heavy rain event caused post-fire flooding in and around the Pajarito Canyon and Water Canyon drainages that flowed onto LANL, south of Pajarito Canyon and north of Cañon de Valle. The flow crossed Anchor Ranch Road and destroyed about 20 feet of fence (Photographs 41 and 42).

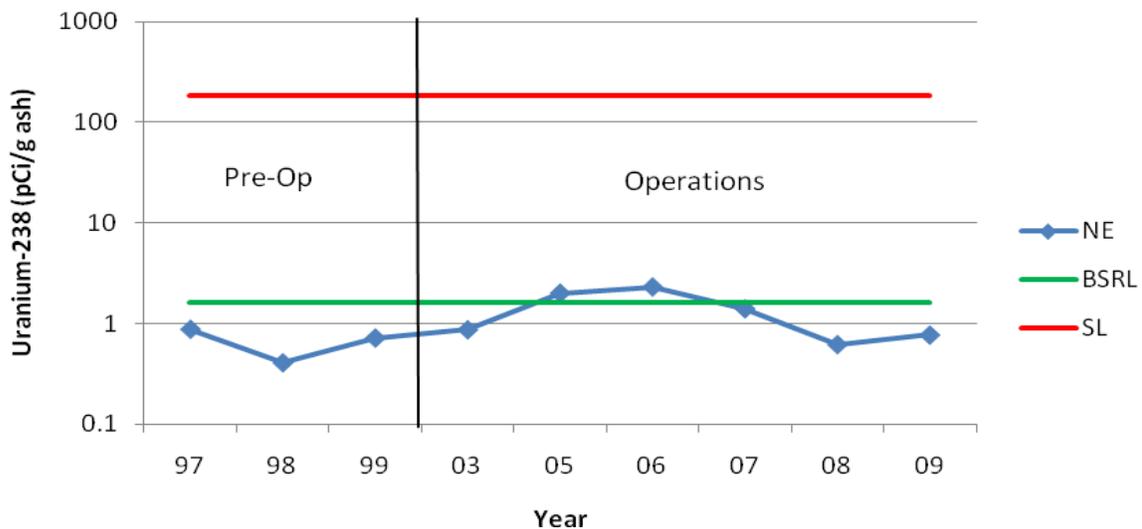
**Figure 6.** Uranium-238 concentrations in bees collected from the northeast (NE) side of the DARHT facility at TA-15 from 1997–1999 (pre-operations) through 2003–2009 (during operations) compared with the baseline statistical reference level (BSRL) and the screening level (SL). Note the logarithmic scale on the vertical axis.

Because we did not have a strong background data base for TAL elements, resources were diverted to analyze bees from regional sites; one sample from the DARHT facility was analyzed for TAL elements, however. Most of the TAL elements in bee samples collected from hives northeast of the DARHT facility were similar to RSRLs. The few TAL elements in bees that were higher than the RSRLs included aluminum, copper, vanadium, and lead. There are no ESLs listed for these elements in soil for bees, but the highest levels of these elements in soil around the grounds at DARHT are far below ESLs for other indicator biota receptors.

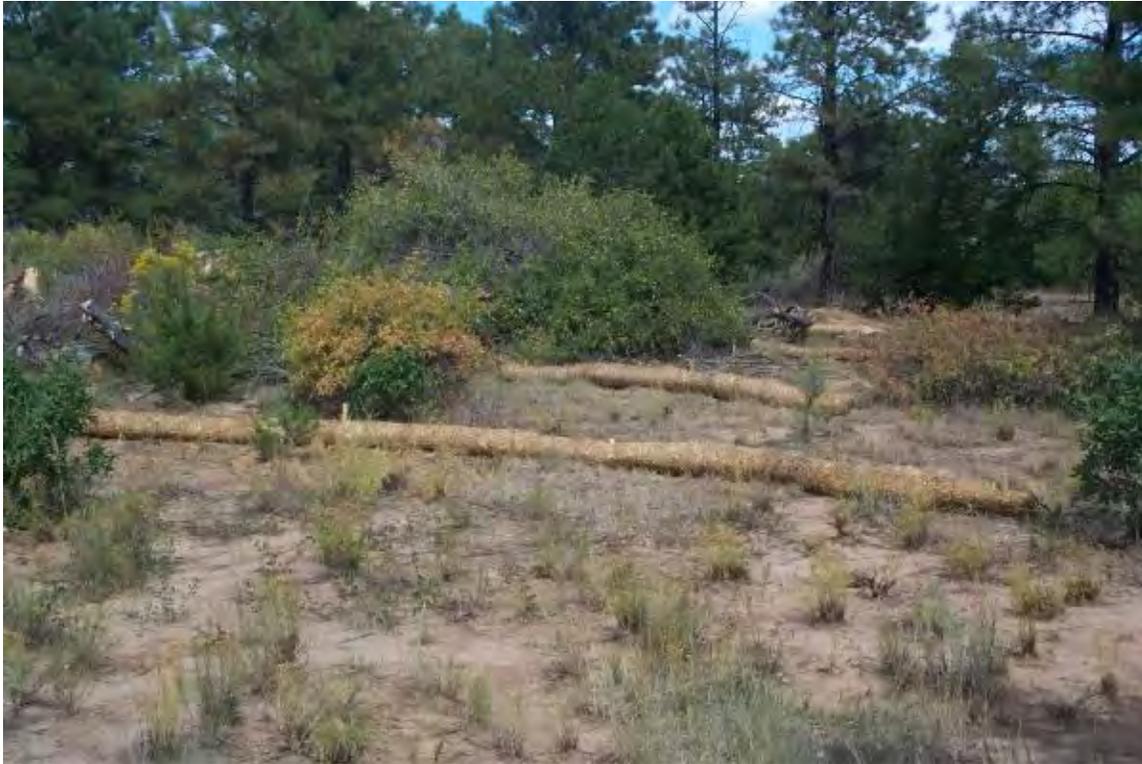
**Figure 3.** LA 89779, before wattle reinstatement (FY 2010).

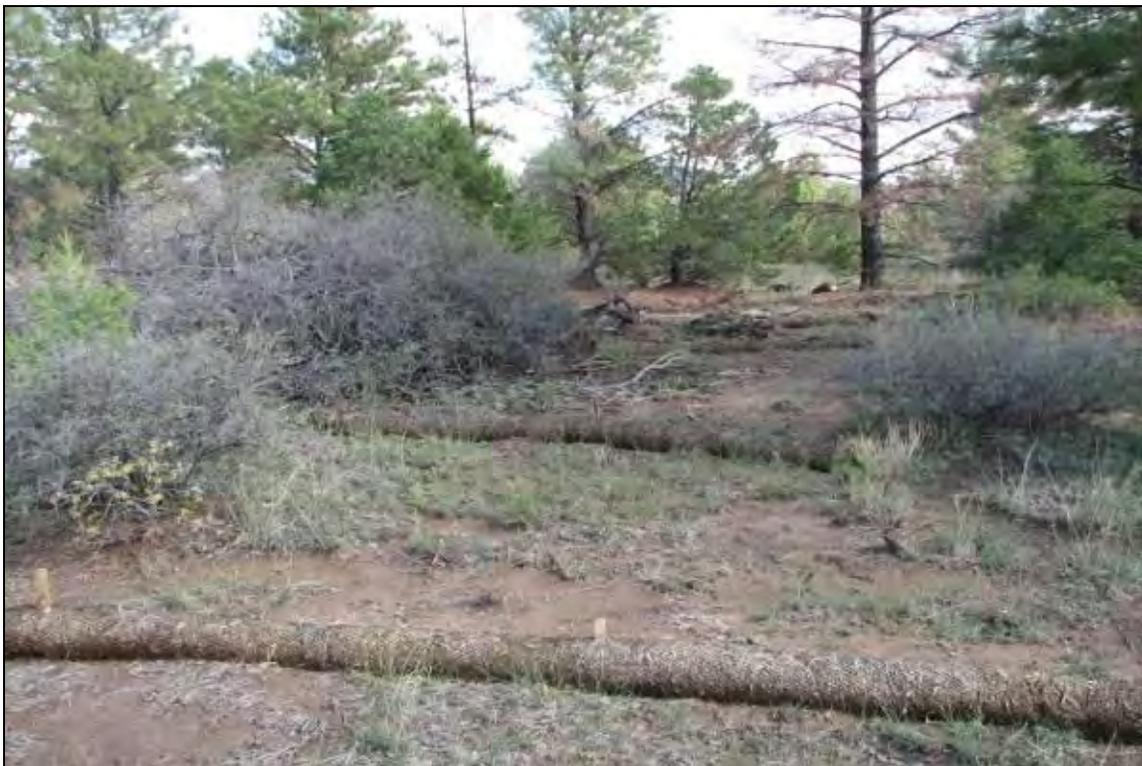
**Figure 4.** LA 89779, after lowering wattles (2011).

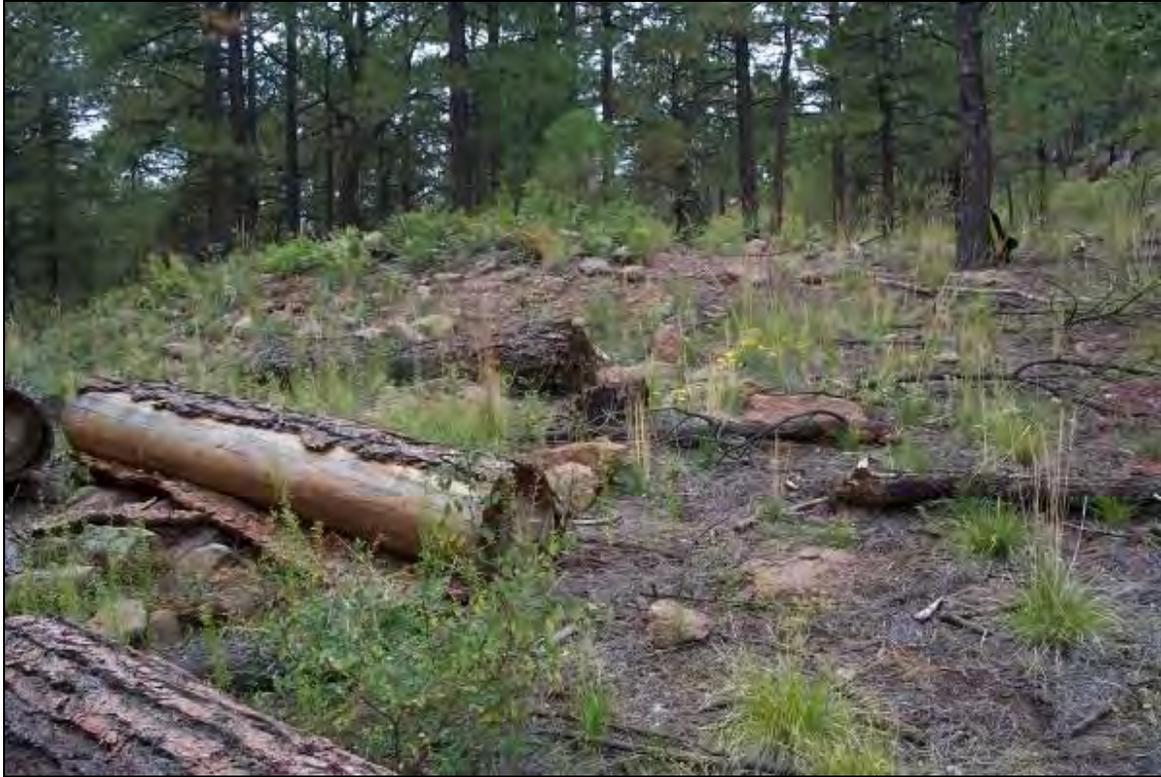
**Figure 5.** LA 86651, logs for erosion control (FY 2009).

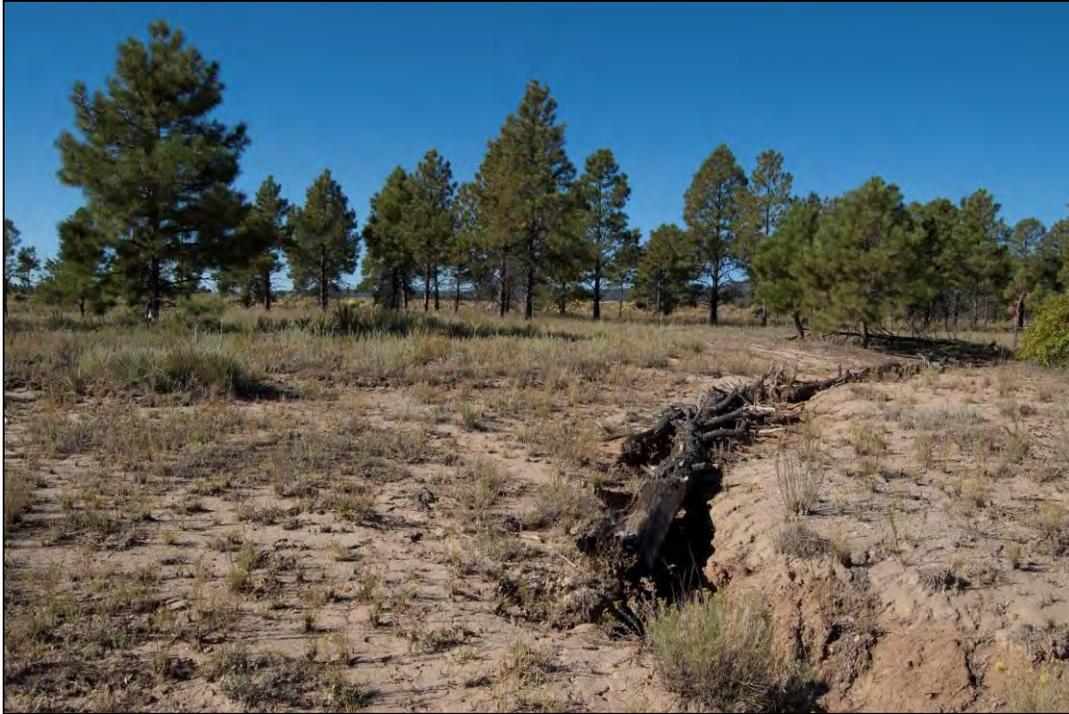
**Figure 11.** Detail of erosion channel, Montoya Homestead, LA 21334 (2010).

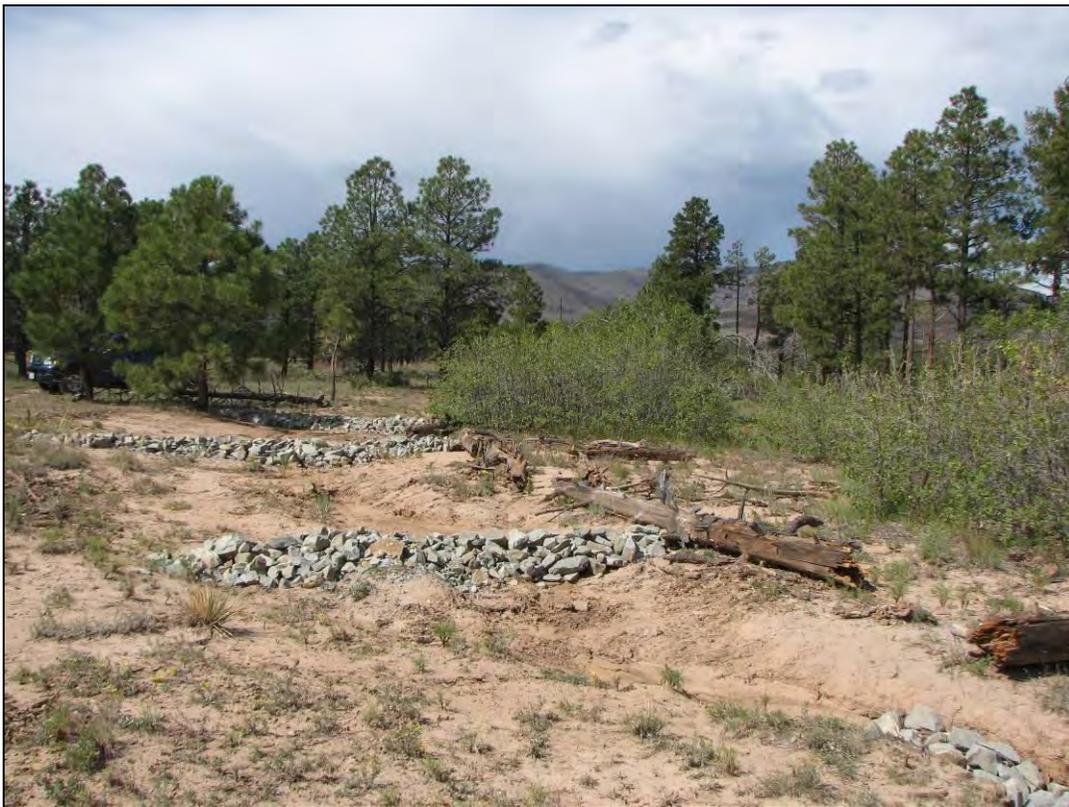
**Figure 12.** New rock erosion-control measures, LA 21334 (2011).
