Title: Geomorphology and Structure of the Pajarito Fault Zone West of Los Alamos National Laboratory, New Mexico

GEOMORPHOLOGY AND STRUCTURE OF THE
PAJARITO FAULT ZONE WEST OF
LOS ALAMOS NATIONAL LABORATORY,
NEW MEXICO

Prepared by:
Dr. James P. McCalpin
GEO-HAZ Consulting, Inc.
P. O. Box 1377
Estes Park, CO 80517

April 9, 1997

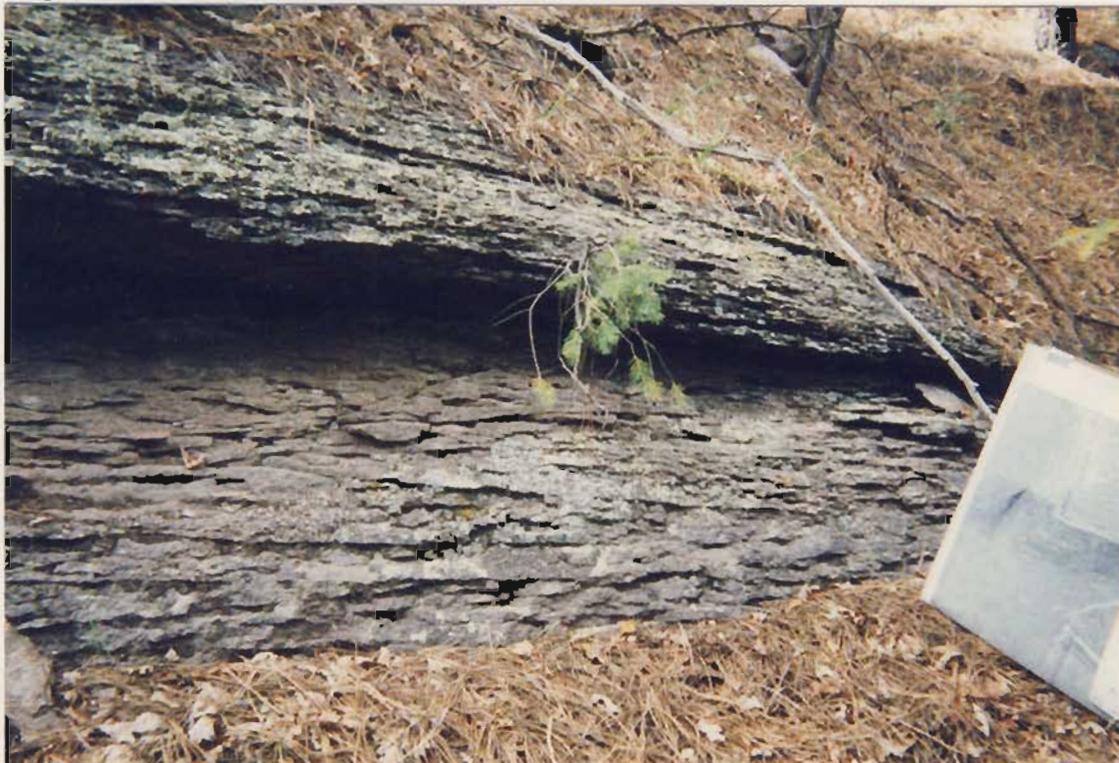
Fig. 2. Outcrop of "flaggy"-weathering Bandelier Tuff. This is within cooling unit 4 as defined by Reneau and McDonald (1996) and probably equivalent to "unit E" of Rogers (1995). In this report it is map unit B4.

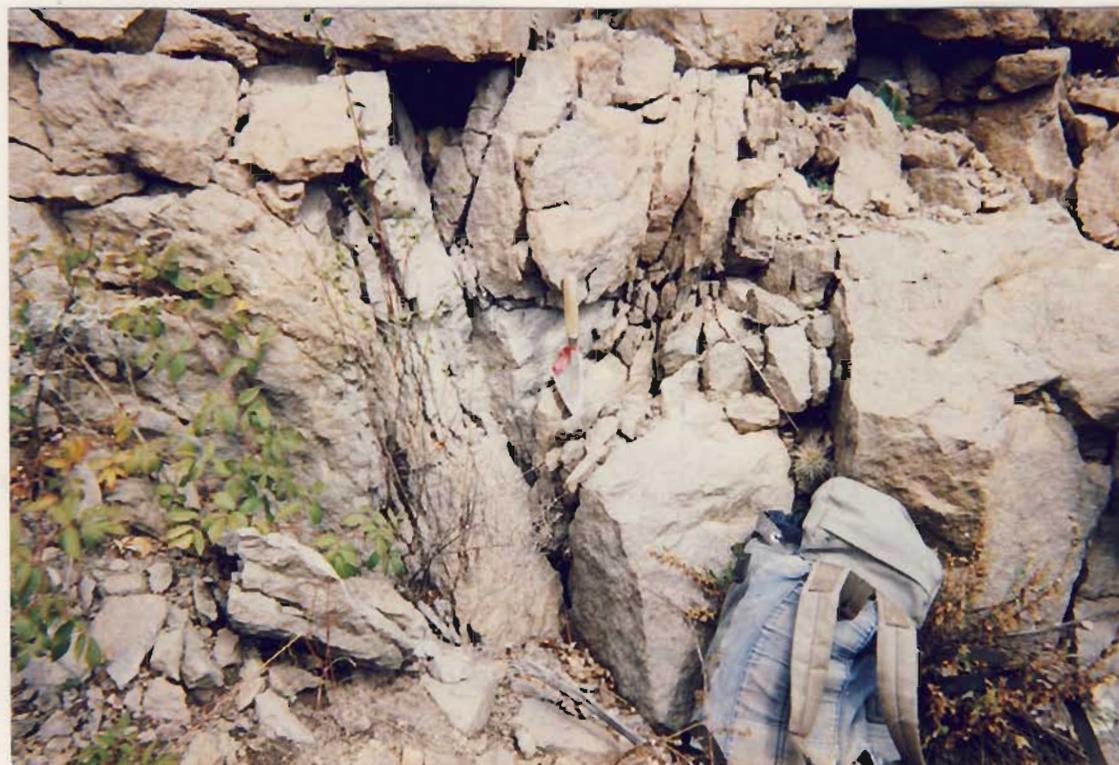
Fig. 3. Example of anomalous "shear-fractures" that are truncated by overlying beds in the tuff. The intense fracturing to the left and right of the trowel (at center, 20cm long) stops abruptly near the upper edge of the photo. Photo taken in the quarry at the mouth of Canyon de Valle.

At numerous roadcuts and quarry cuts I observed 5-20 cm-wide zones of intense subvertical fracturing that were restricted to individual beds in the tuff 1-2 m thick. These zones had steep dips, but were truncated at top and bottom against parting fractures at the boundary with over-and underlying tuff beds (Fig. 3). In detail, the fractures begin to curve as they approach the over-and underlying units, and become asymptotic to the "bedding-plane" partings. Viewed in plan, the shear-fractures are more circular than planar, forming a columnar zone of deformation. Fractures radiate outward from the axis of the column. Notably, where the largest of these shear-fractures cut across subhorizontal partings and joints, the latter show no vertical displacement (Fig. 4). The lack of vertical continuity and displacement across these features seems to suggest that they may date from the initial placement and cooling of the tuff, perhaps due to the presence of a pre-Bandelier fault scarp at this site (Fig. 5).

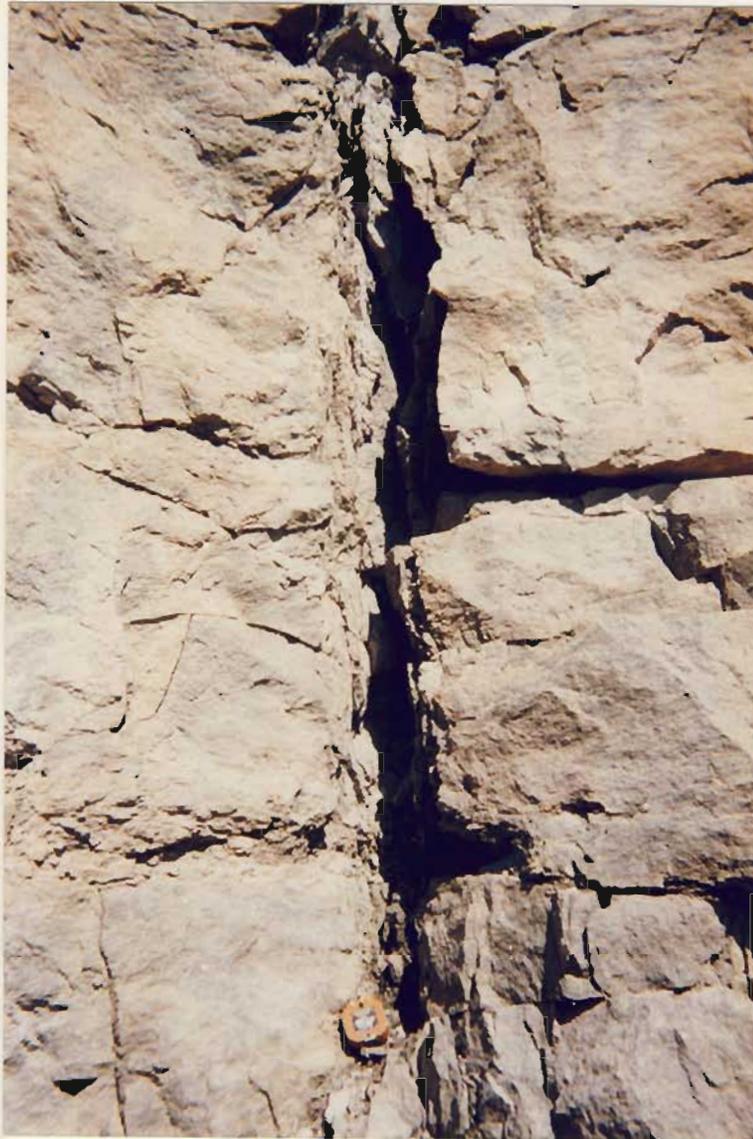
Fig. 4 Large shear- fracture exposed in the wall of the quarry at the mouth of Canyon de Valle. Brunton compass at bottom is 7 cm in diameter. Note that subhorizontal fractures are not offset.

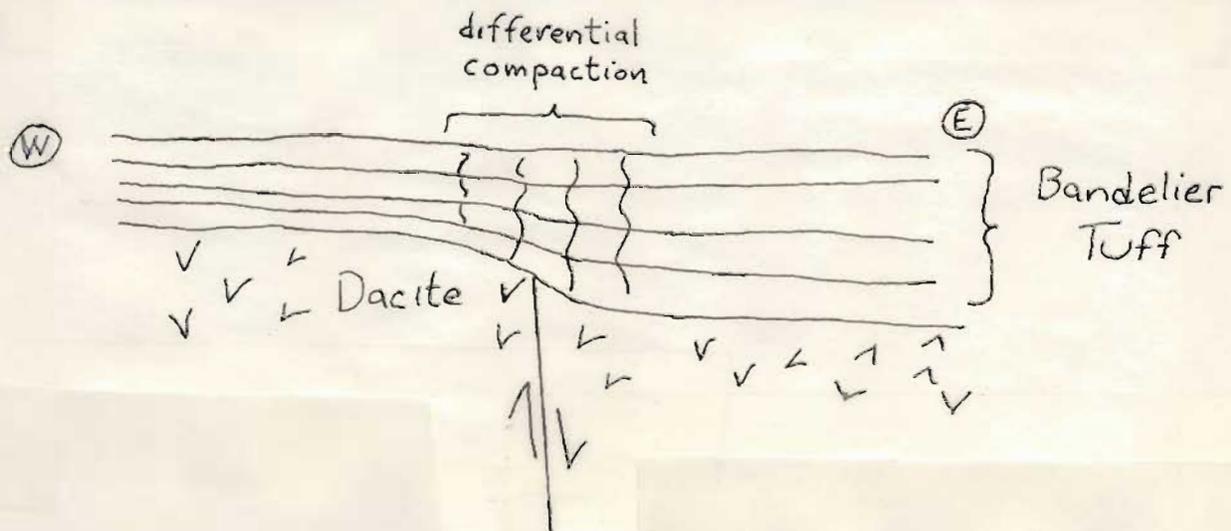
Fig. 5 Possible origin of the shear-fractures related to differential compaction and cooling as the Bandelier Tuff was deposited over a preexisting scarp in the underlying Tschicoma Dacite. Not to scale.

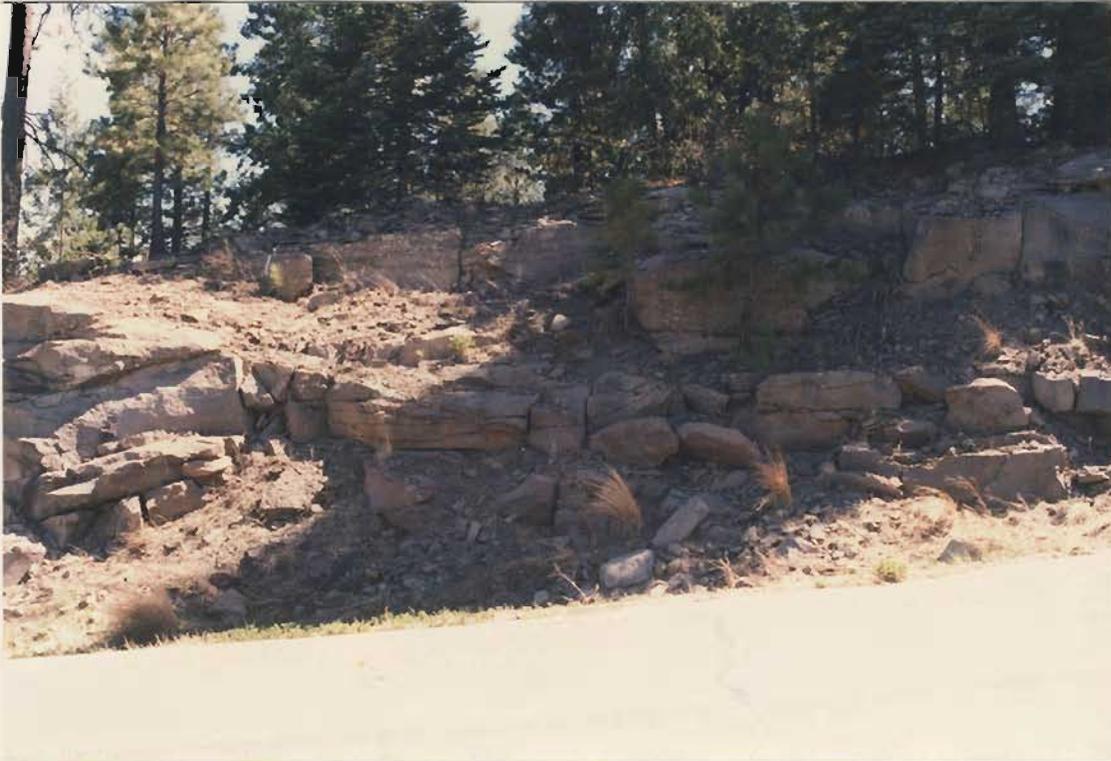
Fig. 6. The dominant subhorizontal partings in cooling unit 4 near the crest of the main Pajarito fault scarp dip 3 degrees-4 degrees east. Roadcut on Ski Hill Rd, looking south. The cut is about 3.5m high.

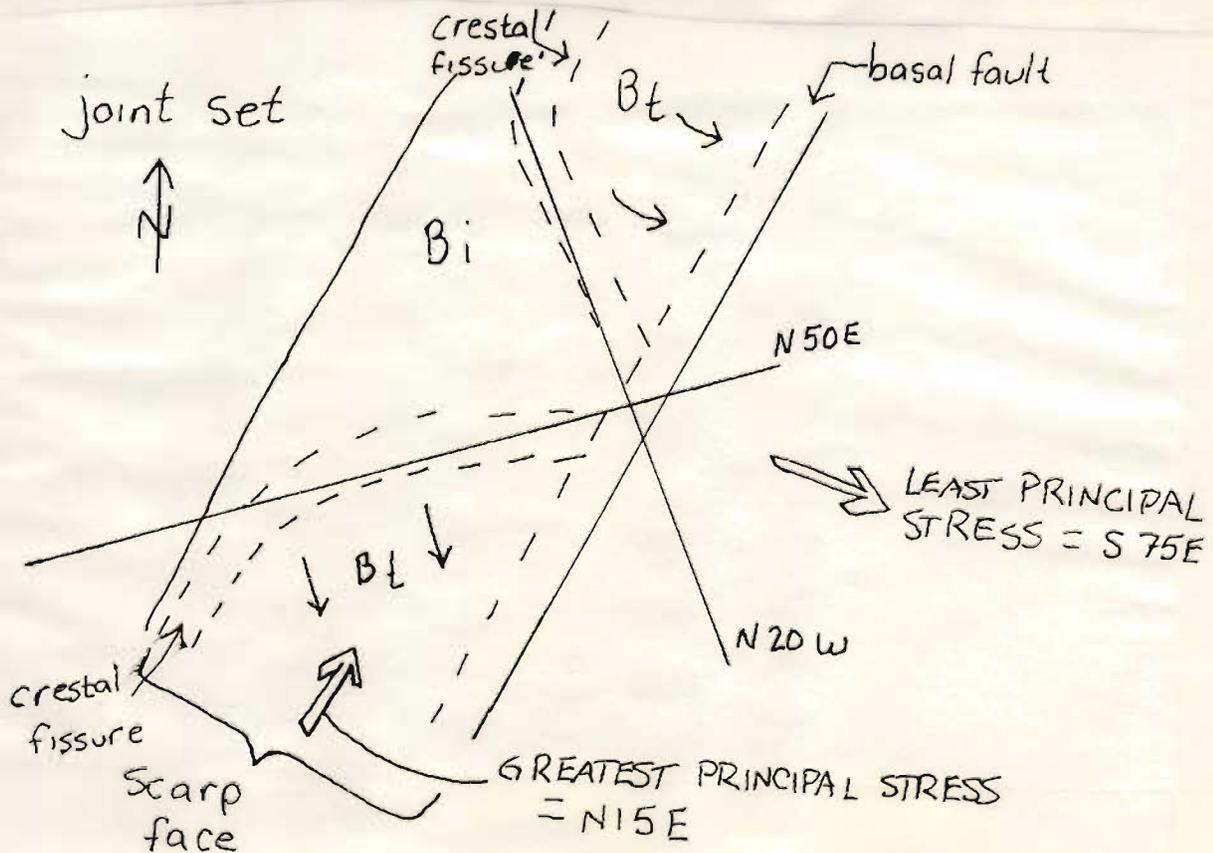
Fig. 7. Sketch of joint sets in relation to strike of the fault scarp, with data taken from south of the Los Alamos Canyon. The crestal toppling fissures here turn down-scarp to follow the joint directions.

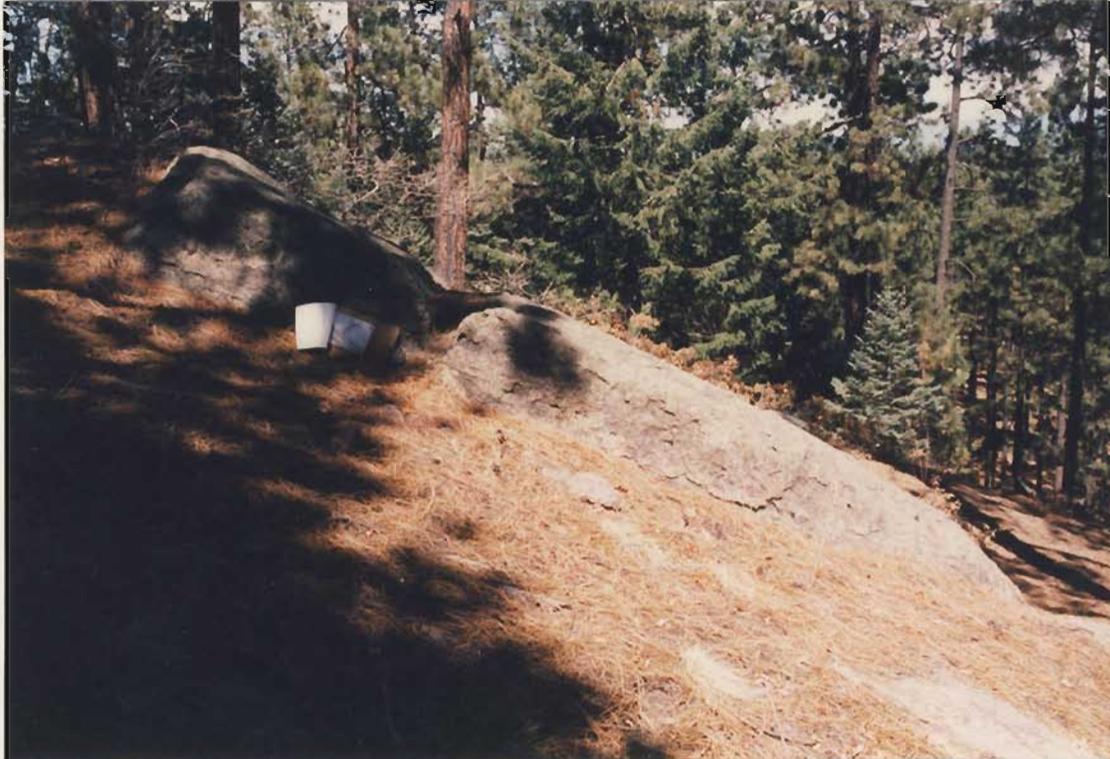
Fig. 8. Outcrop of Bandelier Tuff on the main scarp face downhill on Ski Hill Rd. Joints orthogonal to bedding dip into the hillside at about 60 degrees. This area is mapped as forward-topped tuff (Bt).

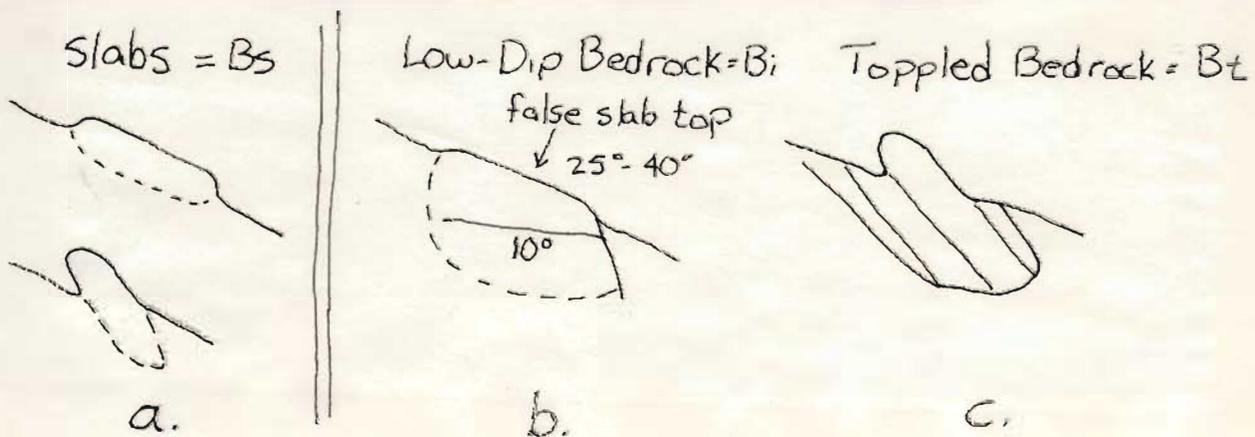
Fig. 9. Map units representing Bandelier Tuff outcrops on the Pajarito fault scarp. (a) slabs of tuff (map unit Bs). This designation is purely descriptive, and is used for areas where the depth dimension cannot be observed. Thus, it could represent either loose slabs of tuff lying on the scarp face, overlying in-situ tuff of any orientation, or forward-topped in-situ tuff. (b) low-dip bedrock (map unit Bi), where the prominent joint set is interpreted as "bedding" and dips <math><10^\circ</math> (typically 3 degrees-4 degrees). Due to granular disintegration a false slab top can develop on Bi parallel to the ground surface. (c) toppled bedrock (map unit Bt). Mapped where vertical exposures show that east-dipping prominent joints extend to depth, and other joint sets are orthogonal to that set.

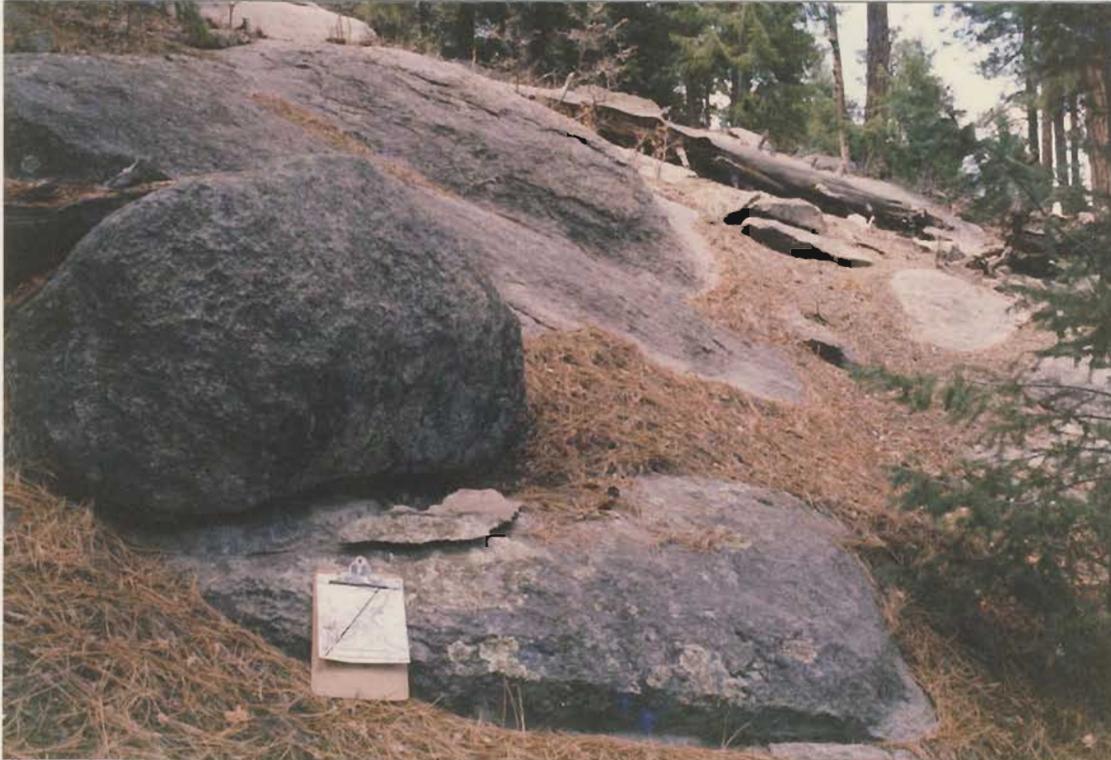
Fig. 10. Area of ground-parallel slabs sloping 30 degrees E on the upper scarp face at Ski Hill Rd. These are false slab tops. Note subhorizontal joints above clipboard.

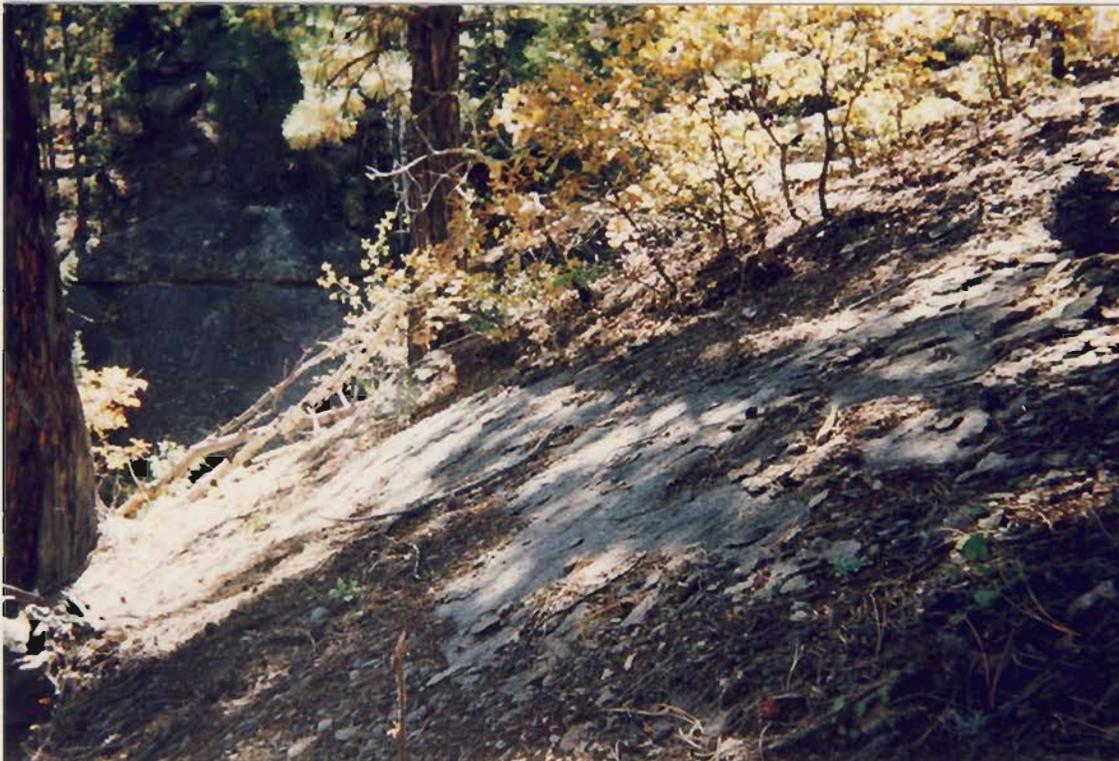
Fig. 11. Ground-parallel slabs (foreground) sloping 30 degrees E south of Twomile Canyon. Deeply-incised gully in left shows only horizontal jointing, indicating outcrop surface is not joint controlled.

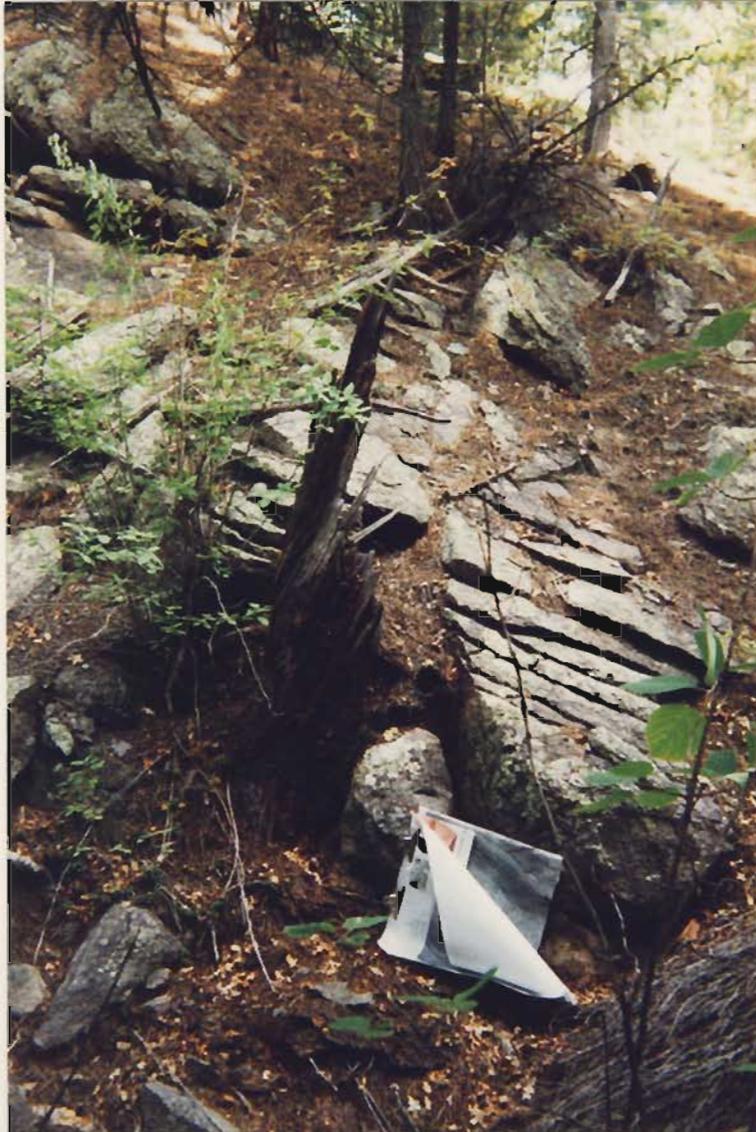
Fig. 12. Typical gully exposure of Tuff on the scarp face where the prominent joint set dips 25-40 degrees E, or roughly parallel to the surface of the scarp face. Clipboard at bottom is 60 cm square.

A second map unit is used where the prominent joint set dips 25-40 degrees E, and where vertical exposures show this trend persists downward for several meters (i.e., it is not a surface weathering effect). Fig. 12 shows a typical gully exposure into this unit, mapped as a toppled bedrock (Bt). Where dip in the tuff is approximately parallel to the surface on the scarp face and there are no vertical exposures, this unit is difficult to distinguish from loose slabs of tuff simply lying on the surface. In that case, I mapped a descriptive unit of bedrock slabs (Bs; Fig 9a) which might represent either possibility. In many cases, however, either the vertical exposures do exist, or the tuff outcrops are defined by prominent joints that are steeper than the ground surface (e.g., Figs. 9c, 13). Where joints dip more steeply than the ground surface, tuff outcrops make small "fins" that stuck out of the ground as shown in Fig. 13. This geometry would be difficult to create with loose slabs of tuff that were creeping down the scarp face; those would tend to remain parallel to the surface slope.

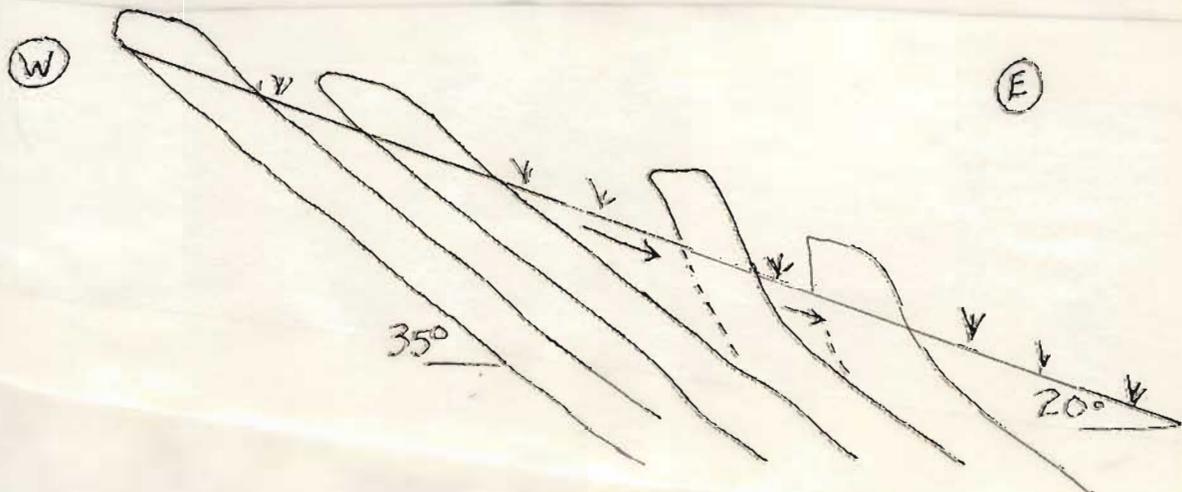
Fig. 13. Schematic diagram showing the shape of tuff outcrops where the prominent joint dip (35 degrees here) is steeper than the surface slope (20 degrees). The two tuff "fins" at left protrude above the surface at the ambient dip angle. The two fins at right have been bent forward and steepened by downslope creep of the regolith.

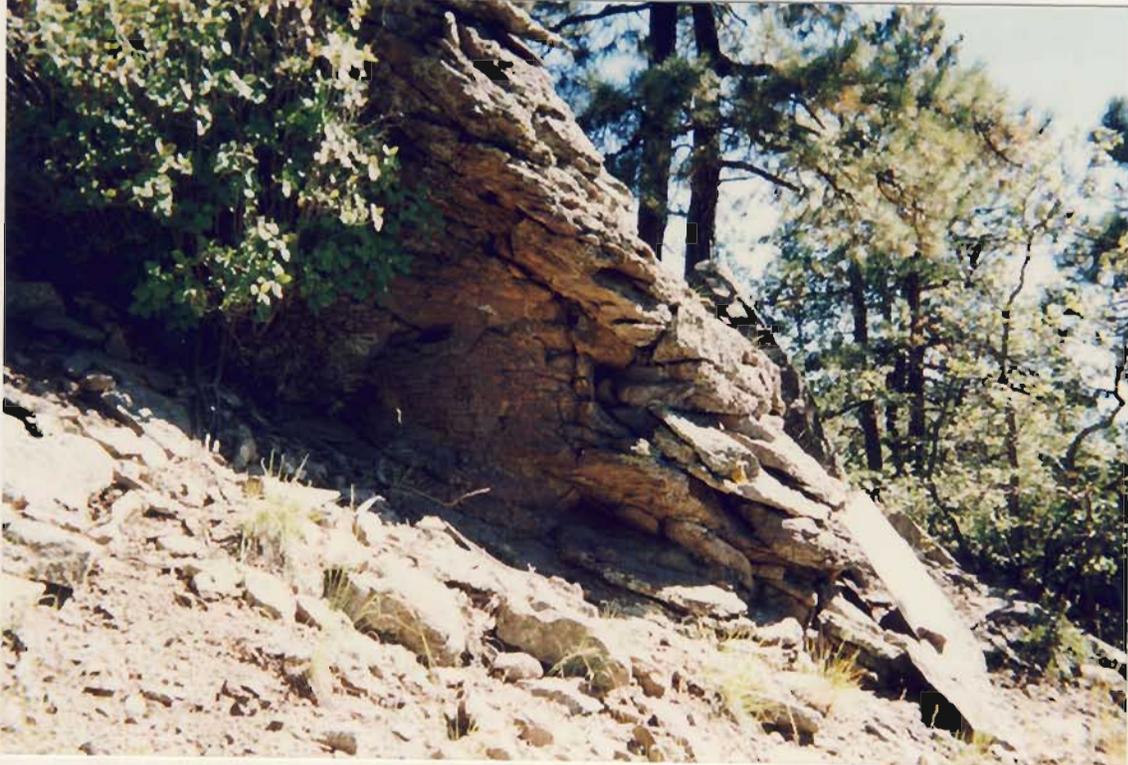
Fig. 14. The "disturbing outcrop" on the north side of Pajarito Canyon. Jointing in the interior of the outcrop is mainly vertical and horizontal, but gives way to more surface-parallel jointing at right. These two joint sets clearly cross-cut each other. Outcrop pictured is about 2 m high.

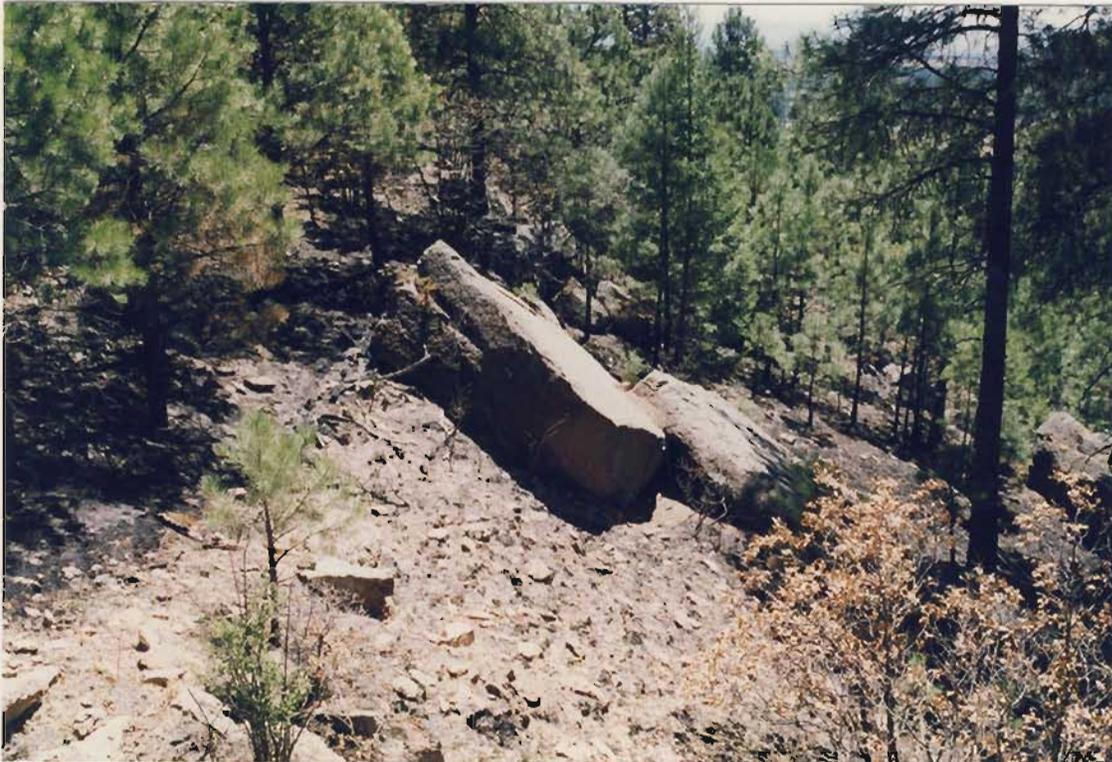
Fig. 15. Detached slabs of Bandelier Tuff on the ground surface, upper north slope of Canyon de Valle, above the quarry. The local dip of in-situ bedrock here is 3 degrees-4 degrees E (view is looking E), whereas the slabs are lying on a south facing slope.

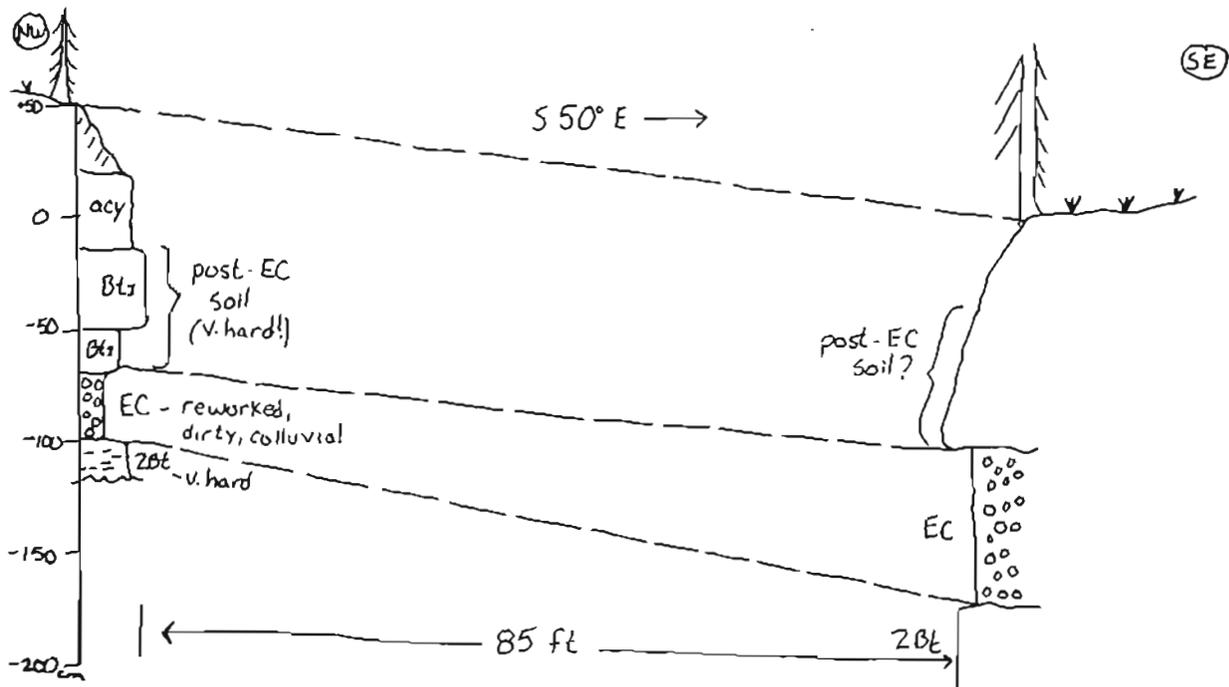
Fig. 17. Correlation of El Cajete pumice and associated colluviums across Ski Hill Road, in the graben south of Los Alamos Canyon.

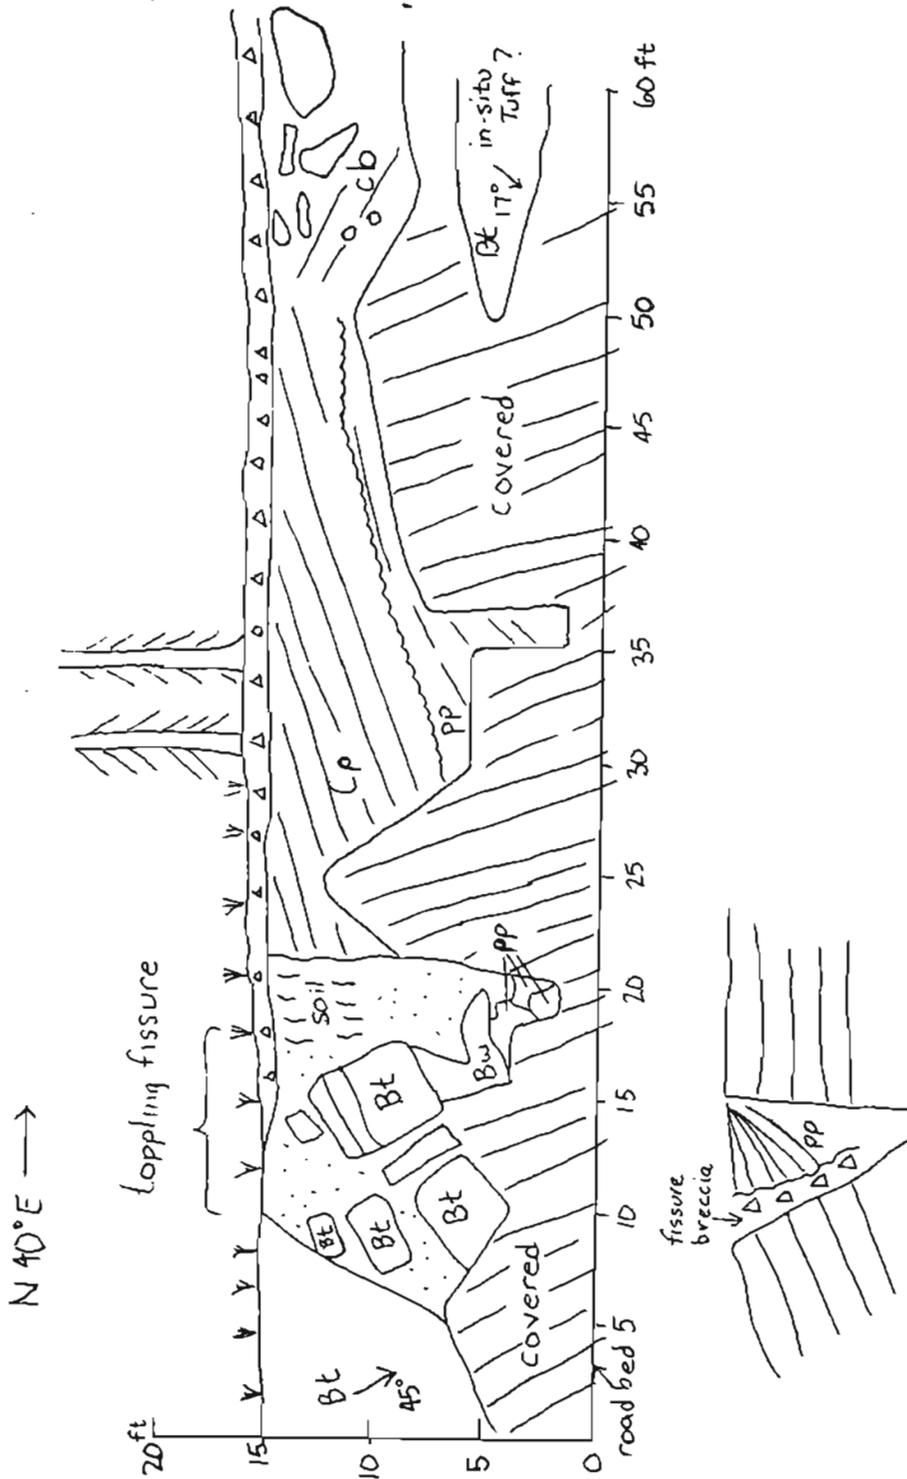
Fig. 18. Sketch of the roadcut immediately south of the lowest hairpin turn on Highway 4 as it ascends the fault scarp. The roadbed is drawn as horizontal, but actually dips 3 degrees to the right. Bt, toppled blocks of Bandelier Tuff; Bw, welded tuff; pp, primary (airfall) pumice, very clean and well-sorted; cp, colluviated (reworked) pumice; cb, bouldery colluvium containing little or no pumice. The inset at lower left shows how the primary pumice (pp) may have accumulated in an open toppling fissure.

In addition to the El Cajete pumice an older pumice is exposed just south of the hairpin curve in Highway 4 as it ascends the fault scarp (Fig. 18). This pumice has not been previously described, so its age and origin is unknown. J. Gardner (pers. comm. 1996) suggested that the pumice may be fractionally younger than the main eruption of the Bandelier Tuff. The pumice is restricted to deep toppling fissures, which suggests that toppling may have immediately preceded pumice eruption. If this outcrop is typical of topple fissure fills, then the toppling process may have initiated soon after initial post-Bandelier faulting, and fissures of various ages may be filled with pumice and colluvium of many ages.

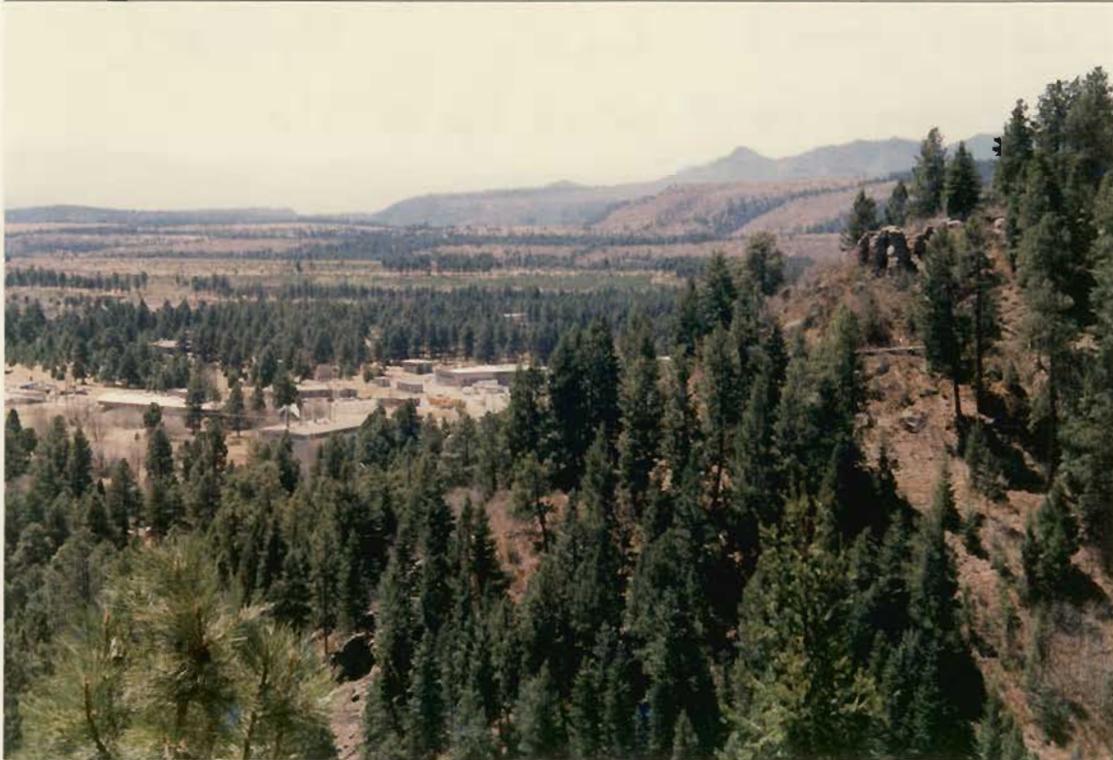
Fig. 20. Schematic cross-sections of the Pajarito main scarp and graben south of Los Alamos Canyon. Units B5 and B4 refer to Bandelier Tuff, cooling units 5 and 4 as defined by Reneau and McDonald (1996). Stippled pattern shows alluvium and colluvium in the graben; triangles indicate coarse rubble in tension fissures. The existence of the basal fault zone in option 1 is uncertain, as is its throw.

On the latter area the fault zone is at its widest, measuring about 2 km wide between the farthest western and eastern fault traces. However, most of the vertical offset is contained on the main east-facing scarp, which is about 50 m high here. Fig. 20 schematically shows two possible subsurface geometries for the fault zone (minor splay faults are omitted for clarity). In both options, the scarp face is an east-tilted monolithic block of tuff strata, forming a large segmented monocline with a tension (toppling) fissure at the scarp crest. In option 1 there is a normal fault zone at the base of the 50 m high scarp, thus making the adjacent sediment-filled depression a true graben. In option 2 this fault does not exist, and the depression is a half graben with a deep thickness of fill at its eastern margin. I propose to run a seismic refraction survey prior to trenching in this graben, since the two geometries outlined above would dictate very different trenching strategies (see section 6.2).

Over most of the main scarp eastward toppling appears to be the main mode of accommodating vertical deformation (see Fig. 20). The best exposures of this deformation style are on Highway 4. On the south facing roadcut horizontally bedded tuff on the west is separated from 35 degree east dipping tuff by a rubble-filled crack that is about 10 m wide at road level. The western boundary fracture of the crack is vertical and the eastern boundary crack dips 55 degrees W, perpendicular to "bedding" in the toppled eastern block (Fig. 32). If this geometry is correct then the toppled slab is only 70-80 ft thick, or only about 1/4 as thick as the scarp is high here. Given this thickness, what is the style of deformation below 70-80 ft depth? A simple geometric model (Fig. 33) shows that there are severe space problems with tilting forward a slab as thick or slightly thicker than the scarp height. Perhaps some of the space problem is solved by the transition and rotation of smaller and smaller fault-bounded topple blocks. Such pervasive deformation is observed in the toppled zone along Highway 4 (Fig. 34), so it is presumably as or more common in the subsurface.

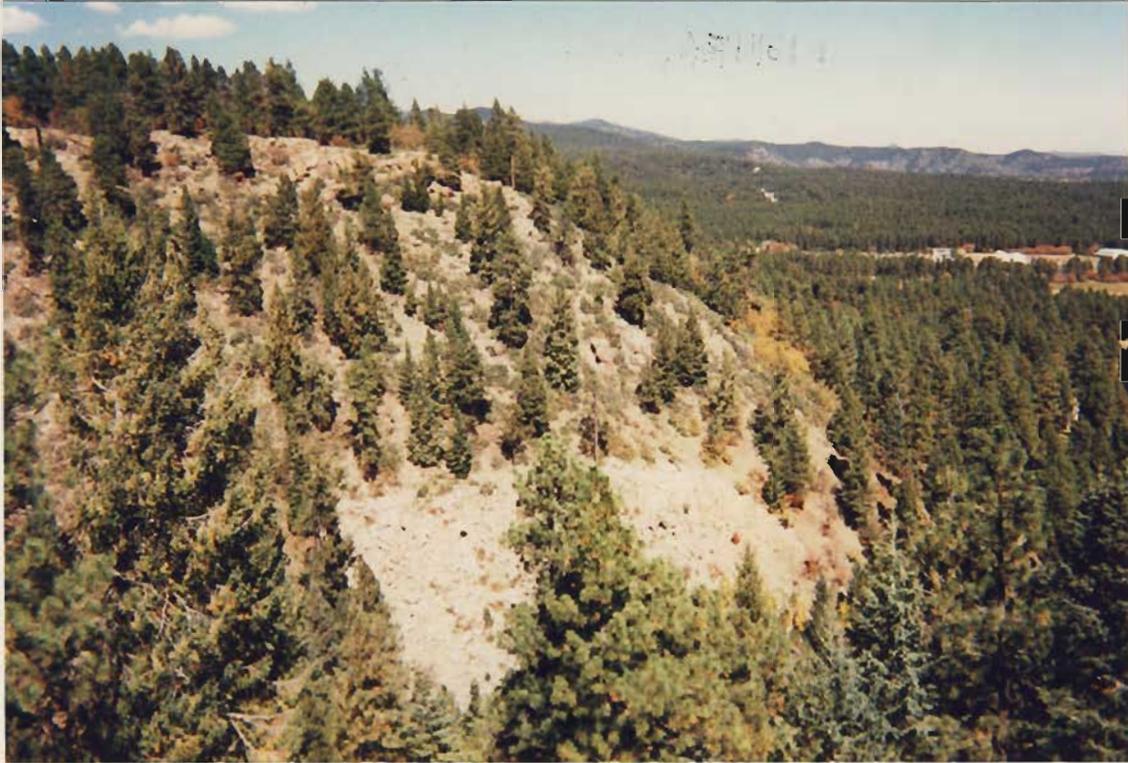
Fig. 21. Photograph of the main scarp looking north across Canyon de Valle. The unvegetated area at lower center is a quarry, which at its eastern end exposes the main fault zone. Tuff at the scarp crest dips 3-4 degrees east, but is broken up by several troughs paralleling the scarp crest. These troughs probably represent extension and normal faulting due to gravitational spreading or incipient landsliding toward the east. However, the scarp face here is very planar and shows no signs of deep-seated landsliding.

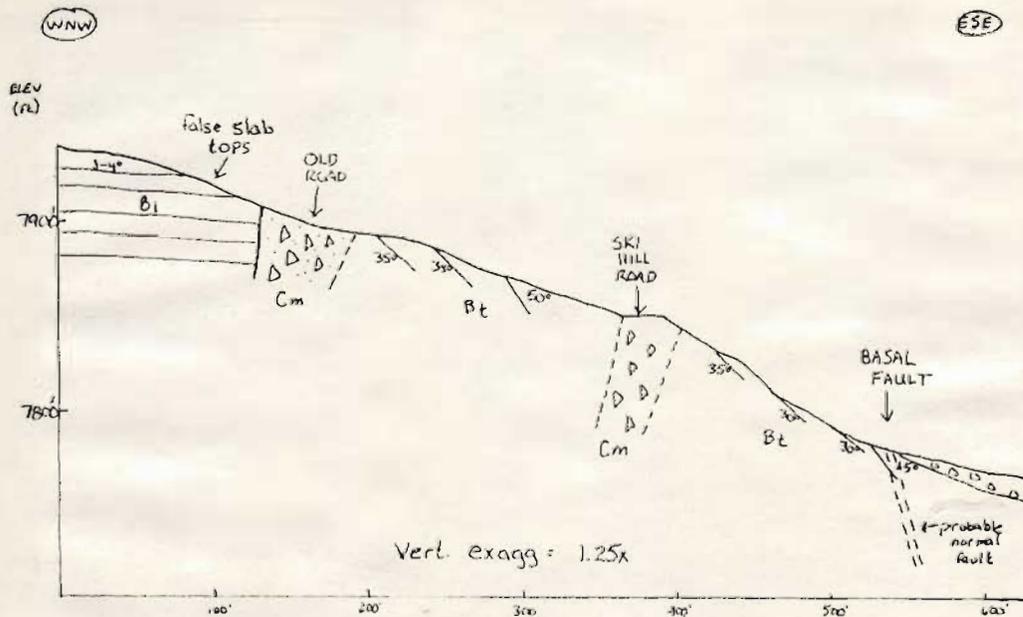
Fig. 22. Cross-section of the main scarp in the vicinity of Ski Hill Road. Dips are from field measurements. cm = megablock colluvium; Bt = tilted Bandelier Tuff; Bi = intact (untilted) Bandelier Tuff. Circles at far right indicate graben fill (alluvium and colluvium).

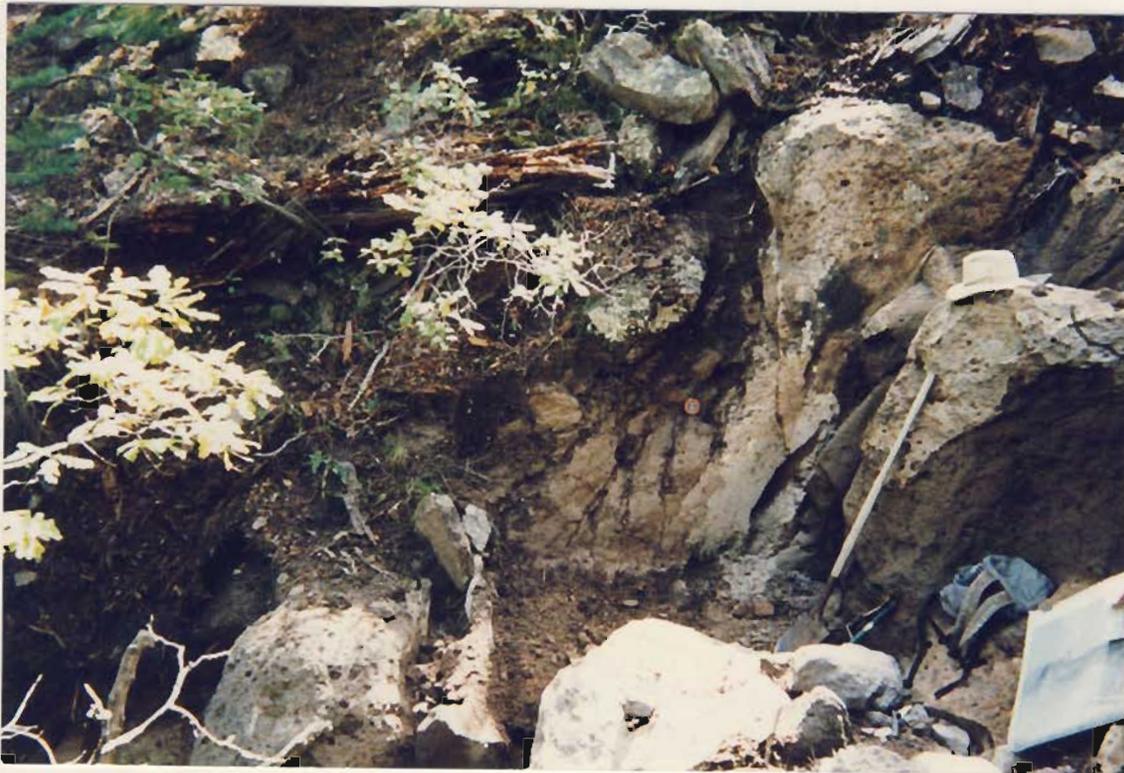
Fig. 23. Hand-cleaned exposure of the basal fault zone downslope from the lowest hairpin curve on Highway 4.

Downslope of the lowest hairpin curve in Highway 4, runoff diverted from the highway has incised a gully which flows over the bedrock-colluvium contact, forming a waterfall (Fig. 23). Downslope of the waterfall Bandelier Tuff is fractured and faulted with about 5-15cm between fault traces. The bedrock-colluvium contact steps down to the east before disappearing beneath the elevation of the gully bottom. This site is tentatively proposed for future trenching (see Sec. 6.3).

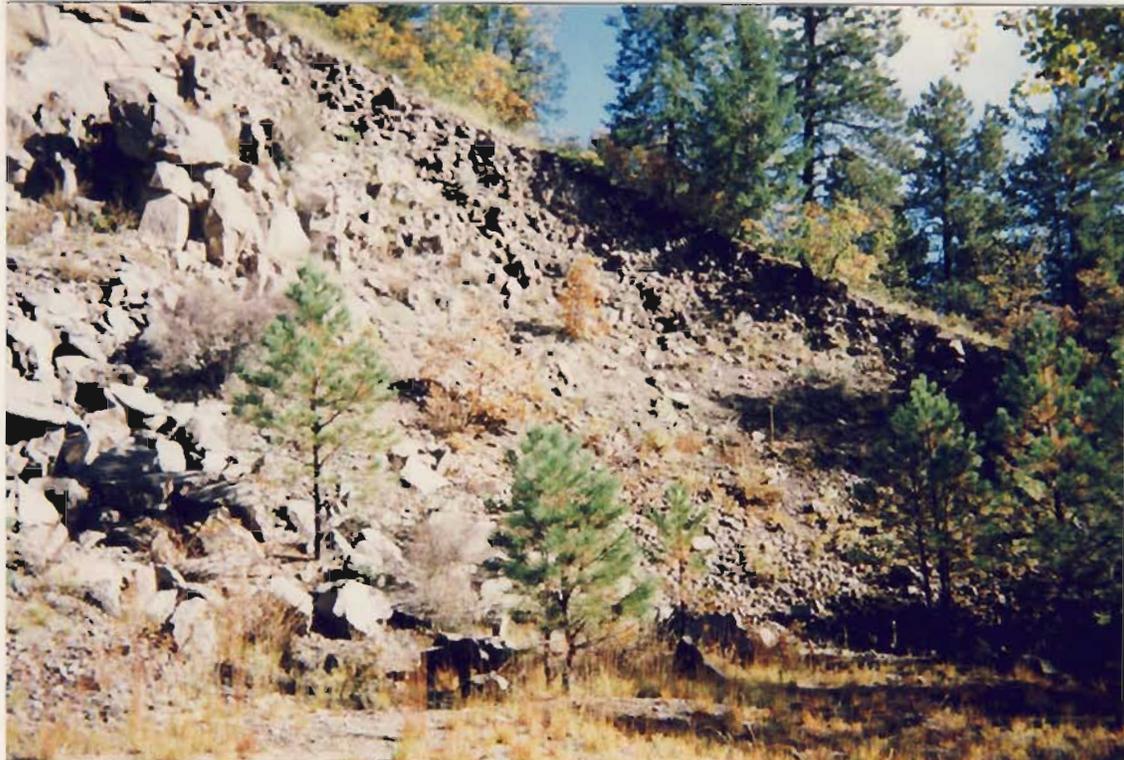
Fig. 24. Photograph of the north wall of the quarry at the mouth of Canyon de Valle. The basal fault zone is located at right center. Fig. 25 shows the inferred structures in this poorly-exposed cut.

The deepest exposure of the basal fault zone, although not the best exposed, is in the quarry wall at the mouth of the Canyon de Valle (Fig. 24). The zone of deformation is roughly 30 ft wide (Fig. 25) and is composed of increasingly fractured tuff blocks which give way eastward to detached blocks dipping about 60 degrees E. The contact between these detached blocks and true colluvium is indistinct.

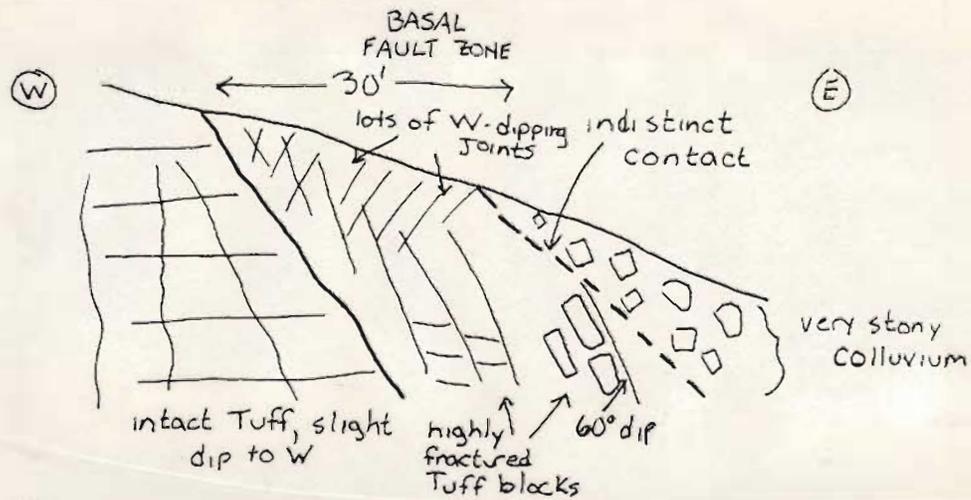
Fig. 25. Sketch of structural relations in the north wall of the quarry at the mouth of Canyon de Valle. Heavy lines bound the deformation zone.

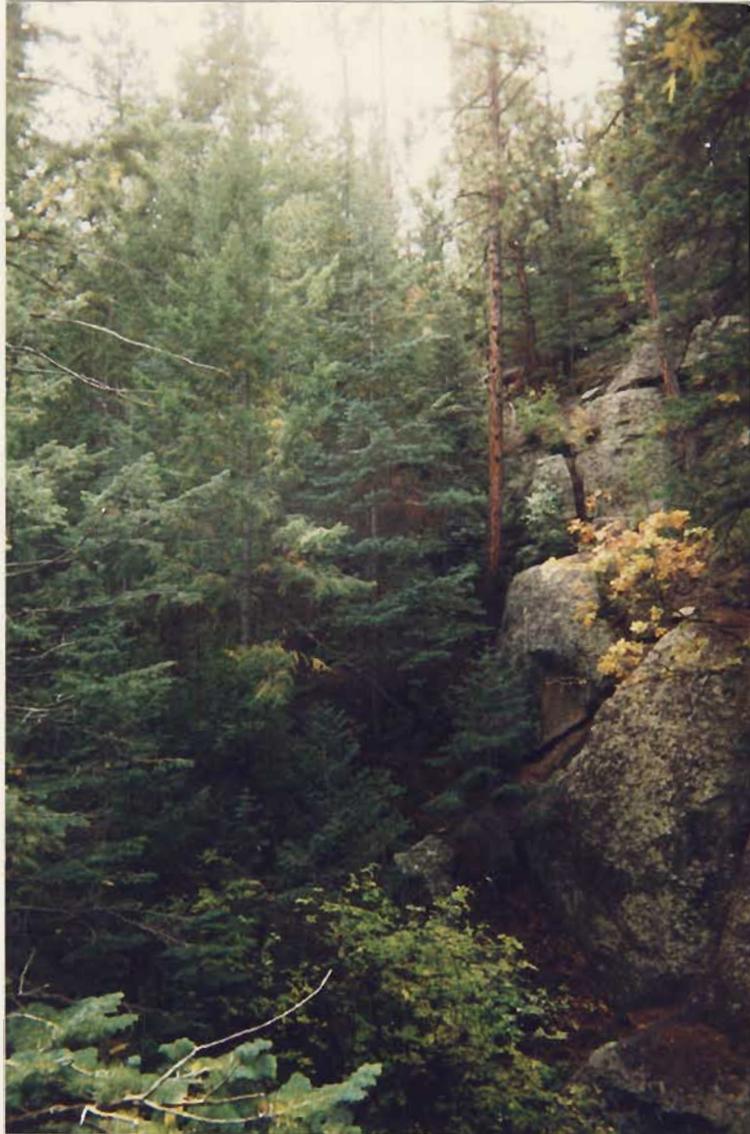
Fig. 26. Photograph of the south wall of the large drainage that cuts through the fault scarp south of Ski Hill Road. Horizontally bedded tuff on the right is abruptly truncated, presumably along a steeply-dipping basal fault zone.
