Title: Geomorphology and Structure of the Pajarito Fault Zone West of Los Alamos National Laboratory, New Mexico

GEOMORPHOLOGY AND STRUCTURE OF THE
PAJARITO FAULT ZONE WEST OF
LOS ALAMOS NATIONAL LABORATORY,
NEW MEXICO

Prepared by:
Dr. James P. McCalpin
GEO-HAZ Consulting, Inc.
P. O. Box 1377
Estes Park, CO 80517

April 9, 1997

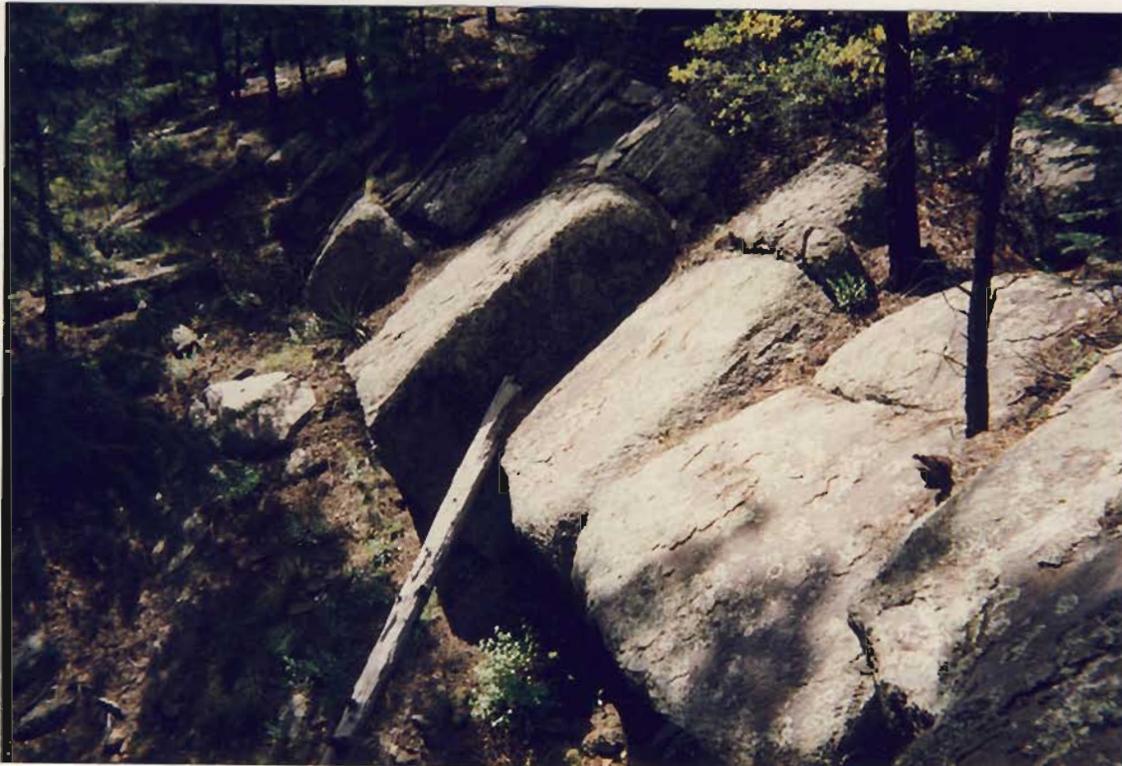
Fig. 27. Photograph of the geomorphic expression of the basal fault zone in the second small gully south of Ski Hill Road. The fault zone creates an overhanging bedrock-colluvium contact defined by the orthogonal joint set which dips about 60 degrees into the hillslope.

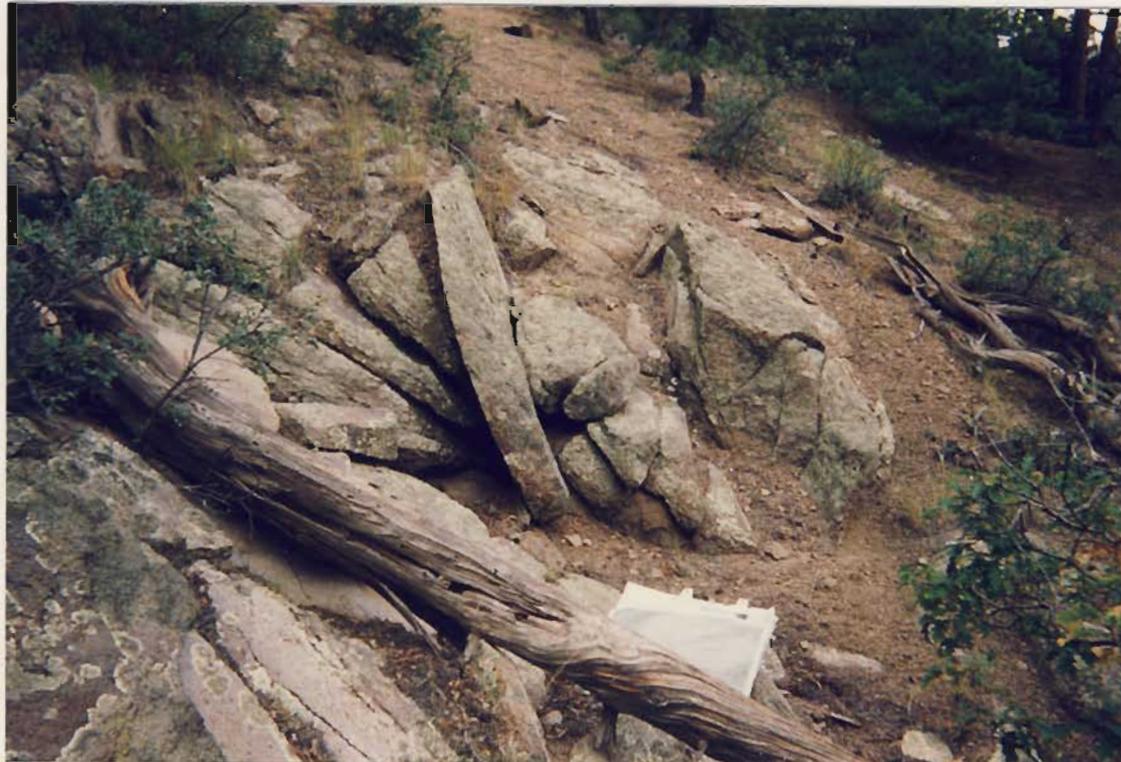
Fig. 28. Photograph of the anomalous east-dipping fractures at the base of the main scarp, south of Ski Hill Road. Clipboard is 60 cm square.

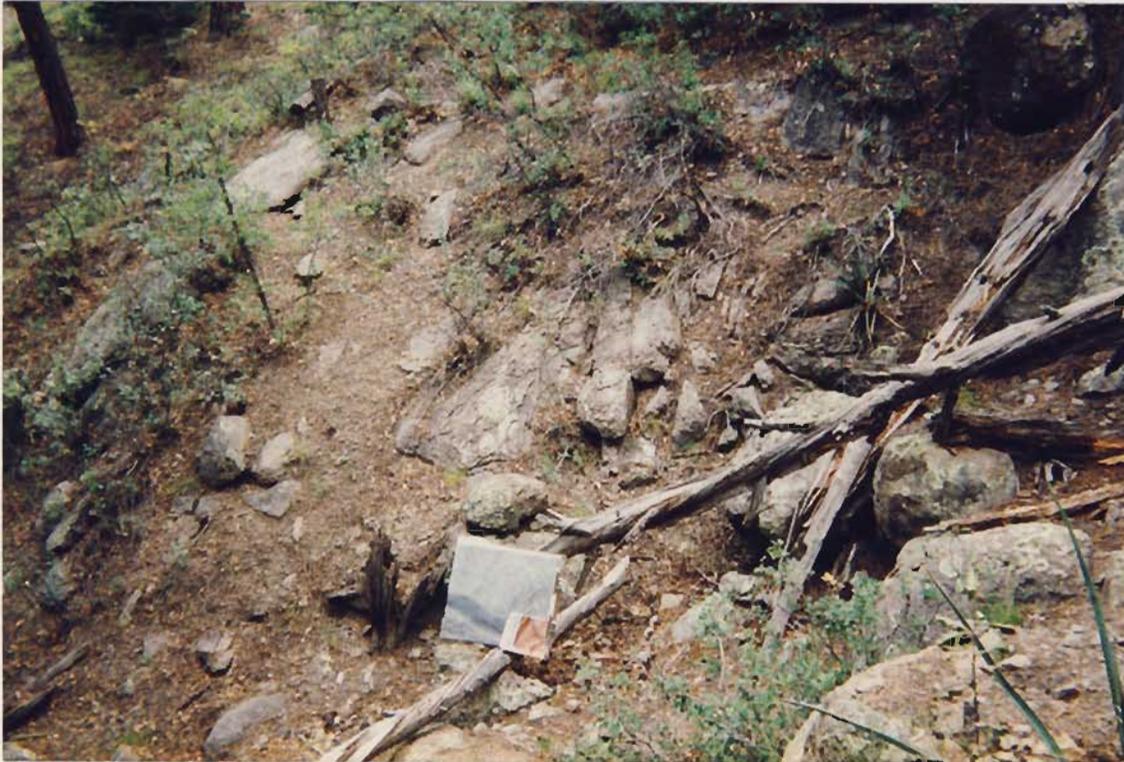
Fig. 29. Photograph of the anomalous east-dipping fractures at the base of the main scarp in the first small gully south of Ski Hill Road. Clipboard is 60 cm square. Both the spacing and orientation of fractures here is anomalous with respect to the rest of the scarp.

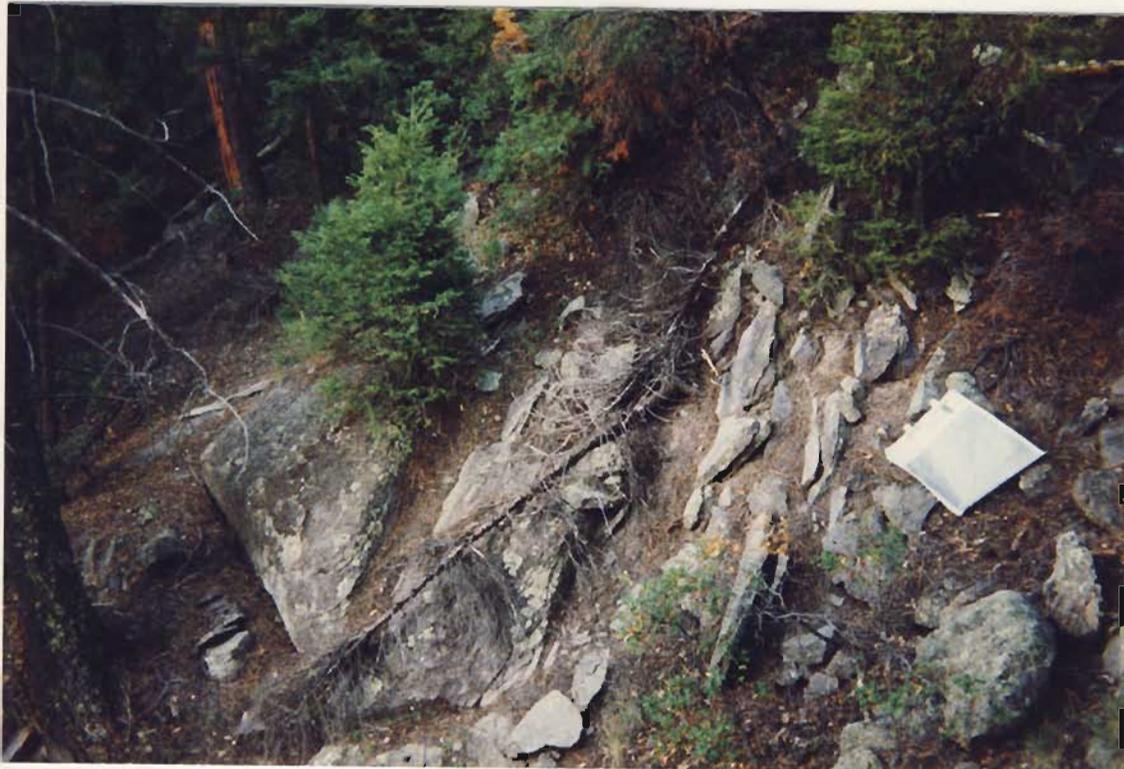
Fig. 30. Photograph of a mid-scarp fault zone in a gully on the scarp face, south of Los Alamos Canyon: Note the anomalous close fracture spacing near the clipboard (60 cm square) and the increase in fracture spacing to the left (east).

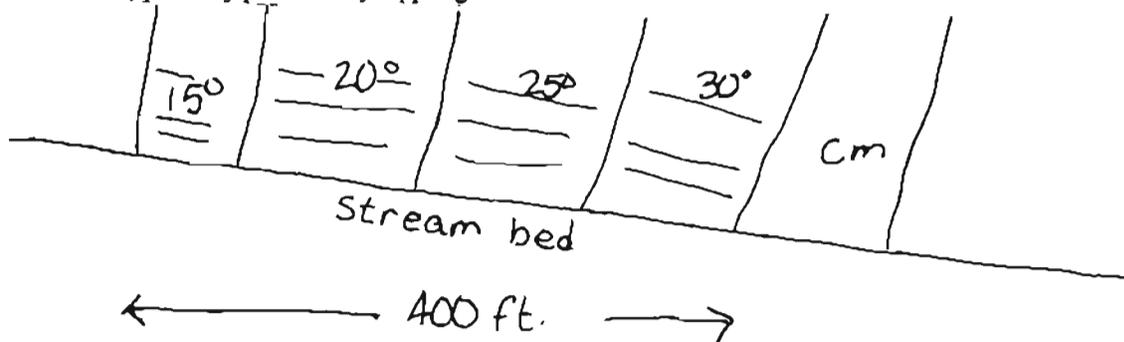
Fig. 31. Schematic sketch of the wide deformation zone exposed in Twomile Canyon where it cuts through the main fault scarp. The structural domains are separated by wide, rubble-filled fractures up to 1.5 m wide, probably produced by toppling.

Each domain of constant dip is separated from the next by a rubble-filled fracture up to 1.5 m wide, down at canyon bottom level. If these fractures formed by the eastward toppling of blocks, then they presumably widen upward, but cannot usually be traced up onto the colluvium-covered scarp face. This diffuse style of deformation results in splintering nearly the entire width of the fault scarp into separate topple blocks. The existence of megablock colluvium (cm) at the eastern end of the transect suggests that a larger-displacement fault truncates the 30 degree-dipping tuff.

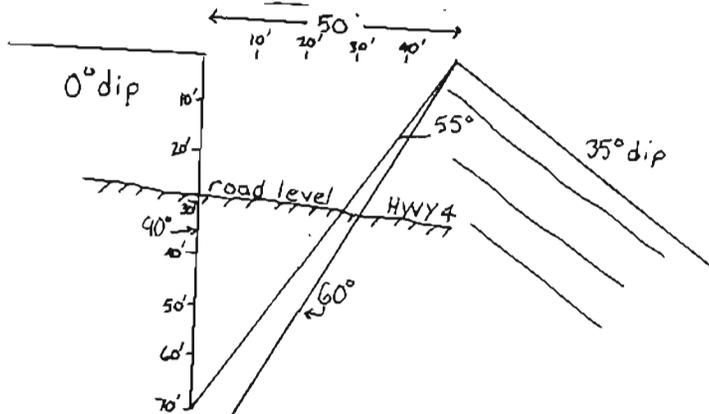
Fig. 32. Schematic diagram of the large topple fissure exposed in the roadcut on Highway 4 near the scarp crest. If the boundaries of the fracture remain planar, it implies that: 1) the fracture would be ca. 50 ft wide at the ground surface, not accounting for erosion, 2) the fracture would taper to zero width about 40 ft below the roadway, and 3) the toppled block of tuff is about 70 ft thick.

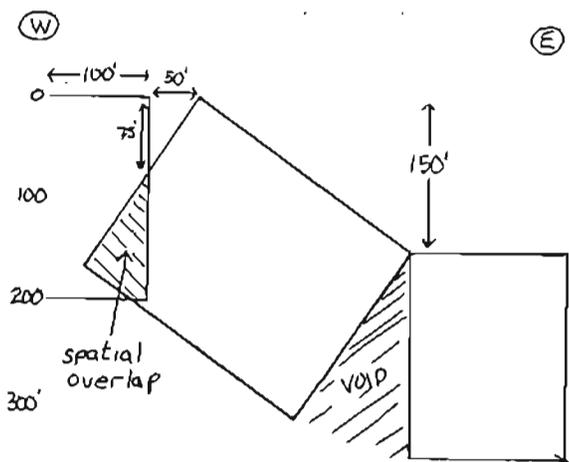
Fig. 33. Schematic diagram showing the space problems created by forward tilting of a 200 ft-thick slab of Bandelier Tuff at the main fault scarp. To avoid creation of large spatial overlaps and void spaces, the style of deformation must change to more vertical faulting at depths greater than 75 ft.

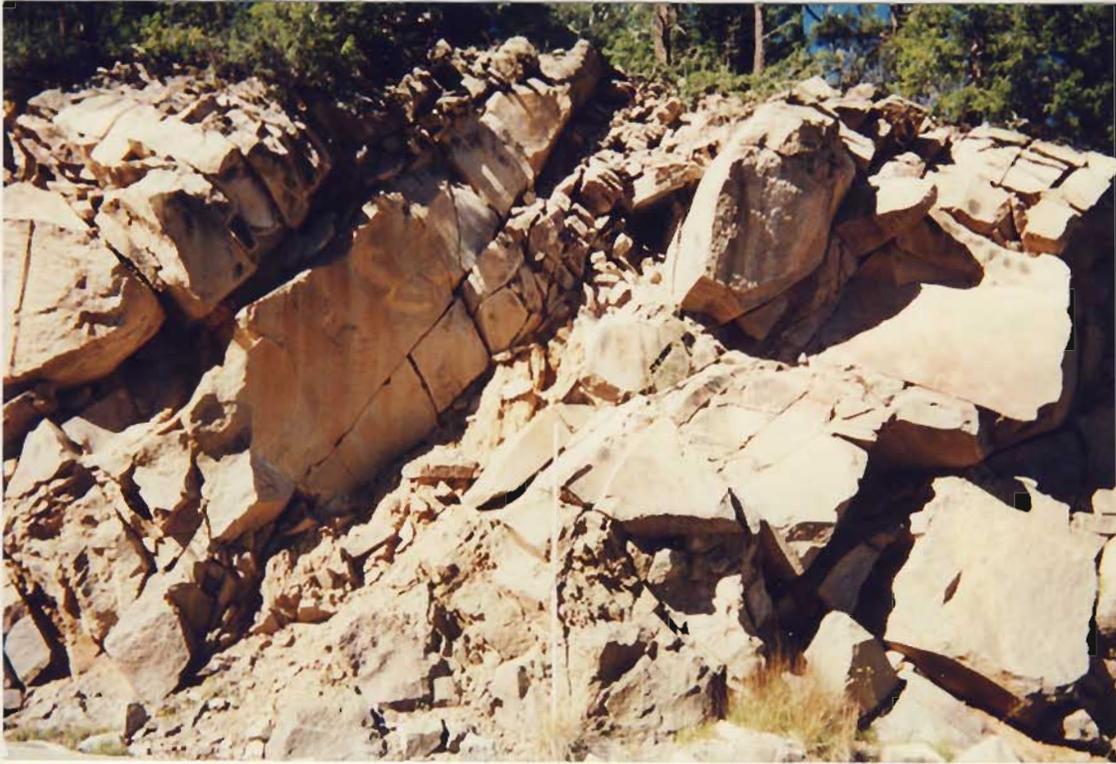
Fig. 35. Photograph of the filled fissure on the inside of the right-angle curve in Highway 4 near the crest of the scarp. The fill is well-stratified and ranges from very coarse sand (lighter brown colors) to silt (red). The fill is crisscrossed by numerous small-displacement conjugate normal faults. The upper part of the fill visible here has soil ped structure which obscures all stratification.

The 10 m-wide topple fissure fill on Highway 4 exhibits no internal structure, being a diamicton-like mass of angular tuff blocks encased in a fine red sandy matrix. However, some smaller tension fissure fills do display stratification and soil development. At the inside of the right-angle curve in Highway 4 near the crest of the scarp, a 1 m-wide fissure is filled with horizontally stratified sands and silts (Fig. 35). The fill is both internally faulted by small-displacement conjugate normal faults, and sheared in 10 cm-wide zones next to the bedrock walls. The upper part of the fissure fill appears to be a buried soil, although it is not clear how a soil would form in a fissure 3-4 m below the ground surface.

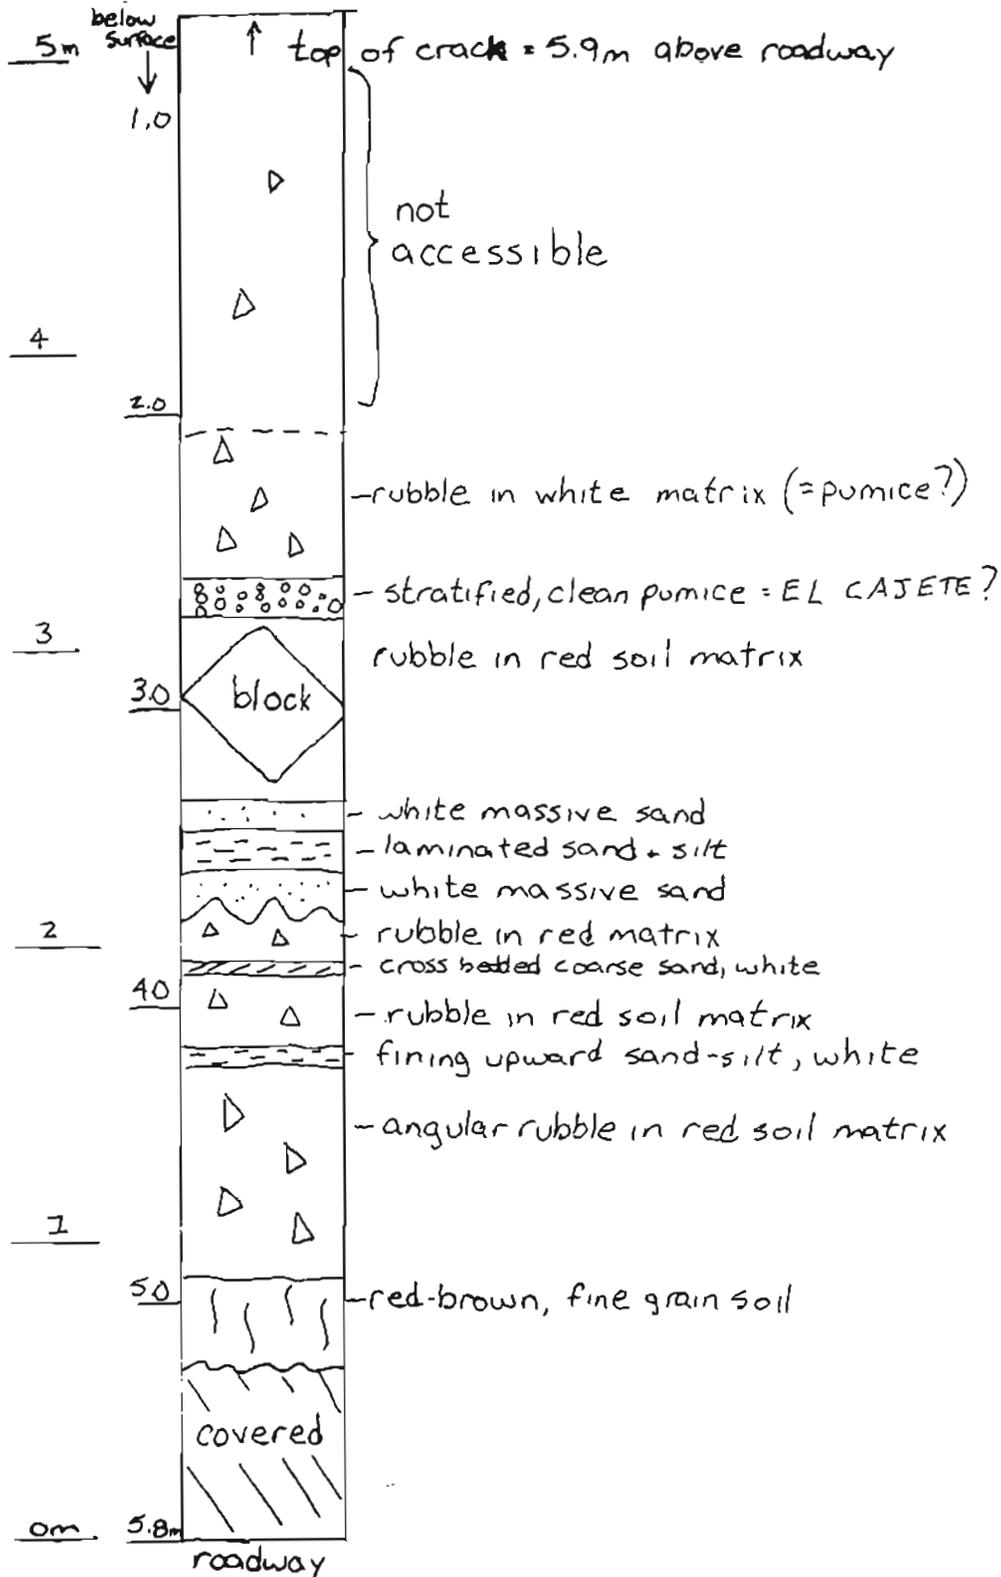
Fig. 36. Measured section of strata in a 30 cm wide fissure fill immediately west of the lower hairpin curve in Highway 4. No deformation was visible at the edges of the fissure, suggesting that this fissure resulted from pure tensile opening.

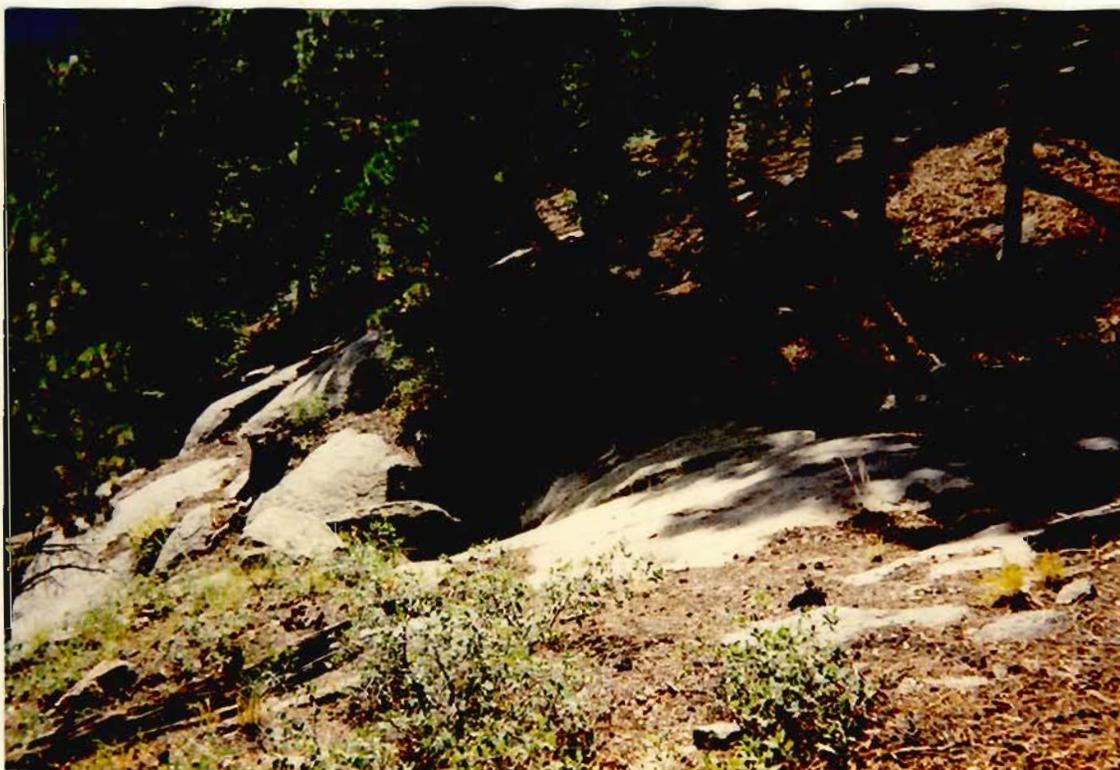
Fig. 38. Photograph of open topple fissures on the main scarp south of Ski Hill Road. The open void at center has not yet been filled in with sediment.

The main part of Highway 4 that crosses the fault scarp parallels a zone of toppling and yields many exposures of topple cracks. My reconnaissance observations suggest that cracks may progressively widen as toppling continues, which leads to rotation of topple cracks to lower angles (Fig. 37). On the northern end of the study area, where Ski Hill ascends the scarp, topple fissures stand open and have not been filled with sediment (Fig. 38).

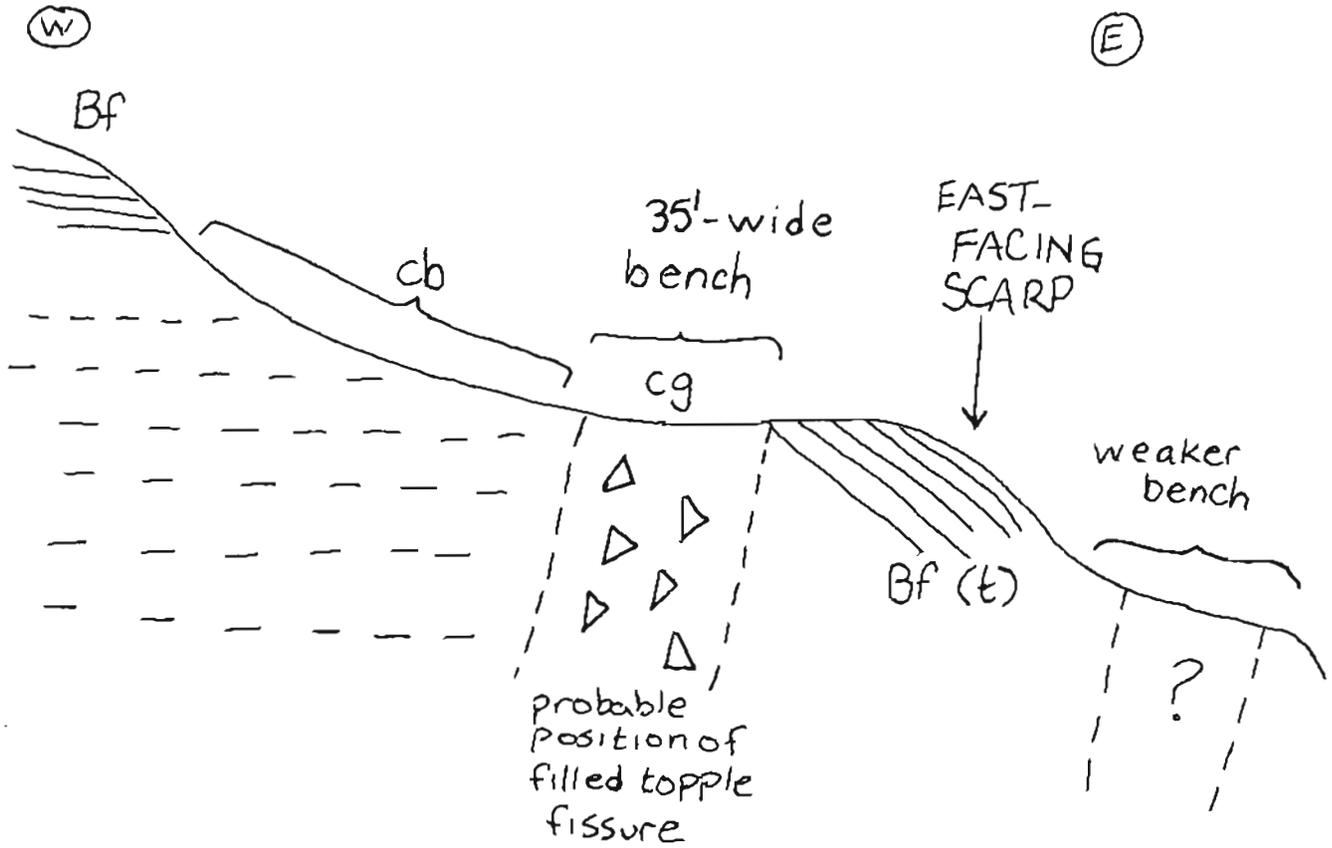
Fig. 39. Schematic section across the filled topple fissure, roughly 100 m north of the Highway 4 roadcut. This is a proposed site for future paleoseismic trenching.

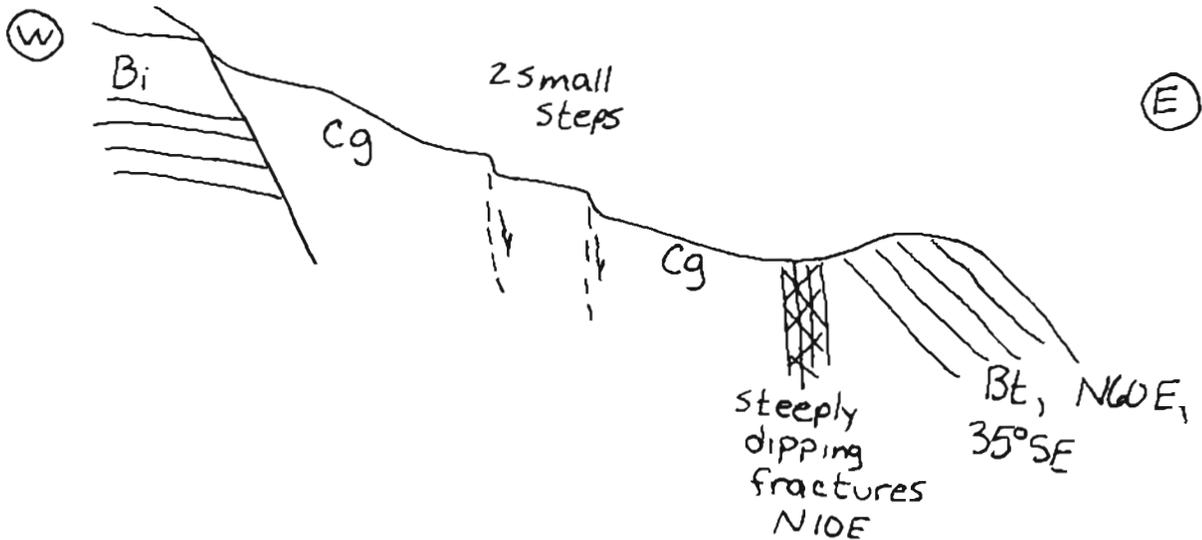
Fig. 40. Schematic section across a filled topple fissure on the north side of Twomile Canyon. An old dirt road takes advantage of the bench underlain by colluvium (cg.).

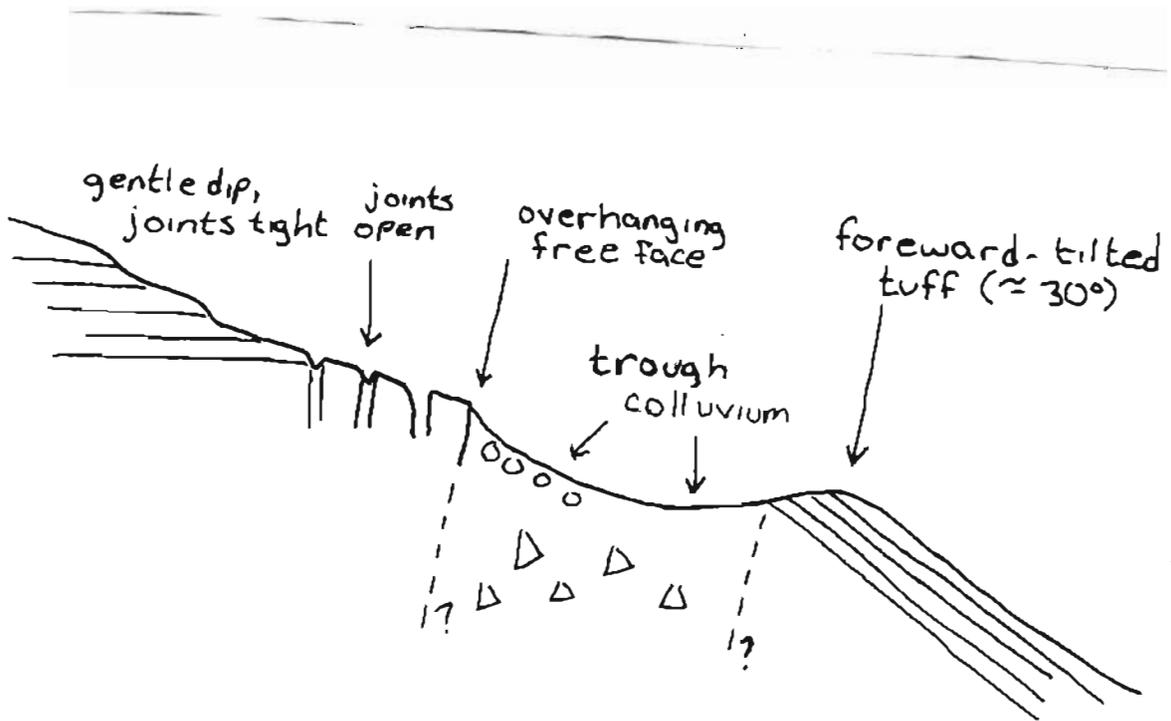
Fig. 41. Schematic diagram showing the common surface morphologic features over a topple fissure. See text for details.

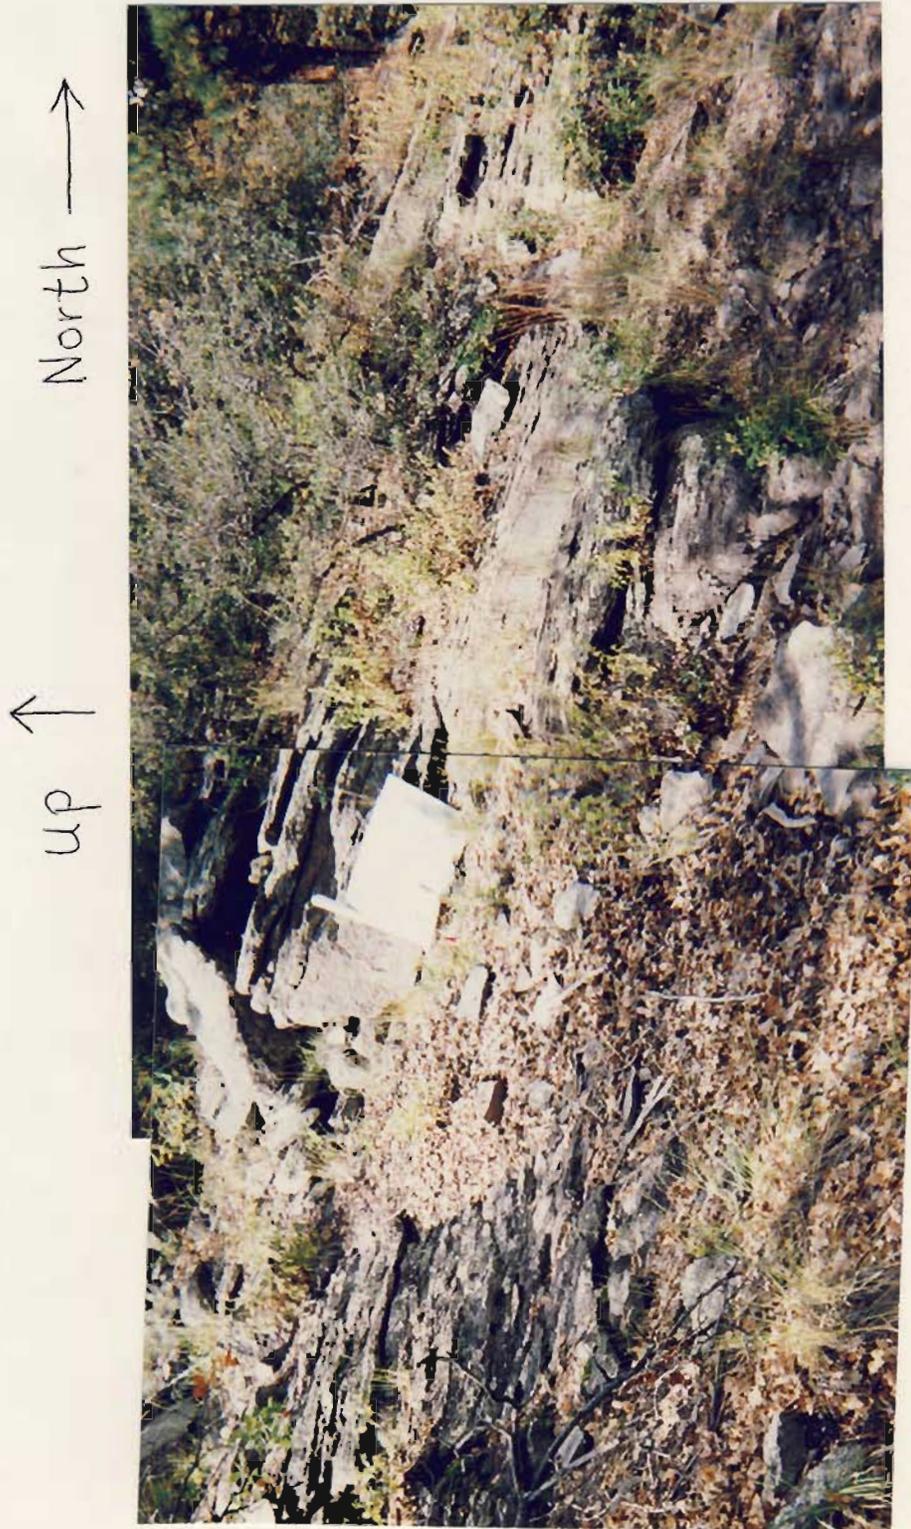
Fig. 42. Photograph mosaic of a suspected transverse structure that separates a domain of horizontal tuff (left) from 20 degree- dipping tuff (behind and right of the clipboard). The boundary lies immediately to the left of the clipboard.

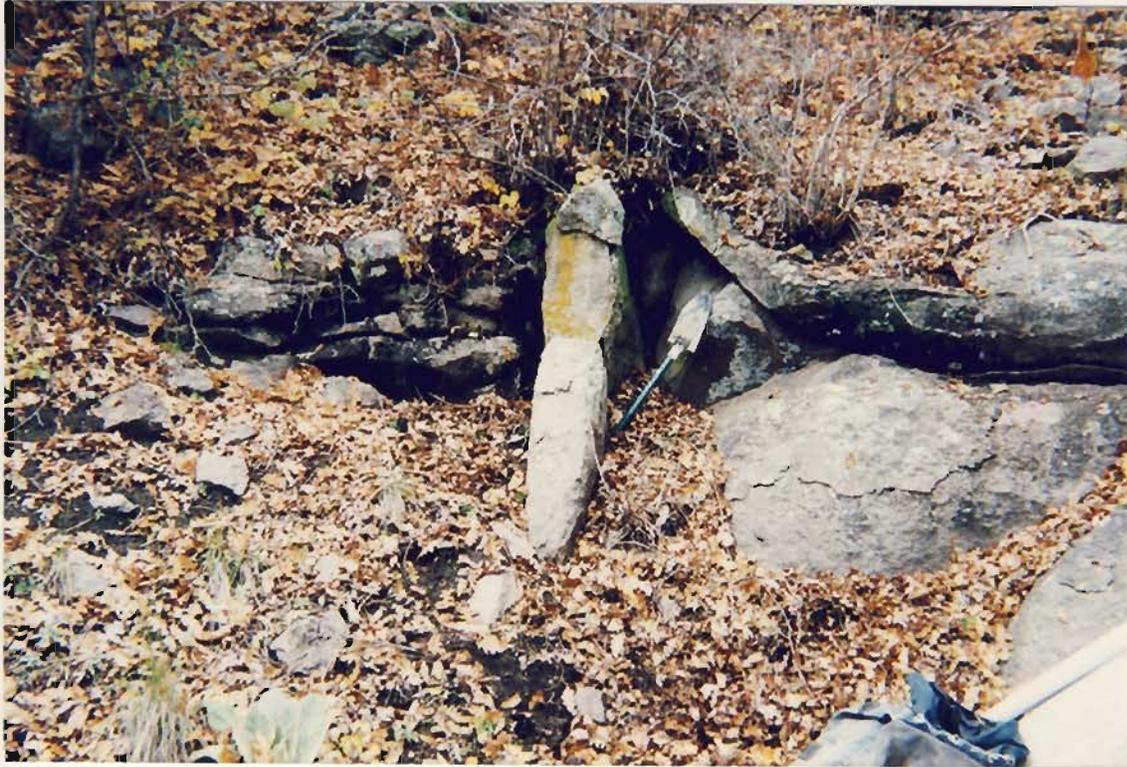
Fig. 43. Photograph of a suspected transverse structure at 7835 ft elevation on the scarp face about 200 m north of Canyon de Valle. Folding shovel is 70 cm long.

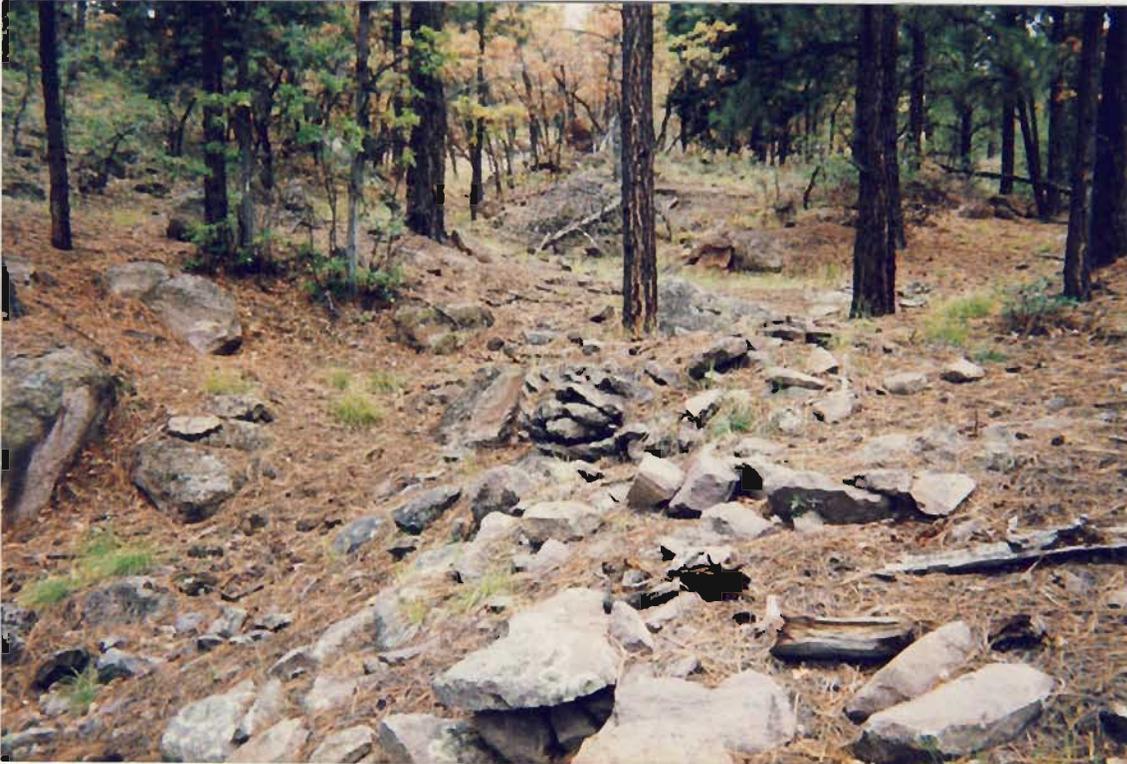
Fig. 46. Photograph of benched terrain at the crest of the main fault scarp north of Canyon de Valle. The block against which the clipboard is leaning displays prominent bedding-type joints dipping 25 degrees W, or back into the slope, as if the block has been back-rotated.

First, troughs are in the proper structural position to overlie crestal tension fissures, such as described in Sec. 4.2.3. This seems to be the case north of Canyon de Valle, where the tuff above the scarp is horizontal but on the scarp face dips 25-30 degrees east. However, the crestal topography is often more complex and chaotic than the simple bench landforms previously defined as overlying topple fissures (Figs. 39-41). Troughs often form an anastomosing network that isolates raised tuff blocks and they divert or behead small drainages from above the scarp. It appears that the troughs outline blocks of tuff, usually bedded horizontally, that are being separated by nearly horizontal extension toward the scarp face. In places small blocks of tuff are rotated back into the scarp, as if responding to rotational slumping (Fig. 46).

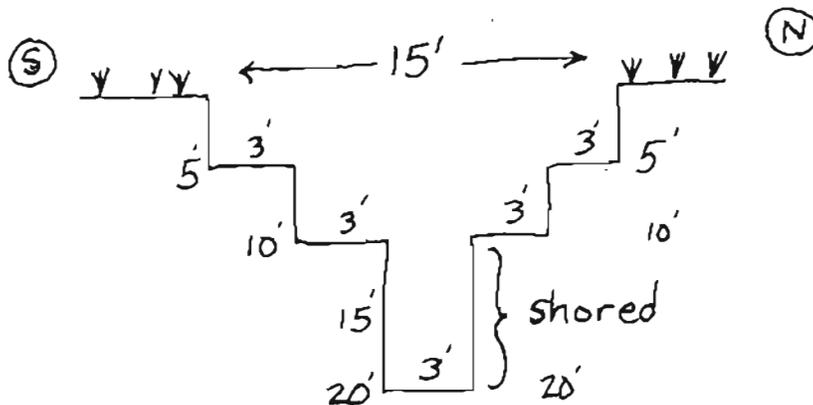
Fig. 48. Schematic cross-section of a 20 ft (6 m) deep trench showing the upper 10 ft can be benched. The lower 10 ft must be shored.

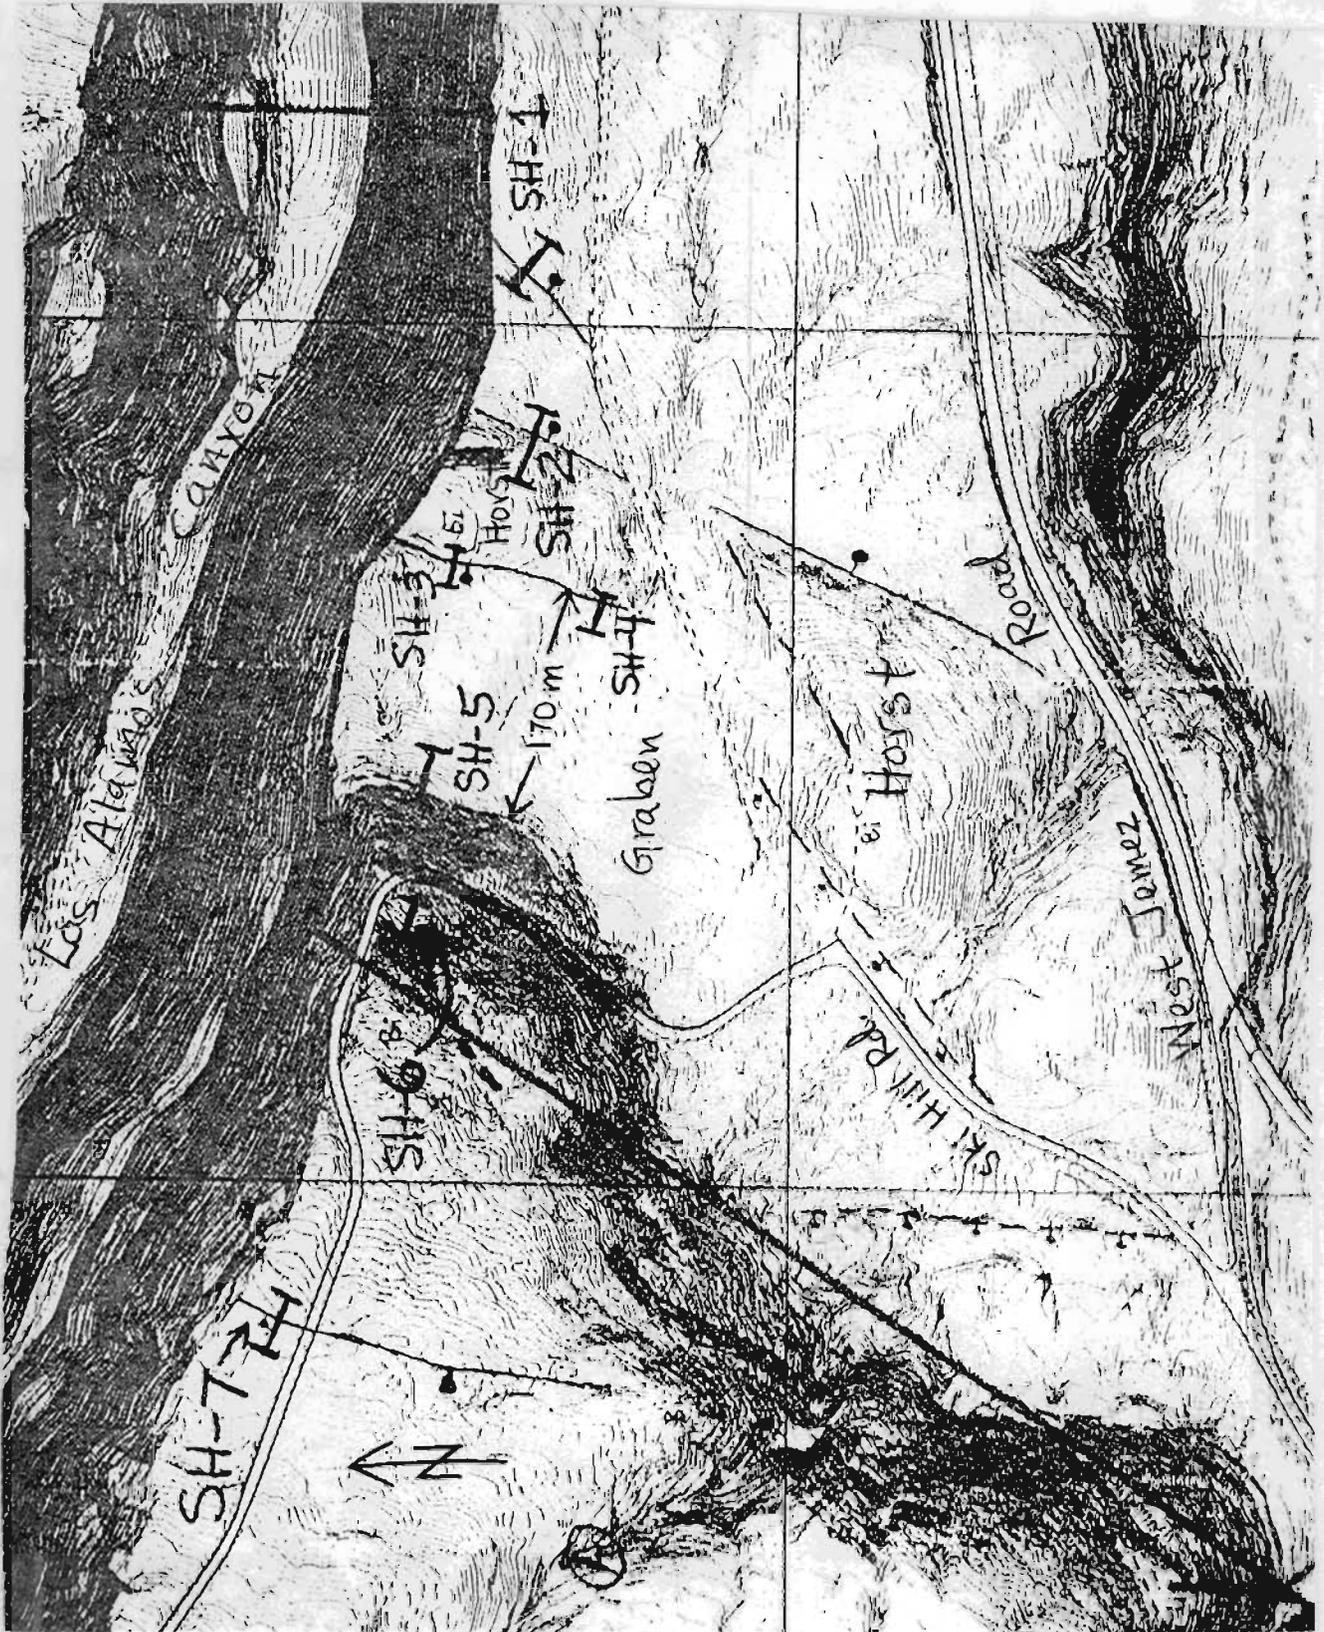
Fig. 49. Topographic map of the Pajarito fault zone south of Los Alamos Canyon, showing the locations for the seven trenches in the transect. Contour interval = 2 ft; 10 ft between bold contours. Bar-and-ball are on the downthrown side of the scarp.

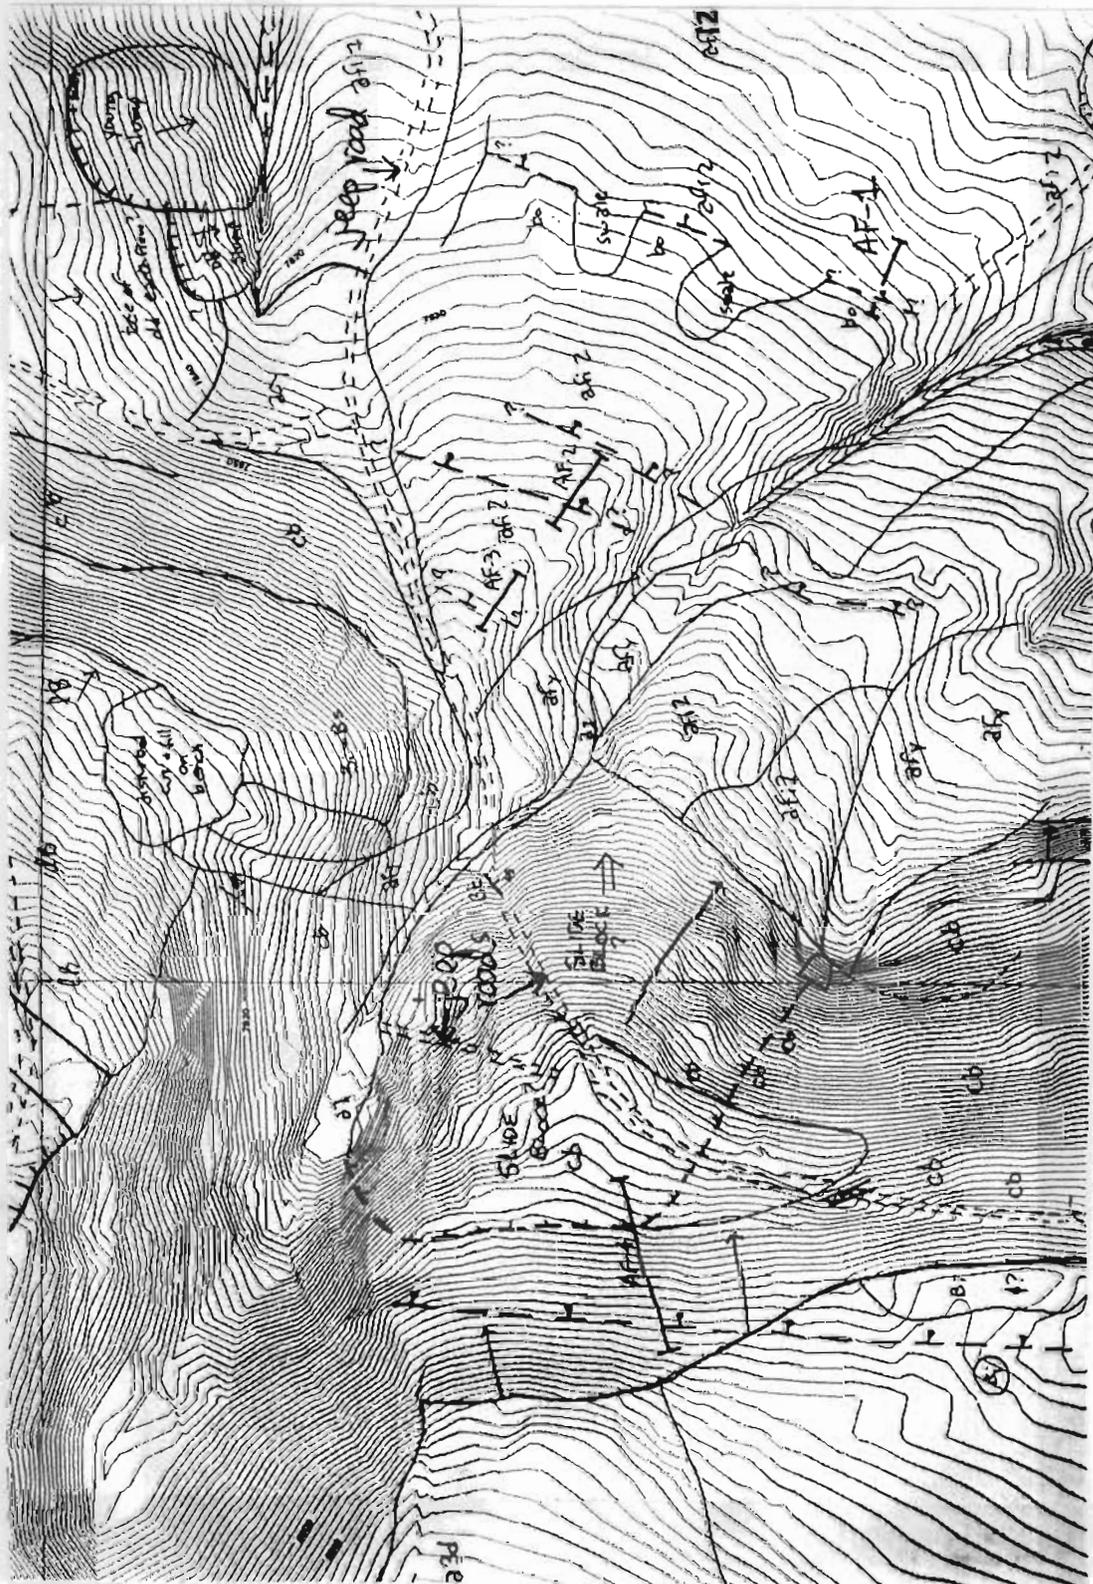
Fig. 51. Geologic map of the head of the large alluvial fan complex about 0.5 km SW of the mouth of Pajarito Canyon. Three trench sites (AF-1, 2, and 3) are located across subtle down-to-the-east flexures on an intermediate-age alluvial fan (afi2). Trench AF-4 is located farther west between old alluvium (a3d) and suspected slide block.
