**SPECIAL WATER QUALITY SURVEY OF THE PECOS AND
GALLINAS RIVERS BELOW THE VIVEASH AND
MANUELITAS FIRES**

Prepared by
J. Scott Hopkins

for
Surveillance and Standards Section
Surface Water Quality Bureau
New Mexico Environment Department
1190 St. Francis Drive - P.O. Box 26110
Santa Fe, New Mexico 87502

February 2001

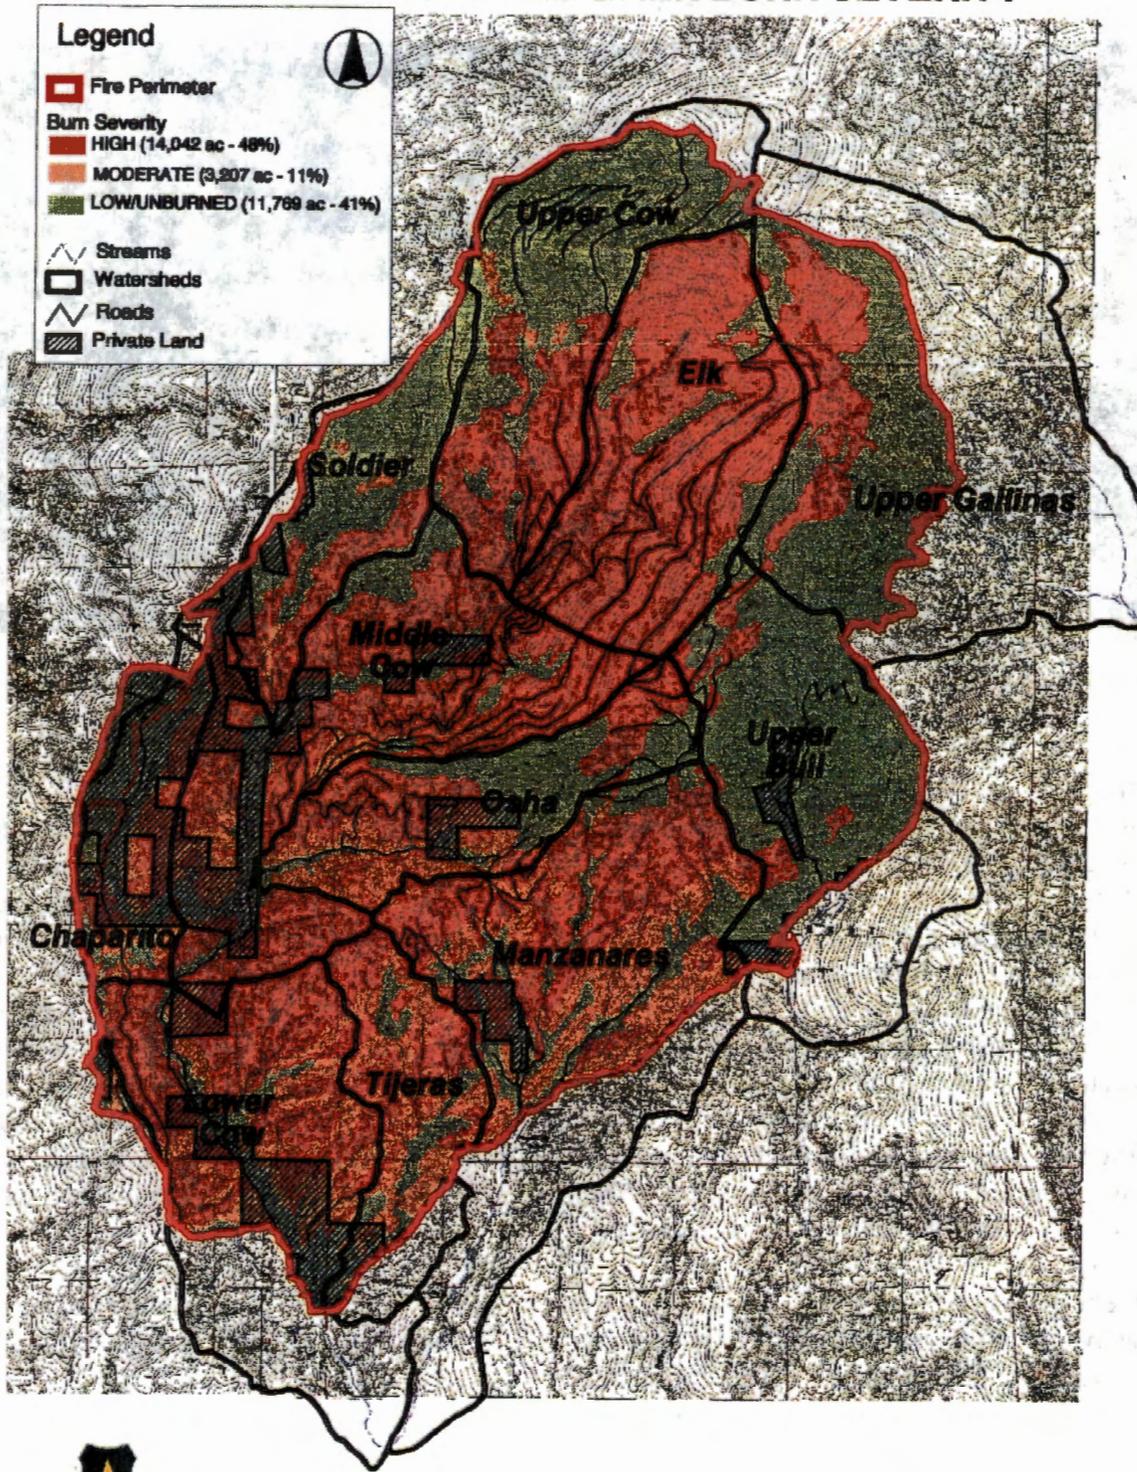
Figure 1 – Areal extent and burn intensity of the Viveash fire.

Subsequent to the 29,000 acre Viveash wildfire (See map, Figure 1), staff of the Surface Water Quality Bureau of the New Mexico Environment Department conducted water quality studies of the Pecos and Gallinas rivers downstream of the Viveash fire. The Viveash fire did extensive damage to the Cow Creek watershed in the south central Sangre de Cristo Mountains. Large quantities of ash, sediment and debris entered the Pecos River from Cow Creek, potentially destabilizing the Pecos system. The initial sampling run was conducted in response to citizen complaints of fish kills and black, ash-laden water. Of particular concern was recently received information indicating that sodium ferrocyanide ($\text{Na}_4\text{Fe}(\text{CN})_6 \cdot 10 \text{H}_2\text{O}$) (MSDS, 2001) may have been a constituent of the fire retardant slurry used to combat this fire (Little and Calfee, 2000). Additional water samples were taken at selected locations below the Manuelitas fire, again in response to citizen complaints. Sampling efforts were coordinated, to the extent possible, with runoff events from the watersheds of interest.

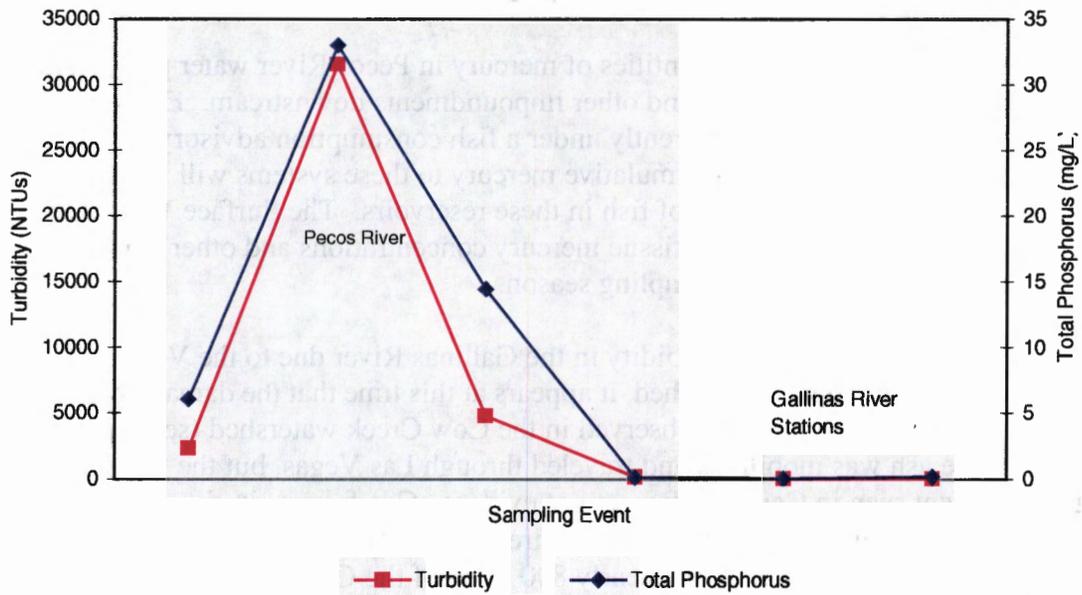
Figure 2 - Comparison of Total Phosphorus vs Turbidity in Viveash Runoff, Summer 2000

Cyanide was found in both water and sediment at the Pecos River above I-25 station (see Table 1), most of it probably bound to suspended sediments in water (see Figure 2). While some cyanide is produced naturally in wildfires (Yokelson, R. J., *et al.*, 1997), it is most likely that the cyanide found in the course of this survey was derived from fire retardant slurry. The degree of toxicity attributable to the levels of CN⁻ found in the Pecos River is difficult to determine. Free cyanide is acutely toxic to salmonids at concentrations ranging from 30 µg/L (ppb) to 160 µg/L, depending on species. Other species of freshwater fish are somewhat more tolerant (Moore, 1990). The above values were developed using free CN⁻; the cyanide used in fire retardants is strongly bound to the sodium/iron complex and is therefore minimally biologically available. Moreover, bioavailability is further reduced by adsorption to fine particulates (see Figure 2). Concentrations seen in water were potentially high enough to elicit toxic reactions in aquatic life, but actual levels of free CN⁻ and HCN are not known. Observed levels were not high enough in water or sediment to produce toxicity in terrestrial organisms. It is unlikely that any aquatic life could have survived the exceedingly high concentrations of ash long enough to have succumbed to cyanide toxicity.

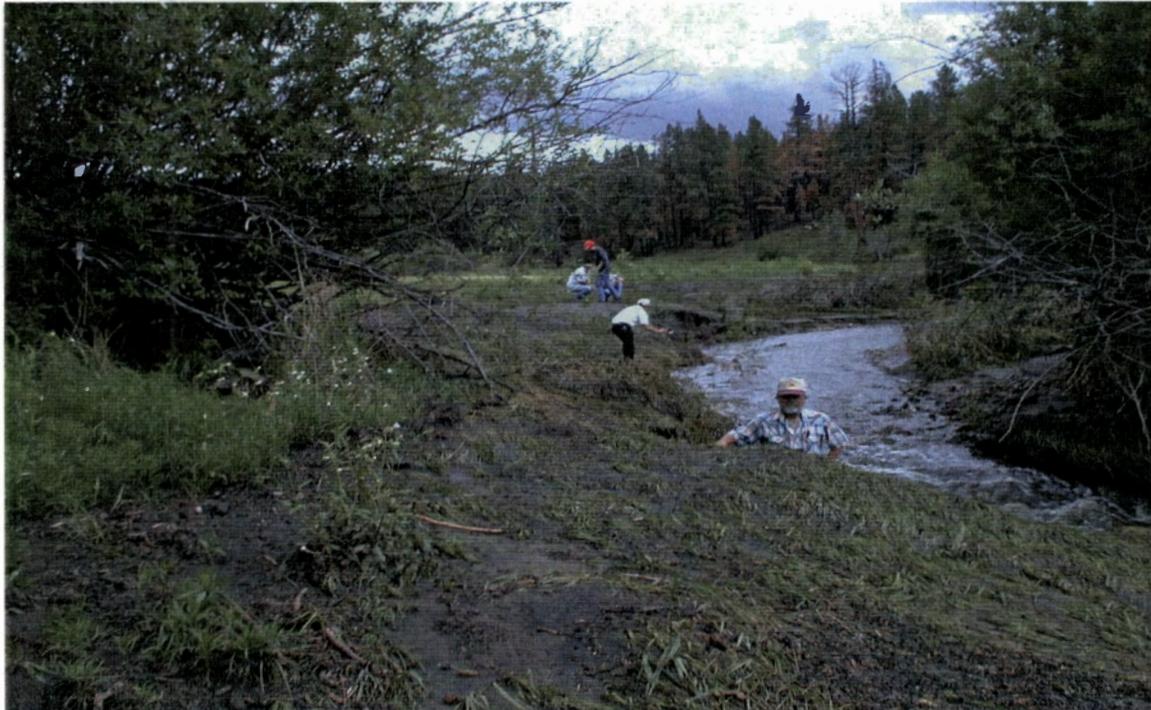
Figure 5 – Upper Cow Creek, June 2000.

While there may be increases of turbidity in the Gallinas River due to the Viveash fire's encroachment into the upper watershed, it appears at this time that the damage was insufficient to cause the type of extreme impacts observed in the Cow Creek watershed (see Figures 5, 6, 7, 10 and 13). Some ash was mobilized and traveled through Las Vegas, but the massive quantities of ash and sediment seen in Cow Creek were not evident. Careful monitoring is called for, however. Surveys conducted by the Viveash fire Burned Area Emergency Rehabilitation (BAER) team determined that, while nearly 800 acres of the Gallinas watershed were heavily damaged (Robbie *et al.*, 2000), no drainages directly feeding the Gallinas River were seriously impacted.

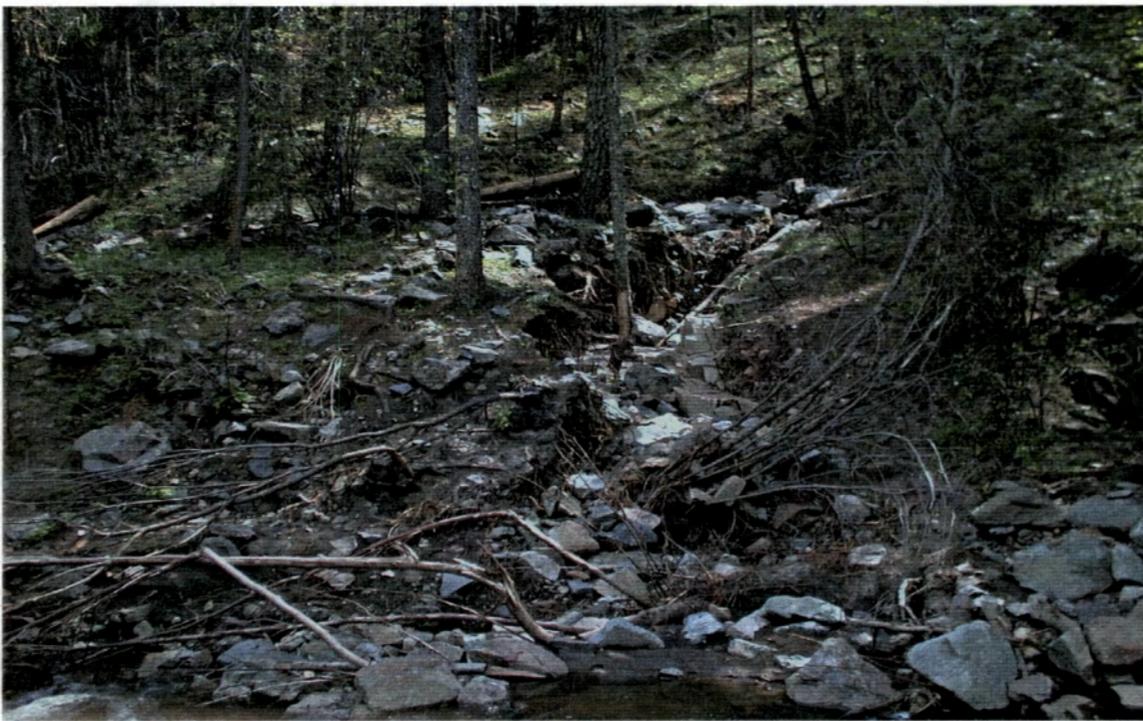
There are no tributaries involved in the Viveash fire between the Village of Pecos and Cow Creek. Fire-related inputs to the Pecos River must then have come from the Cow Creek drainage. Time and resource limitations allowed for only one visit to the Cow Creek watershed. During that visit (August 7, 2000) Cow Creek was found to have incised approximately two feet into the alluvium of the canyon floor (Figures 4 – 10). Extensive areas of recently exposed colluvial deposits were visible where the channel contacted the canyon wall. Many ephemeral tributary drainages had already begun to rejuvenate (head cut). No fish were observed during this visit. A cursory examination of the macro-benthic community indicated that benthic invertebrates had been completely extirpated. Deposits of ash and sediment were one to two meters deep in some low gradient areas below the burned area (see Figures 4, 6). It has been reported by staff of the Forestry Division of the New Mexico Energy, Minerals and Natural Resources Department that by fall of 2000, Cow Creek had cut its channel another two to three feet deep (Charlie Wicklund, pers. com.). Future runoff events and monsoon storms will almost certainly exacerbate this situation. It is reasonable to assume that where the channel is eroding the canyon wall there will be significant episodes of mass wasting in the unsupported colluvium, accompanied by extensive rejuvenation of existing side drainages (See Figure 7).

Figure 7 – Upper Cow Creek, June 2000. Rejuvenation of a side drainage.

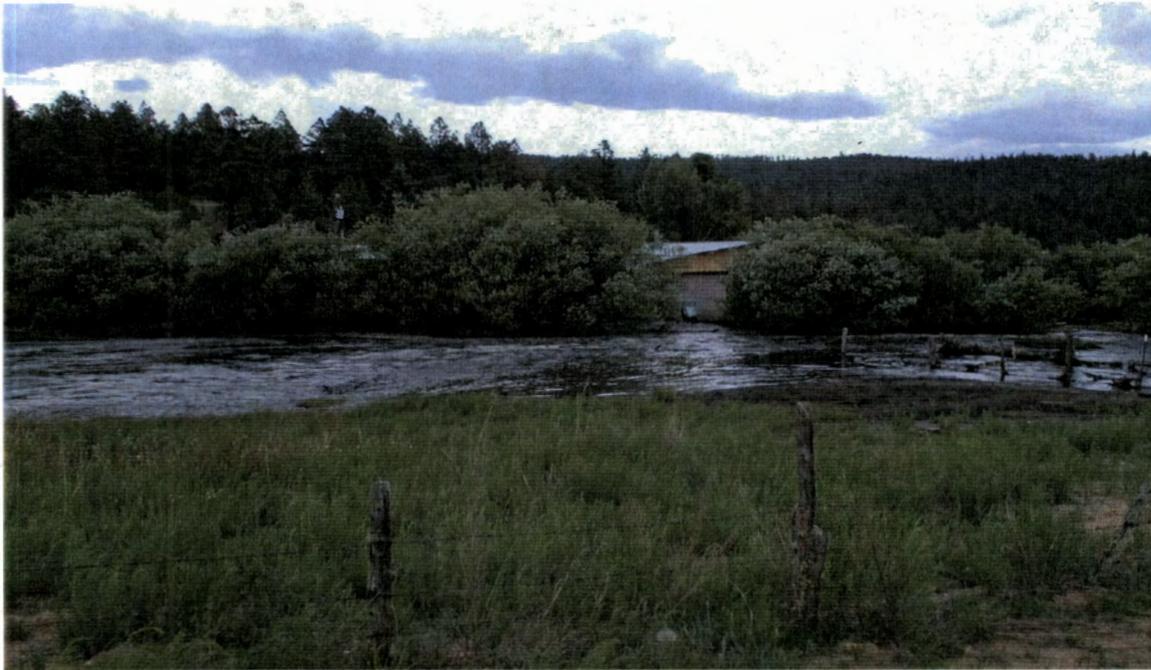
Figure 8 – Cow Creek in flood below Santa Fe National Forest.

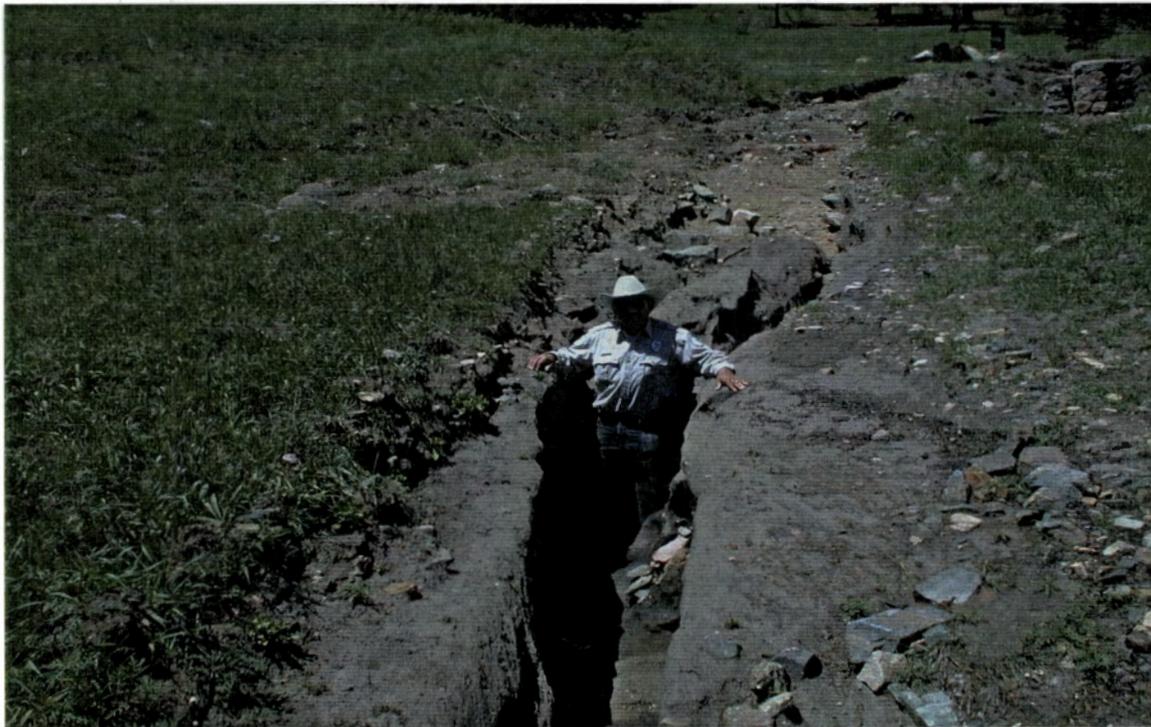
Figure 9 – Upper Cow Creek, June 2000. Severe erosion of low gradient uplands. Photo courtesy of Charlie Wicklund,
New Mexico Div. Of Forestry.

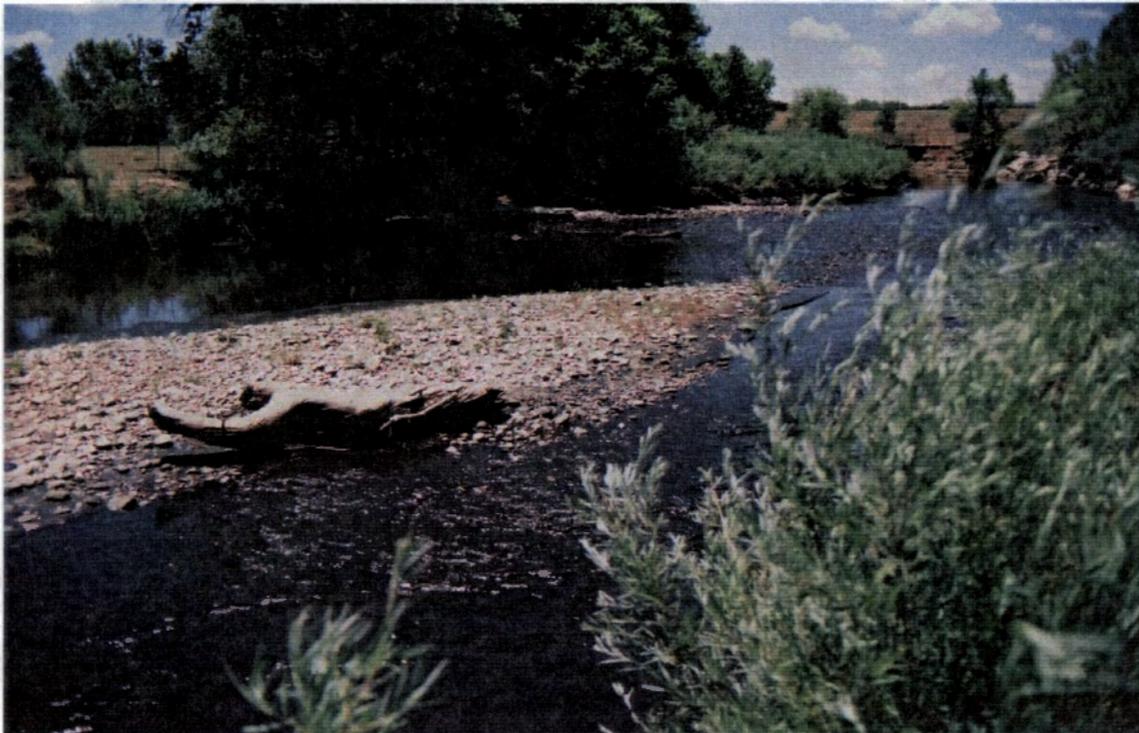
As the Pecos River below the Village of Pecos is already in a state of adjustment (disequilibrium), as indicated by many eroding, vertical banks (see Figure 11), the effects of additional sediment loading may be intensified. Channel adjustments can result in significant

Figure 11– Pecos River, June 2000. View down stream. Note vertical bank in background. Photo courtesy of Dan Davis, NMED.

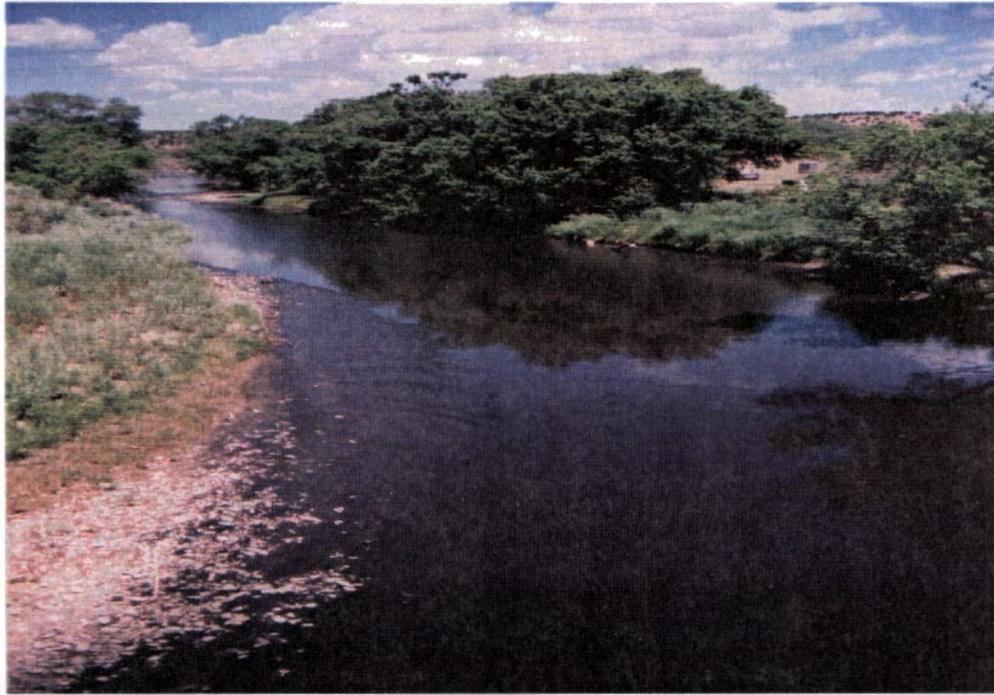
Figure 12 – Pecos River, June 2000. View upstream. Note ash bar at left.

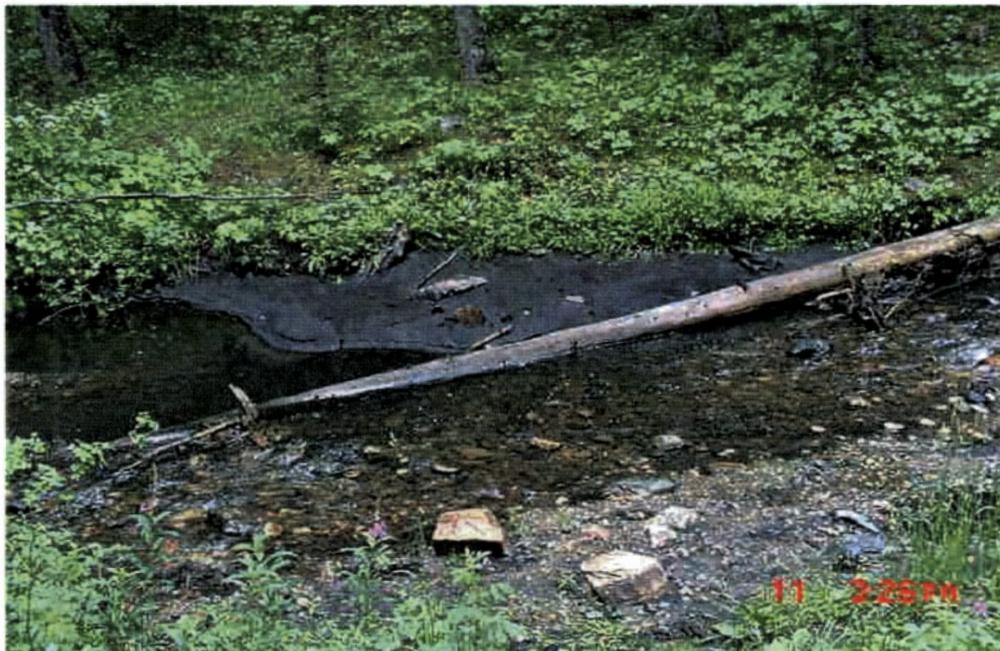
Only one sampling run was conducted on the Gallinas River. On that day only one station (Gallinas R. at end of Forest Road 263) had ash deposits substantial enough to sample (see Figure 13). With the exception of trace amounts of cyanide (3.0 µg/L), no water quality parameters were found to be elevated. Despite finding the highest level of sediment cyanide (2,225 ug/kg) seen in the course of this investigation, the level of cyanide seen in whole water at the time of sampling was insufficient to kill aquatic organisms (see Table 1). Trout were observed feeding during the sampling effort, and a cursory examination of the benthic macroinvertebrate community revealed a diverse and healthy community structure. Water samples taken from the Gallinas River at the USGS gage near Montezuma and at the end of the Storrie diversion (CN⁻ only) yielded no water quality standards exceedences.

Figure 13 – Gallinas River, June 2000. Note ash bar behind log. The banks are not eroding and there is no sign of flooding.
