LA-UR-10-2076
April 2010
EP2010-0138

Demolition Documentation Report for the Bayo Canyon Wastewater Treatment Plant, Area of Concern 00-018(b)

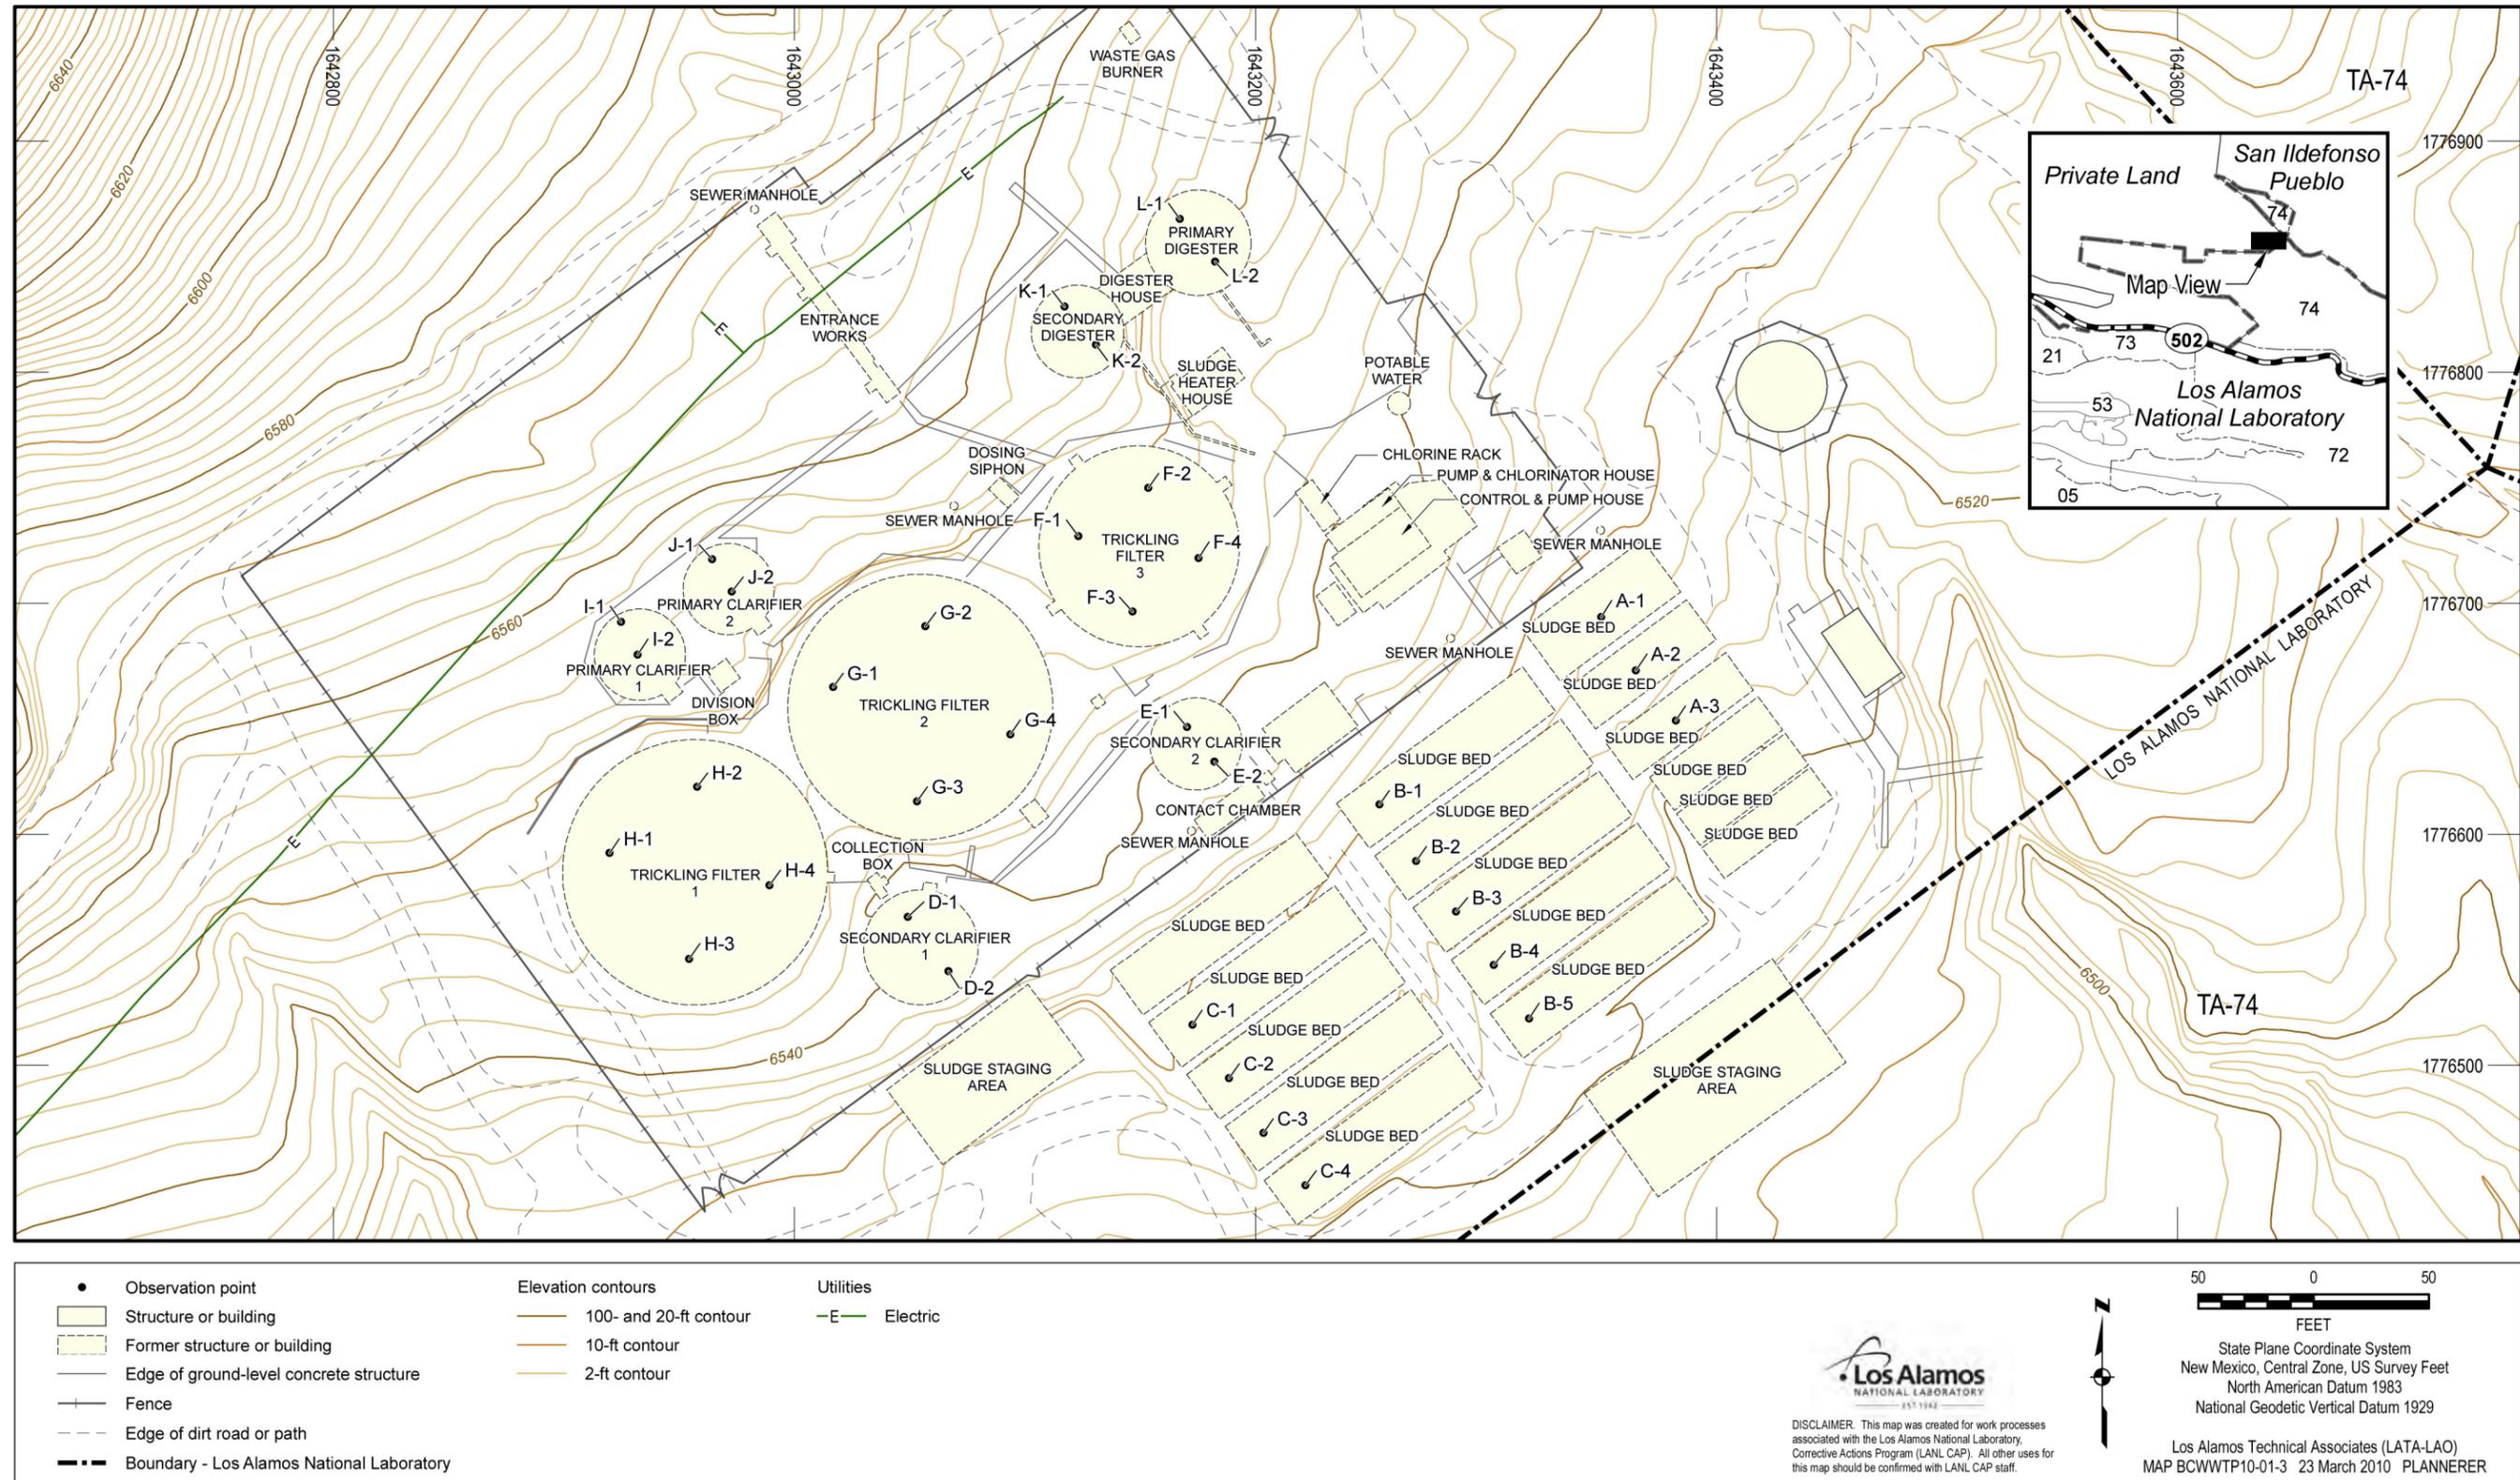
Figure 4.0-1 Bayo WWTP structures and observation points

The clarification letter from NMED (2009, 108132) specifies that one location be observed in each sludge bed that may have received wastes from the HRL (i.e., any sludge drying beds used before 1981). The sludge beds did not have concrete bottoms, so observations were made in holes dug down to native soil using an excavator. Figure 4.0-1 shows the observation points for the sludge beds at the Bayo WWTP.

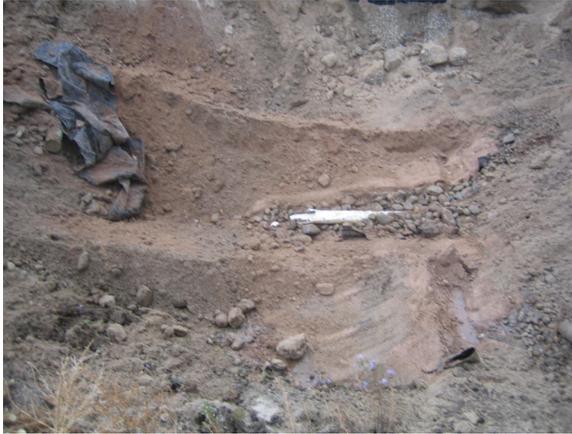
Observation point A-2

Site visit. Two observations made in sludge beds (Structure Group A). No odors or discoloration. Photos taken.

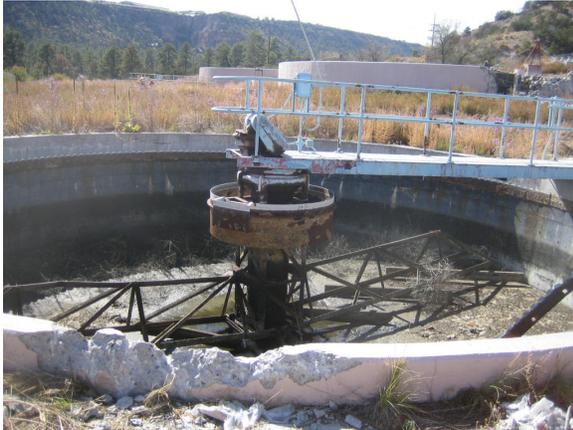
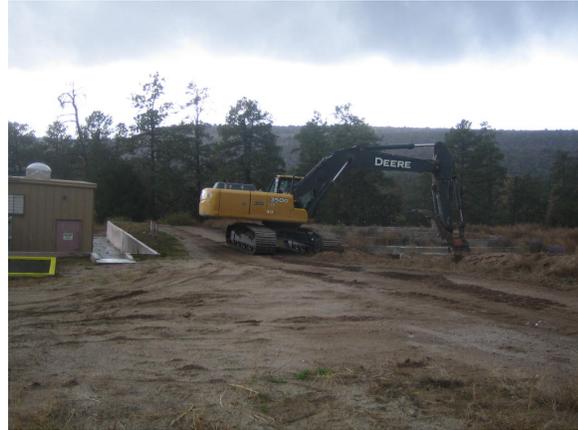
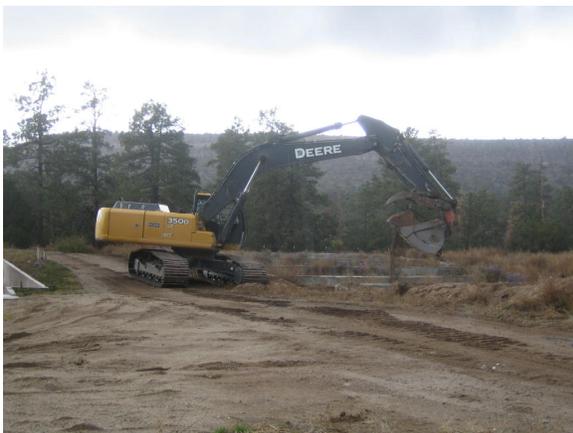
Site visit. Demolition of secondary clarifier (Structure E) in progress. Unit previously observed. No concerns noted. Photos taken.

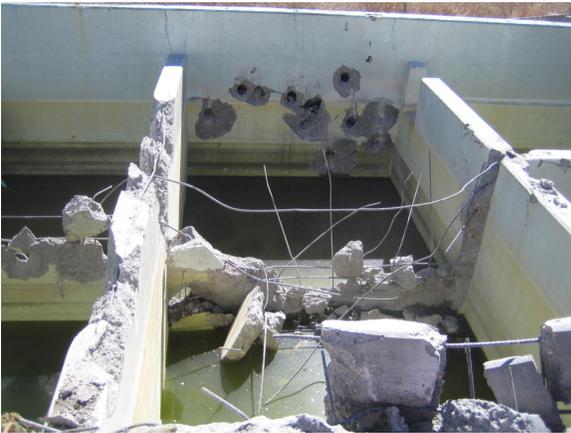
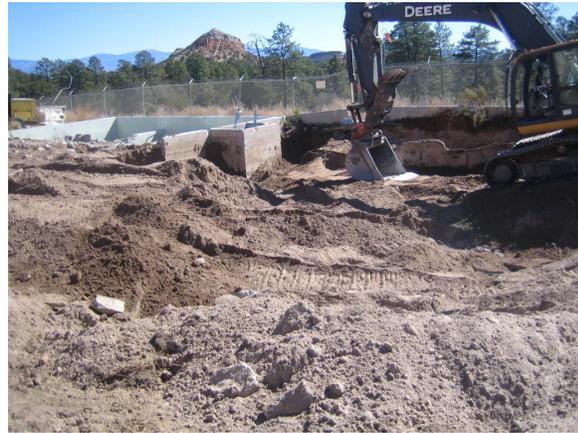
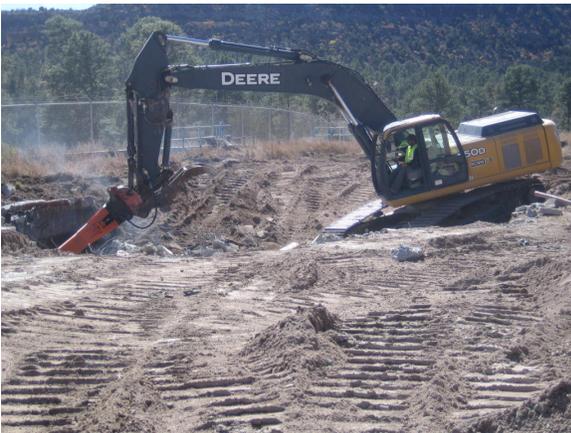
Site visit. Observed demolition of chlorine contact chamber. Photos taken.

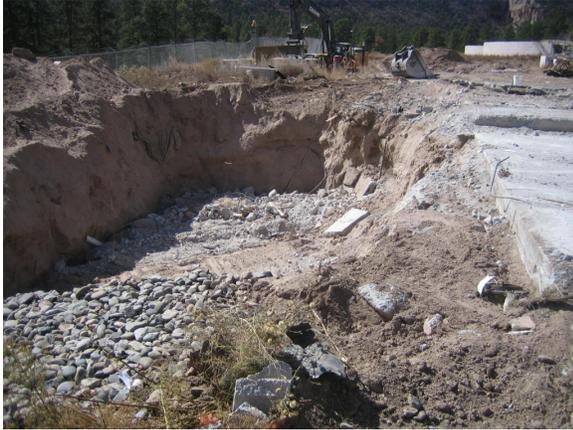
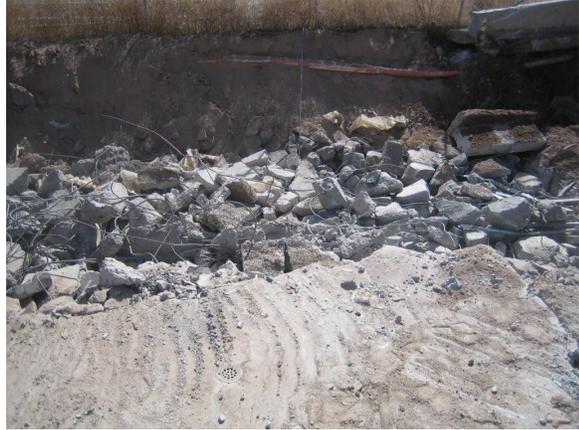
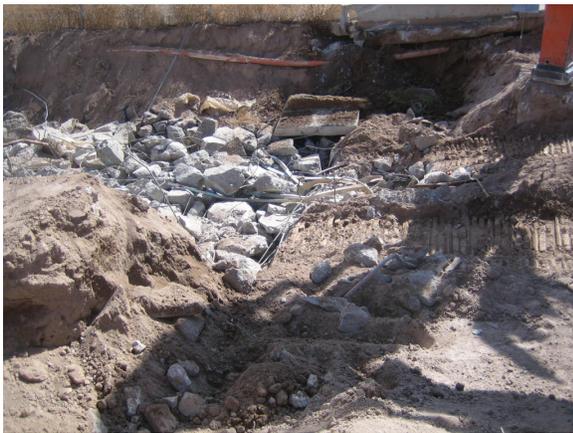
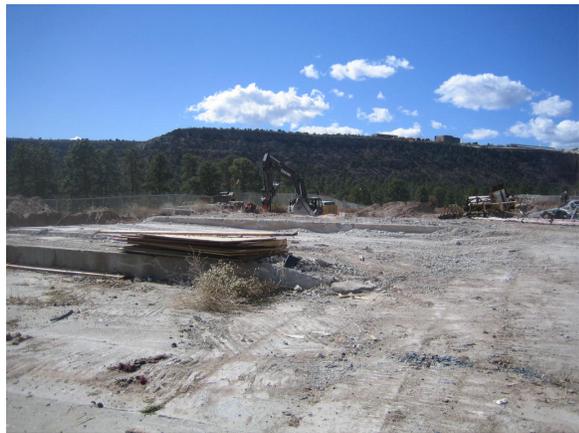
Crew finished demolition of chlorine contact chamber and will move to secondary clarifier (Structure D). Crew reported no unusual observations. Observation did not show any signs of discoloration or other indicators of concern. Photos taken.

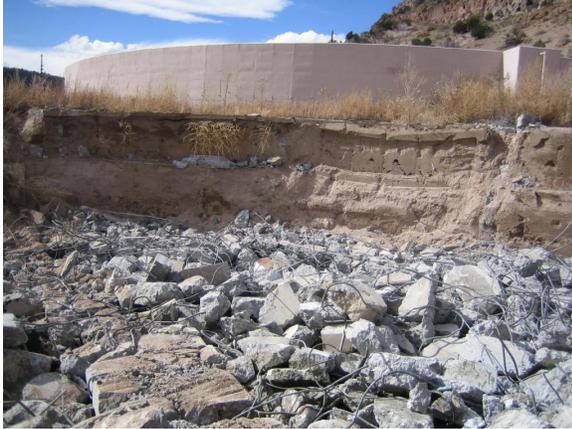
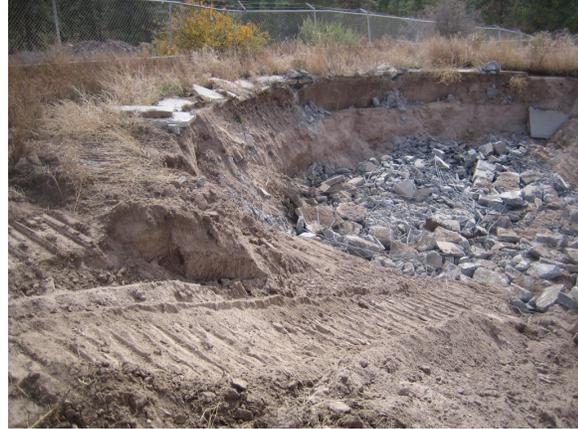
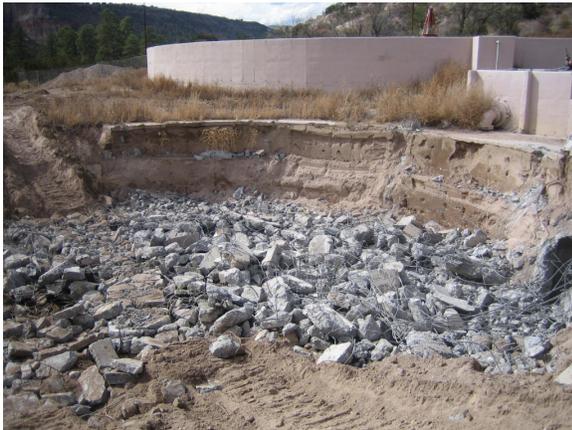
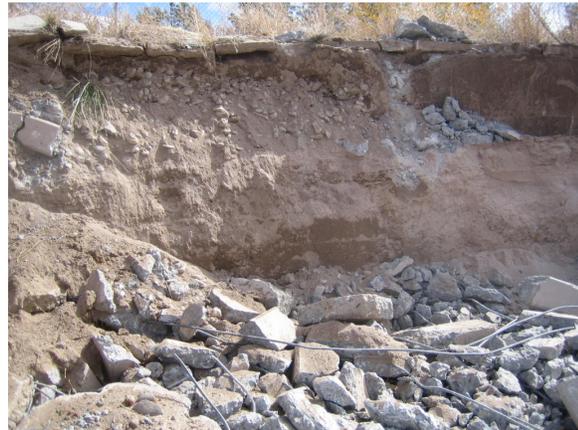
Crew finished demolishing secondary clarifier (Structure D). Visual observation (observation points D-1 and D-2) did not show any signs of discoloration or concerns. Photos taken.

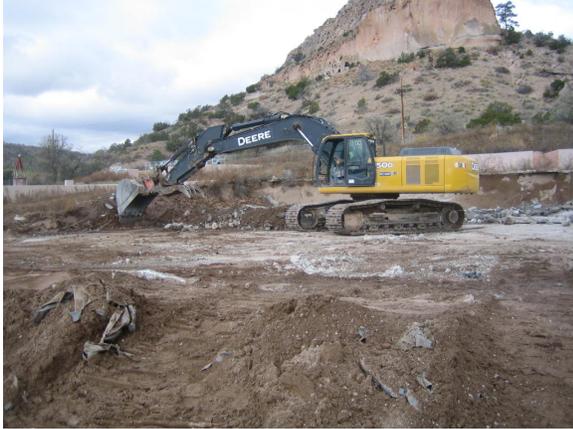
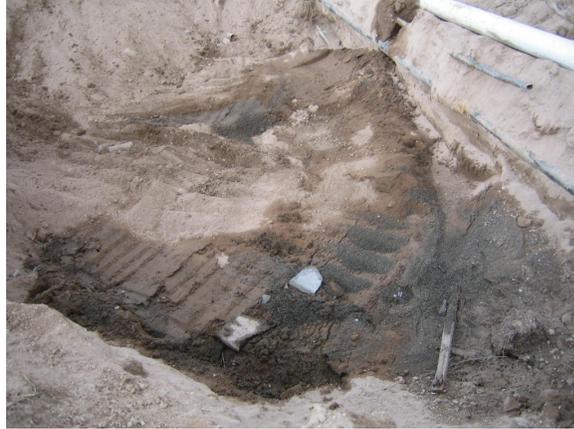
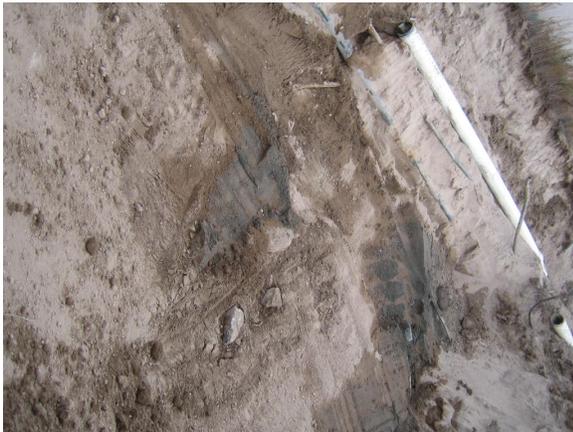
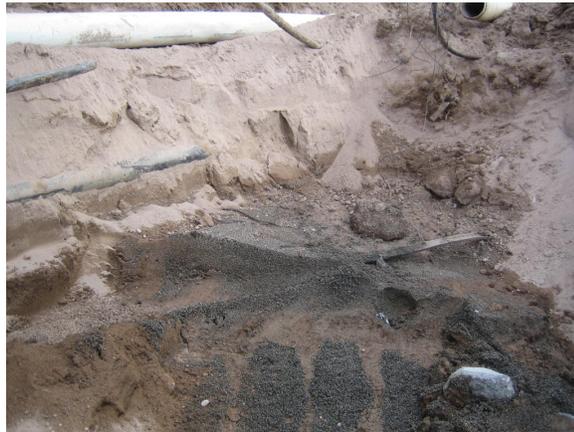
Work crew punched holes below the trickling filter (Structure G). No unusual observations or concerns. Visual observation showed no sign of discoloration. No abnormal olfactory observations. Photos taken.

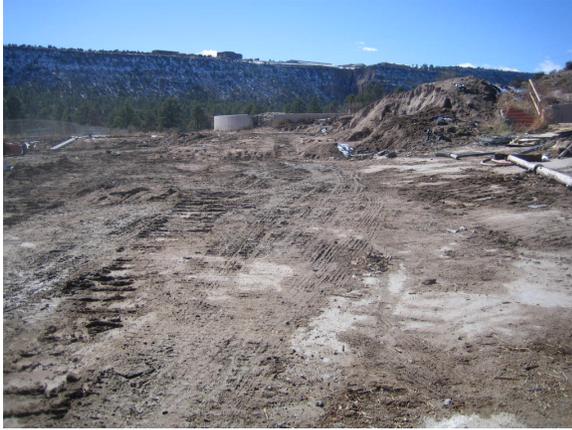
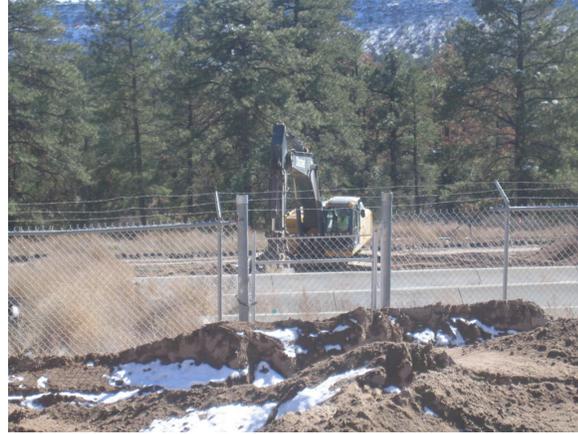
Excavator moved to the sludge beds; now in the process of pulling up concrete walls. Work is being done on the southernmost beds, which were previously cleared. No further excavation points within the fence area exposed, so no field observation were made. Photos taken.

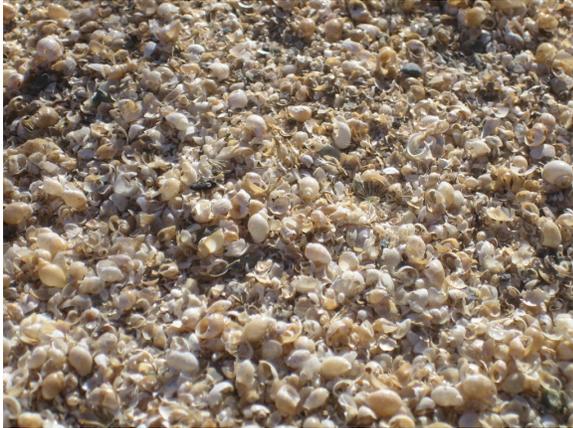
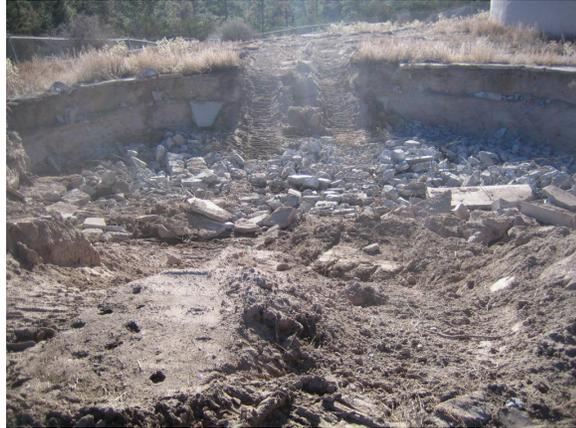
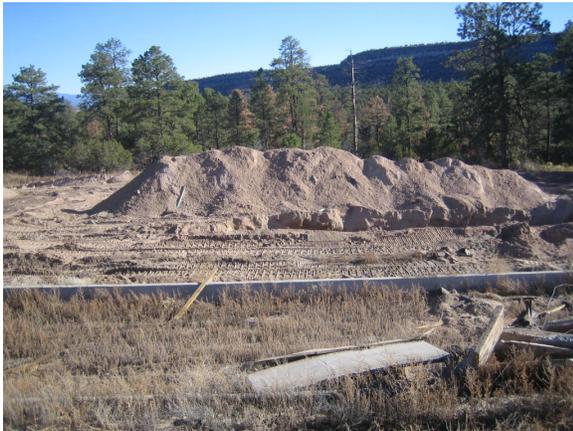
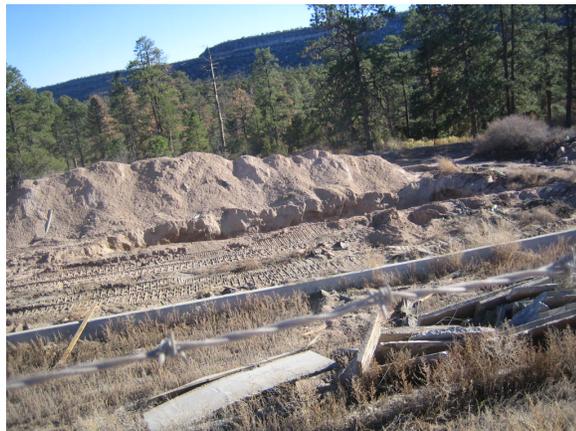
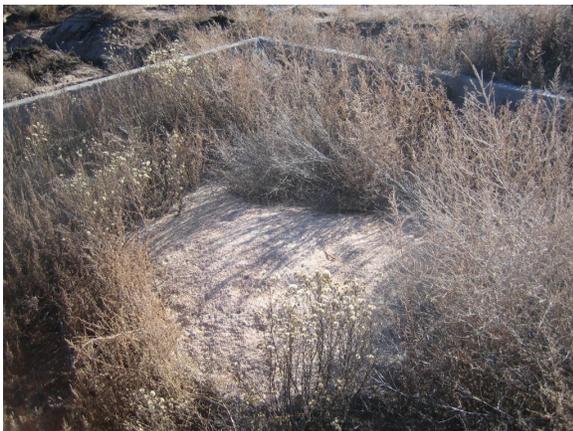
Material pulled up from the sludge beds was not to be buried there per instruction of Andrew Alarid (Los Alamos County project manager). That area is intended for composting. A pit will be dug between the former clarifiers; material will be buried in that location. Demolition has begun on clarifier (Structure E). Tomorrow morning the County's hazardous materials contractor will determine how best to manage the mercury from the two towers above trickling filters (Structures G and H). Operator made an observation of a light-colored material located at the northernmost corner drying bed. He was not concerned but had not noticed the material before. Upon closer inspection, the material turned out to be a dried cluster of snail shells (first photo). No other unusual visual or olfactory observations. Photos taken.

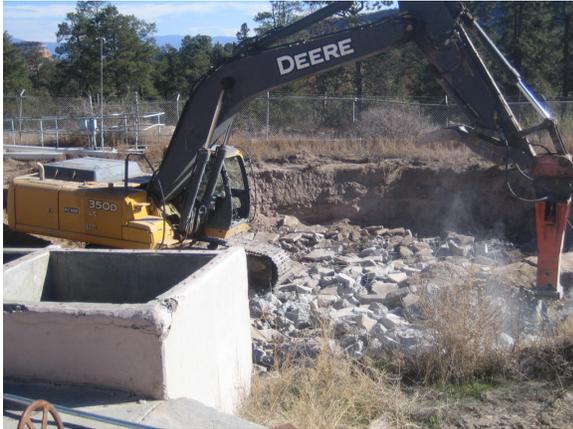
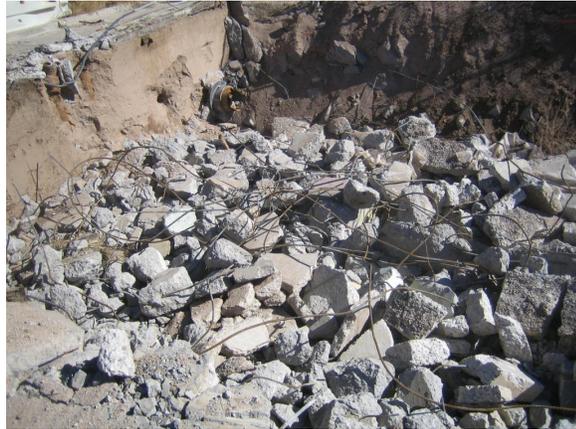
Work was being done on the secondary clarifier (Structure E). A pit has been dug and contains debris; it is located below where secondary clarifier (Structure D) had previously been. We did not get a chance to talk to the operator who was busy working on the clarifier. We will return tomorrow. No unusual visual or olfactory observations. Photos taken.

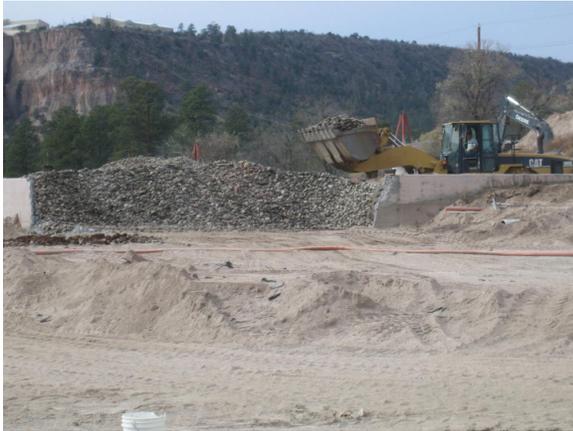
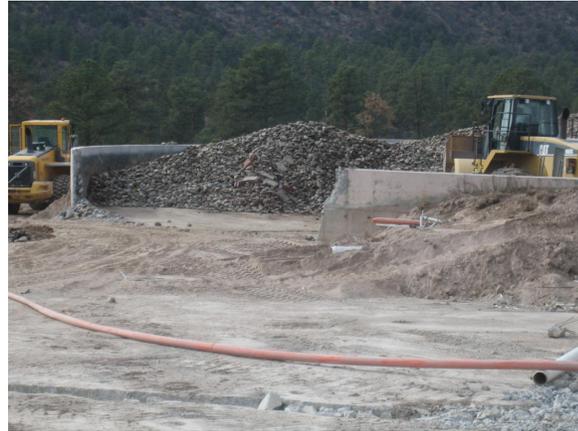
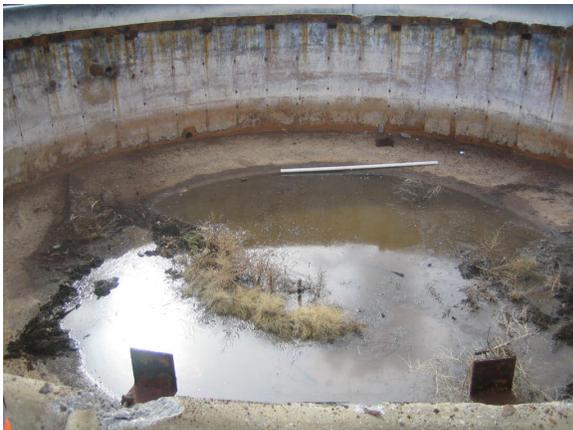
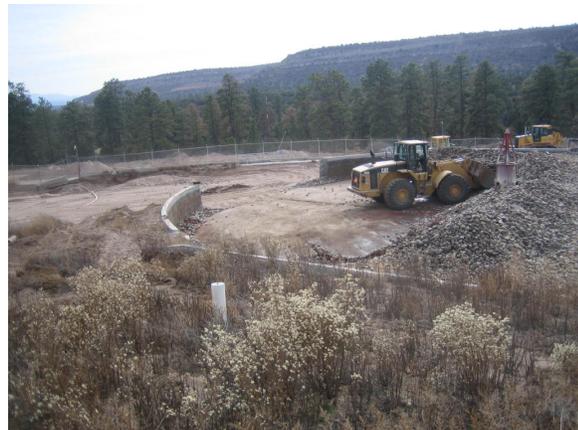
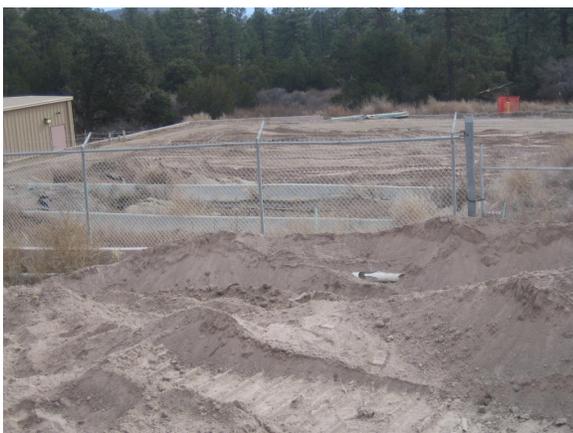
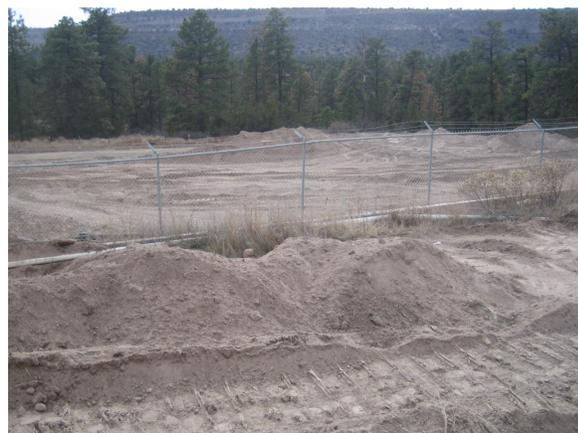
Rock removal from trickling filters (Structures G and H). Operator is removing steel from primary clarifiers I and J and will punch holes in it later today. He dug a hole next to the primary clarifiers to be used to bury materials previously buried in a hole near the secondary clarifiers, which are to be dug up. No unusual visual or olfactory observations. Photos taken.

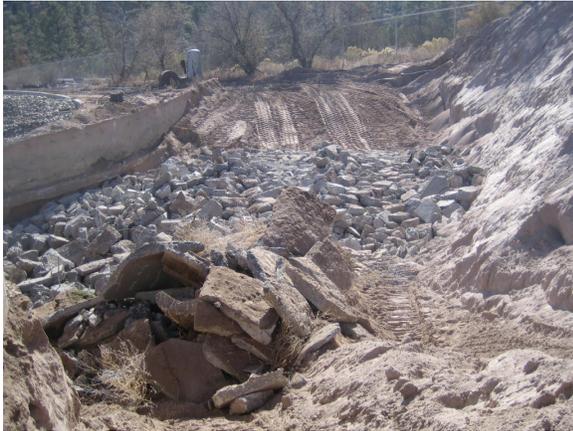
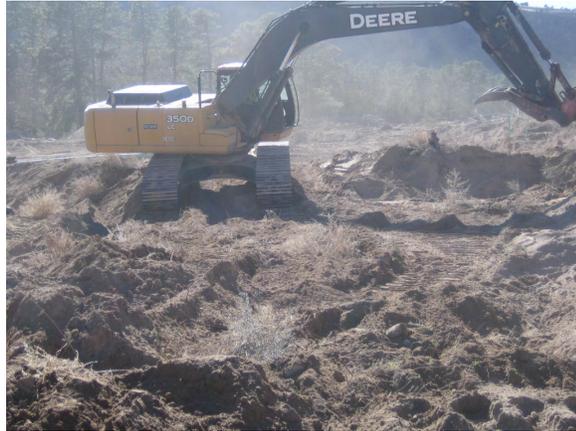
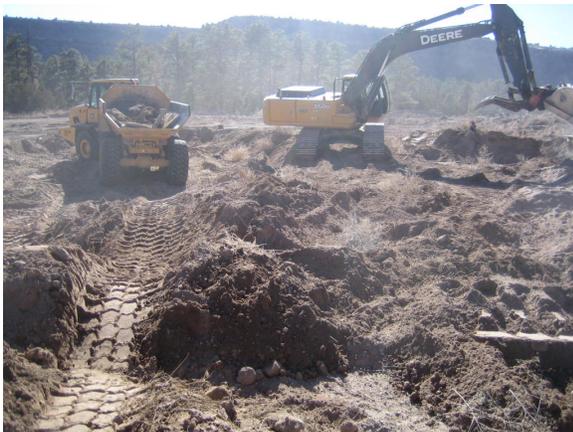
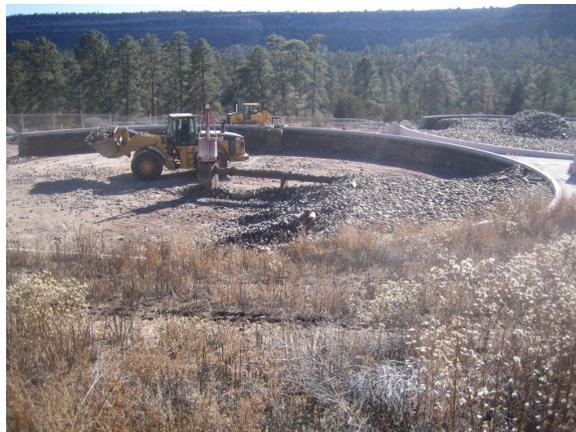
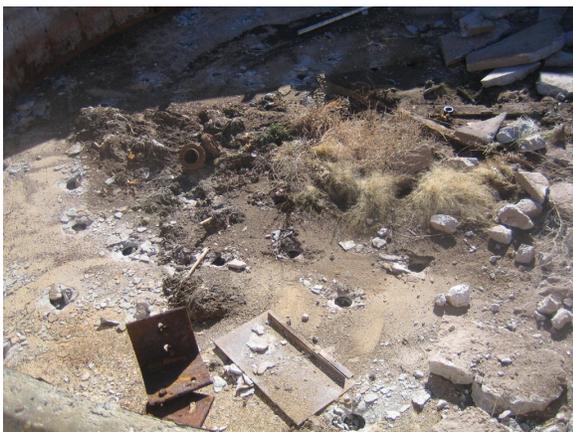
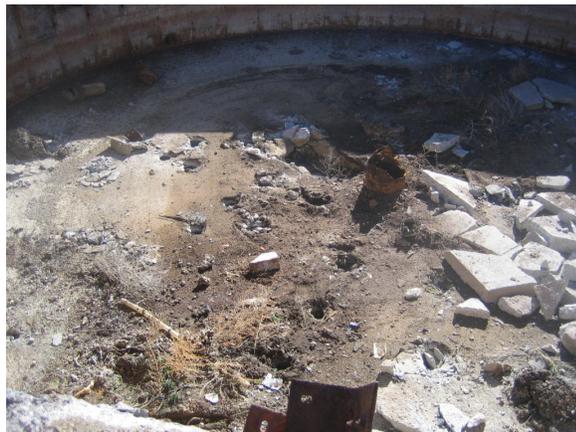
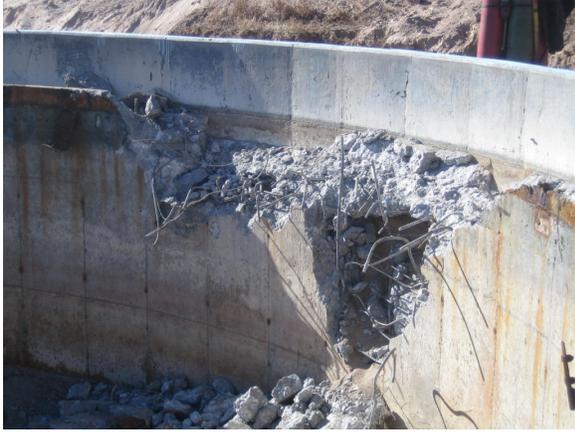
November 16, 2009

Rock removal from the trickling filters (Structures G and H) continues. One observation made while the operator was removing material from a sludge bed (observation point A-1). Holes punched in the primary clarifiers. Four observation points made in primary clarifiers (Structures I and J); 12 remain. No unusual visual or olfactory observations. Photos taken.

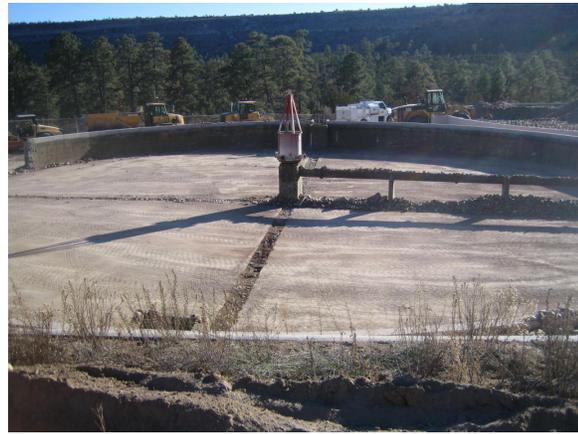
November 20, 2009

Rock from trickling filter (Structure G) has been completely removed. Work has started to remove the rock from trickling filter (Structure H). There is no work today. No unusual visual or olfactory observations. Photos taken.

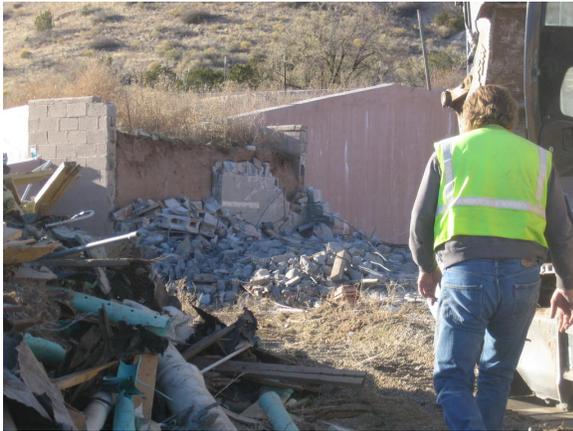
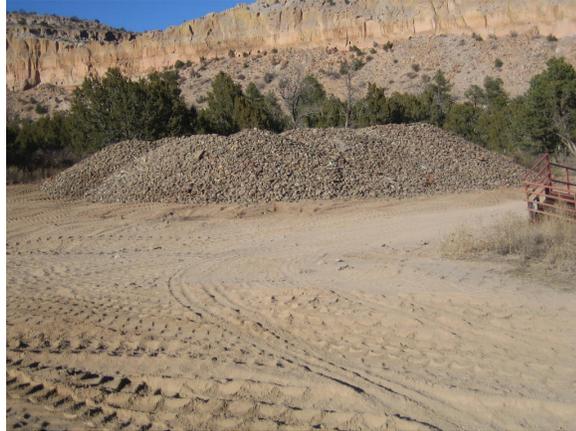
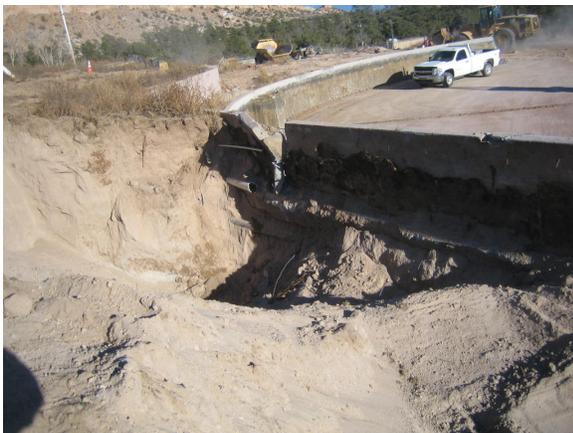
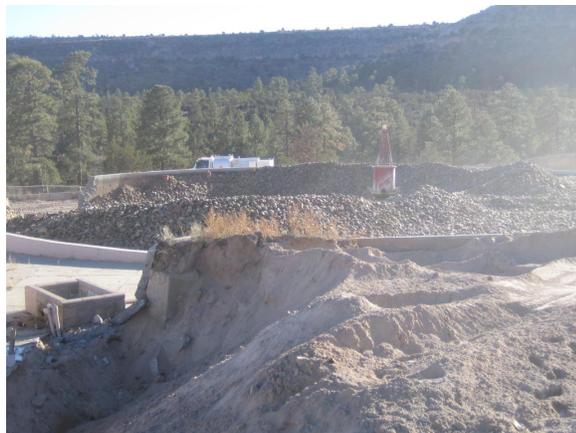
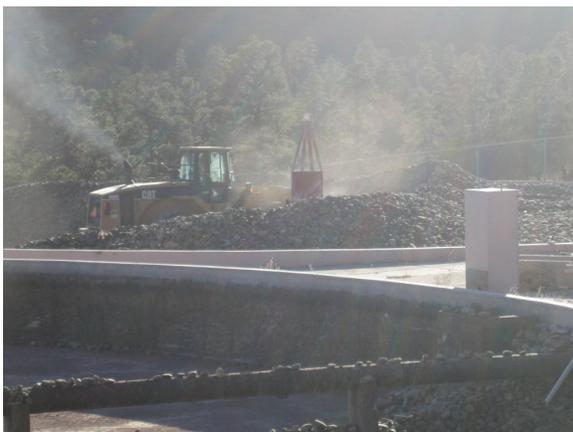
November 24, 2009

The primary clarifiers were collapsed in and buried. Rock removal from trickling filter (Structure H) is approximately 25% complete. The rock is being piled near the site entrance. The steps and sidewalk near the digester have been cut and removed. Mercury remains in the towers and is scheduled to be removed 12/2/2009. No unusual visual or olfactory observations. Photos taken.

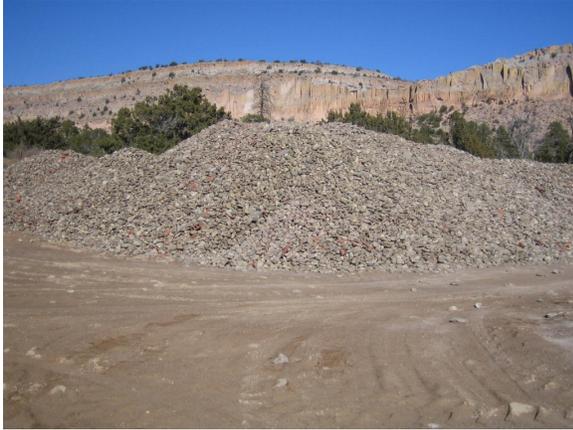
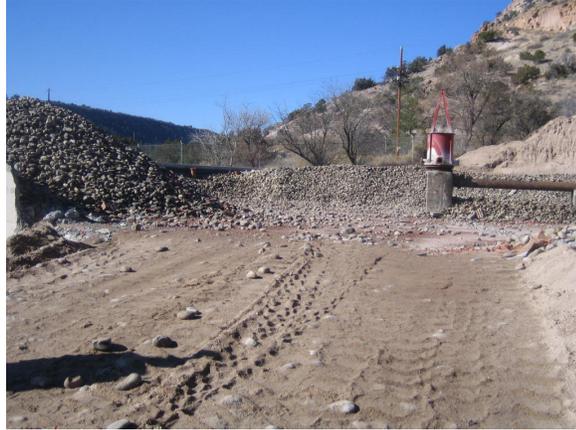
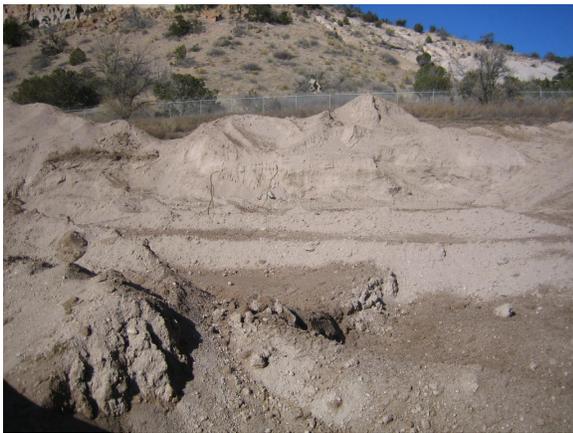
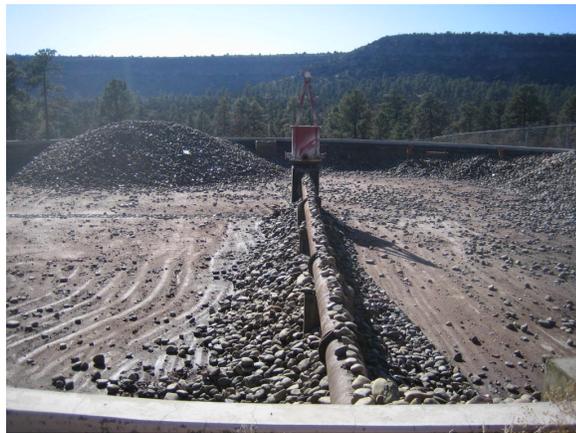
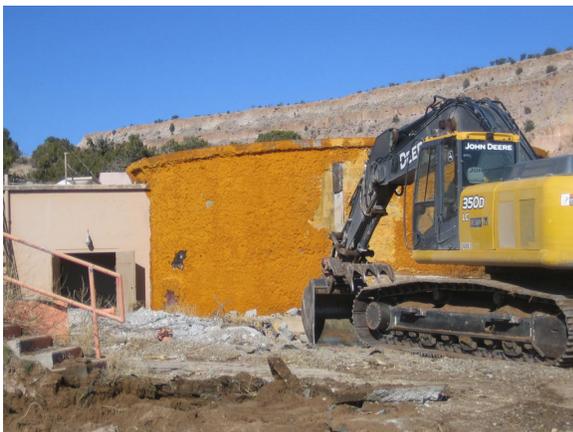
November 30, 2009

Rock continues to be removed from trickling filter (Structure H). The structure next to the digester (the sludge heater house) was taken down and the surrounding area was being cleaned up. No unusual visual or olfactory observations. Photos taken.

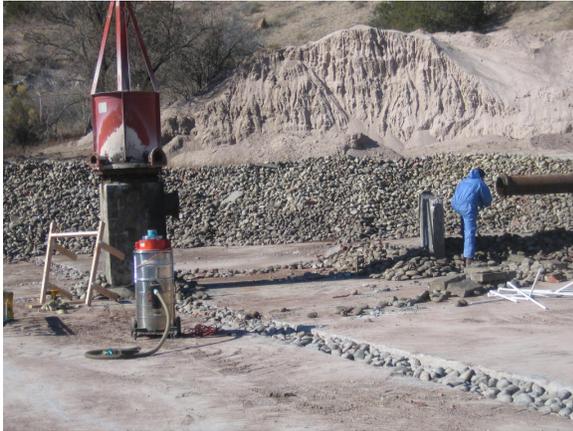
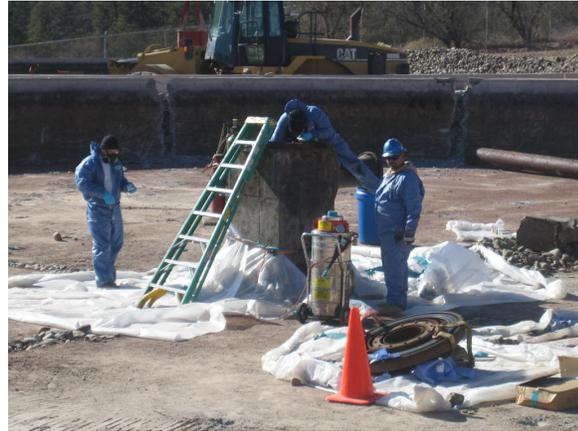
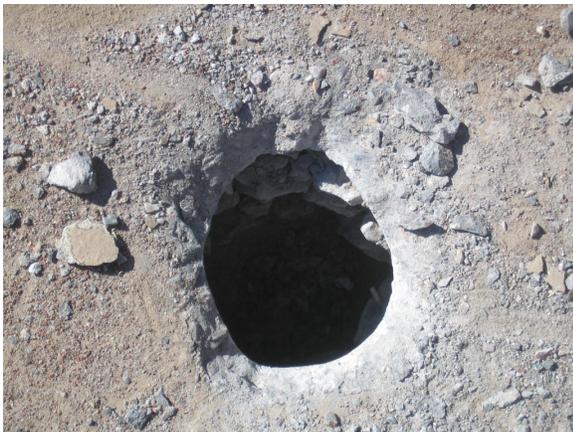
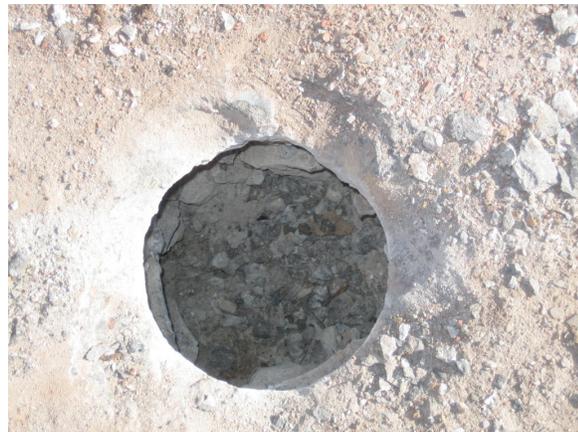
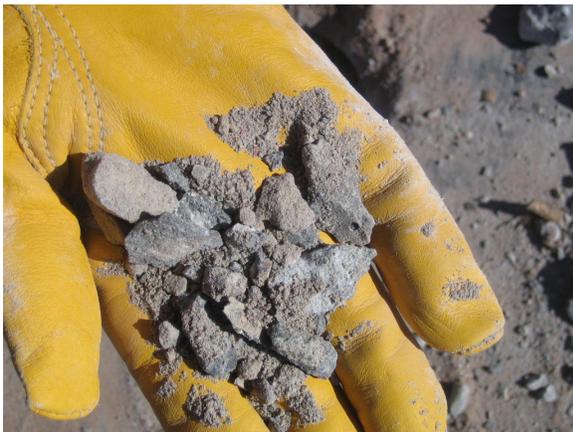
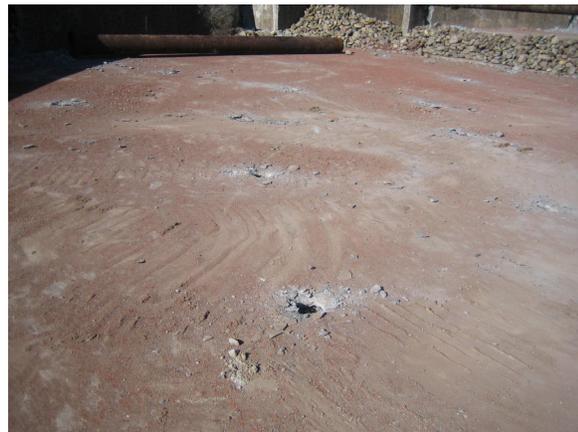
December 2, 2009

Southwest Hazard Control (Tucson, AZ) removing mercury from the towers in trickling filters (Structures G and H). Over 120 lb was removed from the tower of trickling filter ((Structure G). Holes were punched in the floor of trickling filter (Structure G), and we made four more observation points. No unusual visual or olfactory observations. Photos taken.

Recovery of elemental mercury from the seals of the two newer trickling filters (Structures G and H) took place on December 2 and 3, 2009, and is discussed in a report prepared by SHC for the County (SHC 2010, 109000). Although no longer used for this purpose, in the past mercury was commonly used to seal and lubricate the hubs of trickling filters. Residual mercury was found to be present in the seals of Structures G and H during demolition. A total of 133.5 lb of mercury was recovered from the trickling filters (SHC 2010, 109000). Photographs of the mercury recovery activities are included in Appendix A.

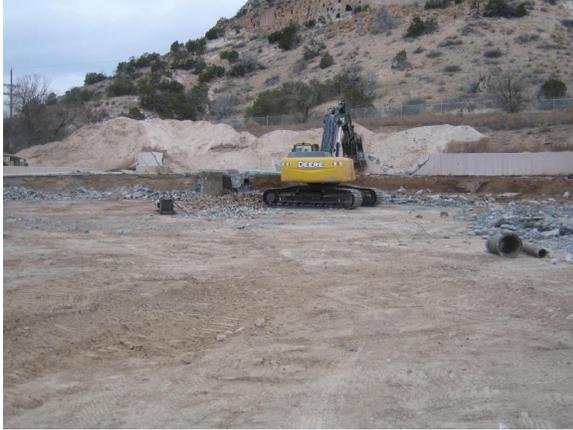
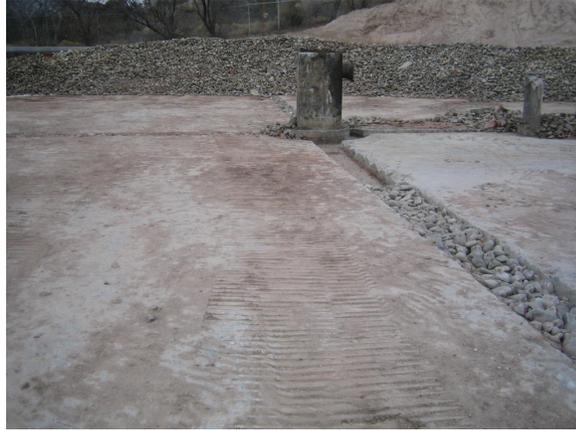
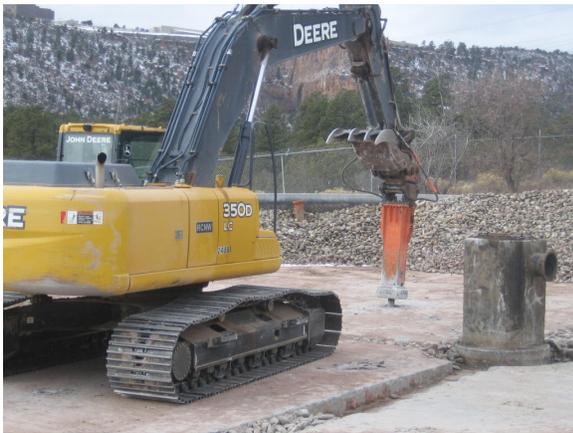
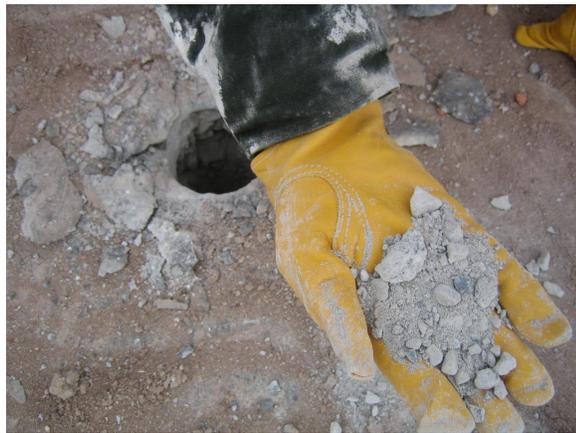
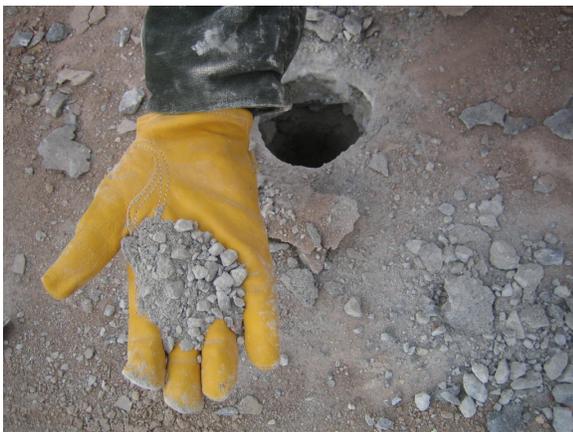
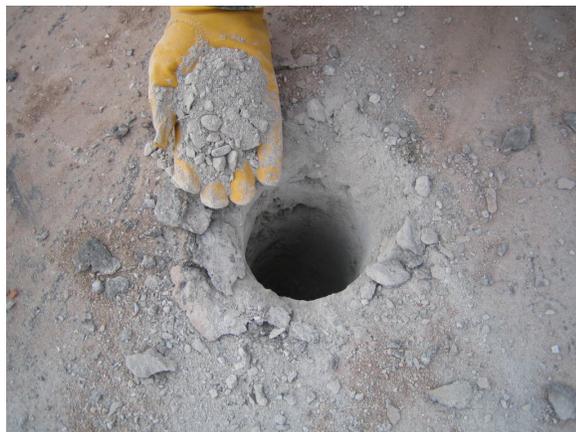
December 7, 2009

Mercury has been removed from trickling filter (Structure H). Holes were punched in the floor and four more observation points were made. There were no unusual visual or olfactory observations. Photos taken.

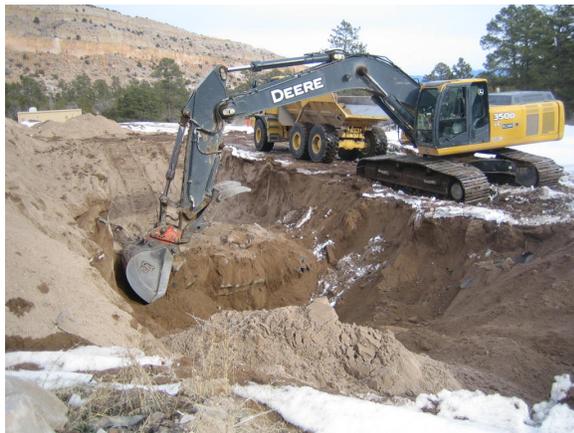
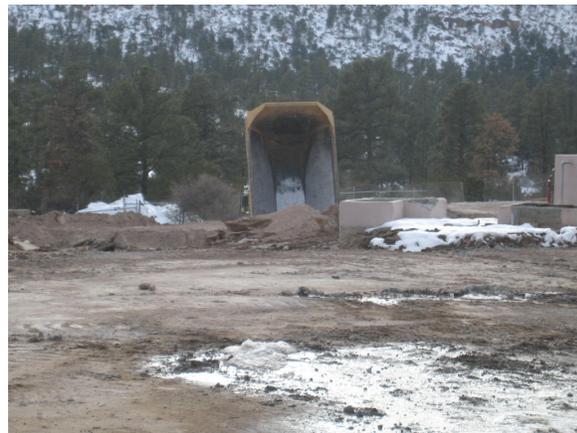
December 21, 2009

Buried material continues to be removed from the drying bed area and transported to the pit within the fence line. We were unable to speak with the operator regarding the schedule of the digester demolition. No unusual observations. Photos taken.

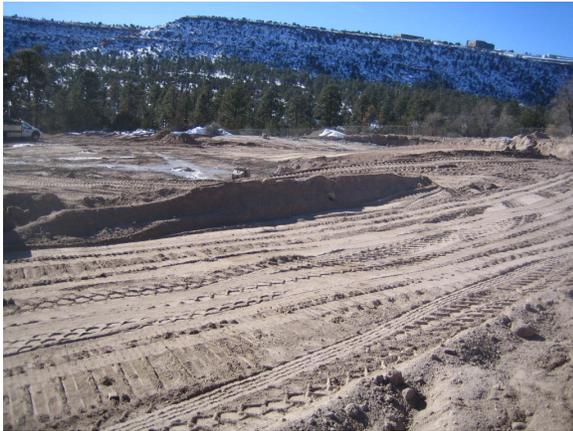
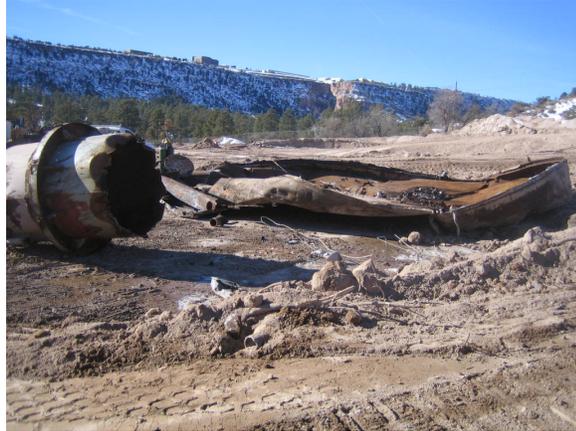
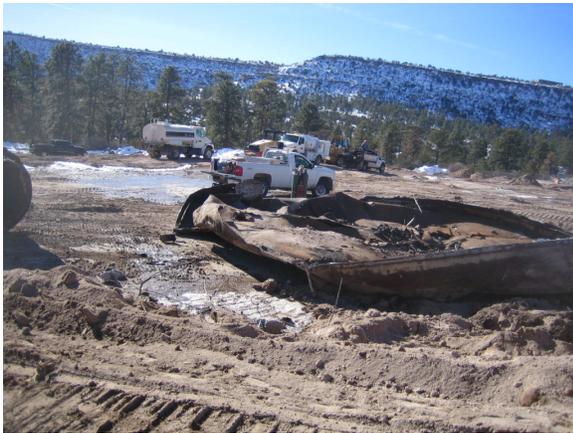
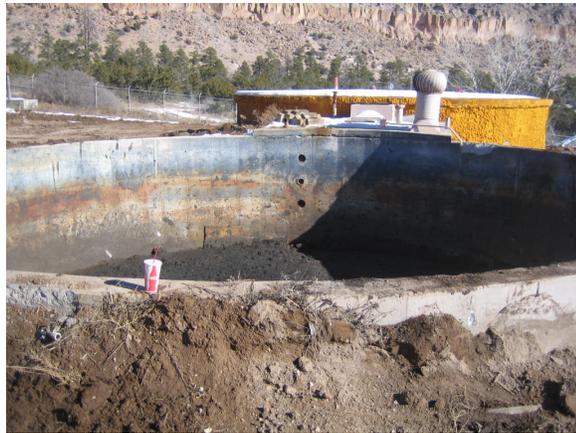
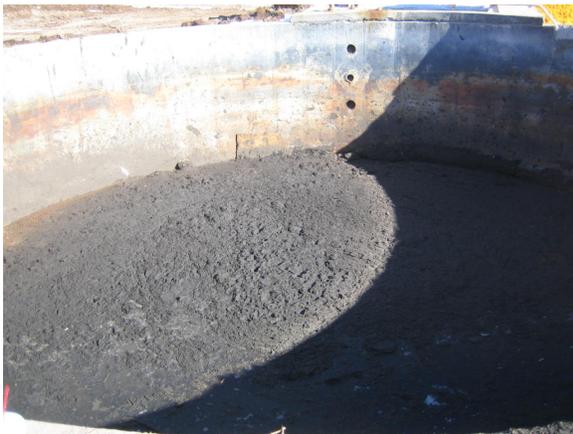
January 6, 2010

The lid of the secondary digester was removed. Operator said they plan on excavating the solids in the tank tomorrow and transferring them to Pojoaque for disposal. Approximately 10 ft of sludge at the bottom of the tank needs to be removed before the crew can begin the demolition of the tank. No unusual visual or olfactory observations. Photos taken.
