LA-UR-10-2076
April 2010
EP2010-0138

Demolition Documentation Report for the Bayo Canyon Wastewater Treatment Plant, Area of Concern 00-018(b)

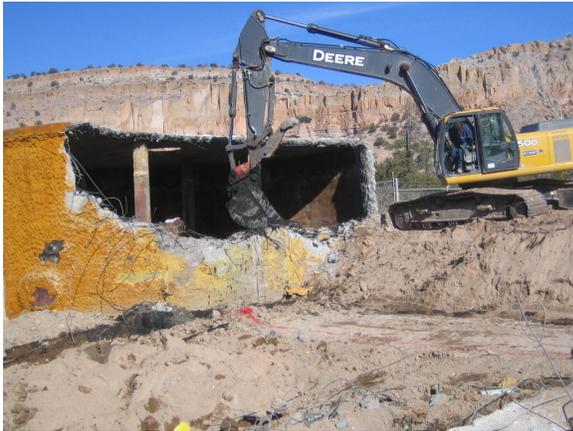
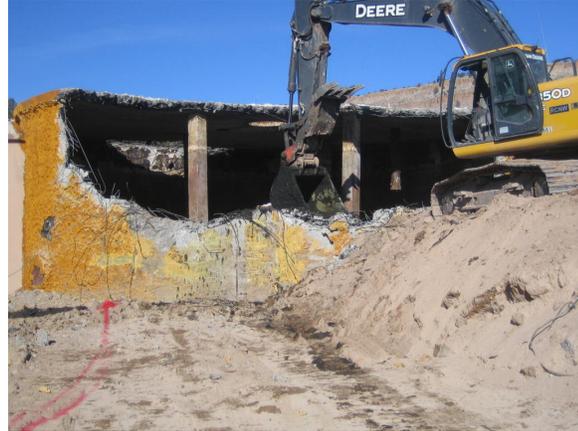
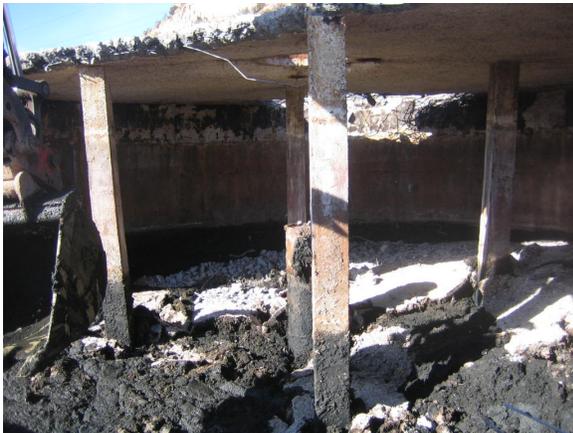
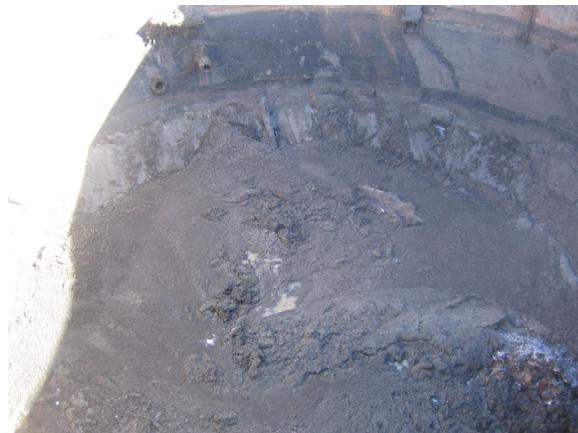
January 11, 2010

Work began on the primary digester. Operator is in the process of removing the sludge from the bottom of the tank. Tomorrow he plans to remove the concrete located at the top of the digester. Sludge from the secondary digester has been removed; the plan is to collapse the tank and bury the rubble. No unusual visual or olfactory observations. Photos taken.

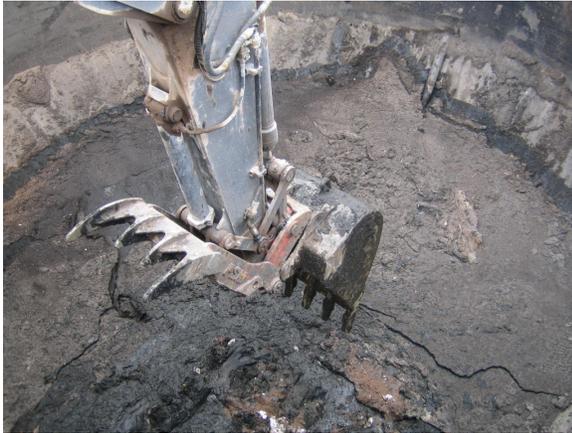
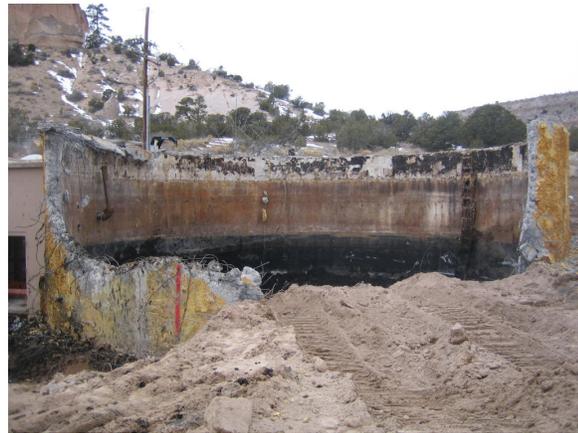
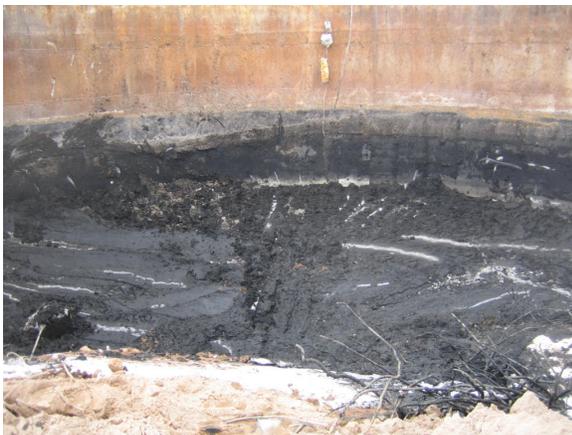
January 13, 2010

The concrete top of the primary digester has been taken down. All sludge has been removed from it. The operator is working on removing remaining sludge in the secondary digester. No one will be working tomorrow (1/14/2010), but work will resume on Friday and Saturday. No unusual visual or olfactory observations. Photos taken.

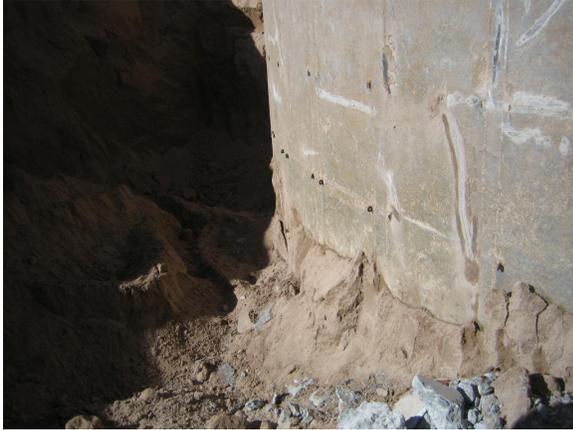
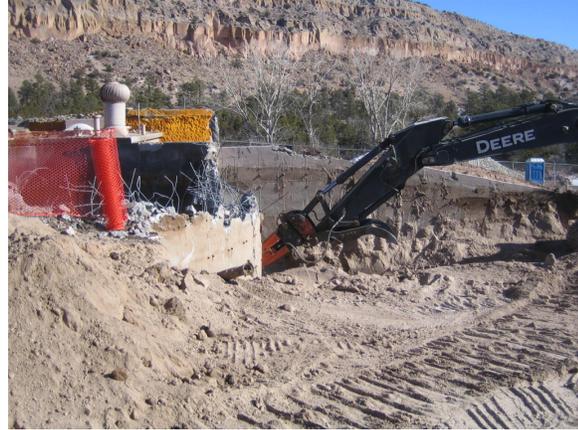
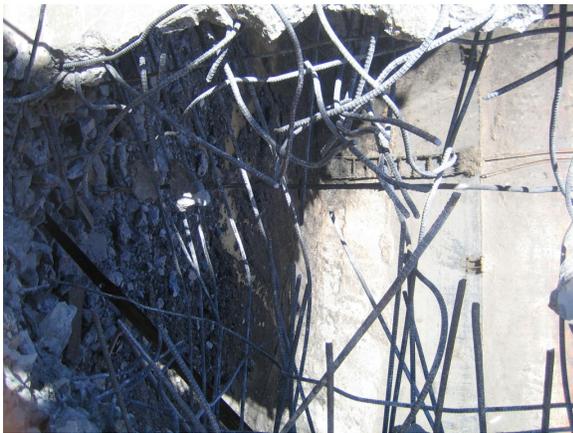
January 15, 2010

Two more observation points were made. K-1 and K-2 were located at the secondary digester. No unusual visual or olfactory observations. Operator is continuing to demolish the digesters. We are hoping to make our remaining observations on Tuesday, 1/16/2010. Photos taken.

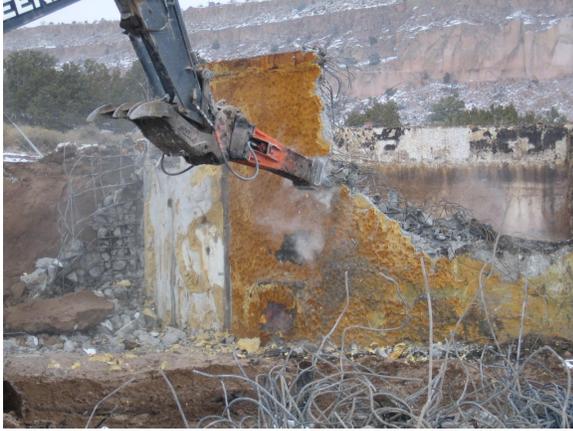
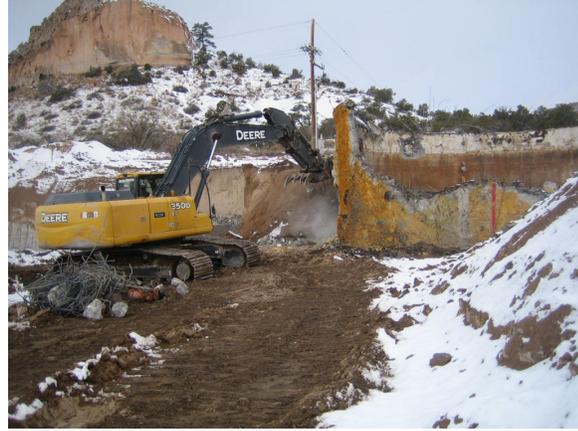
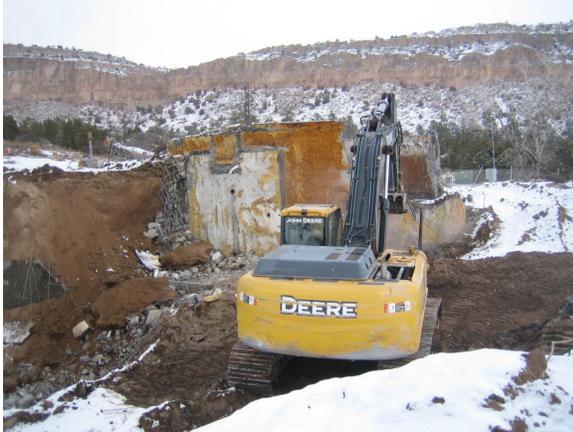
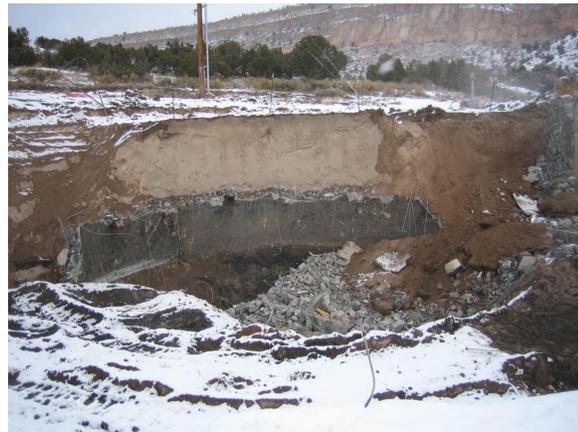
January 20, 2010

Operator has completed the demolition of the secondary digester and the digester house connecting the two digesters. He is continuing to work on the primary digester. No unusual observations. Photos taken.

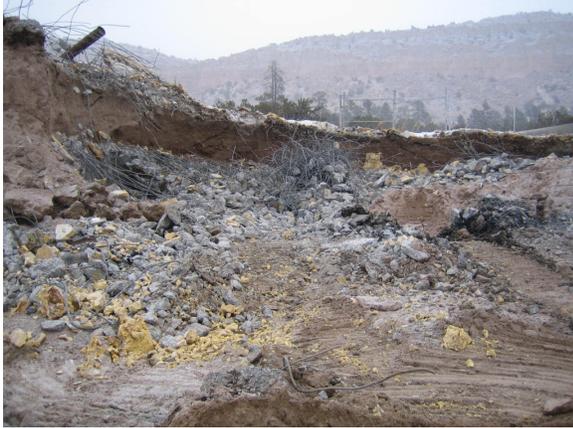
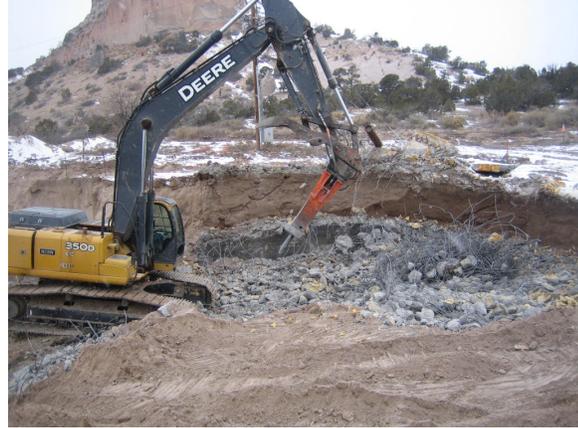
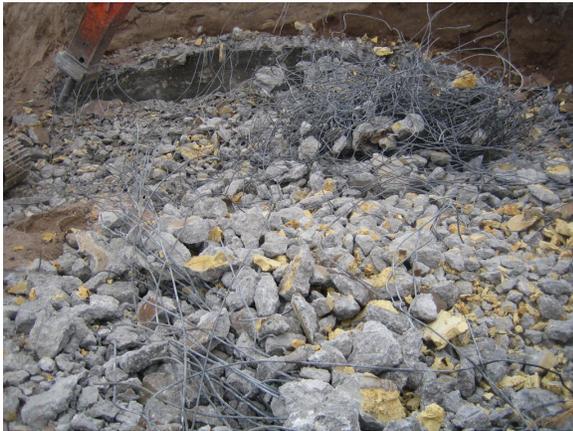
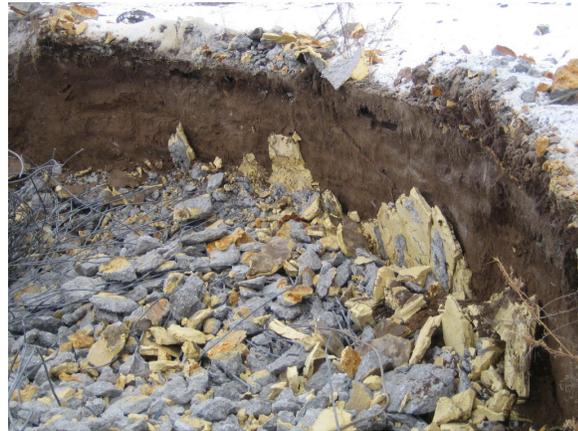
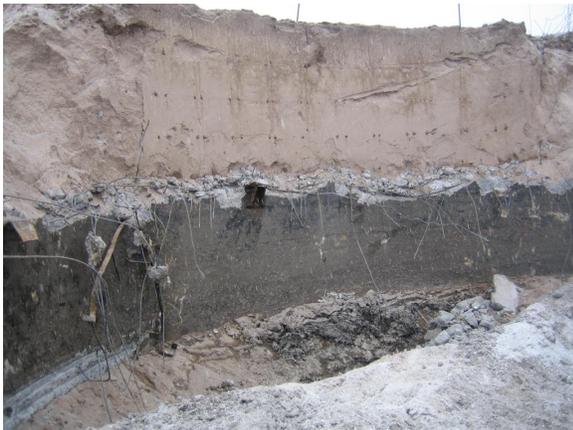
January 21, 2010

Demolition of the primary digester is being completed and should be finished by the end of the day. Remaining two observation points were made (L-1 and L-2). No evidence of discoloration. No unusual olfactory observations. No other unusual visual observations. Photos taken.

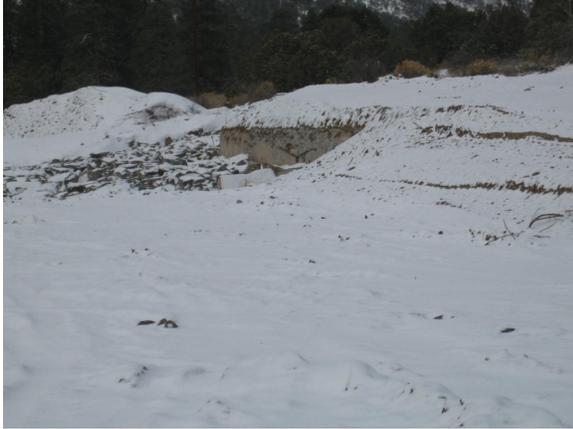
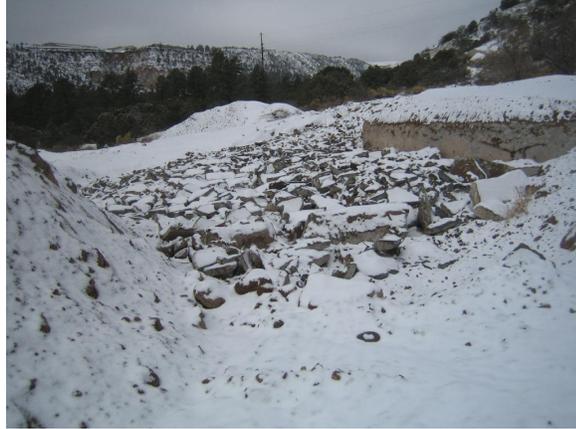
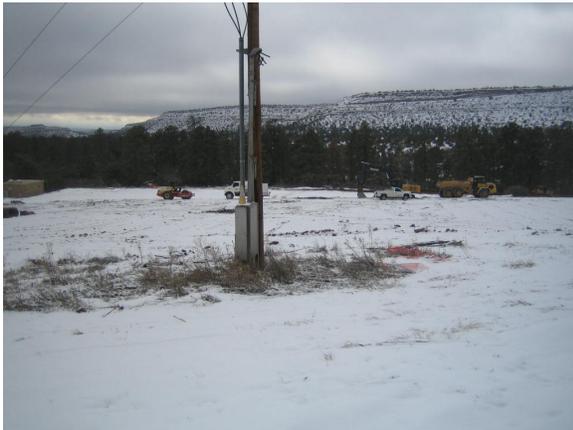
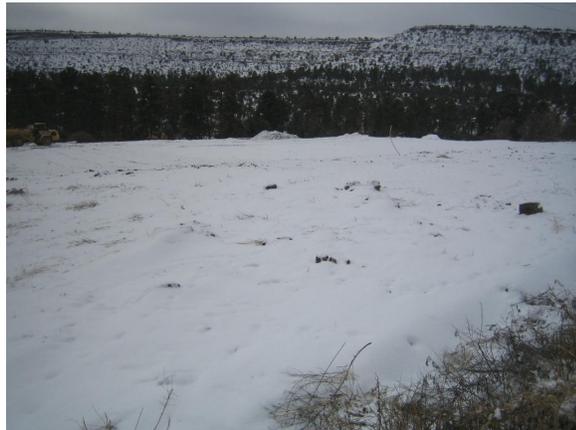
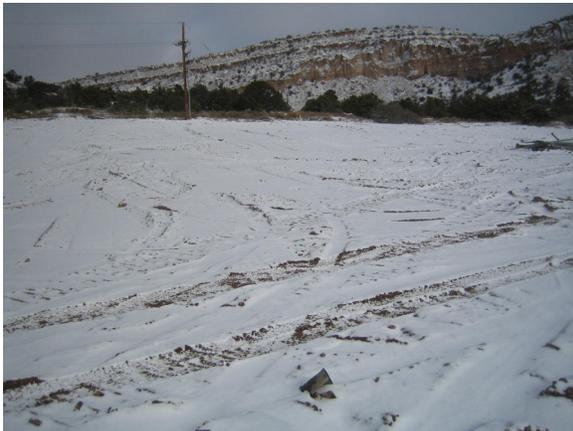
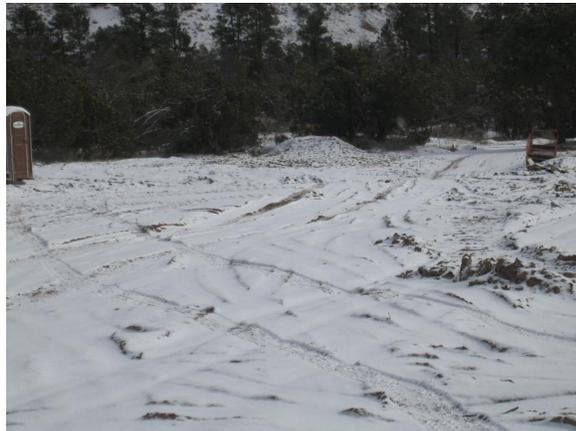
February 9, 2010

Approximately 90% of the site has been brought to grade-level. All that remains is a small debris fill to be covered and leveled. The rock pile has been moved or buried. No other concerns. Photos taken.

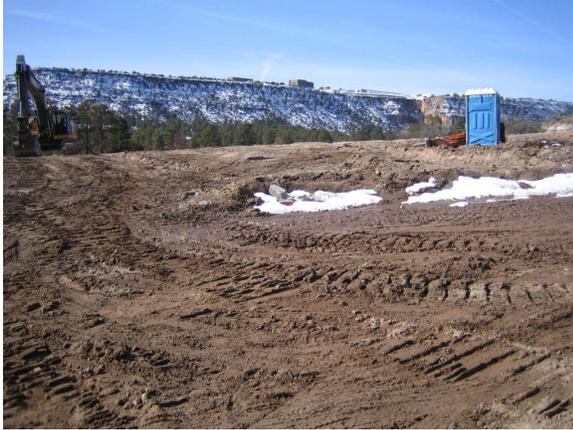
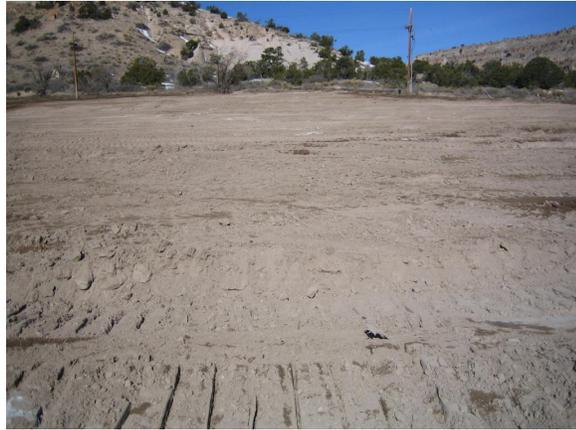
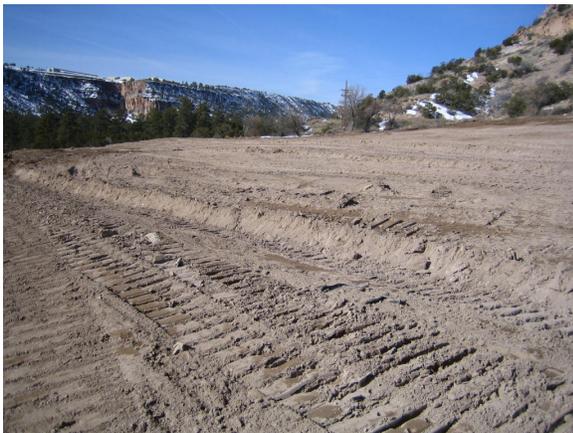
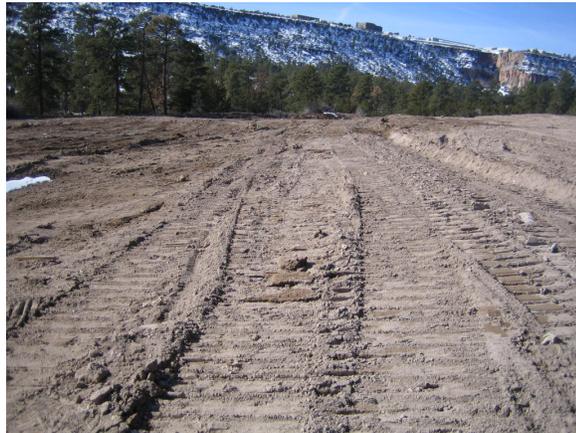
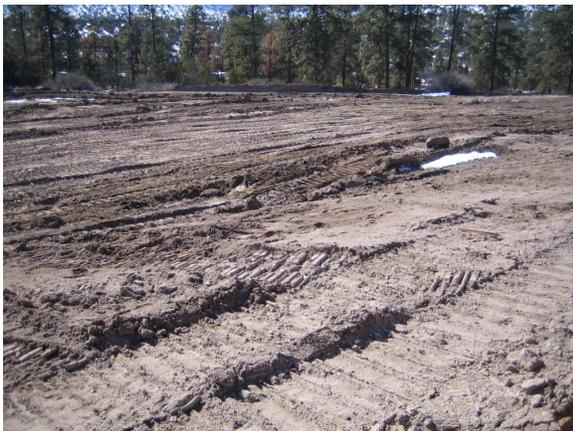
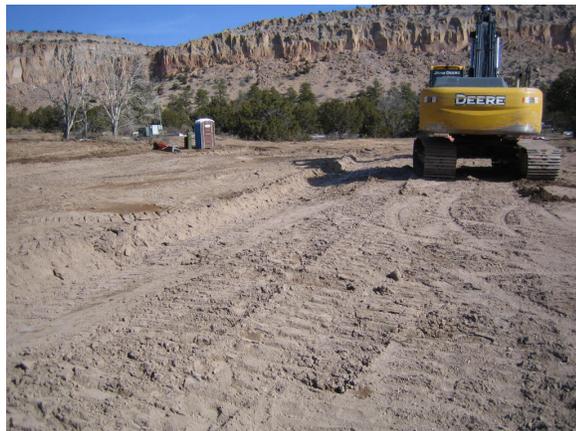
February 17, 2010

Entire site has been brought to grade-level. This observation verifies completion of the site activity. No unusual observations. No employees at work site at the time of the inspection. Heavy equipment remains on site. Photos taken.
