Subject: Submittal of the Response to the Notice of Disapproval Baseline Geomorphic Conditions at Sediment Transport Mitigation Sites in Los Alamos/Pueblo Canyon Watersheds and Revision 1

LA-UR-11-0936
February 2011
EP2011-0077

Baseline Geomorphic Conditions at Sediment Transport Mitigation Sites in the Los Alamos and Pueblo Canyon Watersheds, Revision 1

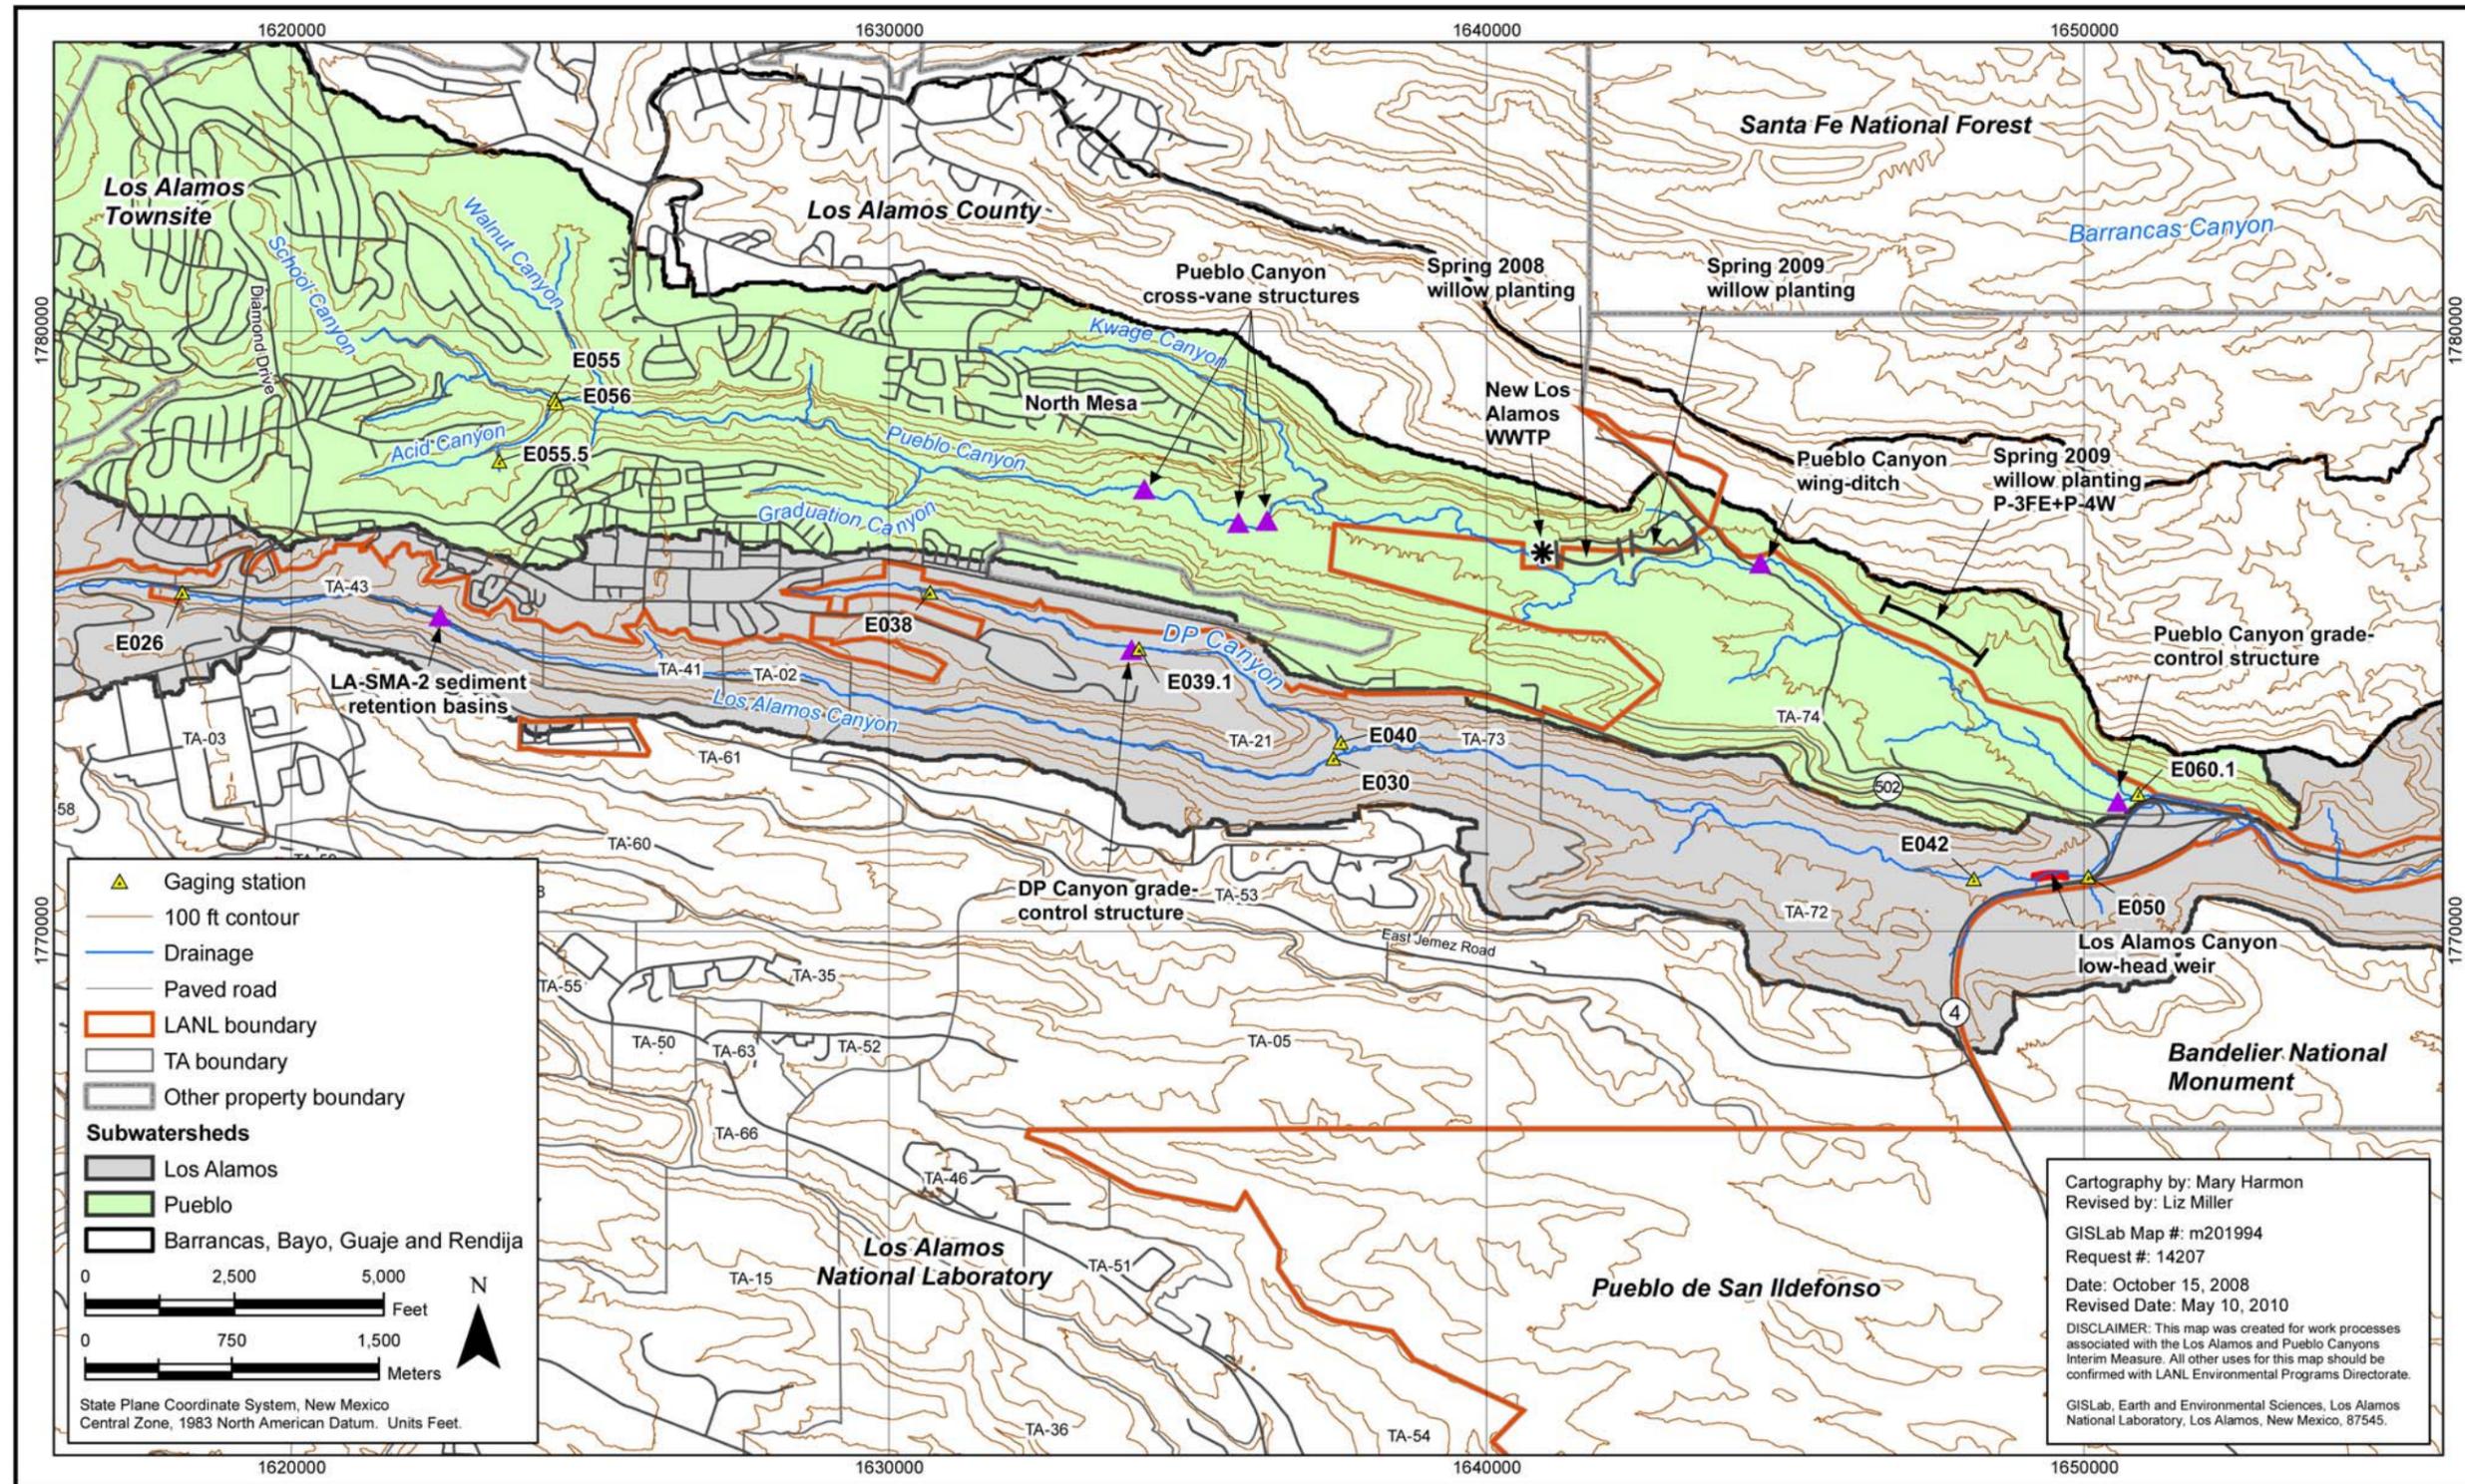
Figure 1 Map of the Los Alamos and Pueblo Canyon watersheds showing sediment transport mitigation sites

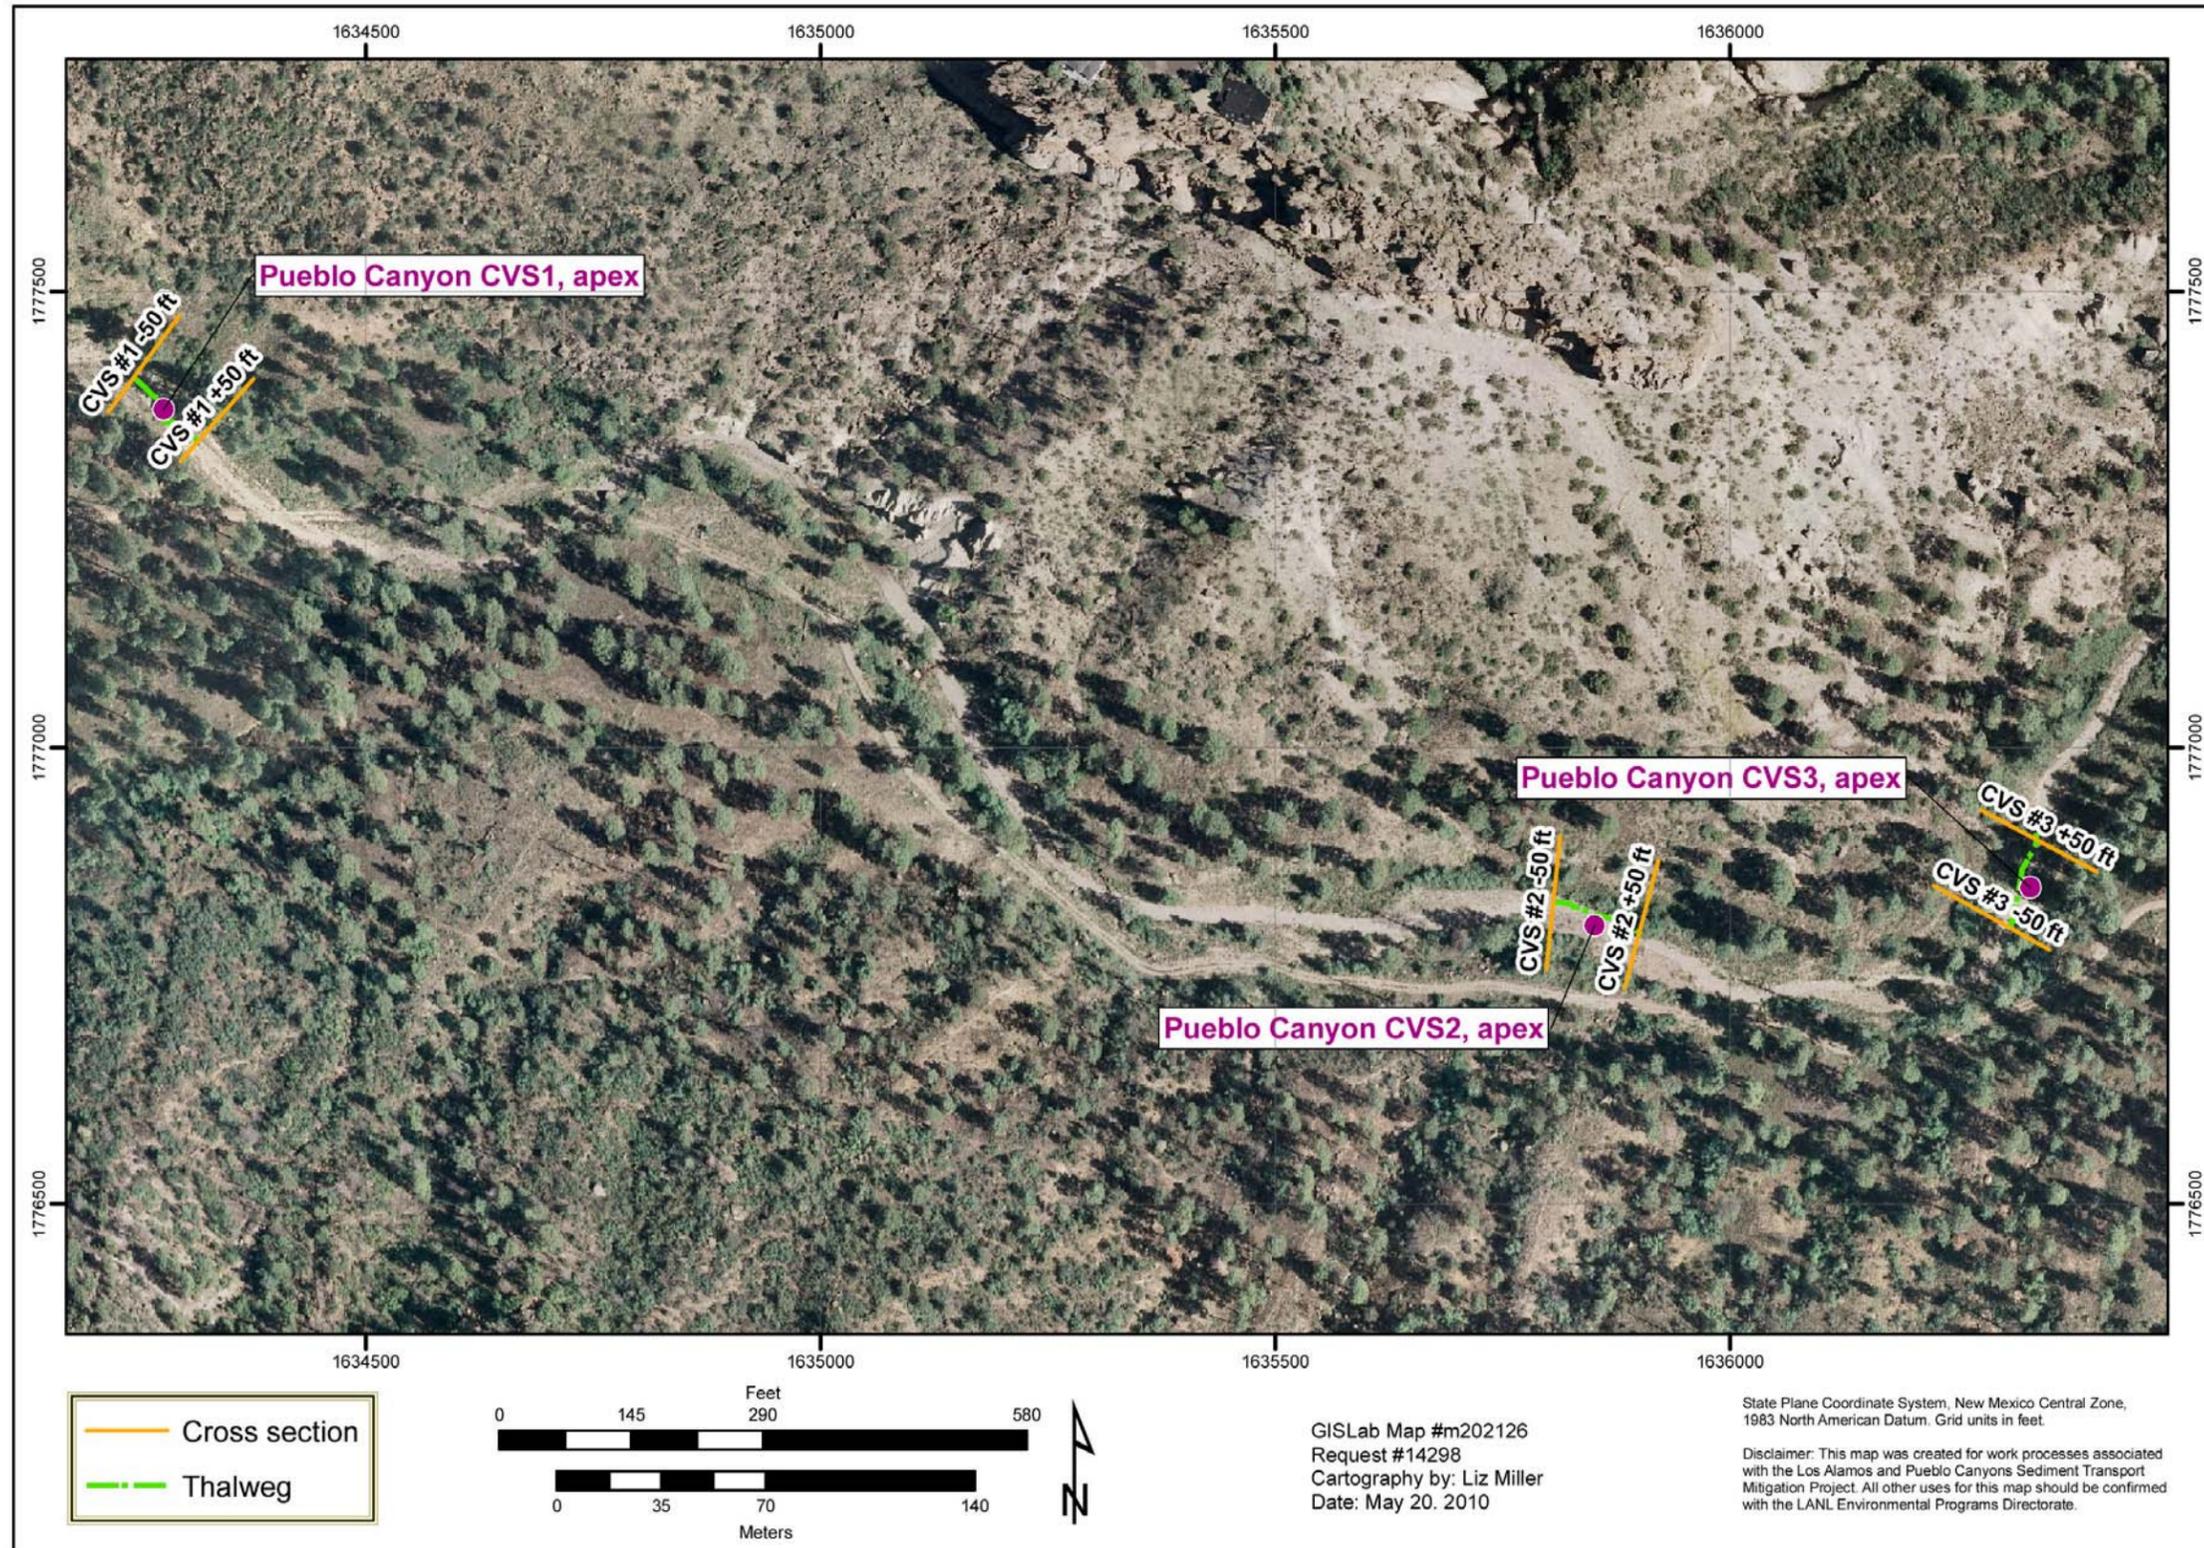
Figure 2 Orthophoto showing the locations of surveyed cross sections and thalweg profiles at the Pueblo Canyon CVSS

Pueblo Canyon Cross-Vane Structures. Two cross sections were surveyed in the vicinity of each of the three Pueblo Canyon cross-vane structures (CVSs) in April and May 2010. One is 50 ft upcanyon, and one is 50 ft downcanyon of the apex rock of each structure. Channel thalweg profiles were also surveyed over these 100-ft distances. Cross-section and thalweg-profile locations are shown in Figure 2, and the cross sections and thalweg profiles for the upper, middle, and lower CVSs are shown in Figures 3, 4, and 5, respectively. Irregularities in the thalweg profiles partially reflect construction-related disturbance and are expected to be smoothed out after the first runoff events.

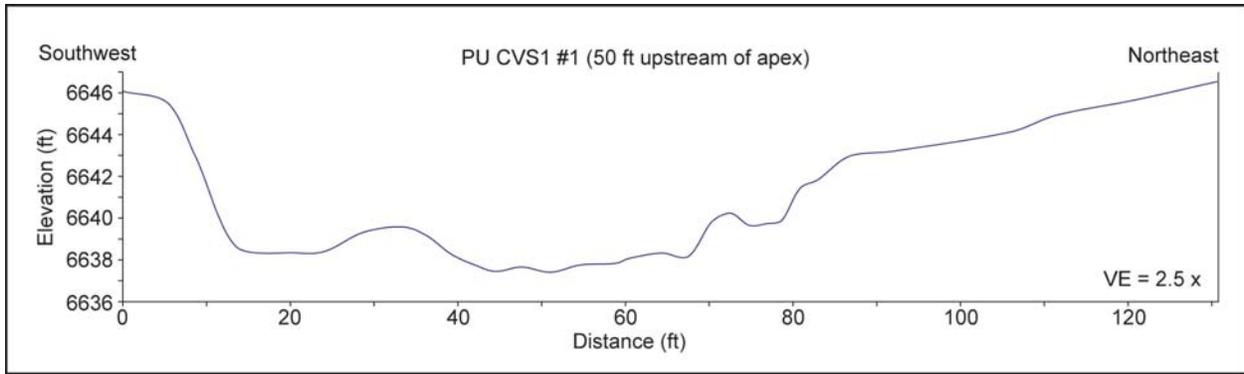
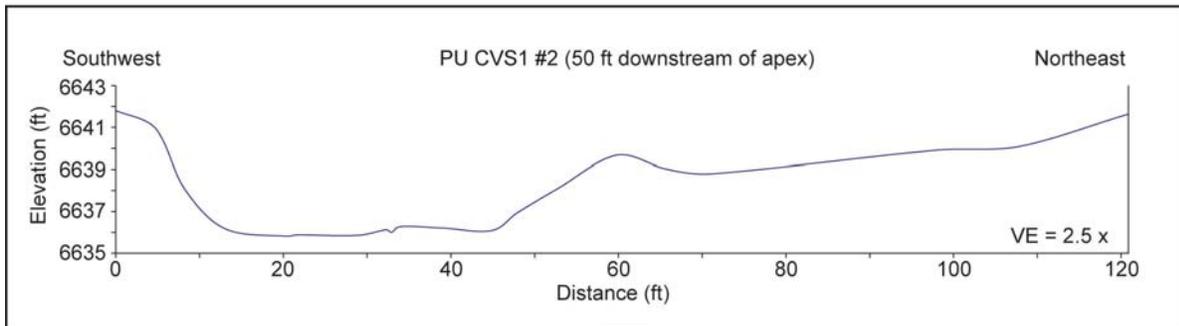
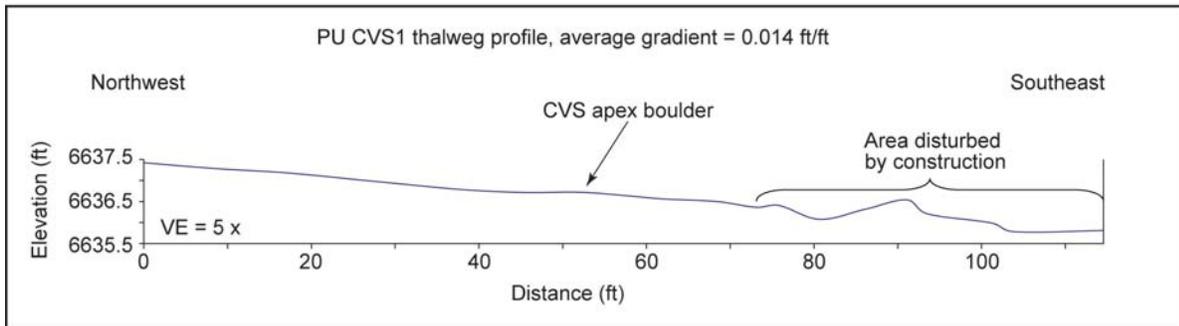
Figure 3 Cross sections and thalweg profile at upper CVS in Pueblo Canyon

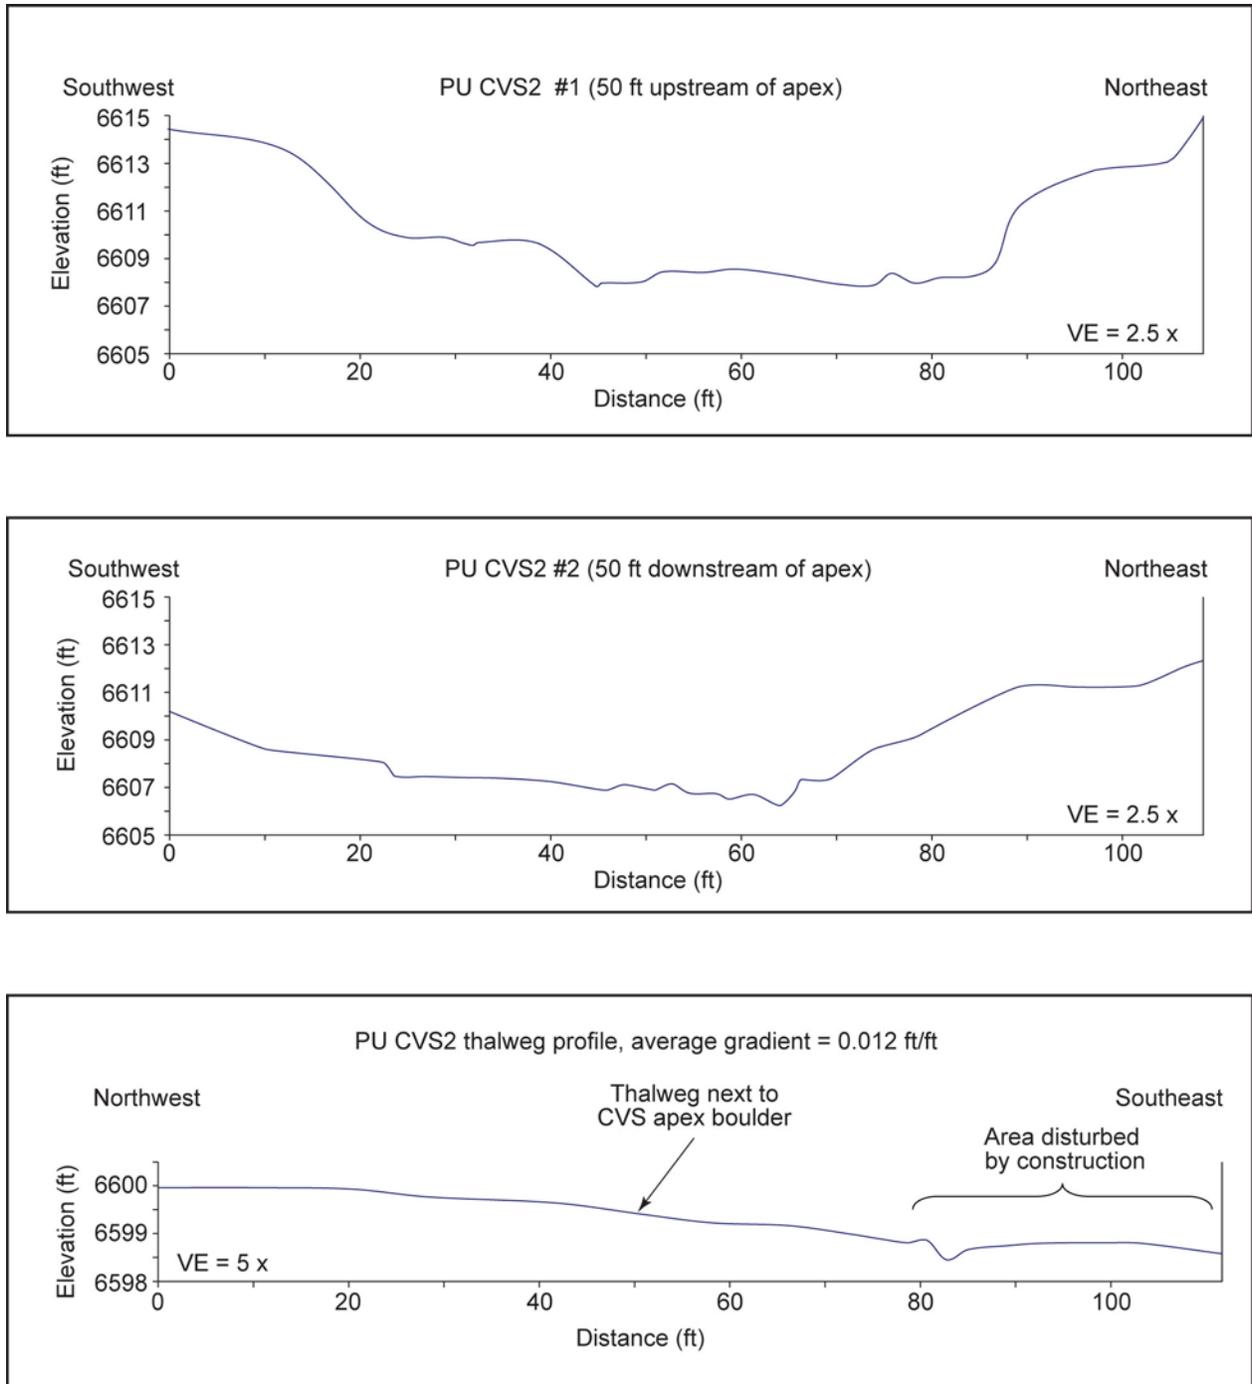
Figure 4 Cross sections and thalweg profile at middle CVS in Pueblo Canyon

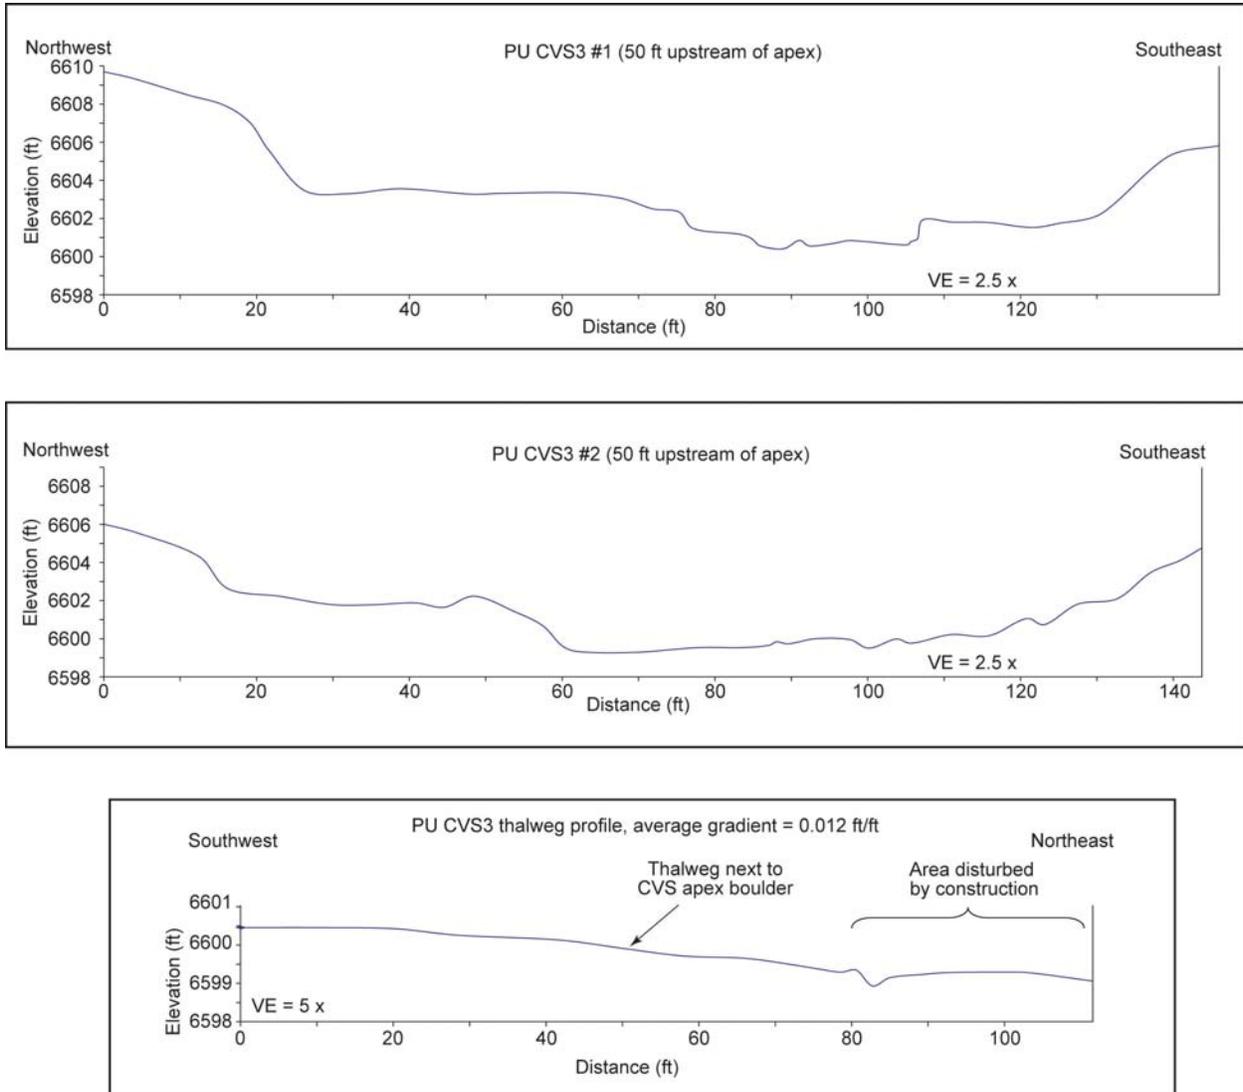
Figure 5 Cross sections and thalweg profile at lower CVS in Pueblo Canyon

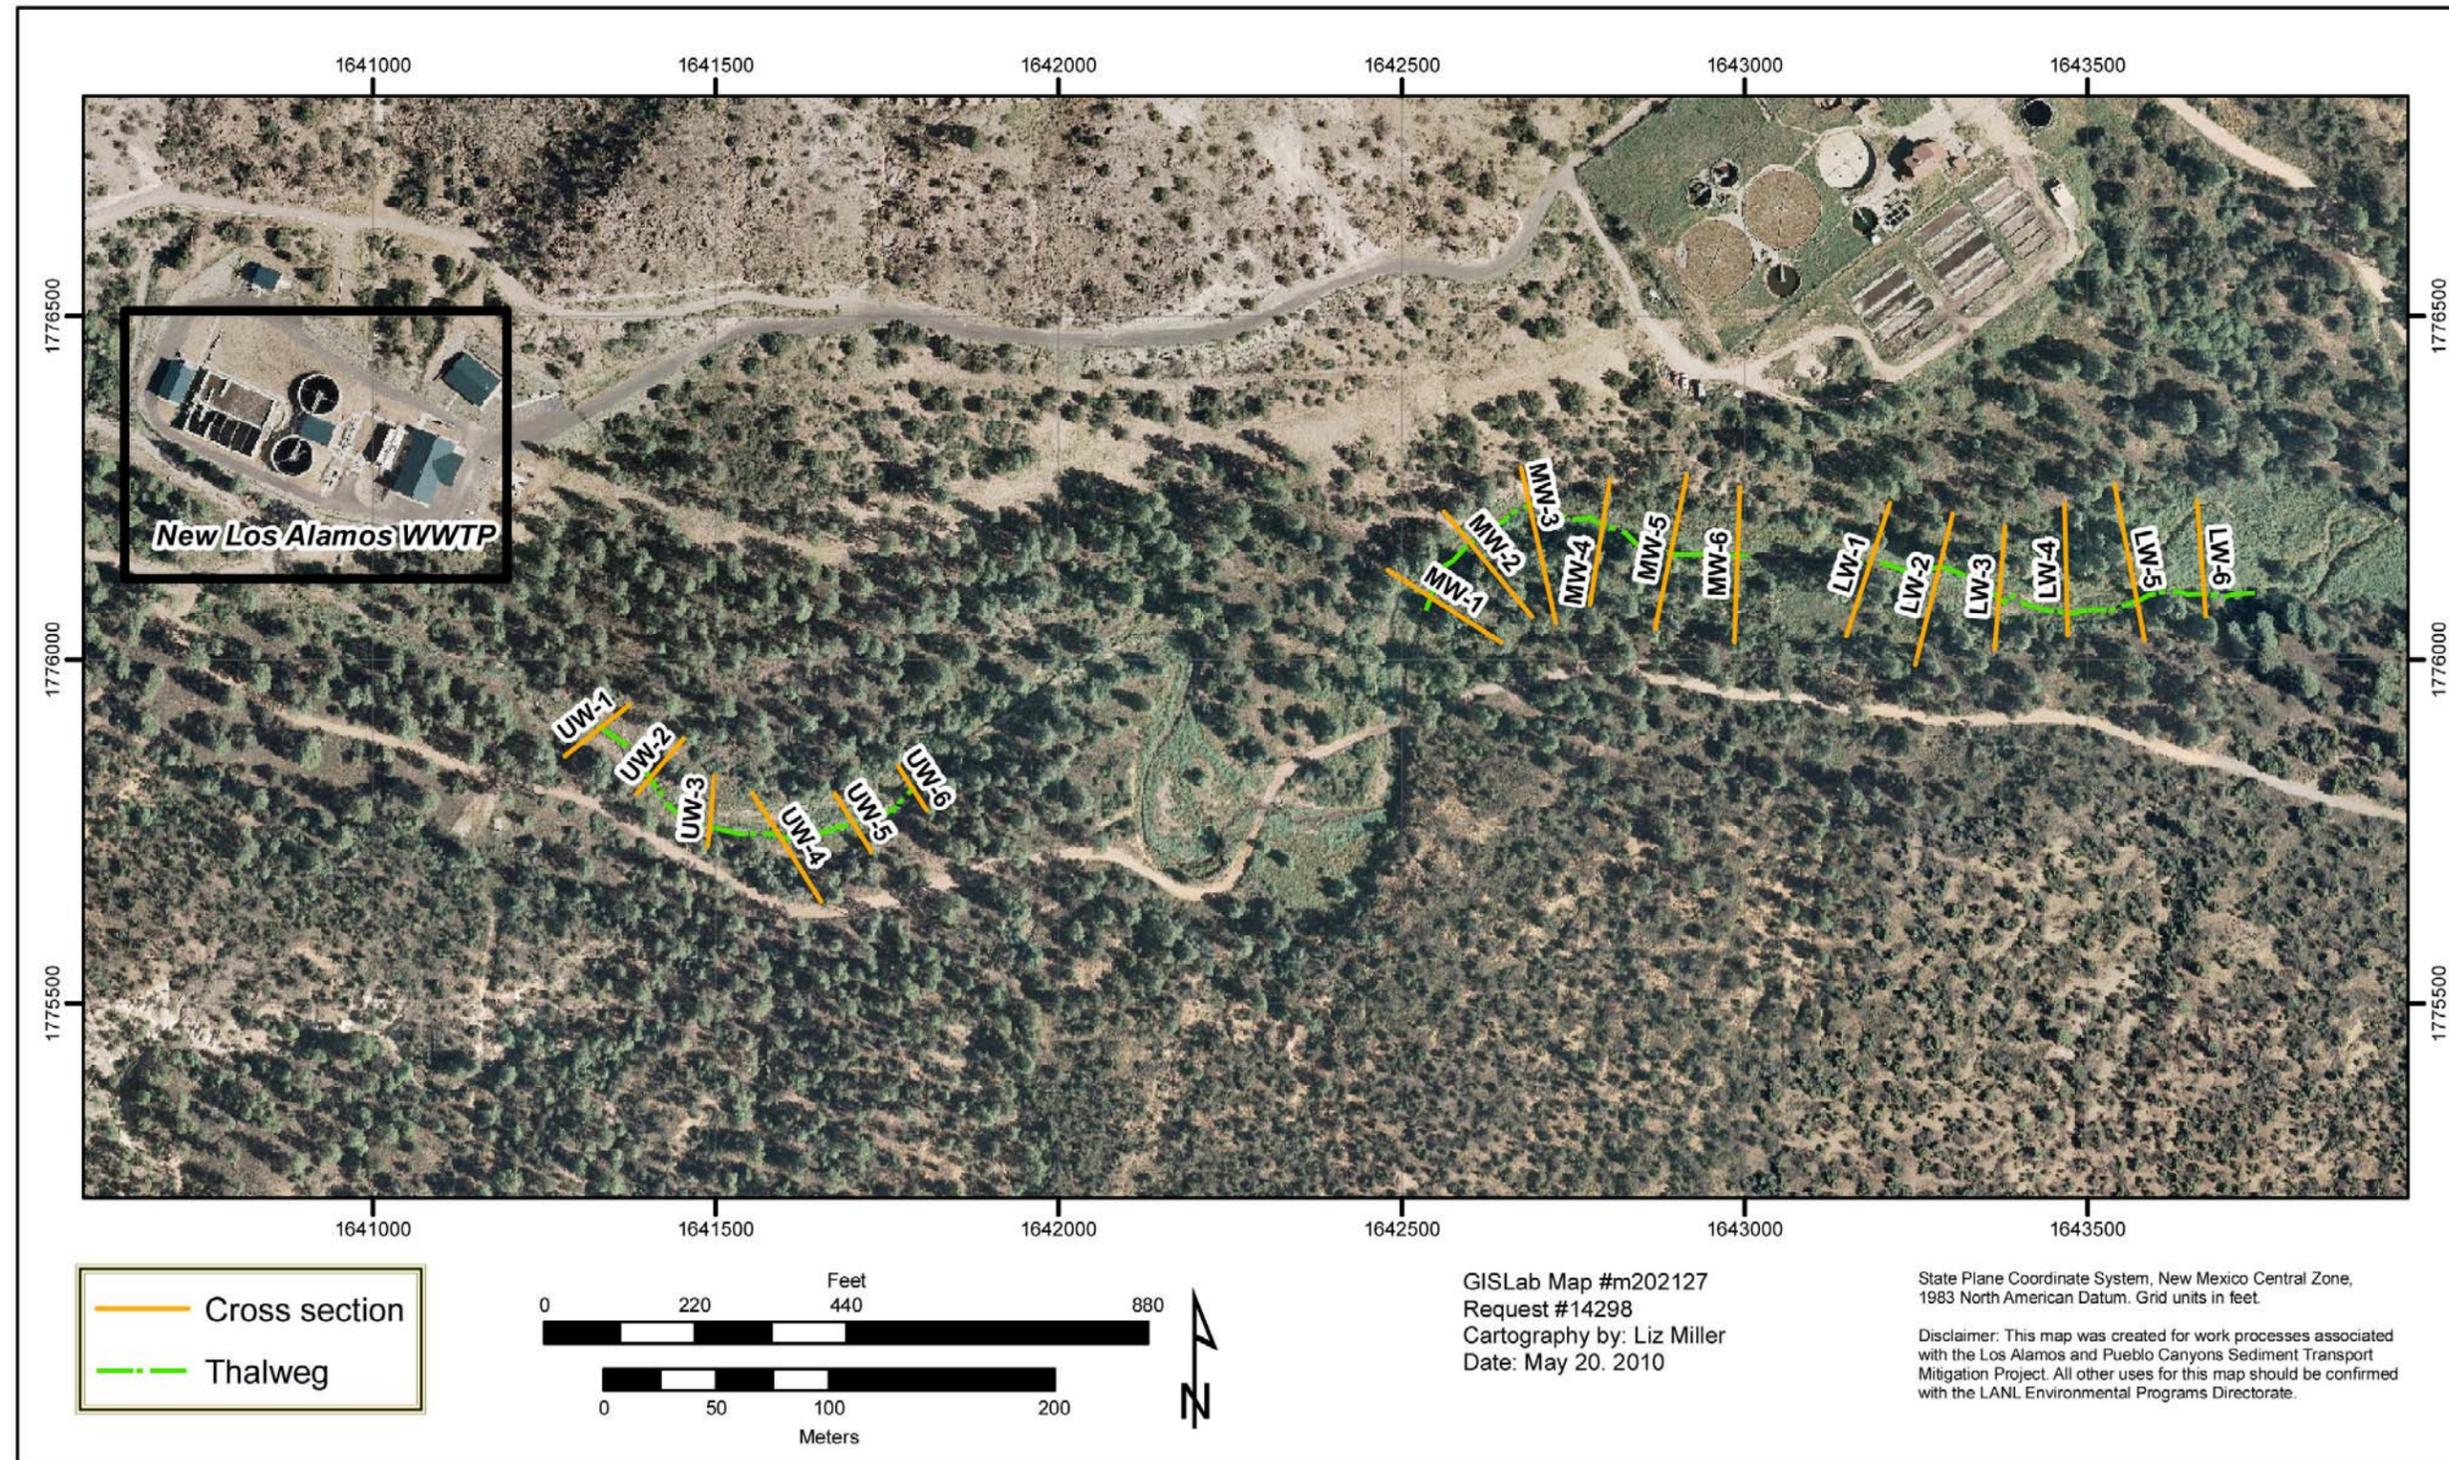
Figure 6 Orthophoto showing the locations of surveyed cross sections and thalweg profiles in the upper Pueblo Canyon willow-planting area

Upper Pueblo Canyon Willow-Planting Area. A total of 18 cross sections were surveyed in October 2009 in the area of Pueblo Canyon downstream from the new Los Alamos wastewater treatment plant (WWTP) outfall and upstream from the access road to the WWTP, where willows were planted in spring 2008 and spring 2009. These cross sections were divided into groups of six within the upper (UW), middle (MW), and lower (LW) thirds of the willow-planting area, and within each group, the cross sections were spaced at 100-ft intervals. Longitudinal channel thalweg profiles were also surveyed over 500-ft intervals through each of these three areas. Cross-section and thalweg-profile locations are shown in

Figure 6. The cross sections in the UW, MW, and LW thirds of the willow-planting area are shown in Figures 7, 8, and 9, respectively, and the thalweg profiles are shown in Figure 10.

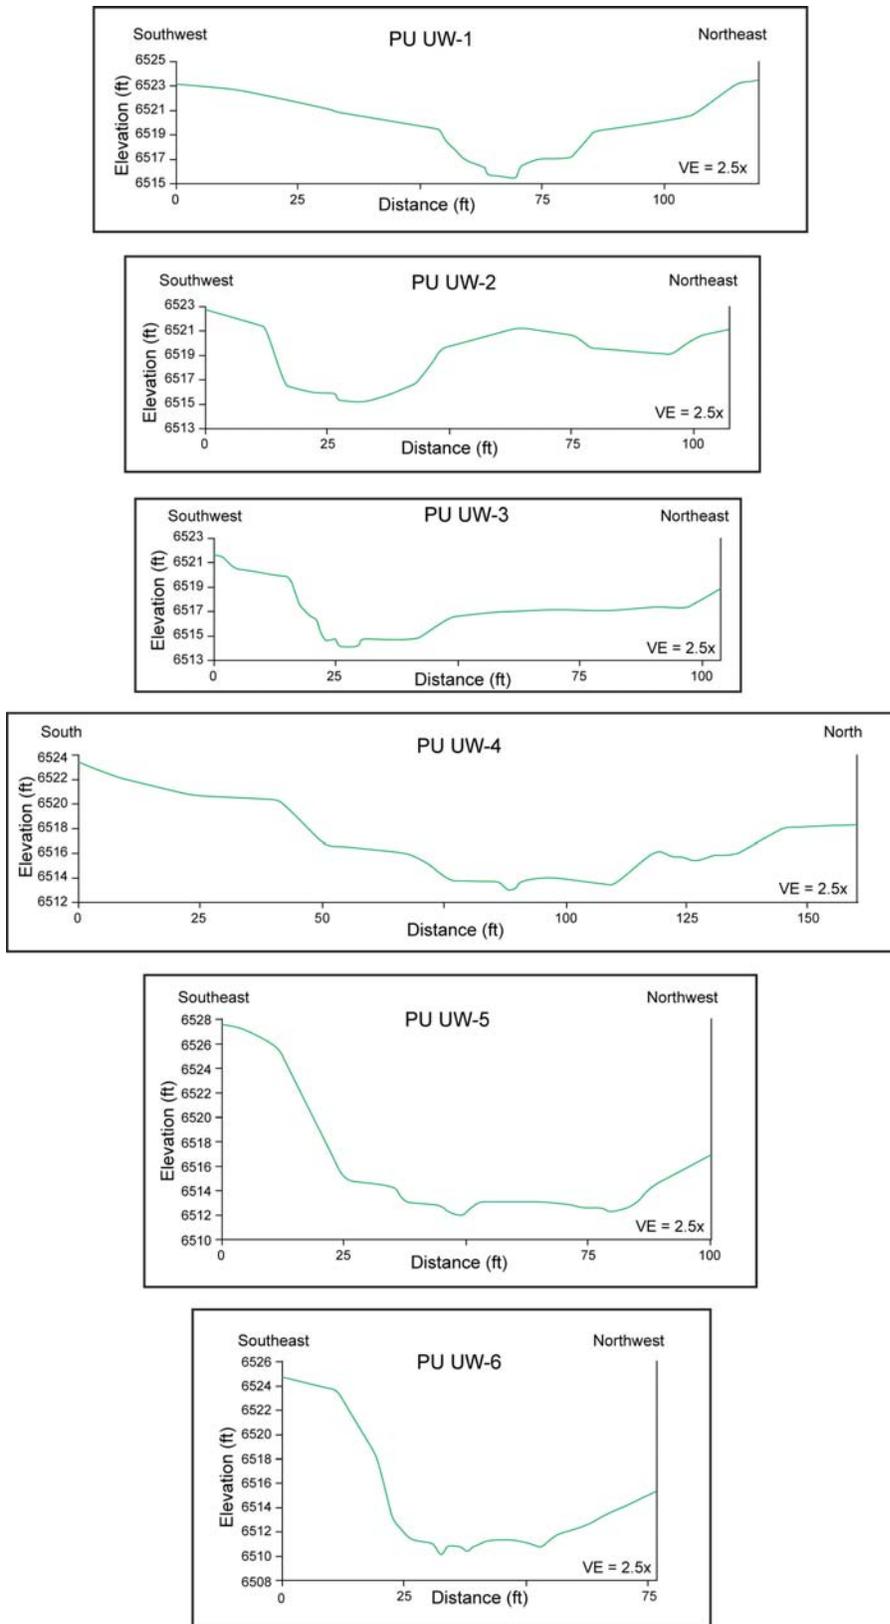
Figure 7 Cross sections in upper third of upper Pueblo Canyon willow-planting area

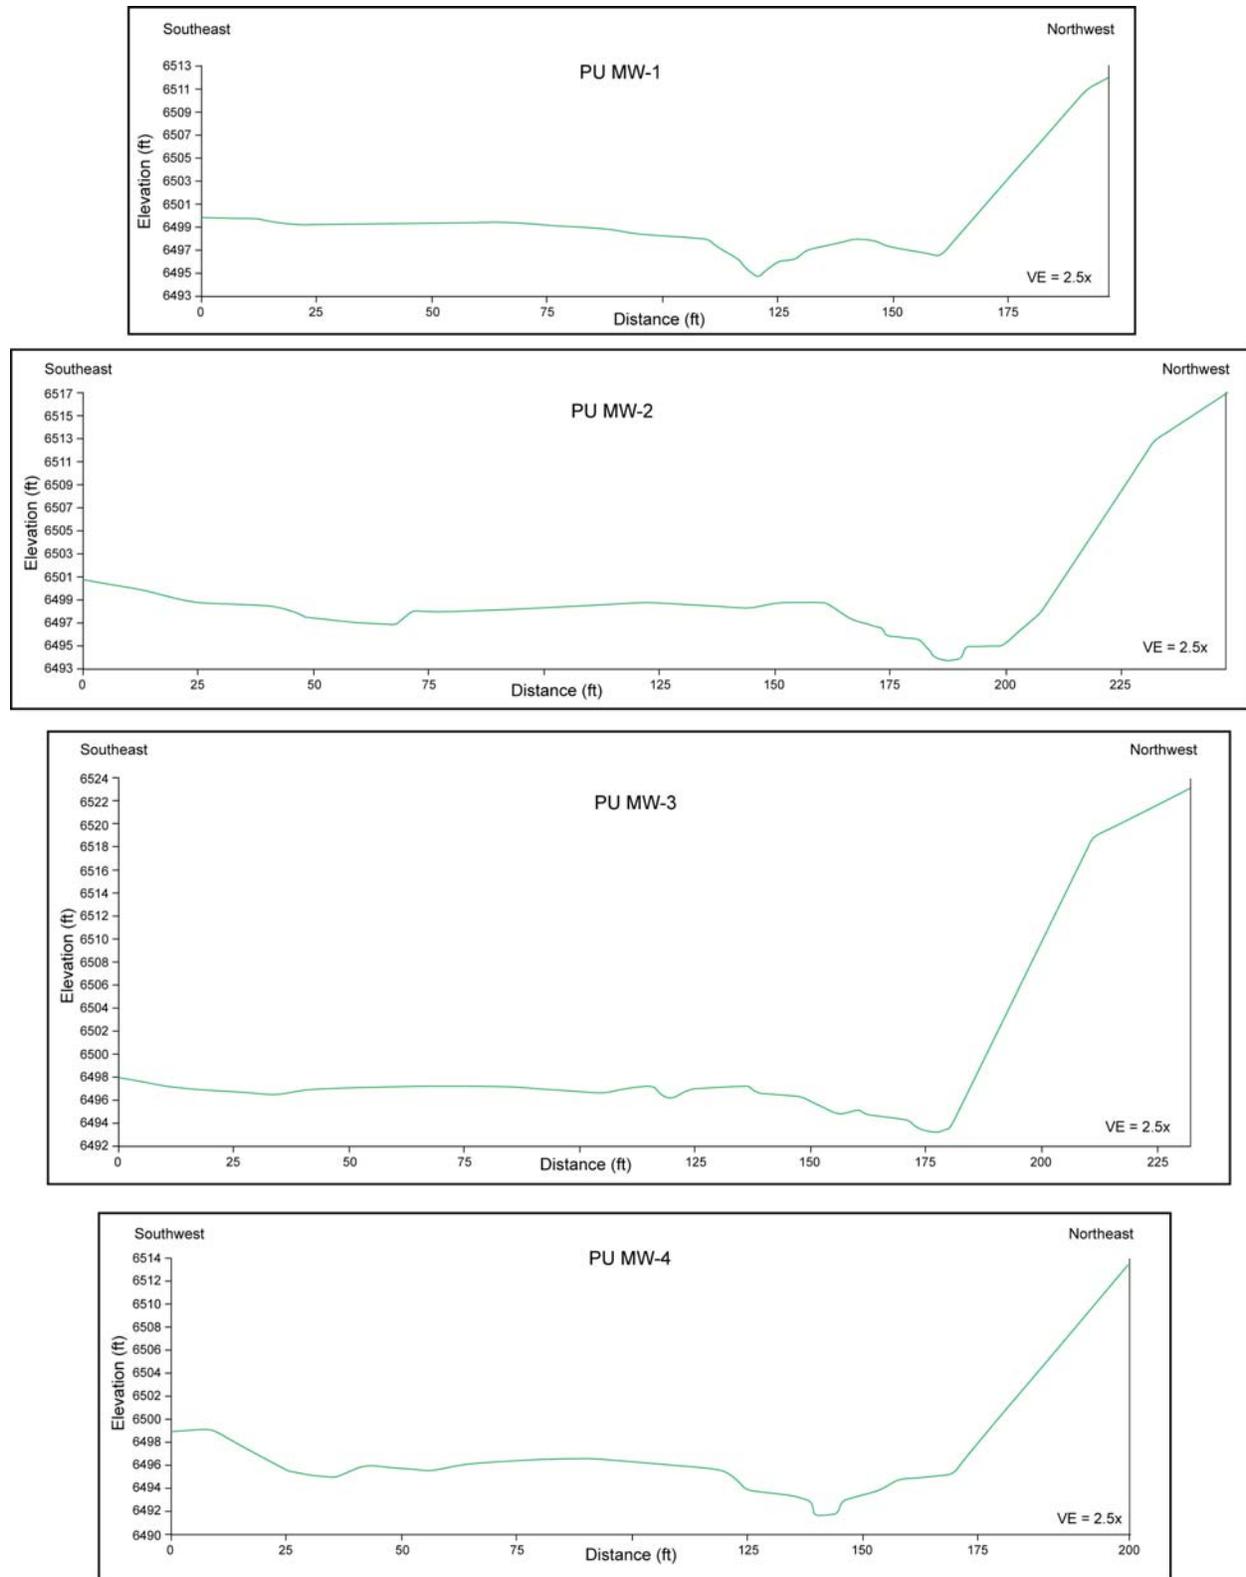
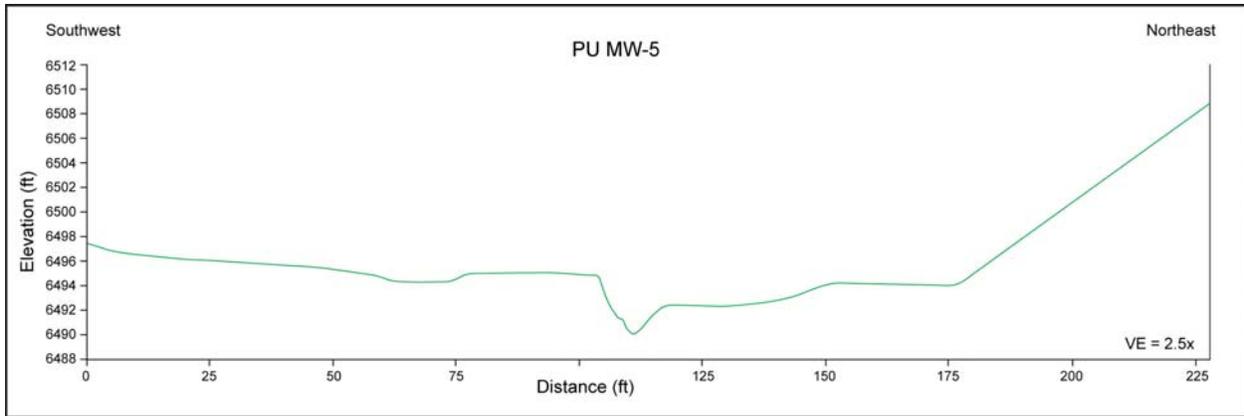
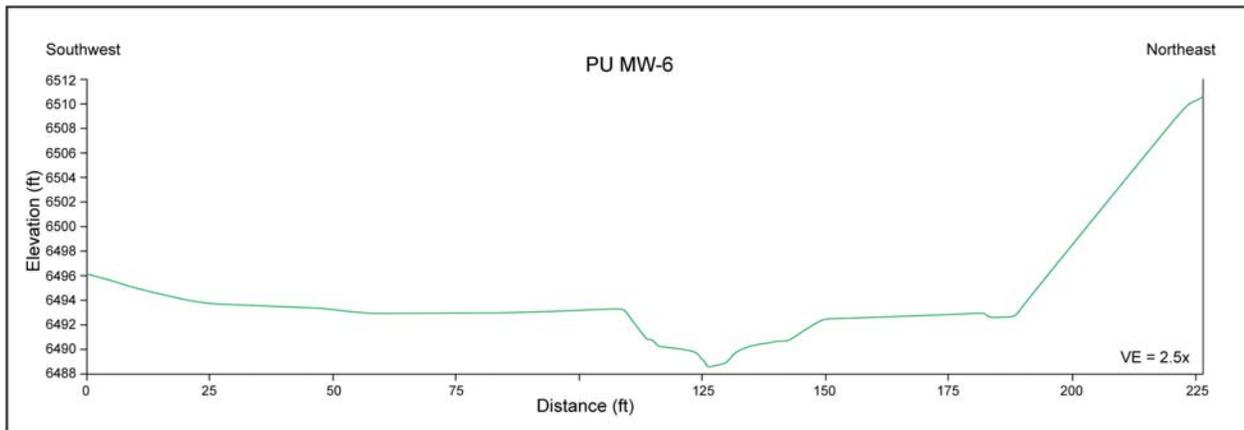
Figure 8 Cross sections in middle third of upper Pueblo Canyon willow-planting area

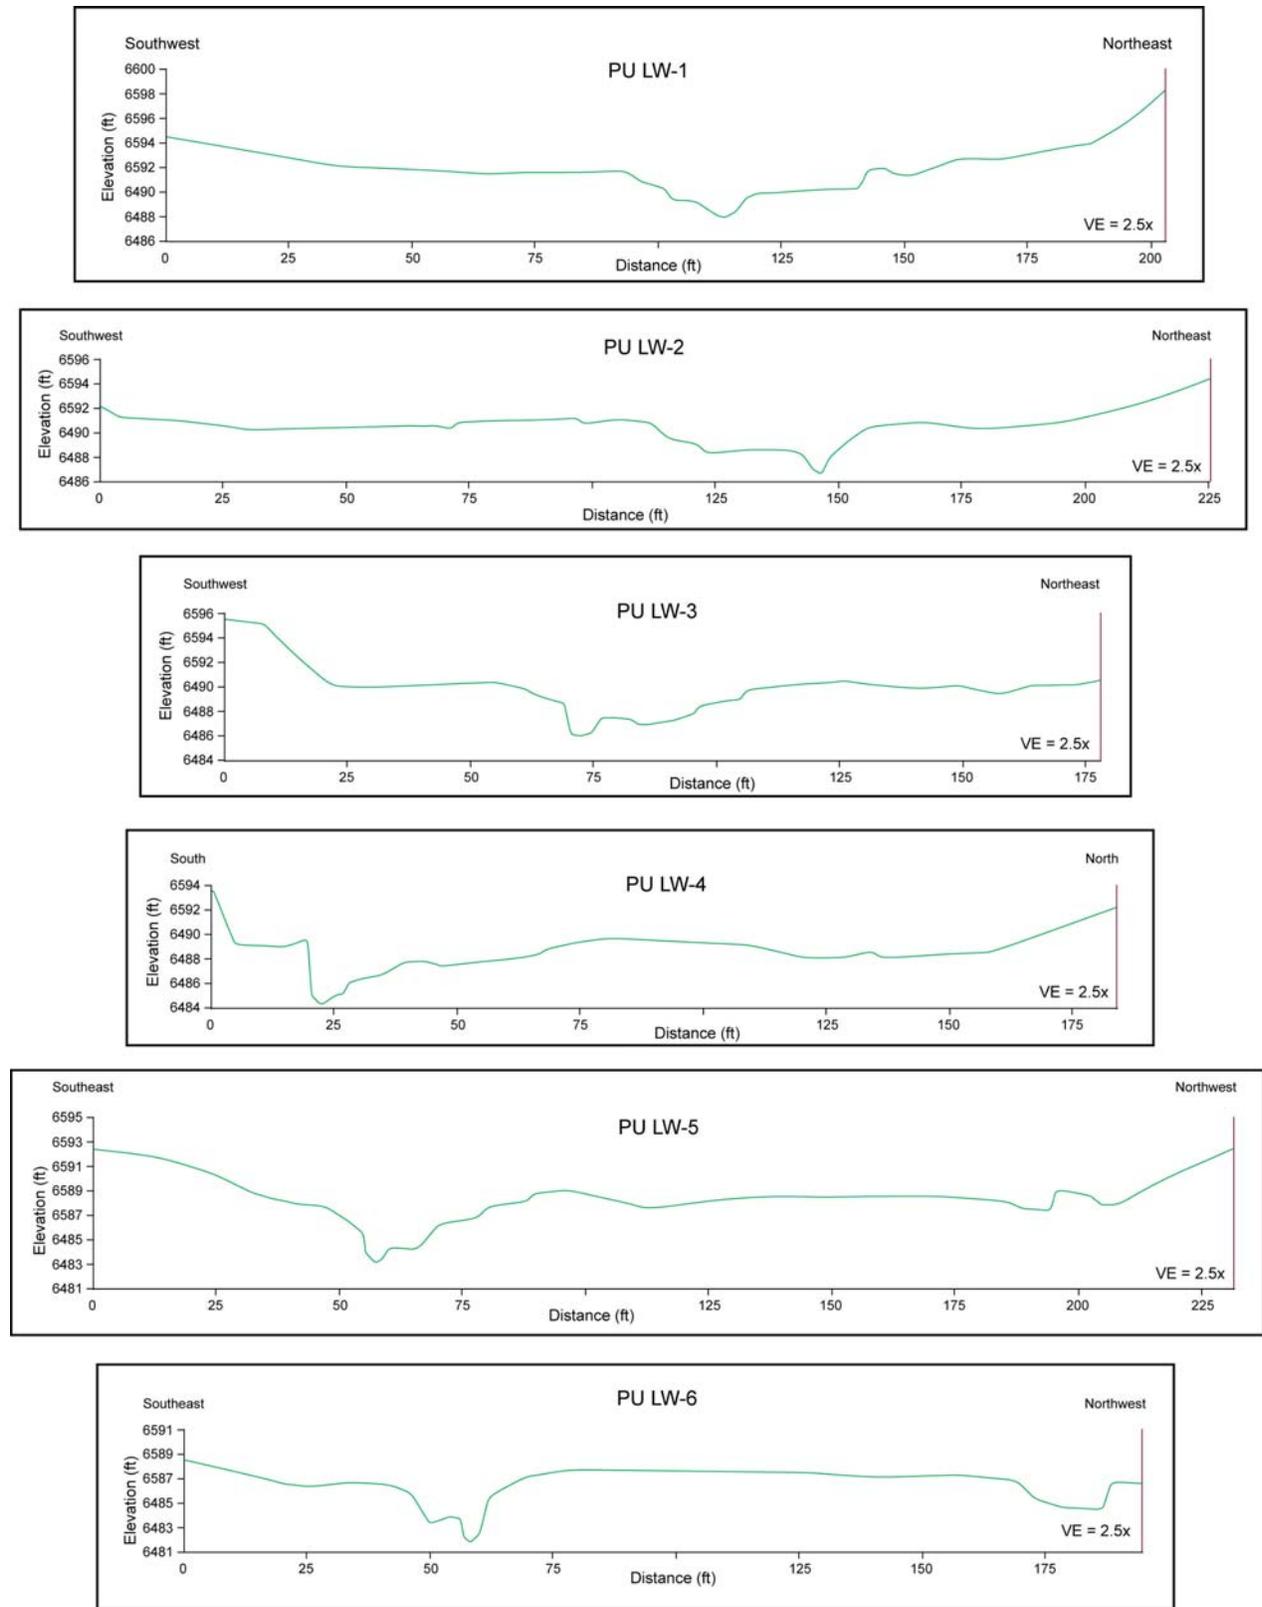
Figure 9 Cross sections in lower third of upper Pueblo Canyon willow-planting area
