Subject: Submittal of the Response to the Notice of Disapproval Baseline Geomorphic Conditions at Sediment Transport Mitigation Sites in Los Alamos/Pueblo Canyon Watersheds and Revision 1

LA-UR-11-0936
February 2011
EP2011-0077

Baseline Geomorphic Conditions at Sediment Transport Mitigation Sites in the Los Alamos and Pueblo Canyon Watersheds, Revision 1

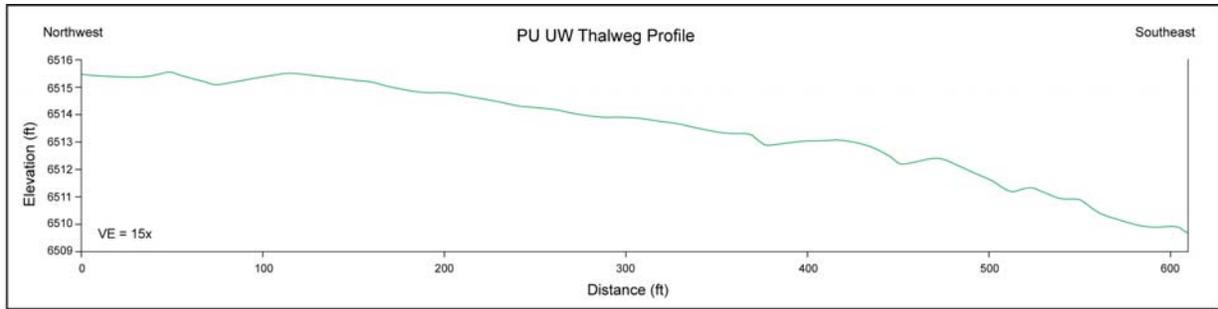
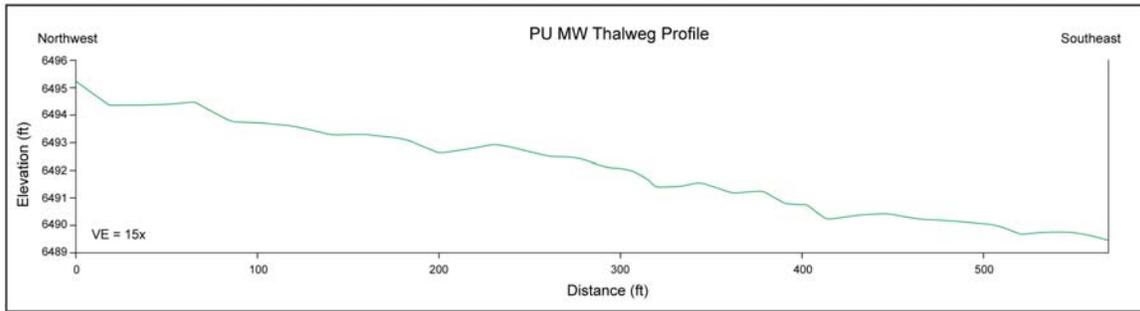
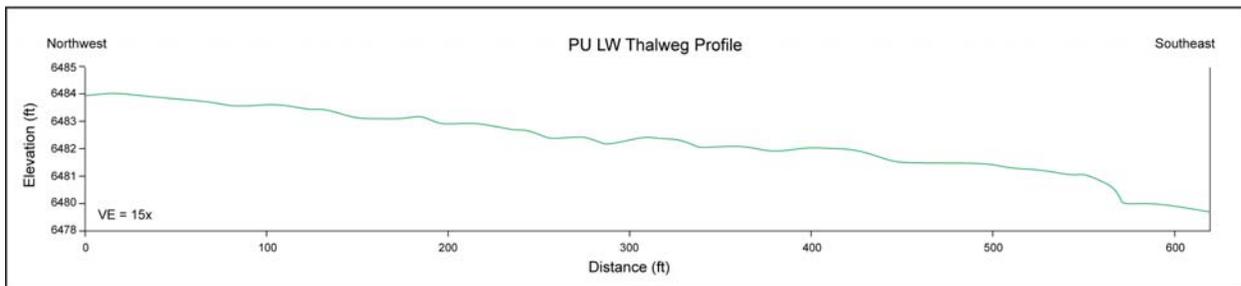
Figure 10 Thalweg profiles in the upper Pueblo Canyon willow-planting area

Figure 6. The cross sections in the UW, MW, and LW thirds of the willow-planting area are shown in Figures 7, 8, and 9, respectively, and the thalweg profiles are shown in Figure 10.

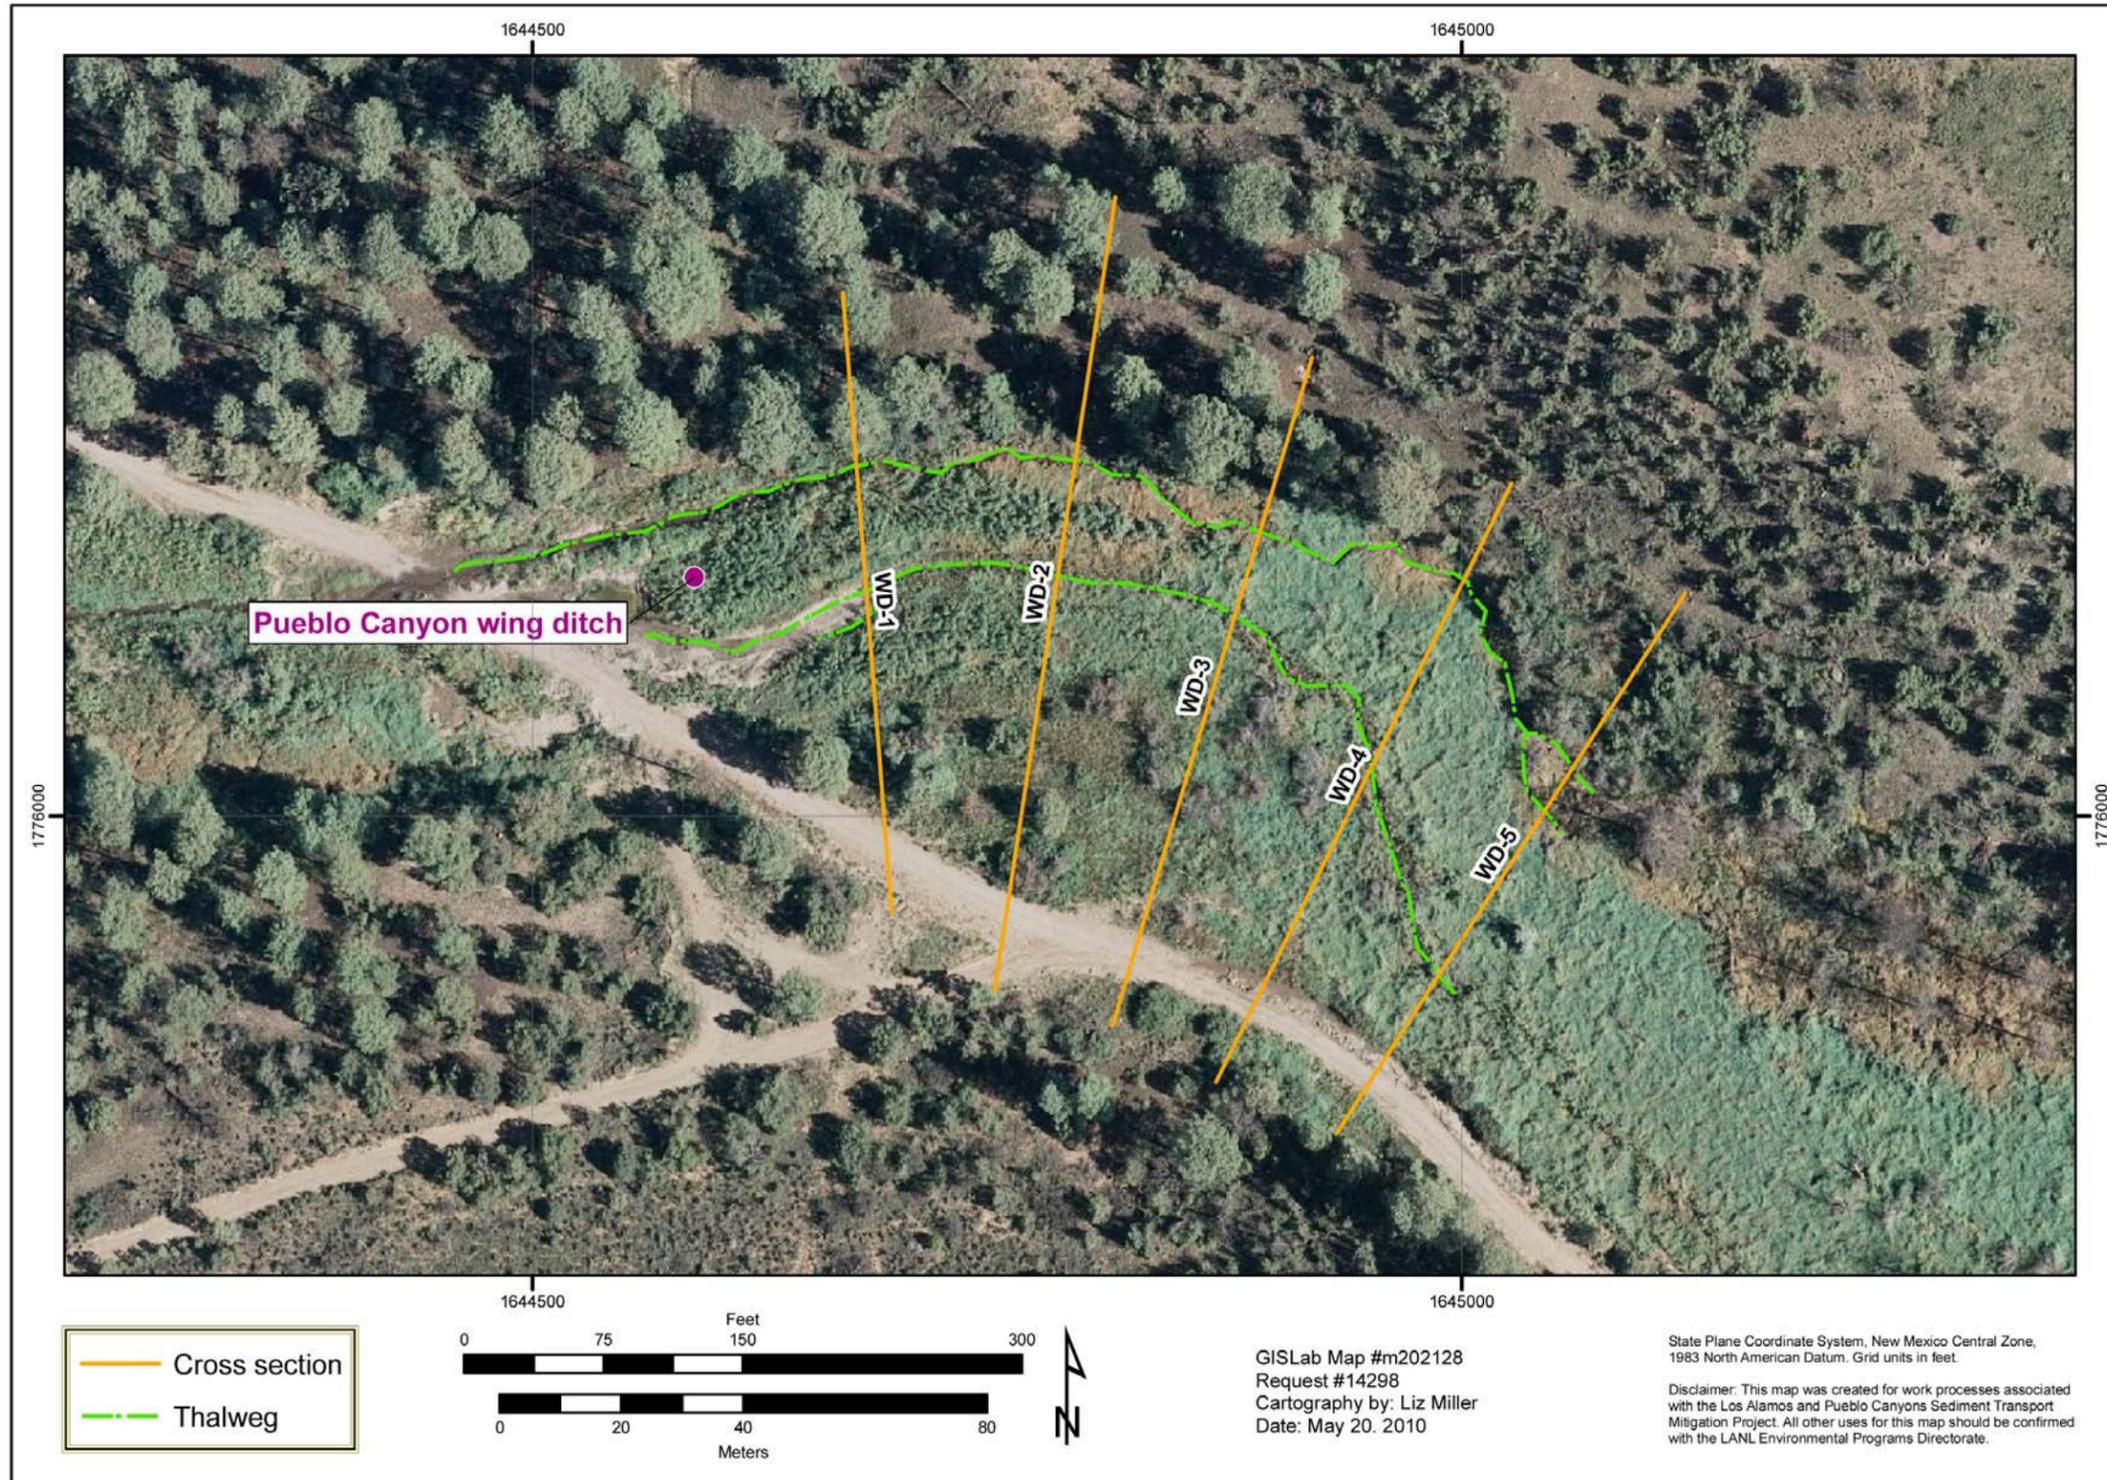
Figure 11 Orthophoto showing the locations of surveyed cross sections and thalweg profiles near the Pueblo Canyon wing ditch

Pueblo Canyon Wing Ditch. Five cross sections were surveyed at 100-ft intervals downcanyon from the Pueblo Canyon wing ditch in November 2009. Longitudinal thalweg profiles of the active channel and an abandoned channel to the south, where the wing ditch will direct water, were also surveyed over this distance. Cross-section and thalweg-profile locations are shown in Figure 11. The cross sections are shown in Figure 12, and the thalweg profiles are shown in Figure 13.

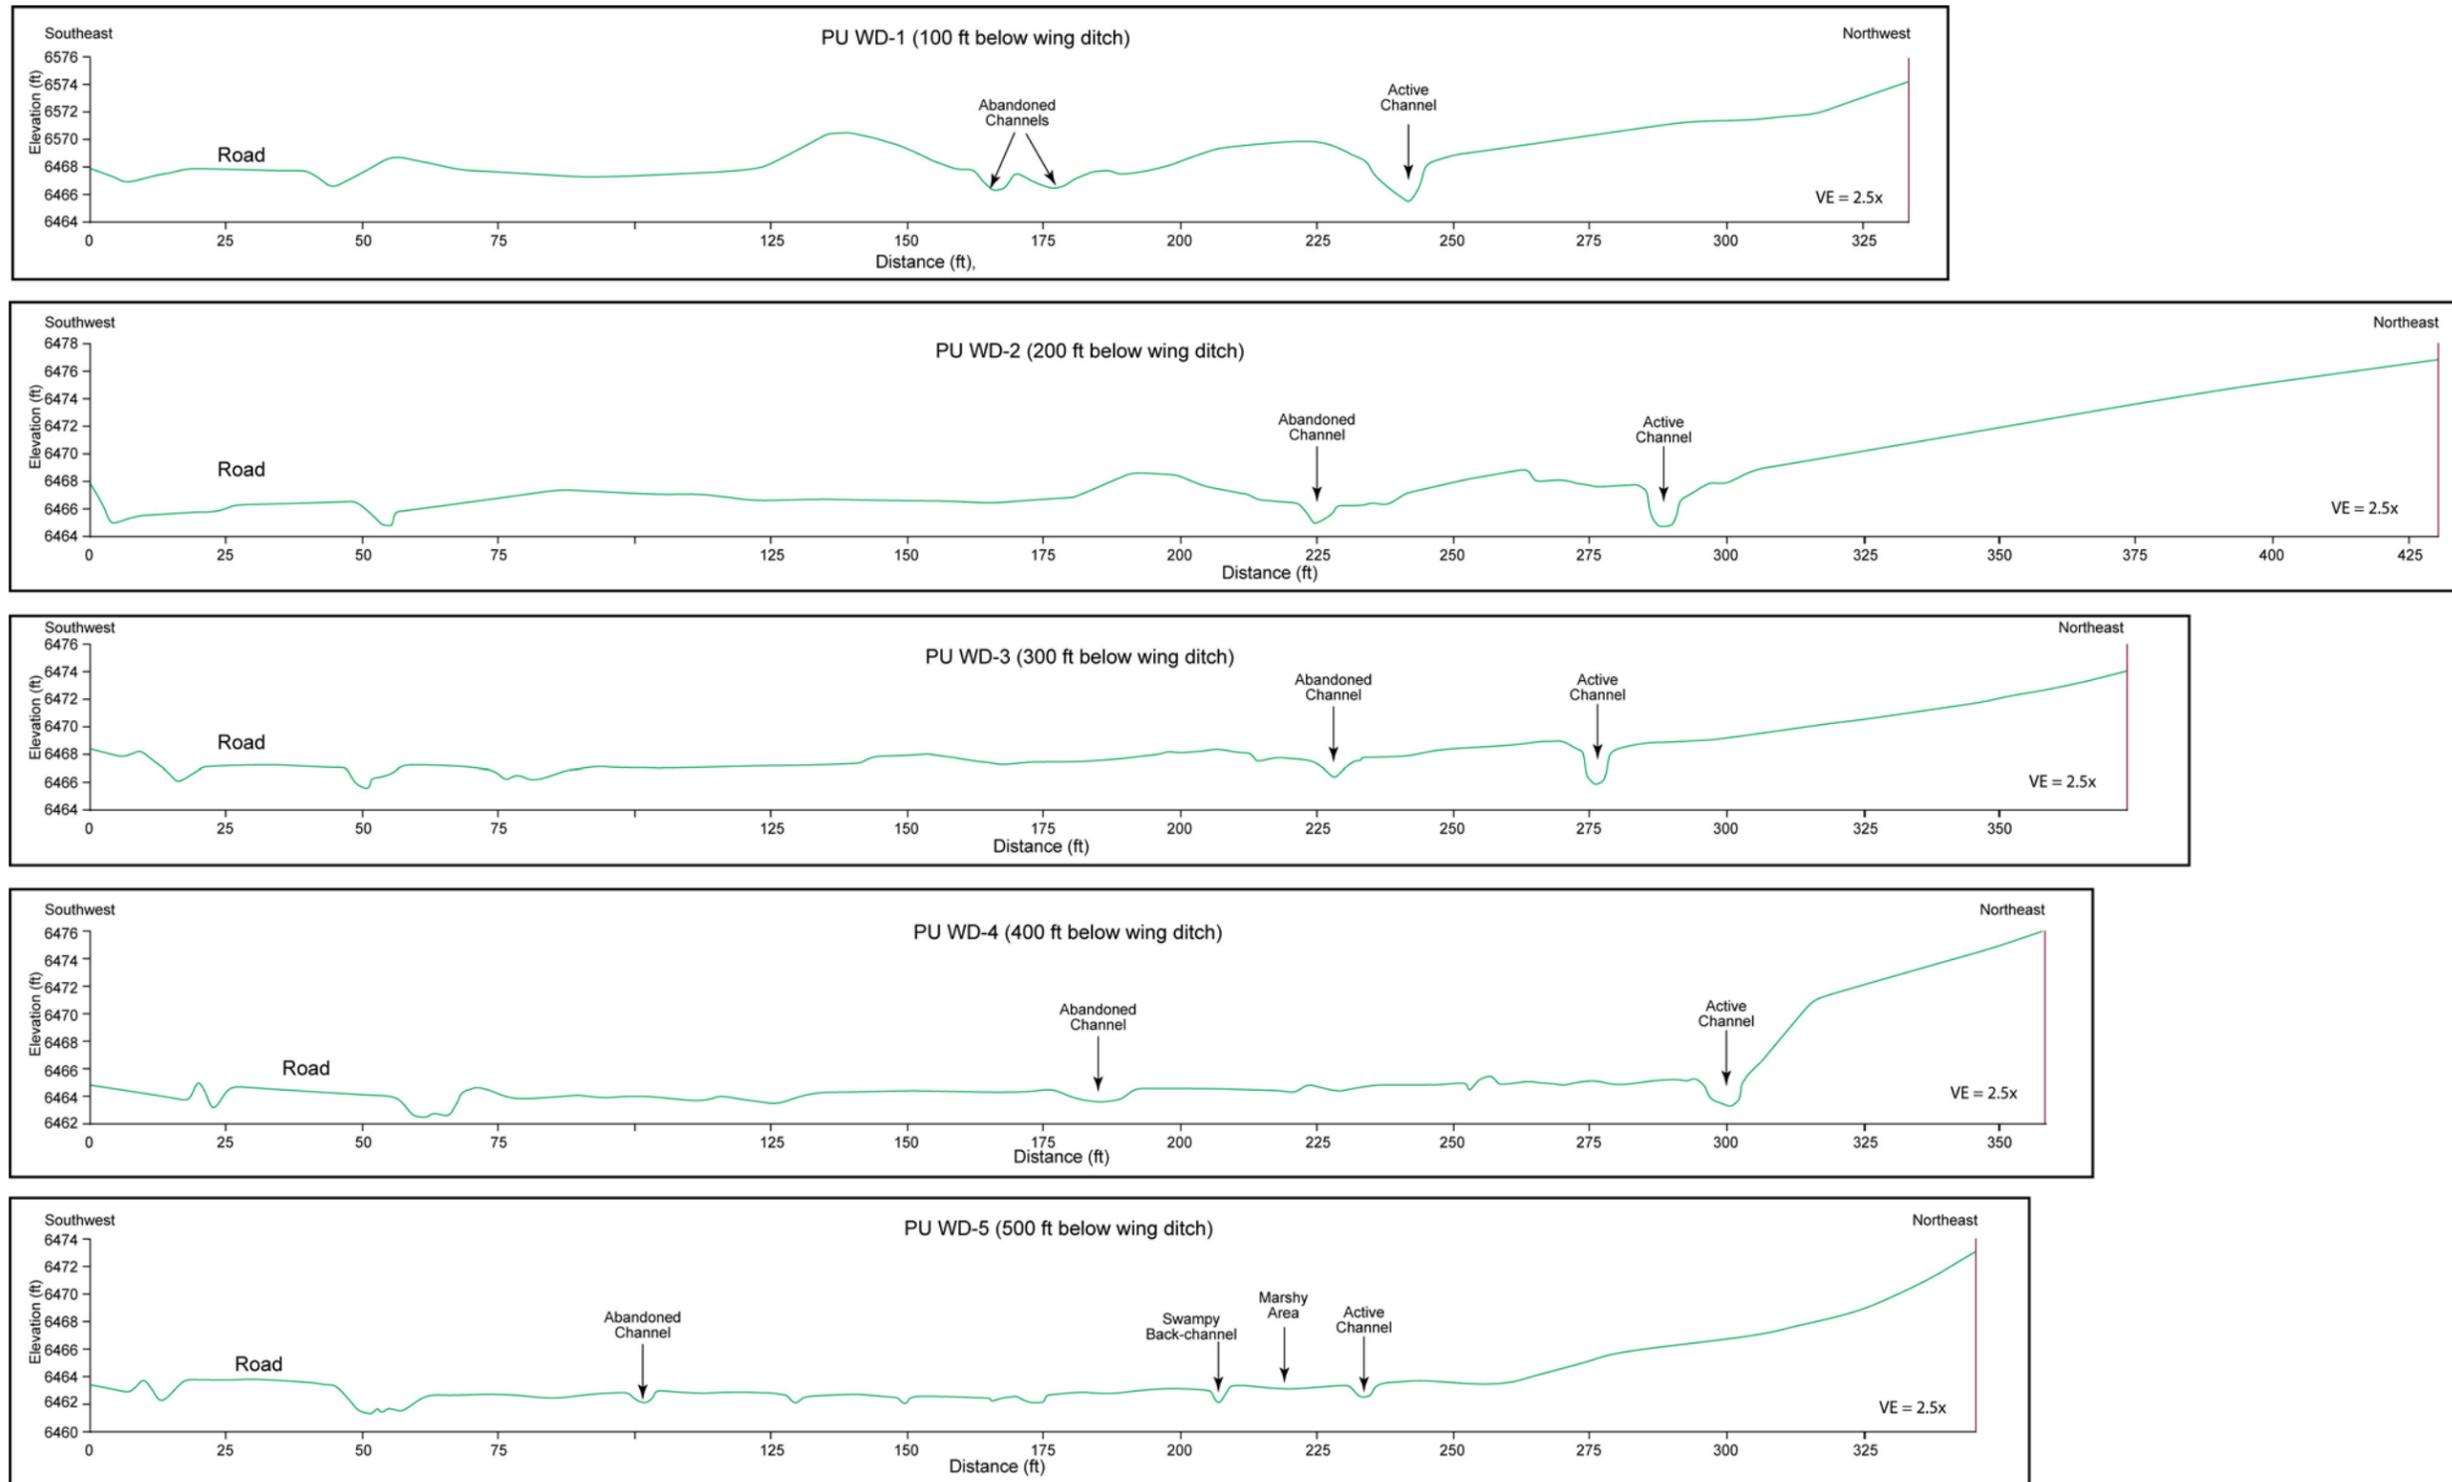
Figure 12 Cross sections below the Pueblo Canyon wing ditch

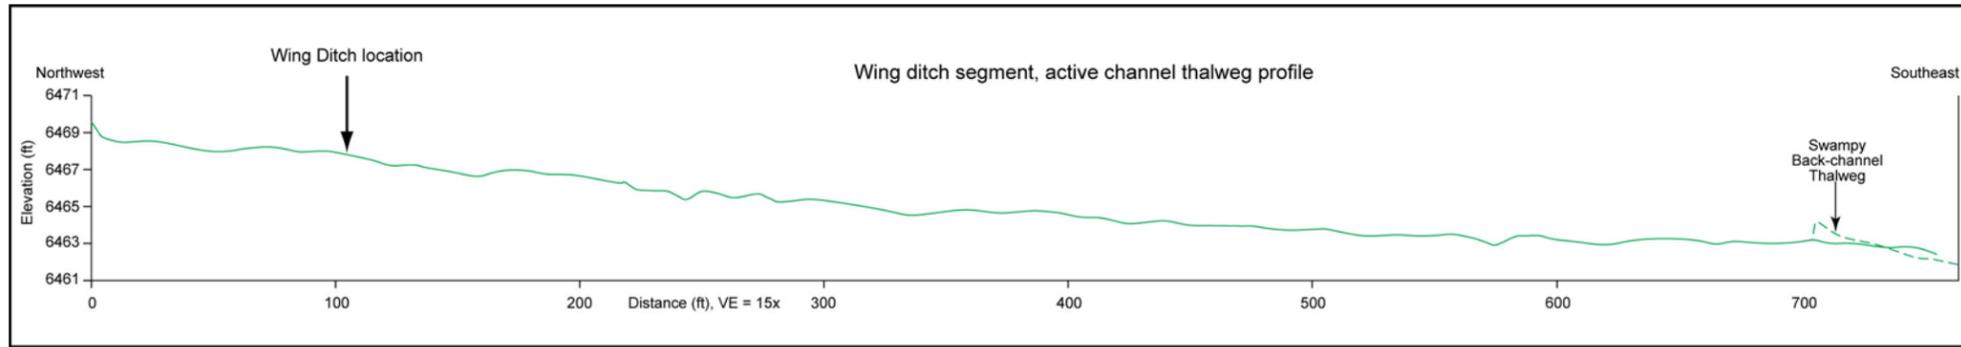
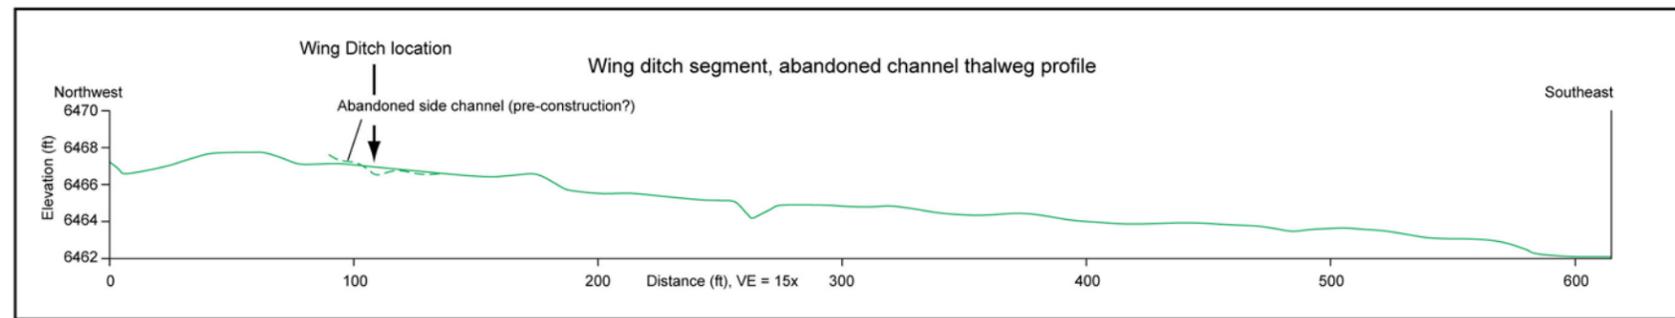
Figure 13 Thalweg profiles near the Pueblo Canyon wing ditch

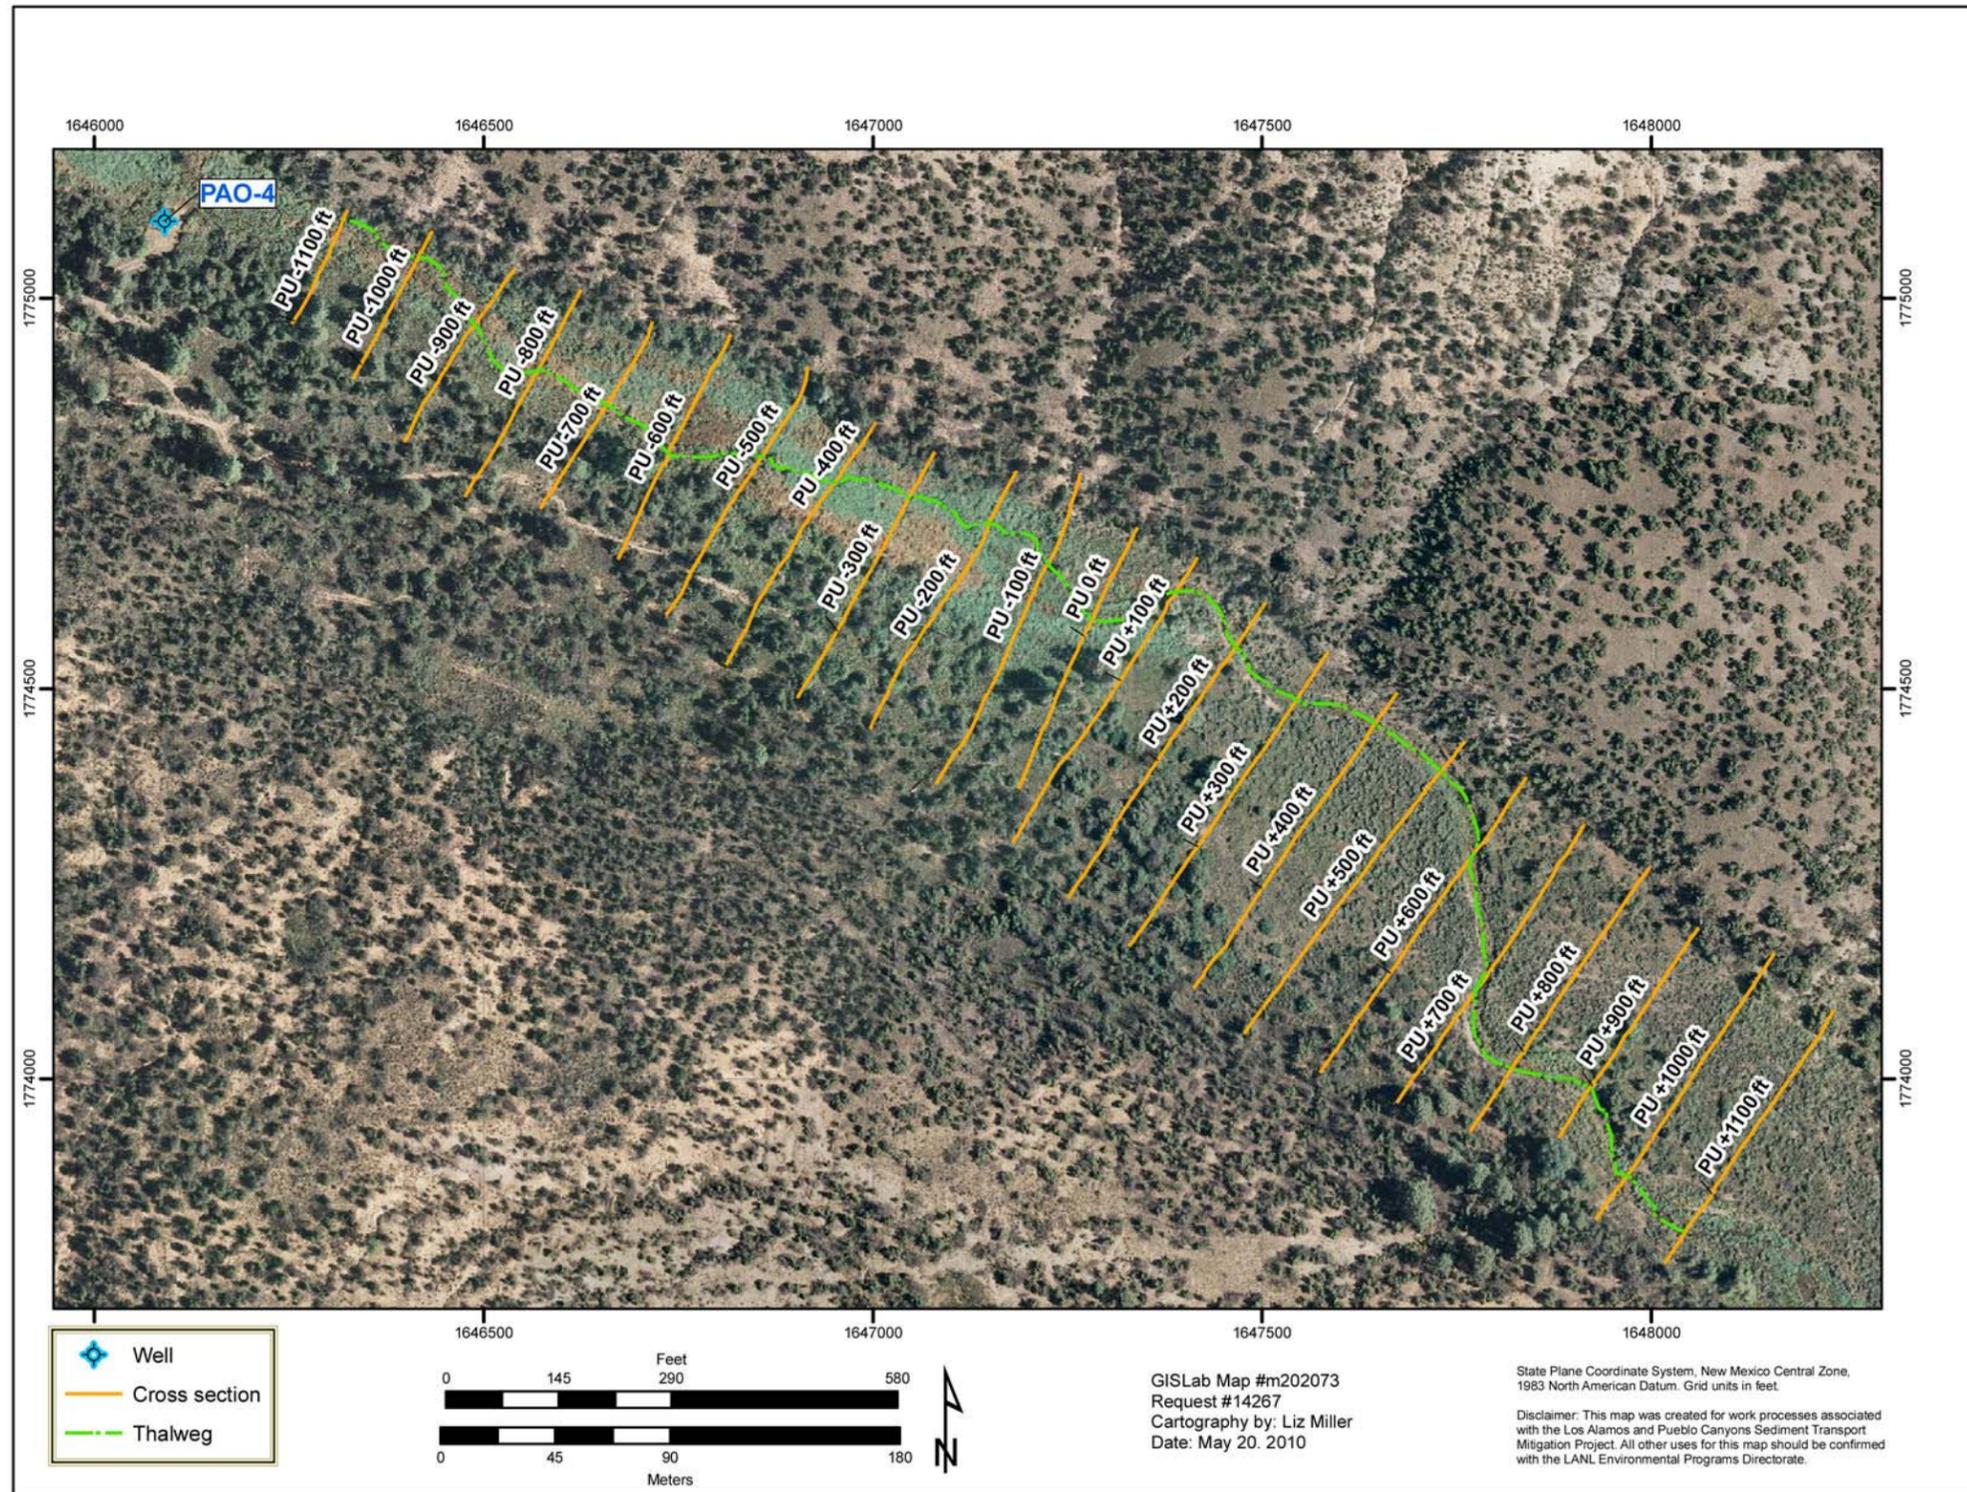
Figure 14 Orthophoto showing the locations of surveyed cross sections and thalweg profiles in the lower Pueblo Canyon willow-planting area

Lower Pueblo Canyon Willow-Planting Area. A total of 23 cross sections were surveyed in September and October 2009 at 100-ft intervals within reaches P-3FE and P-4W in an area where willows were planted in spring 2009. The surveys extended for 1100 ft above and below a transition area separating a broad upcanyon wetland (P-3FE) from a narrower downcanyon wetland within incised geomorphic surfaces (P-4W). The cross sections are labeled with negative numbers above this transition area (e.g., PU-100 ft), and with positive numbers below this transition area (e.g., PU+100 ft). A longitudinal channel thalweg profile was also surveyed over this 2200-ft interval. Cross-section and thalweg-profile locations are shown in Figure 14, cross sections are shown in Figure 15, and the channel thalweg profile is shown in Figure 16.

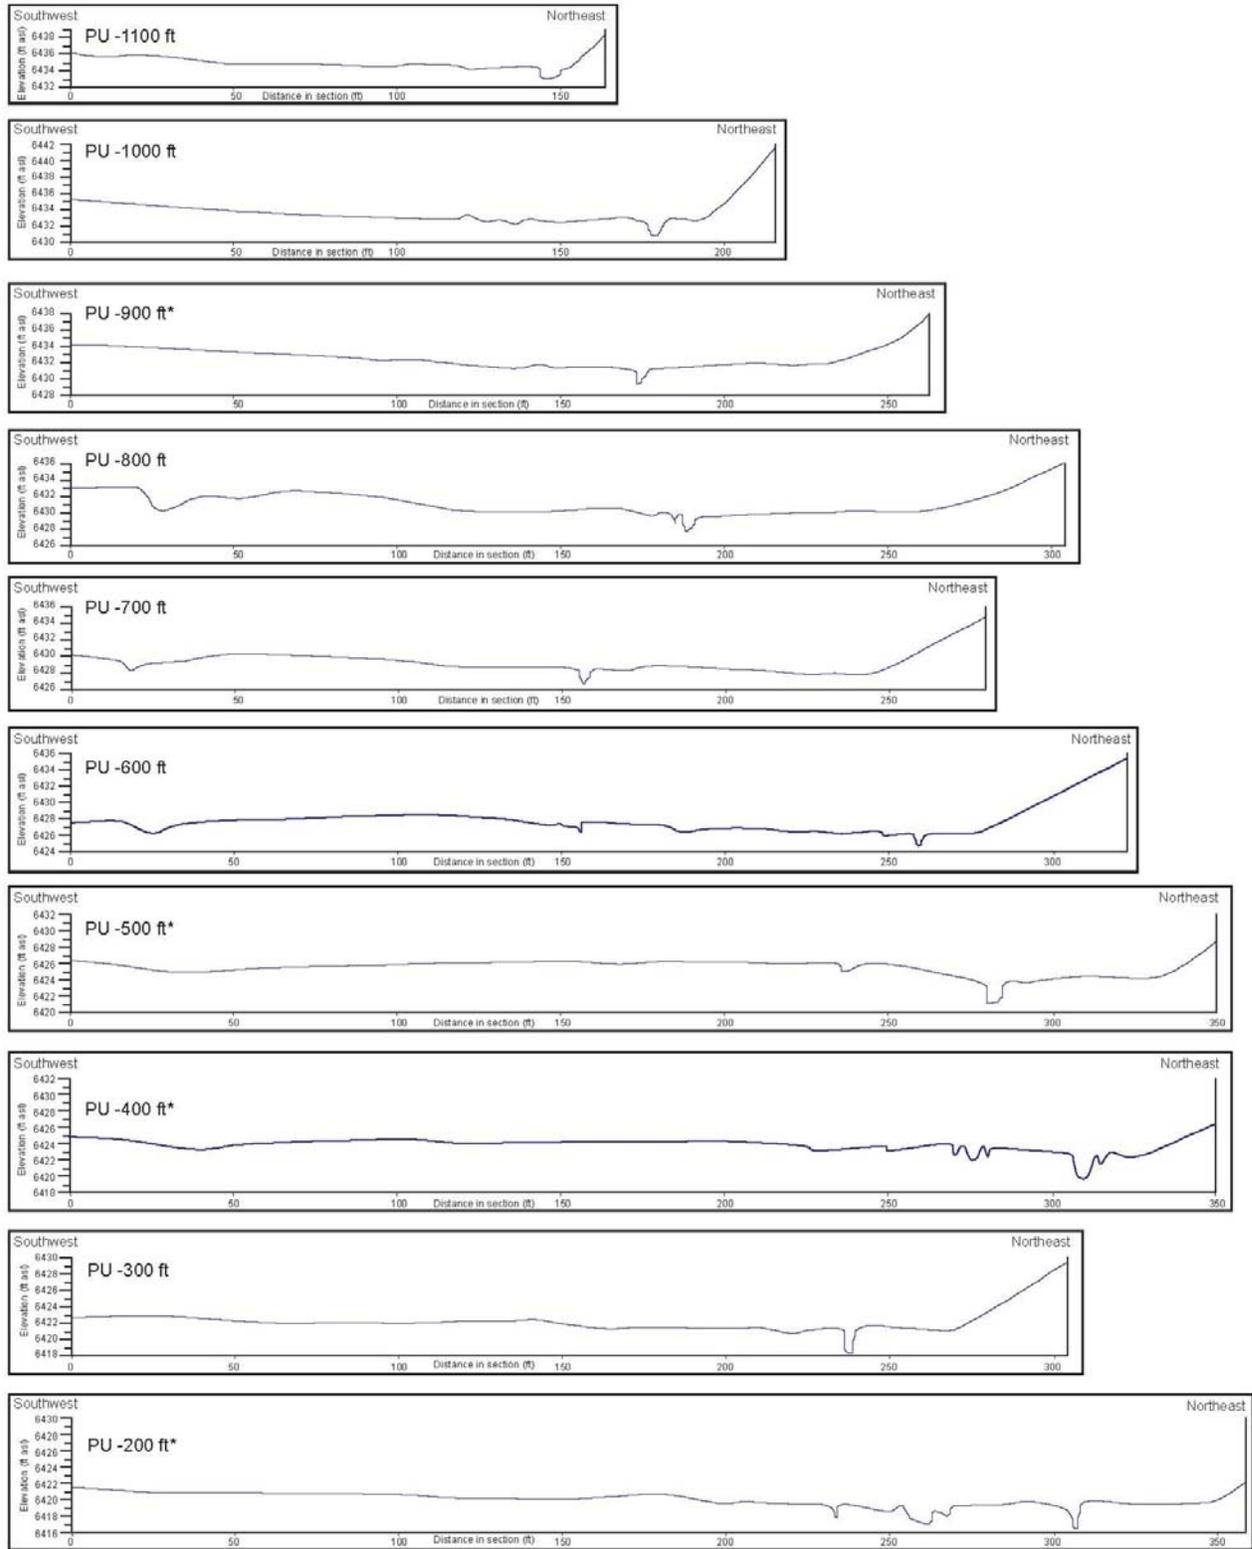
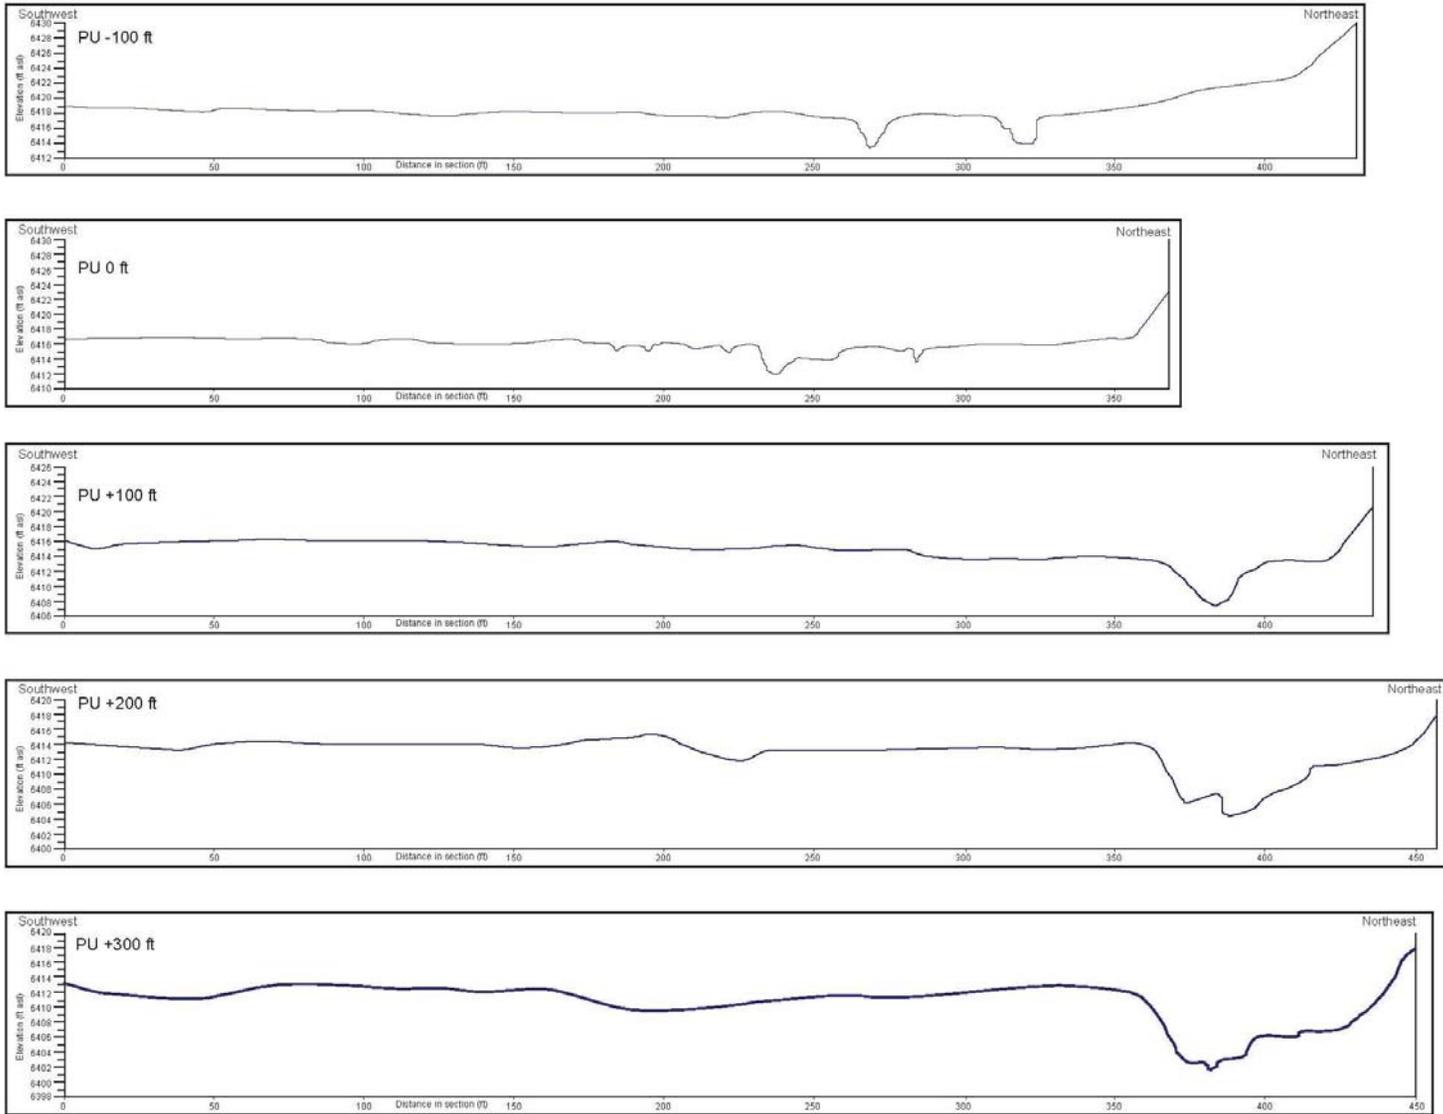
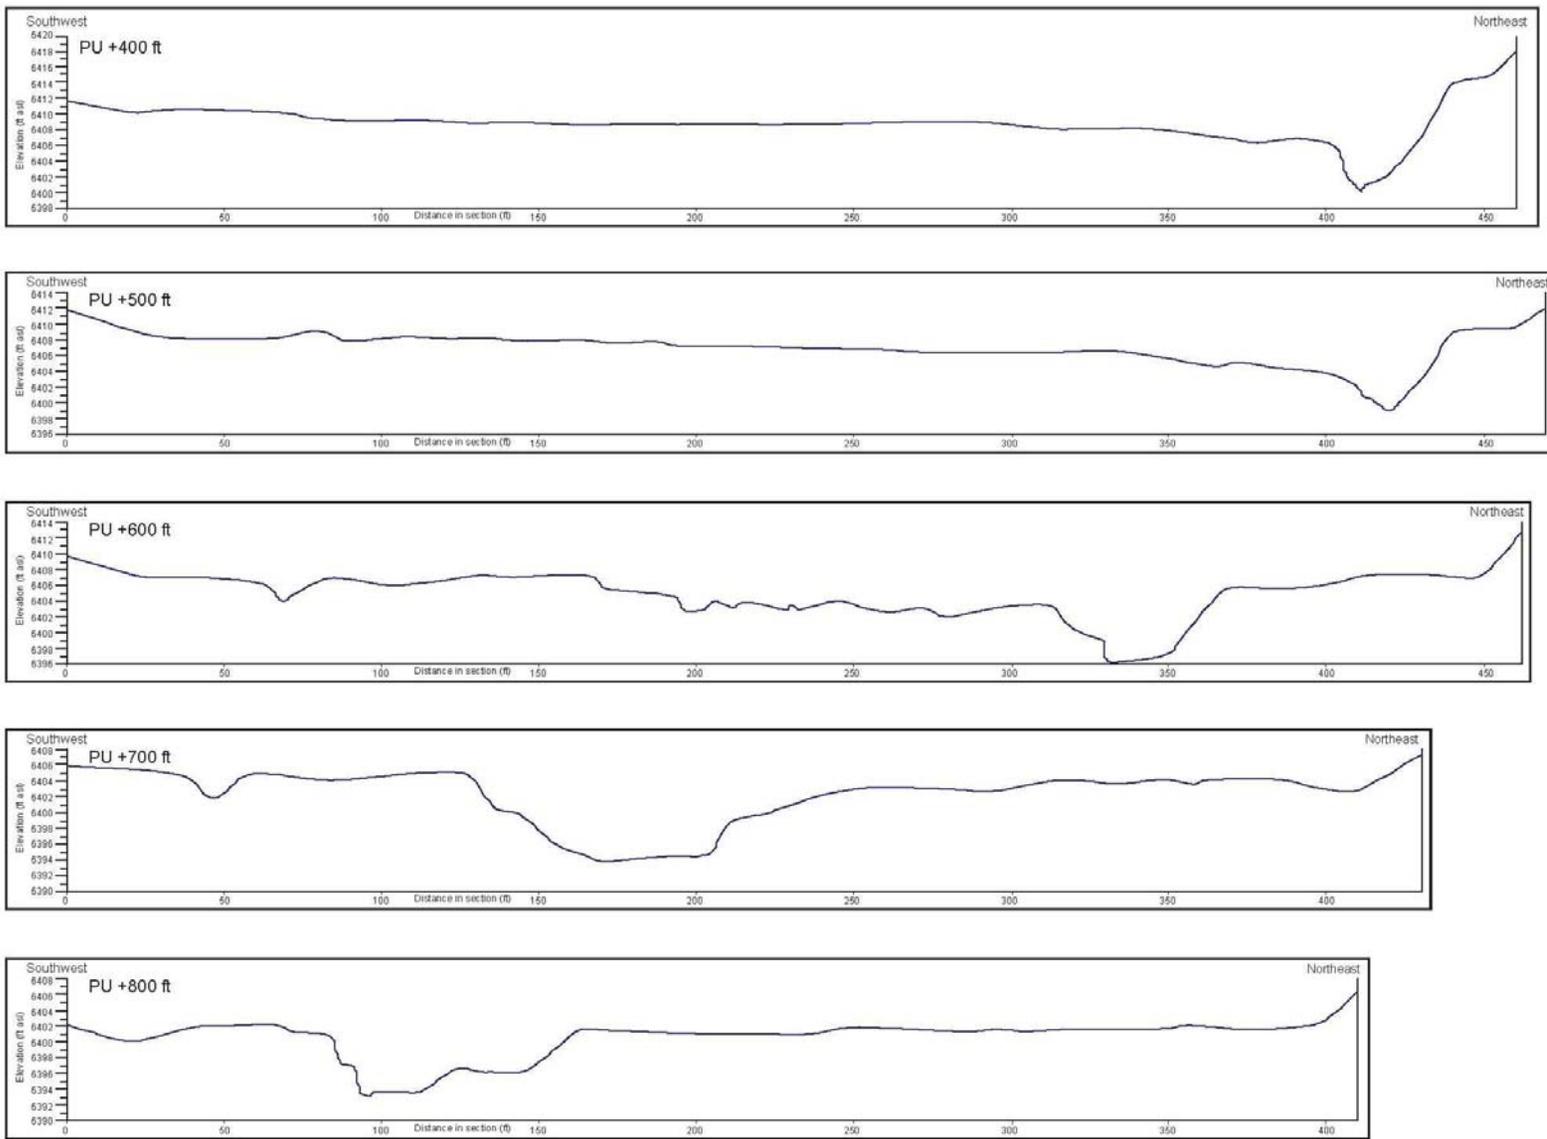
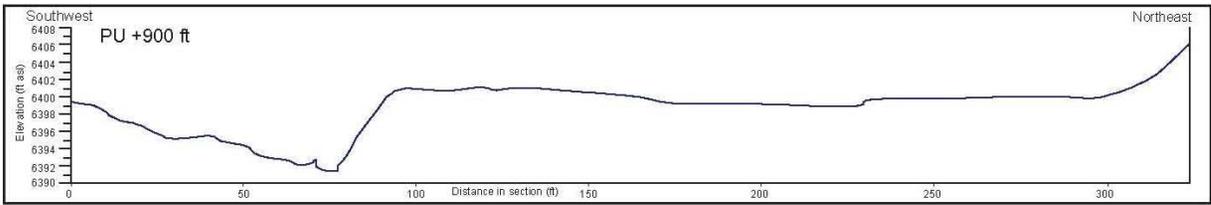
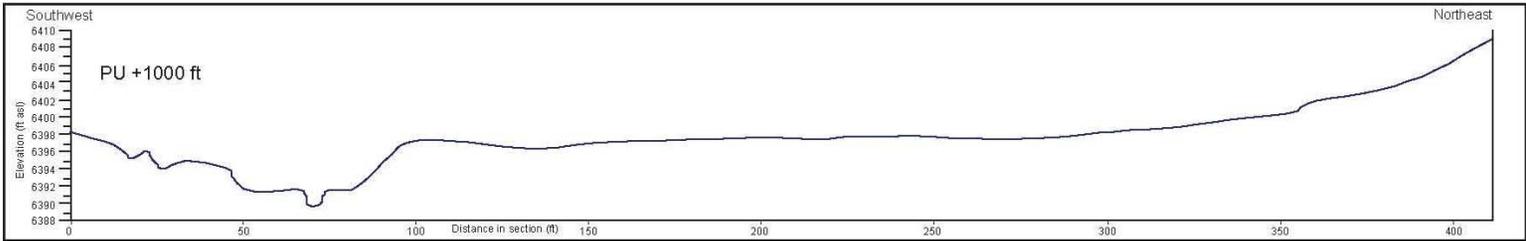
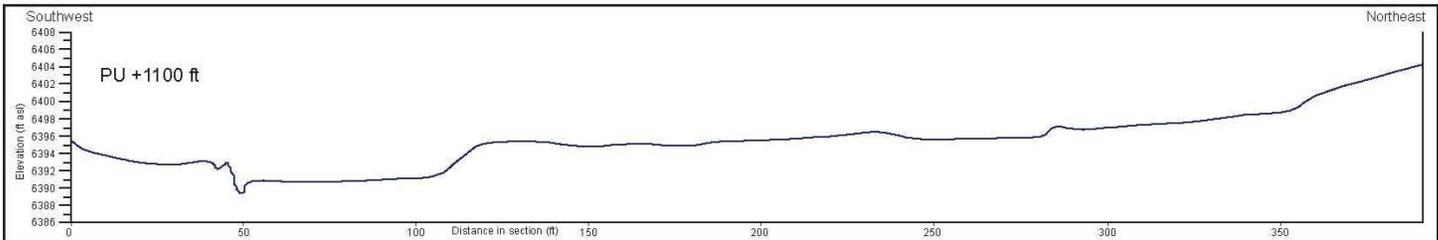
Figure 15 Cross sections in the lower Pueblo Canyon willow-planting area

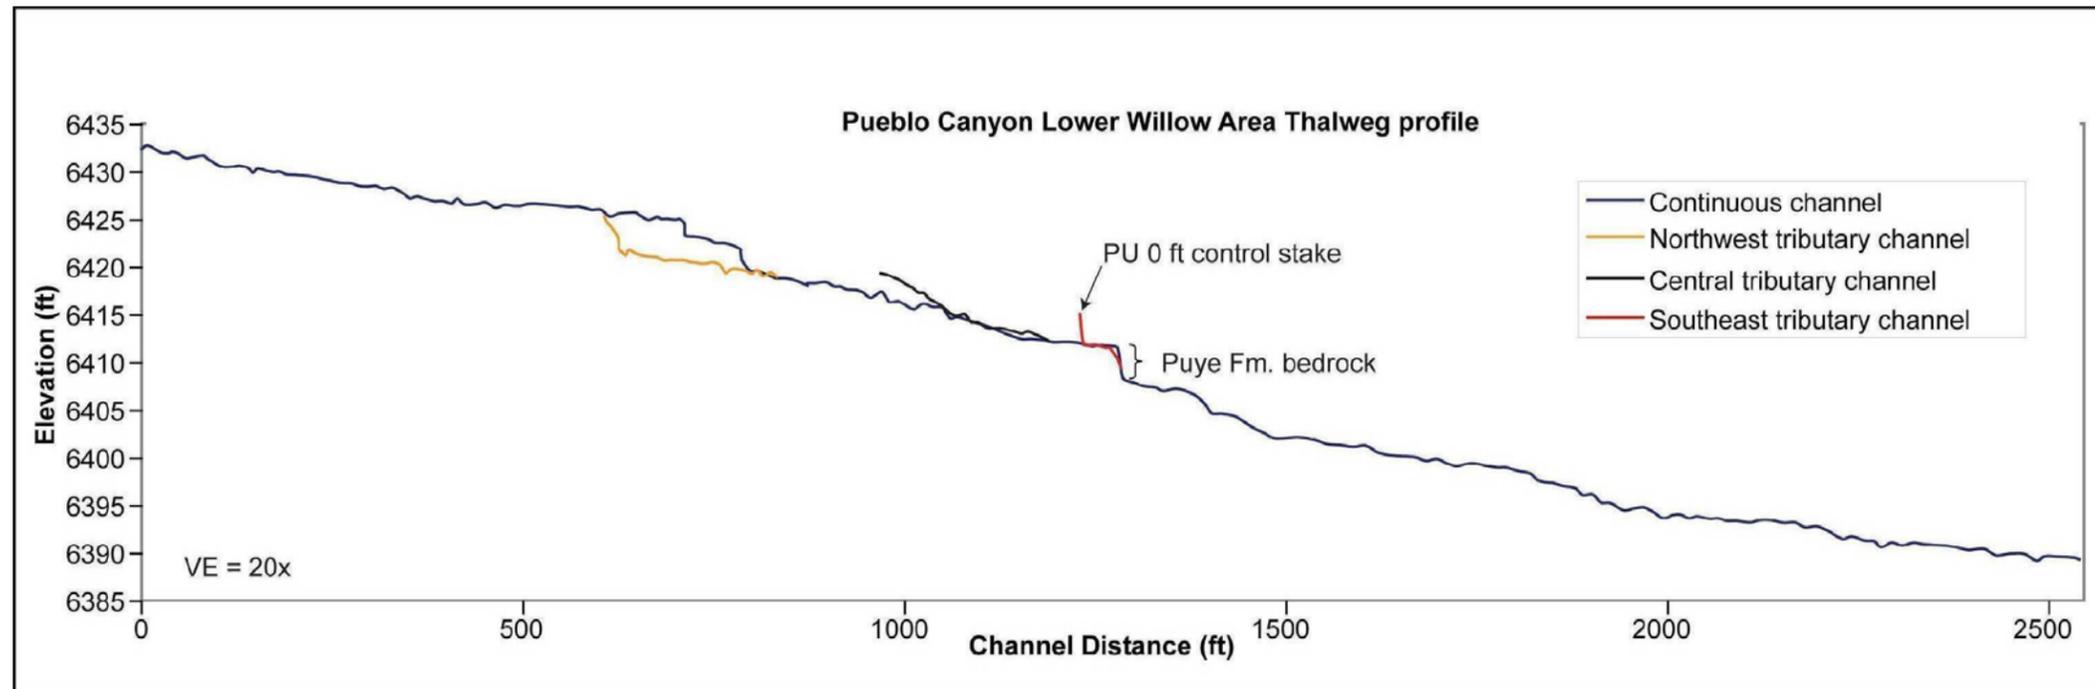
Figure 16 Thalweg profile in the lower Pueblo Canyon willow-planting area
