Subject: Submittal of the Response to the Notice of Disapproval Baseline Geomorphic Conditions at Sediment Transport Mitigation Sites in Los Alamos/Pueblo Canyon Watersheds and Revision 1

LA-UR-11-0936
February 2011
EP2011-0077

Baseline Geomorphic Conditions at Sediment Transport Mitigation Sites in the Los Alamos and Pueblo Canyon Watersheds, Revision 1

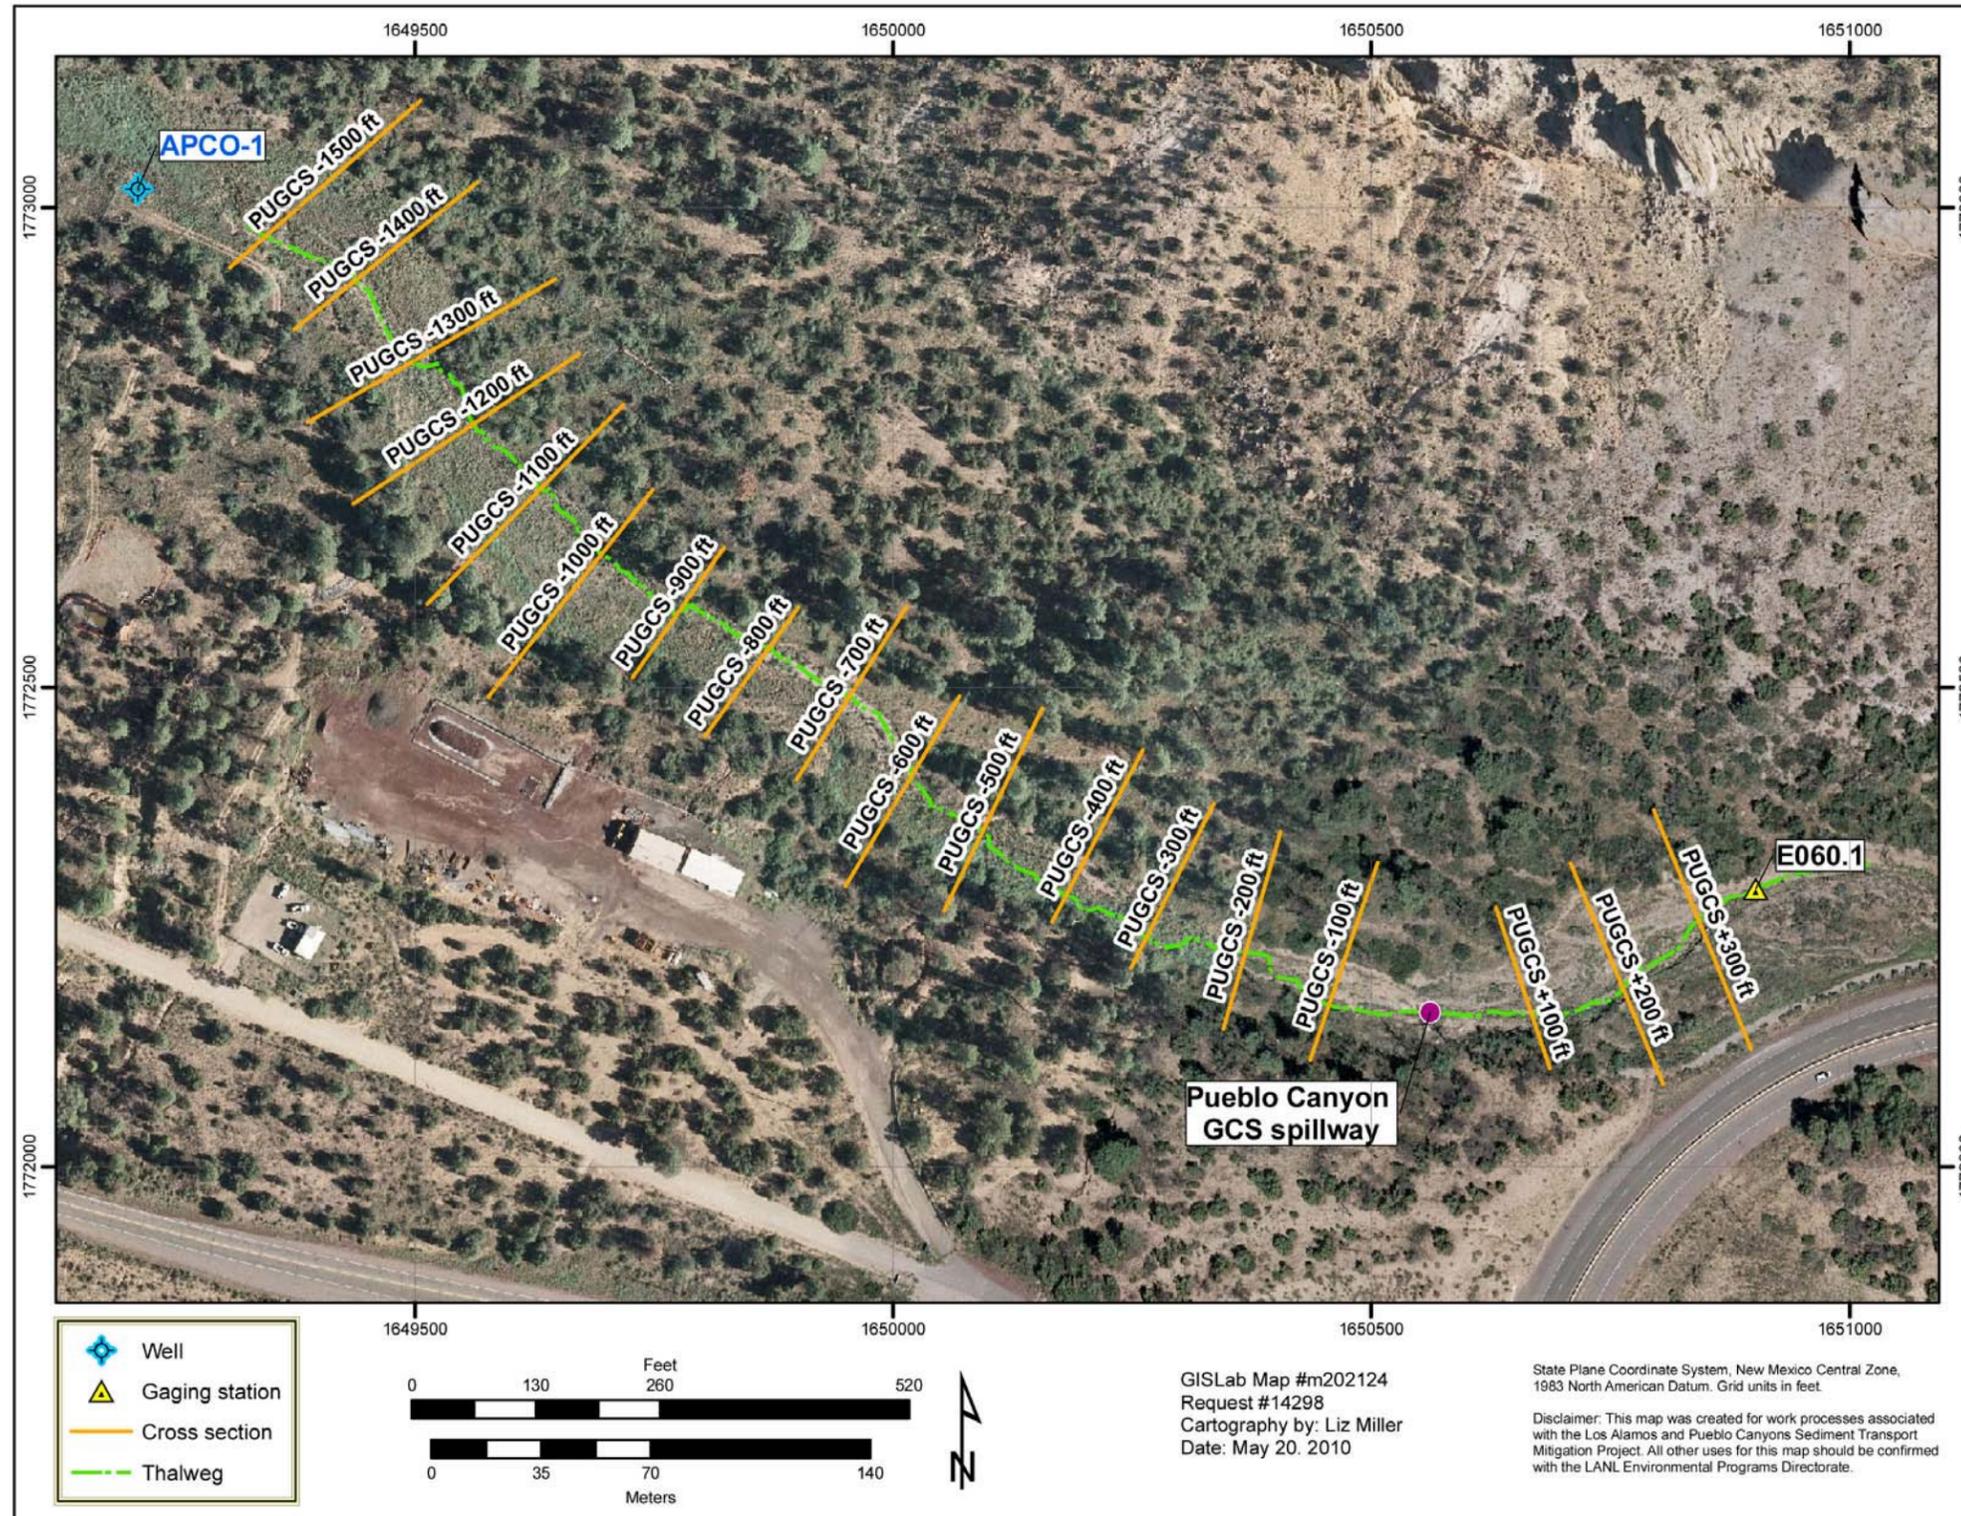
Figure 17 Orthophoto showing the locations of surveyed cross sections and thalweg profiles near the Pueblo Canyon GCS

Pueblo Canyon Grade-Control Structure. A total of 15 cross sections were surveyed in April 2010 at 100-ft intervals upstream of the Pueblo Canyon grade control structure (GCS), and 3 cross sections were surveyed at 100-ft intervals downstream from the GCS. A longitudinal channel thalweg profile was also surveyed over this 1800-ft interval, and was extended downstream past the new E060.1 gaging station. Cross-section and thalweg-profile locations are shown in Figure 17, cross sections are shown in Figure 18, and the channel thalweg profile is shown in Figure 19. The cross sections are labeled with negative numbers above the GCS and with positive numbers below the GCS. Some ground disturbance associated with site restoration has occurred downstream from the GCS after the surveys were completed, and another survey of the area of disturbance is planned before the 2010 monsoon season.

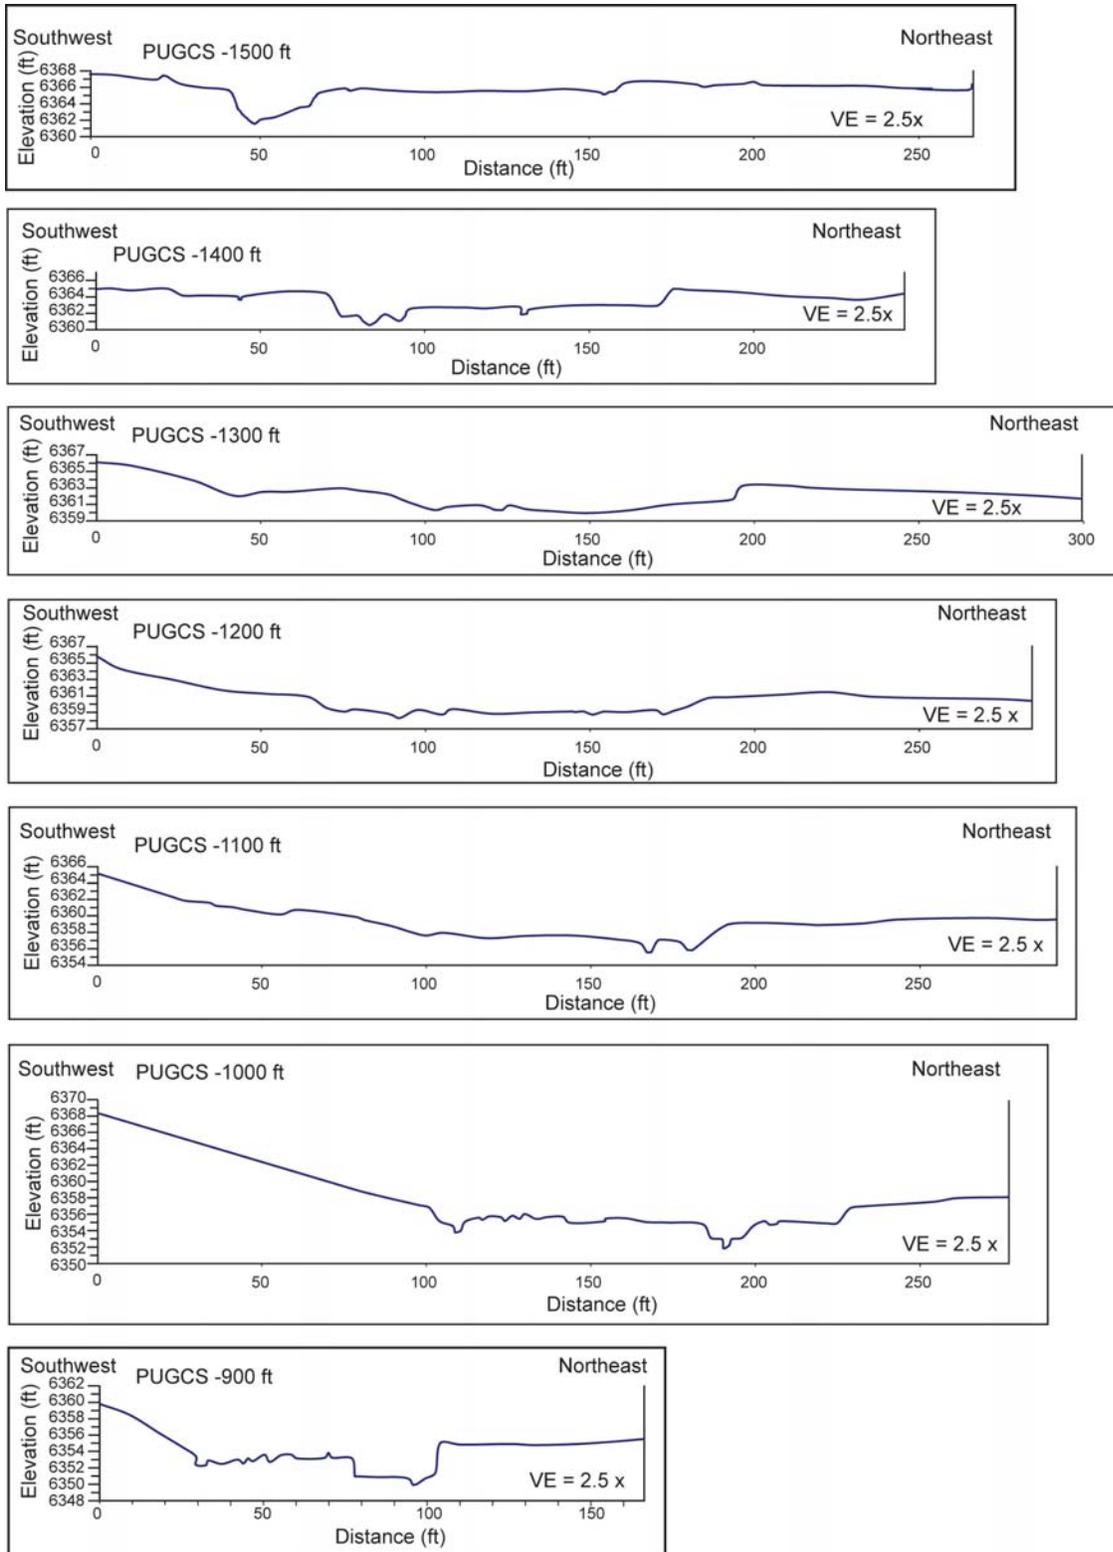
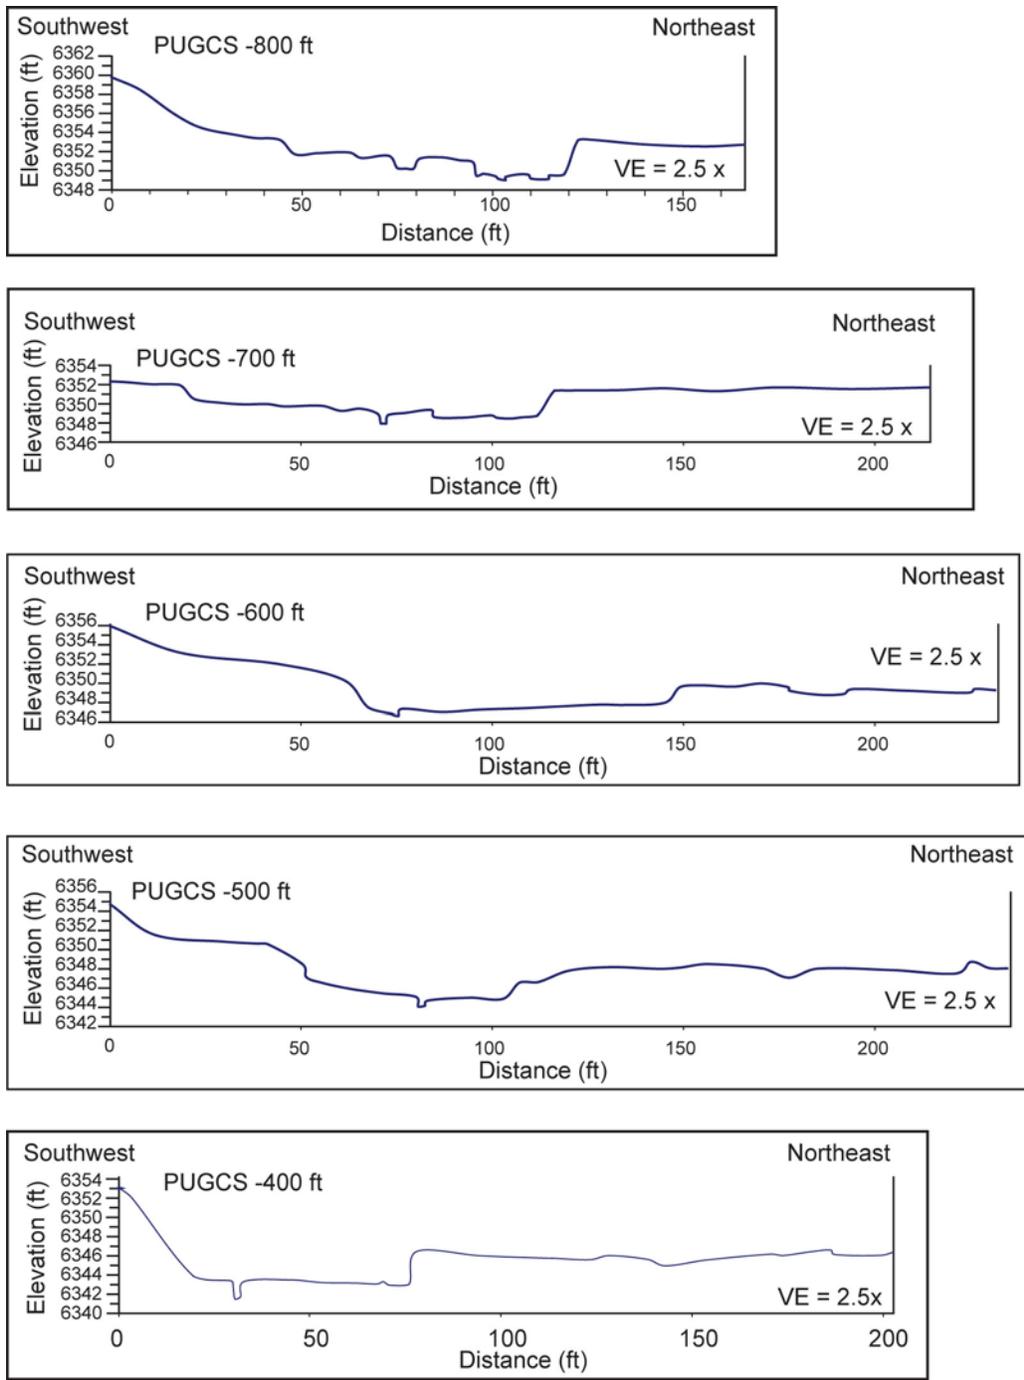
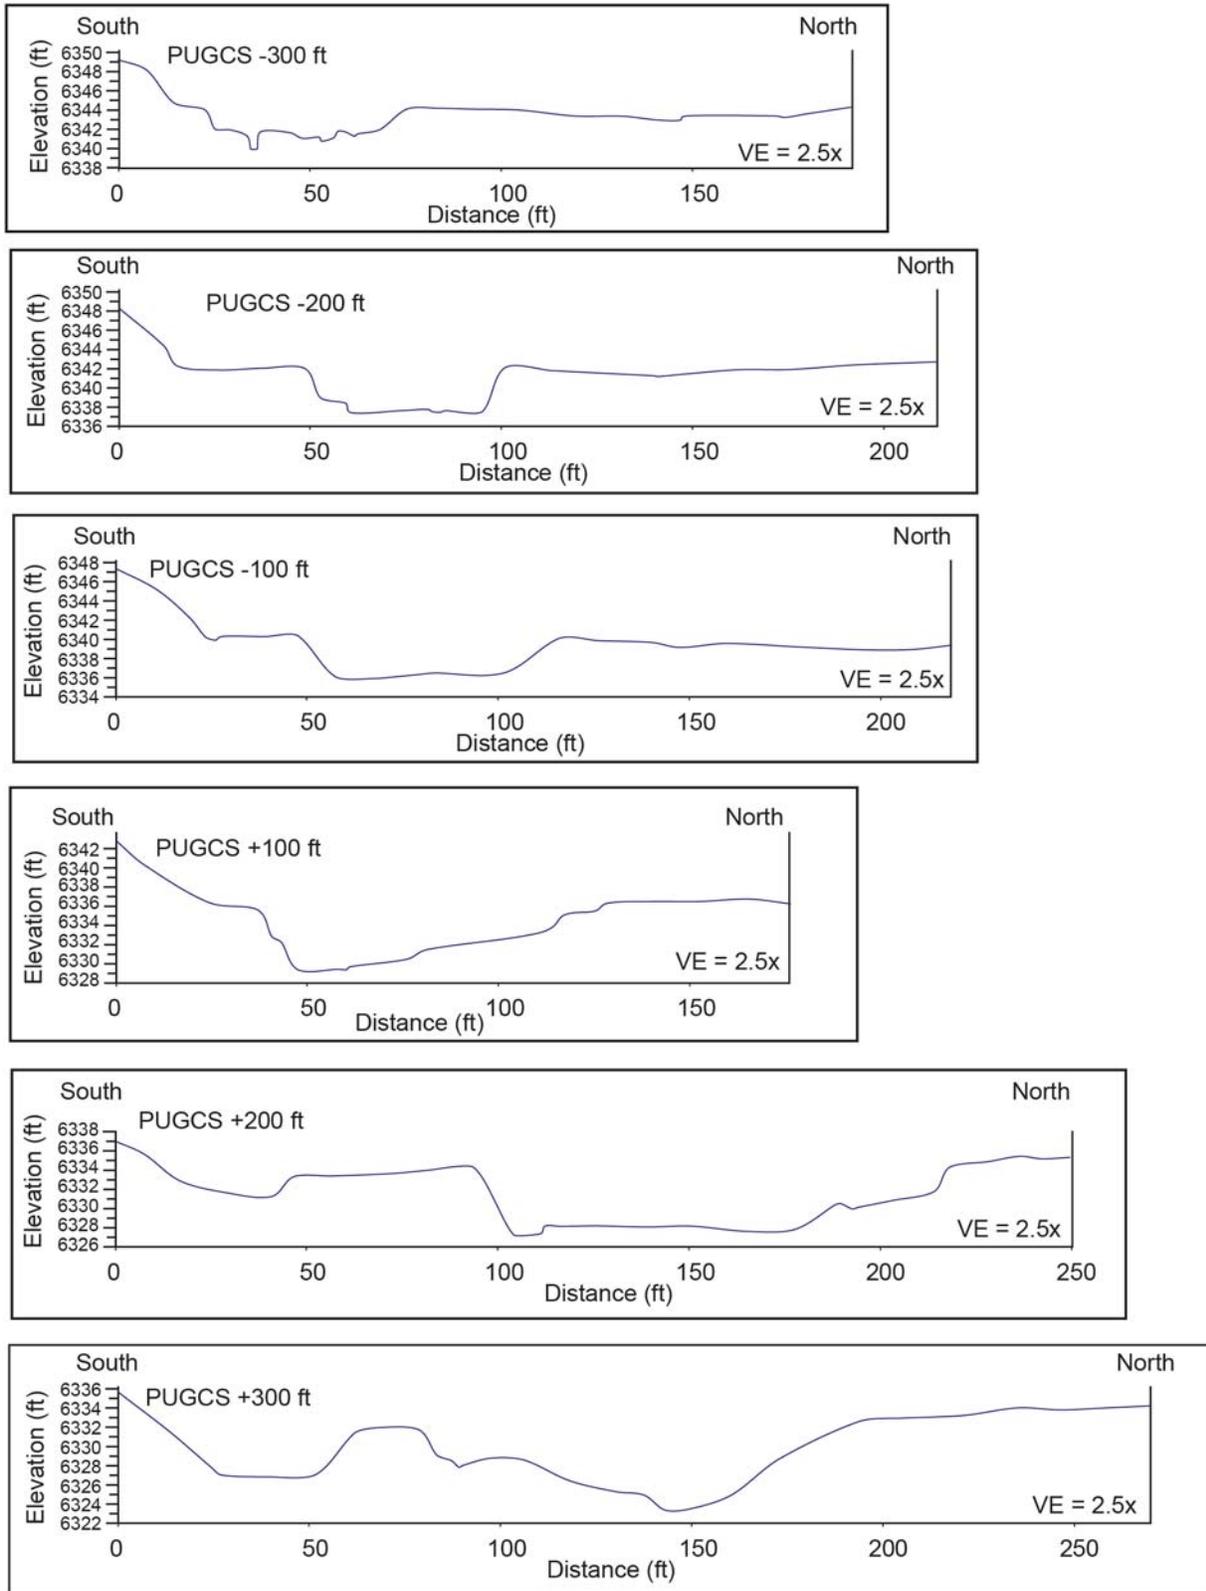
Figure 18 Cross sections near the Pueblo Canyon GCS

1. *Figure 18 (pages 29 - 30), composed of multiple graphs, depicts cross section surveys of Pueblo Canyon near the Pueblo Canyon Grade Control Structure (GCS). According to the Monitoring Plan for Los Alamos and Pueblo Canyons Sediment Transport Mitigation Project, dated October 2009, the Permittees planned to survey a minimum of fifteen cross sections at 100-ft intervals for a distance of 1500 ft up canyon of the planned Pueblo Canyon Grade Control Structure and three cross sections at 100-ft intervals down canyon of the structure. Six cross sections are missing from Figure 18; the three cross sections up canyon and the three cross sections down canyon adjacent to the grade control structure. The missing cross section surveys are identified as -300, -200, -100, + 100, +200 and +300 in Figure 17, page 28. Revise the Baseline Report to include the missing cross sections in Figure 18 or explain why the cross sections were not surveyed.*

1. These cross sections were surveyed in April 2010 and the survey data were included in Attachment 1 of the report, but these cross sections were inadvertently left out of Figure 18 during compositing. The report has been revised to include these cross sections in Figure 18.

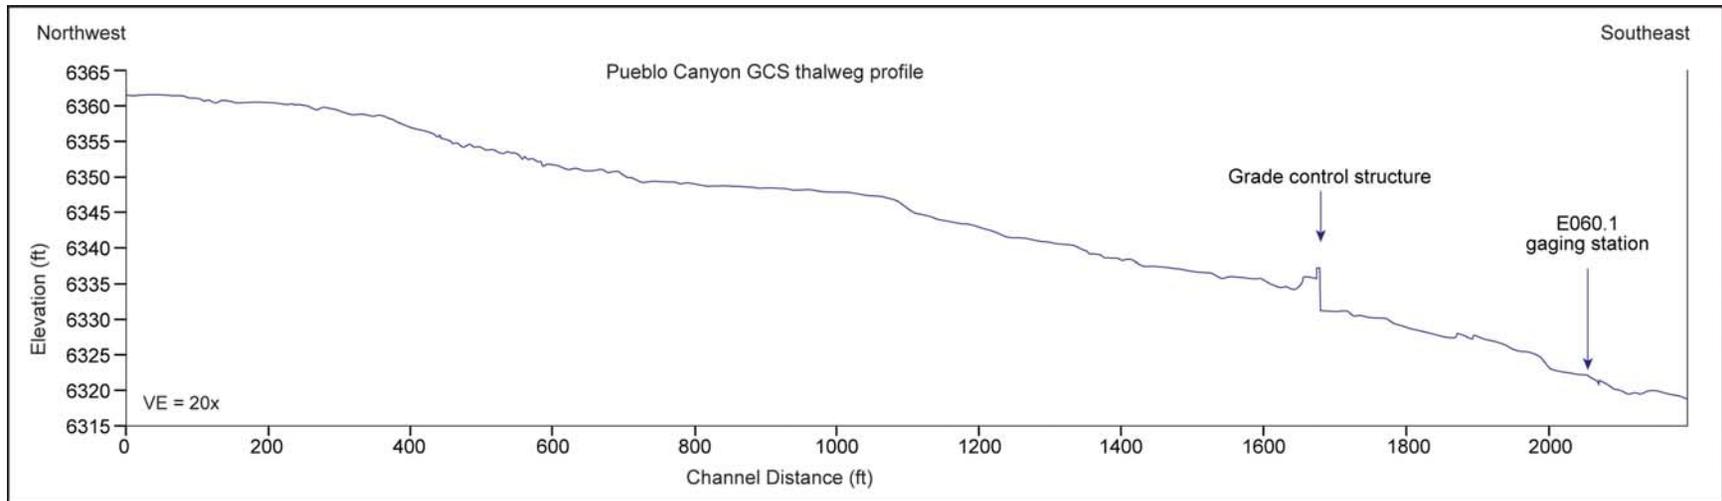
Figure 19 Thalweg profile at the Pueblo Canyon GCS

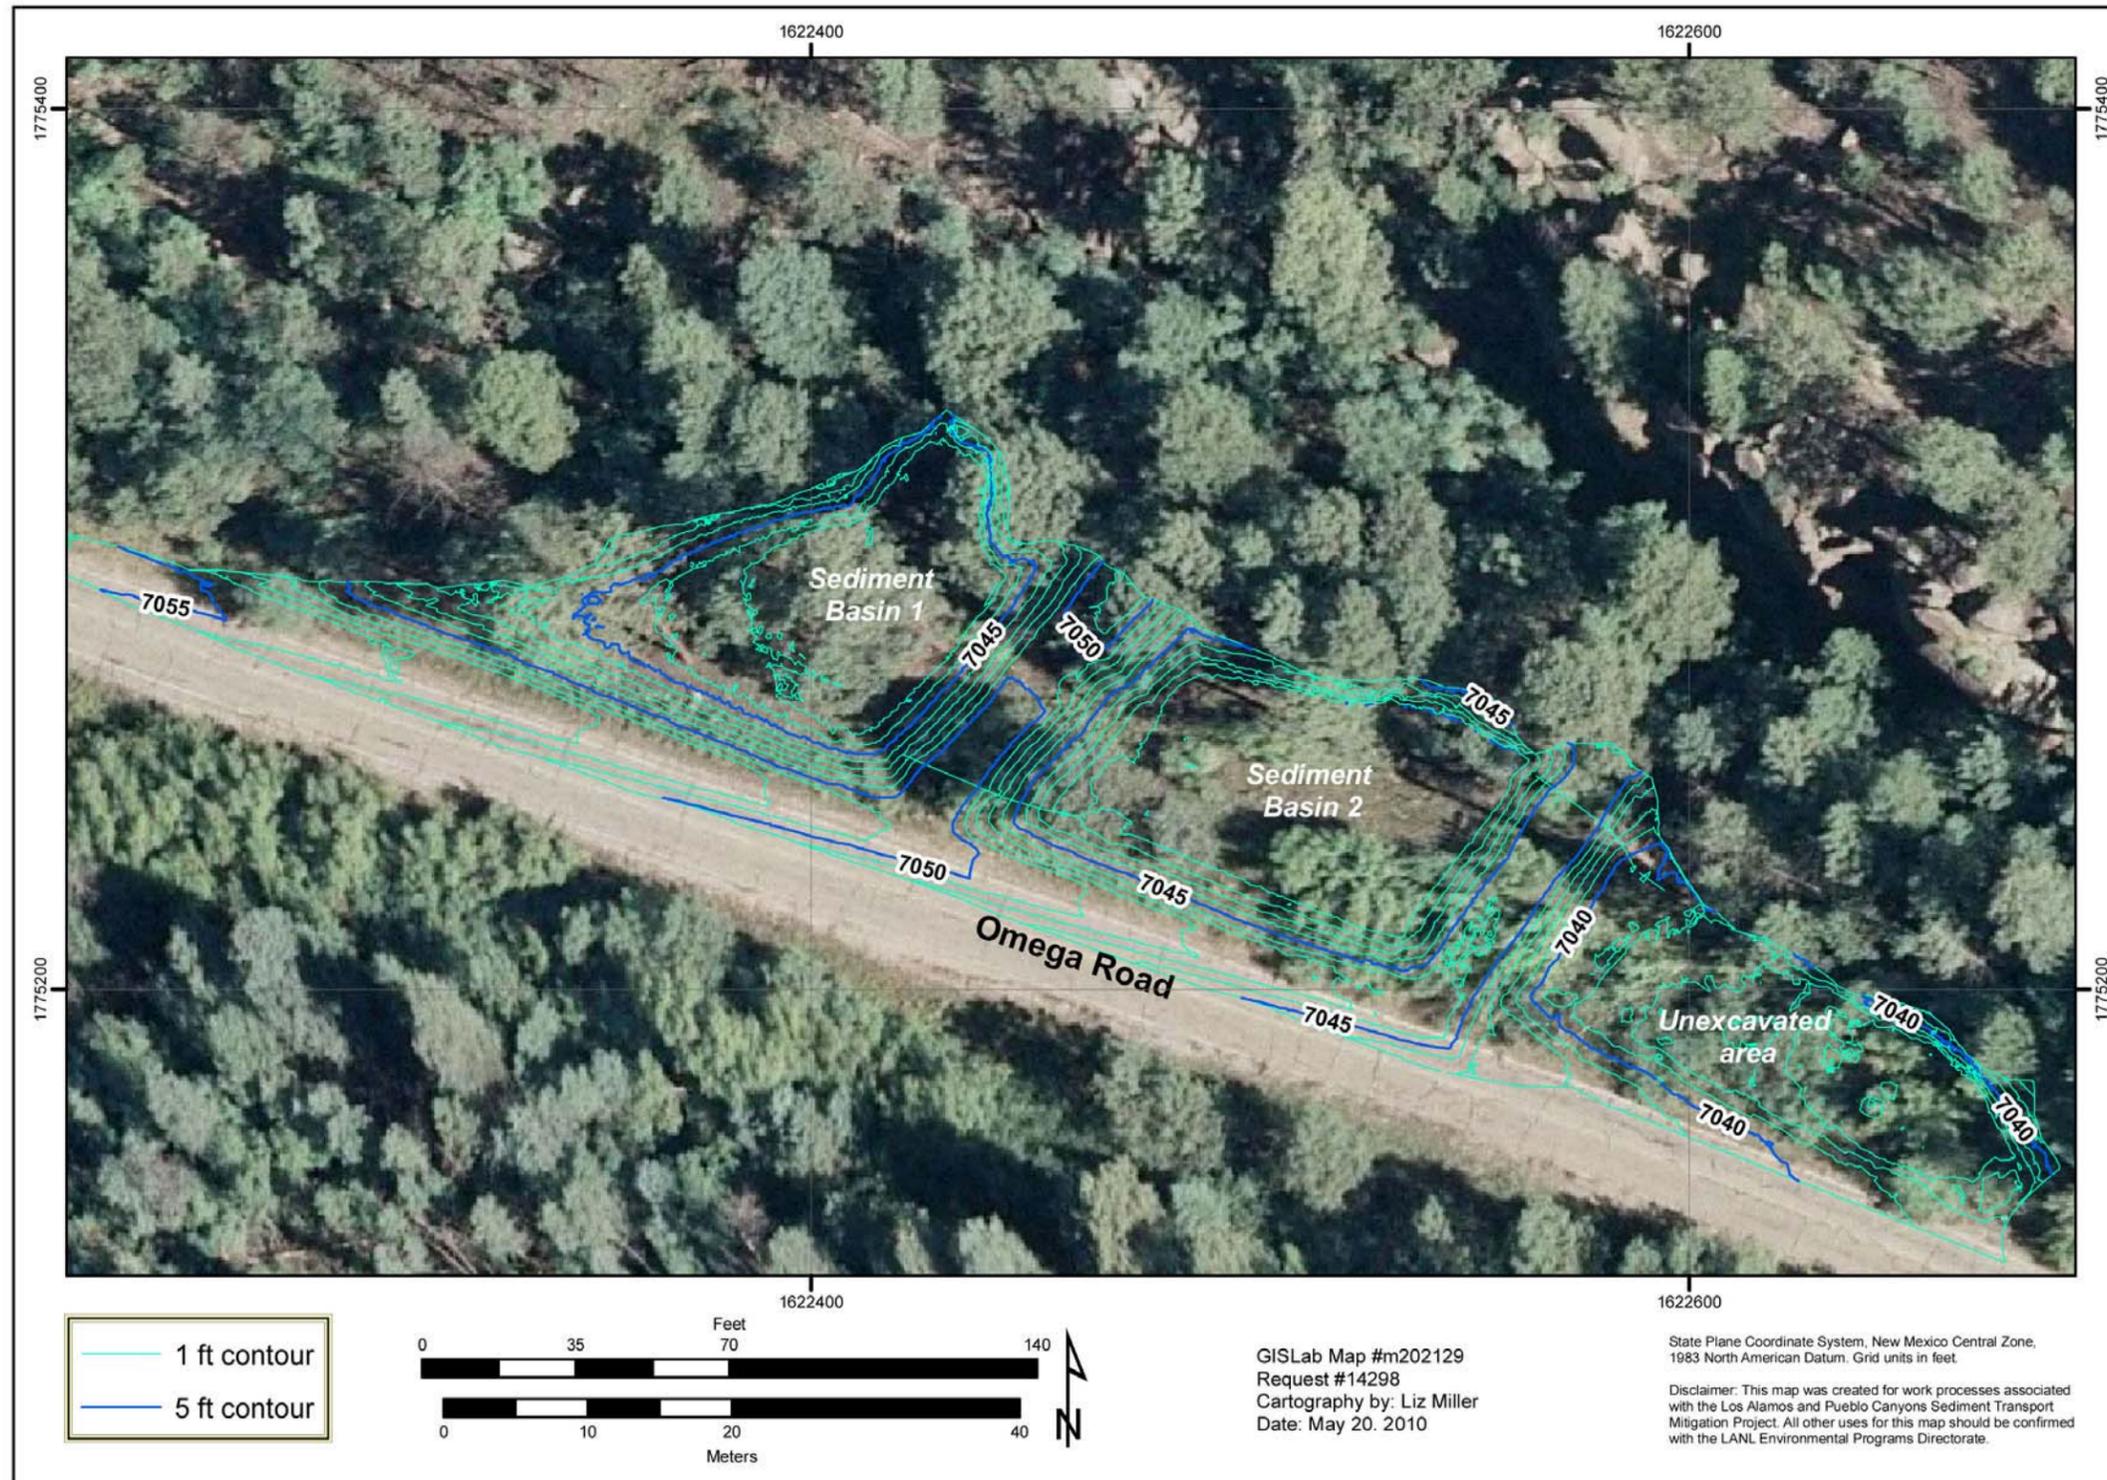
Figure 20 Post-construction topography at the LA-SMA-2 sediment retention basins, overlain on a pre-construction orthophotograph

LA-SMA-2 Sediment Retention Basins. A general topographic survey was conducted that encompassed the area of the LA-SMA-2 sediment retention basins in March 2010. The topography of this area is presented in Figure 20. A general topographic survey will be repeated annually, documenting both the maximum thickness of accumulated sediment and total sediment volume deposited since the previous survey.

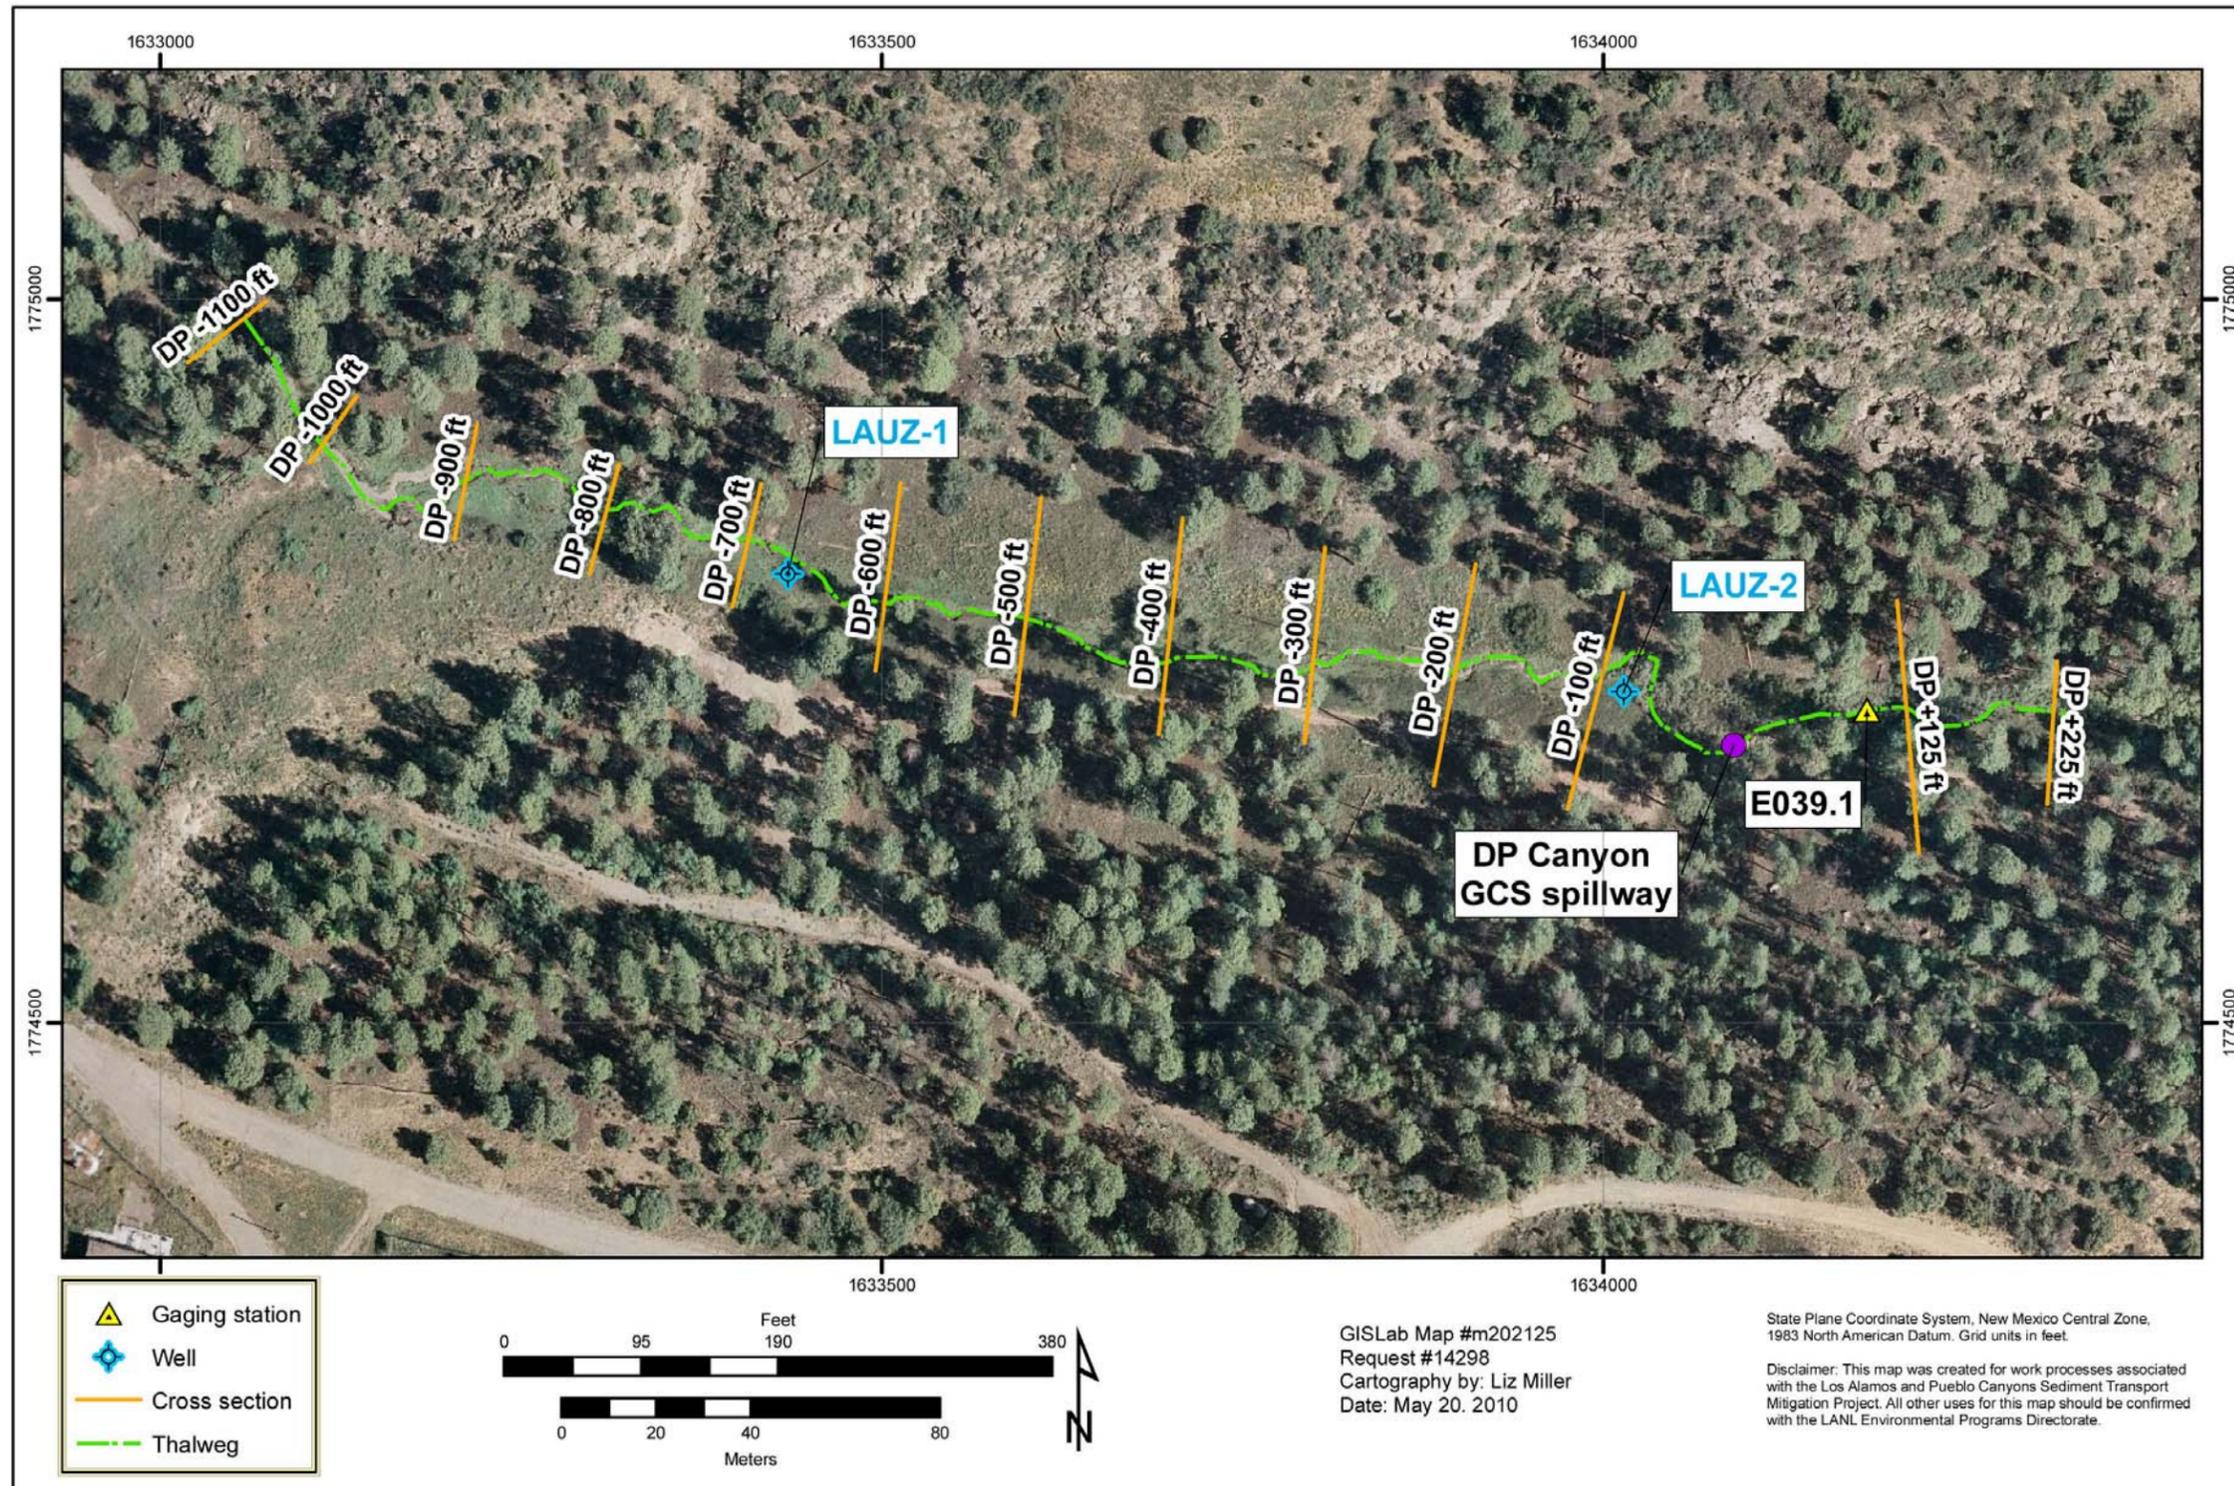
Figure 21 Orthophoto showing the locations of surveyed cross sections and thalweg profiles near the DP Canyon GCS

DP Canyon Grade-Control Structure. A total of 11 cross sections were surveyed in April and May 2010 at 100-ft intervals upstream of the DP Canyon GCS, and 3 cross sections were surveyed at 100-ft intervals downstream from the GCS and downstream from the new E039.1 gaging station. A longitudinal channel thalweg profile was also surveyed over this 1500-ft interval. Cross-section and thalweg-profile locations are shown in Figure 21, cross sections are shown in Figure 22, and the channel thalweg profile is shown in Figure 23. The cross sections are labeled with negative numbers above the GCS and with positive numbers below the GCS.

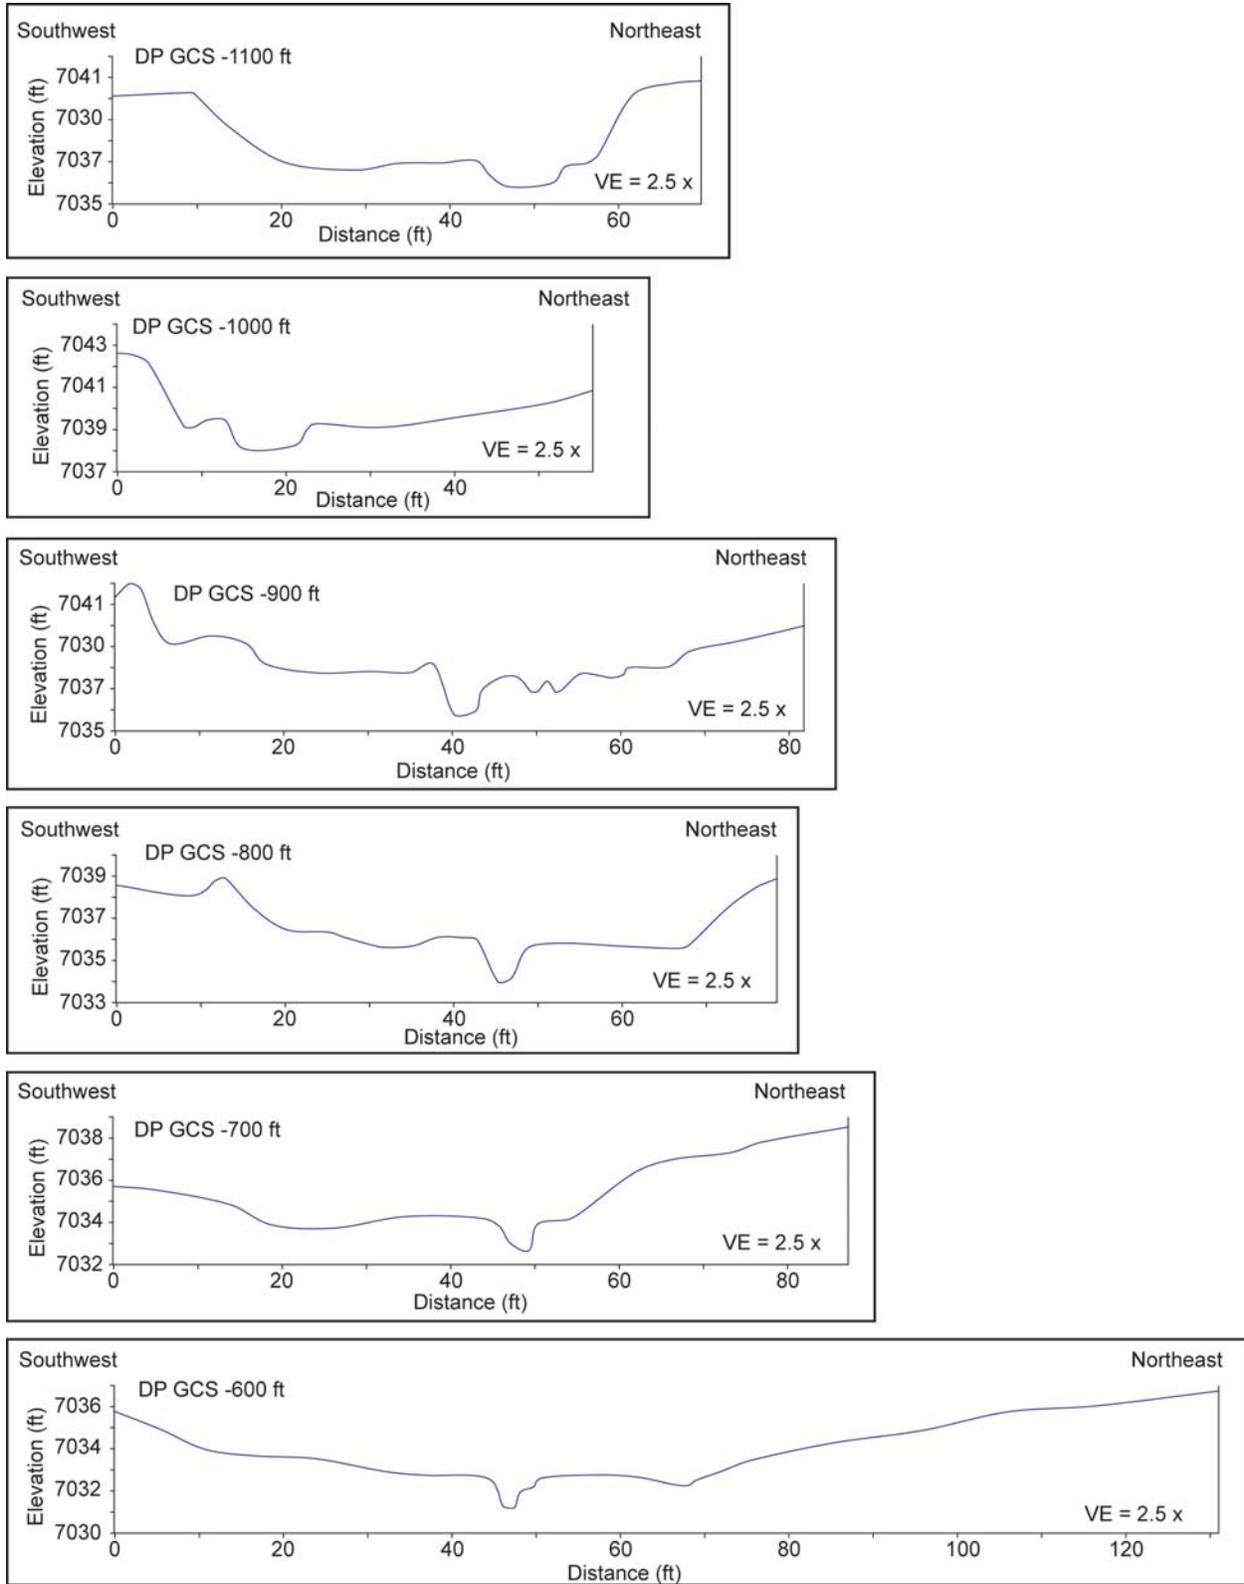
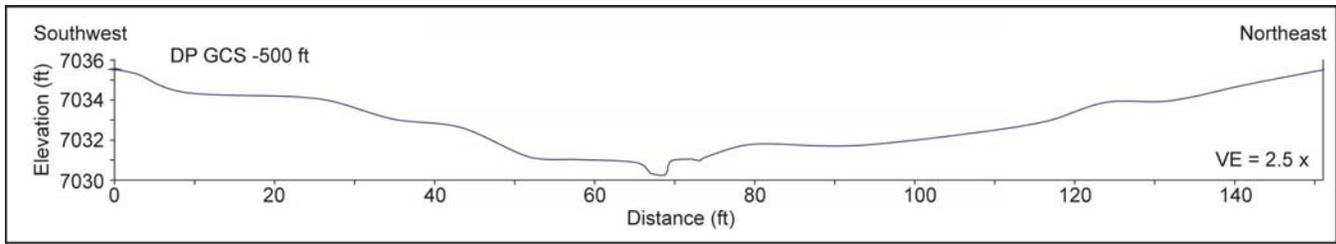
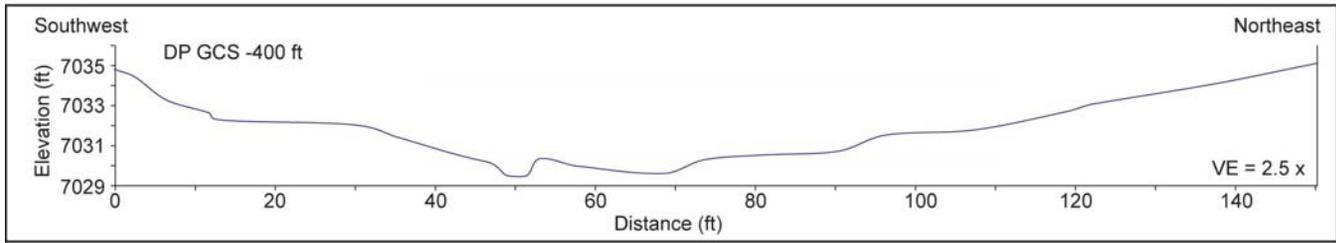
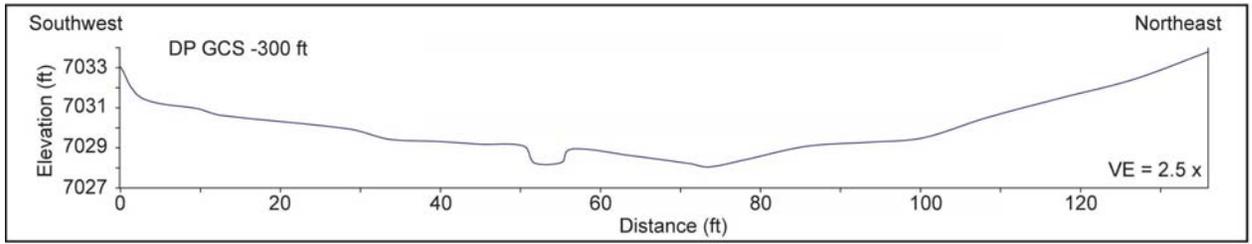
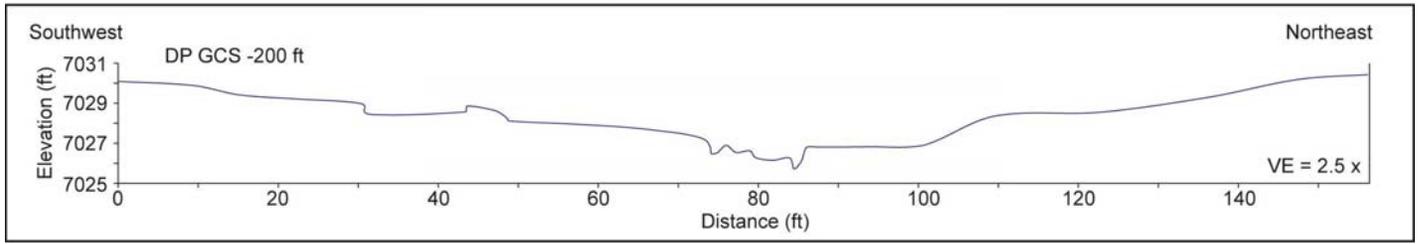
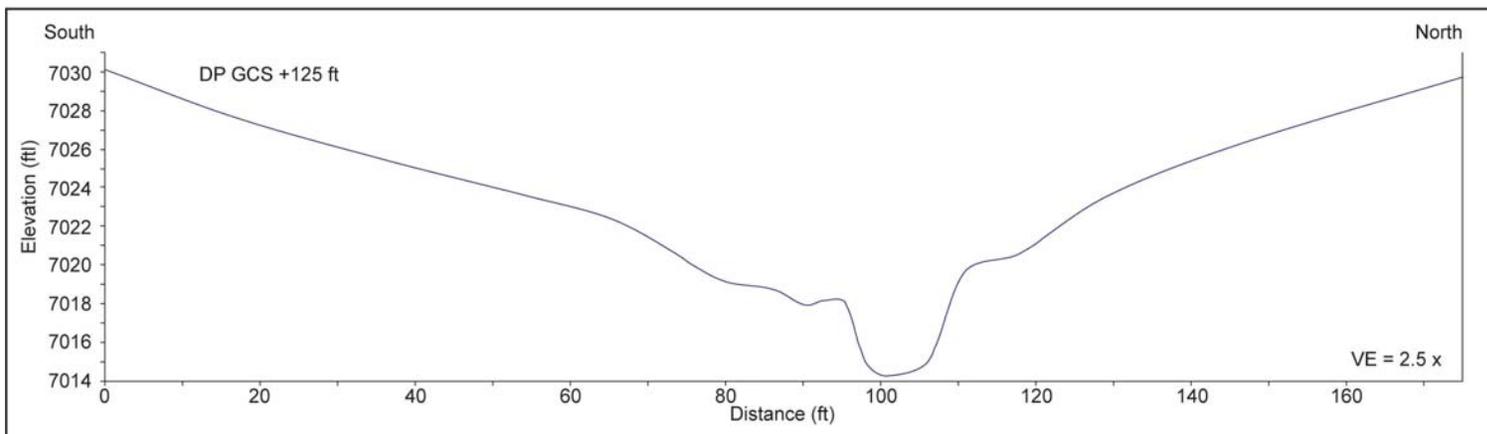
Figure 22 Cross sections near the DP Canyon GCS

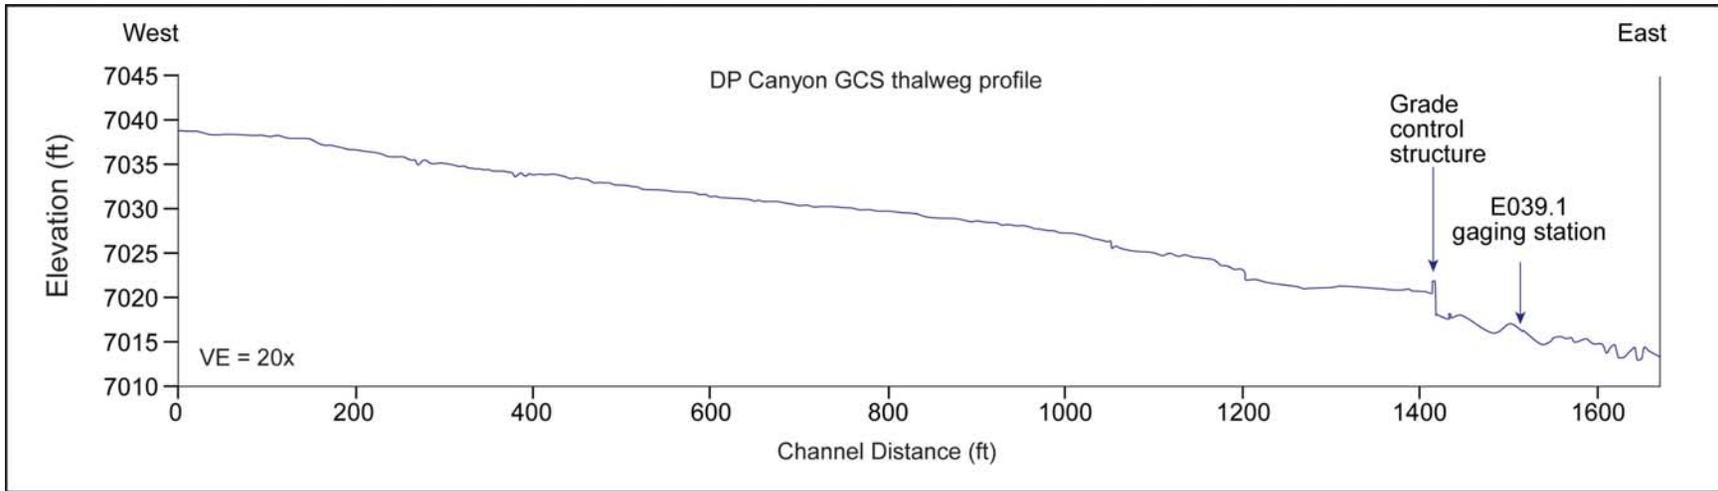
Figure 23 Thalweg profile at the DP Canyon GCS
