Subject: Submittal of the Response to the Notice of Disapproval Baseline Geomorphic Conditions at Sediment Transport Mitigation Sites in Los Alamos/Pueblo Canyon Watersheds and Revision 1

LA-UR-11-0936
February 2011
EP2011-0077

Baseline Geomorphic Conditions at Sediment Transport Mitigation Sites in the Los Alamos and Pueblo Canyon Watersheds, Revision 1

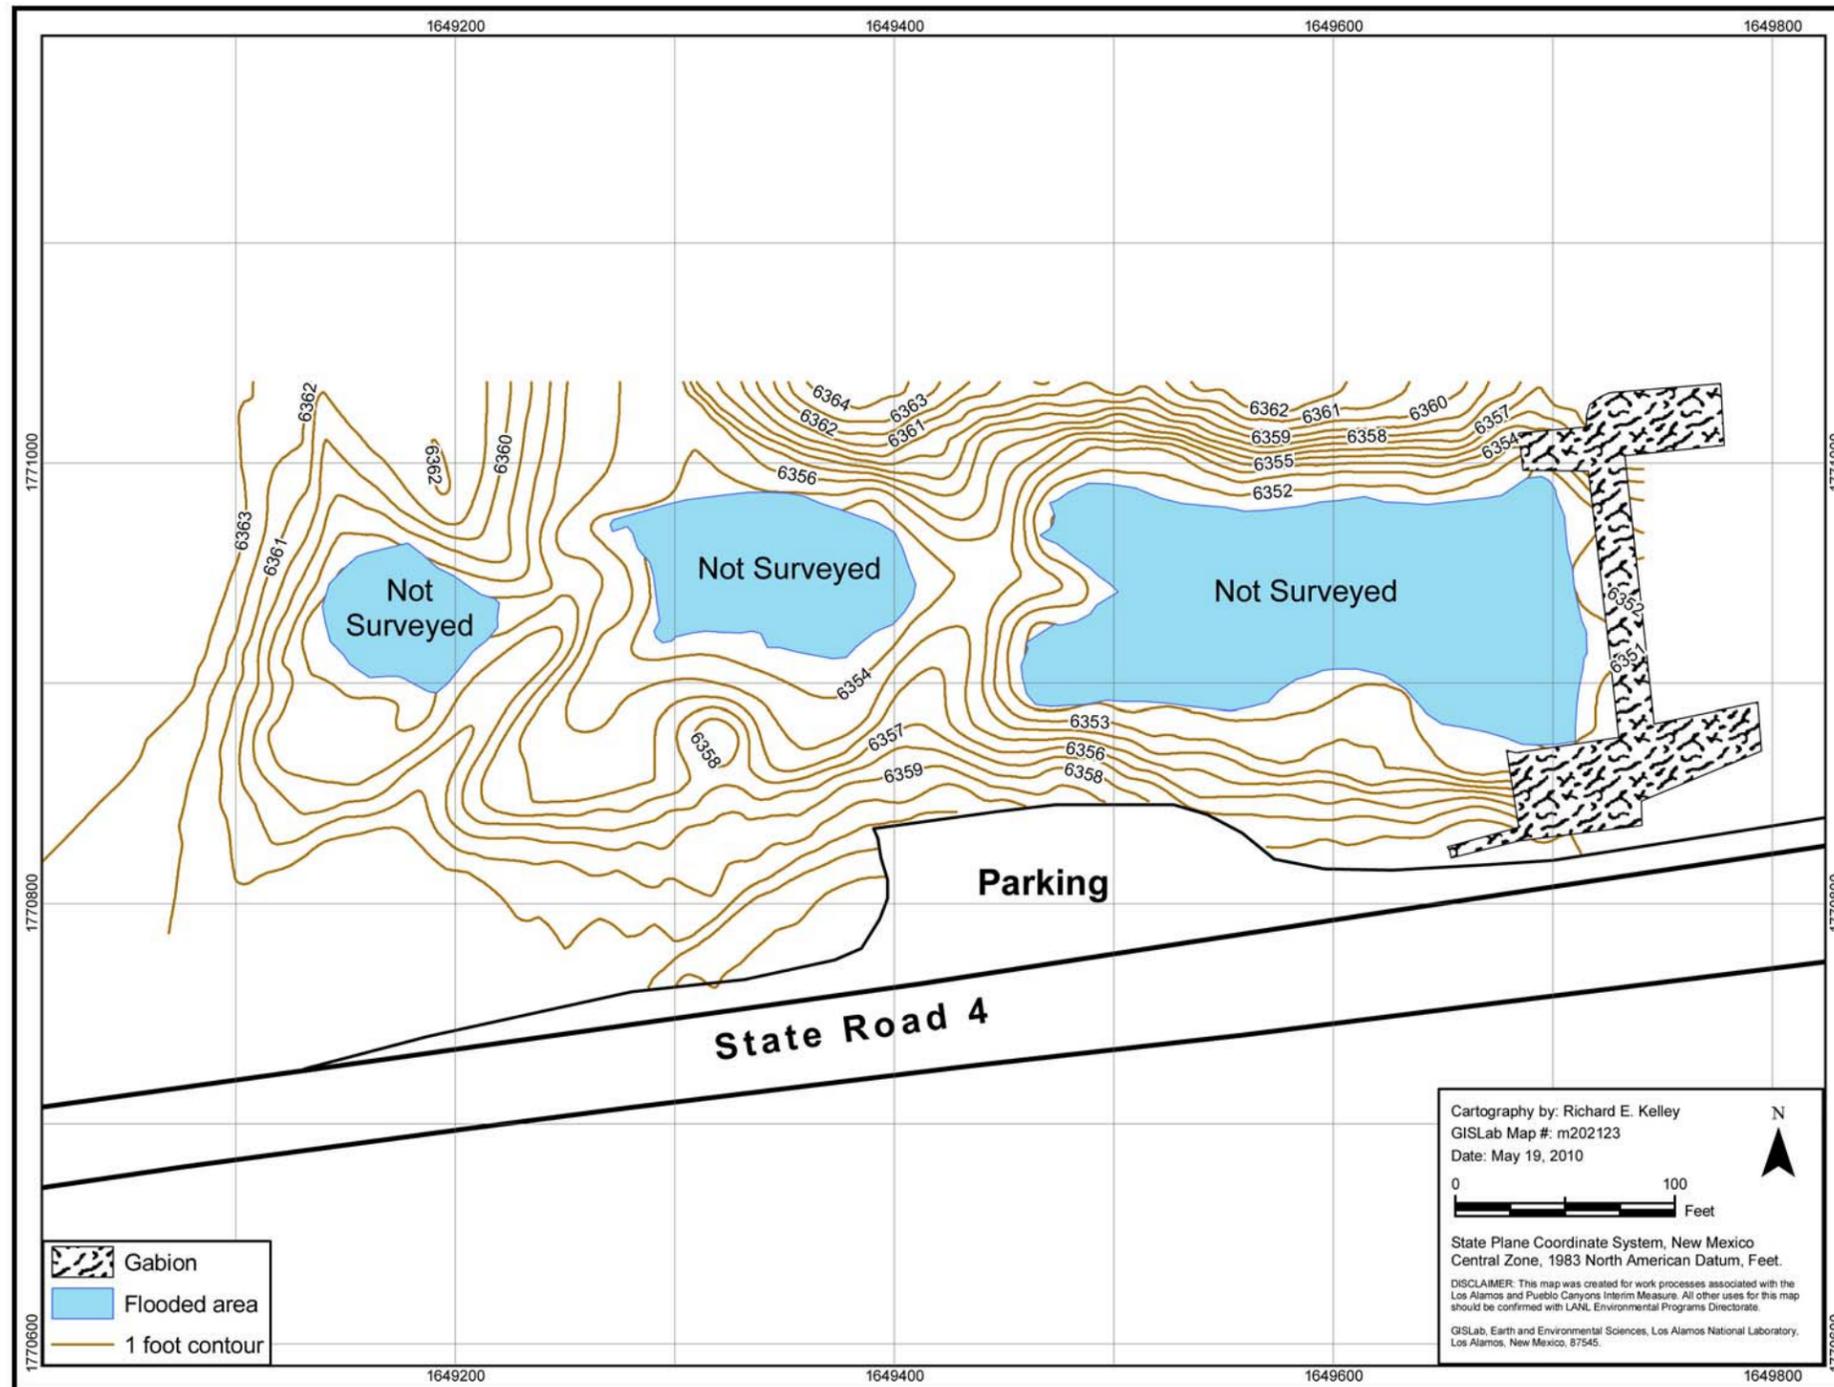
Figure 24 Post-construction topographic map of sediment retention basins above the Los Alamos Canyon low-head weir

Los Alamos Canyon Low-Head Weir. A general topographic survey was conducted that encompassed the sediment retention basins above the Los Alamos Canyon low-head weir in July 2009. The topography of this area is presented in Figure 24. Because water had ponded in the basins prior to the survey, and has remained in the basins continuously since that time, it has not been possible to survey the deepest parts of the basins. The Laboratory plans to drain these basins after cessation of 2010 snowmelt runoff to allow surveying of the deepest parts of the basins. This survey will be presented in the May 30, 2011 report. A general topographic survey will be repeated annually, documenting both the maximum thickness of accumulated sediment and total sediment volume deposited since the previous survey.
