# NFA Report for Potential Release Sites

0-034(a)  
0-034(b)  
73-001(b)  
73-004(c)  
73-004(d)

Field Unit 1

LA-UR-97-3864

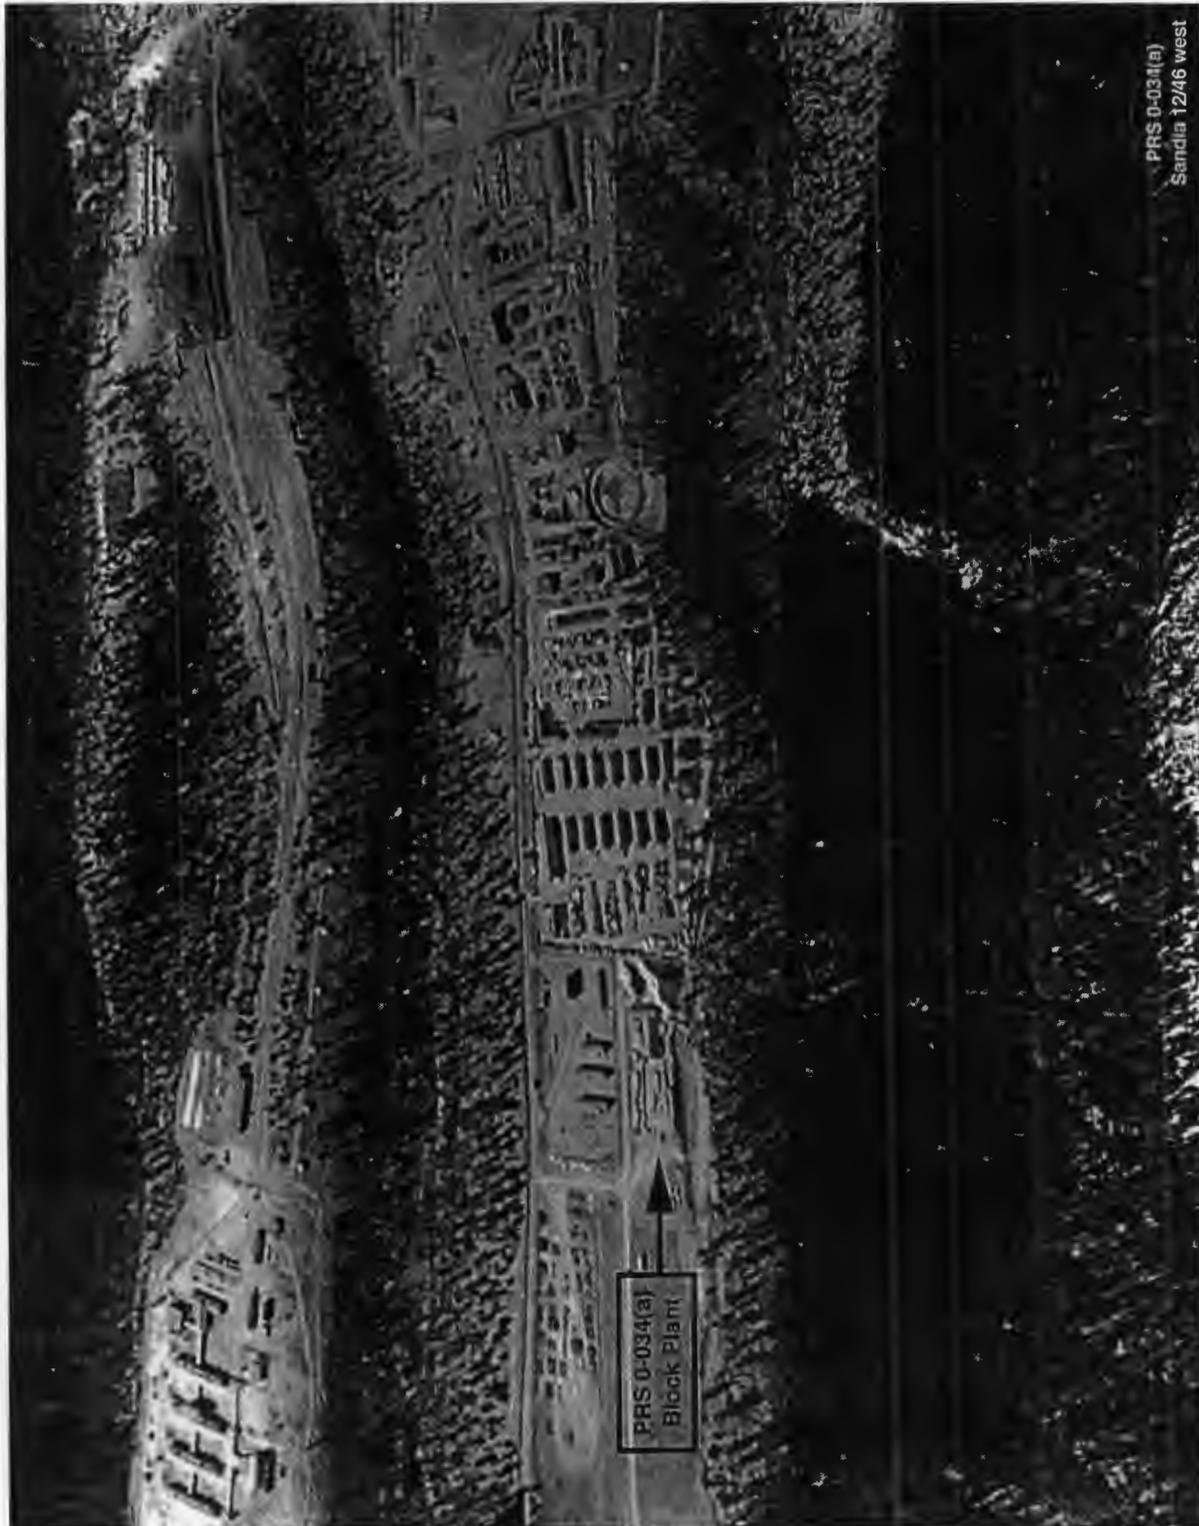
Fig. 1.1-1 Aerial photograph from December 1946 of PRS 0-034(a).

PRS 0-034(a) was identified from 1946 aerial photographs taken in December when the low angle of the sun exaggerates topographic relief (Fig. 1.1-1). In one photograph (Fig. 1.1-2) there appears to be a trench at the PRS location that resembles a trench image further east where the municipal landfill was later placed. The trench image to the east is part of the asphalt batch plant operation, and not a landfill trench. The trench-like image at the location of

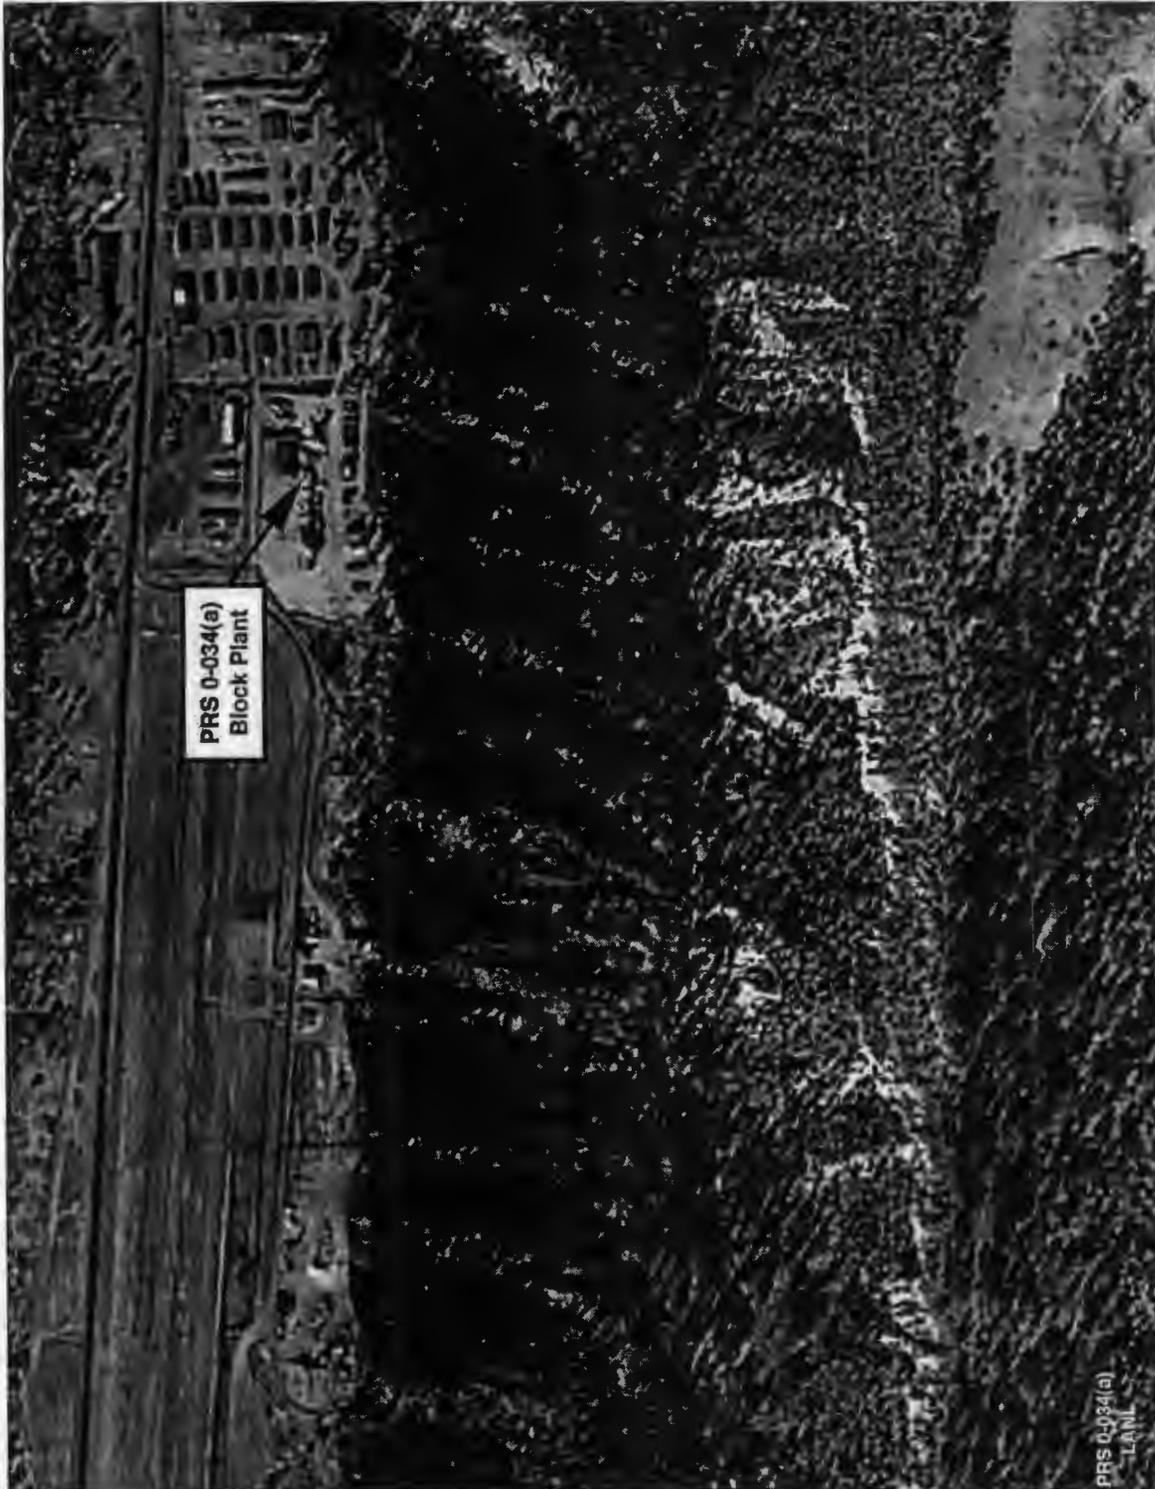
Fig. 1.1-4 Aerial photograph from 1961 showing warehouse structures at the former location of the concrete plant operations at PRS 0-034(a).

In 1946, PRS 0-034(a) was the location of a concrete block manufacturing plant and a small-scale concrete batching plant. Concrete block manufacturing includes mixing aggregate, cement, and water, and then filling molds and curing the blocks. The concrete batching plant used a one-half to three-quarter yard capacity concrete mixer, and the mix was dumped into small dump trucks for hauling to construction sites. An aerial photograph taken in October 1961 shows that the PRS 0-034(a) site, which was used to generate construction materials, was replaced by a warehouse yard (Fig. 1.1-4). Concrete plant operations were moved to East Jemez Road around 1951.

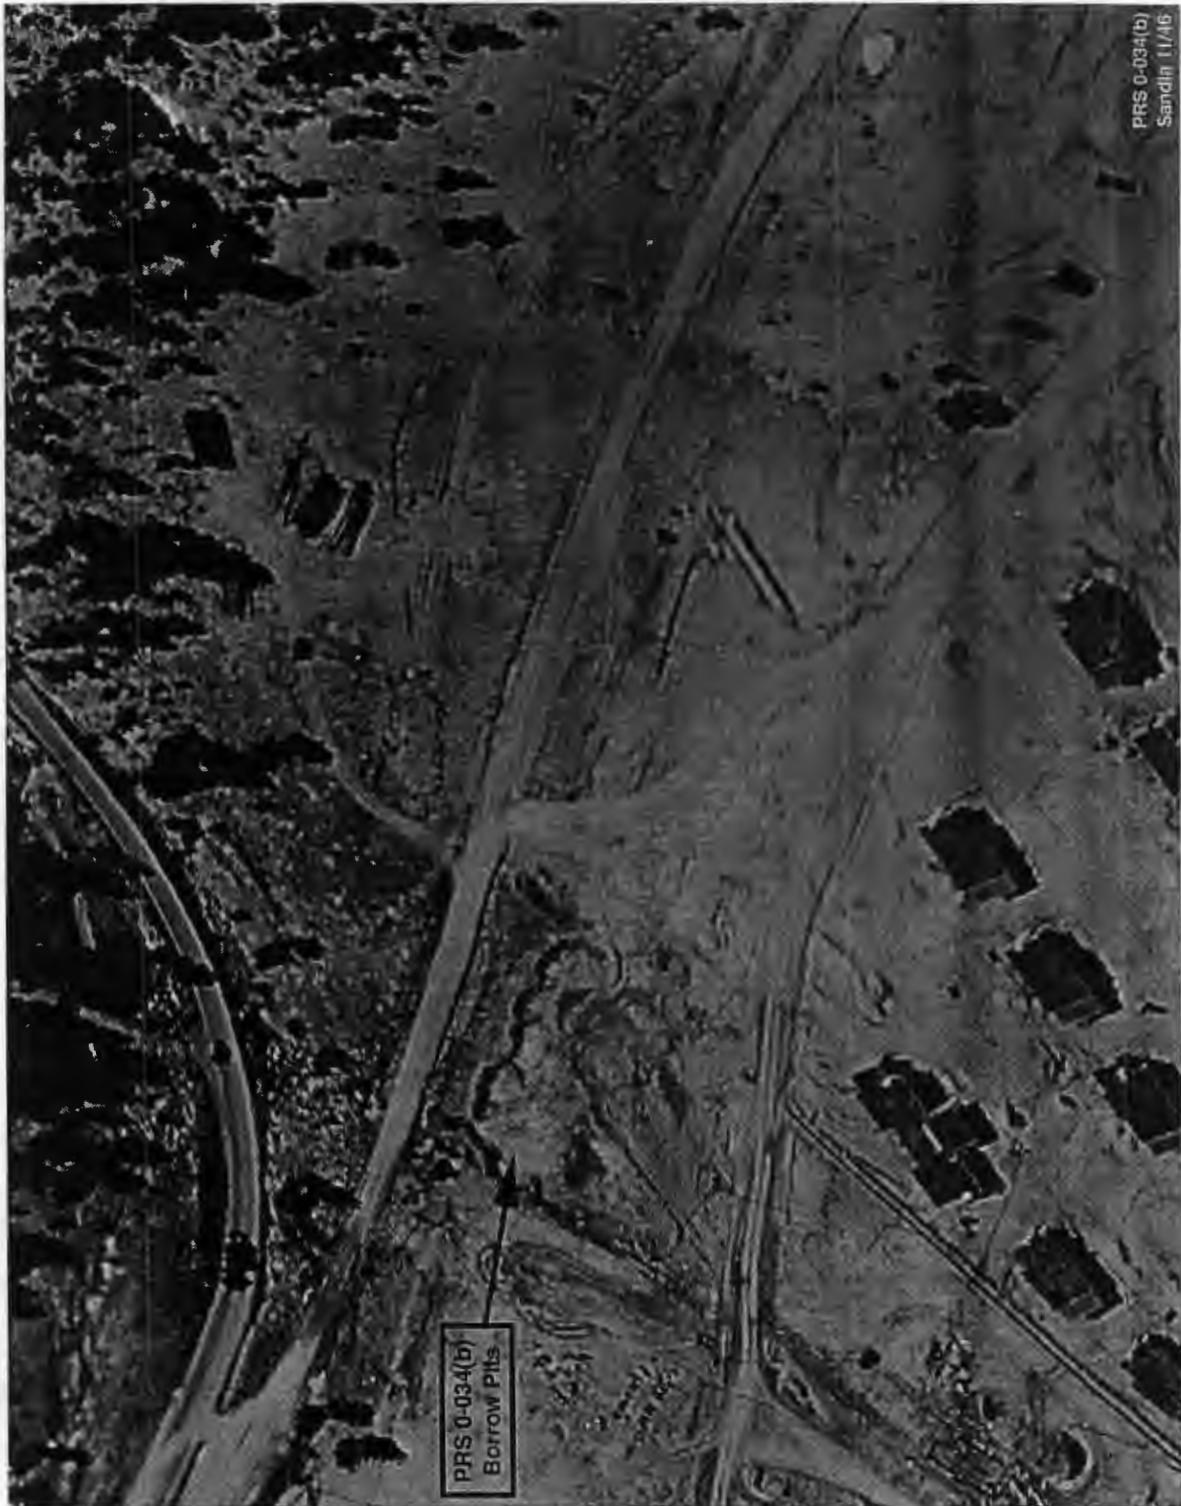
Fig. 2.1-1-1 Aerial photograph from November 1946 of PRS 0-034(b).

PRS 0-034(b) was identified from a 1946 aerial photograph taken in November when the low angle of the sun exaggerates topographic relief (Fig. 2.1-1). Although the pit image in this photograph resembles a shallow borrow pit, the site was also apparently used for temporary storage of spoils piles used as the sources of fill material during construction of the Western Housing Area in Los Alamos. Photographs from this time period show that all of the vegetation was removed from the Western Housing Area before housing was constructed, and that cutting and filling to obtain the needed topographic contours would have been extensive (Fig. 2.1-2).

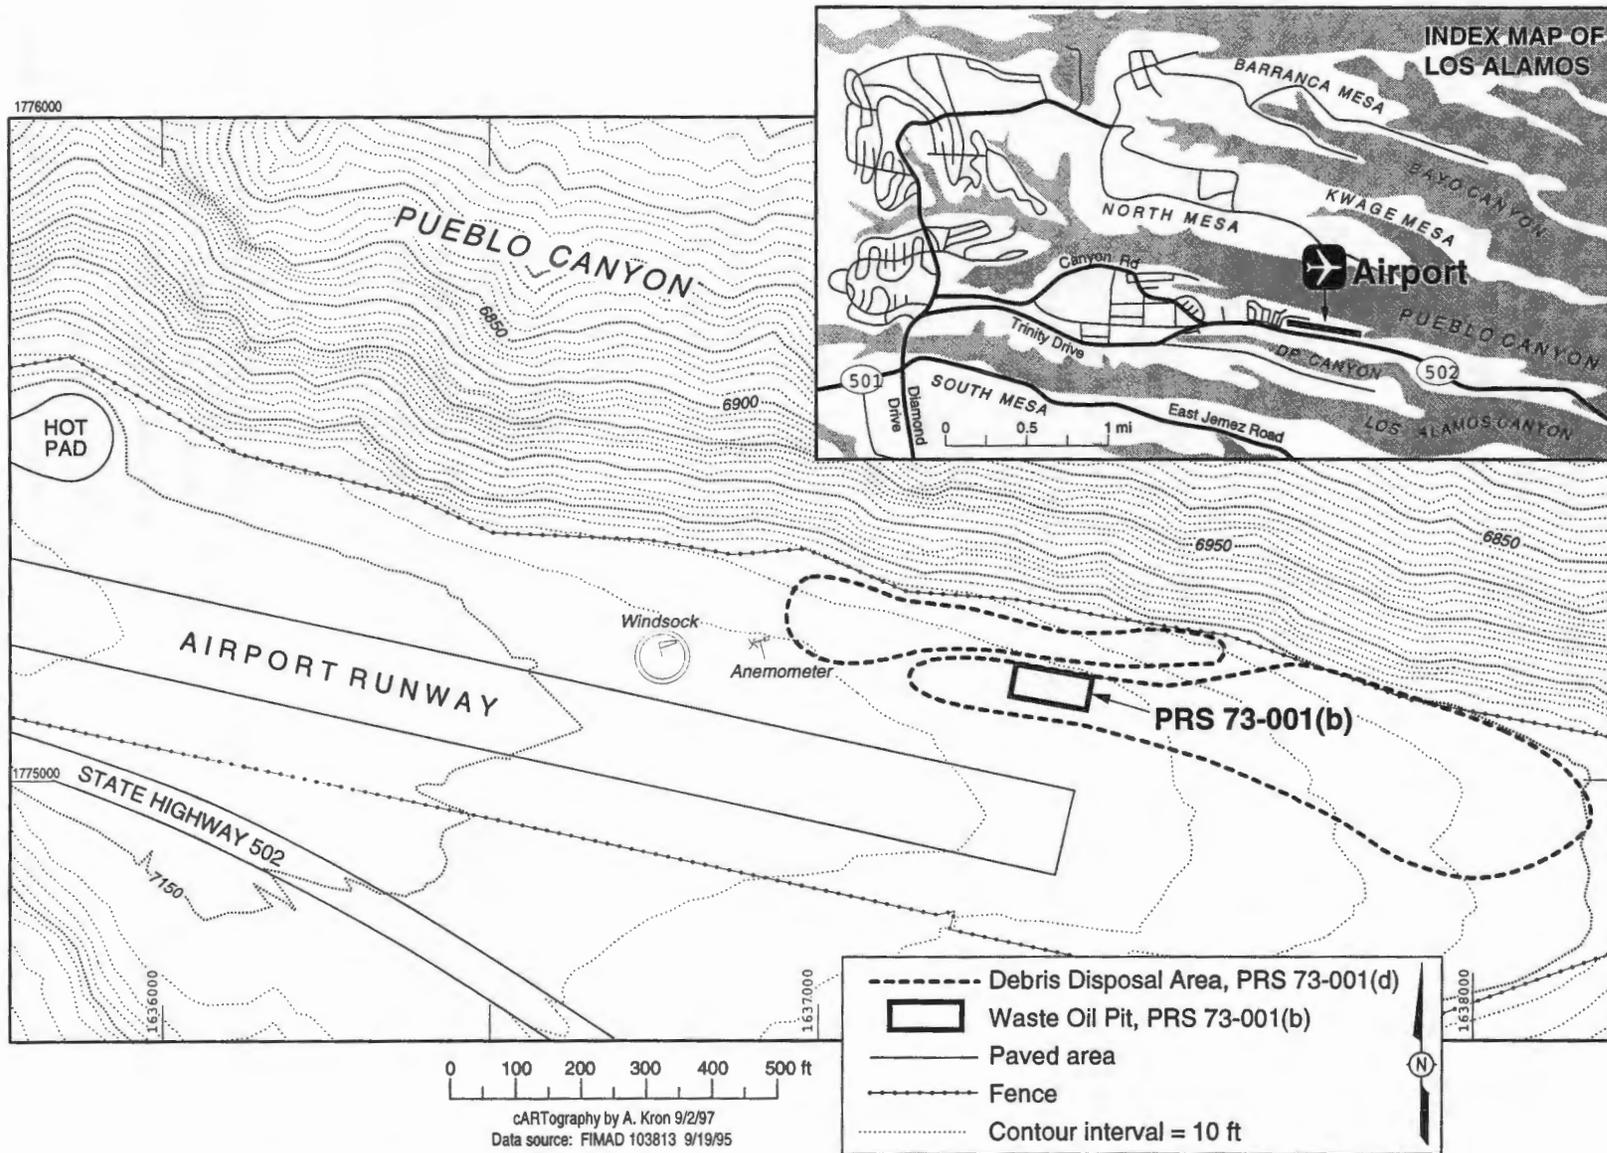
Fig. 3.1-1 Location of PRS 73-001(b), waste oil pit.

PRS 73-001(b) was a pit used for disposal of waste oil. This pit was located just west of the bunker area (PRS 73-001[c]) and northeast of the end of the airport runway (Fig. 3.1-1). The pit is estimated to have been approximately 100 ft long by 25 ft wide with an unknown depth (Limbaugh Engineering & Aerial Services, Inc. 1963, 05-0068). Based on reviews of historic photographs and engineering drawings, the center of the pit is estimated to have been located near the center of the south trench in the debris disposal area (PRS 73-001[d]). A 1947 engineering construction drawing (Black & Veatch Consulting Engineers 1947, 05-0010) shows the dimensions of the pit as 100 ft by 15 ft, and the pit is labeled "Sludge Drying Pit." Presently, there is no visible indication of the waste oil pit at the estimated location.

Based on reviews of historic photographs and engineering drawings, the center of PRS 73-001(b) is estimated to have been located near the center of the south trench in the debris disposal area (PRS 73-001[d]). Although there is no anecdotal or photographic evidence that the waste oil pit (which was backfilled years before the south trench was excavated) was encountered when excavating the trench, it is likely that the pit was destroyed by the trench excavation.

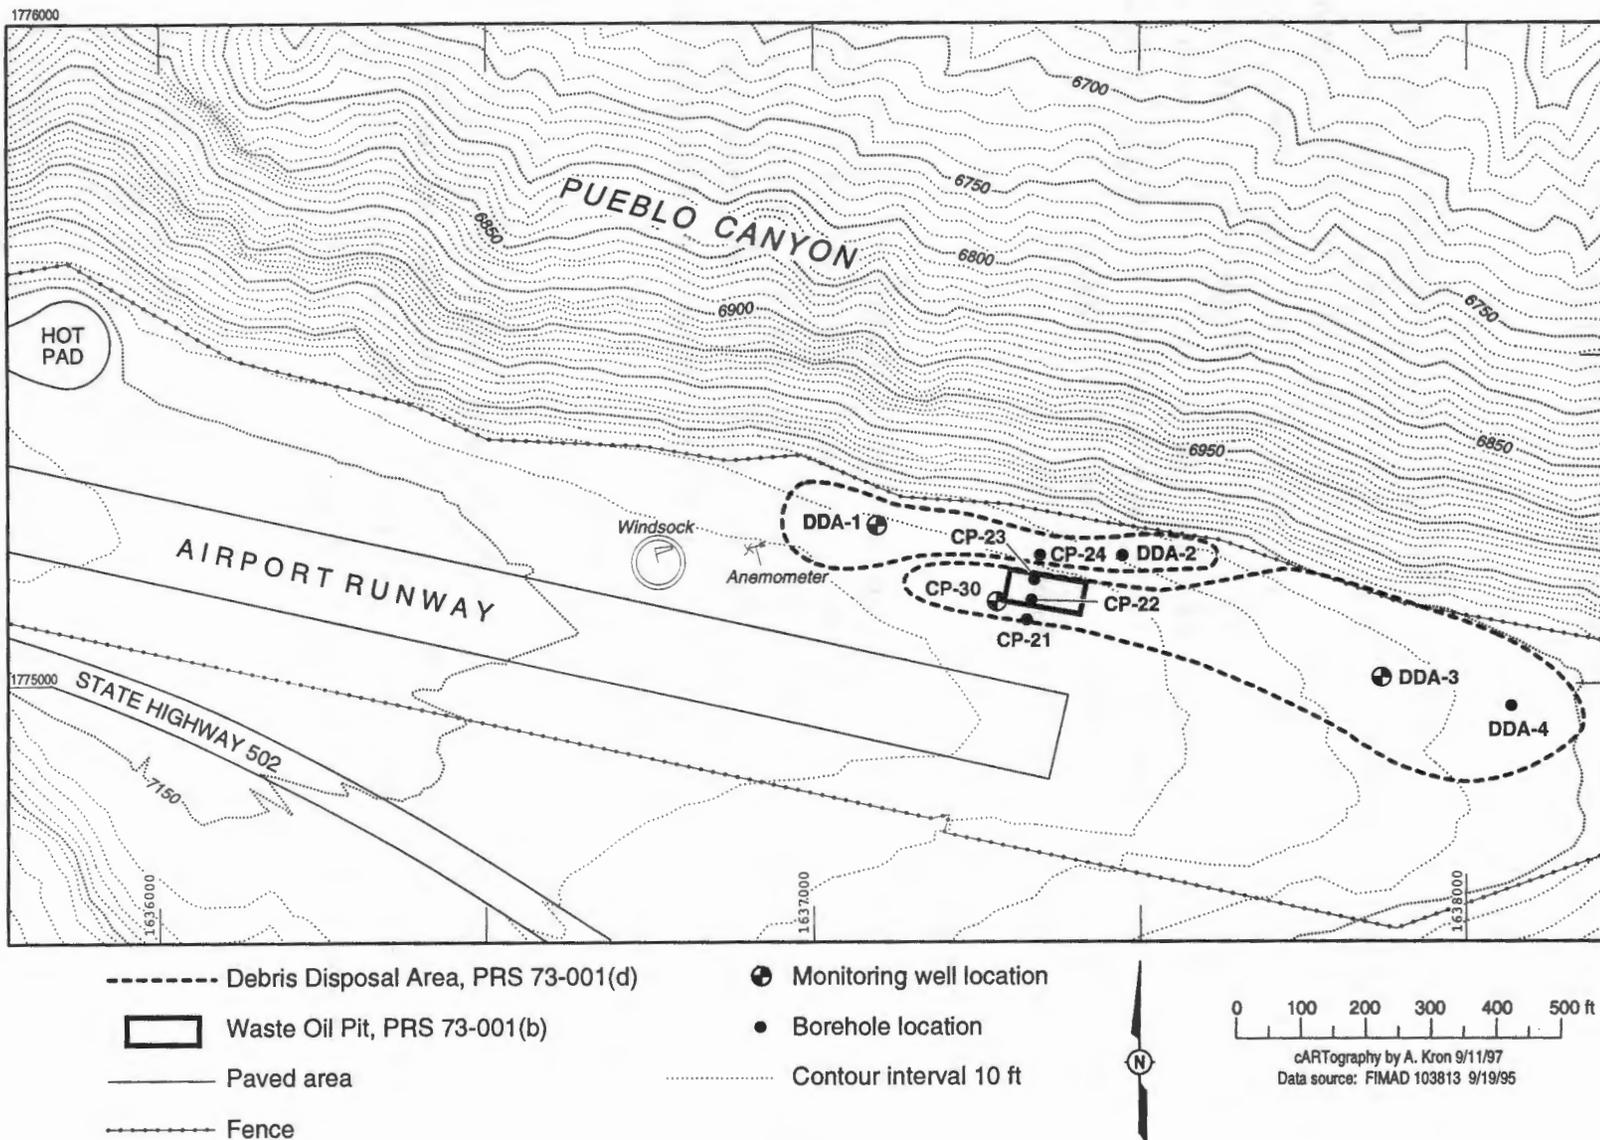
Fig. 3.1-2 Cone penetrometry testing locations near PRS 73-001(b).

During October 1995, several cone penetrometer tests (CPTs) were conducted in the debris disposal area (PRS 73-001[d]) (Fig. 3.1-2). As part of the PRS 73-001(d) investigation, four CPTs were placed in an effort to help determine the location of and, if found, the areal and vertical extent of wastes associated with the waste oil pit. Observations noted in a field log notebook during sampling at CPT locations CP-21 and CP-22 suggest the presence of the waste oil pit or perhaps residual waste oil pit material from activities related to the construction, debris emplacement, and backfilling of the debris disposal area (PRS 73-001[d]). The observation, "strong smell of hydrocarbons upon extracting the brass sleeves," was noted upon opening the sample rod to retrieve sample 0173-95-0171 (collected from the tuff at 28.0–29.3 ft at the bottom of test hole CP-21, location 73-02051). The observation, "no appreciable petroleum smell was noted," was noted upon retrieval of sample 0173-95-0142 (collected from the tuff at 26.0–27.5 ft at the bottom of test hole CP-22, location 73-02052). No visible oil residue was observed on any of the rods during the CPT investigations. The results of this investigation will be presented in a future RFI report for PRS 73-001(d).

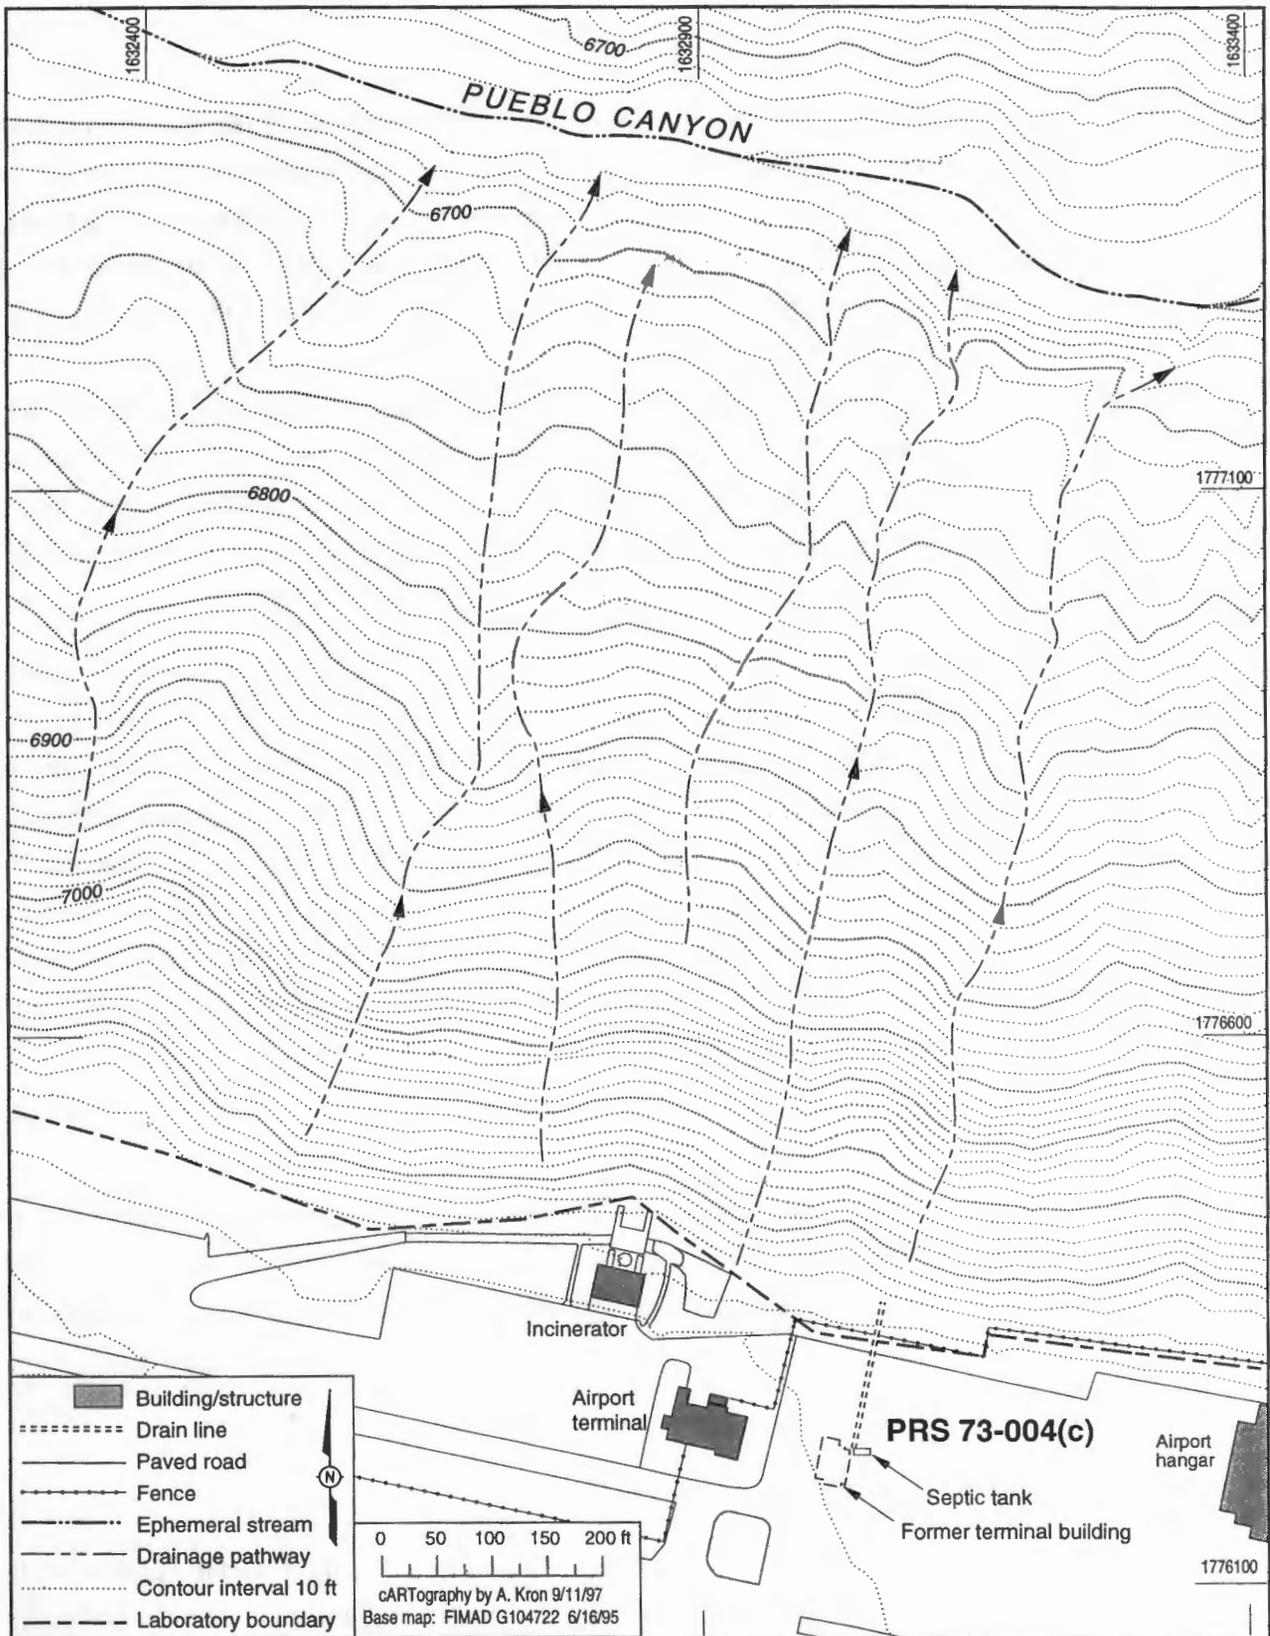
Fig. 4.1-1 Location of PRS 73-004(c), the former airport terminal septic system.

PRS 73-004(c) is a septic tank and outfall system that served the former Los Alamos Airport terminal building, which was located approximately 75 ft directly east of the existing terminal building (Fig. 4.1-1). There were two restrooms in the northeast corner of the building that were connected by a 4-in. diameter vitrified clay pipe (VCP) to the septic tank (Francis 1996, 05-0262). The septic tank, probably constructed of concrete, discharged to the south edge of Pueblo Canyon through a 4-in. diameter VCP. Conflicting information places the septic tank from immediately northeast of the building to as far as 80 ft north of the building. The area of the former terminal building and associated septic system was capped with 9-in. thick concrete pavement as part of the 1984 Los Alamos Airport Improvement Project.

An electromagnetic geophysical survey was completed on a 20 ft grid over the entire 250 ft by 270 ft concrete apron immediately east of the existing terminal building (Newton 1997, 0264). The concrete apron covers the entire area where the former terminal building and septic tank were located. However, no anomalies were noted that potentially represent the septic tank or its drainlines.

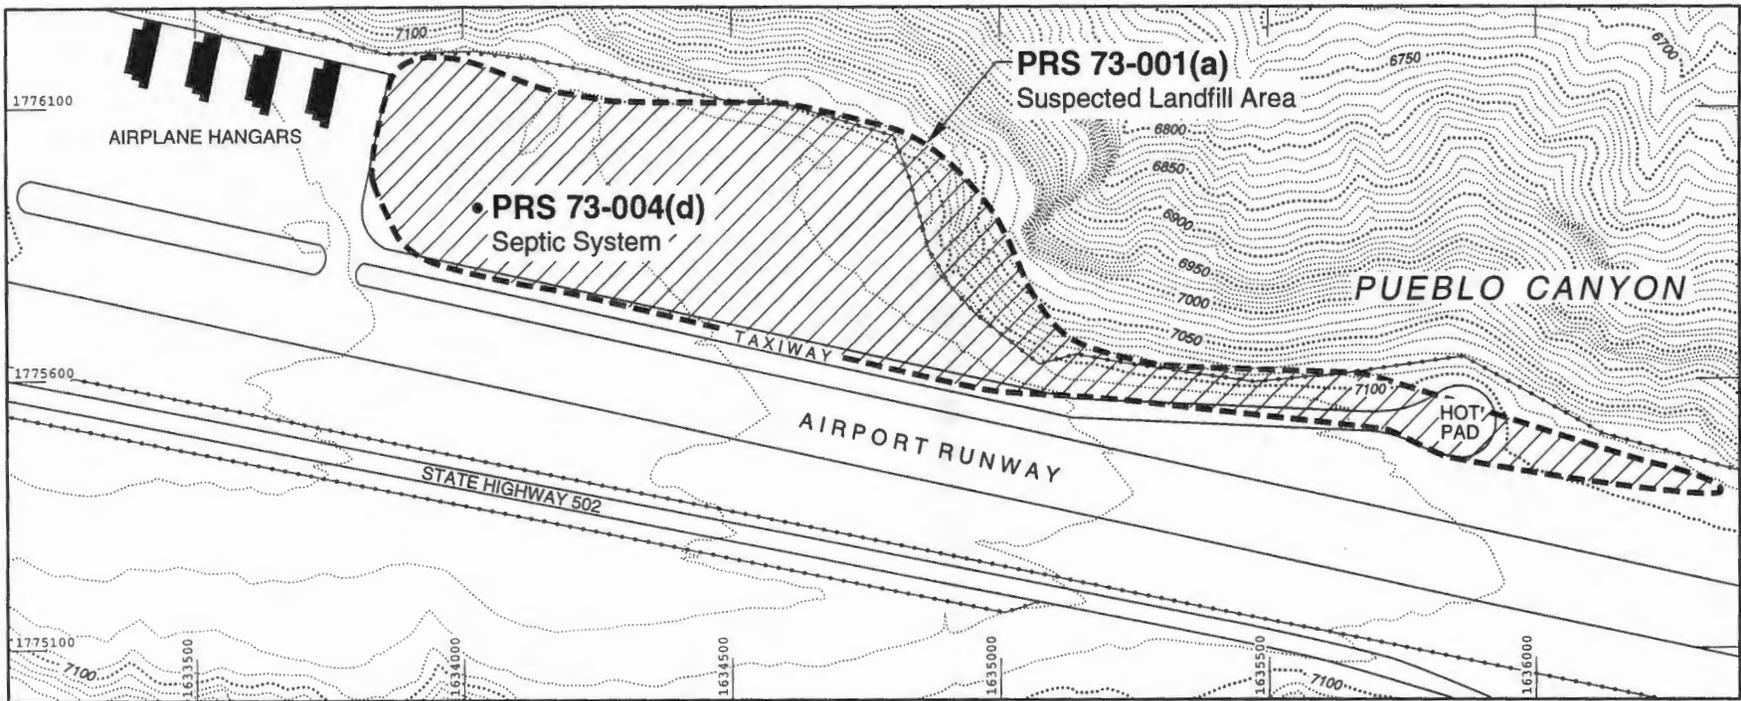
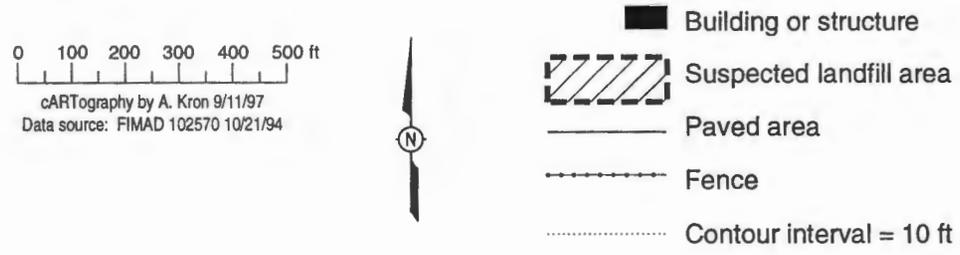
Fig. 5.1-1 Location of PRS 73-004(d), the landfill office septic system.

PRS 73-004(d) is a septic system that served the Los Alamos Airport landfill office, which was located east of the airport terminal building and hangars (Limbaugh Engineering & Aerial Services, Inc. 1963, 05-0067) (Fig. 5.1-1). The landfill office was a flat-roofed building with floor dimensions of approximately 16 ft by 24 ft. The building was anchored at the landfill site to a 4-in. thick reinforced concrete slab of the same dimensions. A 4-in. diameter VCP connected the building's toilet facilities to the septic tank, which was located about 20 ft northeast of the building. The composition and dimensions of the septic tank are not known. It was planned that discharge from the septic tank would enter a distribution box and feed two parallel 62-ft long, 4-in. diameter perforated Orangeberg leach lines, spaced about 7.5 ft apart (The Zia Company 1960, 05-0266). However, the actual septic system may not have included a leach field (Williams 1997, 05-0265). The office building and its concrete slab have been removed from the site. The septic tank was also removed as part of the early 1970s decommissioning operation (Williams 1997, 05-0265).

The estimated location of the former landfill office building and associated septic system lies in an area of the main airport landfill (PRS 73-001[a]) where the geophysical results indicate a landfill waste thickness of 20 to 30 ft. The RFI Work Plan for OU 1071 states that PRS 73-004(d) will be investigated as part of PRS 73-001(a). Therefore, PRS 73-004(d) should never have been designated as a separate PRS.
