SUBJECT: RESPONSE TO RSI FOR THE RFI REPORT FOR PRSs 09-002 AND 09-011(b)

**Response to
Request for Supplemental Information, 09-002 and 09-011(b) RFI Report**

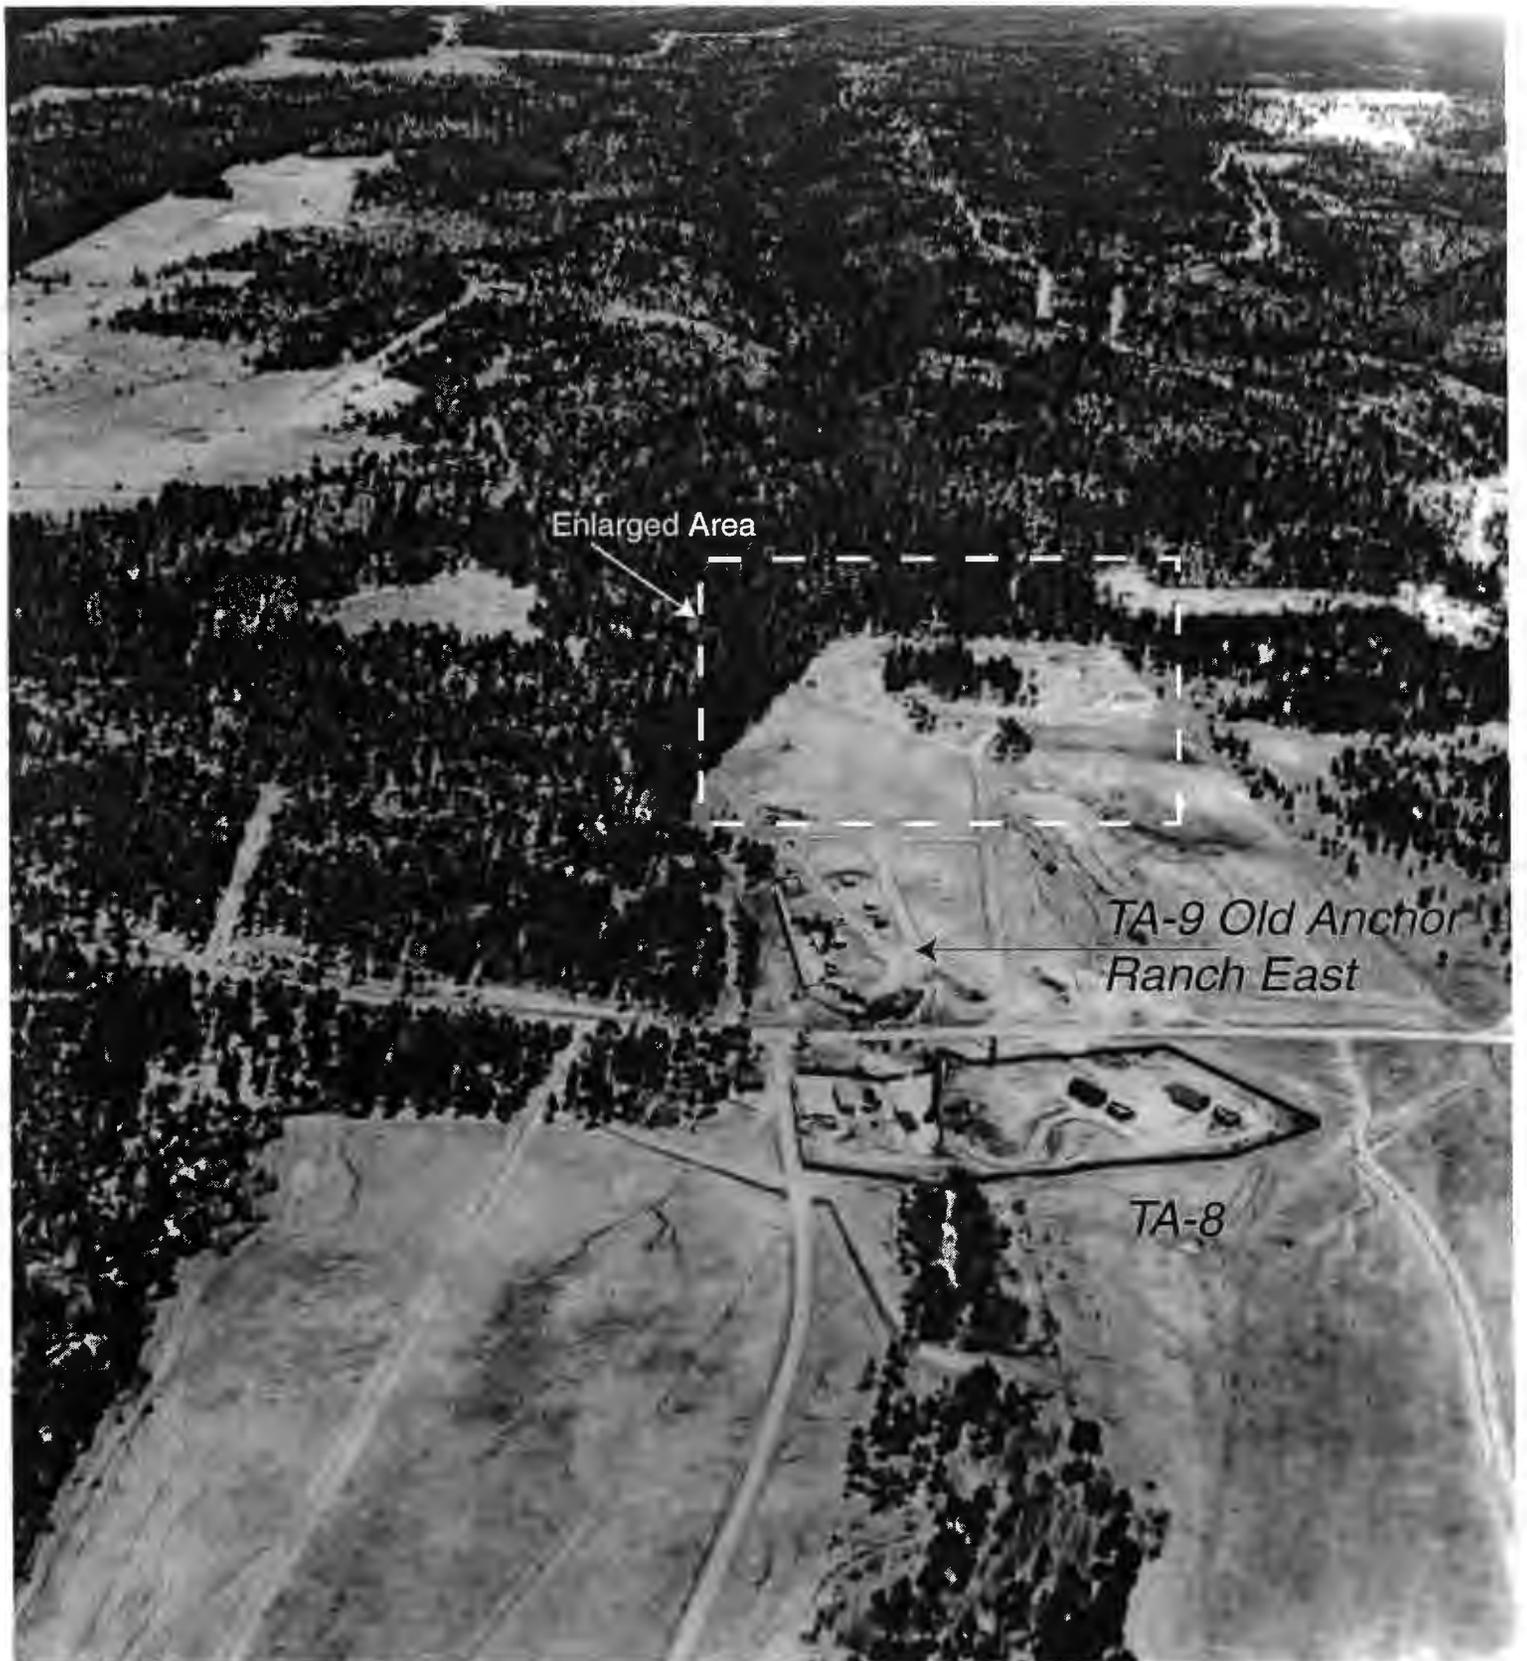
Photo 1 ca 1947

Photo 1- Oblique aerial photograph from about 1947 of TA-8 and TA-9. View toward the east. The Far Point firing Site is in the middle area of the photograph

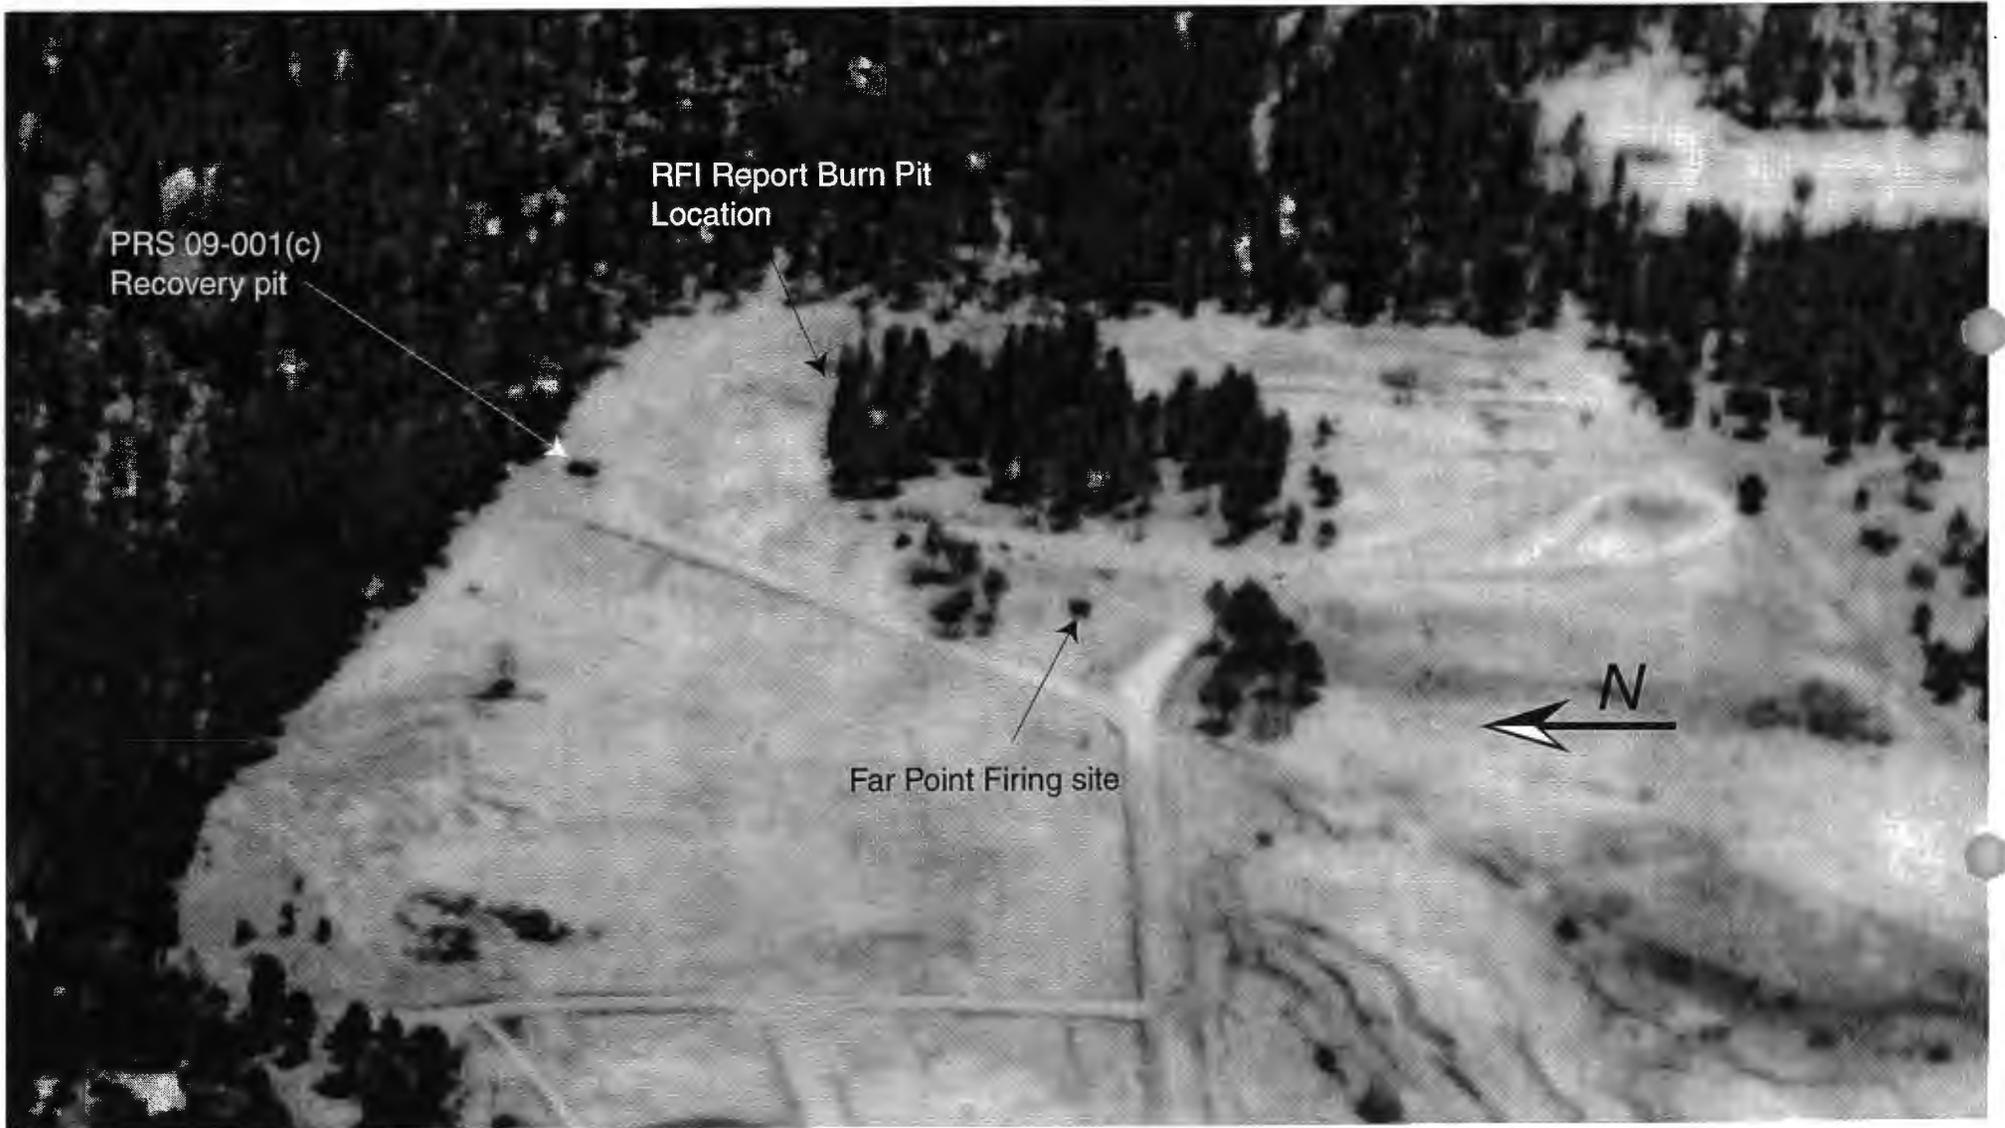
Photo 2 (enlarged area)

Photo 2- Enlargement of the Far Point Firing Site Area of the 1947 photograph. It can be noted that much of the area has been cleared of trees with the exception of the grove of pine trees east of the Far Point Firing Site. This provides a relatively unobstructed view of any ground level structures. The PRS 09-001(c) Recovery Pit, Structure TA-9-15, is clearly visible in the photo. The top of this below ground recovery pit was approximately 12-ft by 12-ft and had a steel cover. Since this 12 by 12-ft structure is visible in the aerial photograph, a 20-ft by 40-ft pit, possibly blackened by burned material should also be visible. Yet, there does not appear to any such feature in the photo.

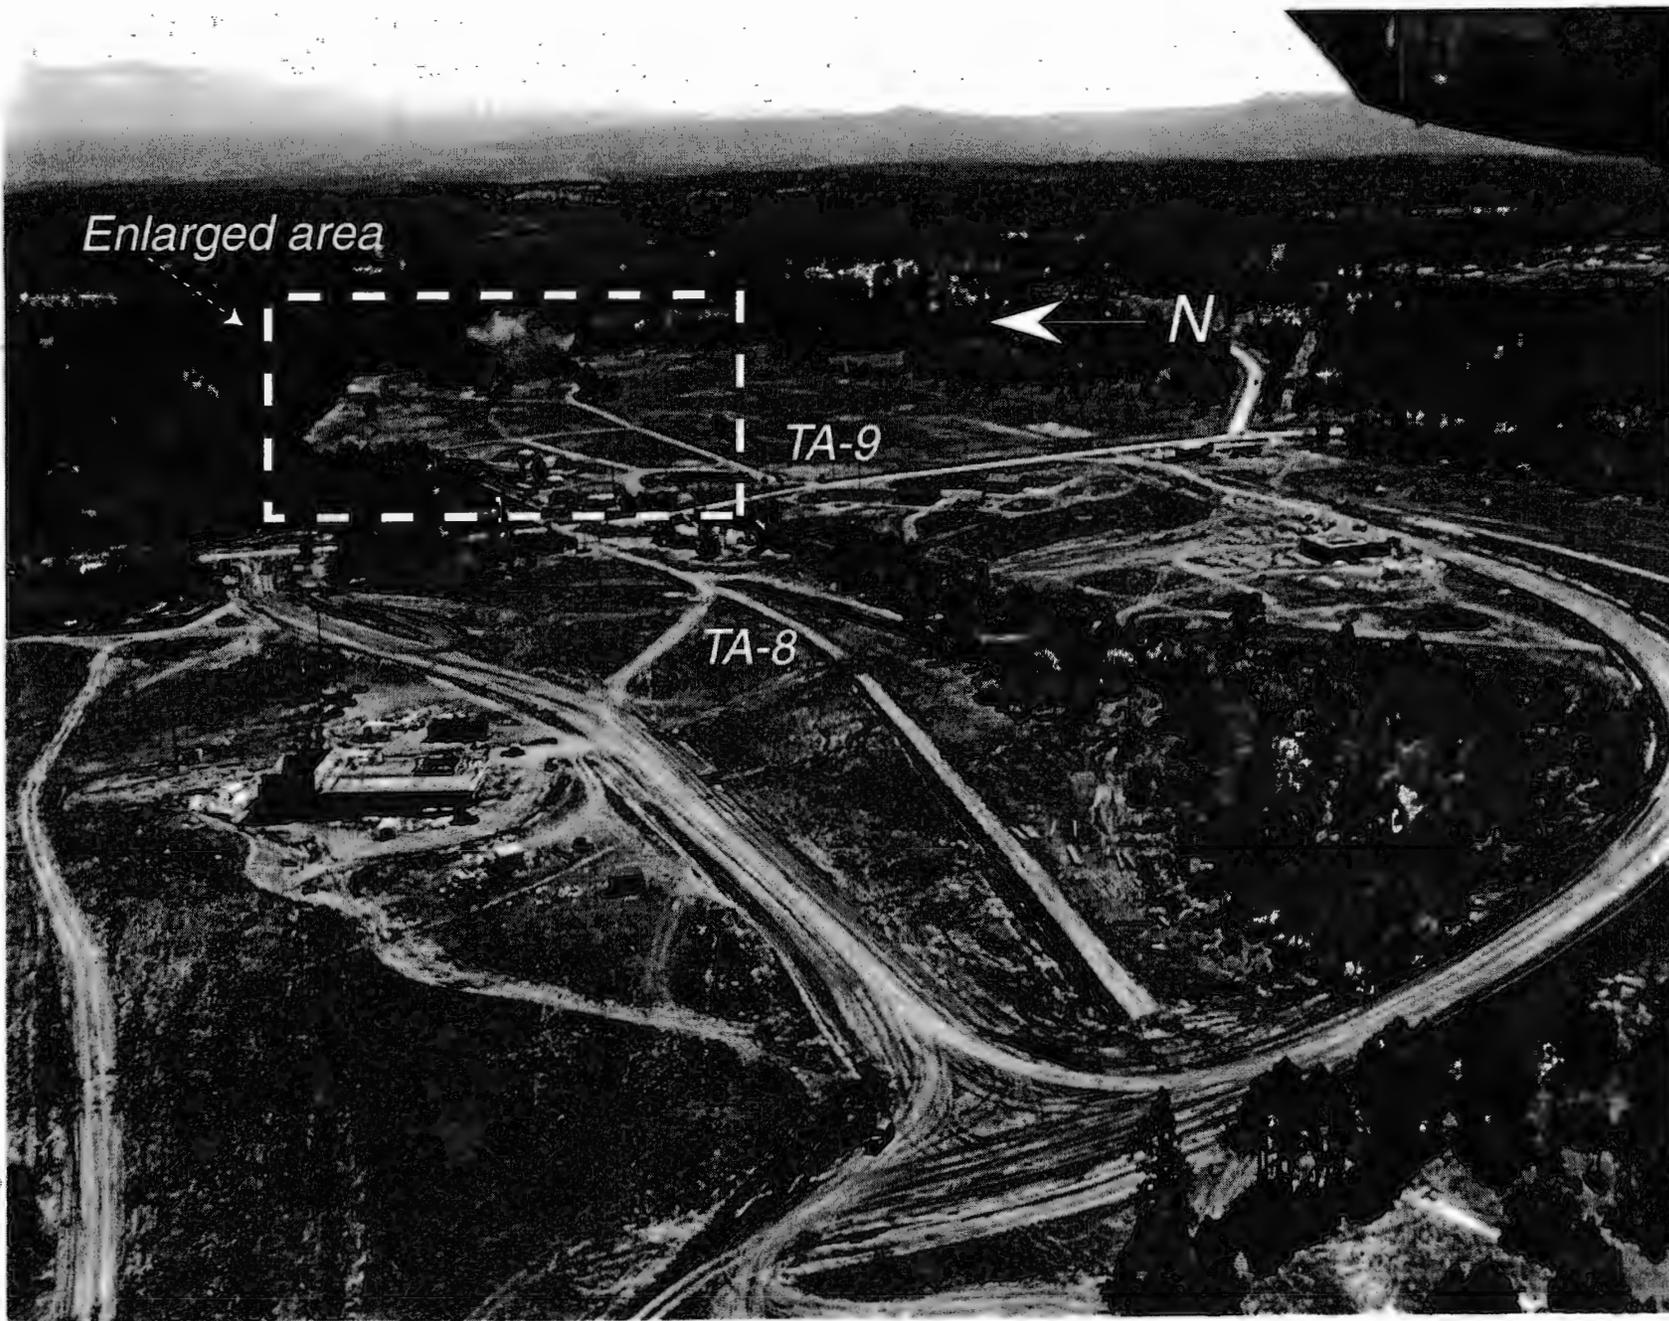
Photo 3 (ca 1949)

Photo 3- Oblique aerial photograph from about 1949 of TA-8 and TA-9. The main subject area of this photograph, with a view towards the southeast, appears to be TA-8 building construction. The Far Point Firing Site, however, is visible in the upper middle left part of the photo.

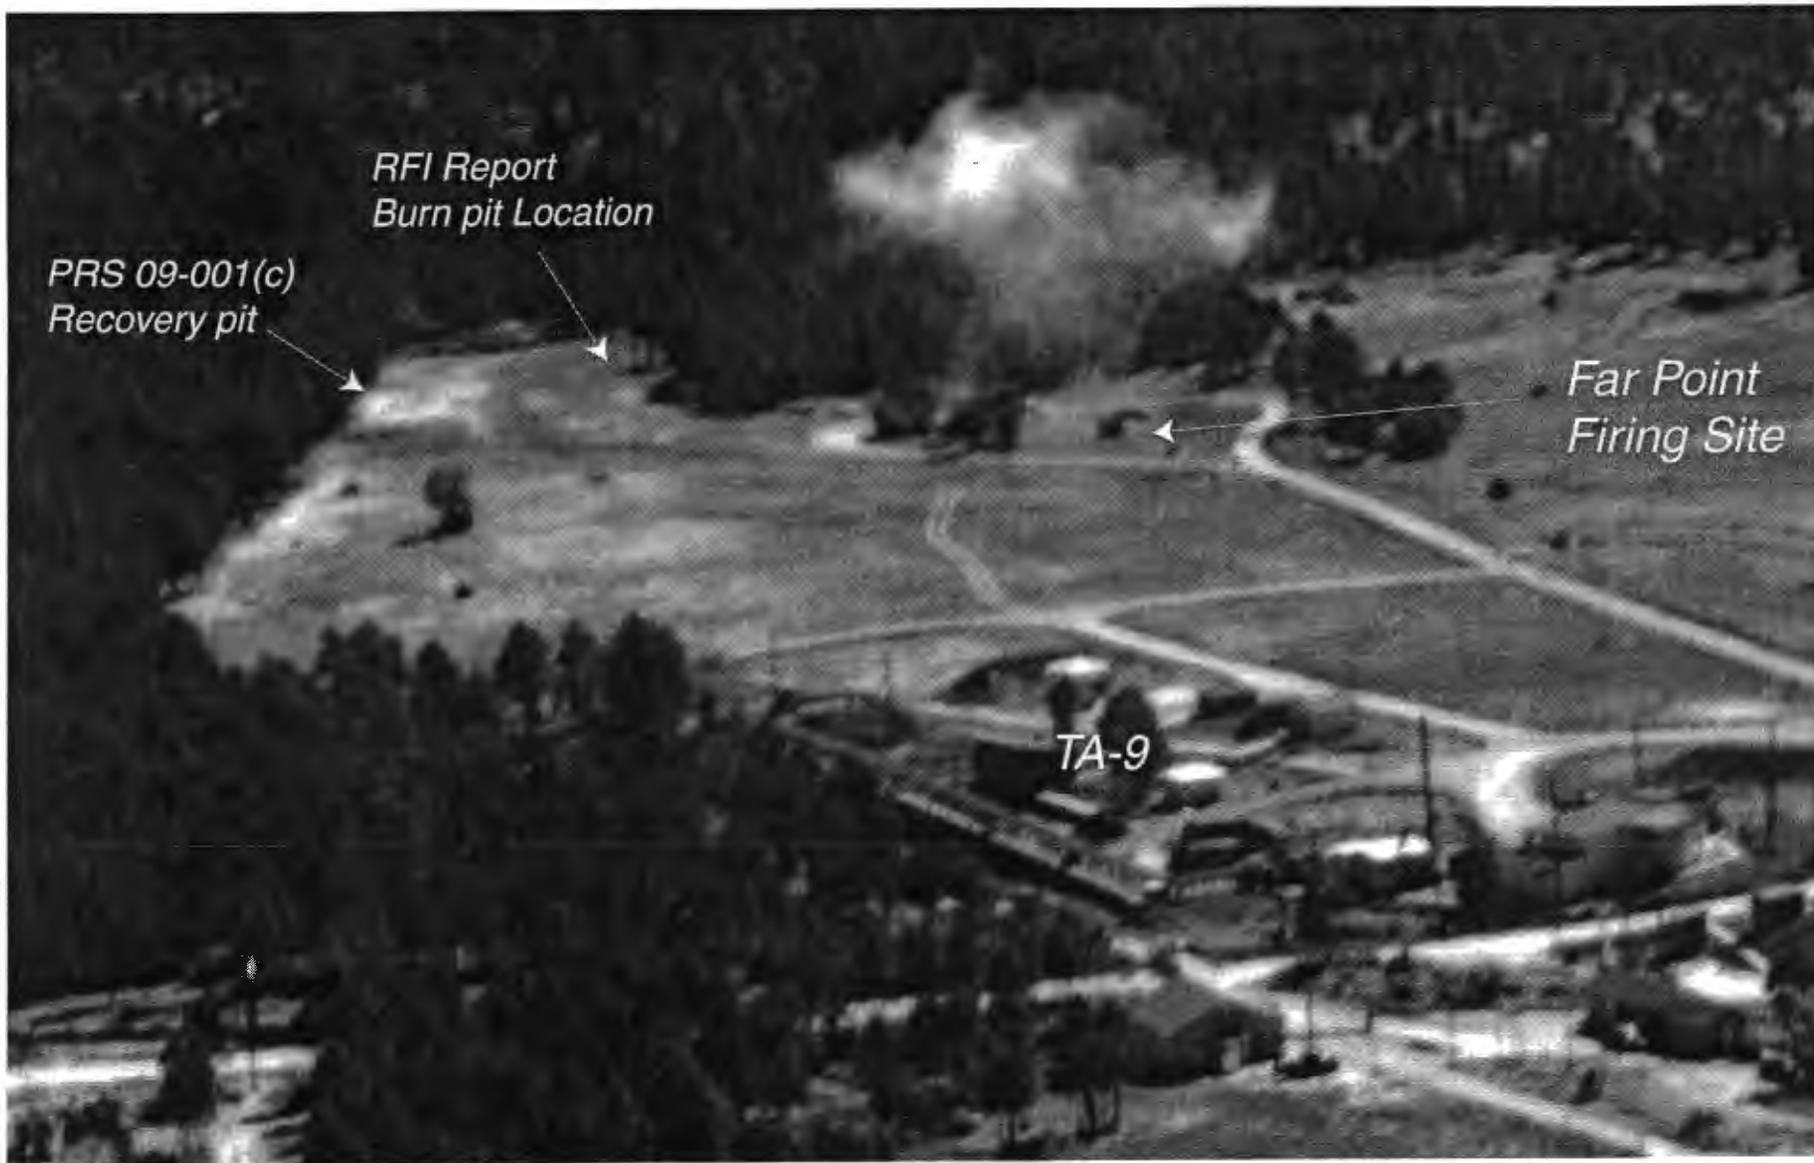
Photo 4 (enlarged area)

Photo 4- Enlargement of the Far Point Firing Site Area of the 1949 photograph.

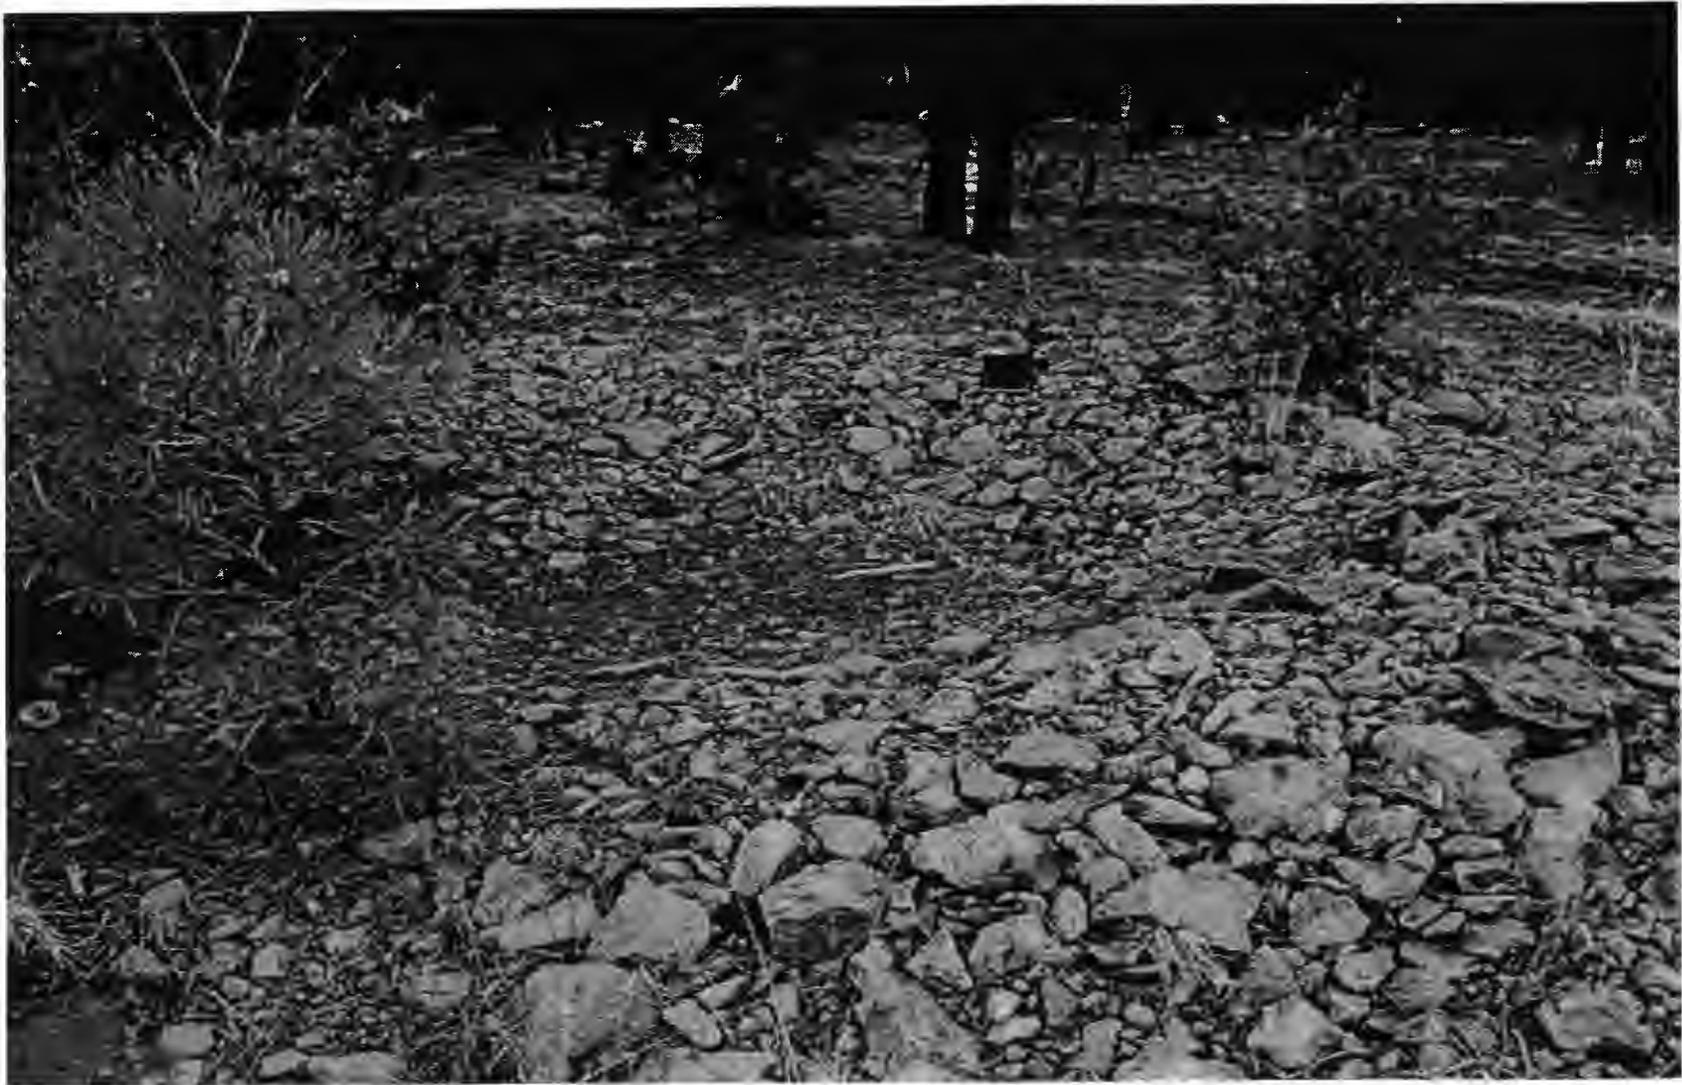
Photo 6- Present day photograph of a small depression at TA-9. This photo shows a small depression located of north of the RFI Report Burn Pit.

A second, small depression does exist in the same general area (Photograph 6). The size of the second depression (roughly a square with 8-10 ft sides, 1 to 2 feet deep) is even smaller than the pit selected for RFI sampling. The soil in the bottom of the depression was examined for the presence of ash and none was observed. Tuff bedrock is exposed at the ground surface in the area surrounding the depression which indicates there is no hidden, backfilled area associated with the depression. Due to its small size, this second depression was discounted as a potential burn pit and was not included in the sampling.

Photo 6 Second small depression at TA-9
