**TA-15 SITE
TOUR**

**NMED BUREAU
PERSONNEL**

**DECEMBER 19,
1996**

PROPOSED ACTIONS FOR TA-15

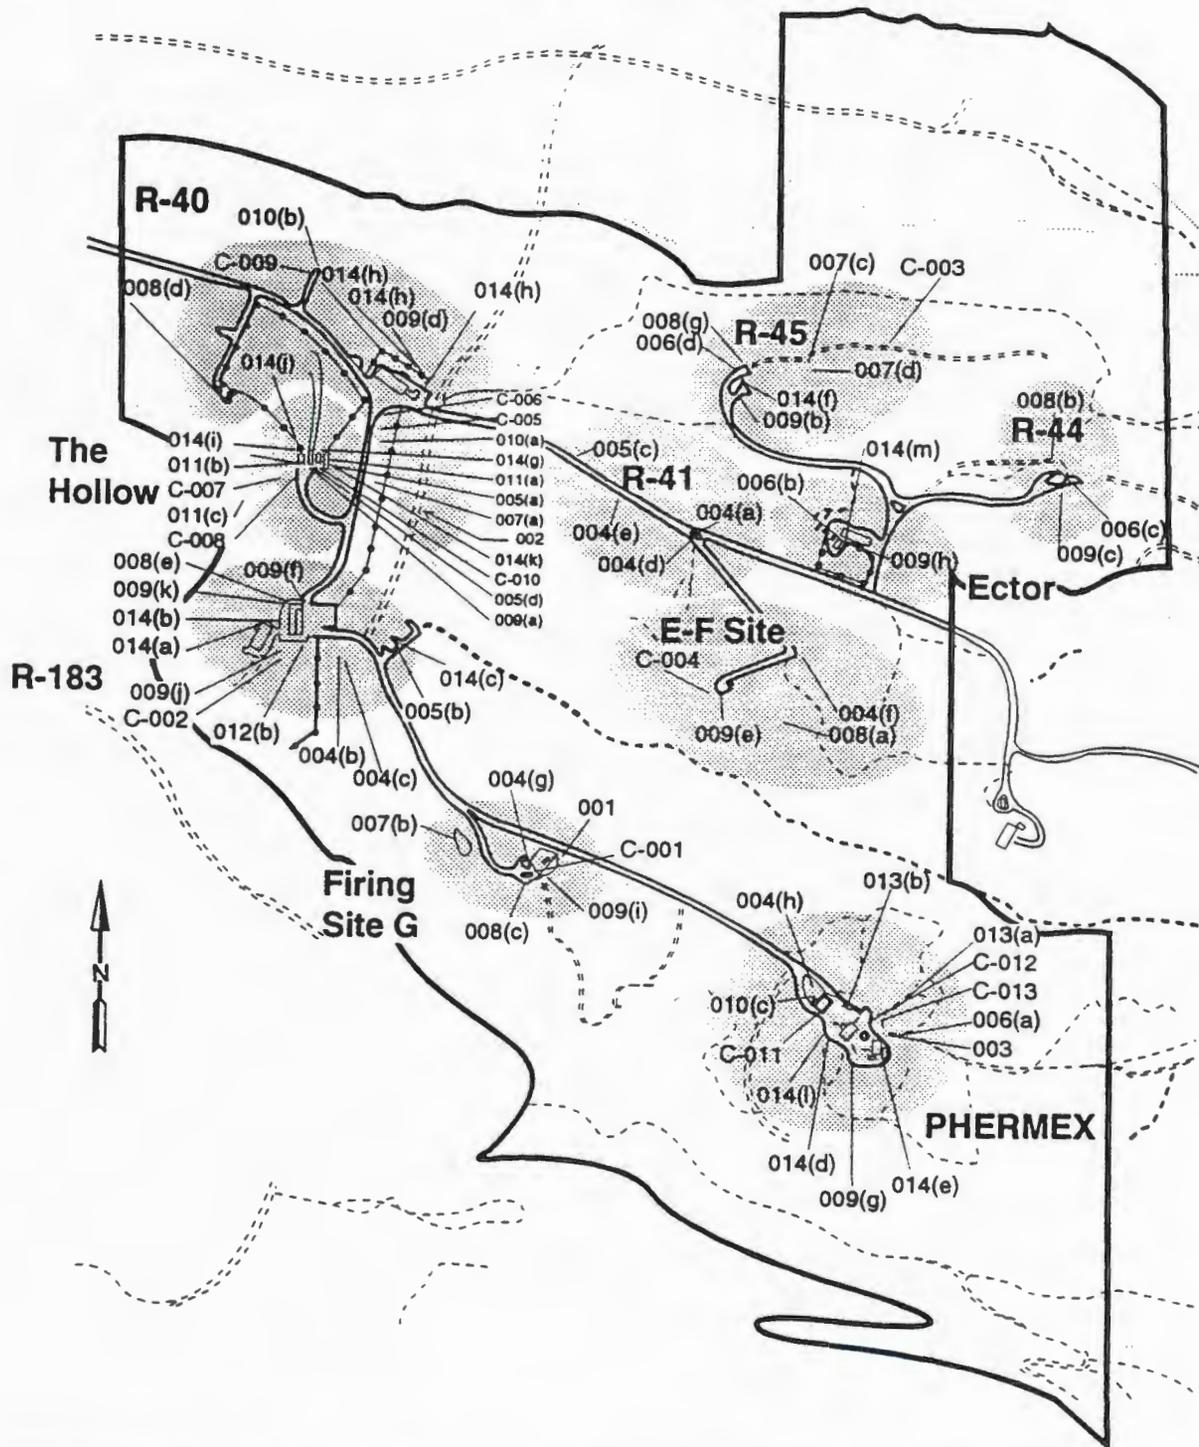
Figure EXEC-3 TA-15 site diagram showing Potential Release Sites (PRSS). Table EXEC-1 lists the PRSS by geographic location and gives the groupings into which the PRSS are placed.

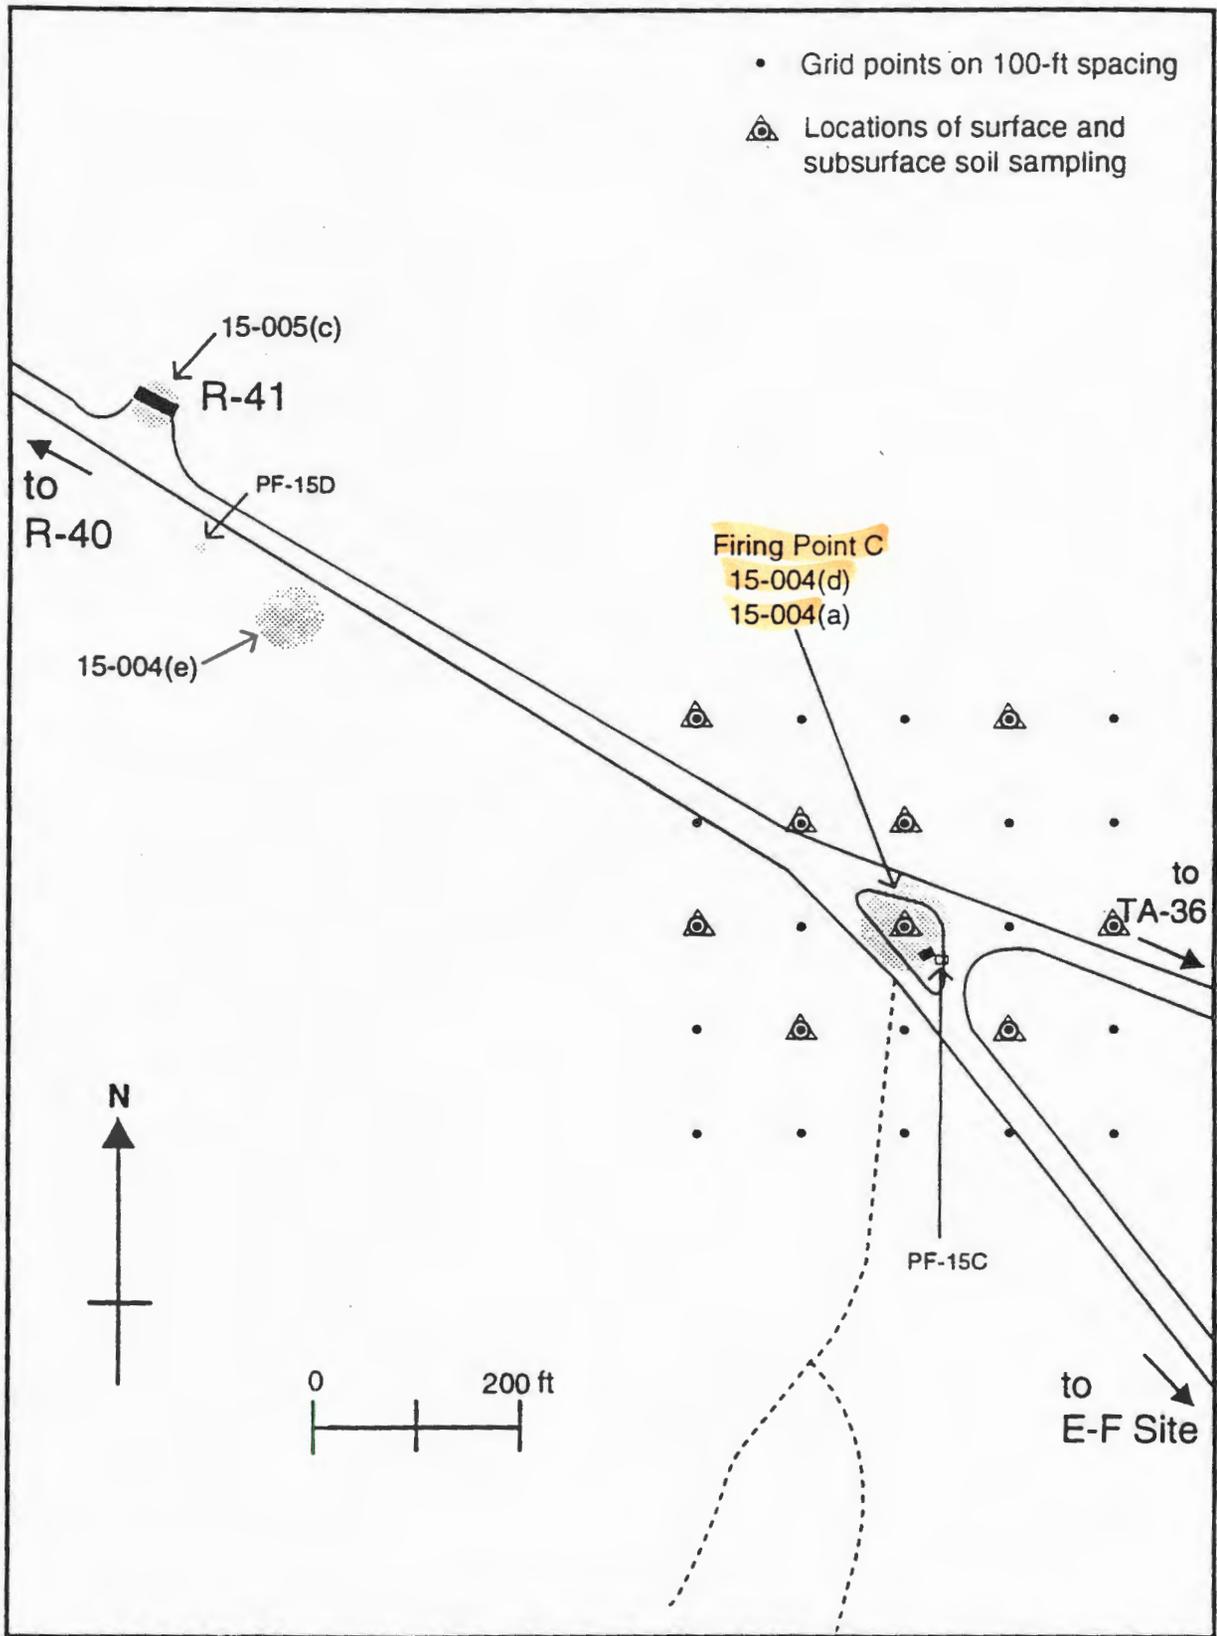
Figure 8.4-1 Site diagram and sampling grid for Firing Point C at TA-15.

Based on the laboratory analysis, no cleanup is required and NFA was requested.

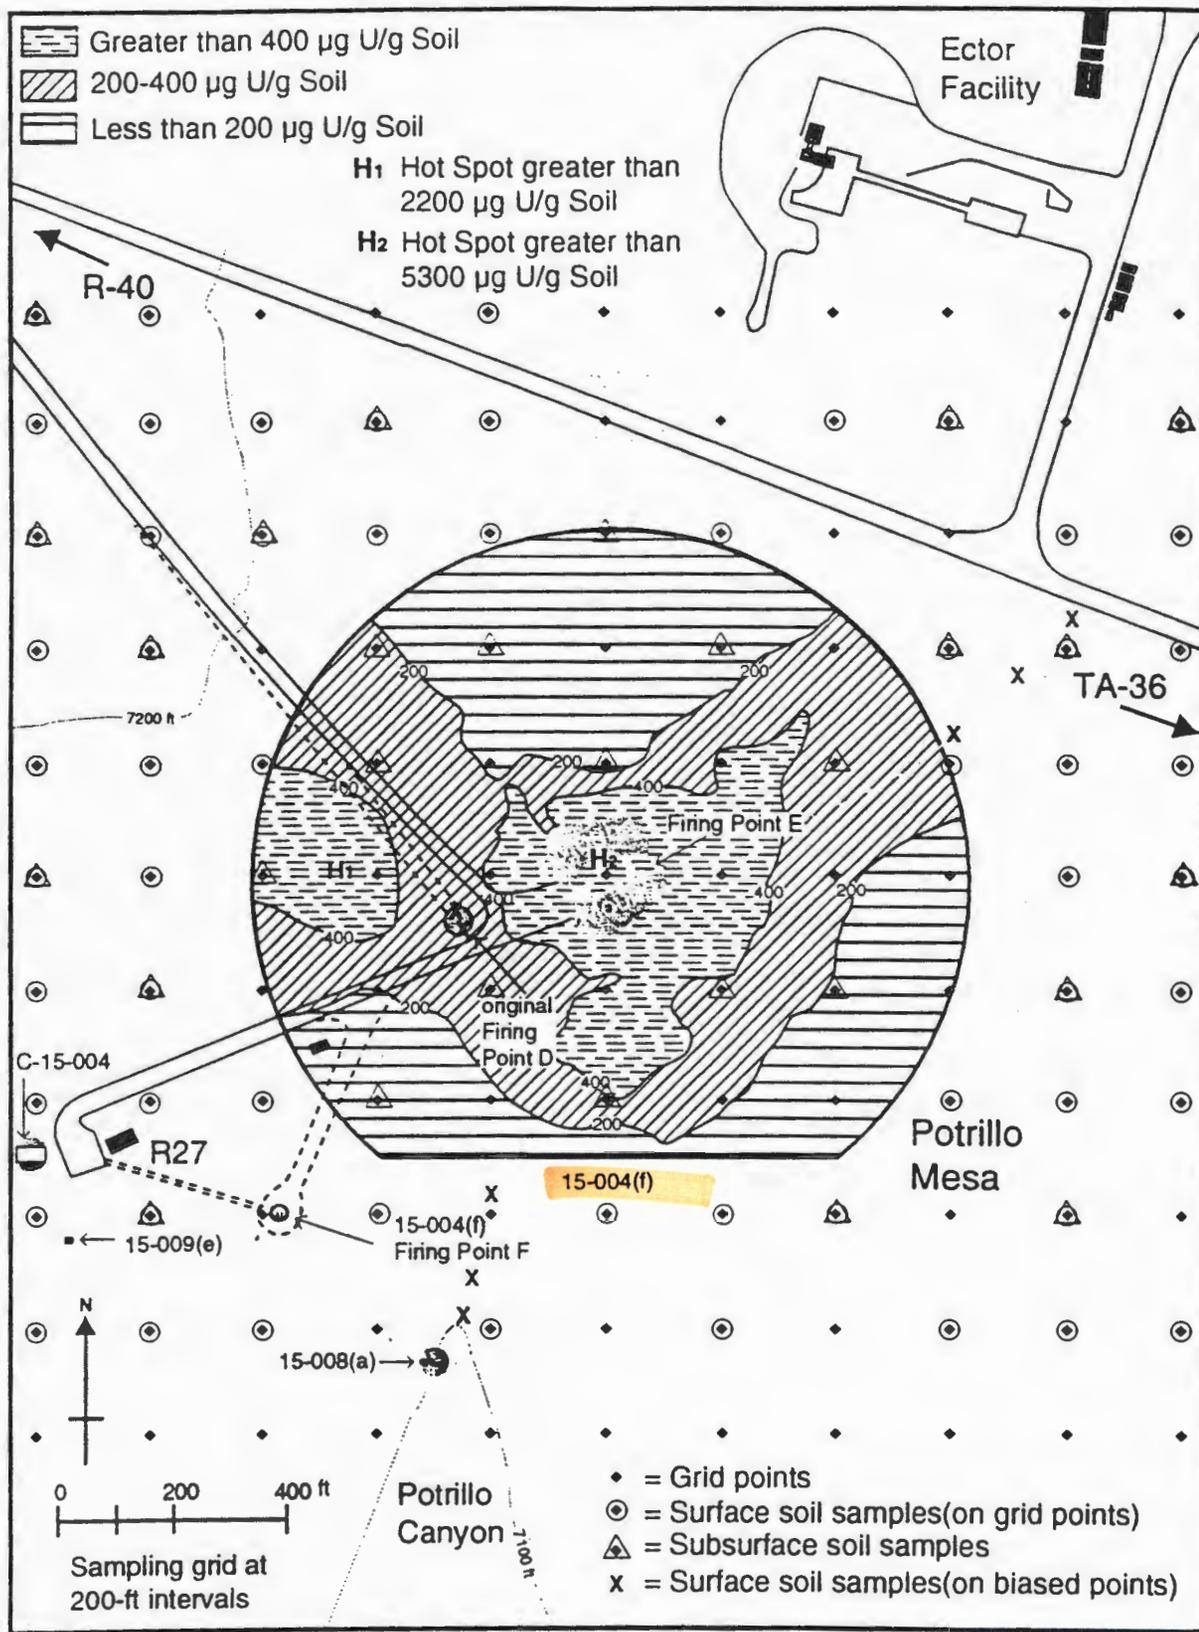
Figure 7.3-12 Site diagram for Firing Site E-F with sampling plan. The contour map of uranium concentrations is taken from Table I (White et al. 1980, 0771).

A Voluntary Corrective Action (VCA) Plan will be prepared to describe methods to be employed for remediating the site. Because of the presence of visible pieces of DU and radioactive contaminated materials (shrapnel) on the surface, hand pick up of the area is occurring. This is not a final remedy, but one that is intended to remove obvious contaminated objects from the surface to assist in stopping the possible transport of contamination via water run off. A pilot study for cleanup will occur in 1998, and the total clean up of the area is being planned during FY99.

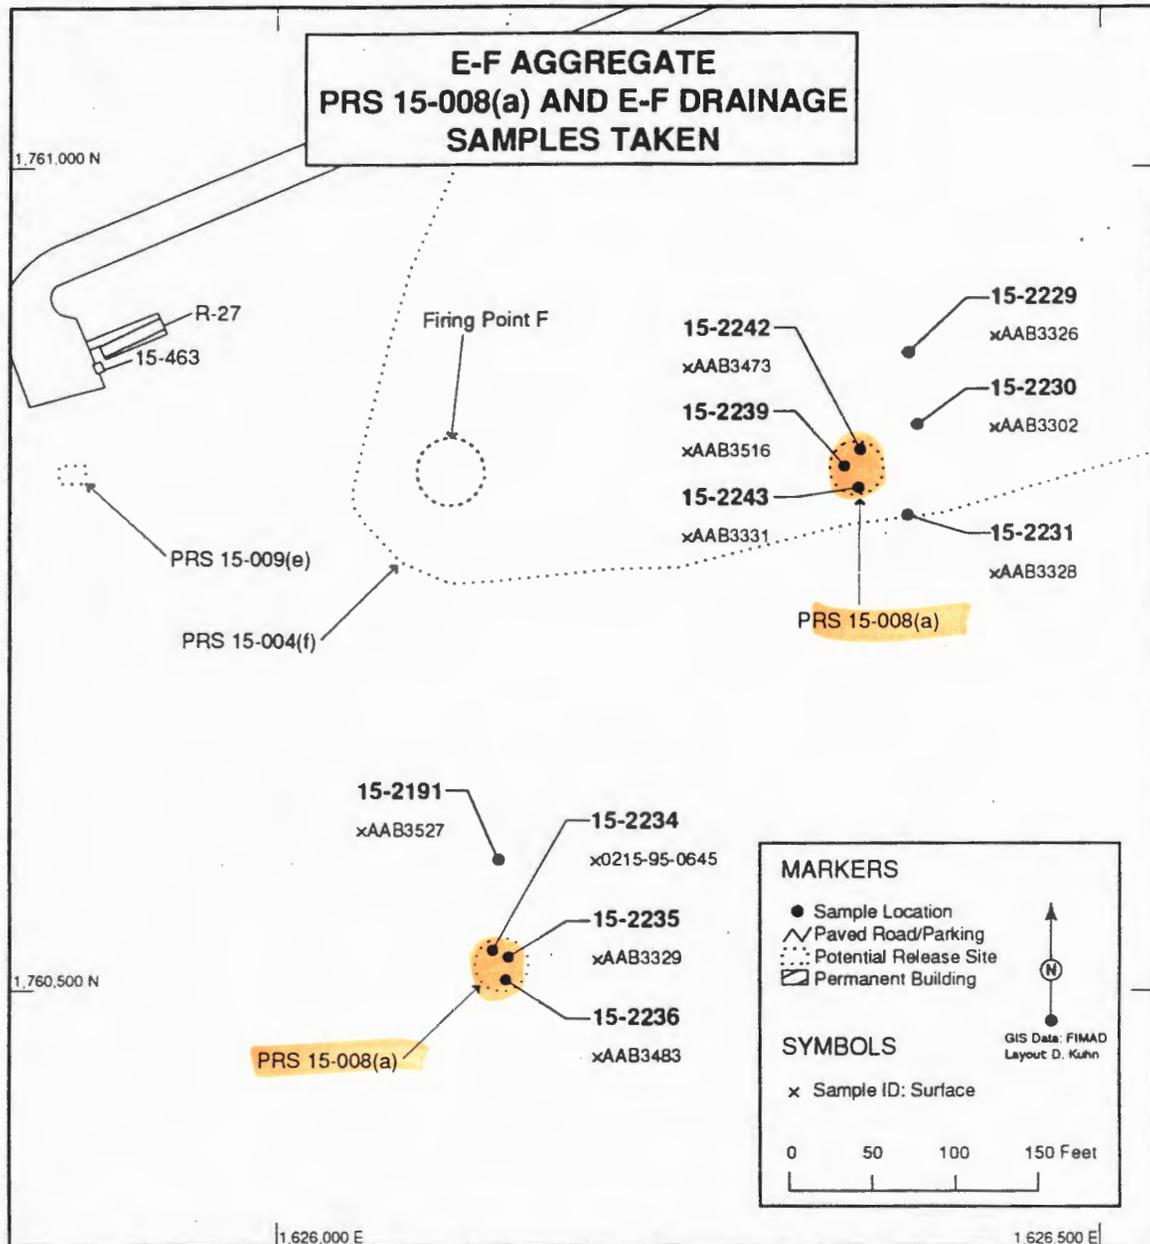
Figure 1-6. Sample locations at PRS 15-008(a)

It is proposed that an Interim Action to pick up the visible pieces of debris be conducted in FY97 with a full VCA planned for FY99 to coincide with the VCA to clean up E-F Firing Site.

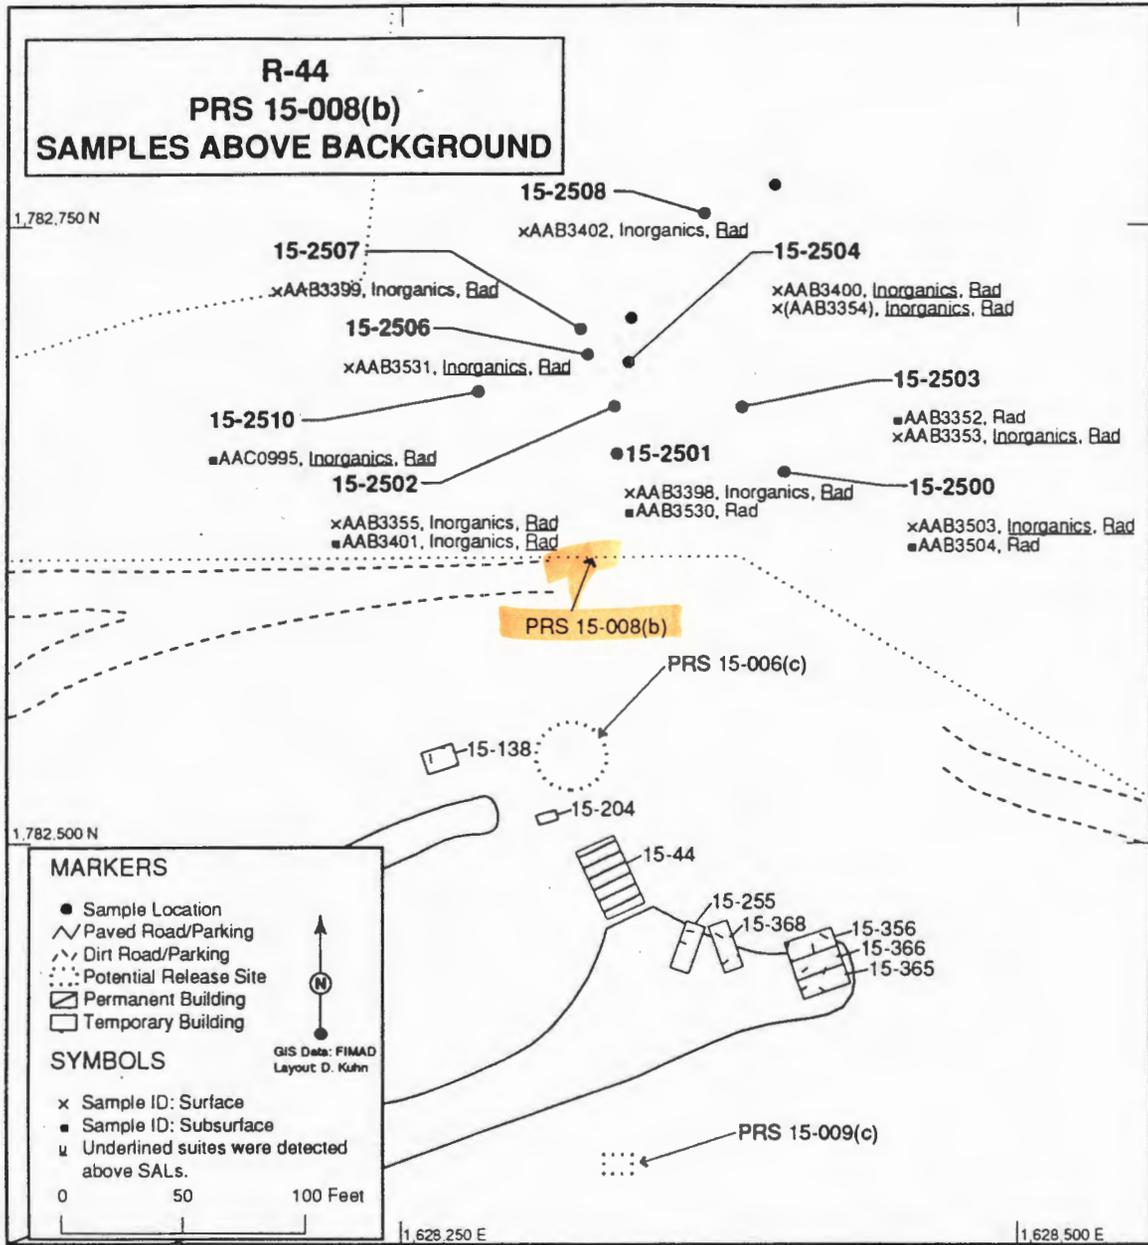
Figure 4-10. Locations of samples above background

Based on the laboratory analytical results, the extensive contamination, and the visible surface contaminated debris, an IA is planned for FY97 with a full VCA planned for FY99.

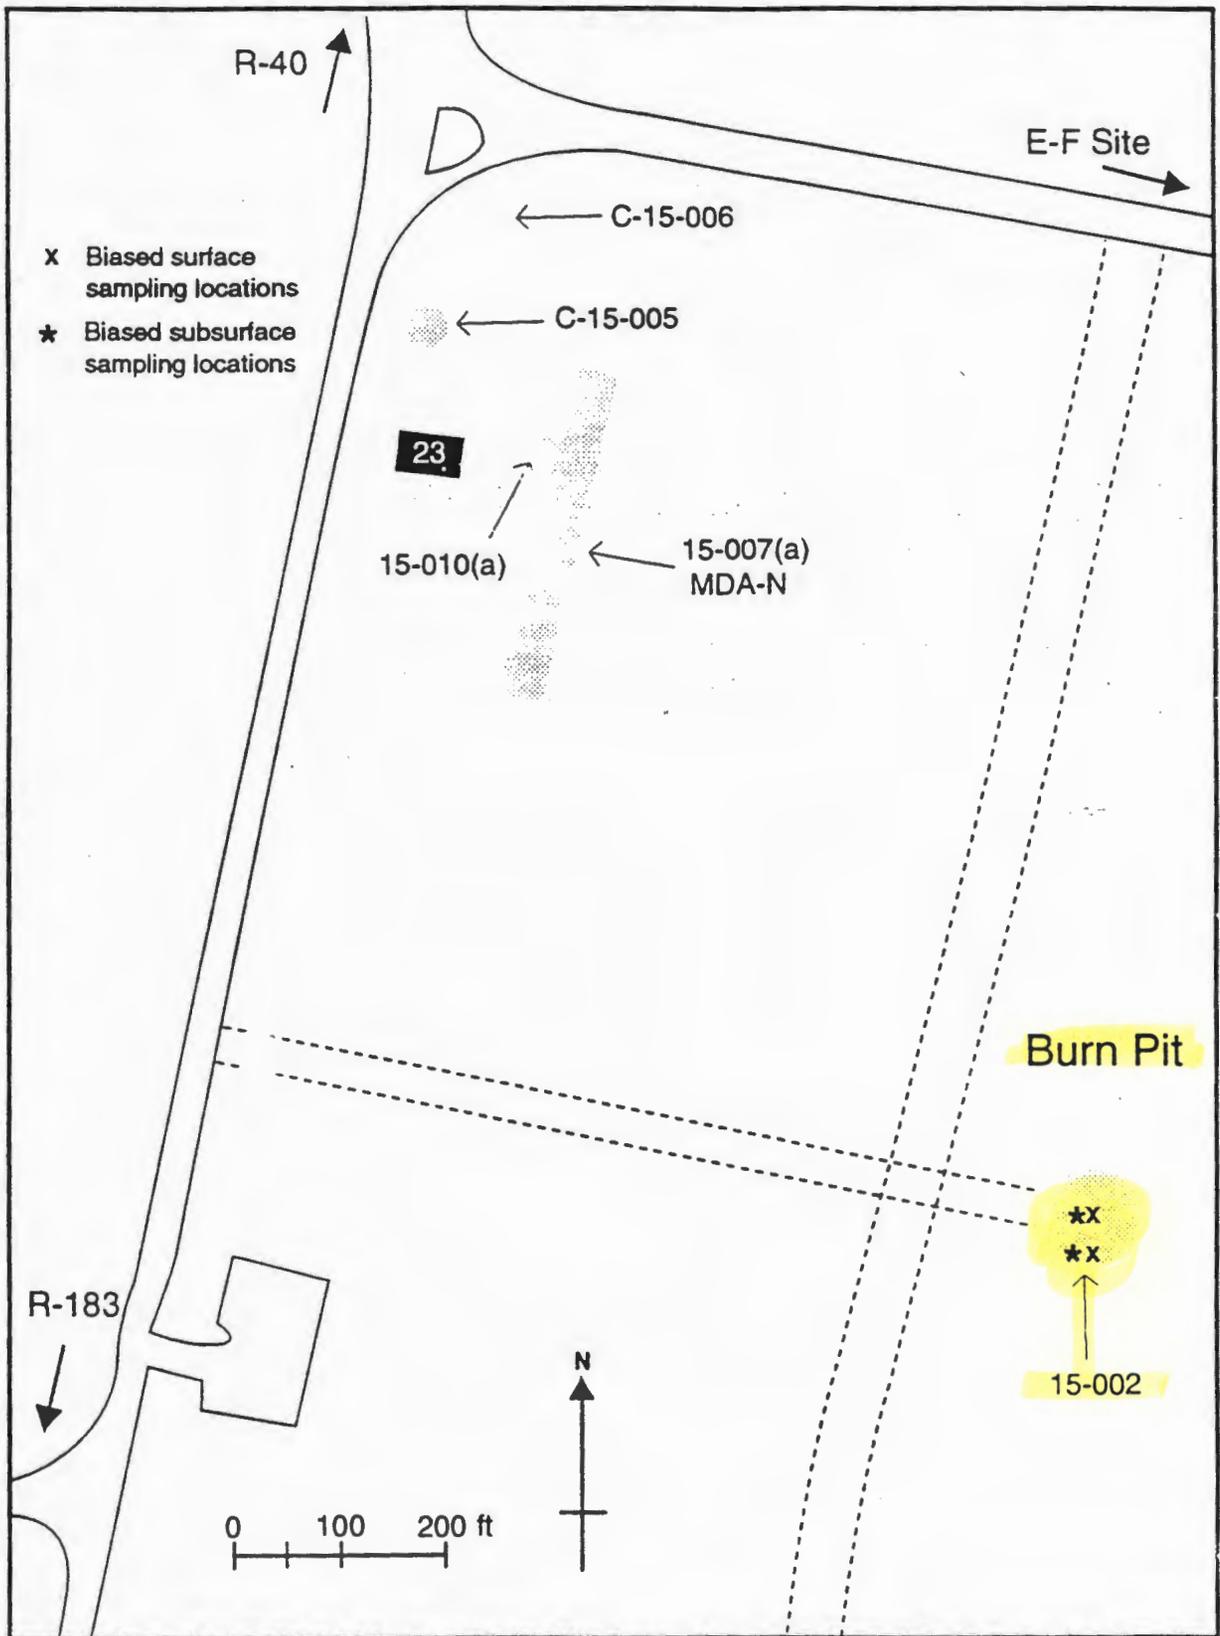
Figure 8.7-1 Site diagram including the burn pit, and MDA-N; also shown are the sampling points at the burn pit.

A No Further Action (NFA) is proposed for this PRS because the analytical results confirm the absence of contaminants.

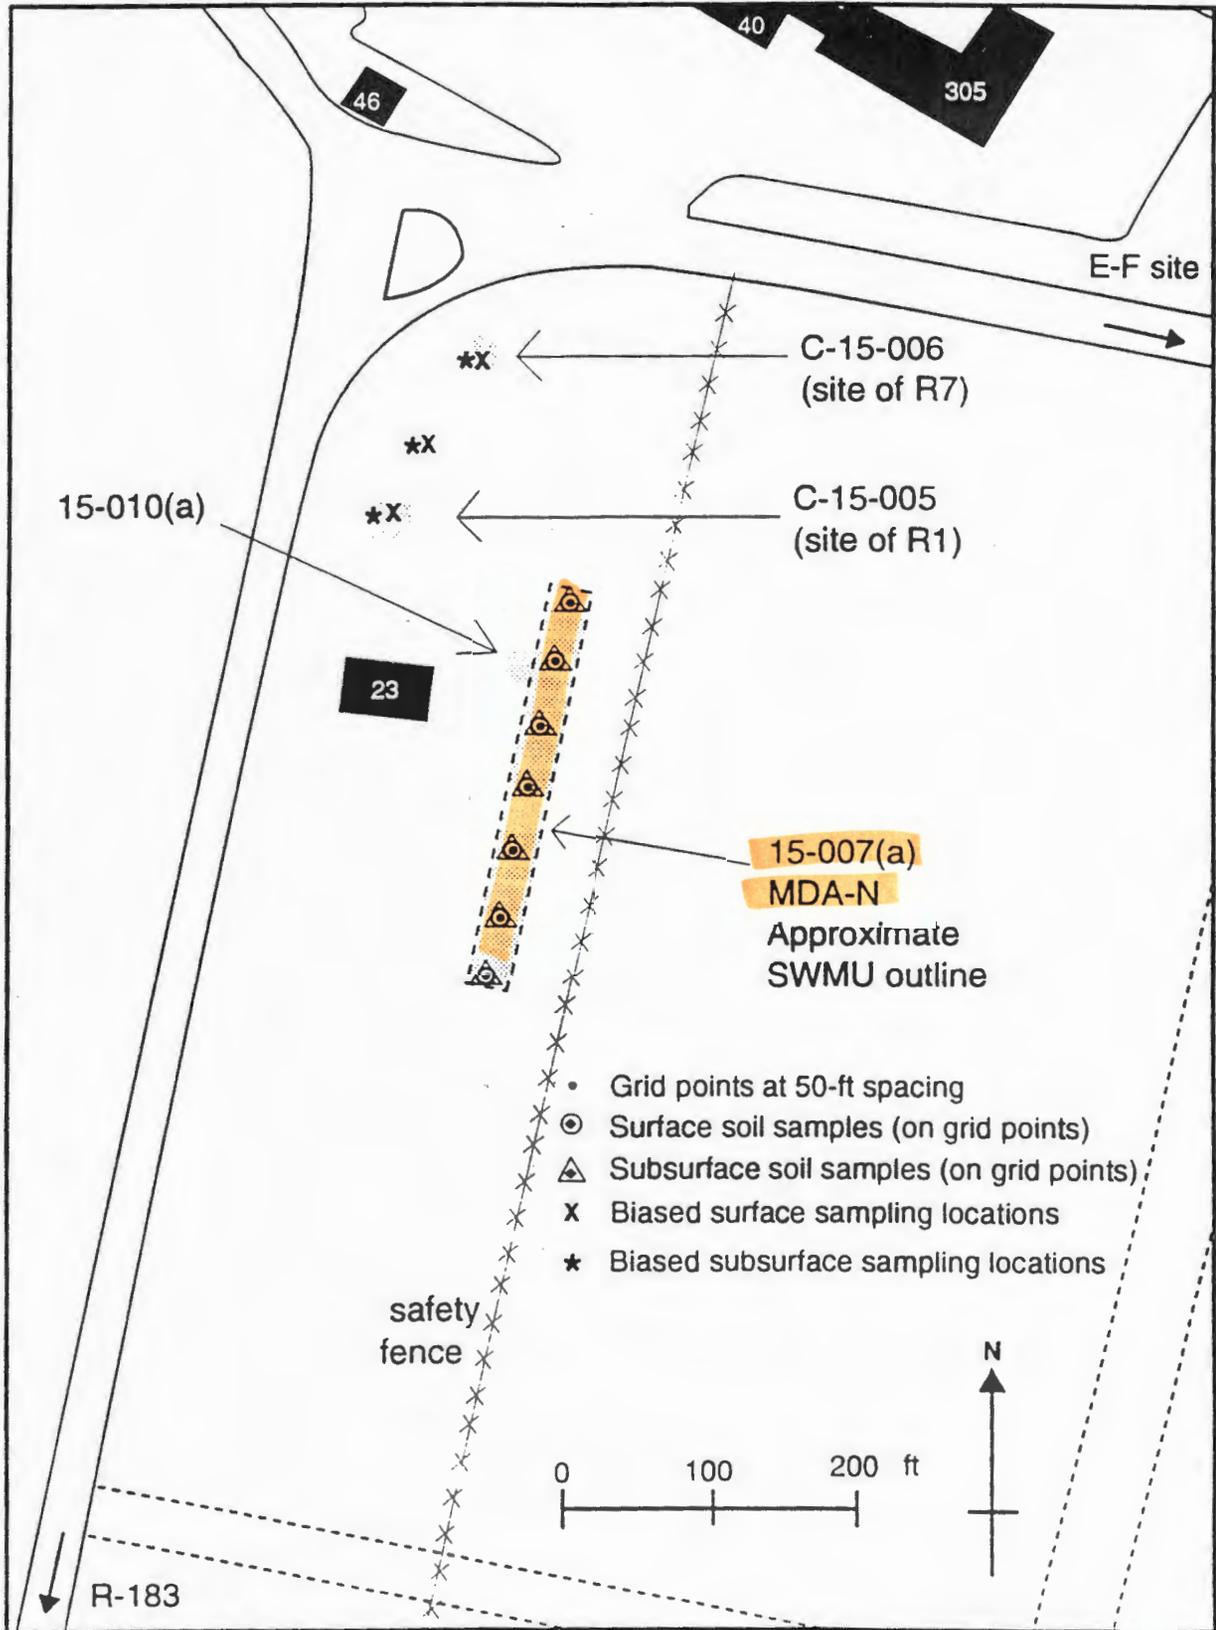
Figure 9.1-1 Sampling plan for MDA-N, C-15-005, and C-15-006.

Although Phase I samples did not indicate the presence of COPCs, we believe further characterization of the landfill is warranted. Phase II investigation is planned for FY97, to better characterize the MDA.

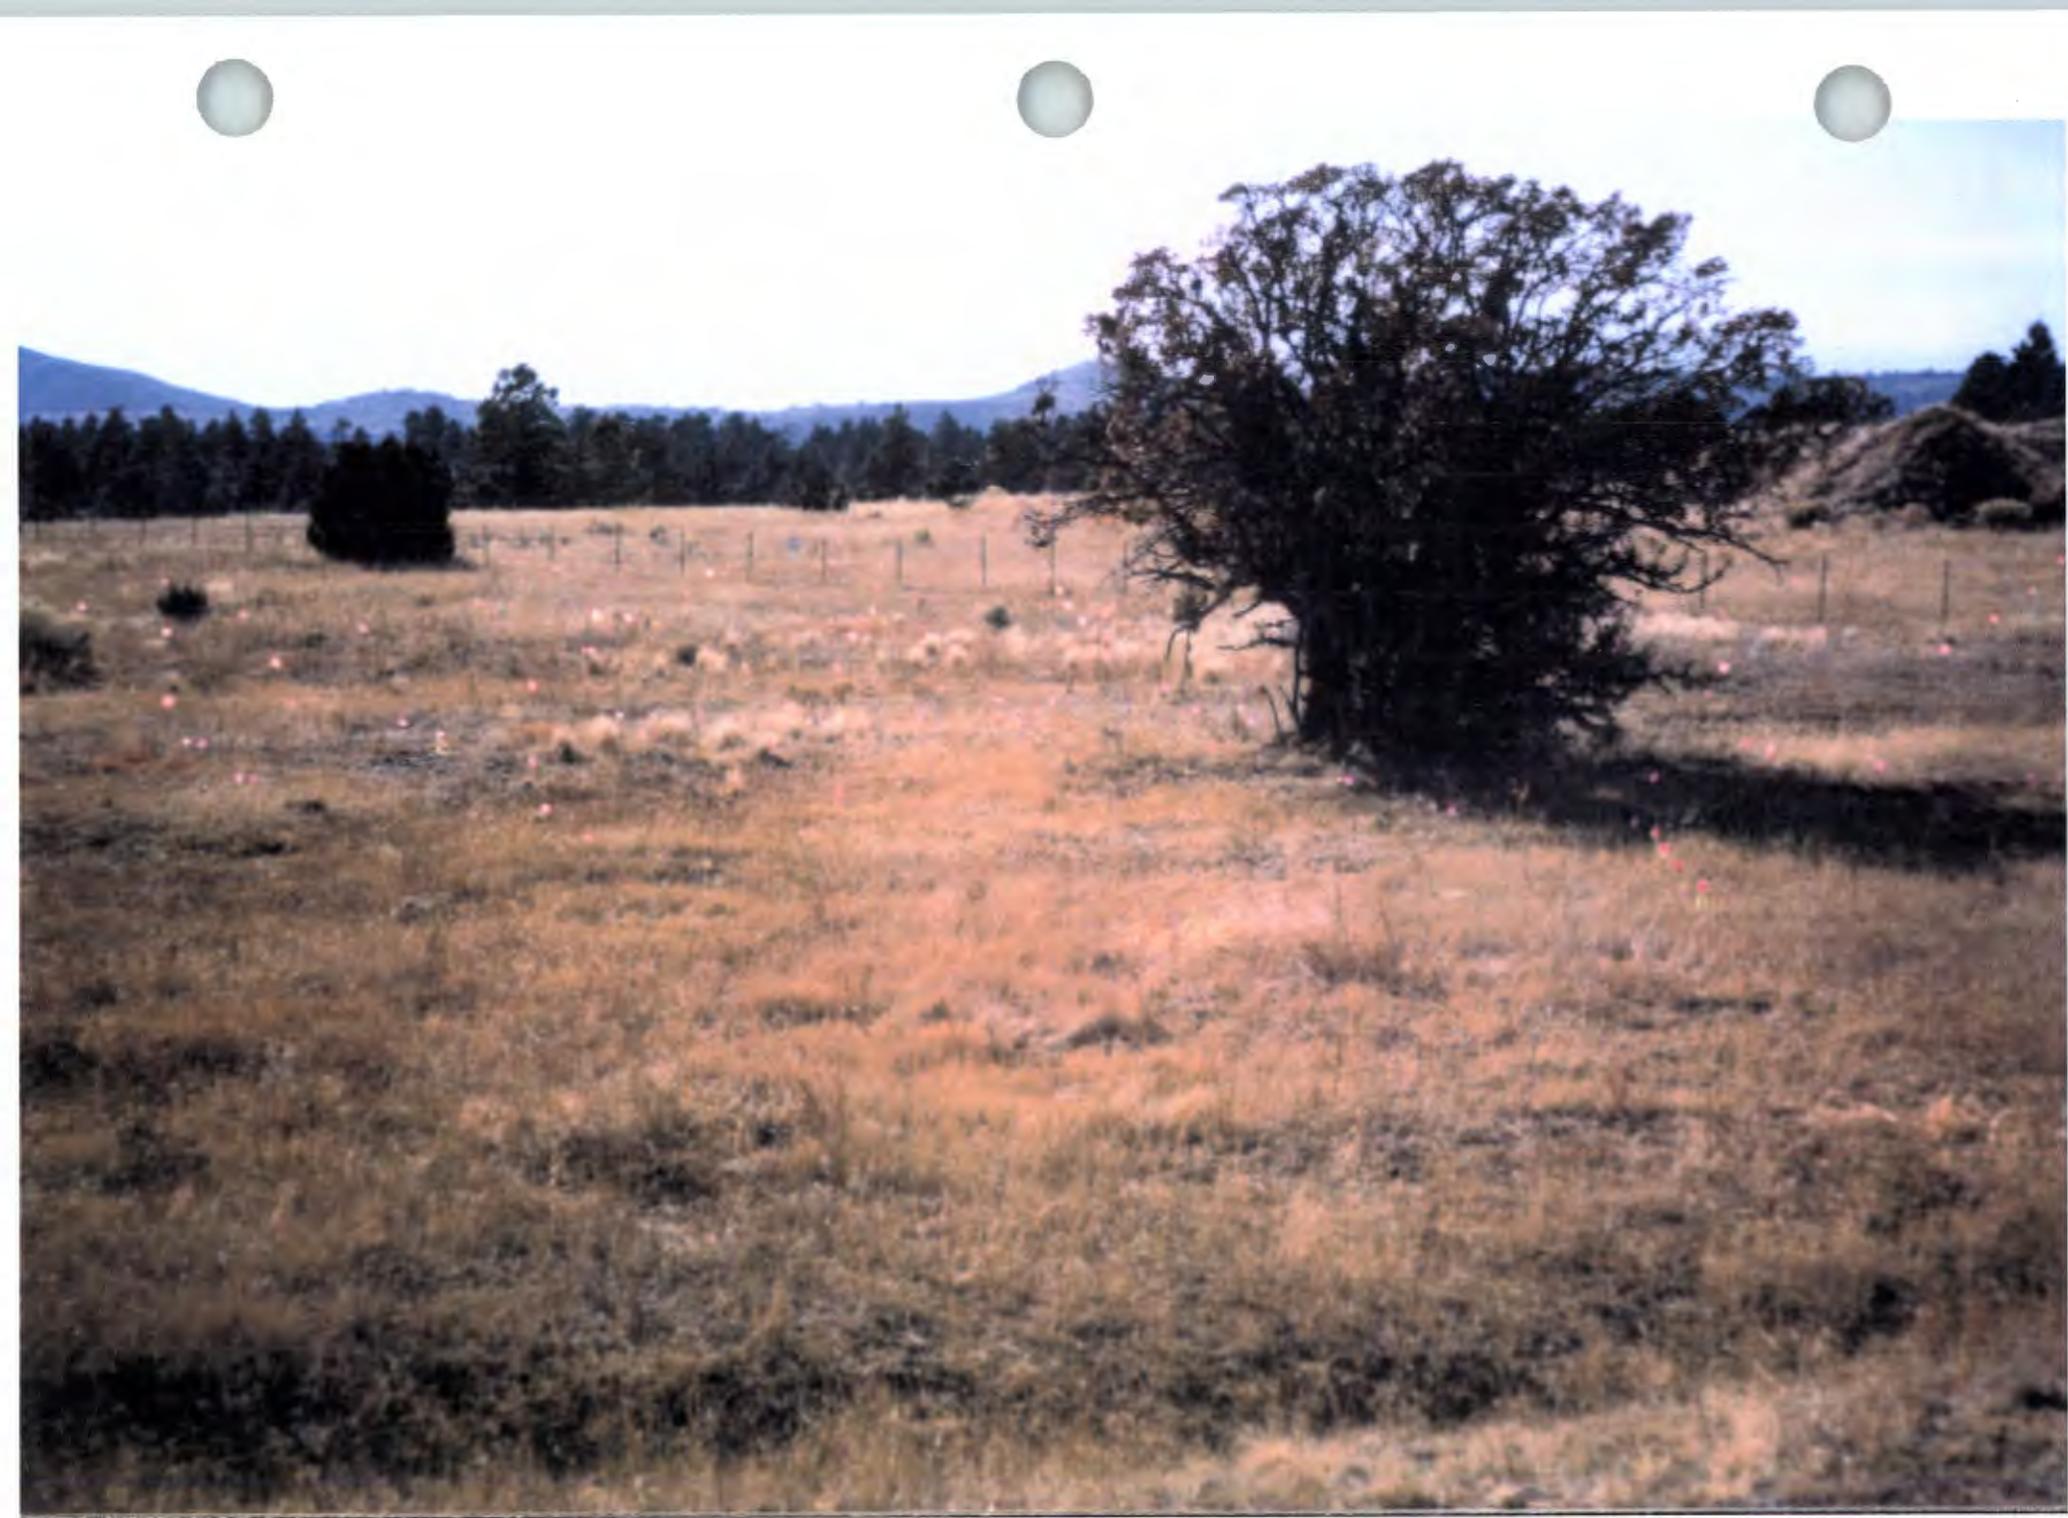
FIRING SITE A-B

Figure 8.3-1 Site diagram and sampling grid for Firing Sites A and B at TA-15. (The PF designations refer to the site of samples taken prior to the installation of a new sewage line, June 1992. See Fresquez 1991,0003.)

A Voluntary Corrective Action (VCA) Plan was prepared to describe the process to be followed in the removal of twelve 55 gallon drums of contaminated soil. Confirmatory sampling was conducted to verify total cleanup of the area of contaminants was achieved. Cleanup was accomplished in FY96.

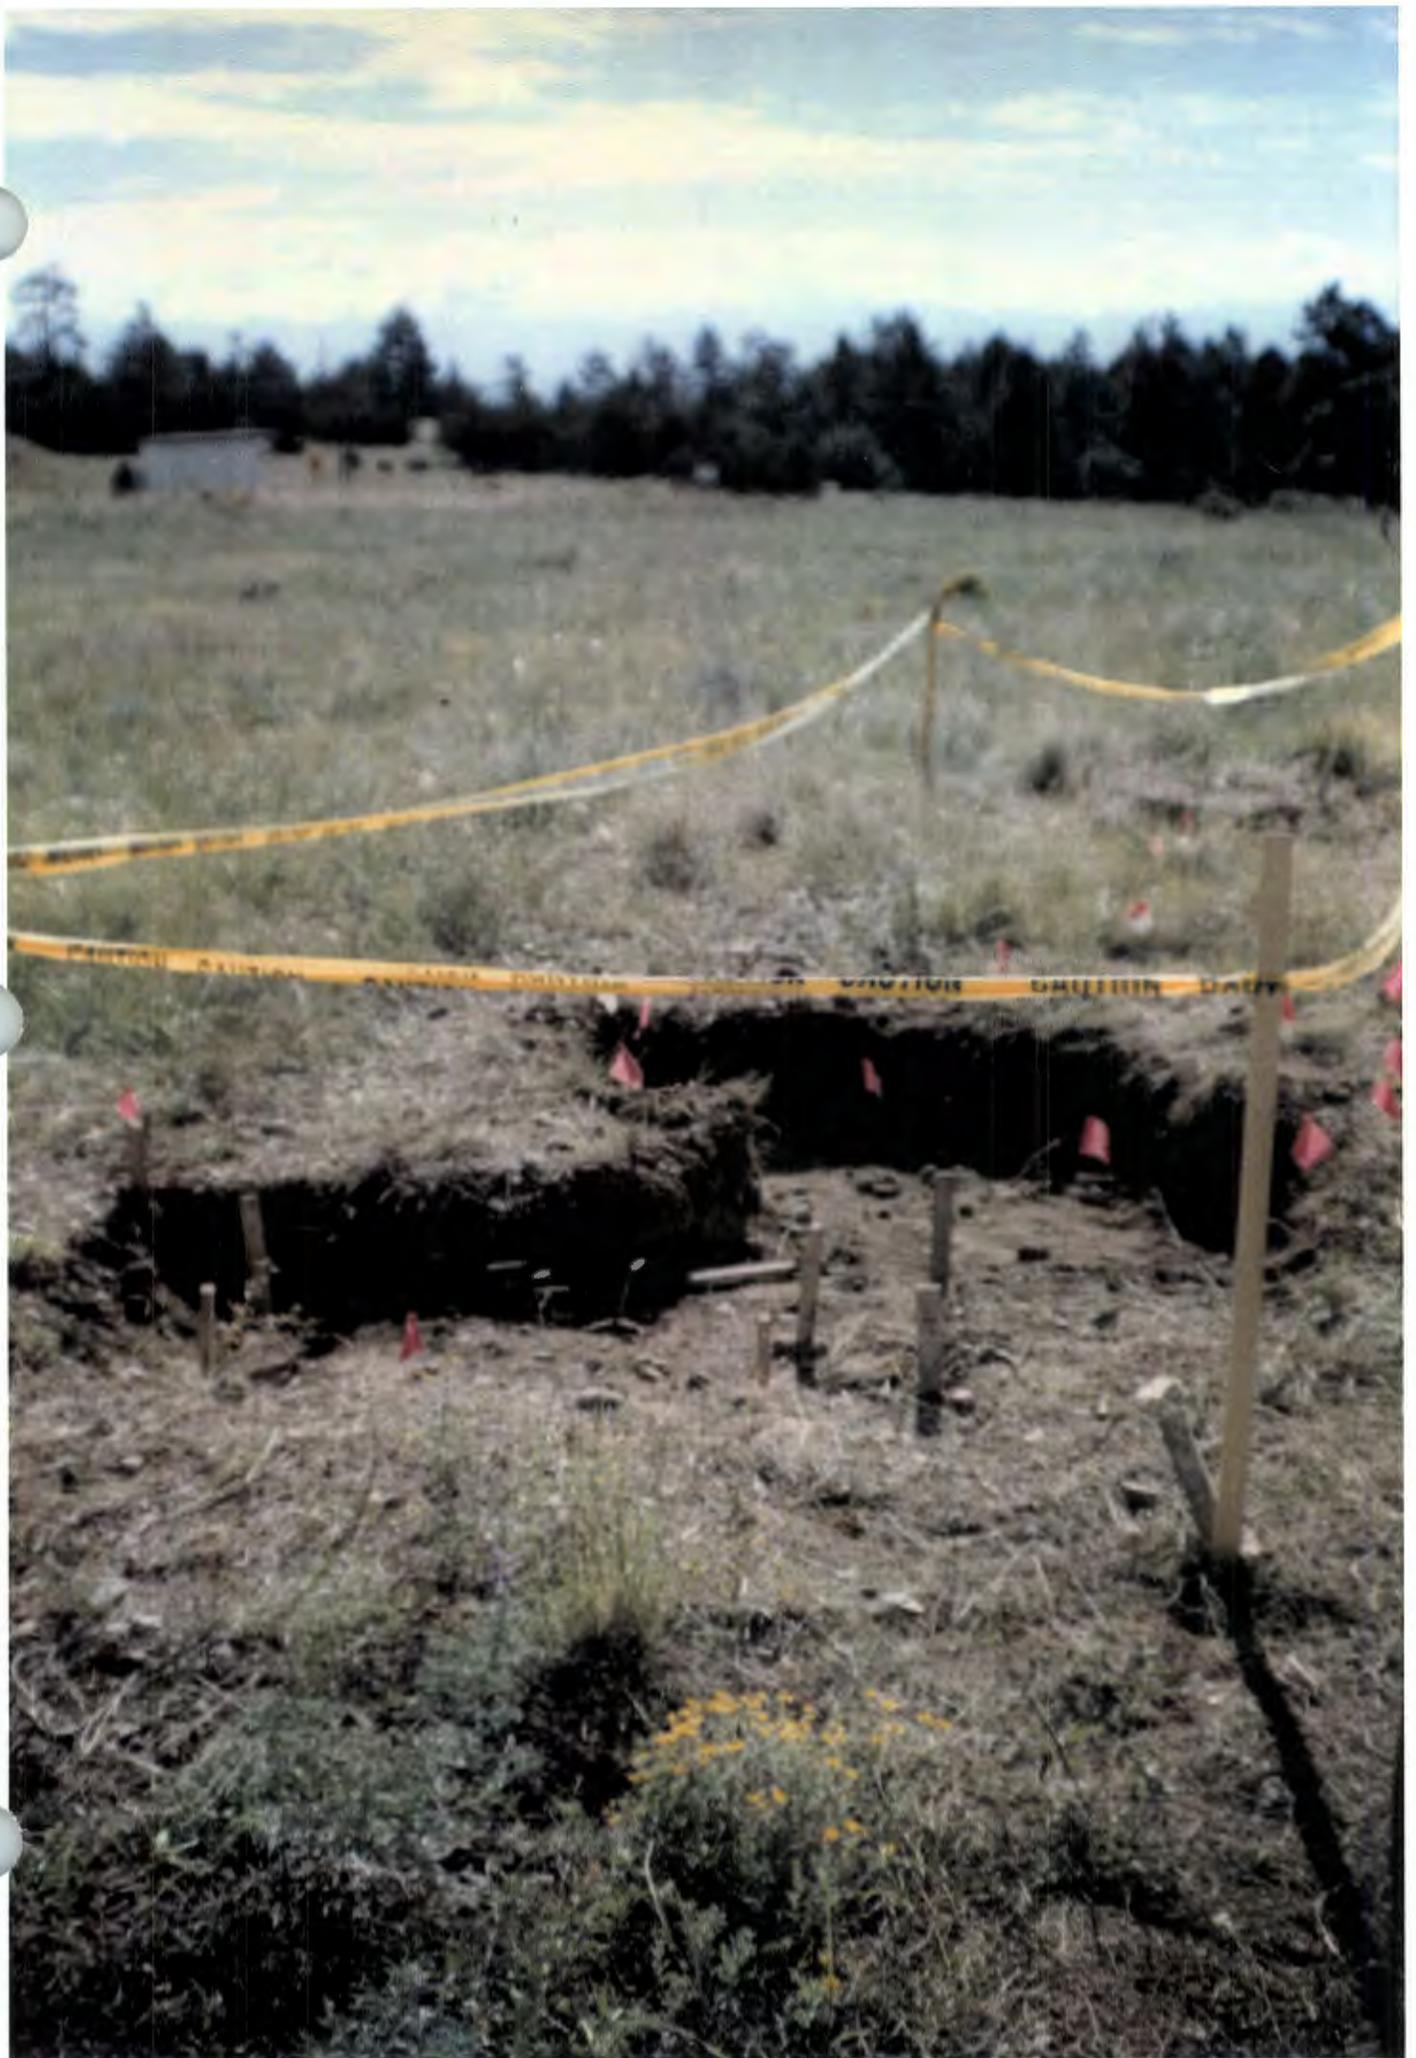
Initial construction at TA-15 (R-Site) was completed in 1944, and the site was ready for research equipment to be installed. Among the first sites to be used were Firing Sites A & B. They were located approximately 200 feet apart on a flat area southwest of the present day building TA-15-183. (See attached map and photo). The experimental work was done largely at Firing Site A, where the size of the explosions were relatively small. It is believed that any contamination by hazardous materials at Firing Sites A & B would be commingled in the area. Therefore, these two sites have been combined into one. Natural uranium was used to a large extent and only a few kilograms were employed at a time. Also other metals, presumably beryllium, lead and mercury were used in small amounts as well as small amounts of HEs. Both sites were used from approximately 1945 to 1952, at which time both sites were decommissioned and the land regraded in 1967. Before decommissioning, two structures associated with Firing Sites A & B were surveyed and found to have no detectable levels of either radioactive matter or HEs.

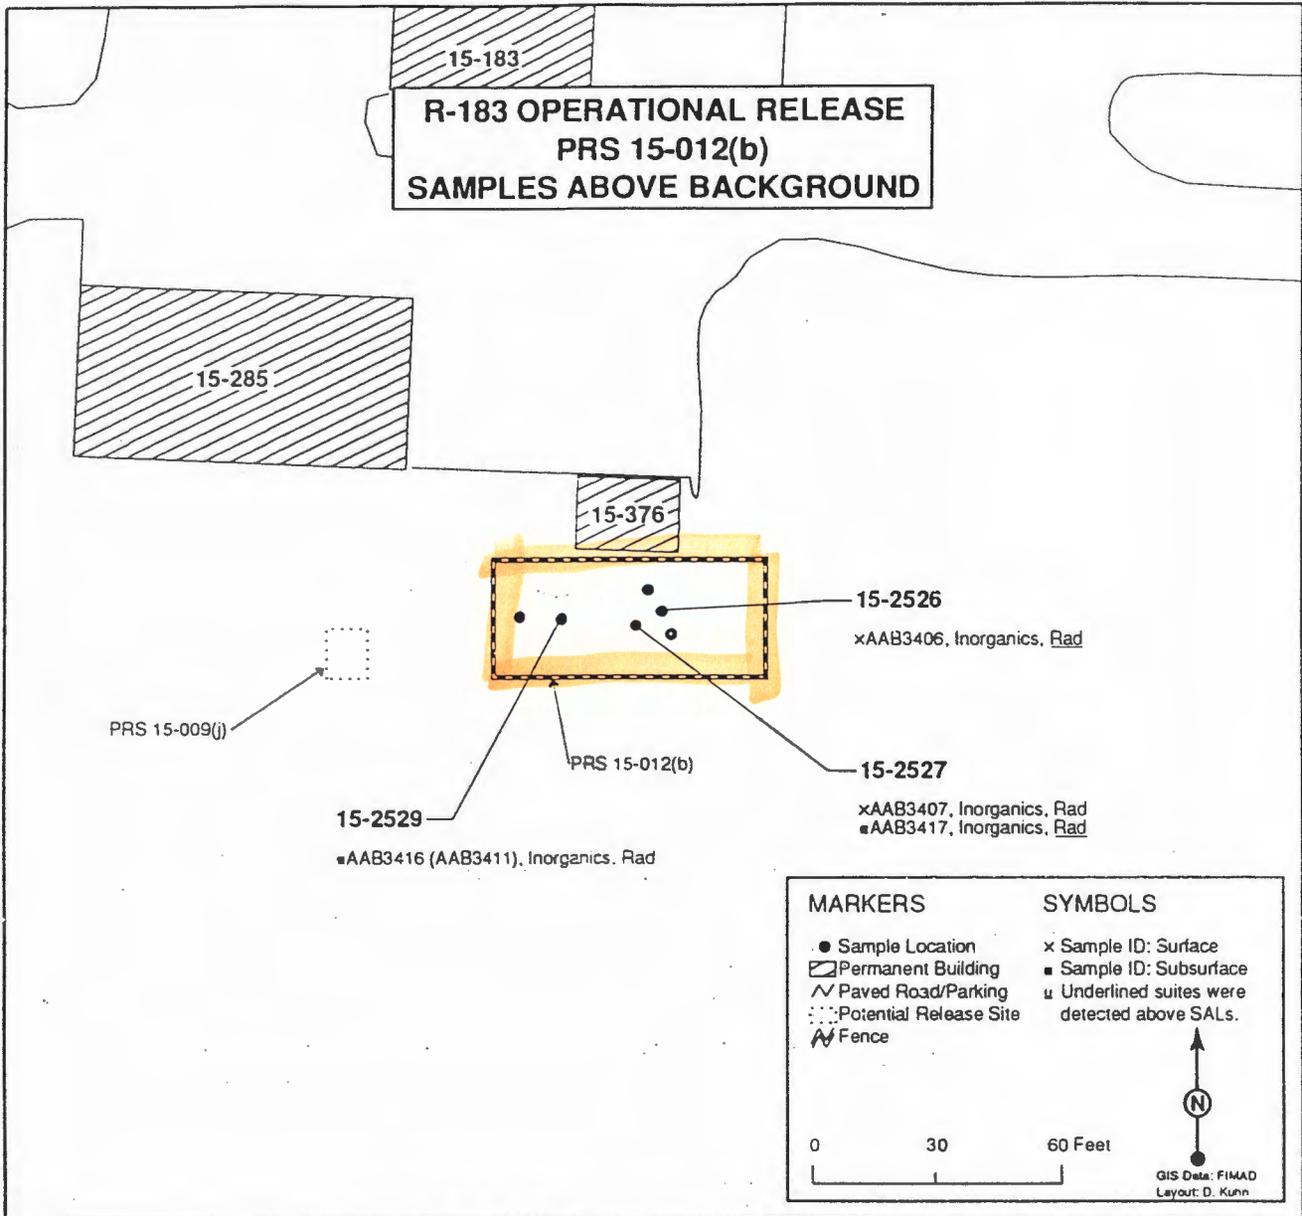
Figure 4-11. Locations of samples above background

A Voluntary Corrective Action (VCA) plan will be prepared to describe the process to be followed in the removal of approximately 150-300 cubic yards of contaminated soil. Confirmatory sampling will be conducted to verify total cleanup of the contaminants was achieved. Cleanup is scheduled for FY97.

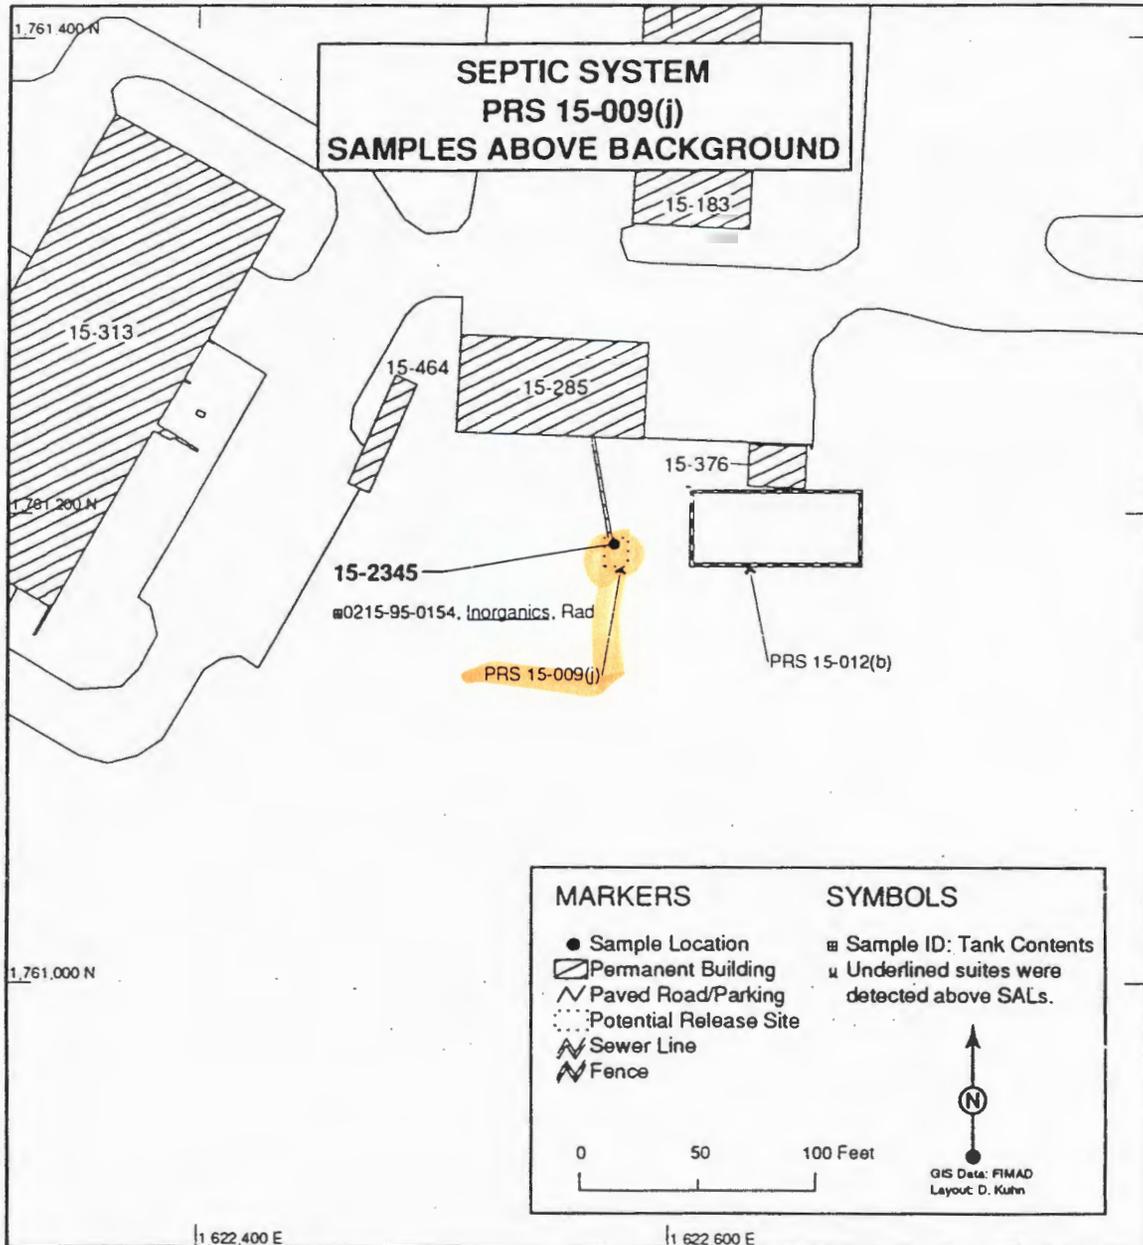
Figure 4-12. Locations of samples above background

A Voluntary Corrective Action (VCA) plan will be prepared to describe the process to be followed in the removal of the named contaminants and the cleaning of the tank. Confirmatory sampling will be conducted to verify total cleanup of the contaminants was achieved. Cleanup will be accomplished during FY97.
