**TA-15 SITE
TOUR**

**NMED BUREAU
PERSONNEL**

**DECEMBER 19,
1996**

PROPOSED ACTIONS FOR TA-15

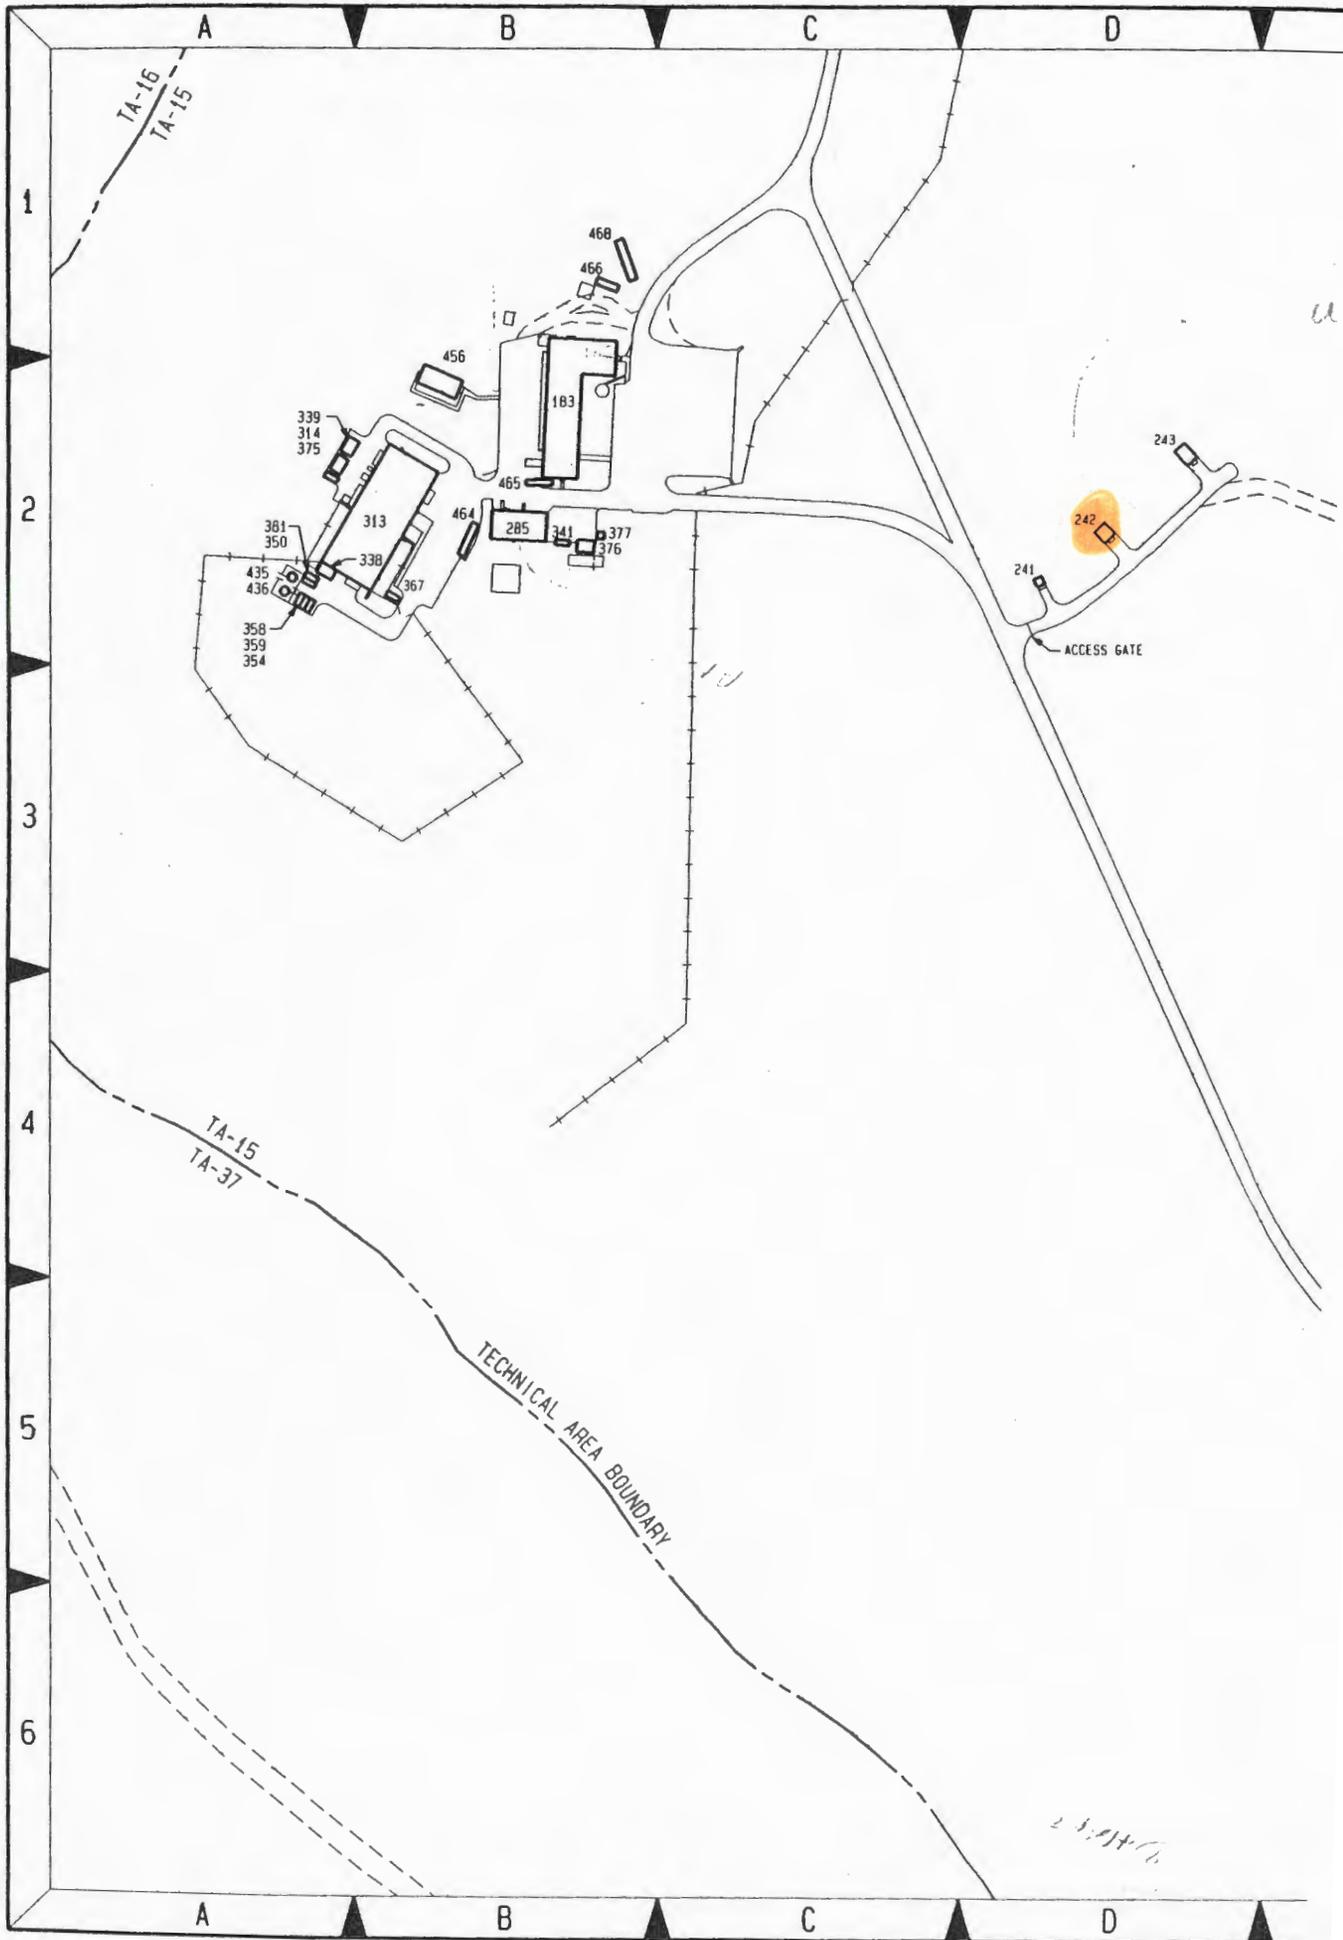
Figure 5.30.4.3-1 Location of PRS 15-005(b) samples

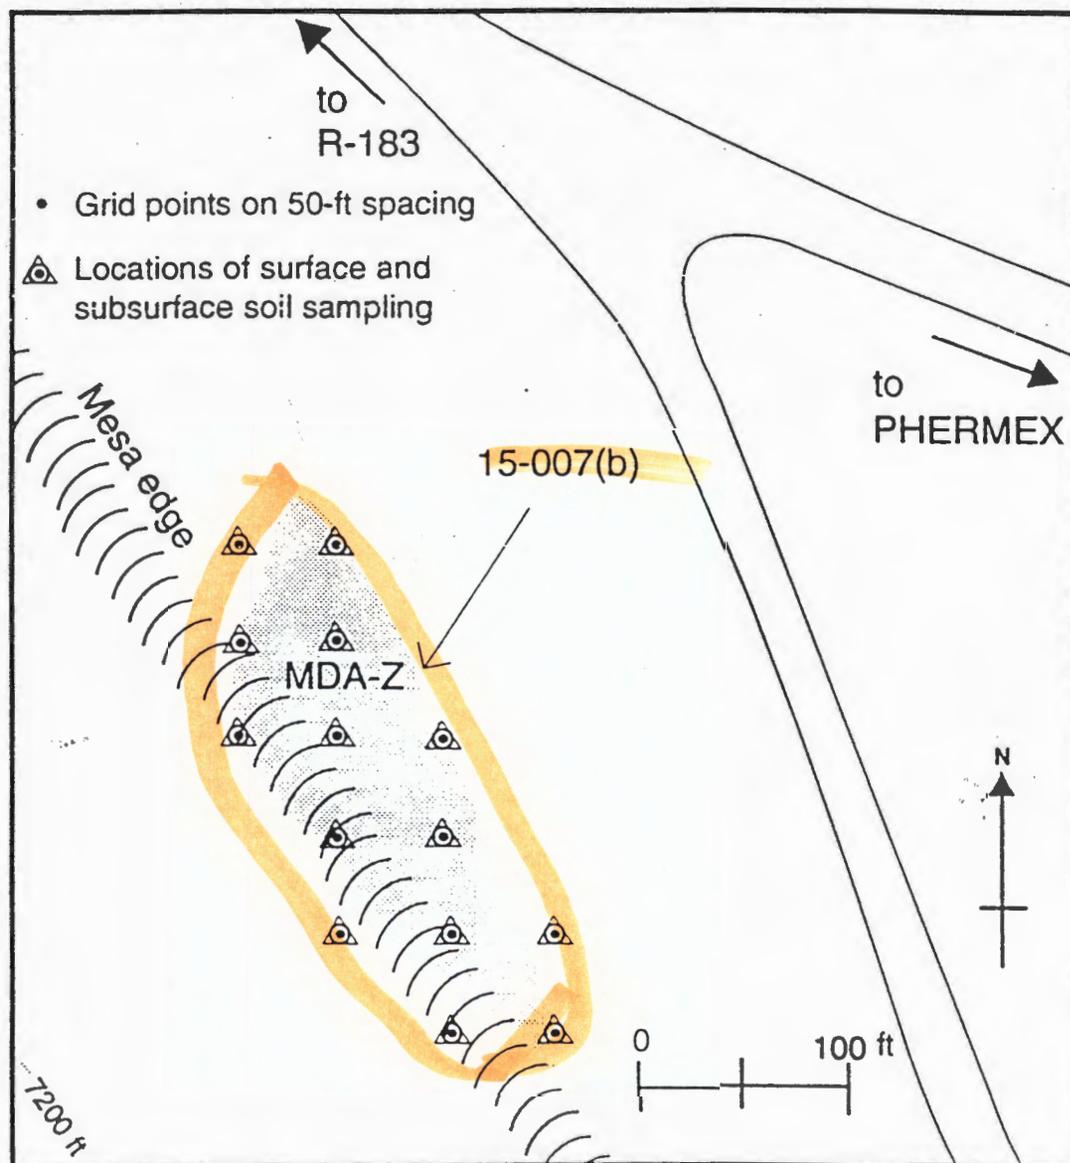
Figure 9.2-2 Sampling plan for MDA-Z [15-007(b)].

Confirmatory sampling will be conducted to verify total cleanup of contamination was achieved.

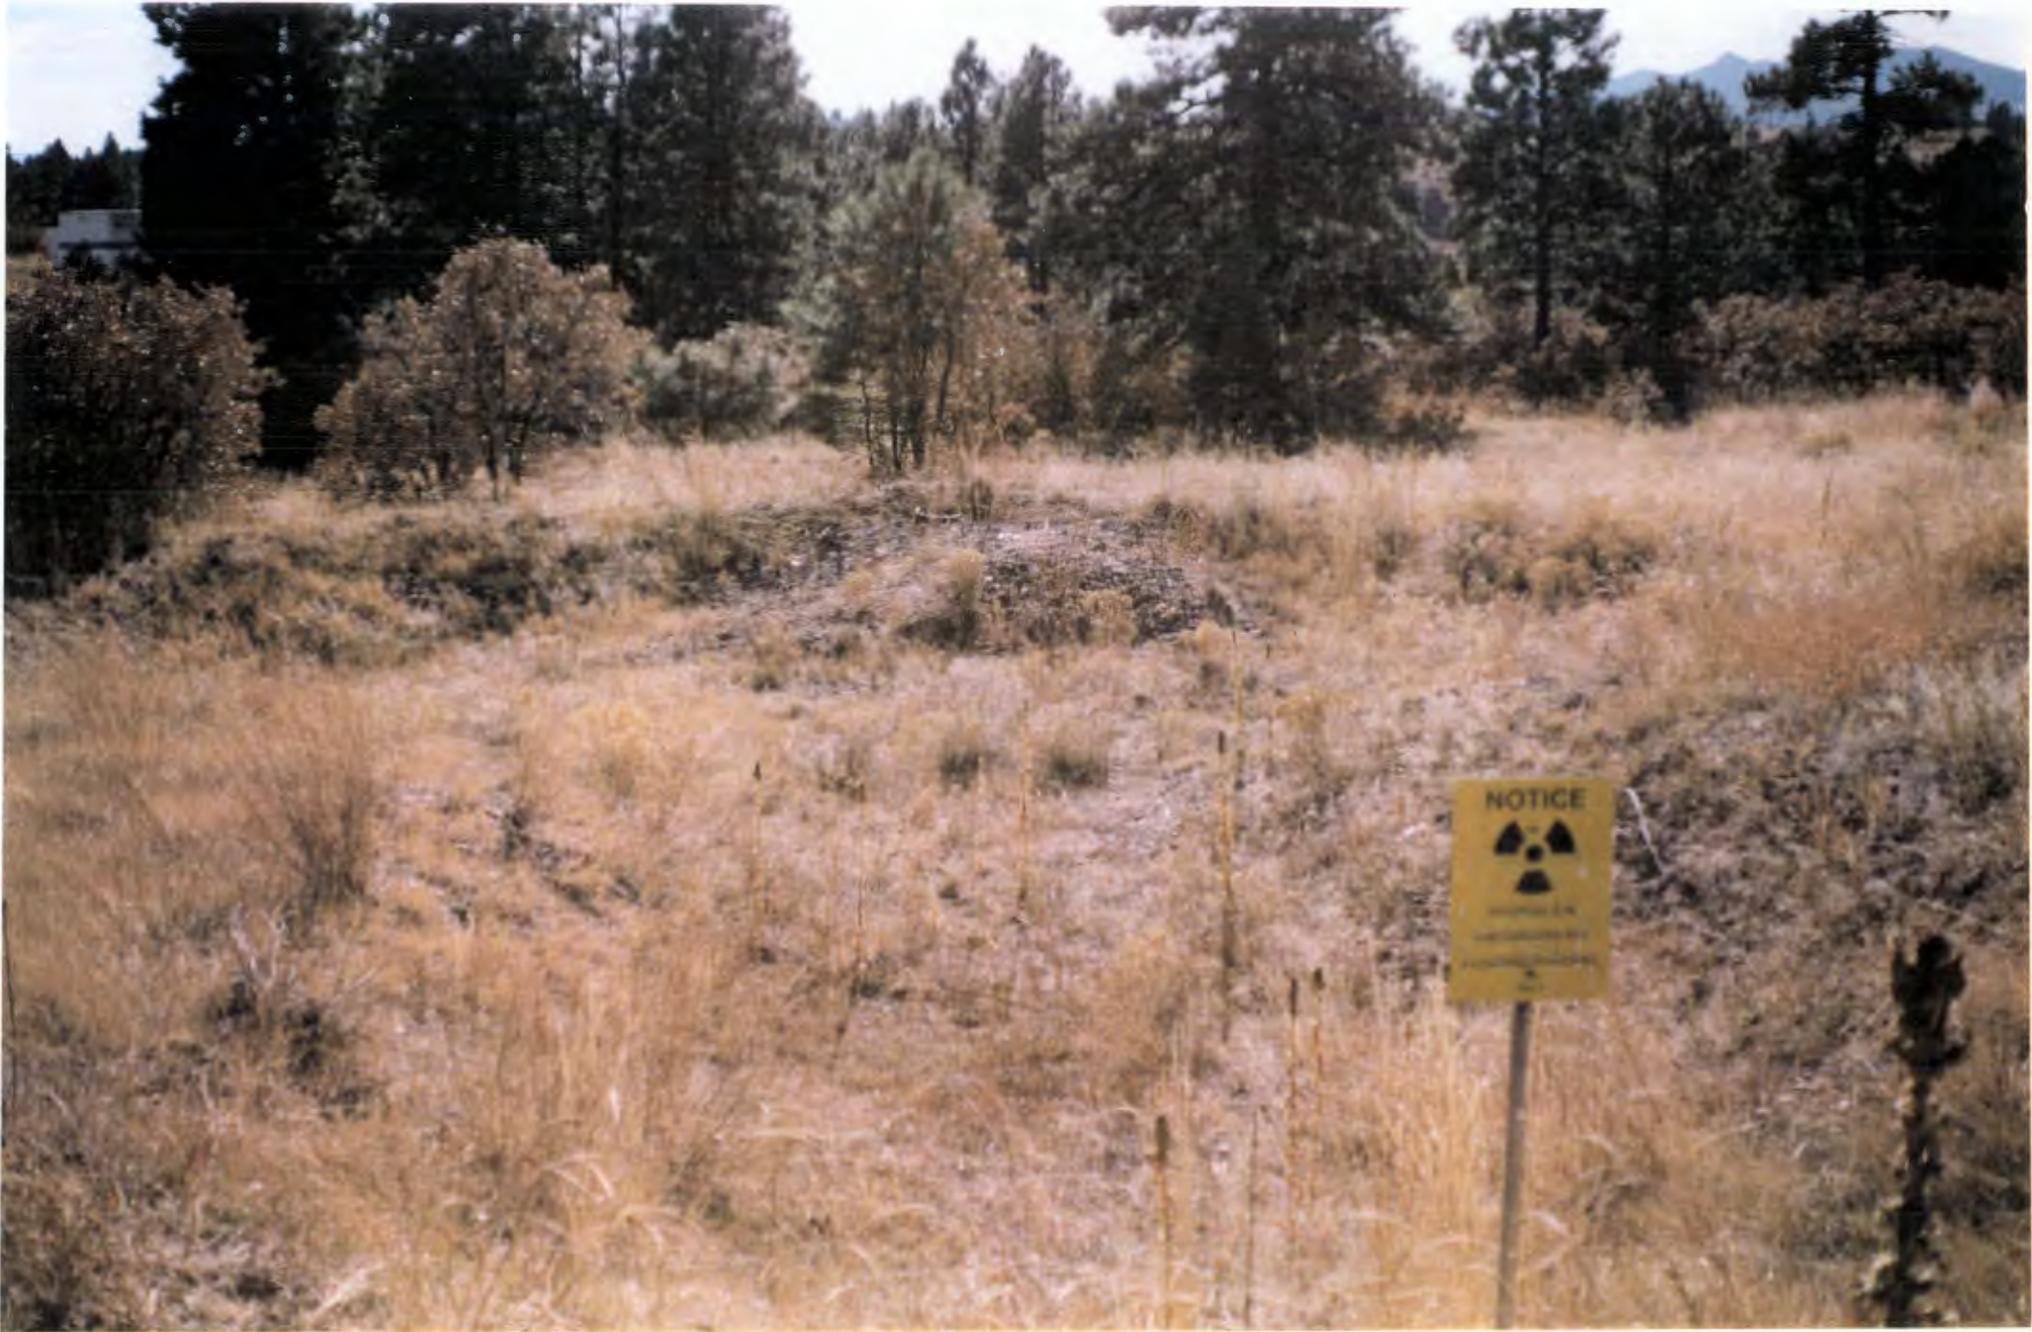
Figure 8.5-1 Site diagram and sampling grid for Firing Site G at TA-15.

The Surface Disposal Area, PRS 15-008(c), is within the security boundaries of TA-15 and is located west of building TA-15-233, and south of Firing Site G, across a single lane asphalt road. (See attached map and photo). A radiological survey and soil sampling of the area was conducted in 1987. Exposure rates and uranium concentrations in soil samples were measured, however no HEs were found. The disposal area measures approximately 10 feet by 30 feet and is suspected of being radioactively contaminated.
