**Subject: Inspection and Maintenance of Erosion Controls in Drainages to the 90s Line Pond at Technical Area 16**

This letter documents the status of storm water management associated with the drainages entering the 90s Line Pond, Consolidated Unit 16-008(a)-99. This letter is required as part of the New Mexico Environment Department's (NMED's) Notice of Approval with Direction (for the) Investigation Report for Consolidated Units 16-007(a)-99 and 16-008(a)-99 at Technical Area 16, Revision 1, dated February 11, 2008, and Approval with Modifications (for the) Supplemental Investigation Work Plan for Consolidated Units 16-007(a)-99 and 16-008(a)-99 at Technical Area 16, dated December 31, 2008.

Attachment: Two hard copies with electronic files – Figures for the Inspection and Maintenance of Erosion Controls in Drainages to the 90s Line Pond at Technical Area 16 (EP2015-0195)

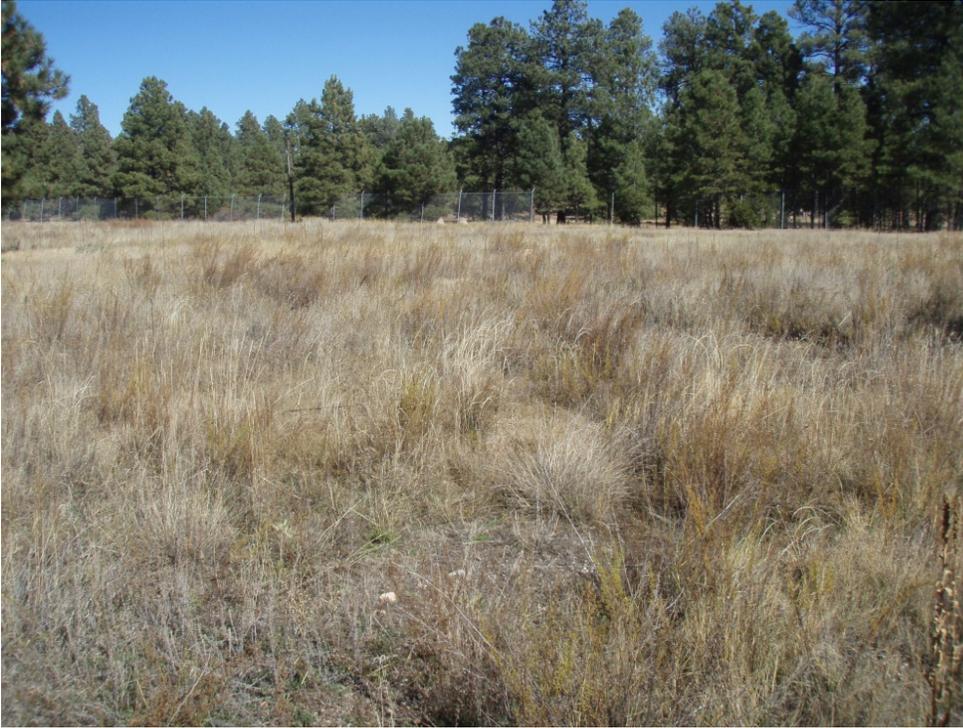
The individual solid waste management units (SWMUs) within Consolidated Unit 16-008(a)-99 are located within a level, well-vegetated area in Technical Area 16 (Figures 1 and 2). Surface flows generated in the area discharge to the 90s Line Pond have little potential to reach any waters of the U.S. The 90s Line Pond was remediated and has no outlet.

**Figure 1** Vegetated area draining to 90s Line Pond

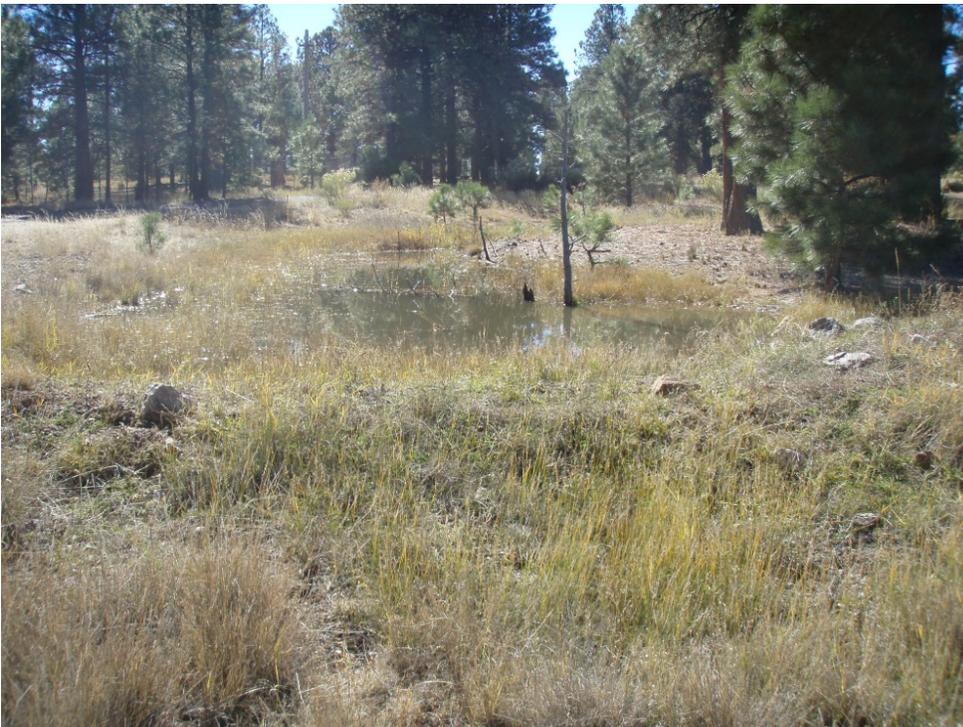
**Figure 2** Run-on control berm in the vegetated area draining to 90s Line Pond

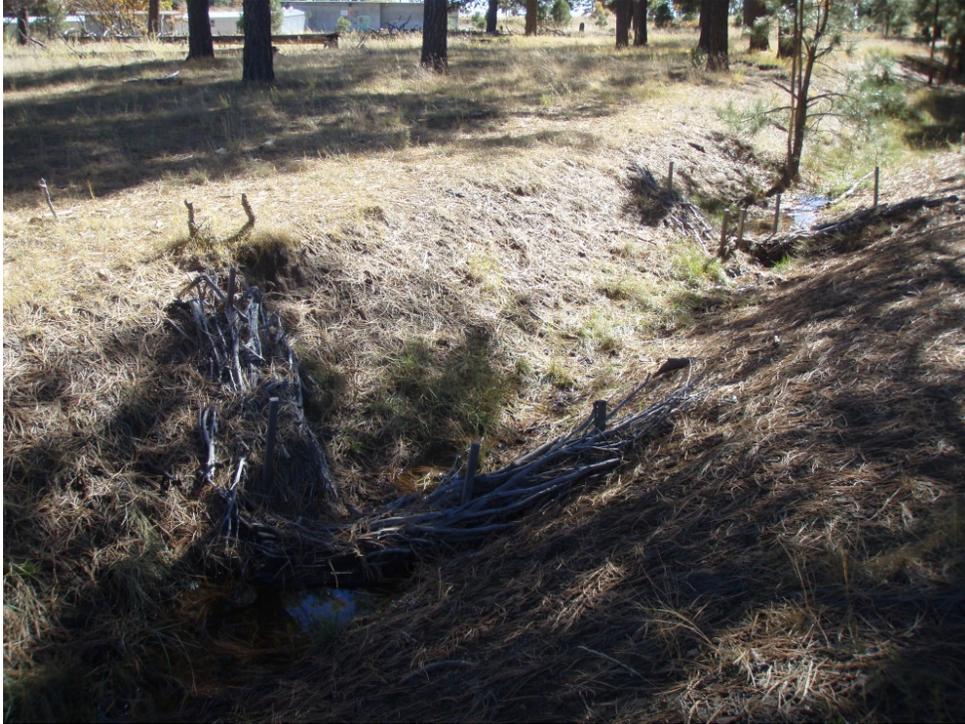
Best management practices (BMPs) were installed in 2008 in the drainages to the 90s Line Pond. The BMPs consist of juniper bales designed to block sediment transport down the drainages into the pond. All controls are currently in good operating condition with no evidence of erosion in the drainages (Figures 3 to 5).

**Figure 3** Juniper bale check dams located in drainage channel to 90s Line Pond, November 2015. Note needle cast and vegetation in channel.

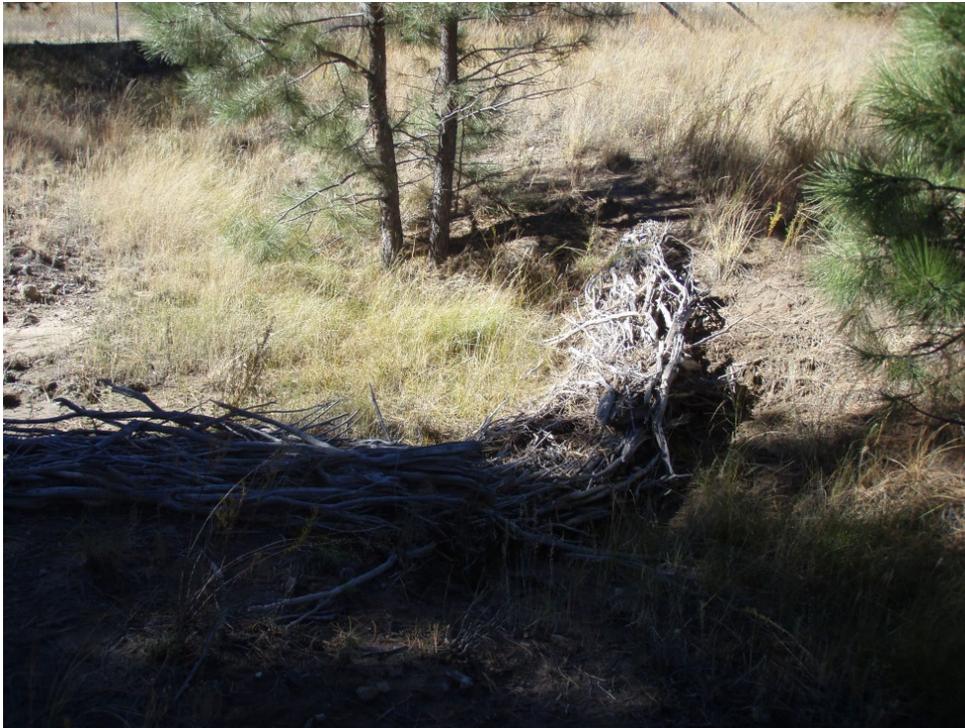
**Figure 4** Juniper bale check dam located in drainage channel to 90s Line Pond, November 2015. Note vegetation in channel.

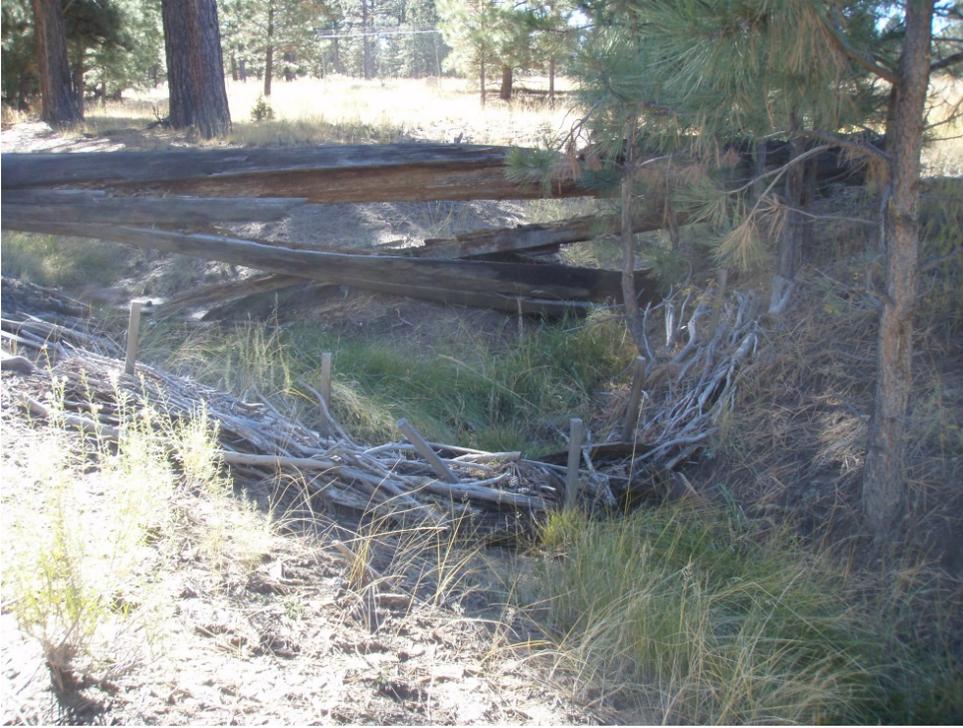
**Figure 5** Juniper bale check dam located in drainage channel to 90s Line Pond, November 2015. Note vegetation in channel.
