**Voluntary Corrective  
Measures  
Completion Report for  
Potential Release  
Sites**

16-013  
16-025(x)  
16-031(d)  
C-16-065  
C-16-068

**Field Unit 3**

LA-UR-97-3677

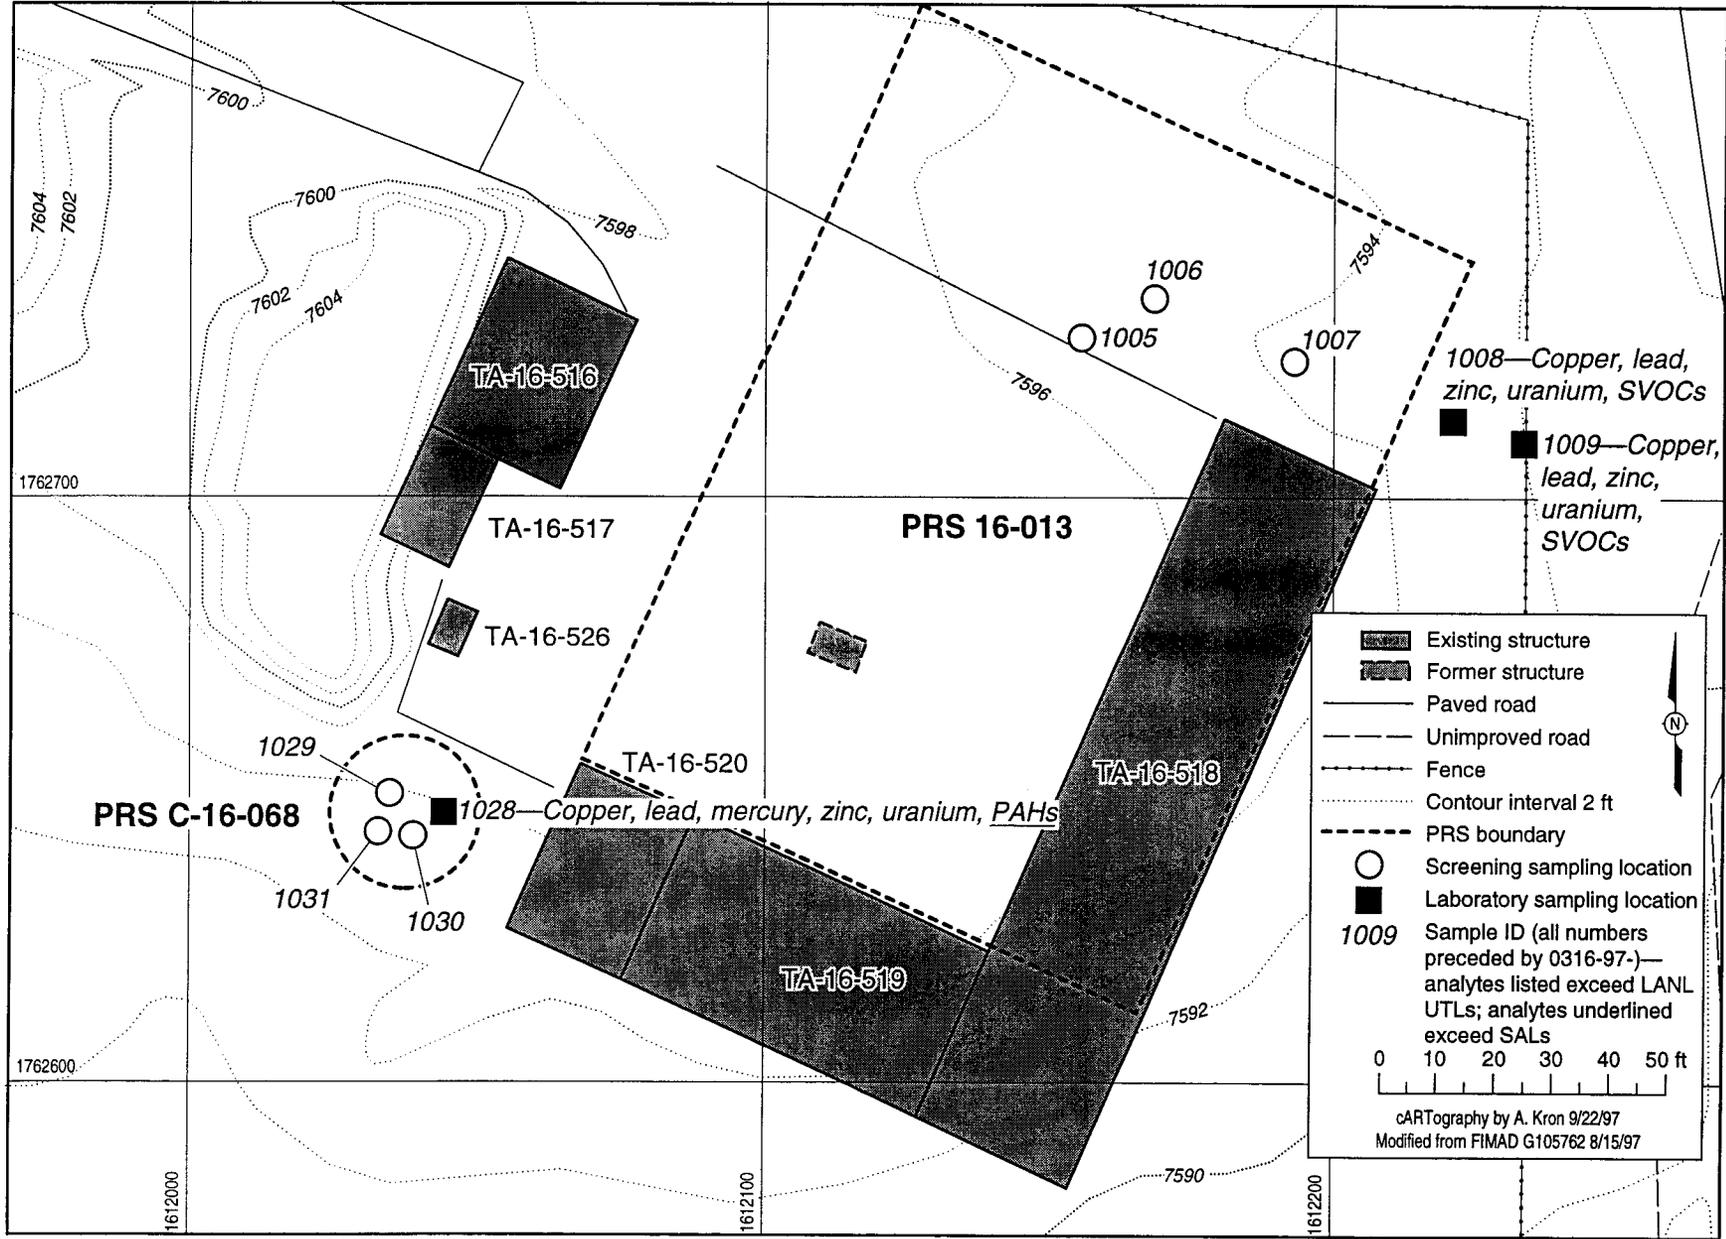
Fig. 1.1-2. Location of PRSs 16-013 and C-16-068 at V-Site.

PRS 16-013 is a waste storage area formerly located in the courtyard that is formed by buildings TA-16-516, TA-16-517, TA-16-518, TA-16-519, and TA-16-520 (Fig. 1.1-2). This site is proposed for human health NFA because all constituents detected were at levels below SALs and proposed cleanup levels.

A summary of the samples taken is presented in Table 2.1.3-2. Two samples were submitted for laboratory analyses. The location of these samples are shown in Fig. 1.1-2.

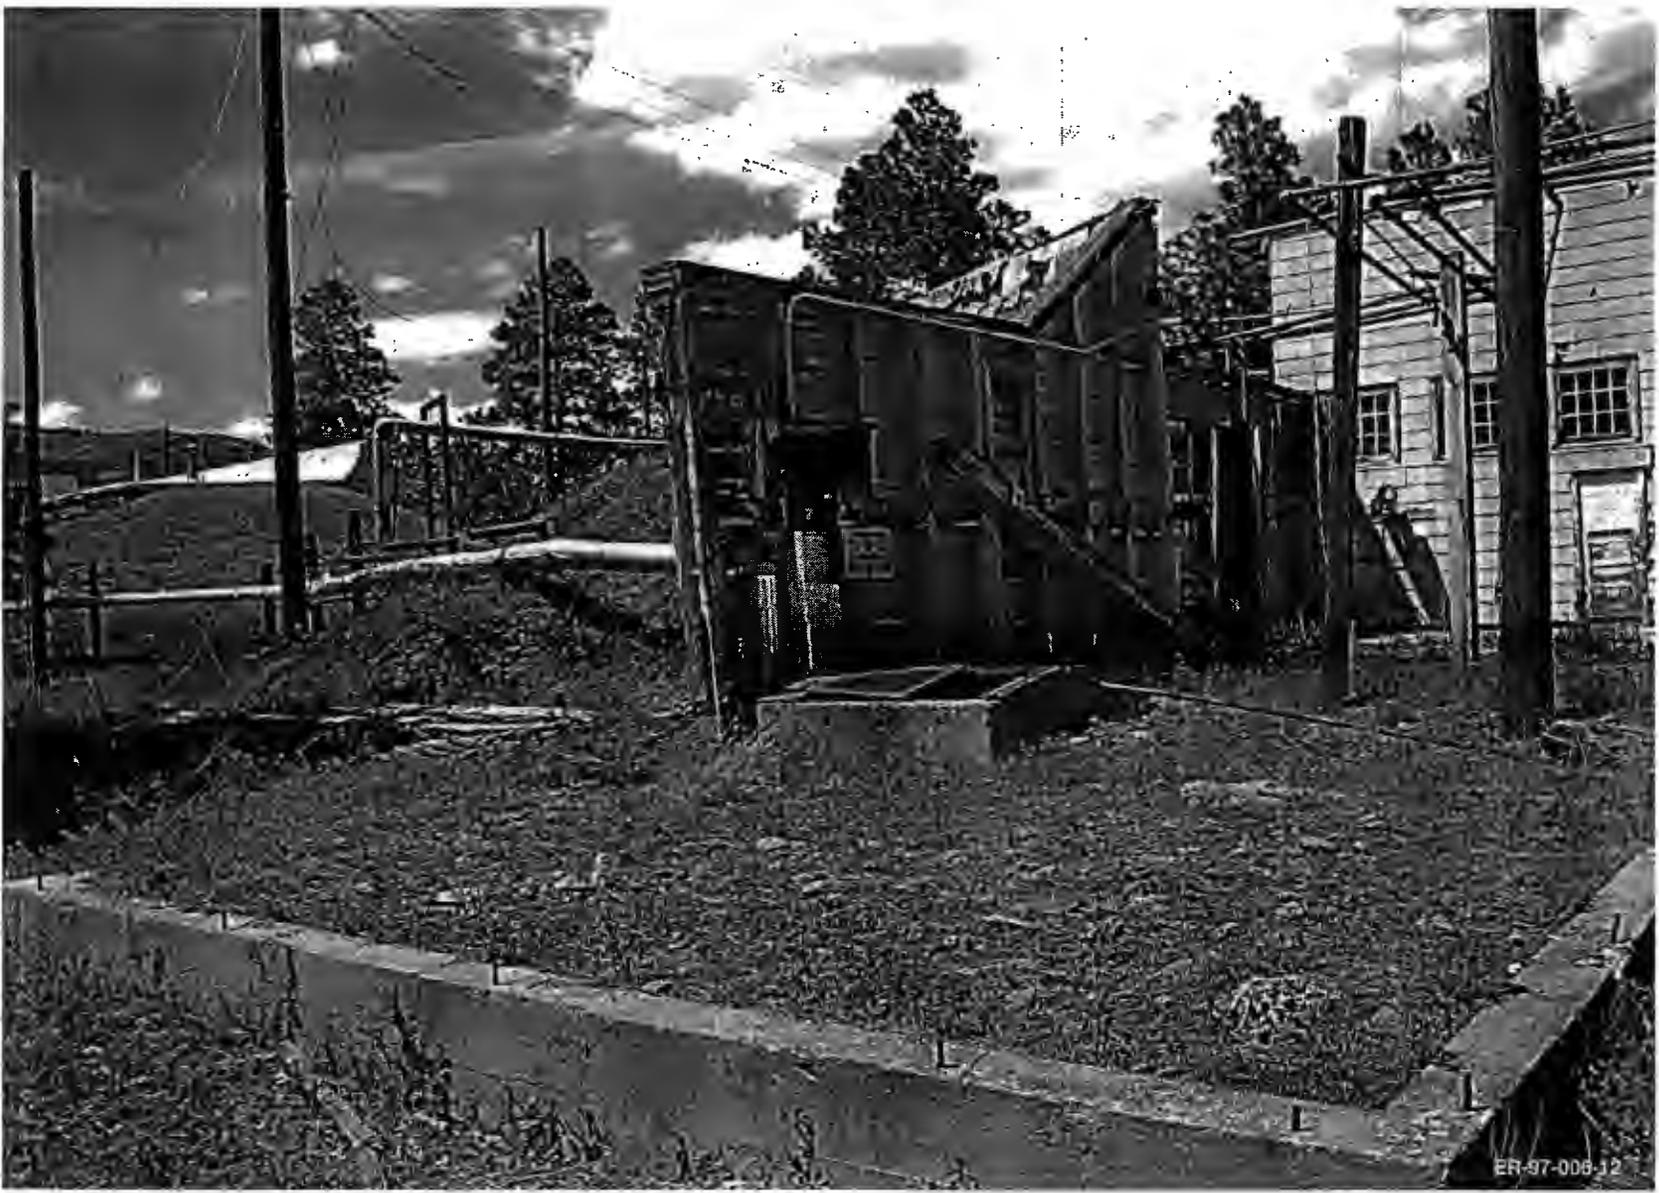
Four samples were collected from the former location of TA-16-522. A concrete foundation filled with soil remains at the site. Samples were collected within the building foundation from a depth of 6 in. using the spade/scoop sampling method. Work was conducted on May 20, 1997. Sample locations were randomly located within a four-celled stratified grid, with one location placed within each cell. The samples were screened for HE in accordance with the general cleanup strategy outlined in the VCM plan. All samples were first screened using the HE spot test kit; no HE was detected. Two samples were screened using the D-Tech kits for TNT and RDX. Two of the four screening samples with detected results are presented in Table 2.5.3-1. Significant concentrations of TNT (> 4.5 ppm) were not detected during screening; therefore, the Ensys kit, which detects TNB, was not used.

PRS C-16-068—Former Laboratory Building.

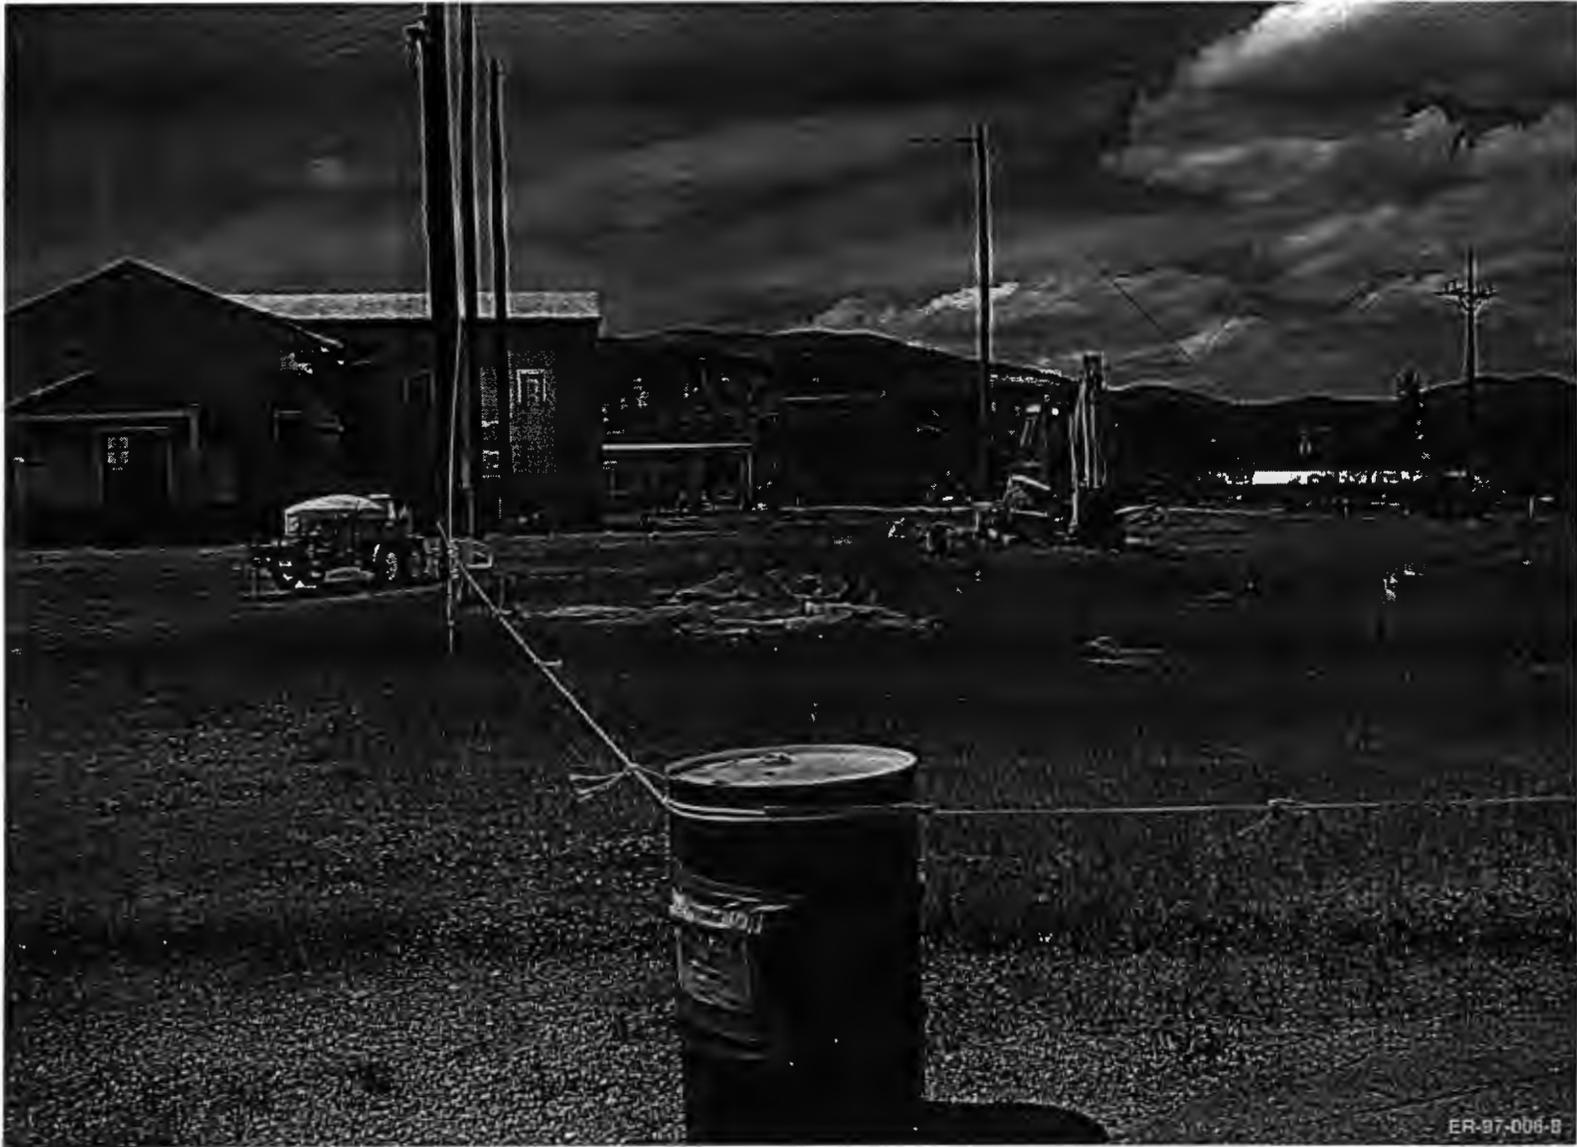
Benzo(a)pyrene, which is not a COPC at this site, was the only constituent detected above SAL but below cleanup level. There is no indication that PAHs were used at this site. C-16-065 is recommended for human health NFA because the only contaminant detected comes from a continuing source and is not PRS-specific.

PRS C-16-065—Storage Area.

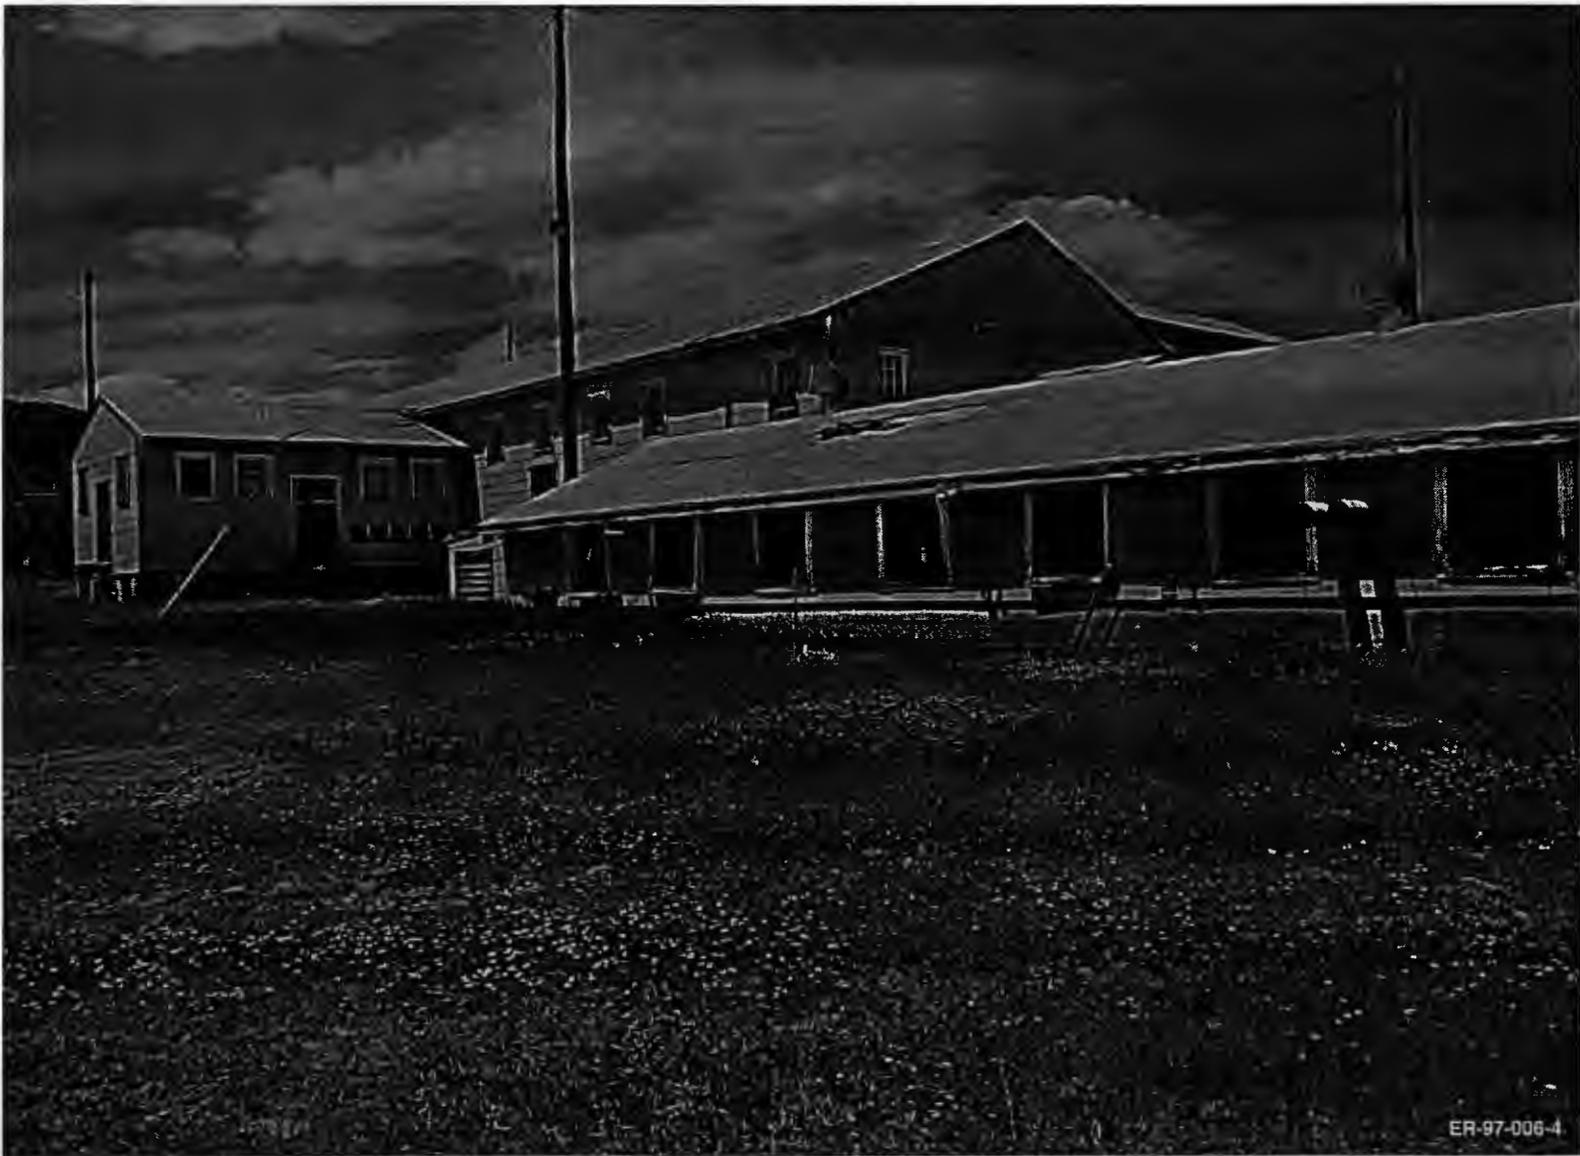
Analytical results for PRS 16-031(d) indicate no contaminants at concentrations greater than the cleanup level; therefore, this PRS is recommended for human health NFA.

PRS 16-031(d)—Location of Former Cooling Tower.

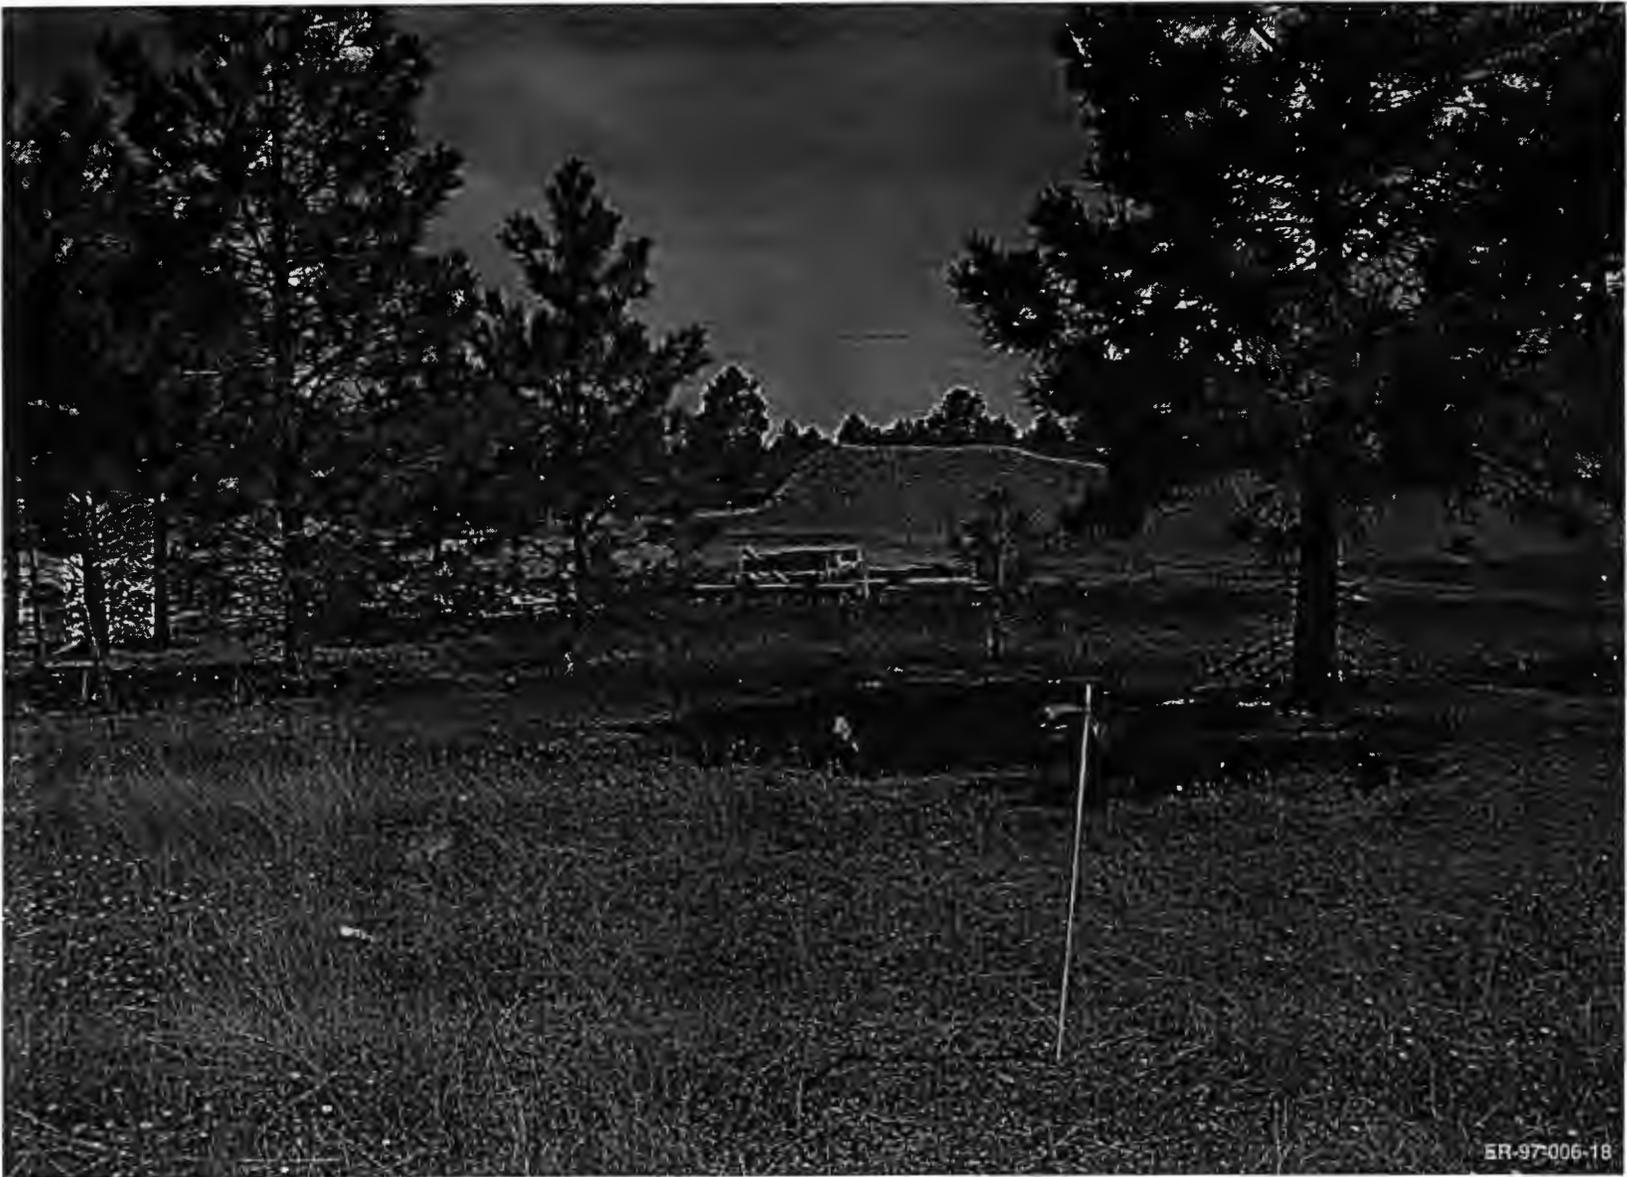
PRS 16-025(x) is the building footprint of a former electroplating laboratory and is proposed for human health NFA because no analytes were detected above SALs and proposed cleanup levels.

PRS 16-025(x)—Electroplate Lab (Abandoned)

The available data for PRS 16-025(x) indicate that COPCs were not detected above cleanup levels and SALs; this site is therefore recommended for human health NFA.

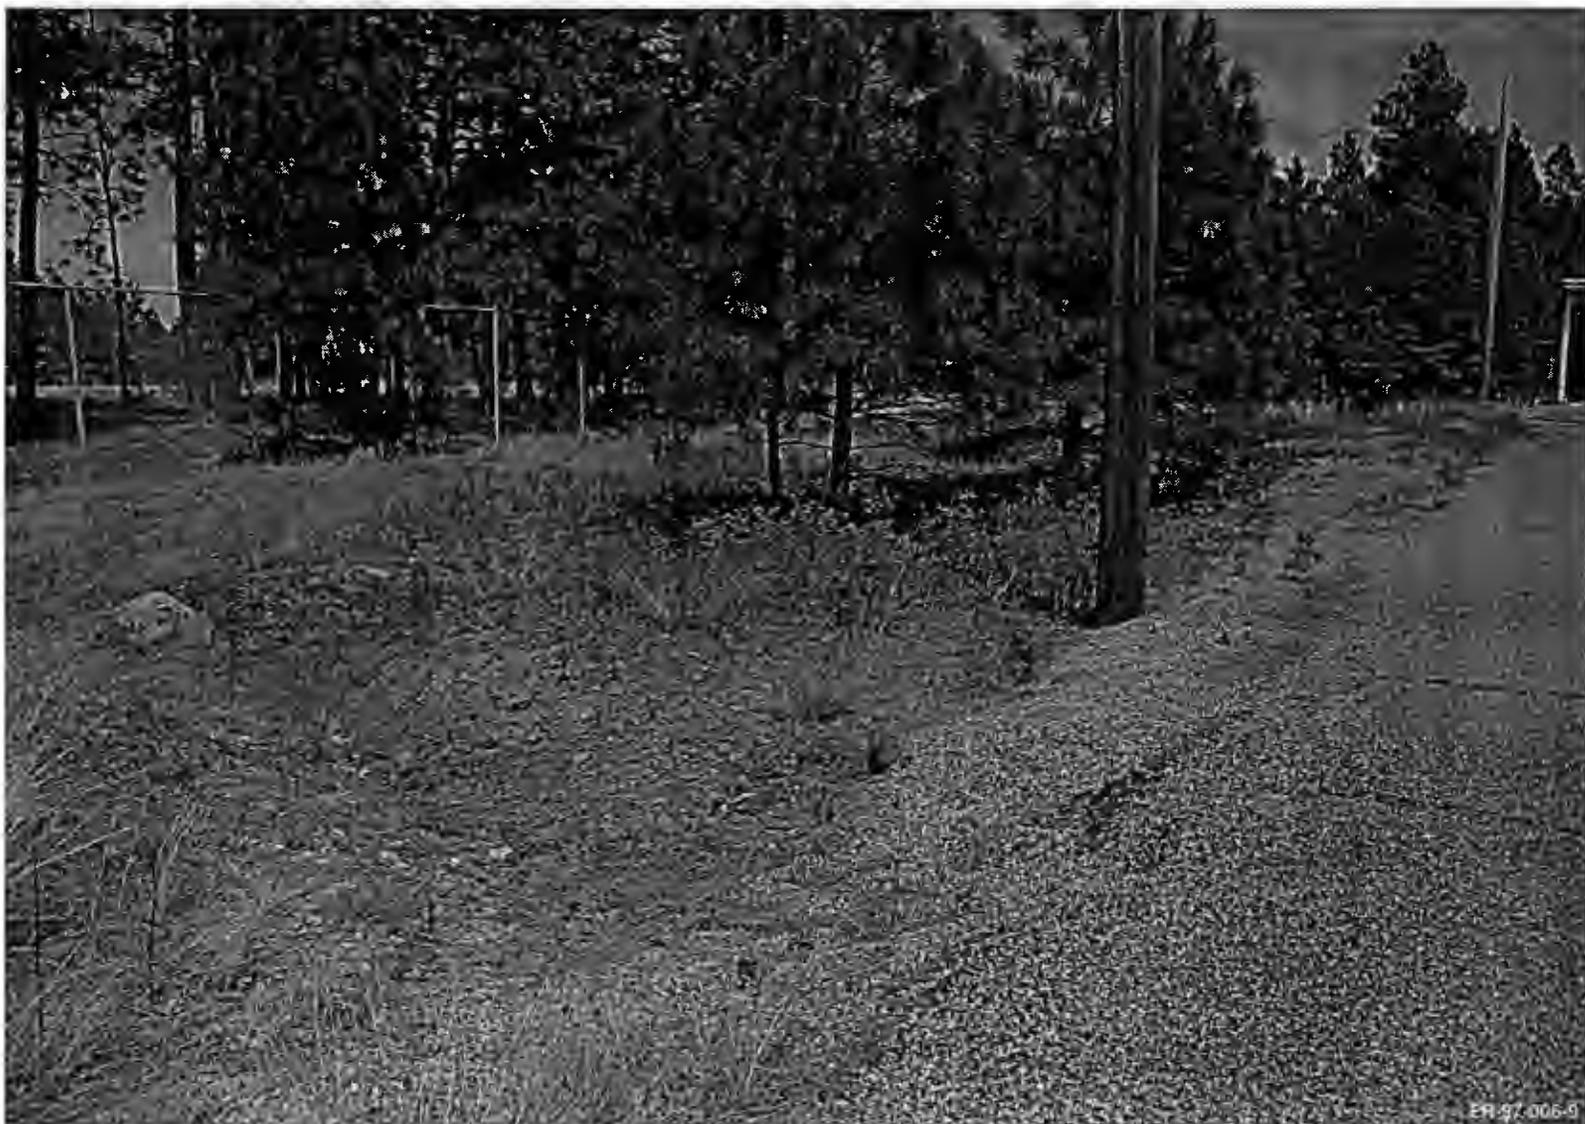
Five screening locations were selected in the shallow drainage ditch where runoff from the paved portion of 16-013 courtyard could have accumulated. The selection of two laboratory samples was biased using the results of the field screening.

PRS 16-013—Drainage from Container Storage Area.

The data for 16-013 clearly indicate analytes above LANL UTLs but well below proposed cleanup levels and SALs; therefore, this PRS is recommended for human health NFA.
