# Los Alamos National Laboratory

ENVIRONMENTAL RESTORATION

**SUBJECT: STORMWATER CONTROLS AT TECHNICAL AREA (TA)**

The Los Alamos National Laboratory is conducting a Phase II Resource Conservation and Recovery Act Facility Investigation at TA-32, the former Medical Research Facility located on Trinity Drive. A site survey was conducted in February 1996 to document potential stormwater run-on and runoff impacts for Potential Release Sites (PRSs) 32-002(a,b). Stormwater run-on from the Los Alamos County Maintenance Complex was identified as a potential source to mobilize contaminants associated with the outfall and canyon bench area of PRSs 32-002(a,b).

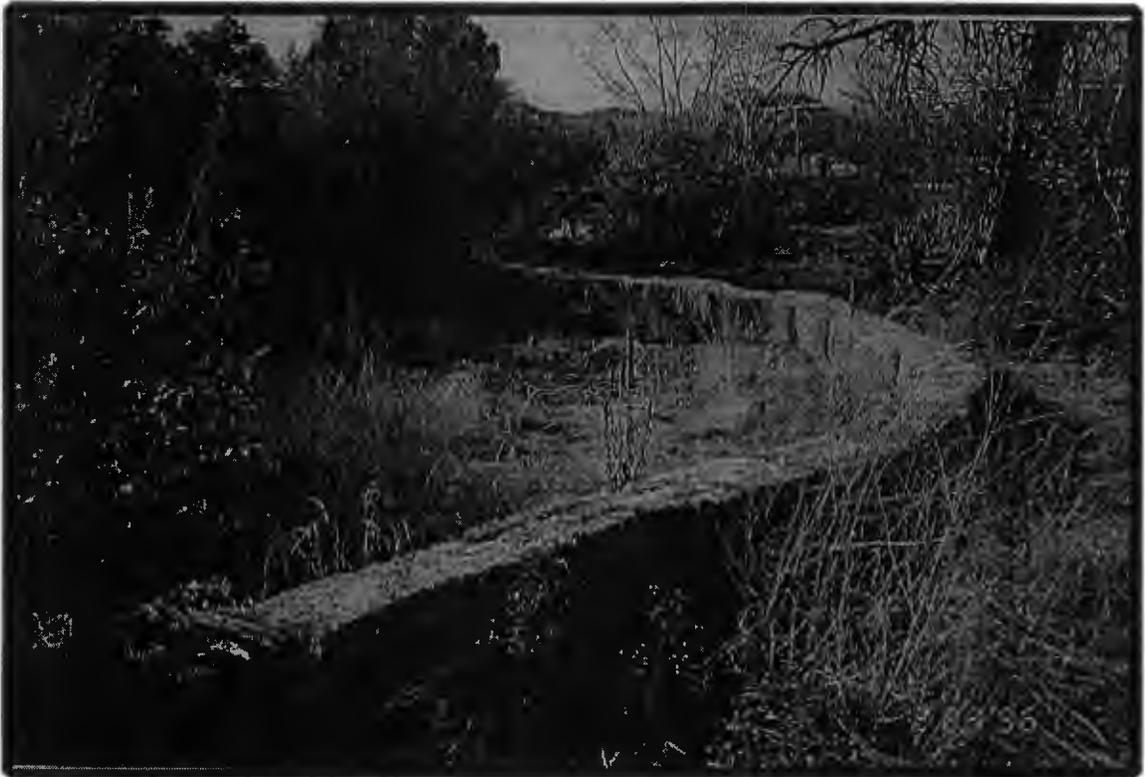
**Photo #1: Looking NW at straw-bale check dam above PRS 32-002(a, b). Dam in place to divert potential run-on from the LA County Roads Division storage lots.**

A straw-bale check dam was placed above the former septic tank location, TA-32-8, to divert run-on around the area of potential contamination at the outfalls and on the adjacent hillside. A straw-bale check dam was also placed at the confluence of the drainage channel on the canyon bench to help stop potential runoff associated with the outfalls area.

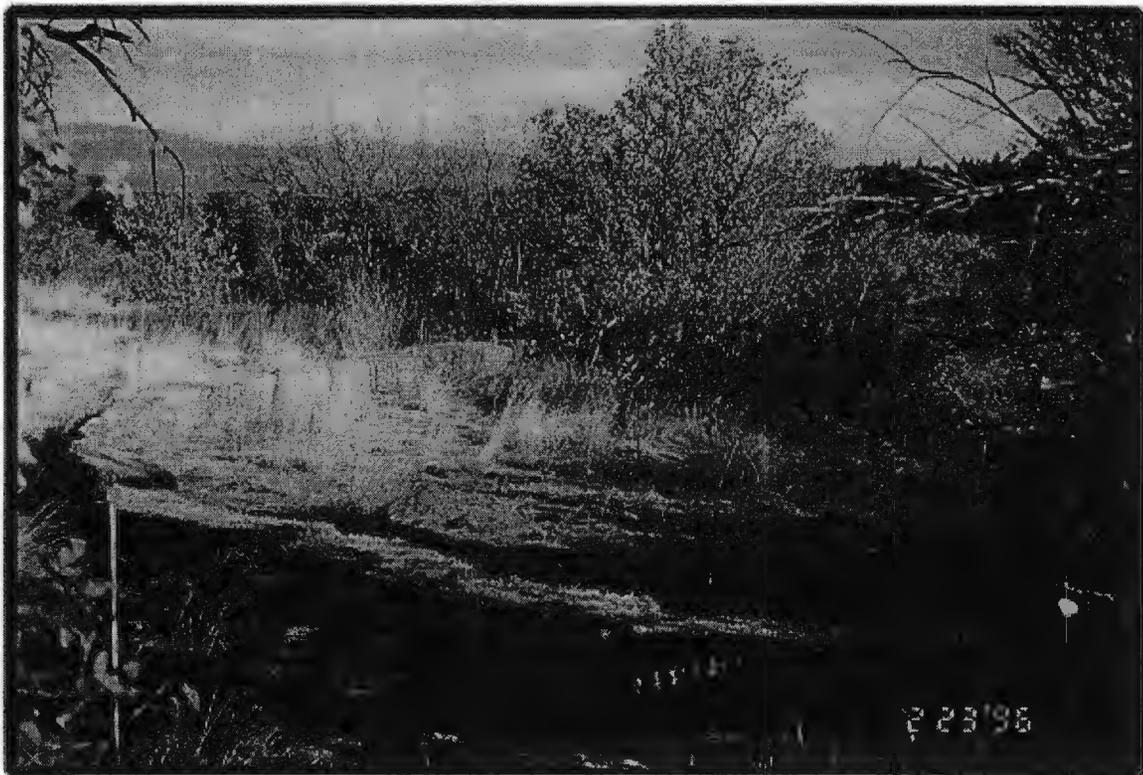
**Photo #2: Looking SE at straw-bale check dam above PRS 32-002(a, b). Former septic tank TA-32-8 was located near lower right of photograph.**

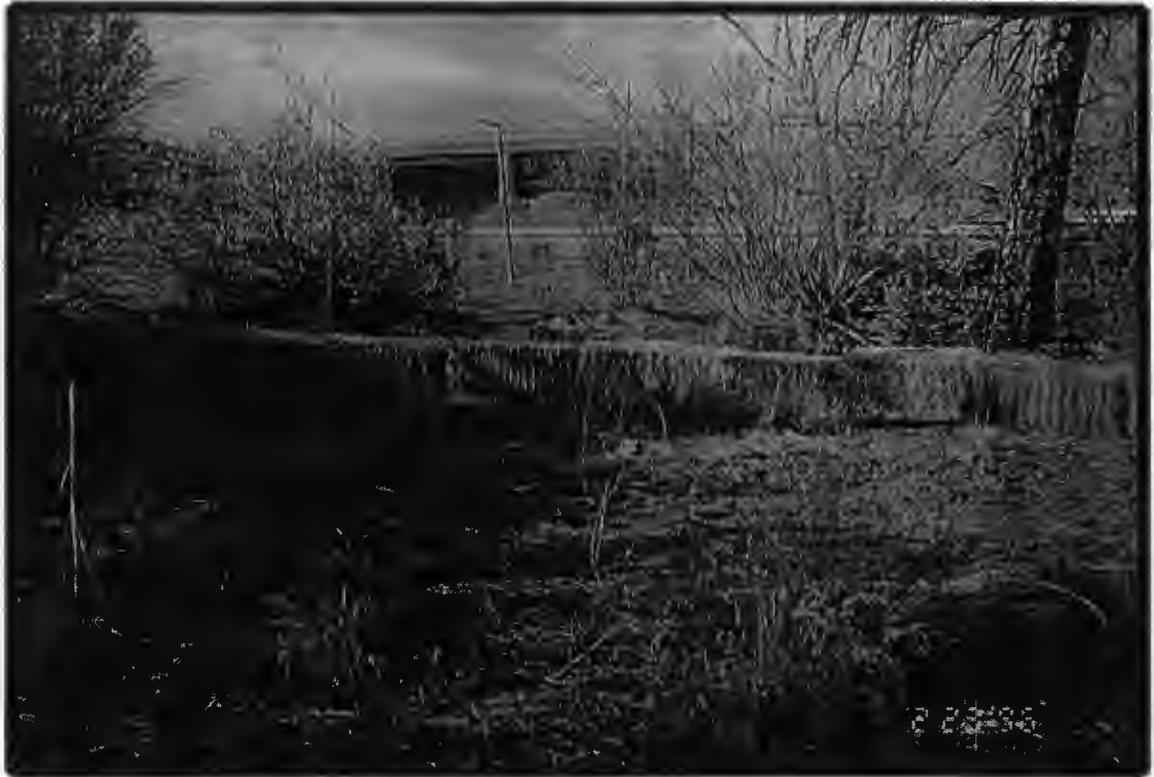
**Photo #3: Looking N at straw-bale check dam above PRS 32-002(a, b). Note the LA County Roads Division salt and sand storage yard.**

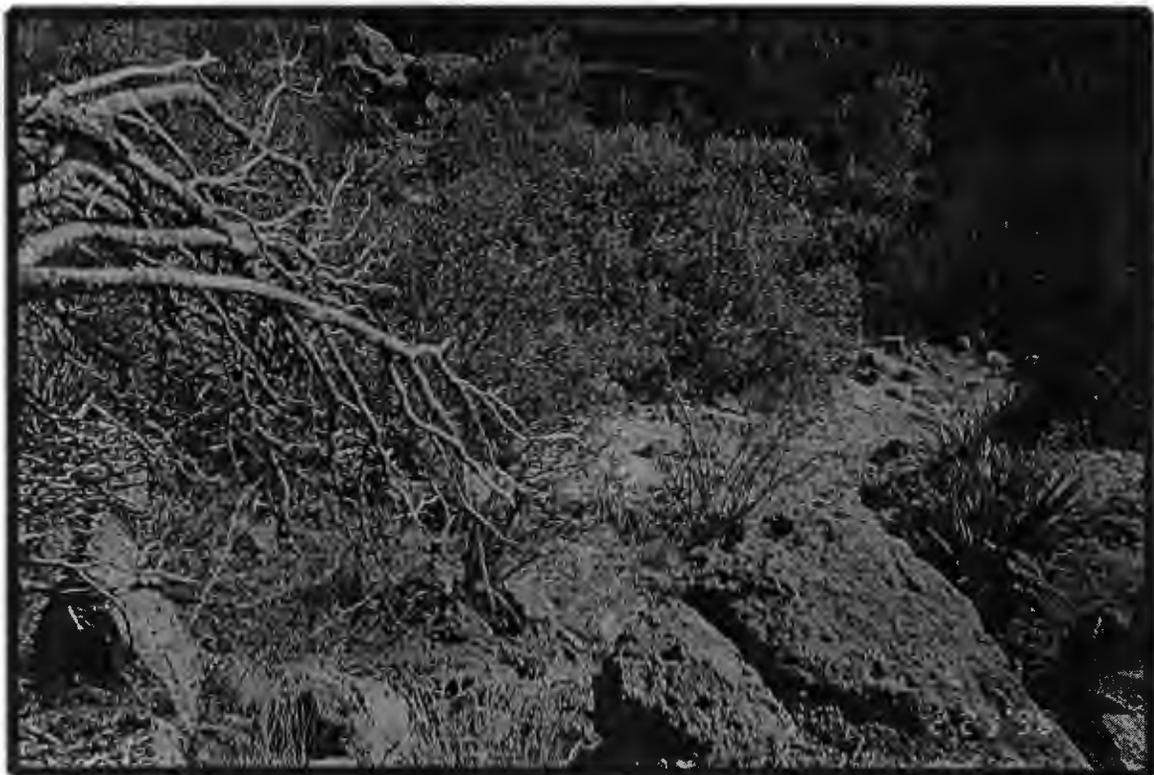
**Photo #4: Looking S down outfall drainage for PRS 32-002(a, b). Straw has been put down to assist with run-off control. Note roadway in LA Canyon.**

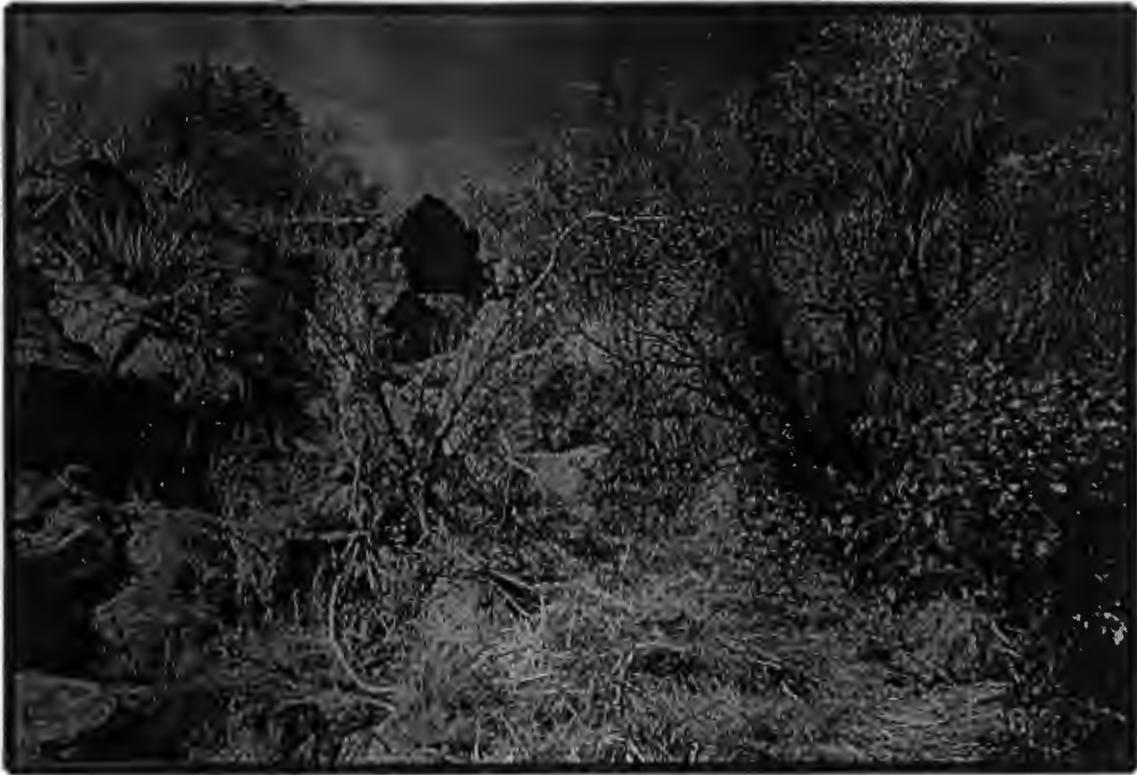
**Photo #5:** Looking N up the drainage towards the outfall pipe located in PRS 32-002(a, b). Straw has been put down to assist with run-off control.

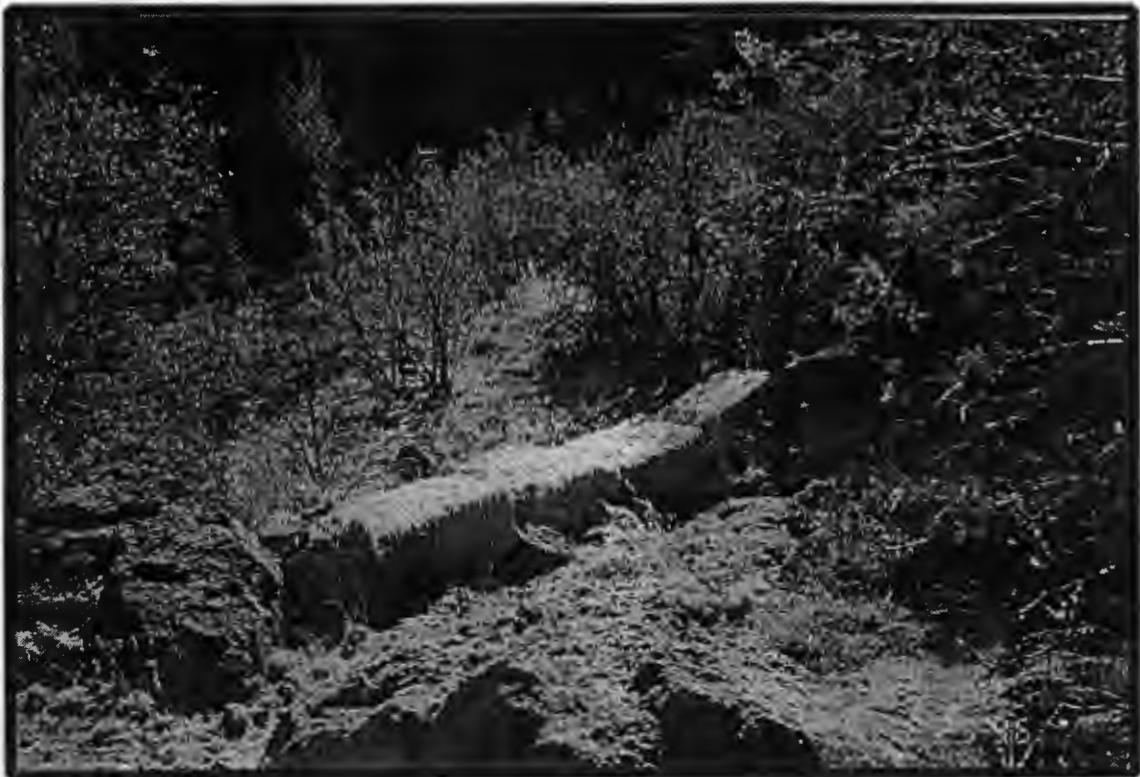
**Photo #6:** Looking S at straw-bale check dams put in place to assist with run-off control from the canyon bench area of PRS 32-002 (a, b). Note the roadway at bottom of LA Canyon.

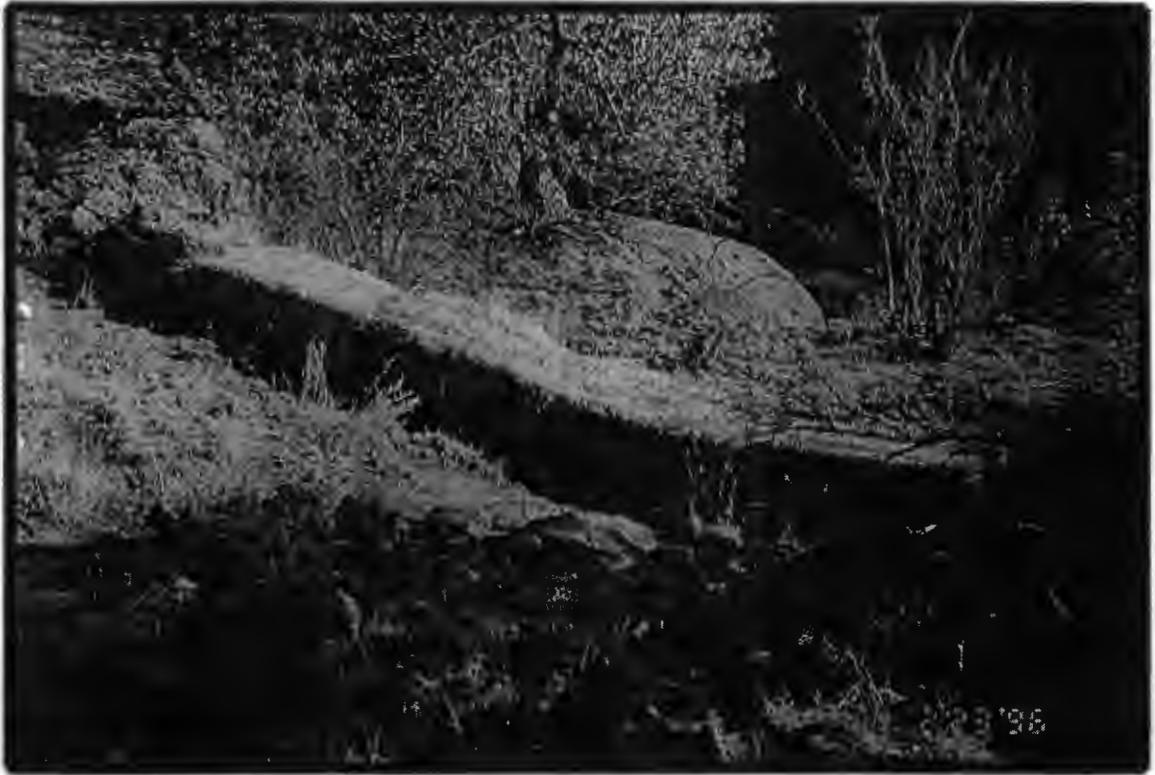
**Photo #7: Looking S at straw-bale check dams put in place to assist with run-off control from the canyon bench area of PRS 32-002 (a, b). Note the roadway at bottom of LA Canyon.**

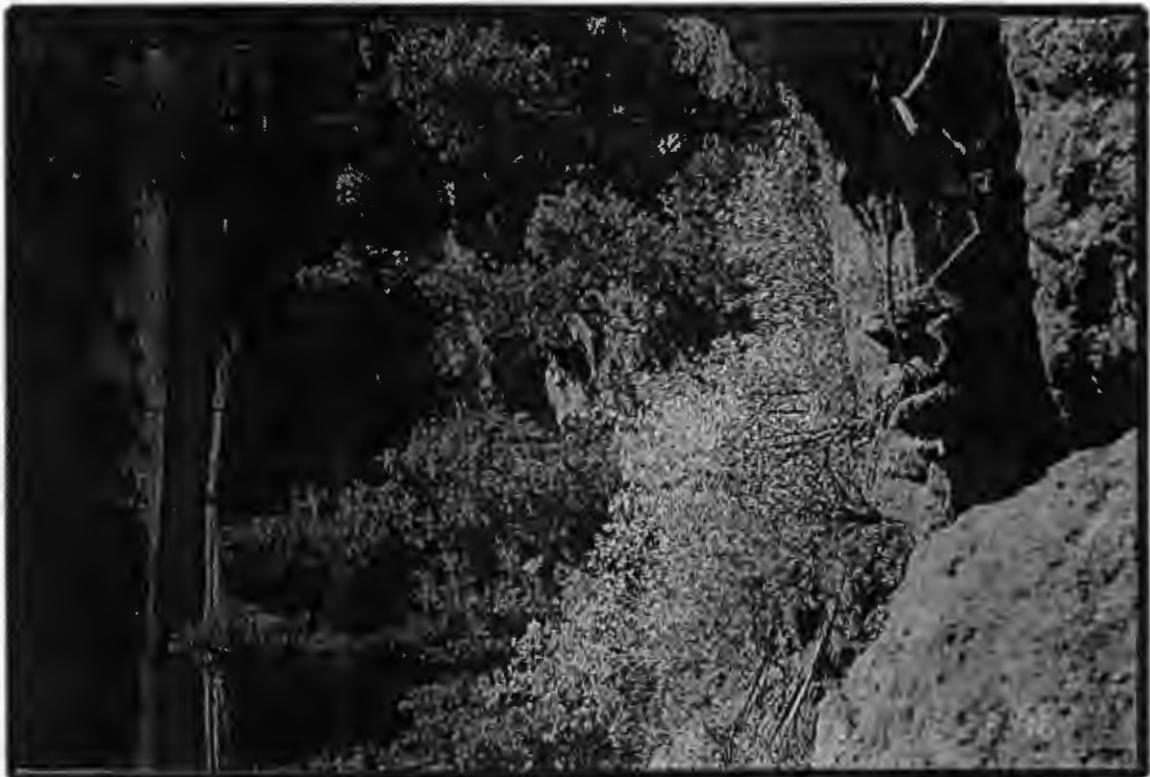
**Photo #8: Looking S down the drainage from the canyon bench area of PRS 32-002(a, b). Note the stream channel north of the roadway in LA Canyon.**
