SUBJECT: SUBMITTAL OF THE RESOURCE CONSERVATION AND RECOVERY ACT FACILITY INVESTIGATION (RFI) REPORT FOR POTENTIAL RELEASE SITES PRSs IN TECHNICAL AREA (TA) 35

Enclosed are two copies of the Los Alamos National Laboratory's RFI Report concerning PRSs 35-004(a), (g), (h), and (m), 35-009(e), 35-014(g1 and g2), and 35-016(b), (j), (n), and (q) in TA-35. One report is for your information and the second should go to your technical branch. The report documents the field work performed as detailed in the approved RFI Work Plan for Operable Unit 1129 and the results of the sampling.

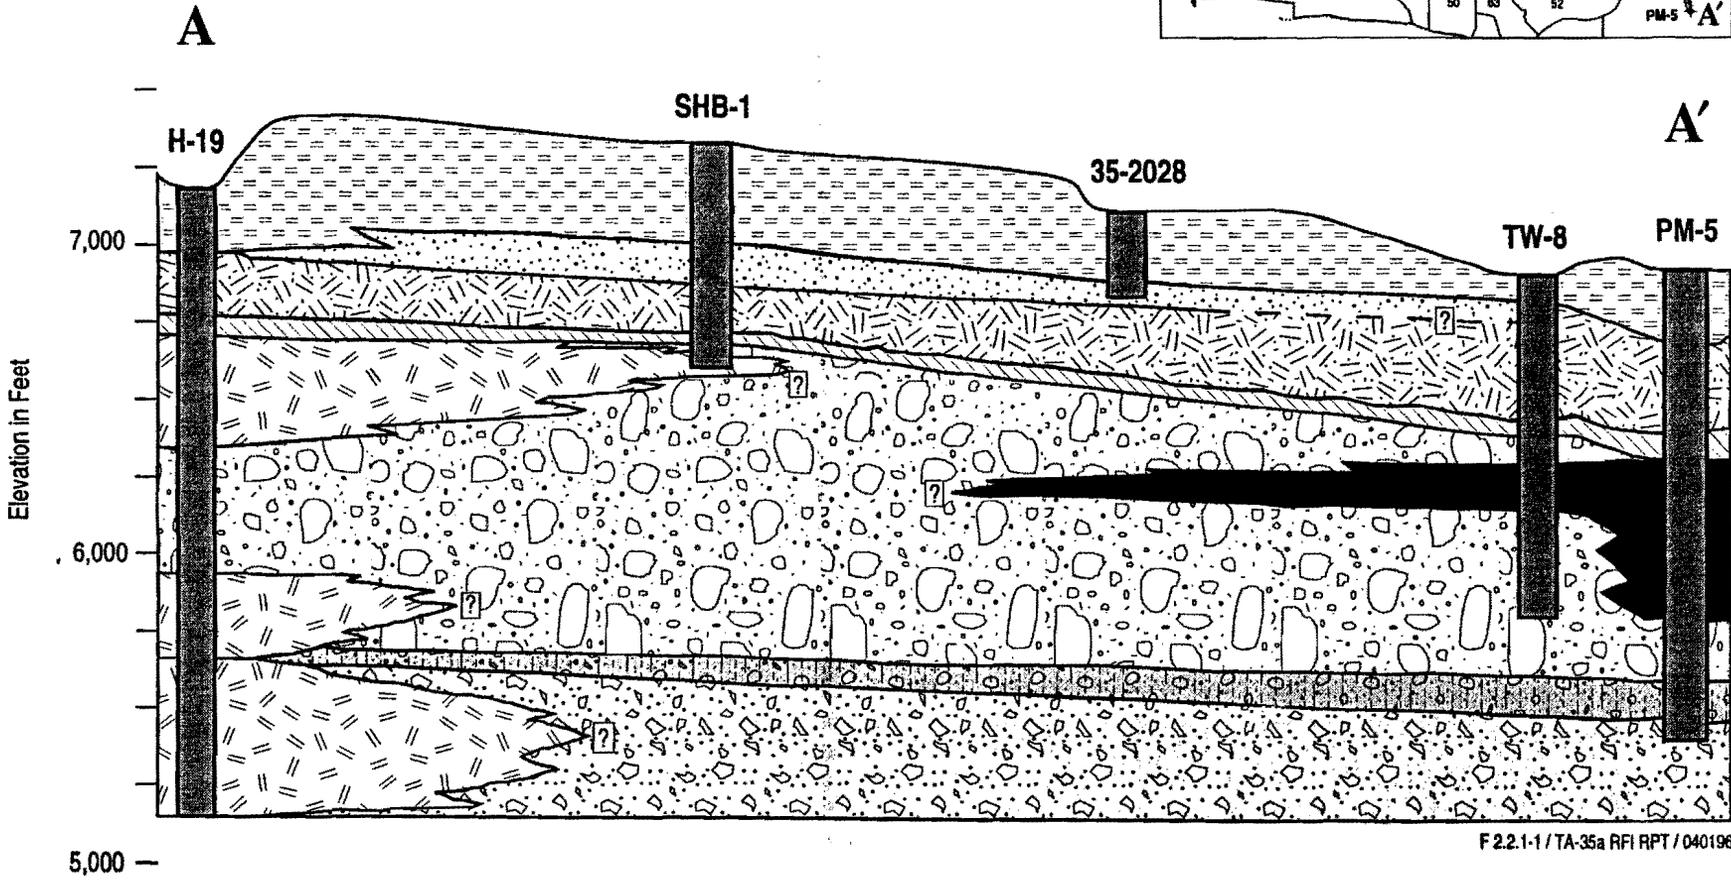
F.2.2.1-1 / TA-35a RFI RPT / 040196

Figure 2.2.1-1 Generalized stratigraphy of TA-35.

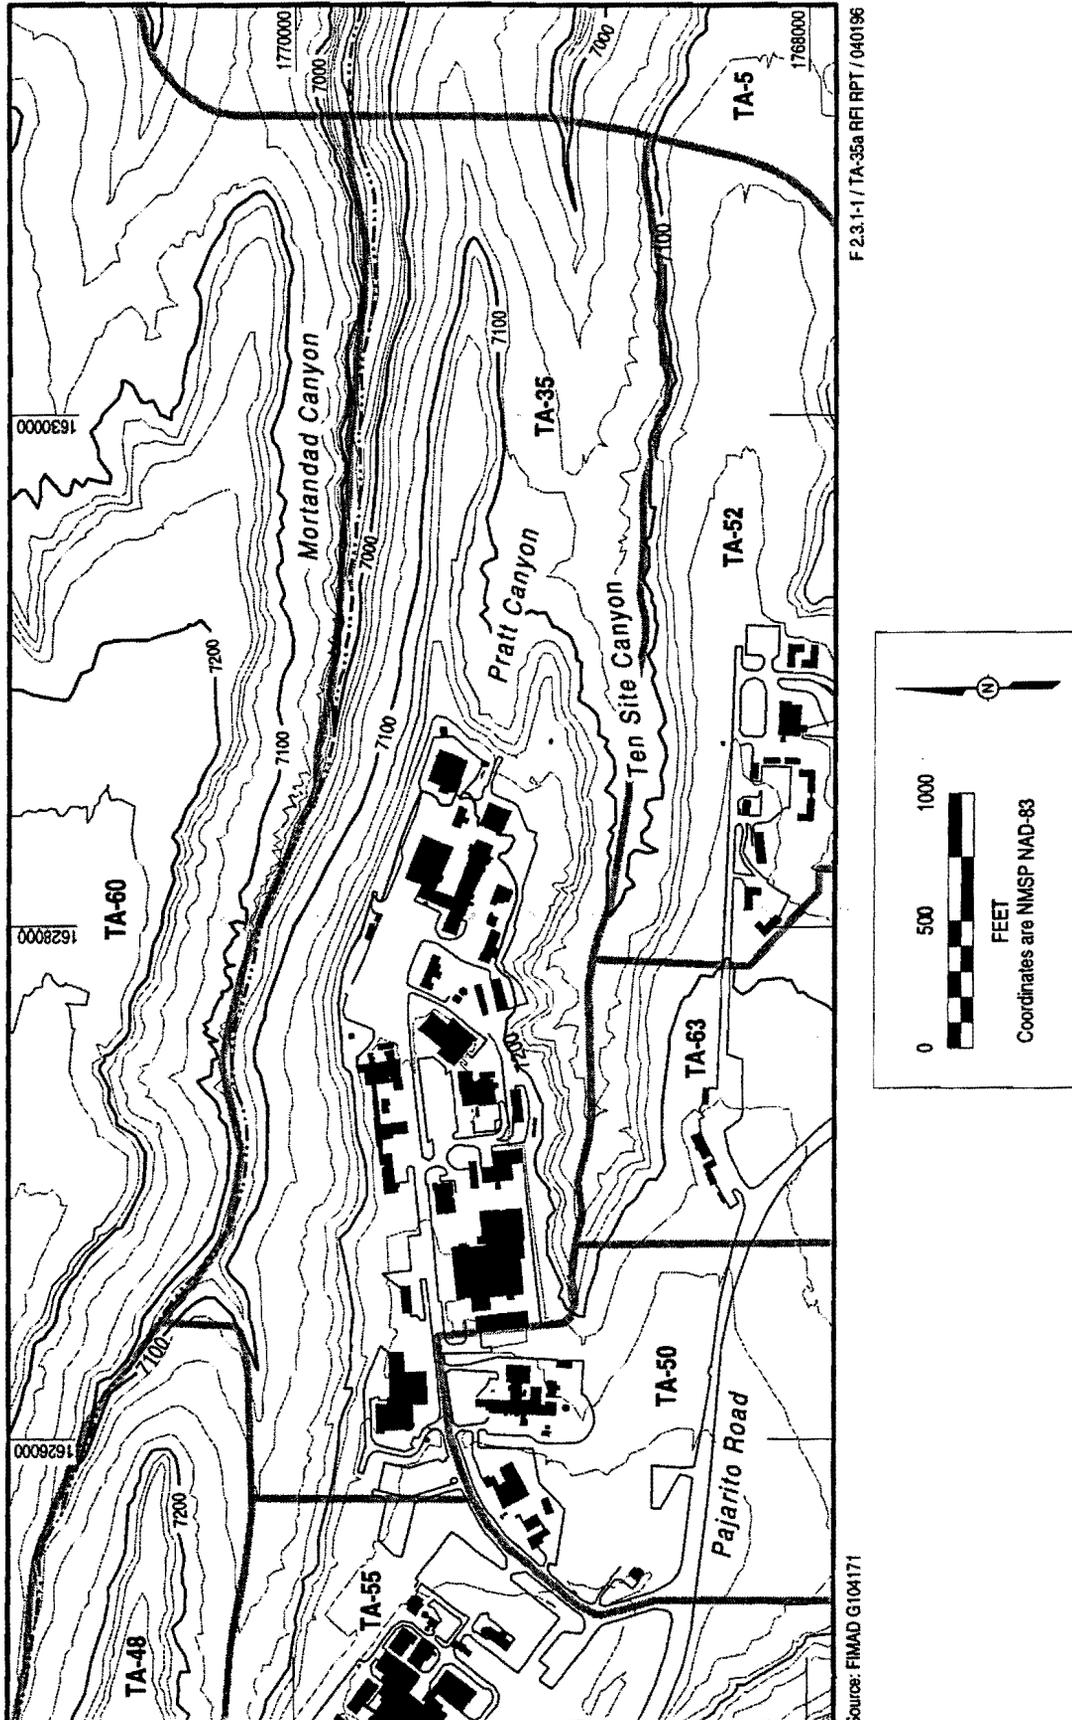
Figure 2.3.1-1. Topography of TA-35.

informally known as Pratt Canyon (to the east of TA-35). Runoff occurs in drainage rills found on the mesa top and in the larger drainage gullies that are characteristic of the canyon walls. No perennial springs are present in Mortandad Canyon. However, perennial water flow is present in Mortandad Canyon; its source is storm water outfalls from Pajarito Road and outfalls from Laboratory facilities west of TA-35, which also flow into Mortandad Canyon (See Figure 2.3.1-1).

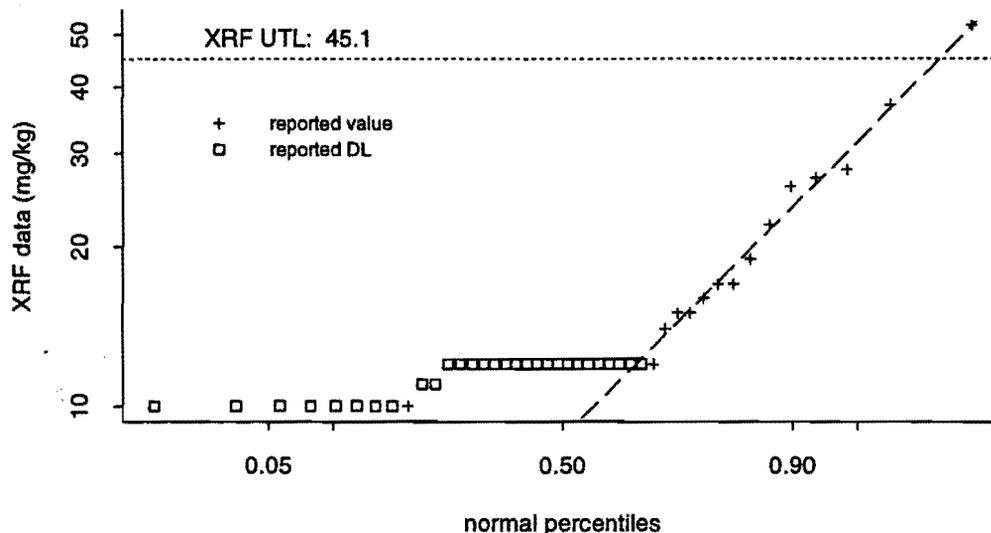
Figure 3.1.3-1. Lognormal probability plot of XRF chromium data for 44 background samples at TA-35 and TA-48.

The computation of the XRF UTL for chromium is illustrated in Figure 3.1.3-1. Of the 48 paired chromium results, 44 have SW-846 results below the SW-846 UTL of 19.3 mg/kg, and 15 of these are reported above the detection limit by XRF. Figure 3.1.3-1 is a lognormal probability plot of the 44 XRF chromium results, including the 29 that are below the detection limit of 10 to 12 mg/kg. The positive upper tail, above 12 mg/kg, is well fit by a straight line, from which a (.95,.95) UTL is estimated at 45.1 mg/kg, very close to the UTL based on the total digestion Laboratory background data.

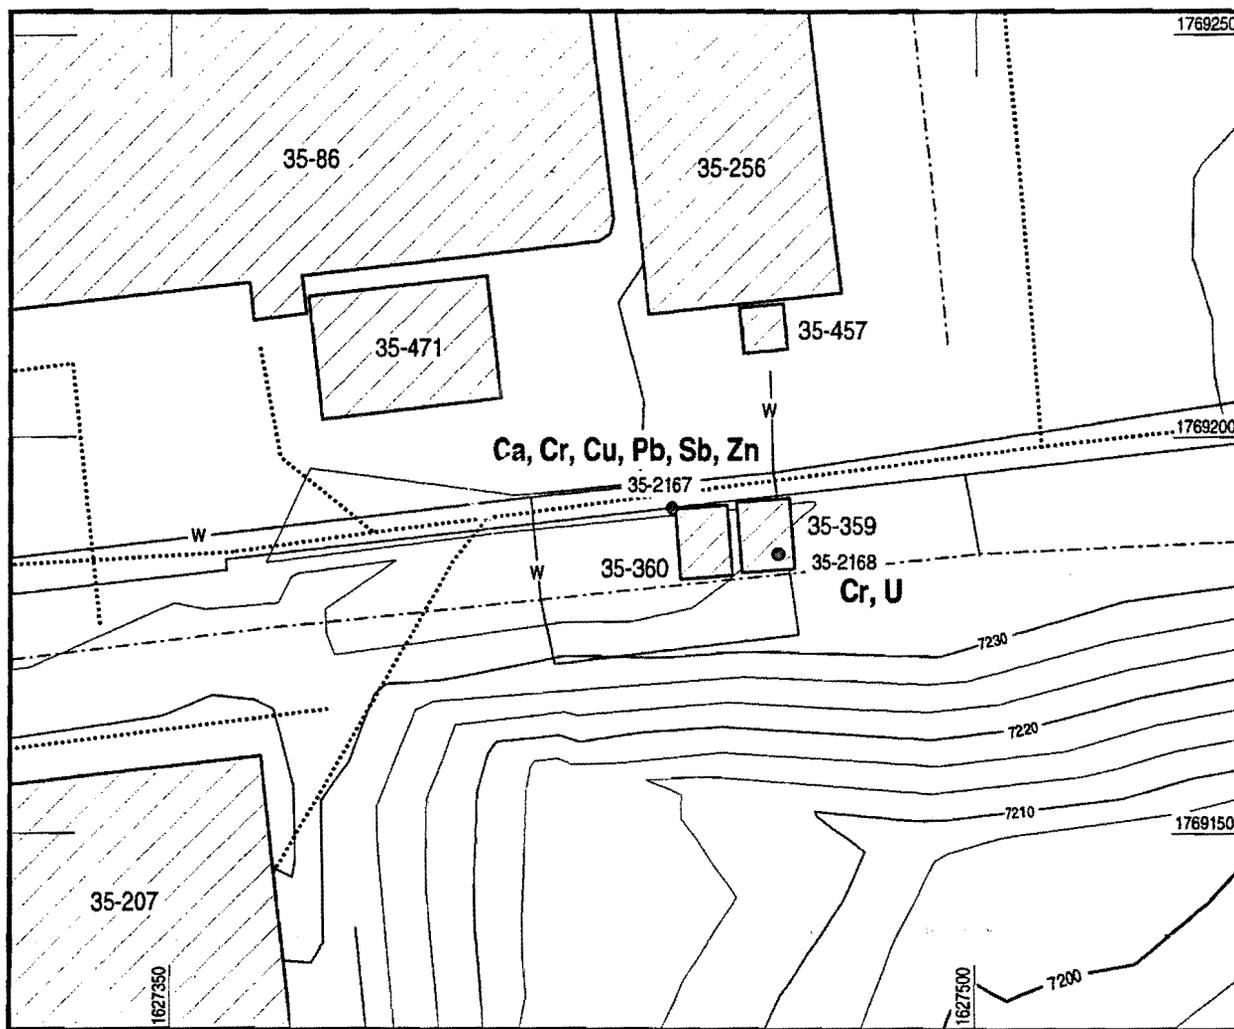
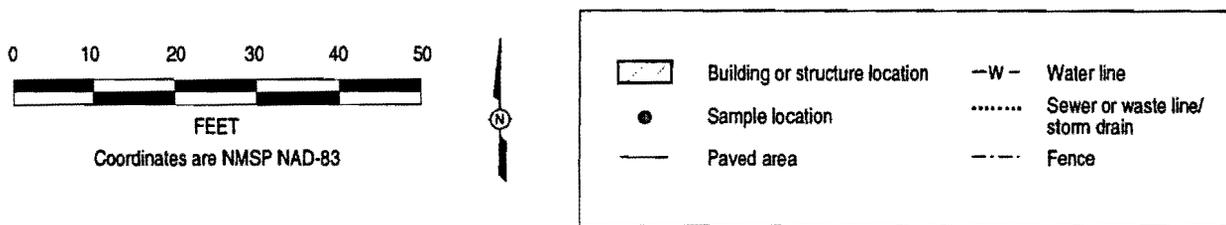
F5.4.5-1 / TA-35c RFI RPT / 061796

Figure 5.4.5-1. Locations of analytes that exceed UTLs at PRS Nos. 35-004(m) and 35-014(g₂).

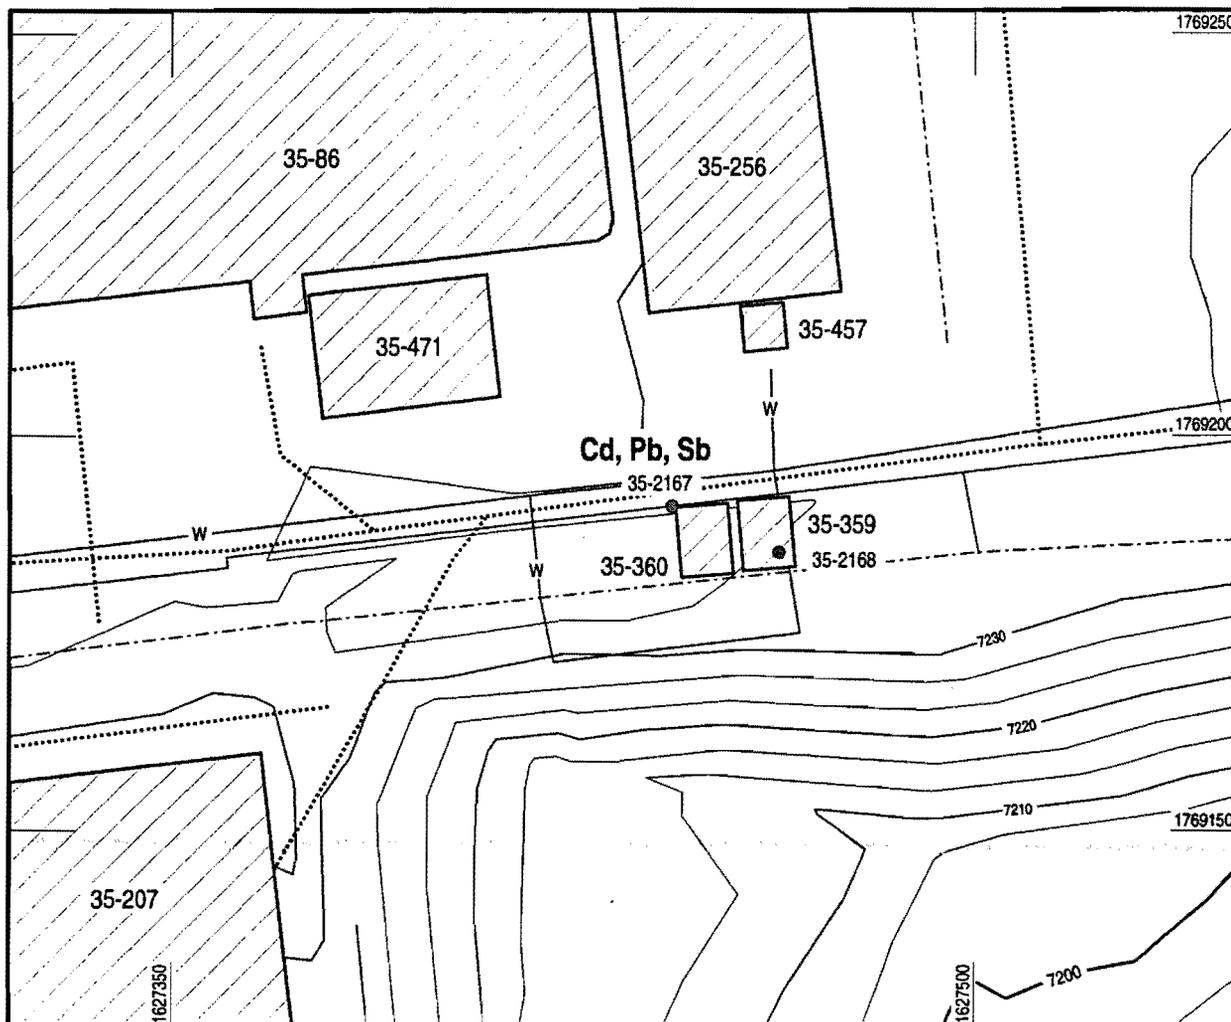
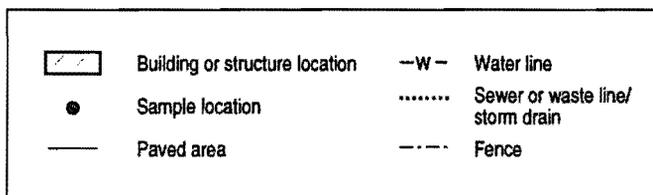
F5.4.7-1 / TA-35c RFI RPT / 061296

Figure 5.4.7-1. Location of COPCs identified in MCE at PRS Nos. 35-004(m) and 35-014(g₂).

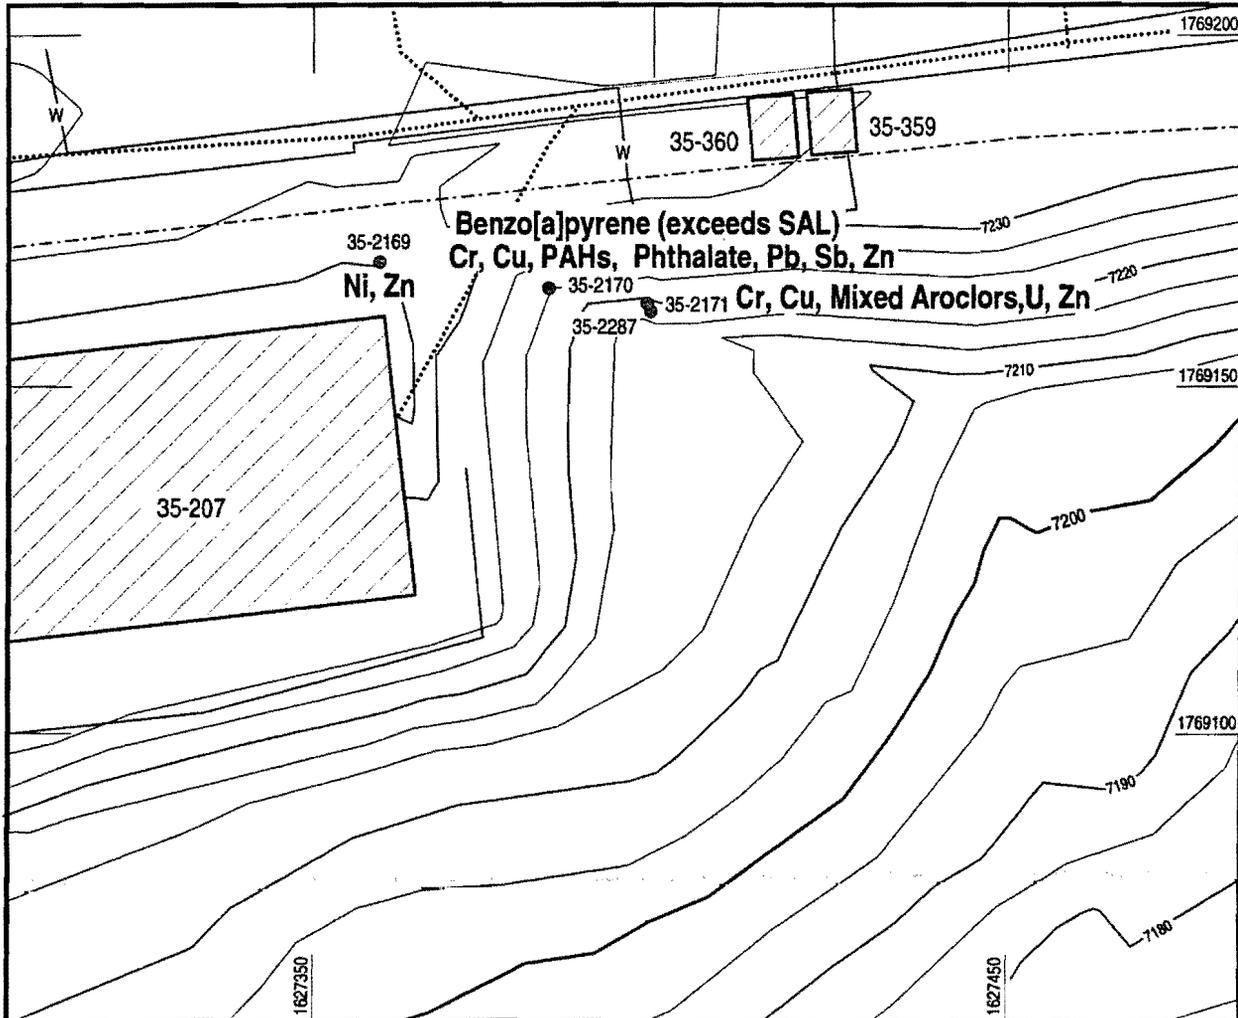
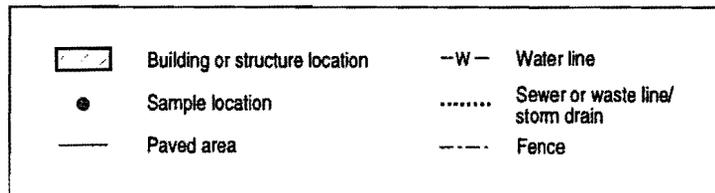
F5.5.5-1 / TA-35c RFI RPT / 061796

Figure 5.5.5-1. Locations of detected organic chemicals and analytes that exceed UTLs and SALs at PRS Nos. 35-014(g,) and 35-016(n).

No VOCs were detected by either the mobile laboratory facility or the fixed-site laboratory. SVOCs and PAHs were detected in the mobile laboratory facility and the fixed-site laboratory, respectively. Detected organic chemicals are shown in Table 5.5.6-1 and Figure 5.5.5-1 and are summarized below.

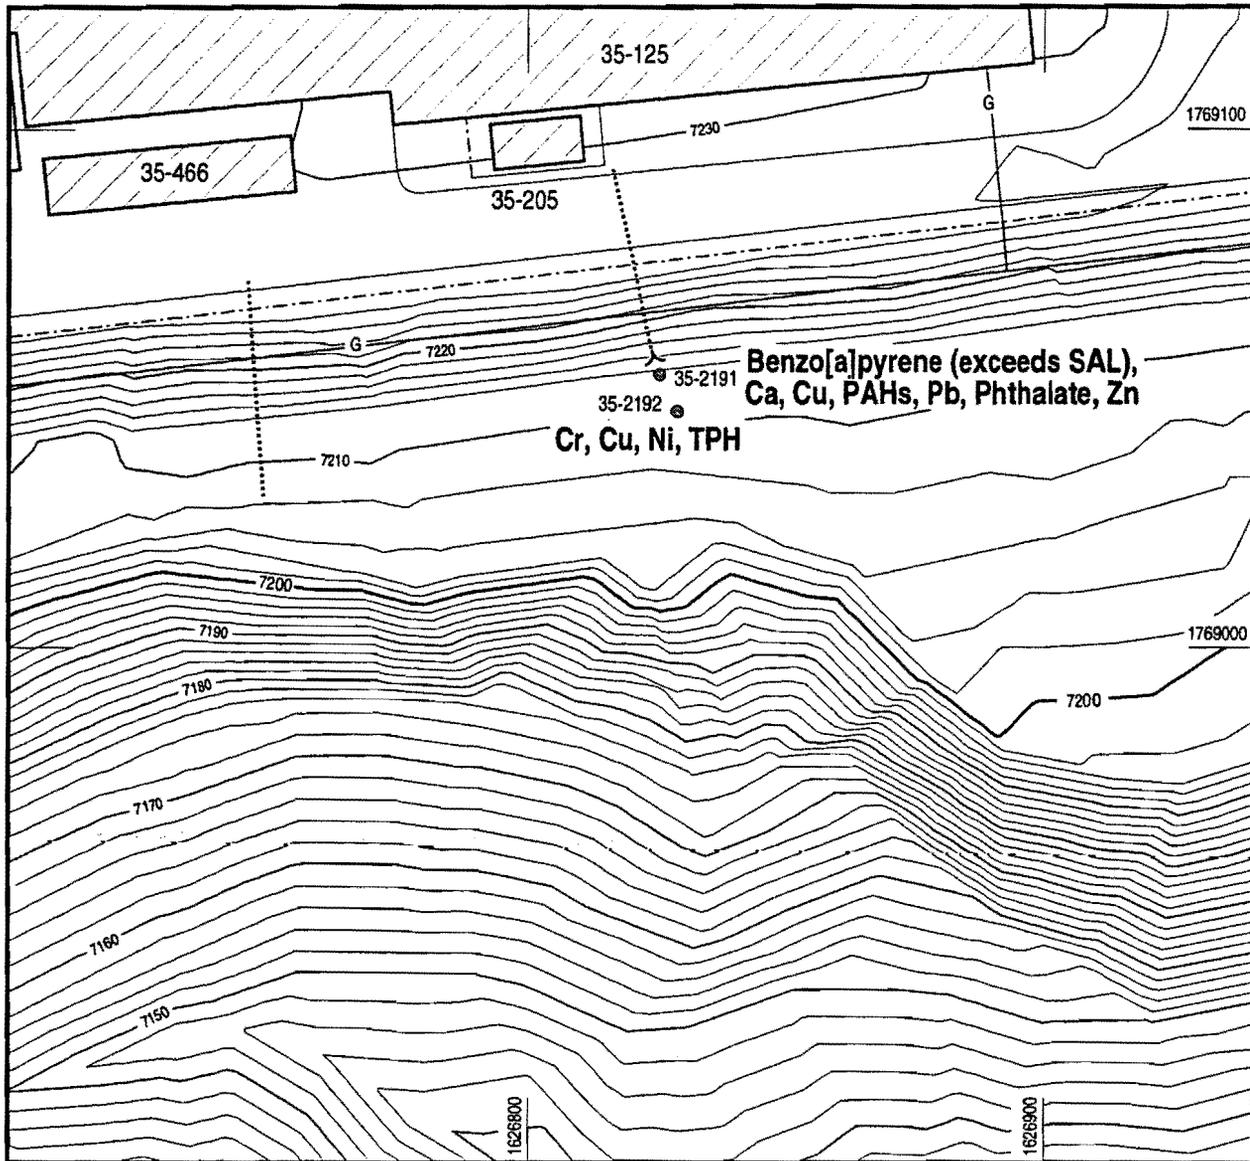
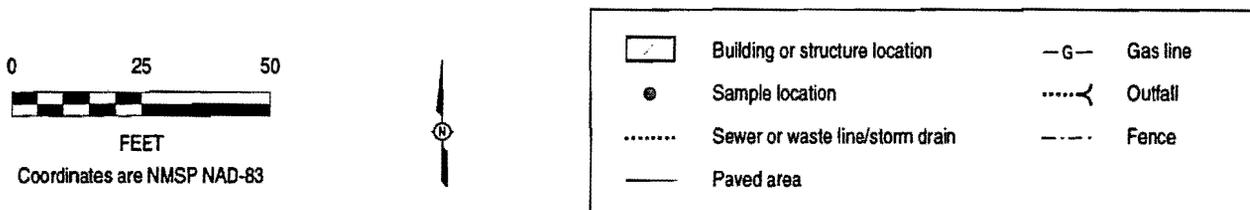
F5.7.5-1 / TA-35c RFI RPT / 061796

Figure 5.7.5-1. Locations of detected organic chemicals and analytes that exceed UTLs and SALs at PRS No. 35-016(j).

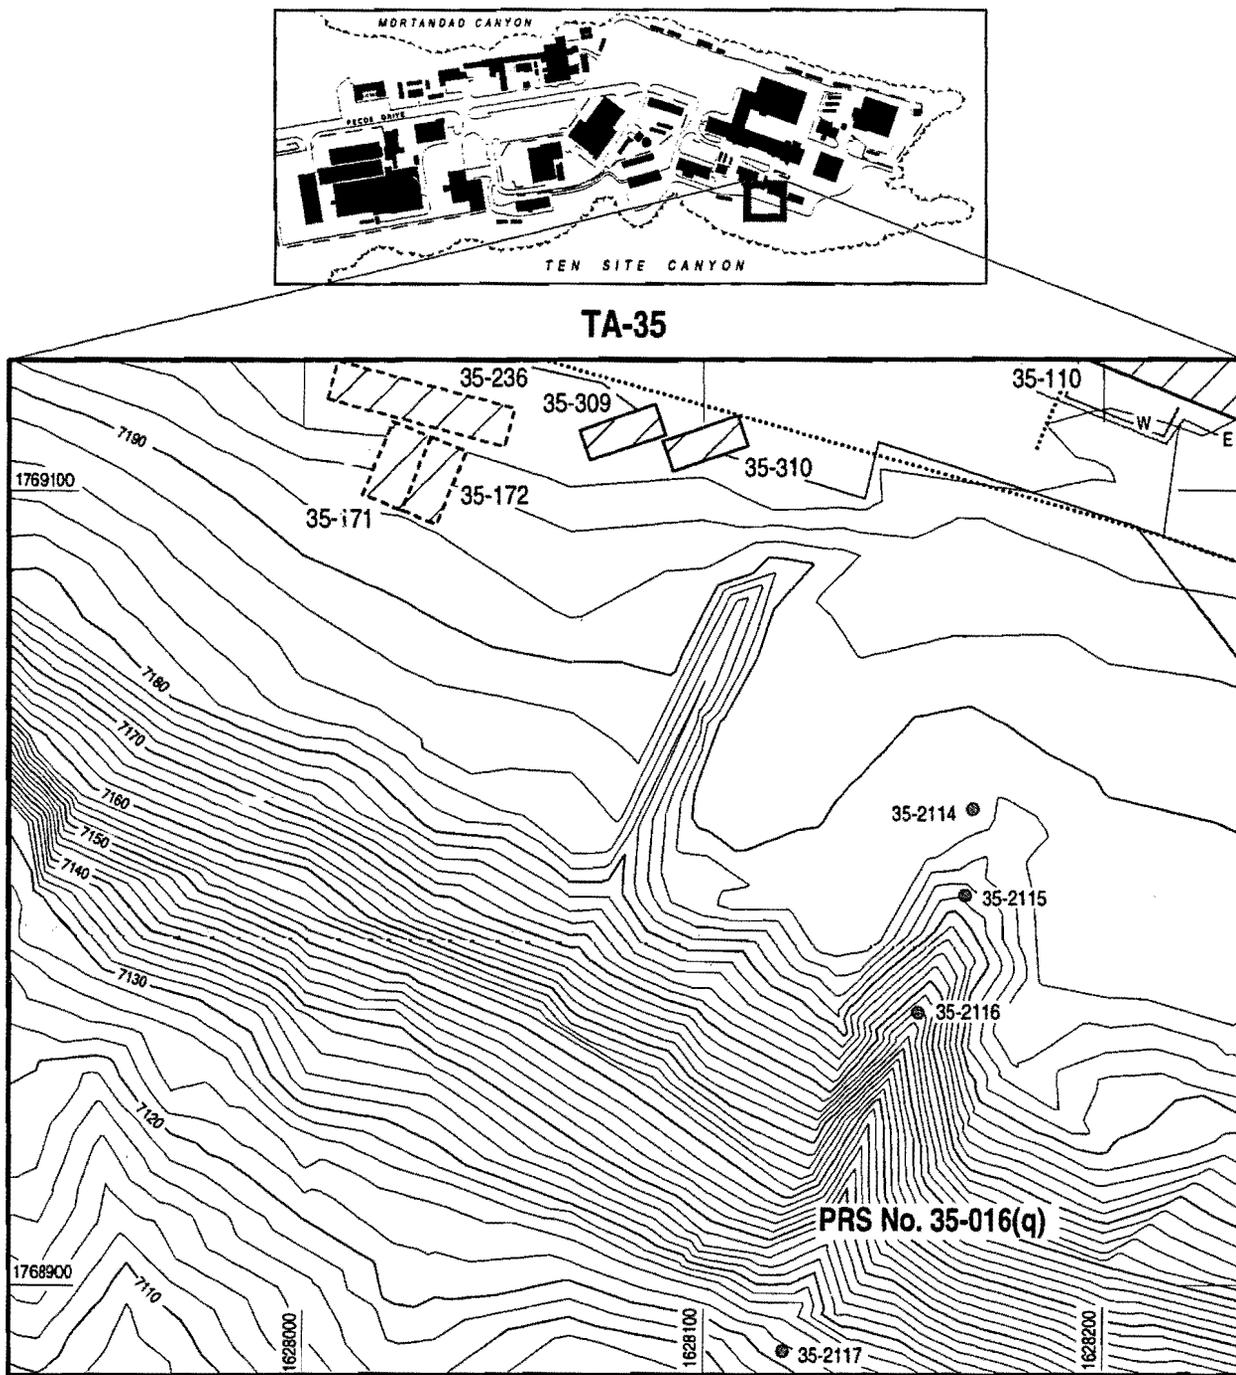
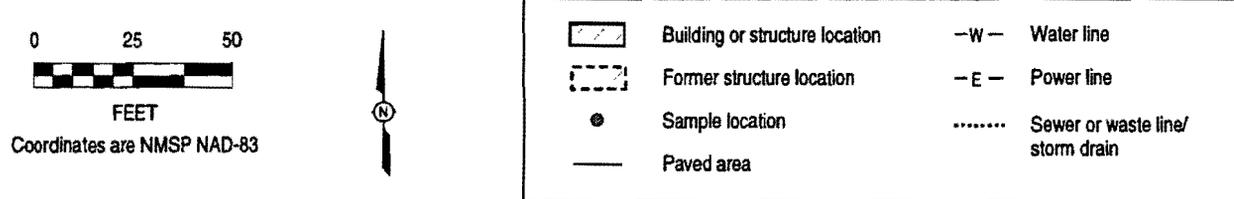
F5.8.4-1 / TA-35c RFI RPT / 060796

Figure 5.8.4-1. Locations of samples at PRs No. 35-016(q).

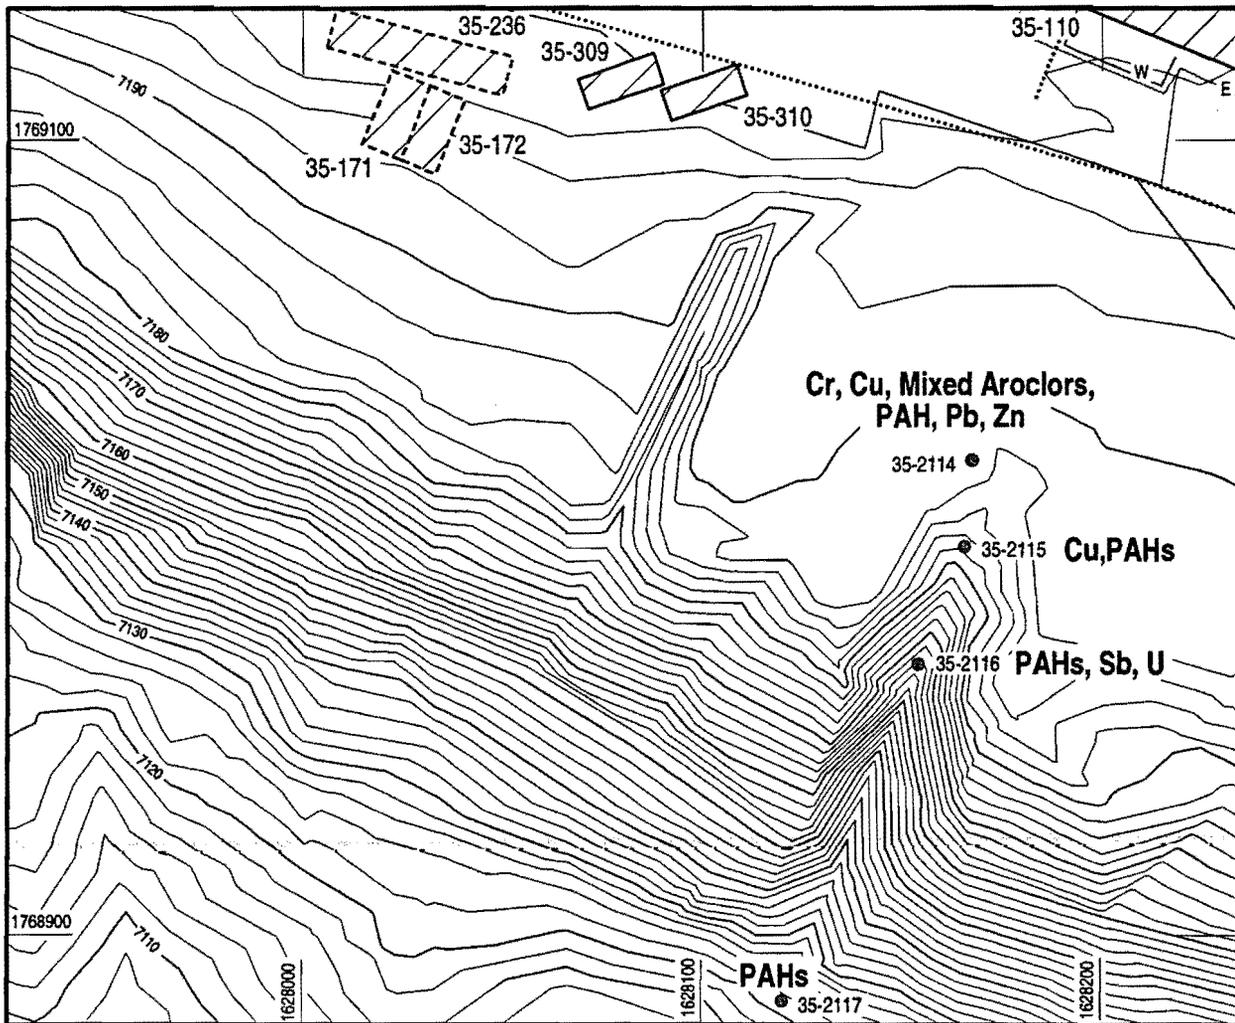
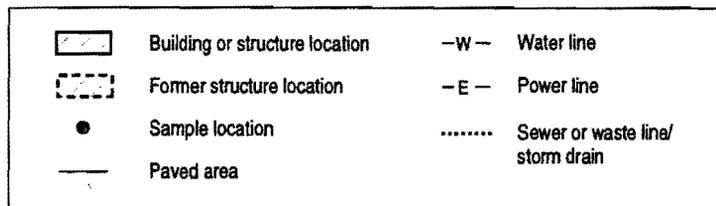
F5.8.5-1 / TA-35c RFI RPT / 061796

Figure 5.8.5-1. Locations of detected organic chemicals and analytes that exceed UTLs at PRS No. 35-016(q).

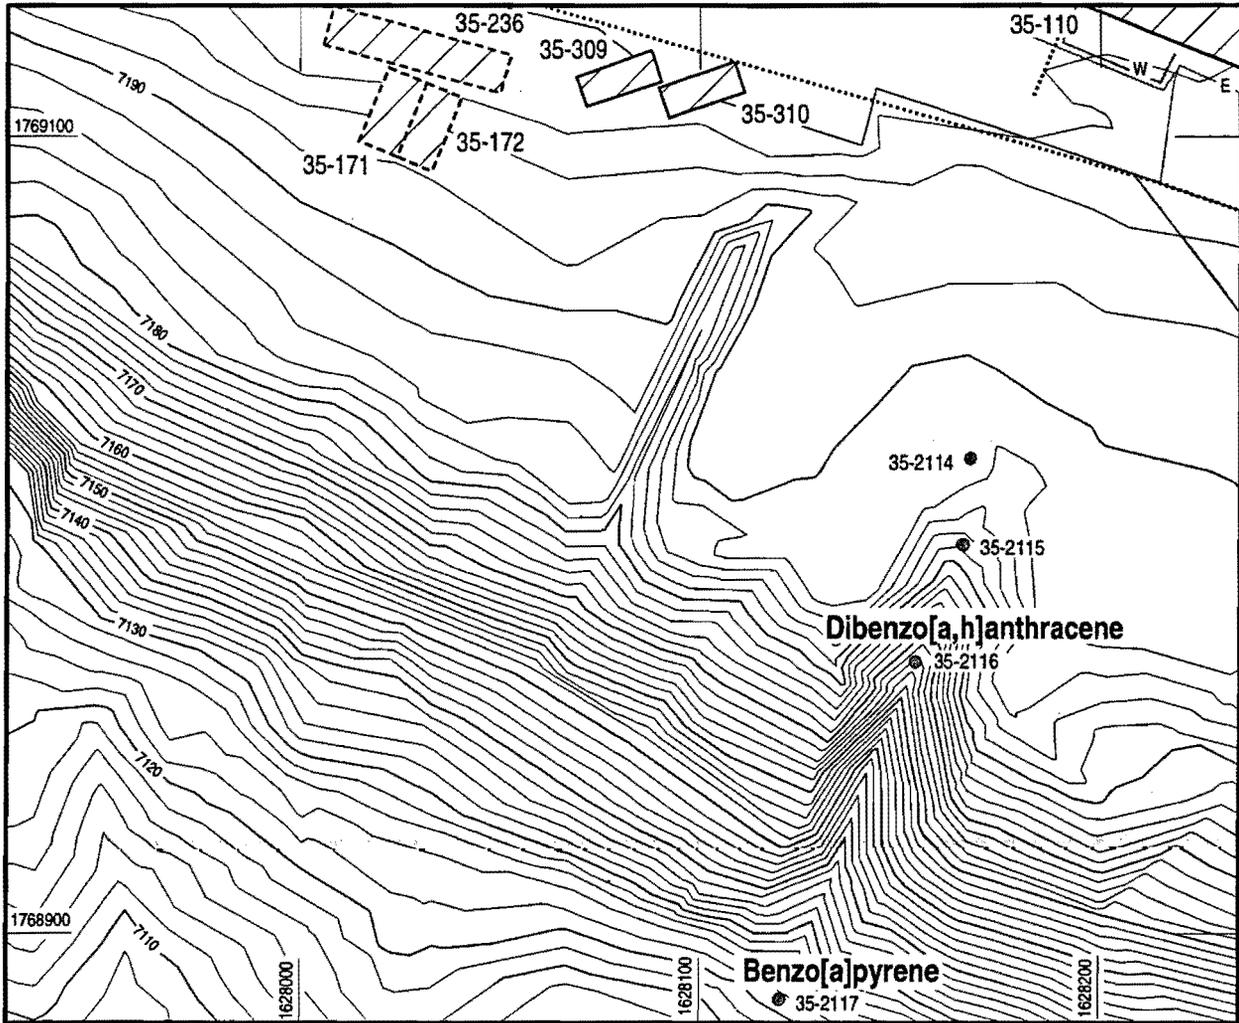
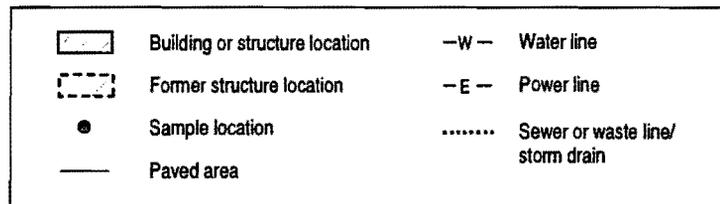
F5.8.7-1 / TA-35c RFI RPT / 061796

Benzo[a]pyrene and dibenzo[a,h]anthracene exceeded SAL values in two separate surface samples. The concentrations of benzo[a]pyrene and dibenzo[a,h]anthracene exceeded SAL values by approximately a factor of four and two, respectively. The fact that these and other PAHs were measured above

Figure 5.8.7-1. Locations of detected organic chemicals that exceed SALs at PRS No. 35-016(q).

EQL values in only one or two samples each, and at concentrations consistently below 1 mg/kg, indicates that a large and widespread release has not impacted surface sediments and backfill material at this location. Because this PRS is associated with surface water runoff only and not a specific release site, the most likely explanation for the observation of PAHs and metals in surface samples is that they represent nonspecific contamination associated with general industrial activities, asphalt roadways and parking areas, and motor vehicle use. The observed concentrations are only slightly above residential screening values and do not indicate the potential for unacceptable human health risk under industrial or recreational land use scenarios appropriate at this location. Therefore, further investigation of these COPCs is not proposed.

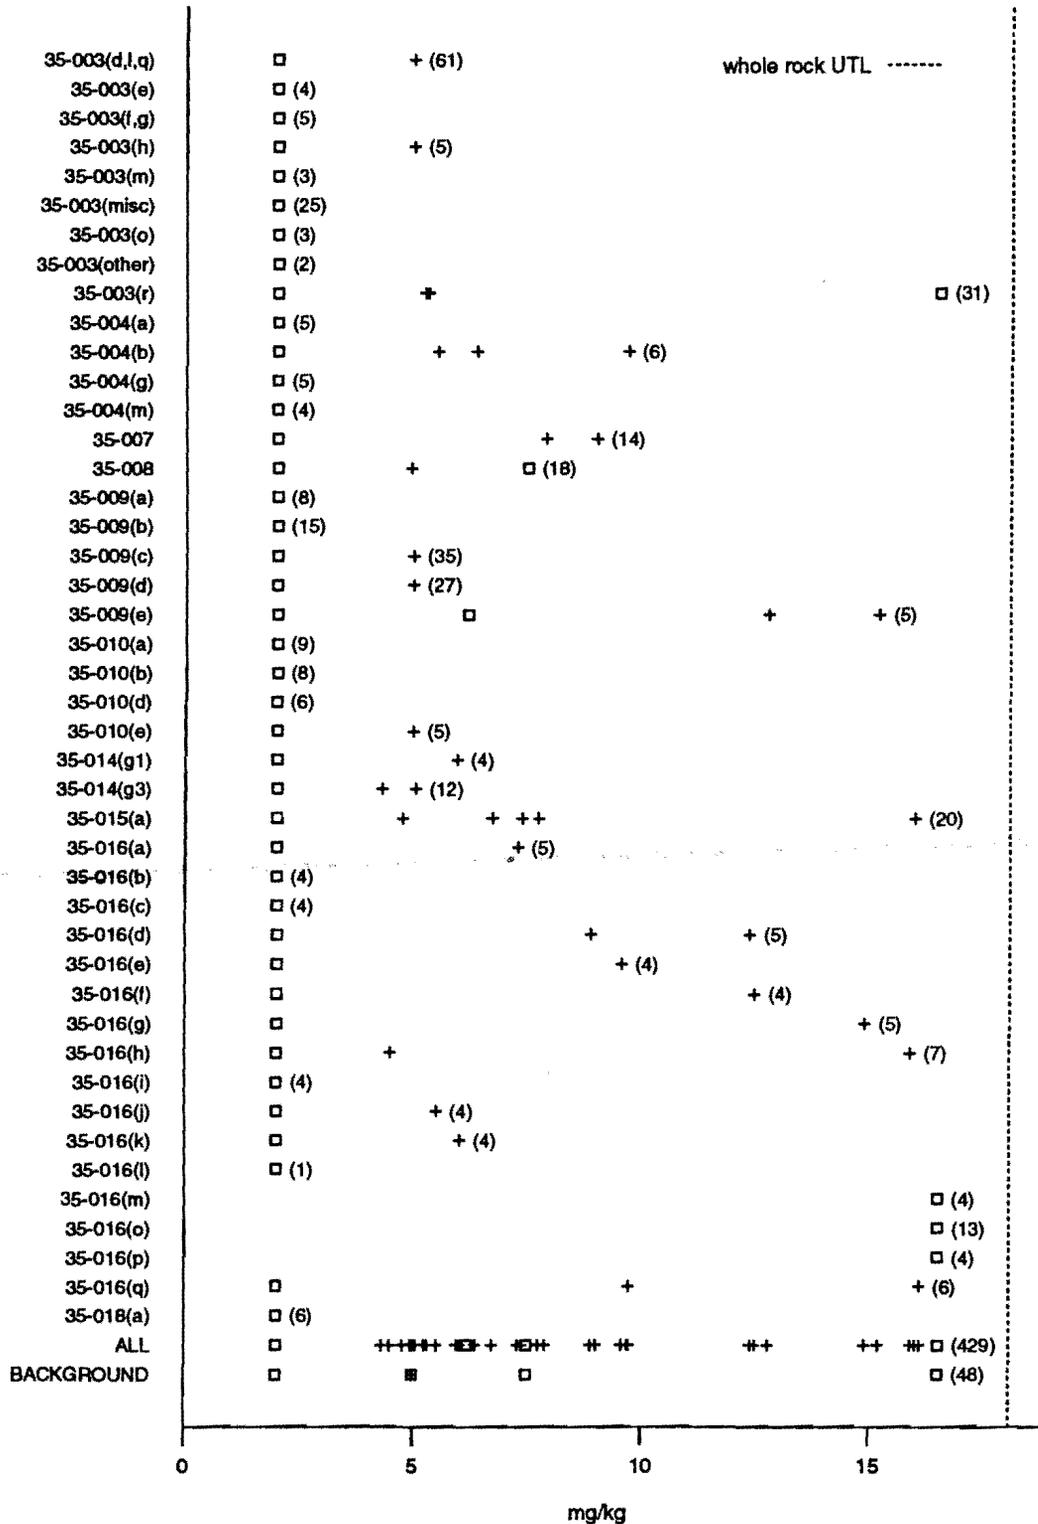
Figure AI-1. Distribution of arsenic in TA-35 PRSs.

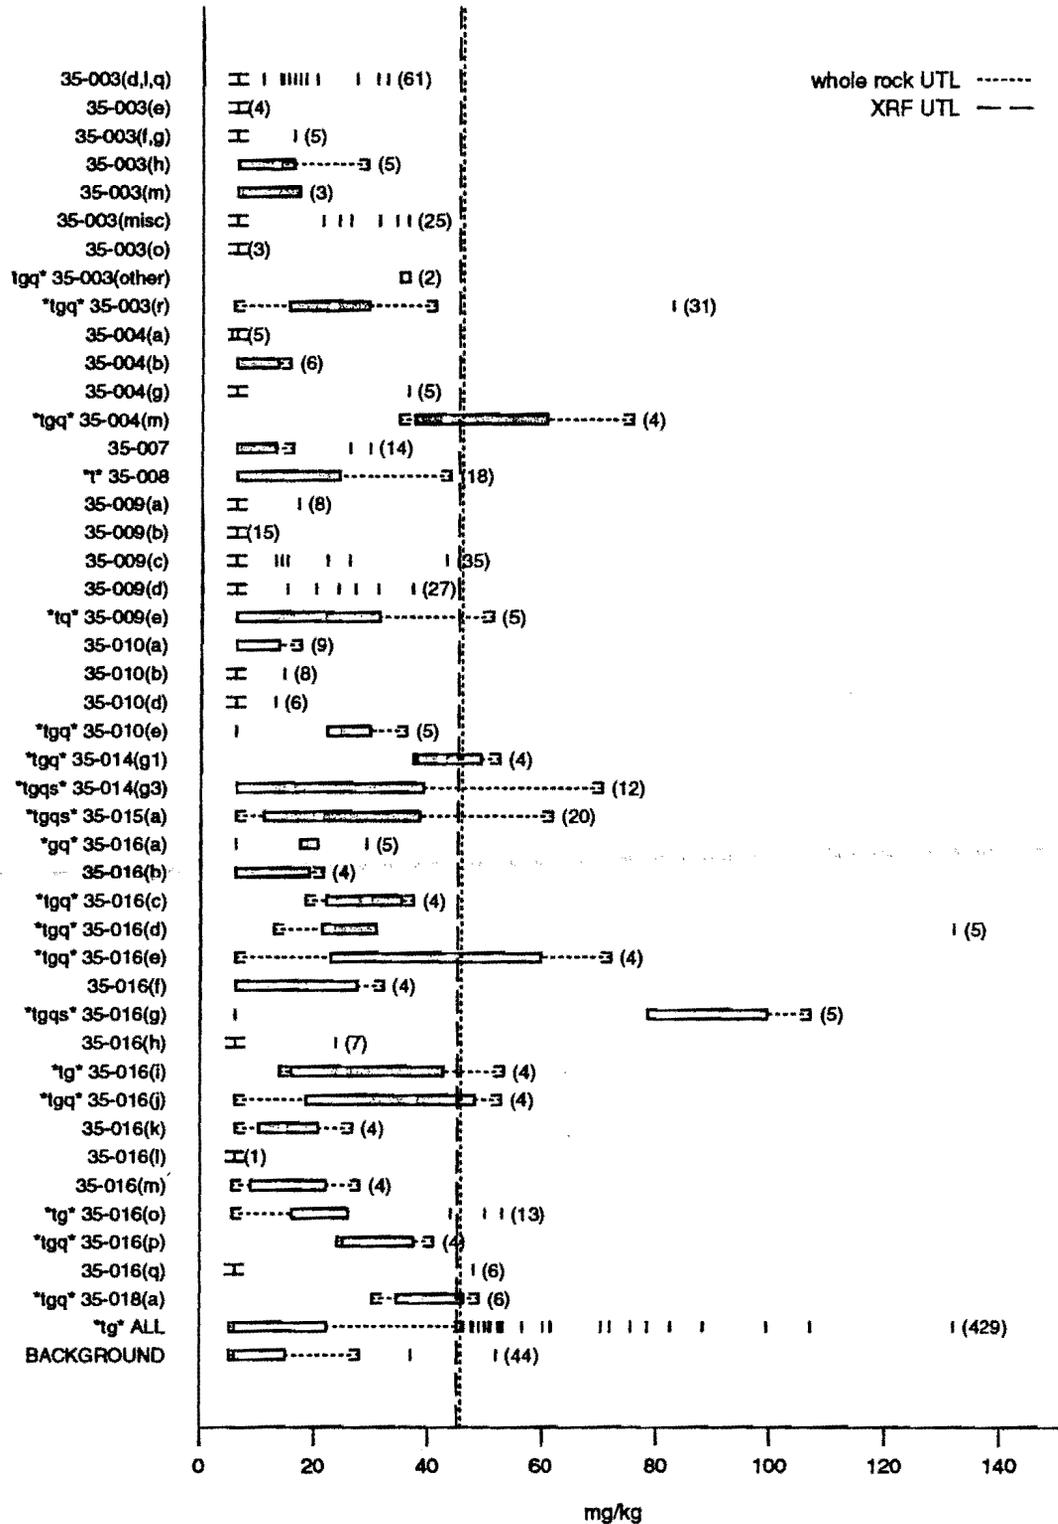
Figure AI-5. Distribution of chromium in TA-35 PRSs.

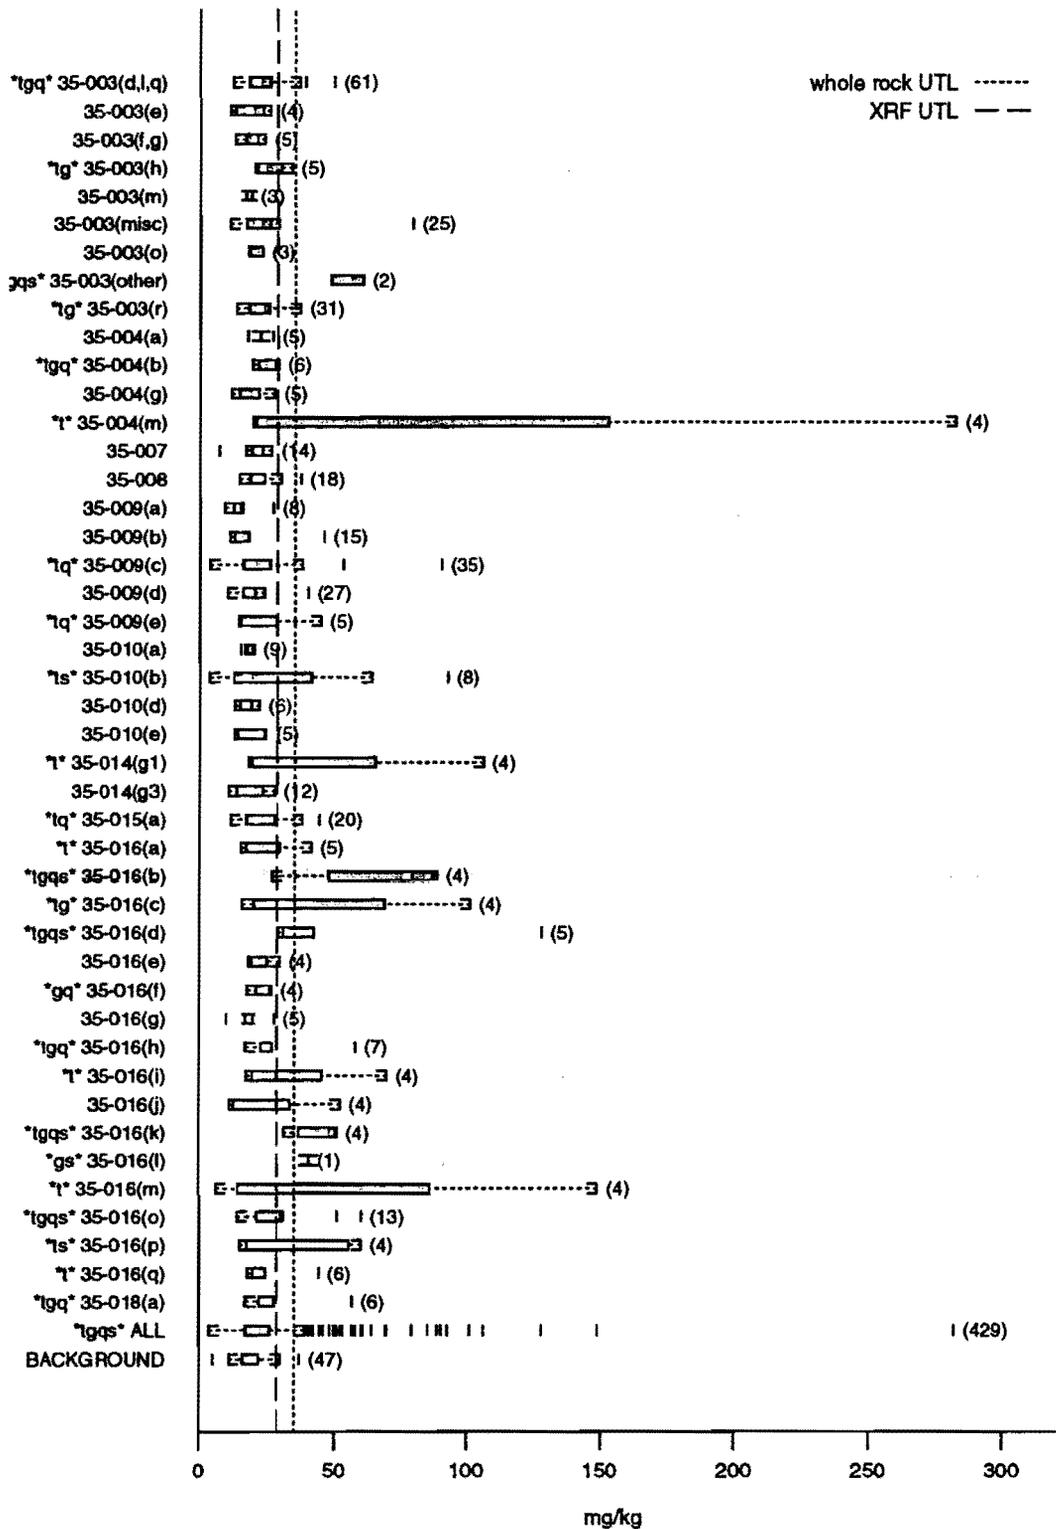
Figure AI-12. Distribution of lead in TA-35 PRSs.
