**Subject: Discharge Permit DP-857 Quarterly Report, Third Quarter 2015, TA-46 Sanitary Wastewater Systems Plant**

Monthly inspection photographs of the  
SERF evaporation basins

SERF Evaporation Basins  
Monthly Inspection Record: August 6, 2015

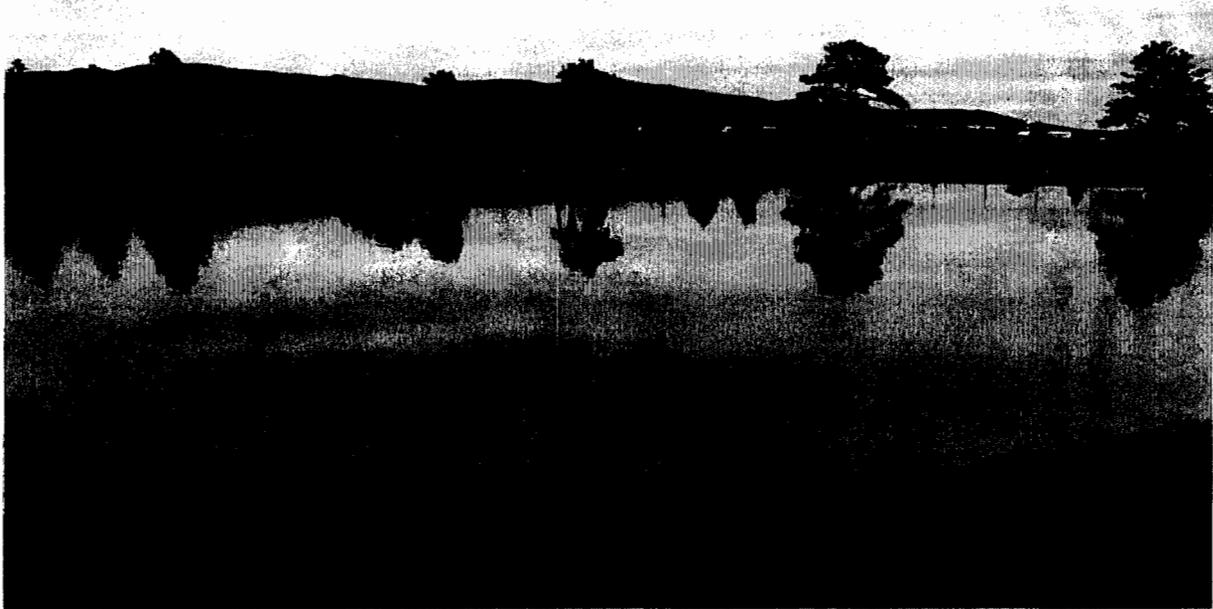
**Northwest Evaporation Basin (Basin 1)**

Inspection Sump #1: Dry

Inspection Sump #2: Dry

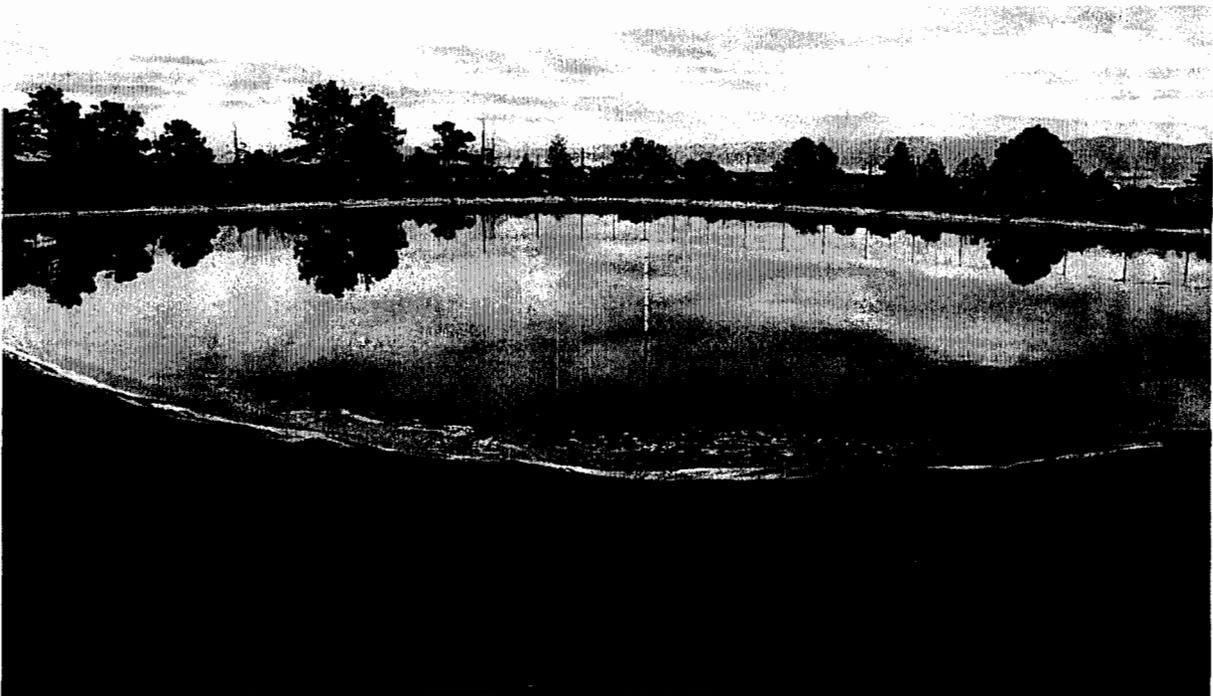
**Northeast Evaporation Basin (Basin 2)**

- **Northeast Basin.** In March 2015 DOE/LANS submitted to NMED a Corrective Action Plan (CAP) for a leak in the primary liner at the Northeast evaporation basin (ENV-DO-15-0081). The CAP identified the steps necessary to locate and repair the leak by September 1, 2015. On August 26, 2015, a contractor completed repairs to the Northeast evaporation basin's primary liner. The basin was immediately returned to service.

Water that accumulated between the primary and secondary liners during the leak was pumped from the leak collection ports on several occasions. Unfortunately, it appears that the contractor was not successful in finding all the leaks in the Northeast evaporation basin because even after pumping the leak collection ports on multiple occasions water continued to accumulate in them.

Inspection Sump #1: 1.0 ft of standing water

Inspection Sump #2: Dry

In summary, the first attempt to repair the primary liner leak at the Northeast evaporation basin was not successful. As a result, the pond was removed from service, drained, cleaned, and evaluated by LANL Craft personnel. Additional defects were identified. A second attempt at repairing the leak is scheduled for October 2015. NMED was informed of this situation in an email from Mr. Robert Beers (ENV-CP) to Mr. Gerald Knutson (NMED GWQB) on September 24, 2015.

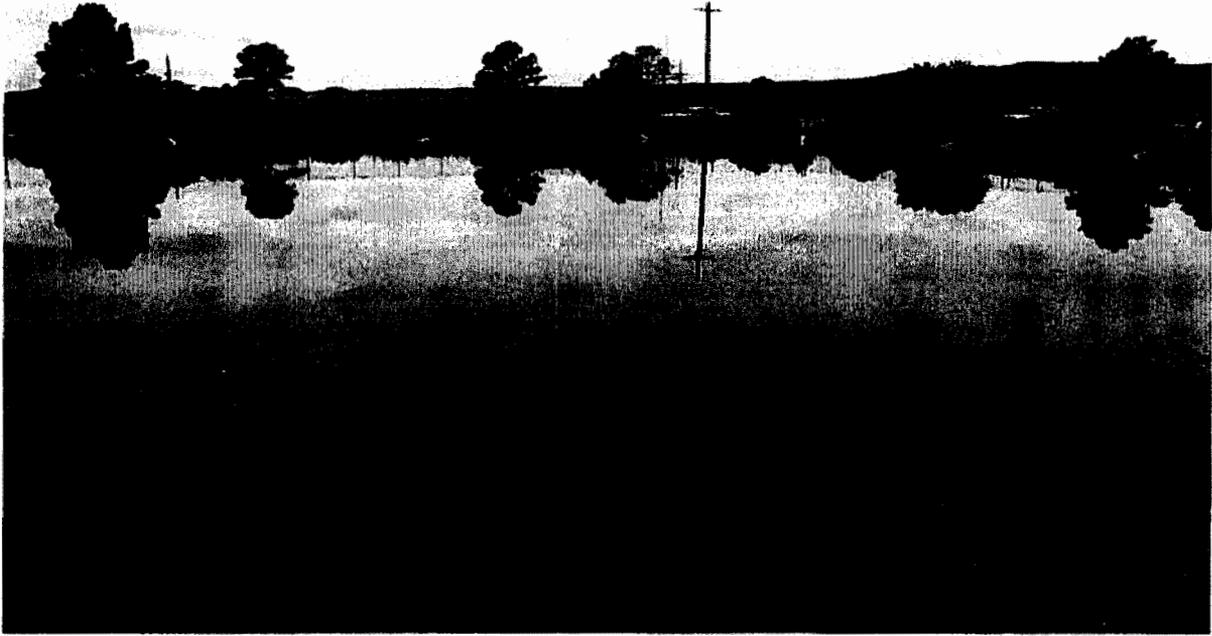
**Southwest Evaporation Basin (Basin 3)**

Inspection Sump #1: Dry

Inspection Sump #2: Dry

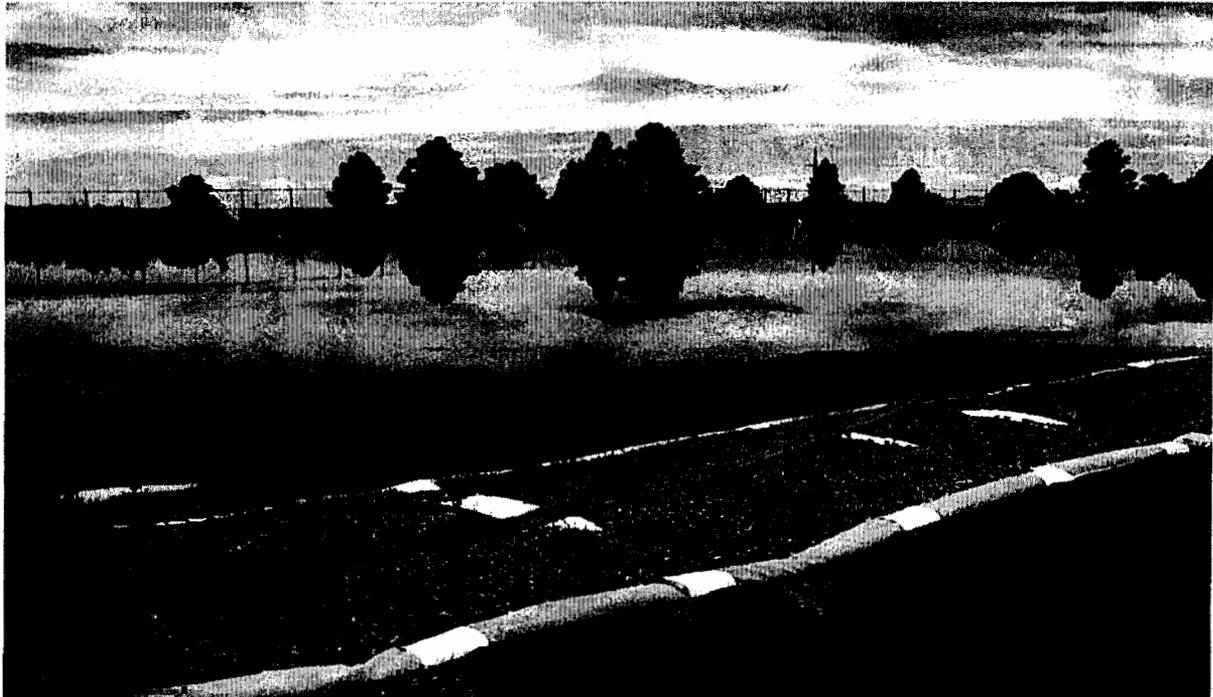
**Southeast Evaporation Basin**

- **Southeast Basin.** An August 6, 2015, inspection of the east (#2) leak collection port showed approximately 2.1 ft. of standing water. The presence of water in this port was unusual since both ports had been free of water greater than a de minimis quantity for the previous 12 months. Following this discovery the pond was removed from service, drained, and evaluated by a qualified lining contractor. It was determined that a joint around the inlet pipe had failed and was the source of the leak. The entire boot was replaced, and the liner thermally fused to the inlet pipe. Post repair inspection was acceptable and the pond was returned to service on September 1, 2015. The monthly inspection performed on September 23, 2015, showed both ports remain dry.

Inspection Sump #1: Dry

Inspection Sump #2: 2.1 ft of standing water

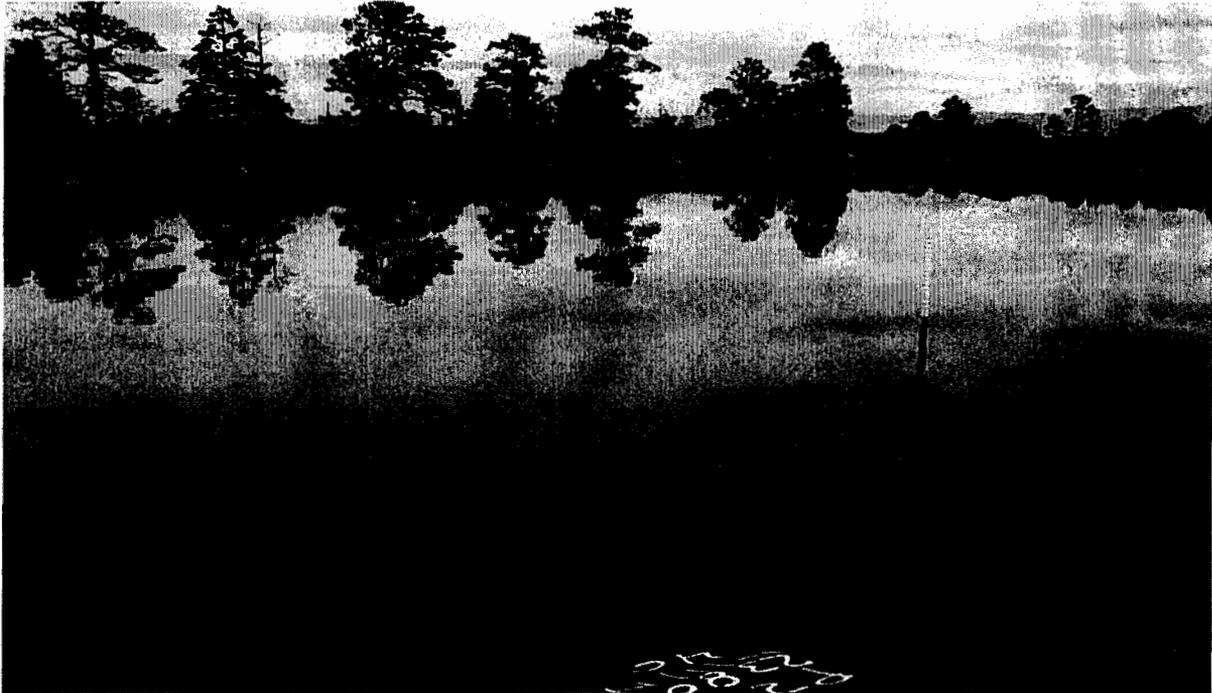
**5<sup>th</sup> Evaporation Basin (Basin 5)**

- **5<sup>th</sup> Basin.** In May 2015 DOE/LANS submitted to NMED a CAP for a leak in the primary liner at the new 5<sup>th</sup> evaporation basin (ENV-DO-15-0123). The CAP identified the steps necessary to locate and repair the leak by November 30, 2015. The contractor responsible for the liner installation performed an inspection of the pond beginning June 22, 2015, and determined that the source of the leak was a boot joint around the inlet pipe. The leak was repaired and the pond was returned to service on June 29, 2015. The ports remained dry until August 26, 2015, when 28 inches of water was found in the west (#1) inspection port. It appears that the initial repair may not have corrected all possible leaks. Due to the delays in completing repairs to the Northeast evaporation basin there is some potential that DOE/LANS will not complete repairs to the 5<sup>th</sup> evaporation basin by November 30<sup>th</sup>.

Inspection Sump #1: 0.1 ft of standing water

Inspection Sump #2: 0.3 ft of standing water

The 5<sup>th</sup> basin cannot be drained and prepared for repair until the Northeast evaporation basin is returned to service. NMED was informed of this situation in a telephone call from Mr. Robert Beers (ENV-CP) to Mr. Gerald Knutson (NMED GWQB) on October 8, 2015.

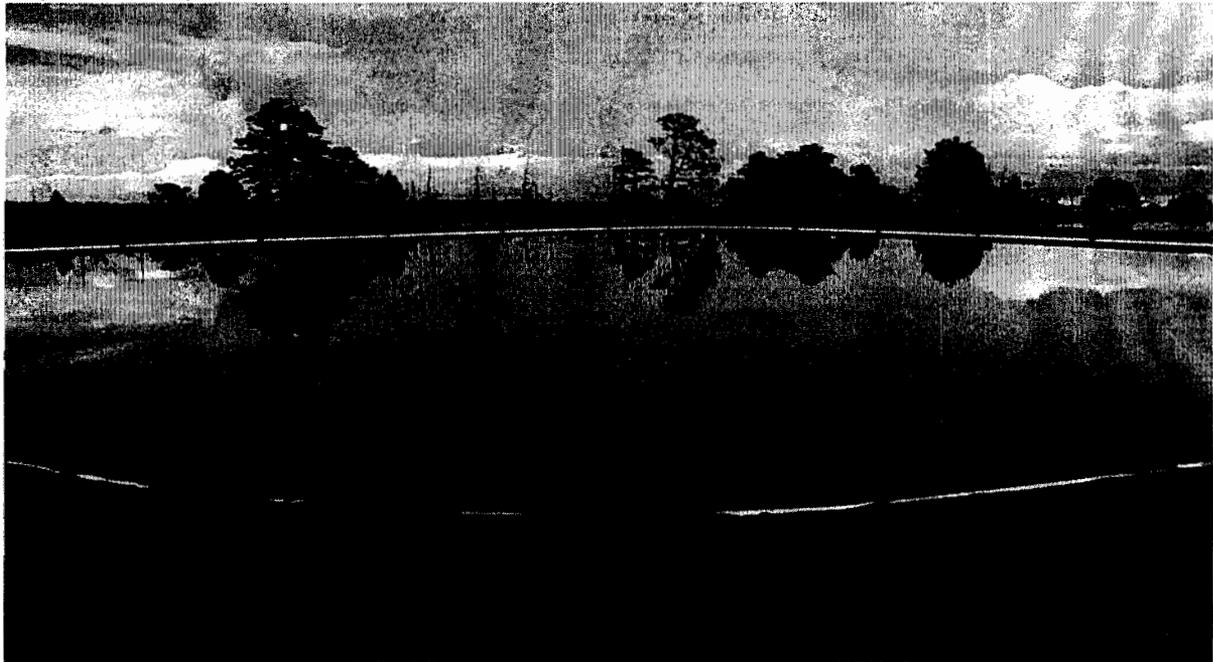
**Northwest Evaporation Basin (Basin 1)**

Inspection Sump #1: Dry

Inspection Sump #2: Dry

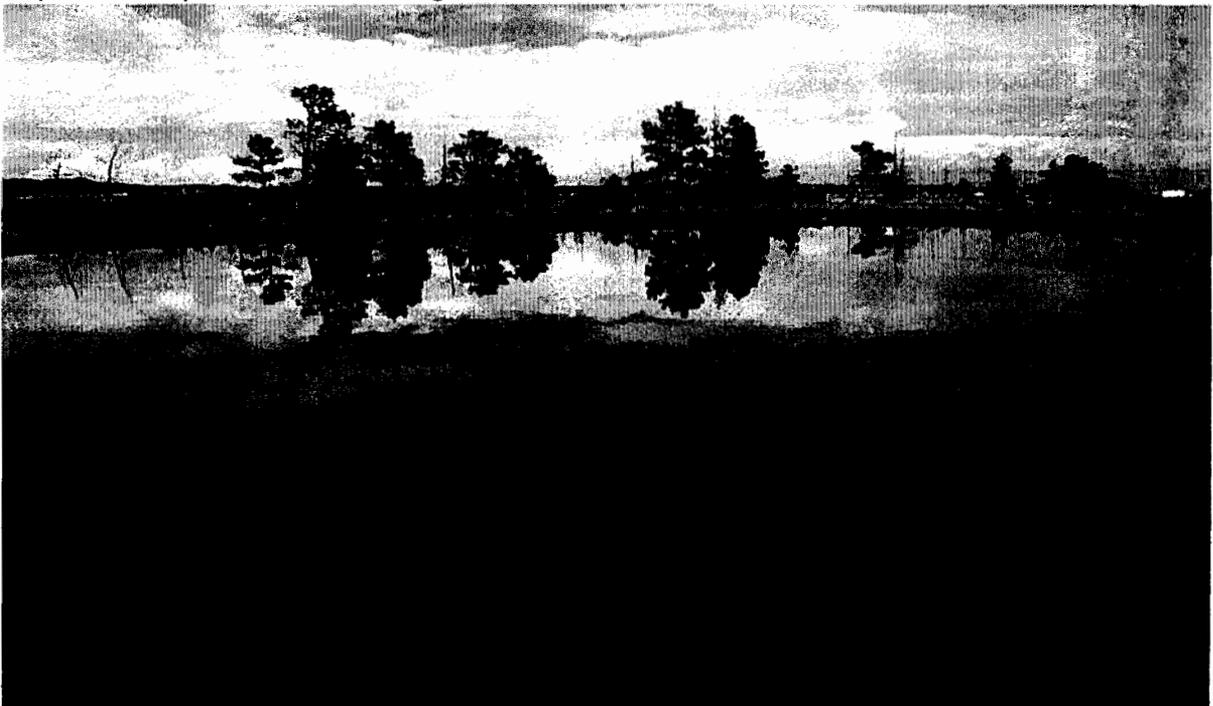
**Northeast Evaporation Basin (Basin 2)**

Inspection Sump #1: 4.6 ft of standing water

Inspection Sump #2: 4.5 ft of standing water

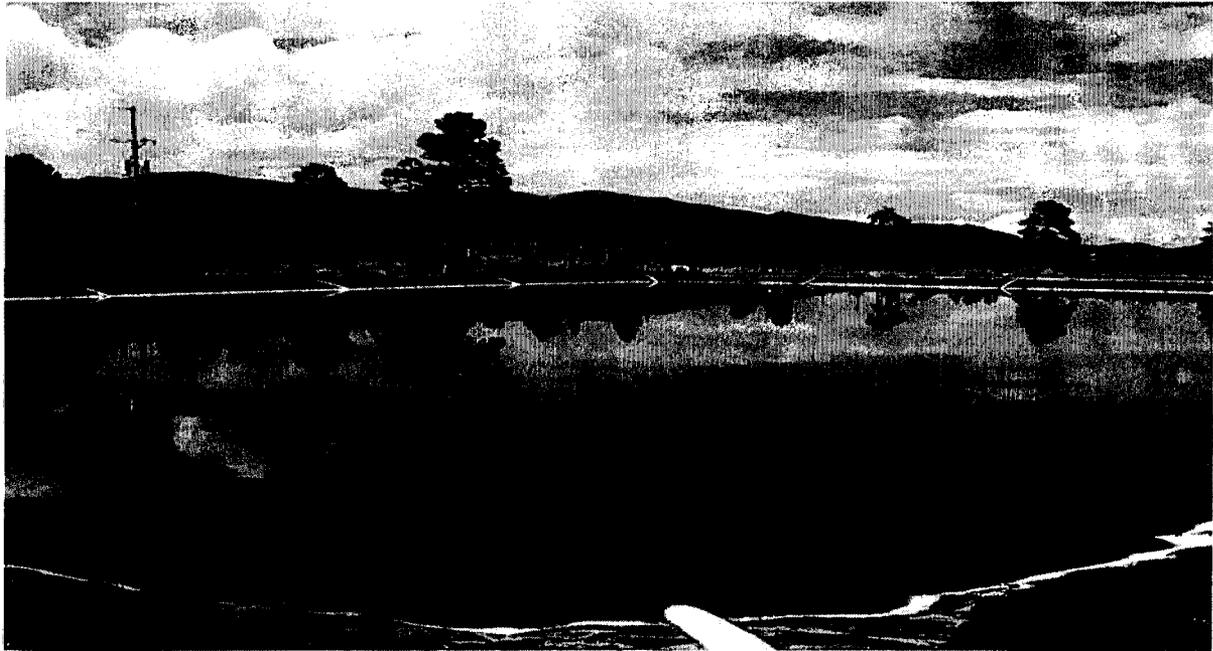
Southwest Evaporation Basin (Basin 3)

Inspection Sump #1: Dry

Inspection Sump #2: Dry

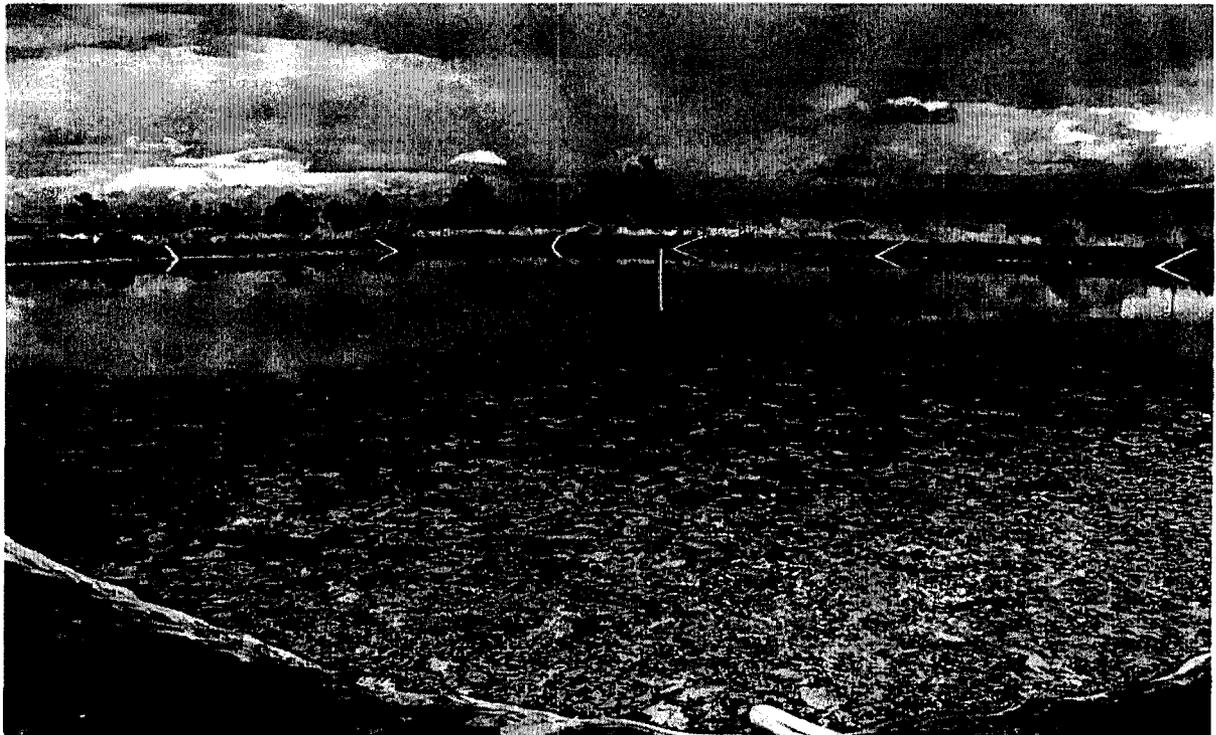
Southeast Evaporation Basin

Inspection Sump #1: Dry

Inspection Sump #2: Dry

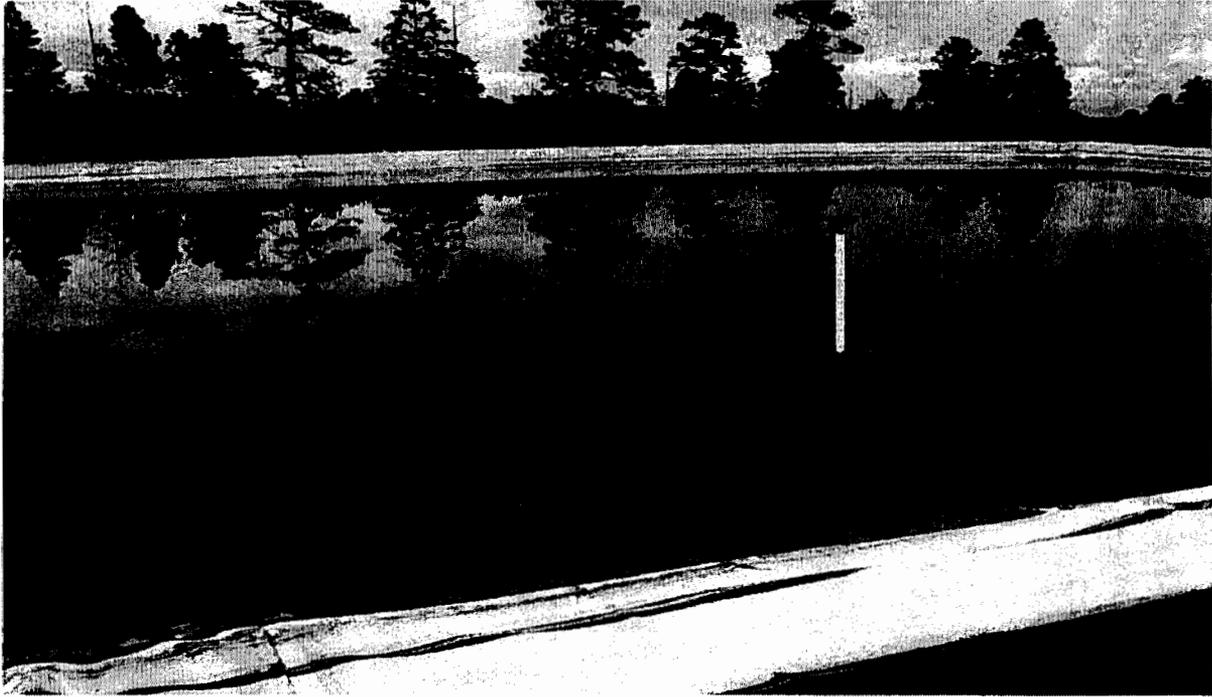
**5<sup>th</sup> Evaporation Basin**

Inspection Sump #1: 2.4 ft of standing water

Inspection Sump #2: 0.6 ft of standing water
