TA54

**Description of Photos of TA-54, Area G, Pad 2
Drum Removal on
April 7, 1992
and
Photo of Overpack Drums as they Appear Currently
at TA-54, Area G, Dome 48**

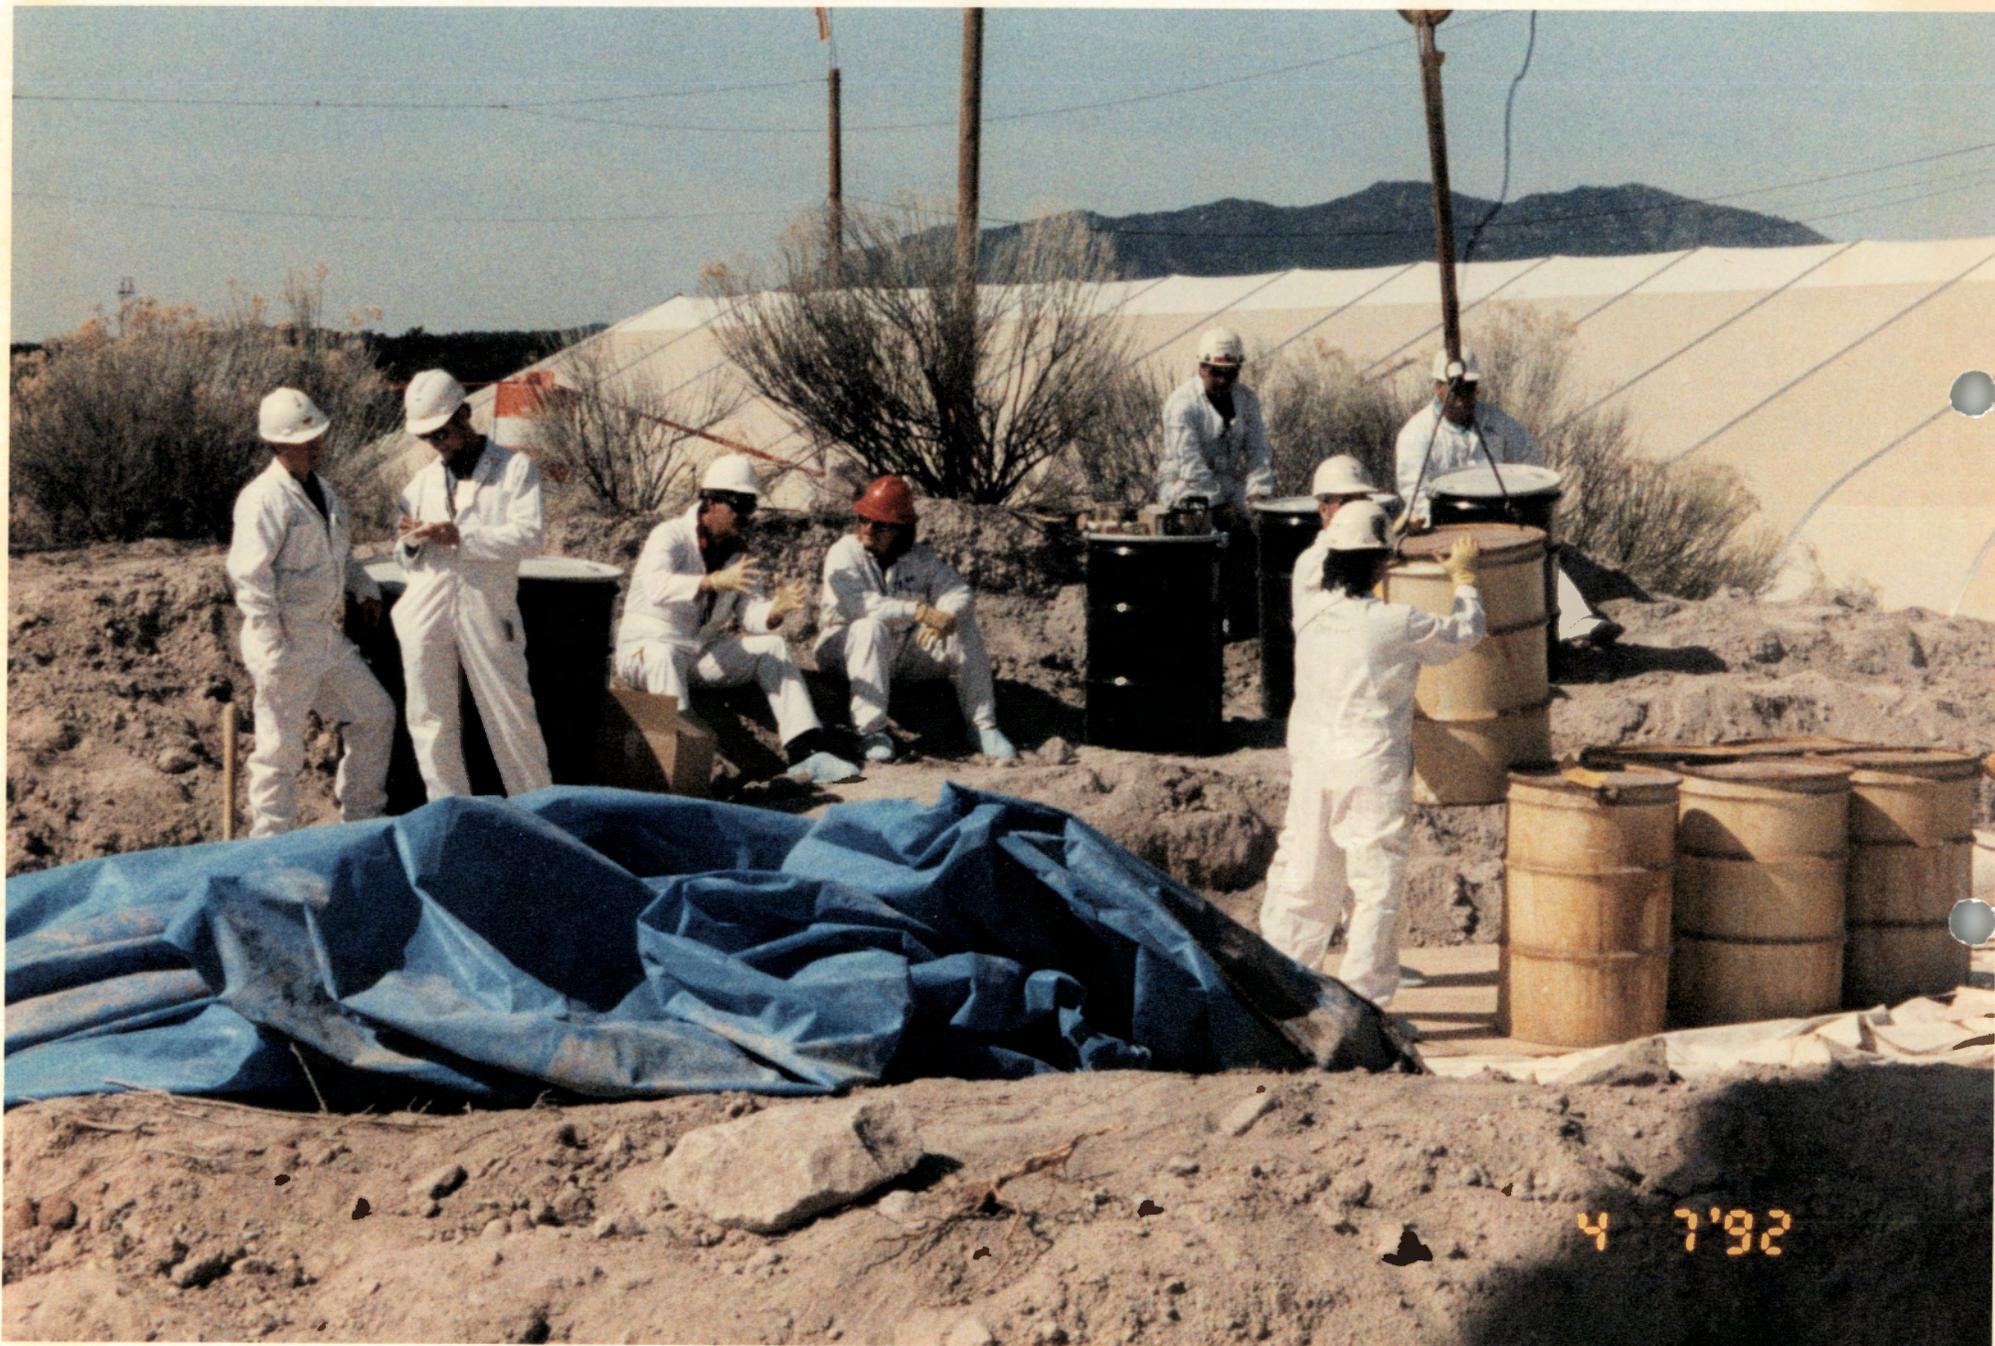
Photo #1

1. TA-54, Area G, Pad 2 - two members of the Johnson Controls Inc. (JCI) crew remove swiped 55-gallon drums containing TRU wastes out of the pad. Streaking discoloration is a rust inhibitor sprayed on drums at the time they were placed in the pad.

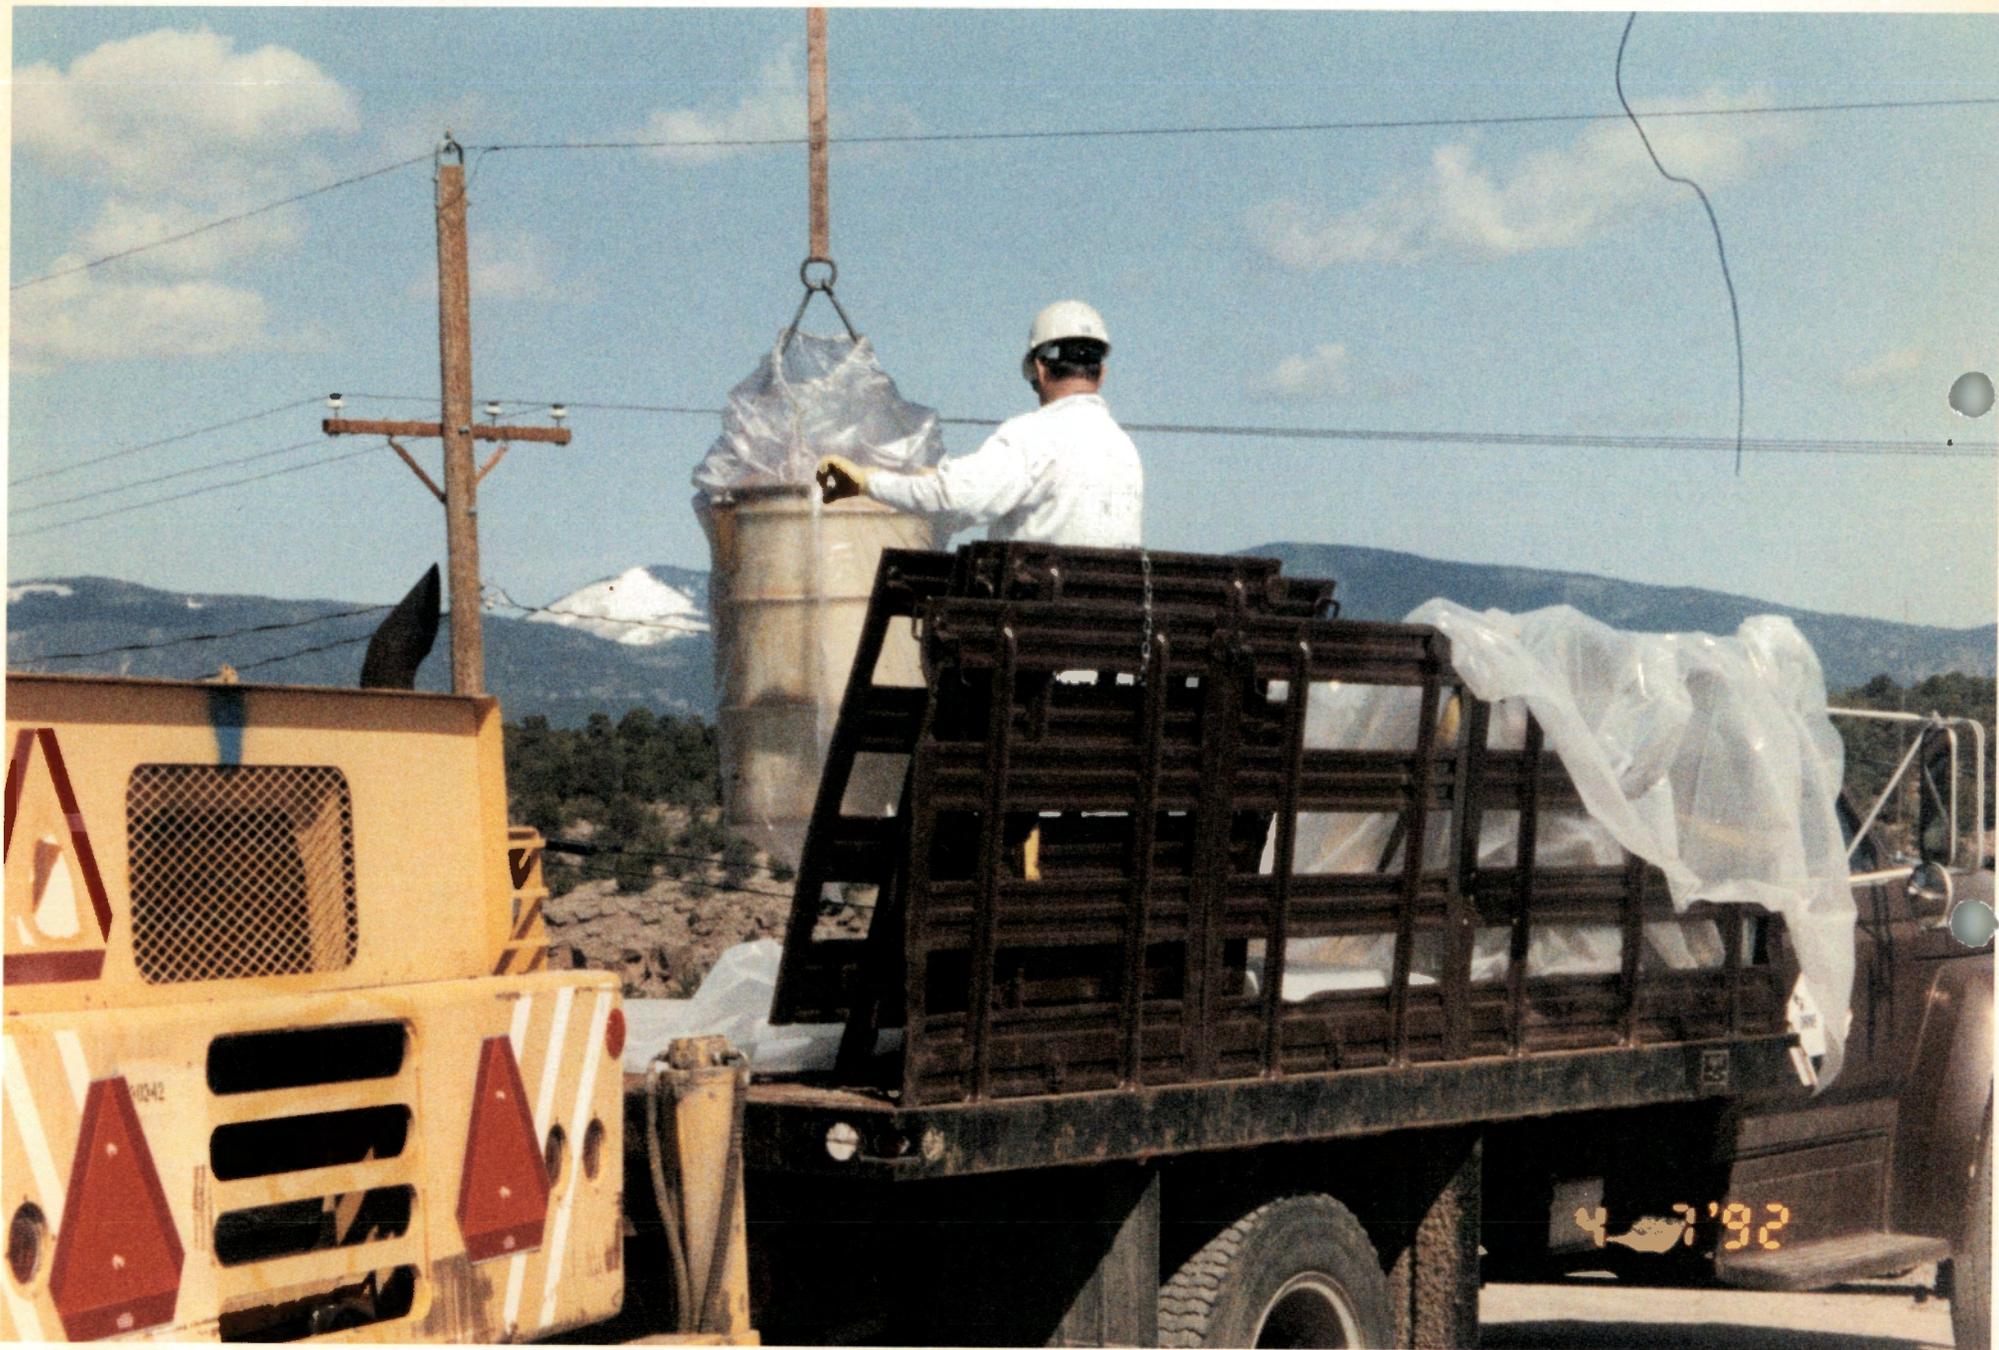
Photo #2

2. A 55-gallon drum of waste is lowered into a 12-mil plastic liner onto a truck, which will be transported to MD-33.
3. Packaged 55-gallon drum of waste at TA-54, Area G, Pad 2 whose outer layer of paint is rusting and peeling off. Streaking discoloration is a rust inhibitor sprayed on drums at the time they were placed in the pad. Corrosion noted on surface of container at the rolling ring either caused by stress or paint scraped off during packaging.

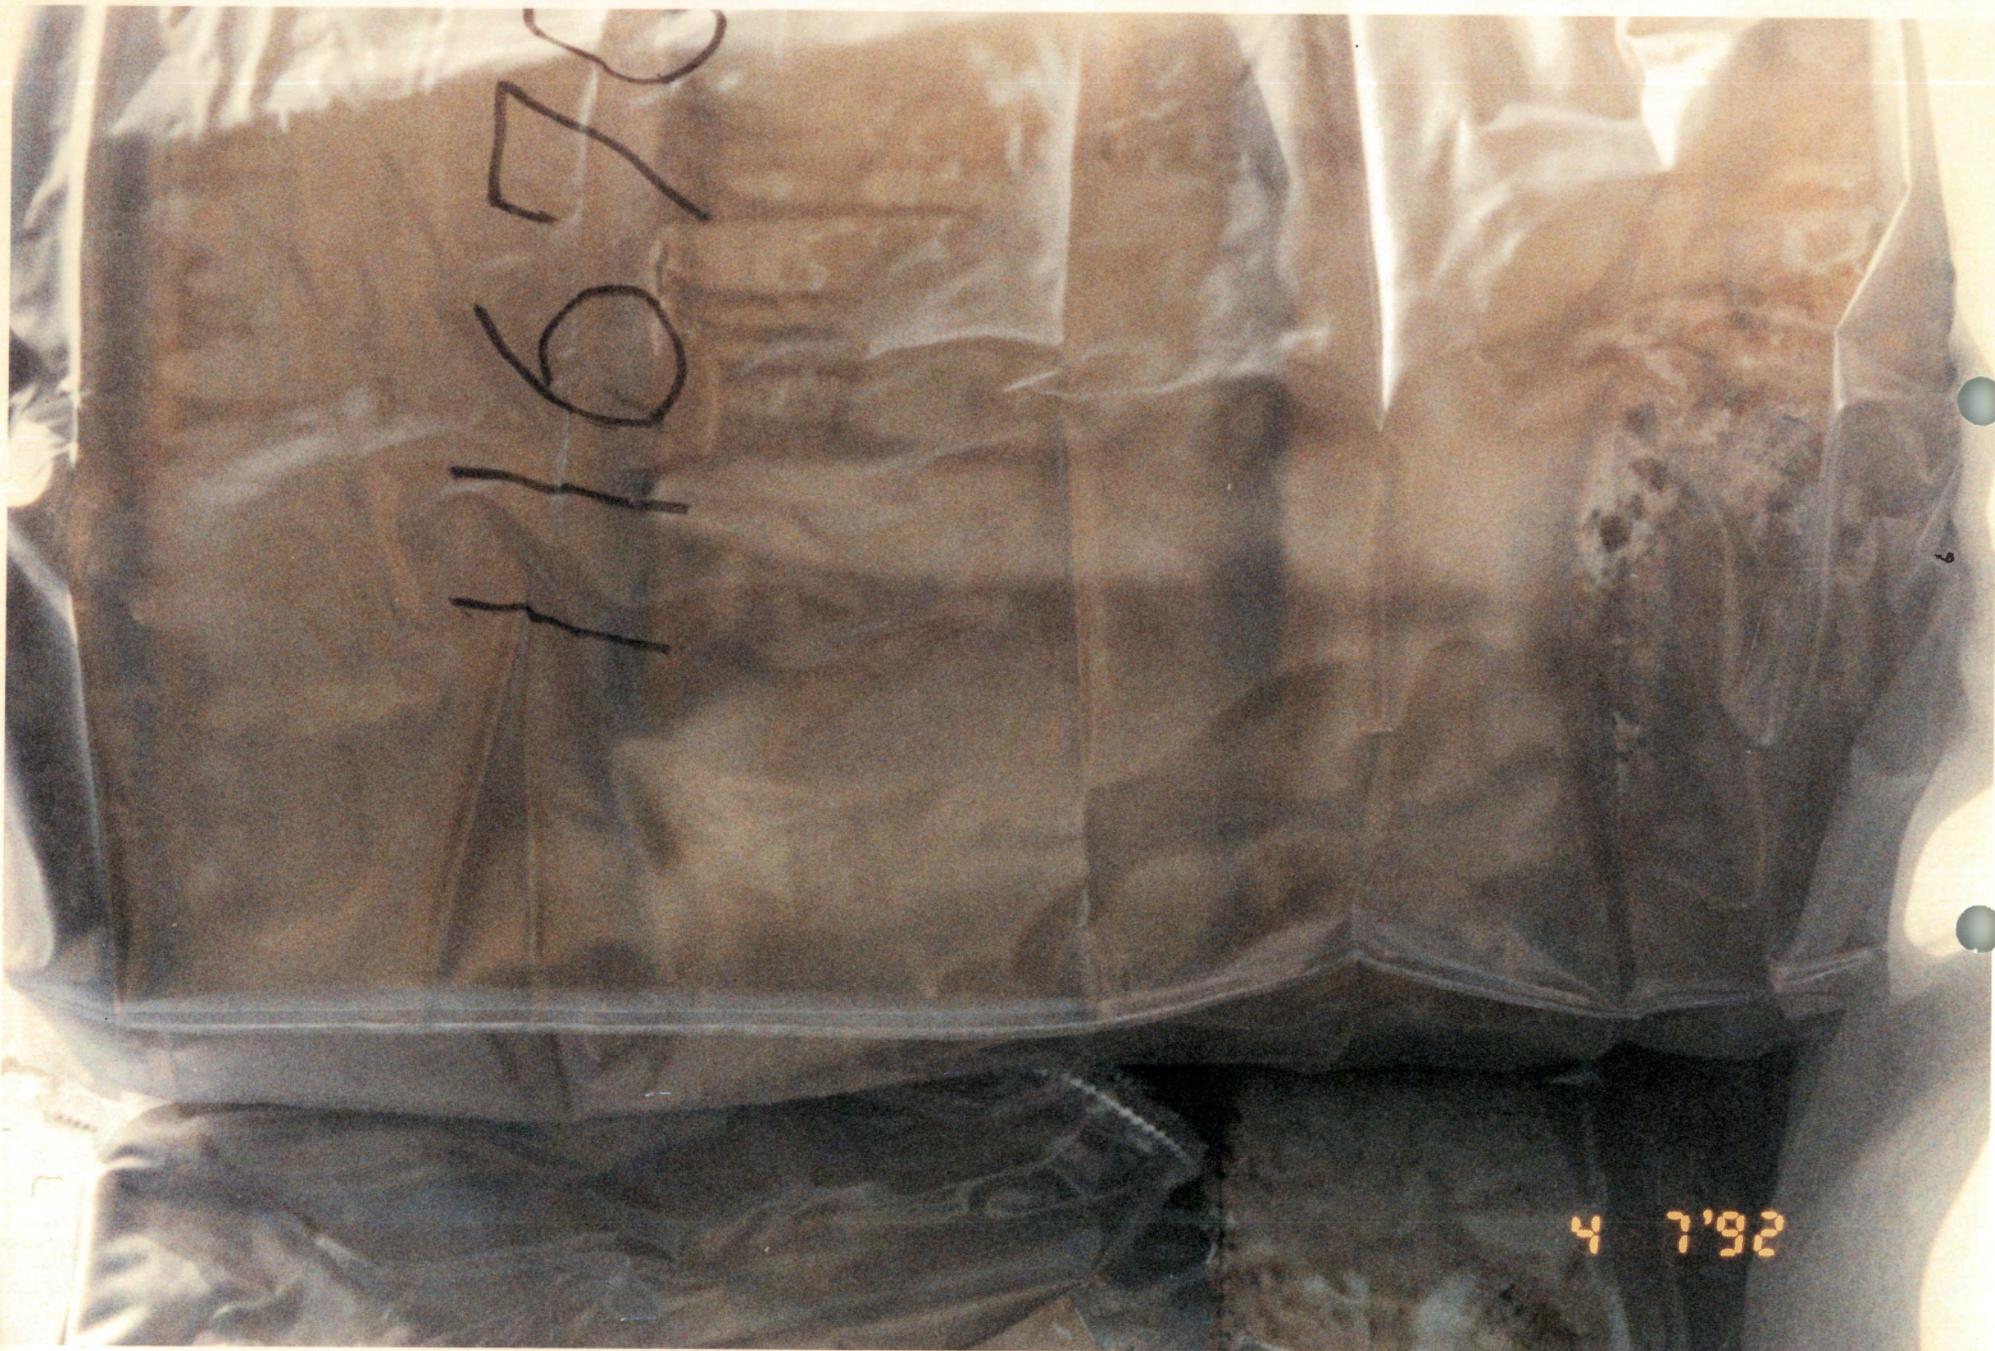
Photo #4

4. Packaged 55-gallon drum of TRU waste at TA-54, Area G, Pad 2 whose outer layer of paint is rusting and peeling off, similar evidence of corrosion as cited in photo #4.

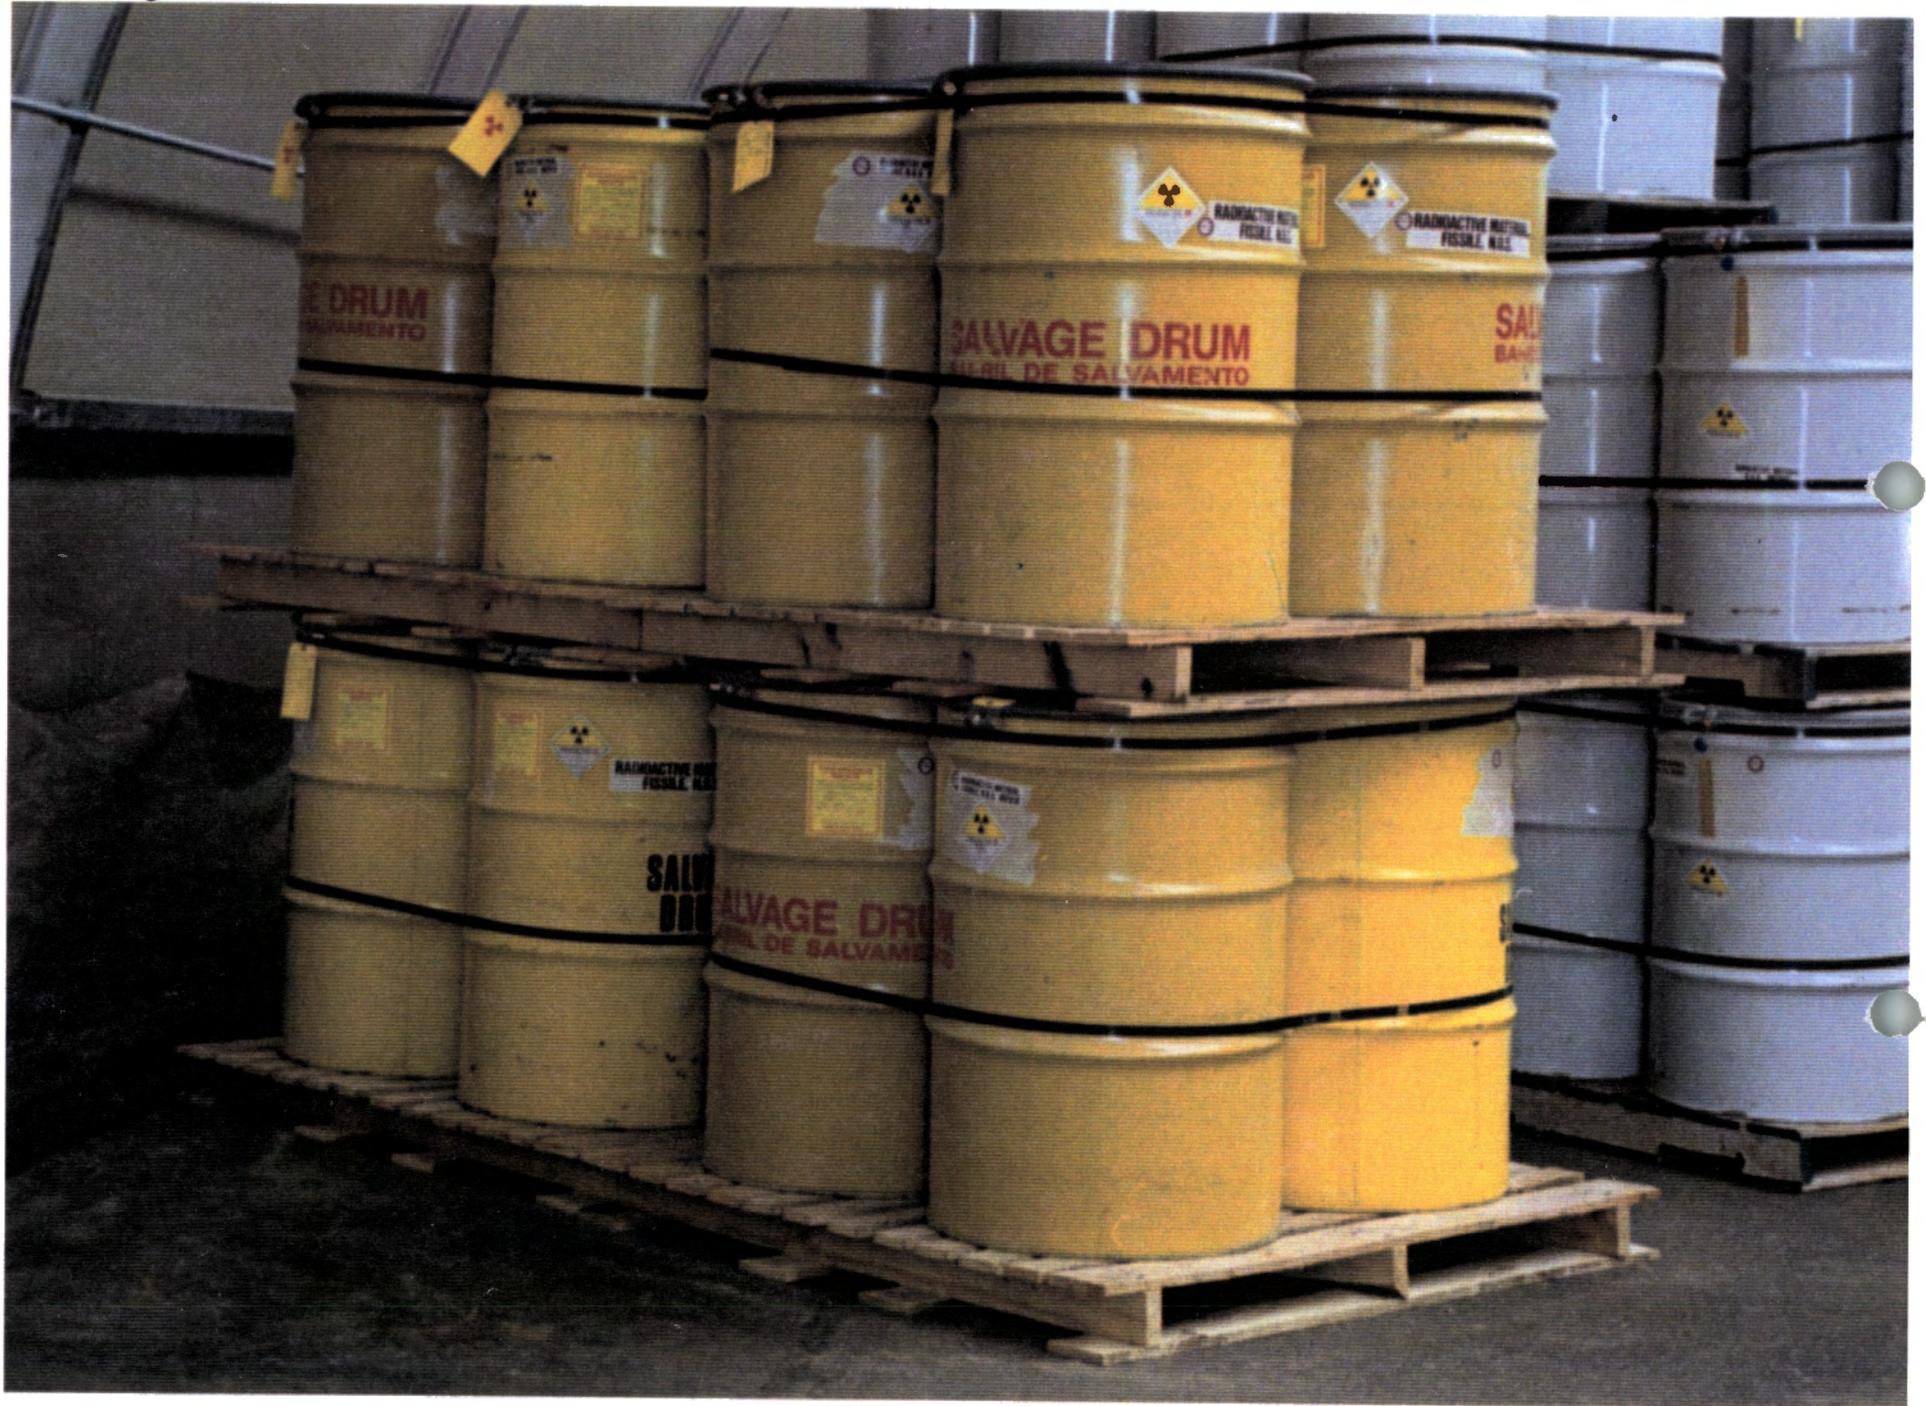
Photo # 5

5. Overpacked drums in current storage array at TA-54, Area G, Dome 48.
