DEPARTMENT OF THE AIR FORCE  
27TH SPECIAL OPERATIONS MISSION SUPPORT GROUP (AFSOC)  
CANNON AIR FORCE BASE NEW MEXICO

MEMO ON THE USTs AT 3121

**Air Force Compliance Clean-Up Sites, Identification and Evaluation of Defense  
Environmental Restoration Account (DERA) Eligibility for Air Force Center for  
Engineering and the Environment (AFCEE), Multiple Locations**

### **3.35 MELROSE ADMINISTRATIVE BUILDING FORMER UST (ST-C506)**

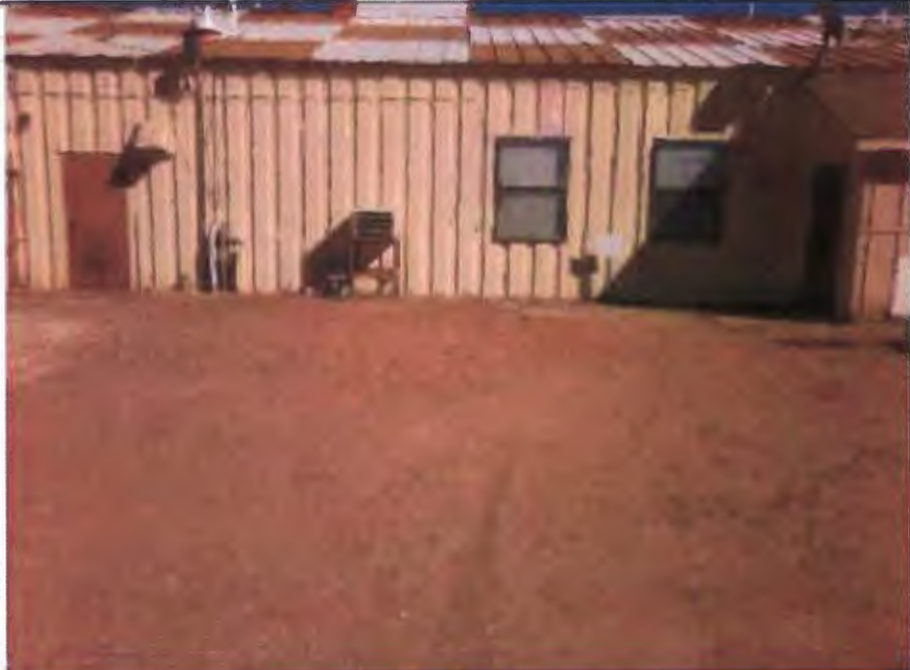
**Photo No.**  
1

**Description:** Former  
UST at Melrose facing  
east

The Melrose Administrative Building Former UST (ST-C506) site contained a 275-gallon heating oil UST located west of Building 3121 at the Melrose Bombing Range. The UST and some contaminated soil were removed in November 1994. Subsequent sampling in April to August 1995 identified additional soil contamination. An actual date of the release cannot be determined; however, it is believed to have occurred during the service life of the tank. A maximum TPH-DRO concentration of 25,000,000 µg/kg was discovered in bore hole No. 3 at a depth of 19 to 21 feet bgs (USGS 1995).

Site ST-C506 is located on land owned by the U.S. and under the jurisdiction of the Secretary of Defense and was owned by the U.S. and under the jurisdiction of the Secretary of Defense at the time of contamination. There was a release of POL at the site. In addition, no site activities met any ineligibility criteria discussed in the Background section in Volume I of this Evaluation Report. Based on these factors, this site is considered DERA(IR) eligible and is recommended for validation. Additional details concerning specific DERA(IR) eligibility criteria evaluated for this site are included in Appendix D.

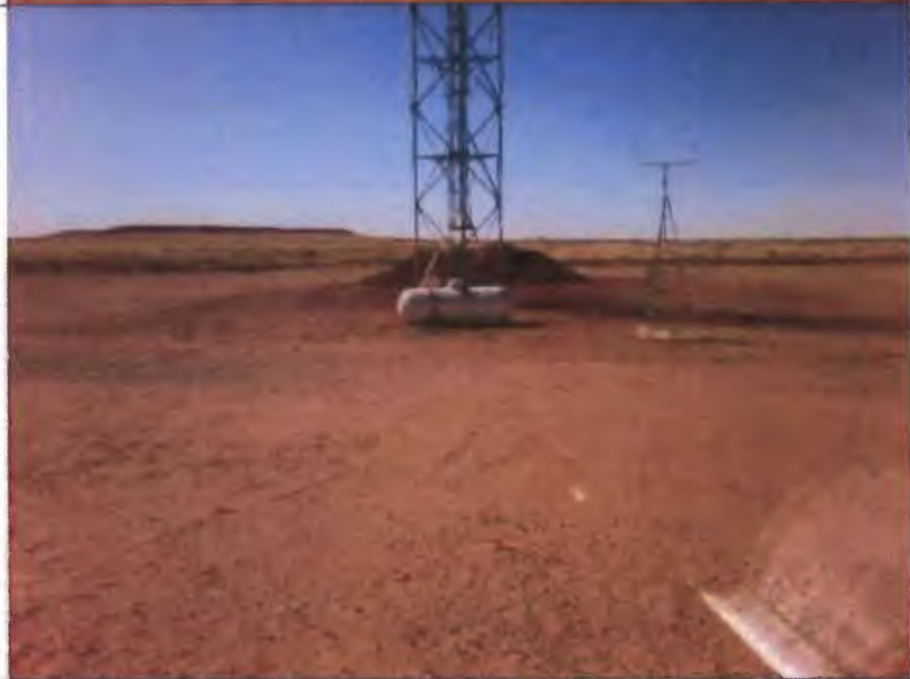
**Photo No.**  
2

**Description:**  
Former UST at Melrose  
facing west
