**Sandia National Laboratories**

Subject: Additional Pages to be inserted into Previously-Sent Document

The US Department of Energy (DOE) and Sandia Corporation (Sandia) recently sent you a copy of our response to 64 comments included in the New Mexico Environment Department's Second Notice of Deficiency HWB-SNL-02-002 for Sandia National Laboratories, EPA ID NM5890110518. The response included five attachments.

Pages that were inadvertently omitted from Attachment C

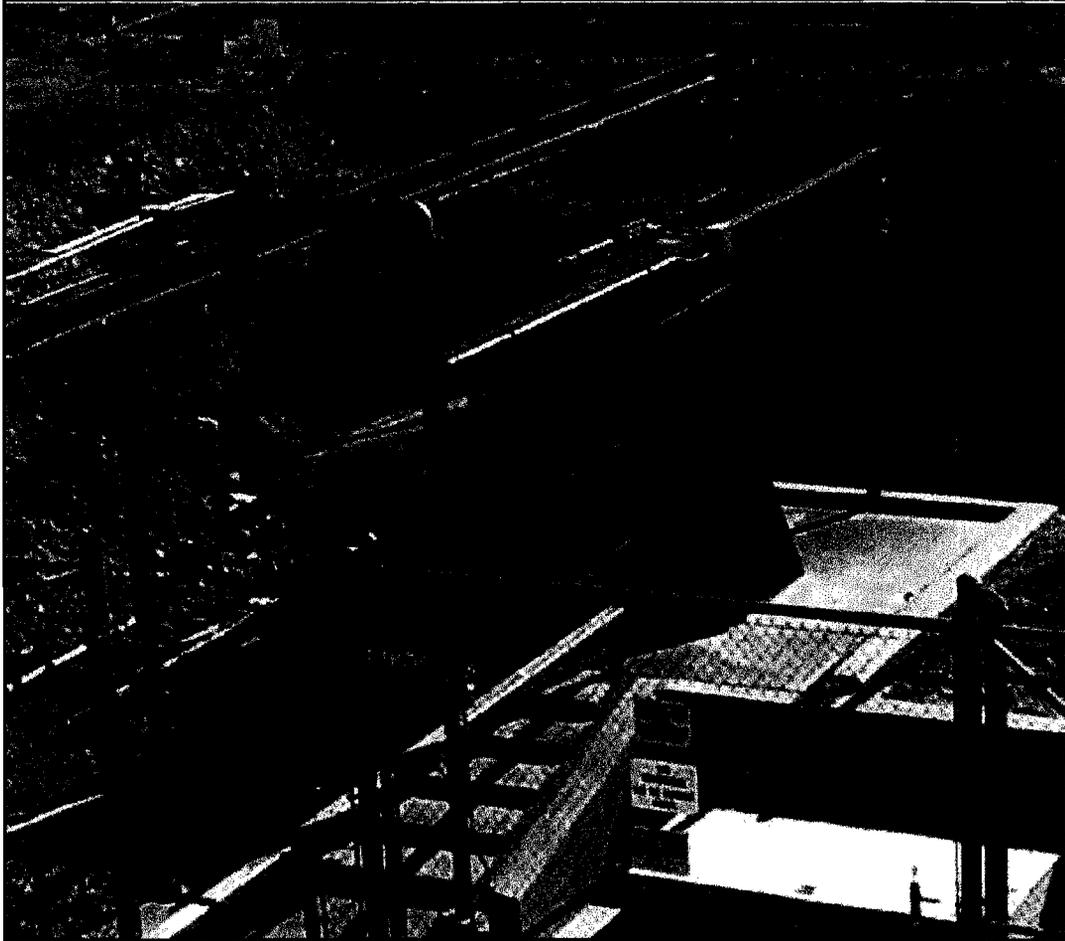
**Thermal Treatment Facility (~~Viewed from the Roof of Building 6715~~)**  
**Viewed from Roof of Building 6715**  
Photograph Taken ~~on December 20, 2004~~ October 23, 2003  
Process Code: ~~X03~~ X01

The sheet metal housing and propane lines for the propane burners ~~is~~ are on the left side of the burn cage. The sheets of steel on the right side and the back of the burn cage are attached at the top and provide protection from wind during waste treatment.

The entire surface of the concrete foundation pad and the inside edge of the concrete pad curb are lined with steel. Runoff water is directed toward the right front corner of the pad, through a filter, and into a covered catchment tank that is visible at the lower right corner of the photograph.

The burn pan lid is in the lowered position. The burn cage is surrounded by an earthen berm. The gate in the fence surrounding the TTF is open.

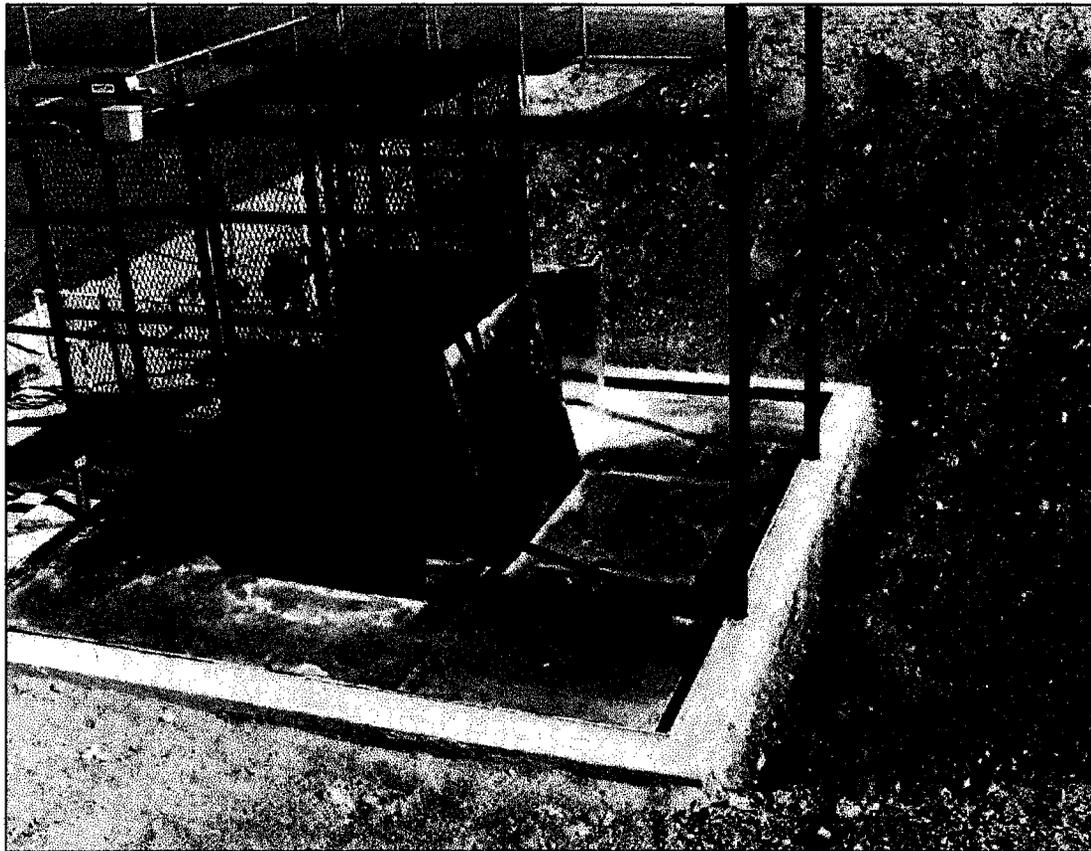
**Thermal Treatment Facility (~~Viewed from the Top of the Earthen Berm~~)**  
**Rear View of Burn Cage from Top of Earthen Berm**  
Photograph Taken on ~~December 20, 2004~~ **October 23, 2003**  
Process Code: ~~X03~~ X01

The door of the burn cage is open on the left (front) side of the cage. The sheet metal housing for the propane burners is visible on the ~~right~~ far side of the burn cage.

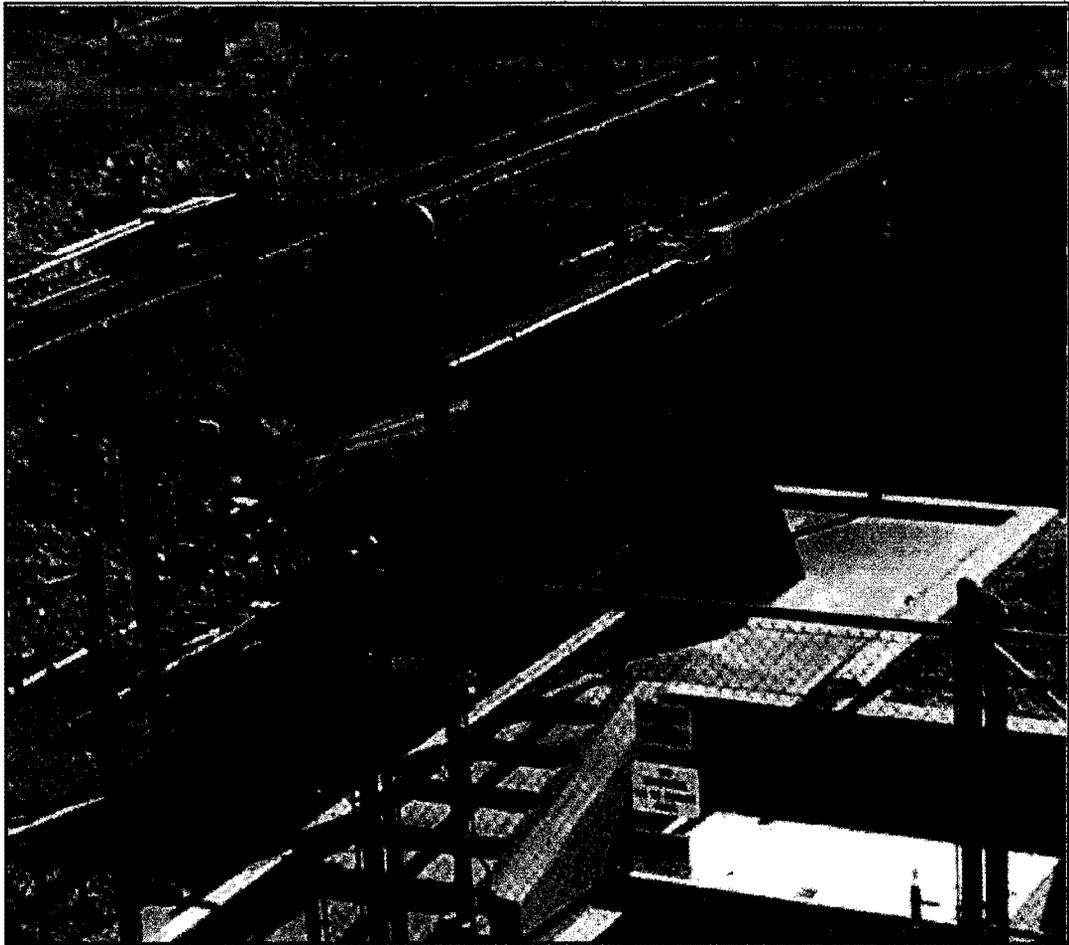
**Thermal Treatment Facility (~~Viewed from the Roof of Building 6715~~)  
Viewed from Roof of Building 6715**

The sheet metal housing and propane lines for the propane burners ~~is~~ are on the left side of the burn cage. The sheets of steel on the right side and the back of the burn cage are attached at the top and provide protection from wind during waste treatment.

The entire surface of the concrete foundation pad and the inside edge of the concrete pad curb are lined with steel. Runoff water is directed toward the right front corner of the pad, through a filter, and into a covered catchment tank that is visible at the lower right corner of the photograph.

The burn pan lid is in the lowered position. The burn cage is surrounded by an earthen berm. The gate in the fence surrounding the TTF is open.

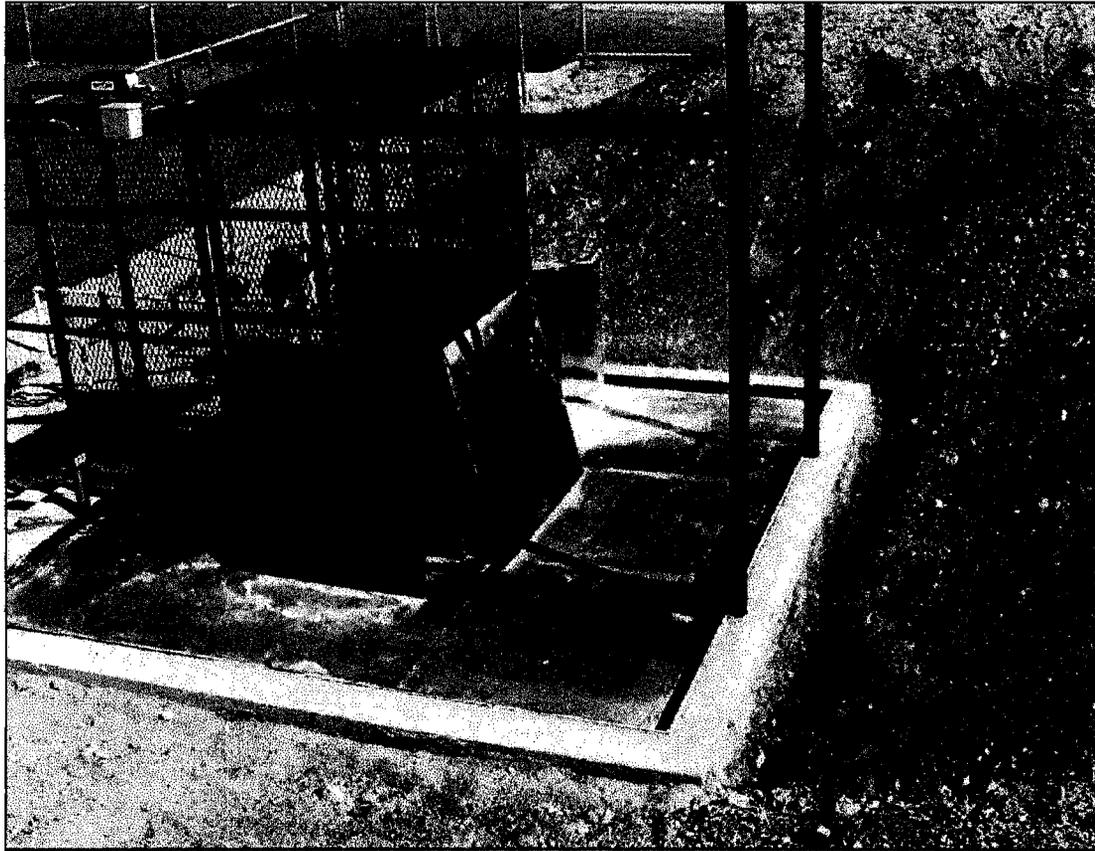
**Thermal Treatment Facility (~~Viewed from the Top of the Earthen Berm~~)  
Rear View of Burn Cage from Top of Earthen Berm**

The door of the burn cage is open on the left (front) side of the cage. The sheet metal housing for the propane burners is visible on the ~~right~~ far side of the burn cage.

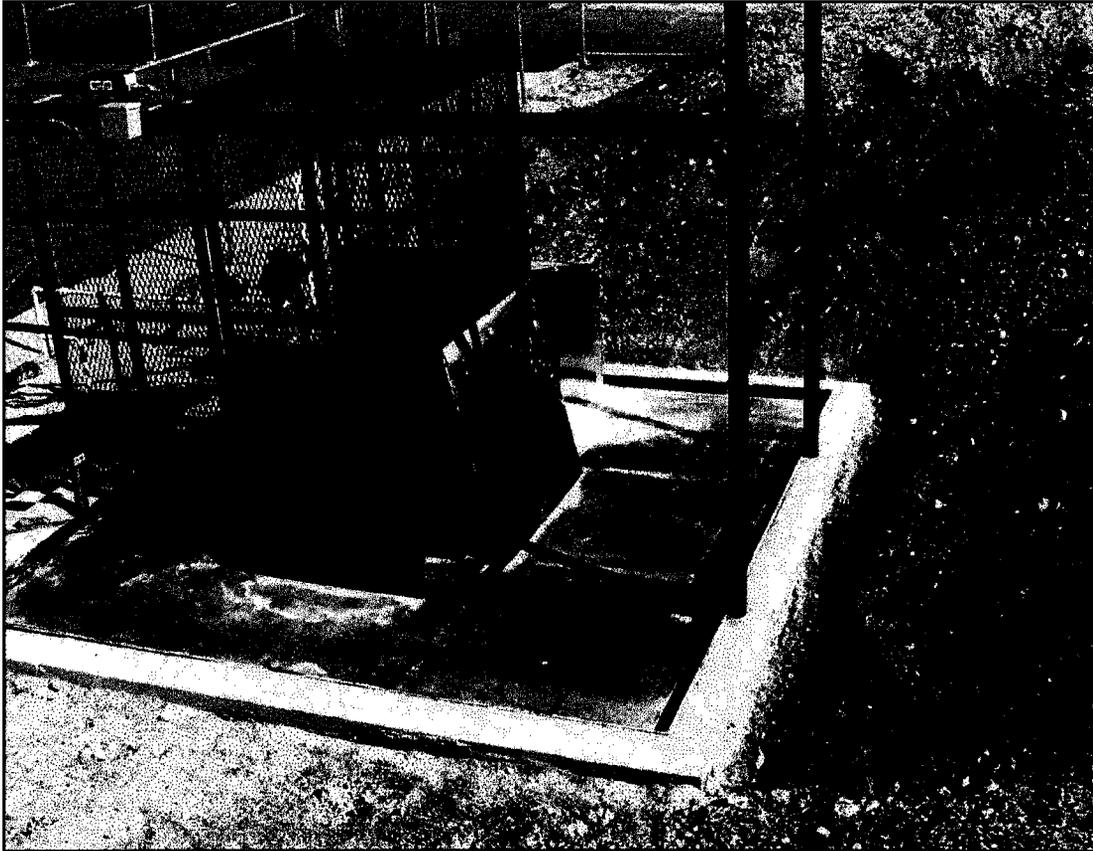
**Thermal Treatment Facility**  
**Rear View of Burn Cage from Top of Earthen Berm**  
Photograph Taken on October 23, 2003  
Process Code: X01

The door of the burn cage is open on the left (front) side of the cage. The sheet metal housing for the propane burners is visible on the far side of the burn cage.
