**SOLID WASTE MANAGEMENT UNITS AND AREAS OF CONCERN
ANNUAL LONG-TERM MONITORING AND MAINTENANCE REPORT
FOR CALENDAR YEAR 2021**

SANDIA NATIONAL LABORATORIES, NEW MEXICO

March 2022

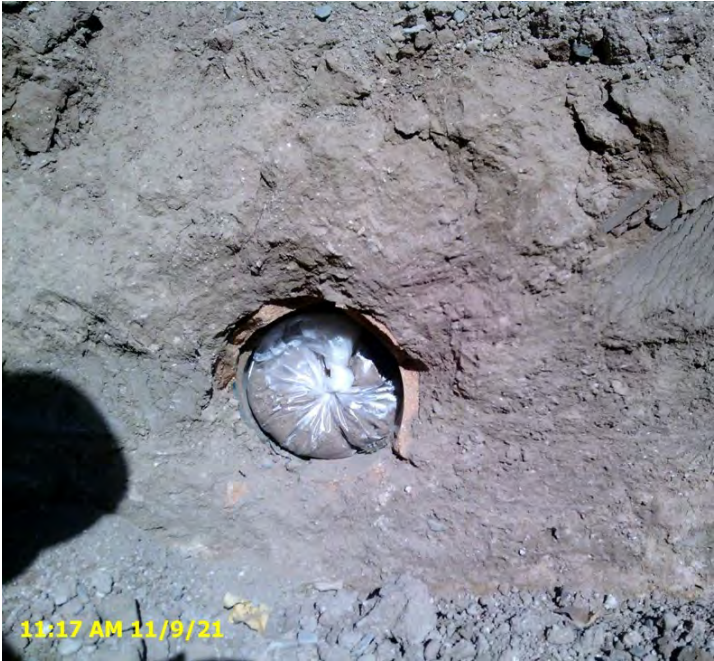
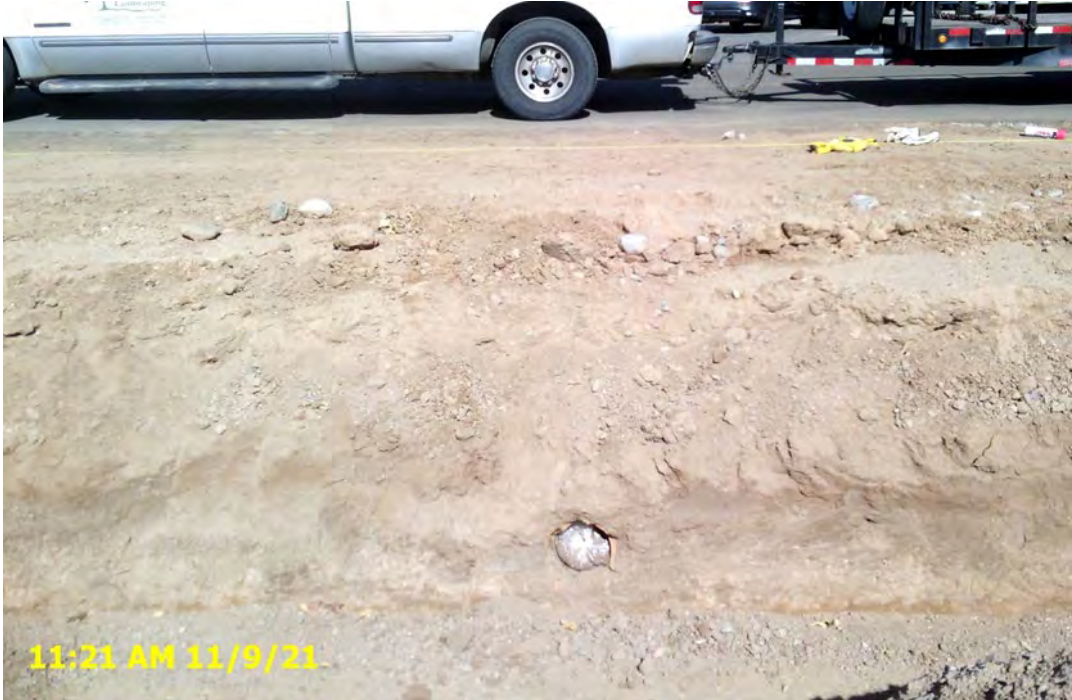
Figure 3-1
Placement of Broken Clay Pipe Pieces in Subsurface Clay Pipe at
SWMU 226, Old Acid Waste Line

On November 9, 2021, SNL contractors working on a construction and landscaping project within Sandia National Laboratories TA-IV, encountered the subsurface remains of SWMU 226 the (Old Acid Waste Line). The project had been reviewed and was approved because the activities were not expected to impact the SWMU. The waste line was encountered during excavation for storm water management features that were part of the project. Work was stopped while the SWMU and site conditions were evaluated.

The subsurface piping features of the Old Acid Waste Line were in good condition and consisted of a 10 inch outer diameter (OD) vitrified clay pipe, approximately 3 feet below ground surface. There was no evidence of liquids, stained soils, or unusual odors. As shown in Figure 3-1, broken pieces of the clay pipe were put into a clear plastic bag and placed inside of the intact subsurface pipe. The pipe was covered in the backfilling process. The GPS location of the broken piping was recorded for future identification.

The Old Acid Waste Line was encountered during a construction and landscaping project. There was no evidence of liquids, stained soils, or unusual odors. Broken piping was placed in a plastic bag before being inserted inside of the intact surface piping and subsequently covered in the backfilling process. The GPS location of the broken piping was recorded for future identification.
