Re: **RCRA Facility Assessment at Transwestern Pipeline Company,  
Roswell Compressor Station, New Mexico**

**RCRA FACILITY ASSESSMENT  
PR/VSİ REPORT**

**ENRON - TRANSWESTERN PIPELINE COMPANY  
ROSWELL COMPRESSOR STATION NO. 9  
ROSWELL, NEW MEXICO**

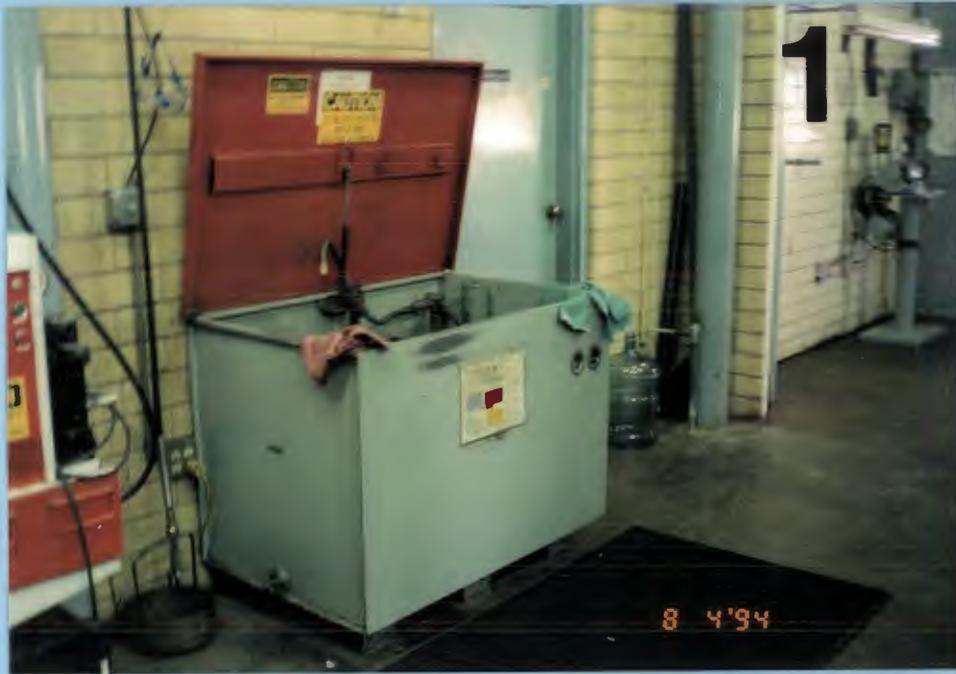
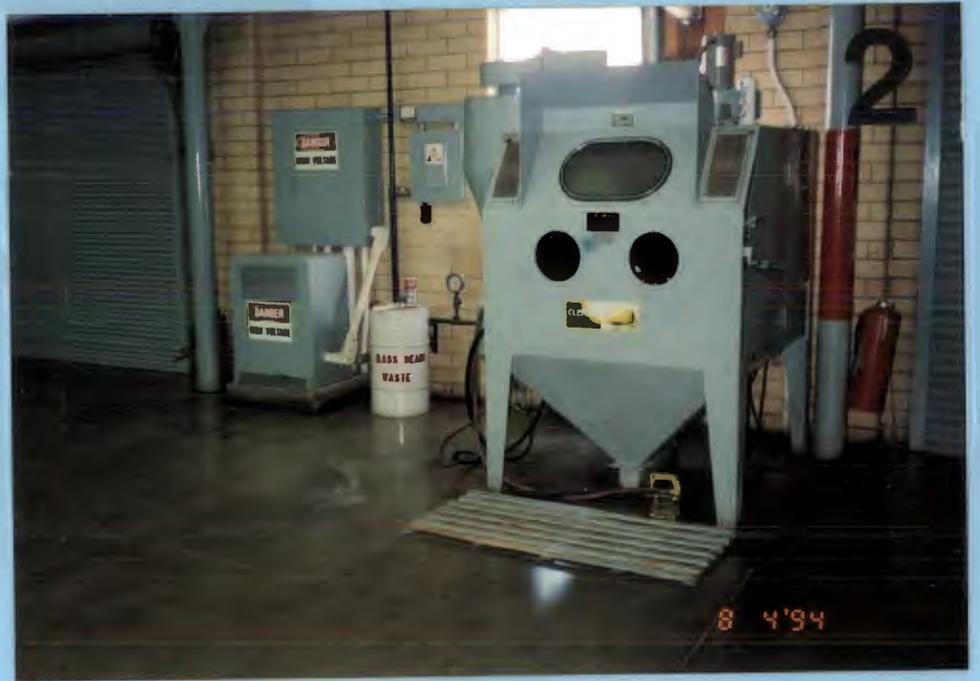
- Photo 1. SWMU 1 - Parts Washer Area  
This SWMU is located within the northwestern portion of the Mechanics Building in the central portion of the facility. During the VSI, no visual signs of a release were observed.

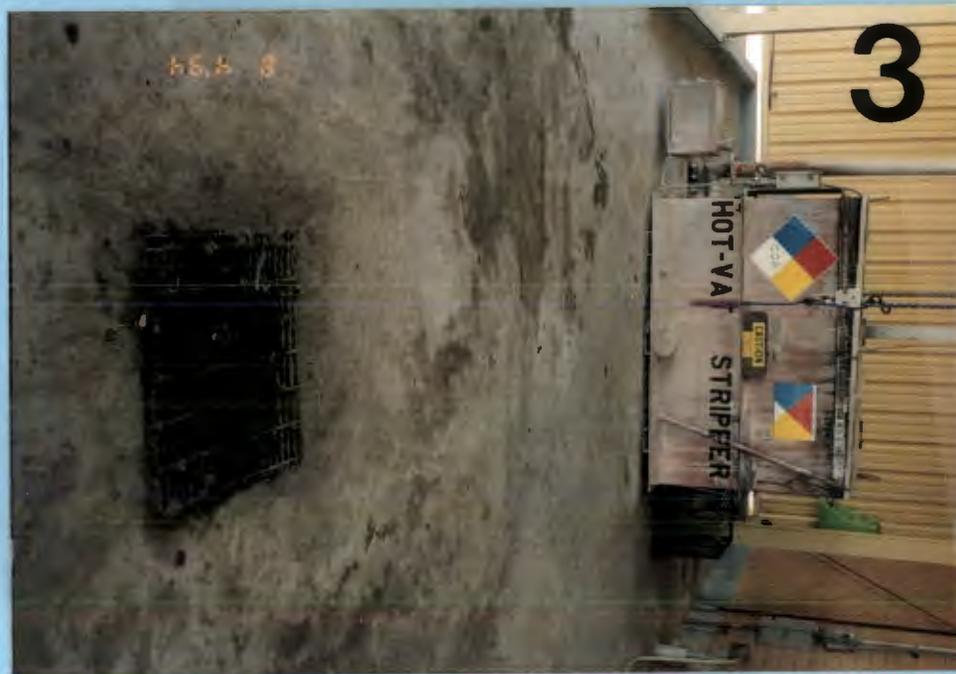
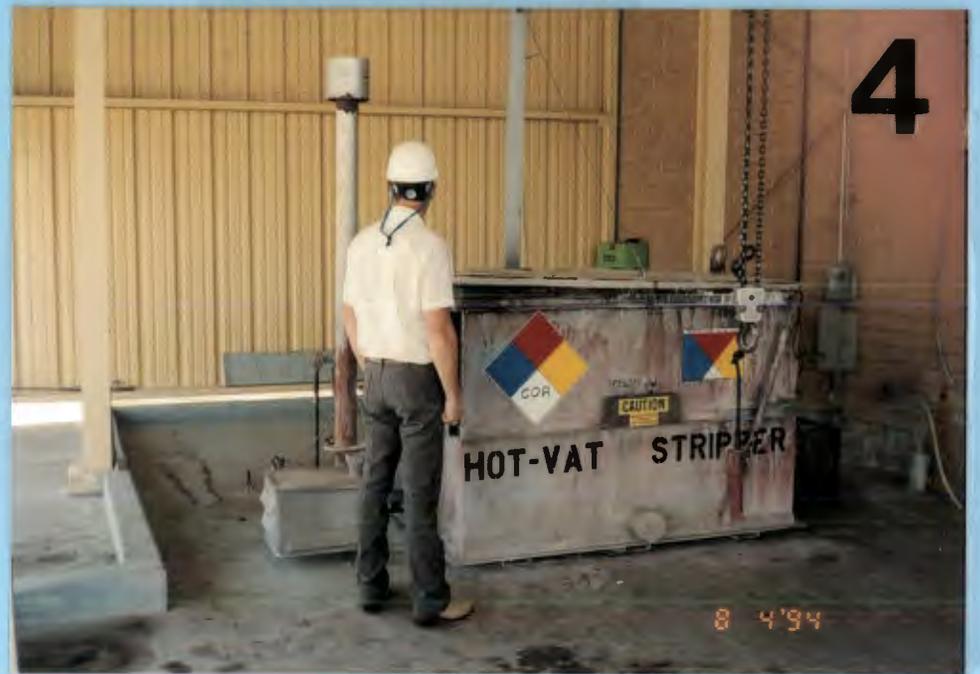
- Photo 3. SWMU 3 - Caustic Tank and Sump in Wash Rack Area  
This area is located adjacent to the south side of the Mechanics Building under a covered patio. This photograph shows the Caustic Tank (hot-vat stripper) in the background and the Sump in the foreground.

- Photo 4. SWMU 3- Caustic Tank and Sump in Wash Rack Area  
This photograph shows the Caustic Tank appropriately labeled by the placard. Note the six-inch concrete berm in the left background. No visual staining or evidence of a release was observed outside the bermed area.

No further action is recommended.

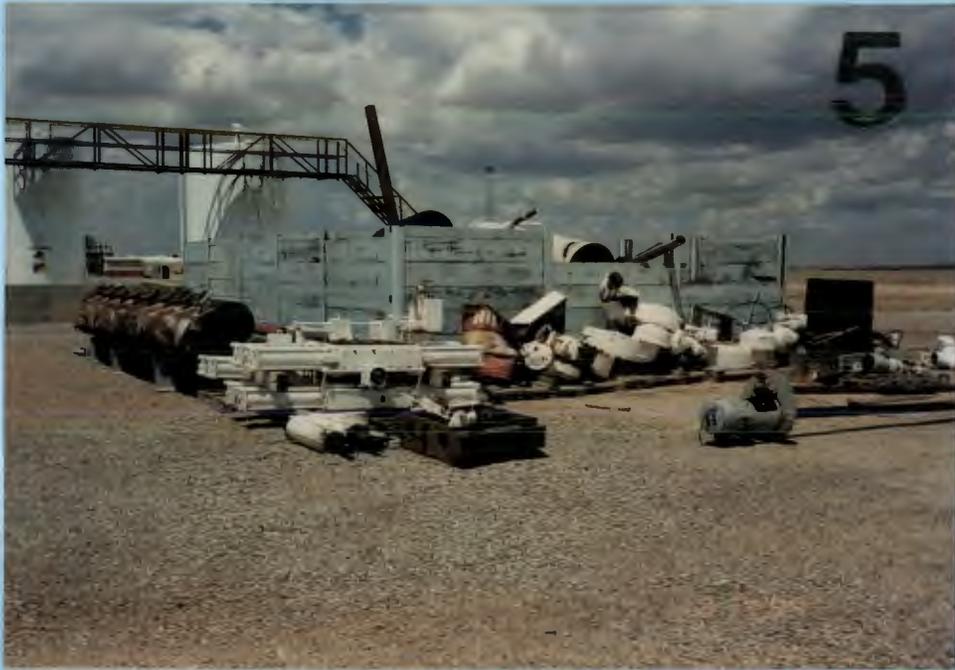
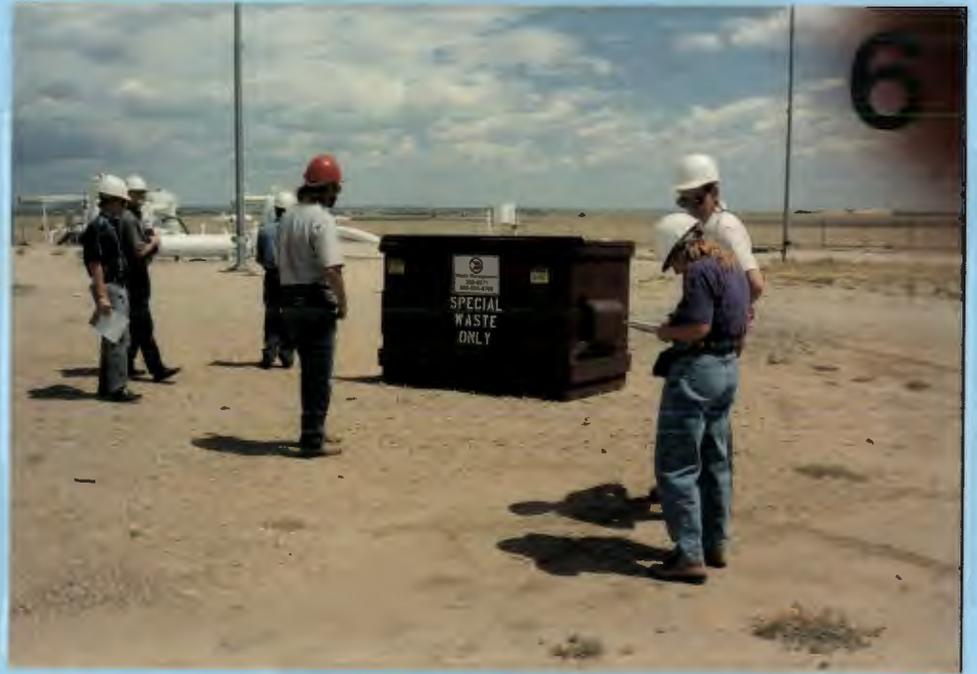
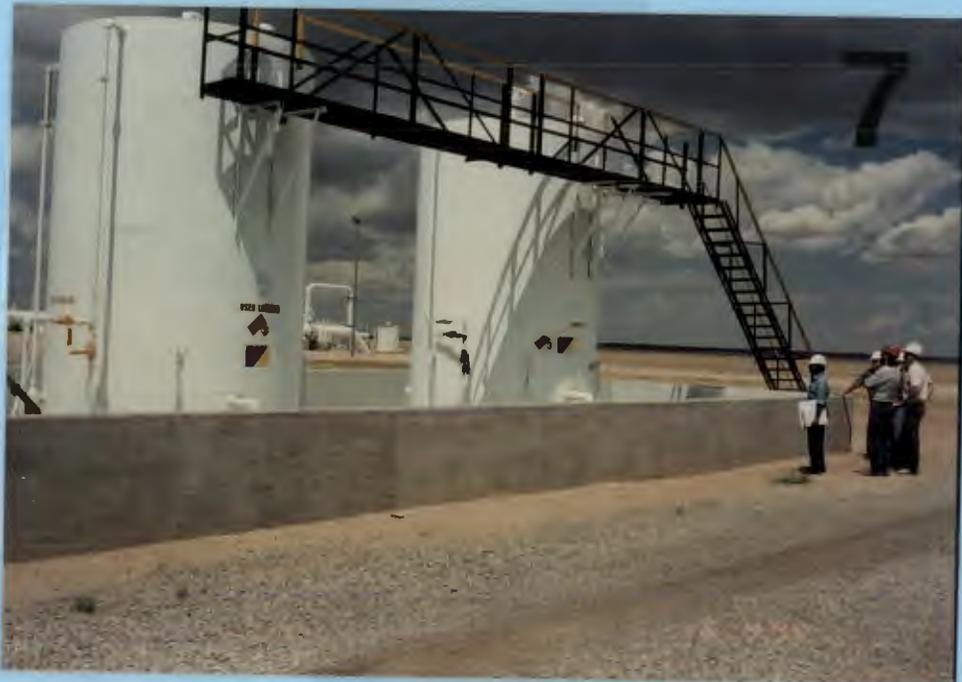
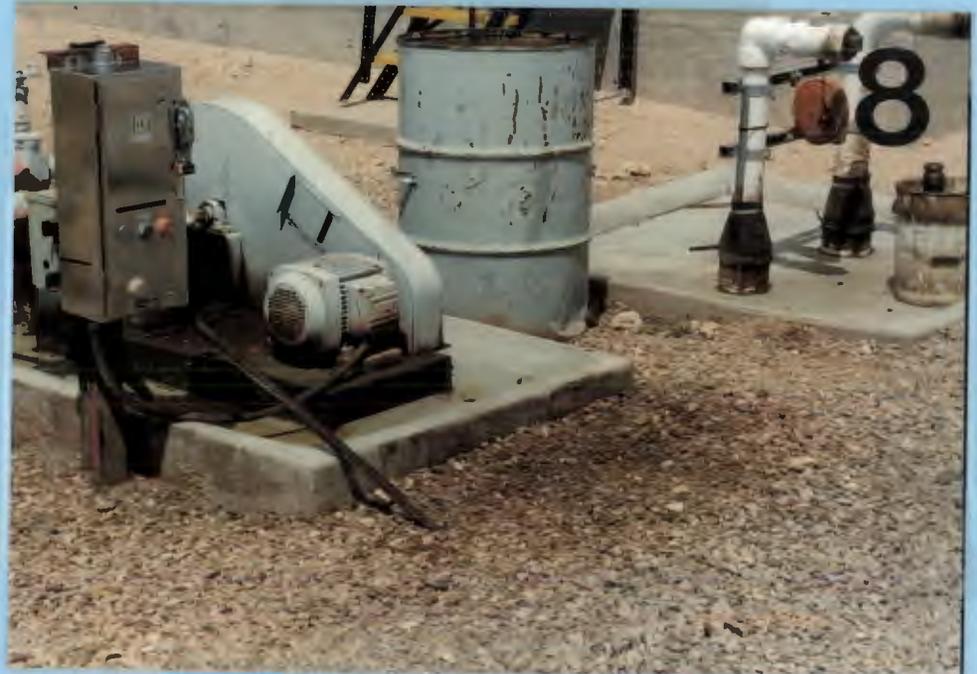
- Photo 5. SWMU 4 - Junk Bin  
This photograph is facing the northeast and shows the area used to store scrap metal and recyclable materials. No visual releases were observed during the VSI. Note SWMU 6 (Waste Lube Oil Tank/Used Oil Tank Area) in the background.
- Photo 6. SWMU 5 - Special Waste Dumpster  
This photograph is facing the southwest. The SWMU is shown with AOC 1 (Pig Launching Area) in the background.
- Photo 7. SWMU 6 - Waste Lube Oil Tank/Used Oil Tank Area  
This photograph is facing the east-northeast and shows the Waste Lube Oil Tank and Used Oil Tank. Note the concrete containment area designed to hold 150 percent total volume of the two tanks.
- Photo 8. SWMU 6 - Waste Lube Oil Tank/Used Oil Tank Area  
This photograph shows the Load-Out-Area located just to the west of the tank area.

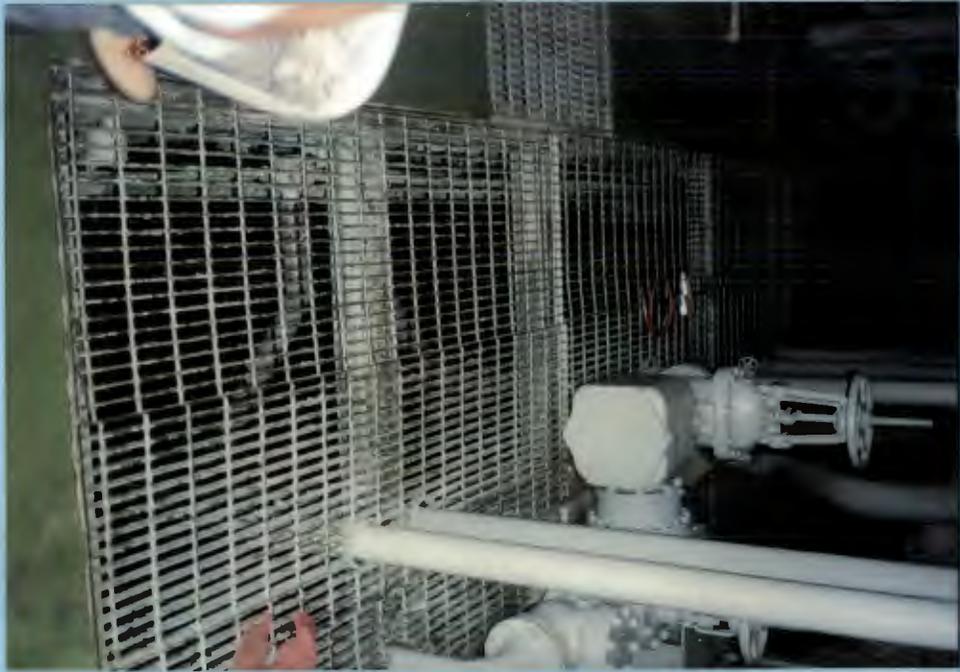
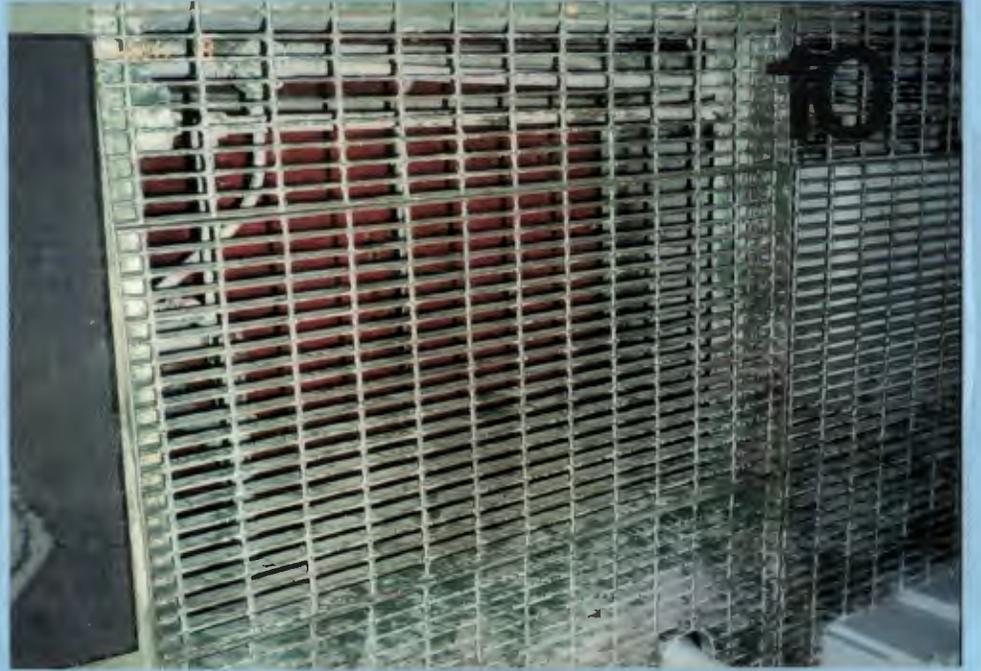
- Photo 9. SWMU 7 - Engine Room Basement (Pipewells)  
This photograph shows the south entrance to the engine room. Note the metal grates across the floor covering the pipewell area.

- Photo 10. SWMU 7 - Engine Room Basement (Pipewells)  
This photograph shows an Ambitrol release in the pipewell area as noticed by the red color below the metal grate.

An RFI is recommended for this SWMU.

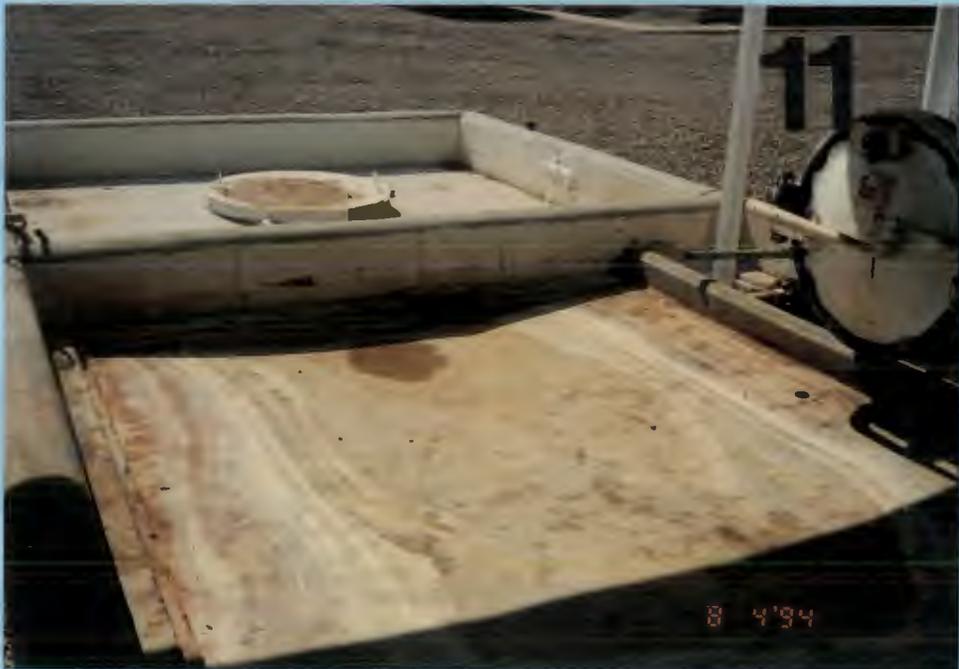
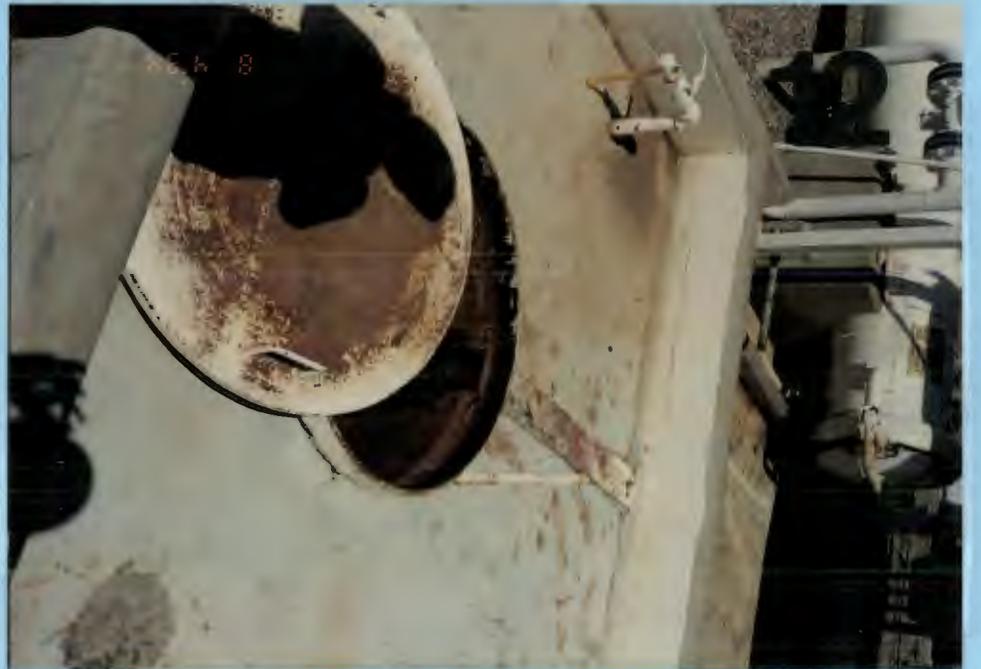
- Photo 11. SWMU 8 - Panhandle Pig Receiving Area  
This photograph is facing north-northwest. This photograph shows the 24-inch incoming pipeline, the pipeline receiver sump area, and the concrete berm area. Liquids or pipeline condensate collects in the incoming pipeline containment area and drains to the sump area through a steel-conduit draining below-grade directly into the sump.

- Photo 12. SWMU 8 - Panhandle Pig Receiving Area  
This photograph is facing east-northeast. The sump show in this picture is a below-grade steel-lined 3-foot diameter by 4-foot deep tank. Prior to 1986, the liquids from the pipeline drained into the former surface impoundments now undergoing RCRA closure.

An RFI is recommended for this SWMU.

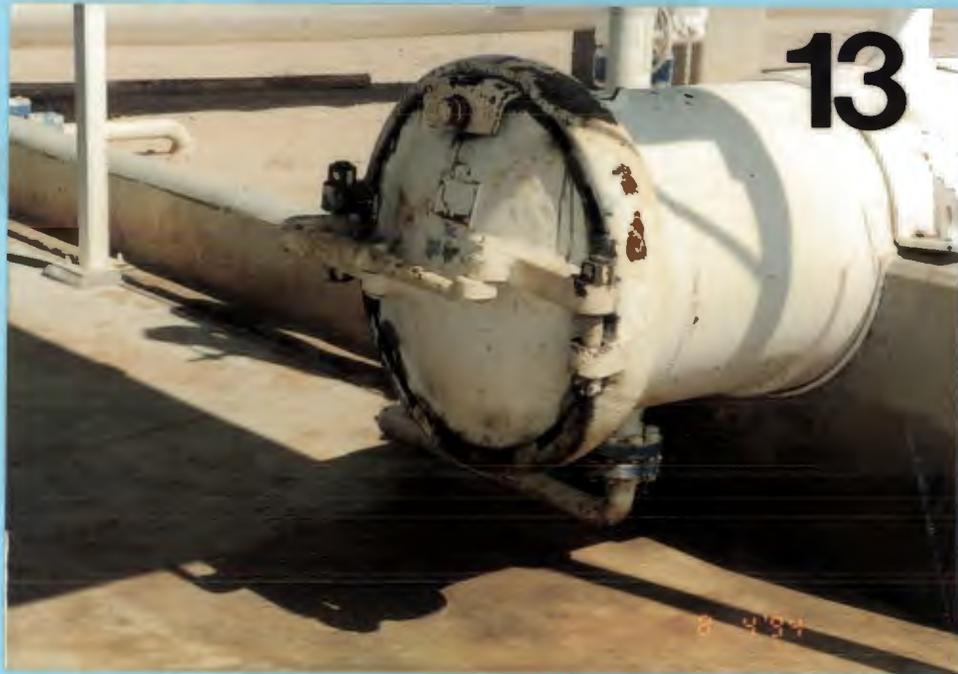
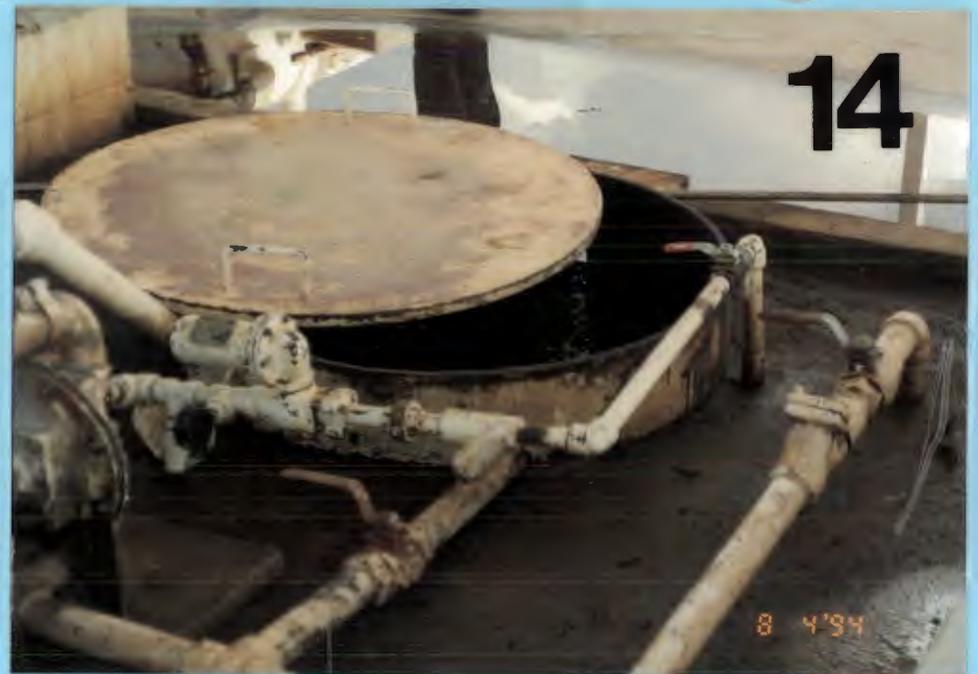
- Photo 13. SWMU 9 - West Texas Pig Receiving Area  
This photograph is facing the northwest. One of the two 24-inch incoming pipelines is shown in this photograph. During the VSI, staining was observed outside the containment area show in this photograph.

- Photo 14. SWMU 9 - West Texas Pig Receiving Area  
This photograph is facing east. This photograph shows a sump which is used to drain the incoming pipeline liquid condensate. During the VSI, cracks were visible in the concrete floor of the bermed area. Liquid was standing over the observed cracks as shown this photograph.

An RFI is recommended for this SWMU.

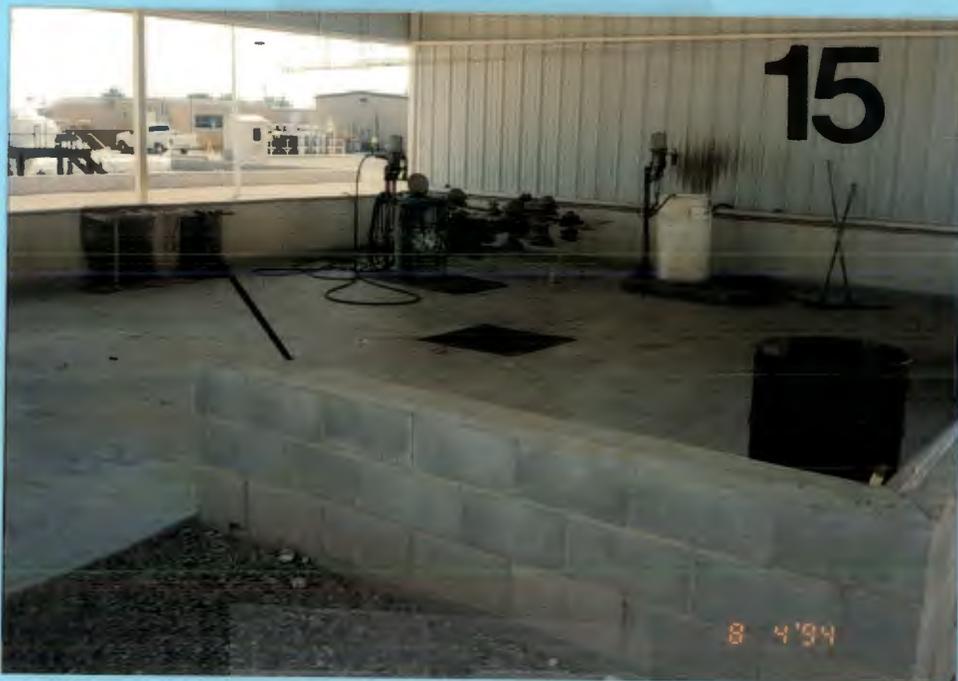
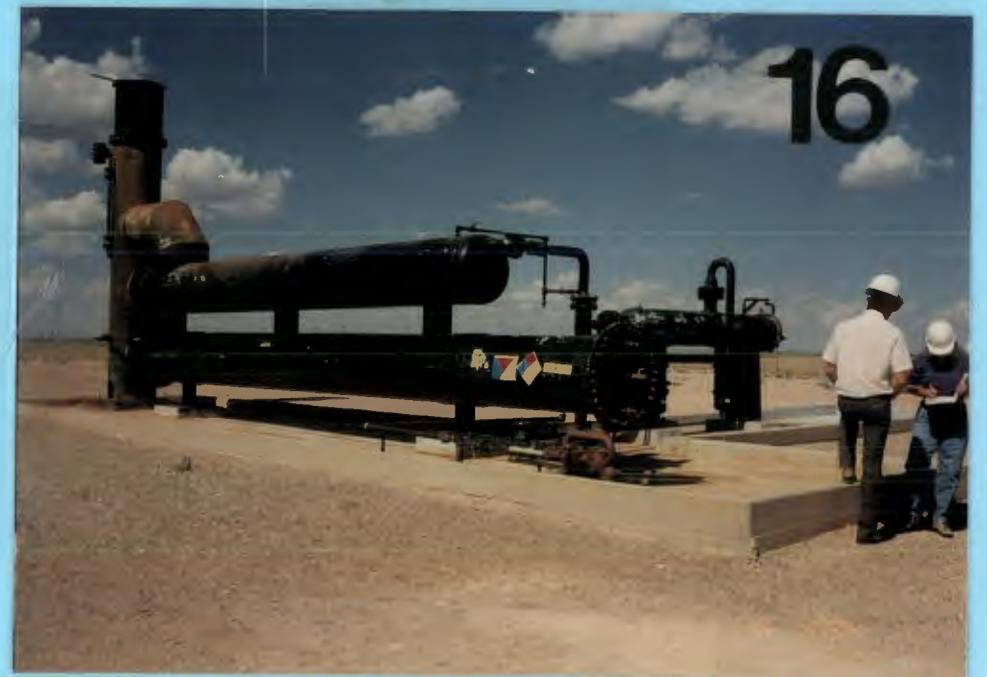
- Photo 15. SWMU 10 - Pig Wash Area  
This photograph is facing southwest. The sump in the floor of the Pig Wash Area is shown in this photograph. No evidence of a release was observed during the VSI.

- Photo 16. SWMU 11 - Mist Extractor or Muffler Area  
This photograph is facing northeast. This photograph shows the piping apparatus used to separate pipeline liquids from gas.

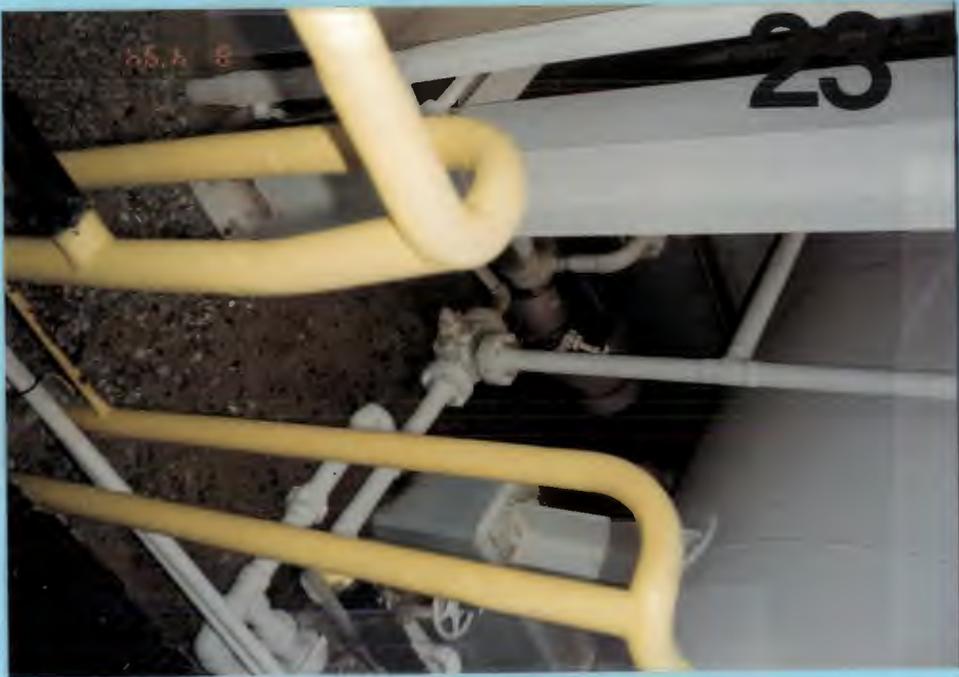
23

- Photo 23.      AOC 2 - Ambitrol Product Storage Tanks  
This photograph shows an Ambitrol spill observed during the VSI; note the red discoloration of the soil. The leak appears to be occurring from a seal associated with a pump connected to one of the Ambitrol storage tanks shown raised above ground in the upper right-hand portion of the photograph.

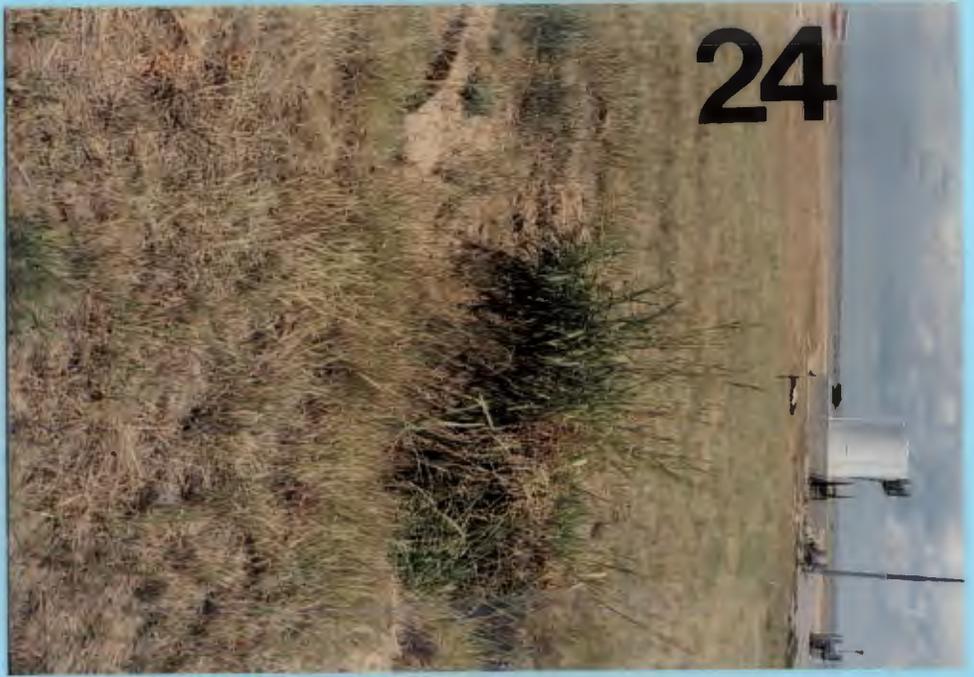
24

- Photo 24.      AOC 3 - Former Sumps/Leachfield  
This photograph is facing east. This photograph shows the former locations of the sumps as indicated by the overgrown weeds. SWMU 6 (Used Lube Oil Tank/Waste Oil Tank Area) is shown in the background.
