Initial Closure of Panel 6 & Closure of Room 7, Panel 7

Prerequisites for Initial Closure of Panel 6 and Closure of Room 7, Panel 7

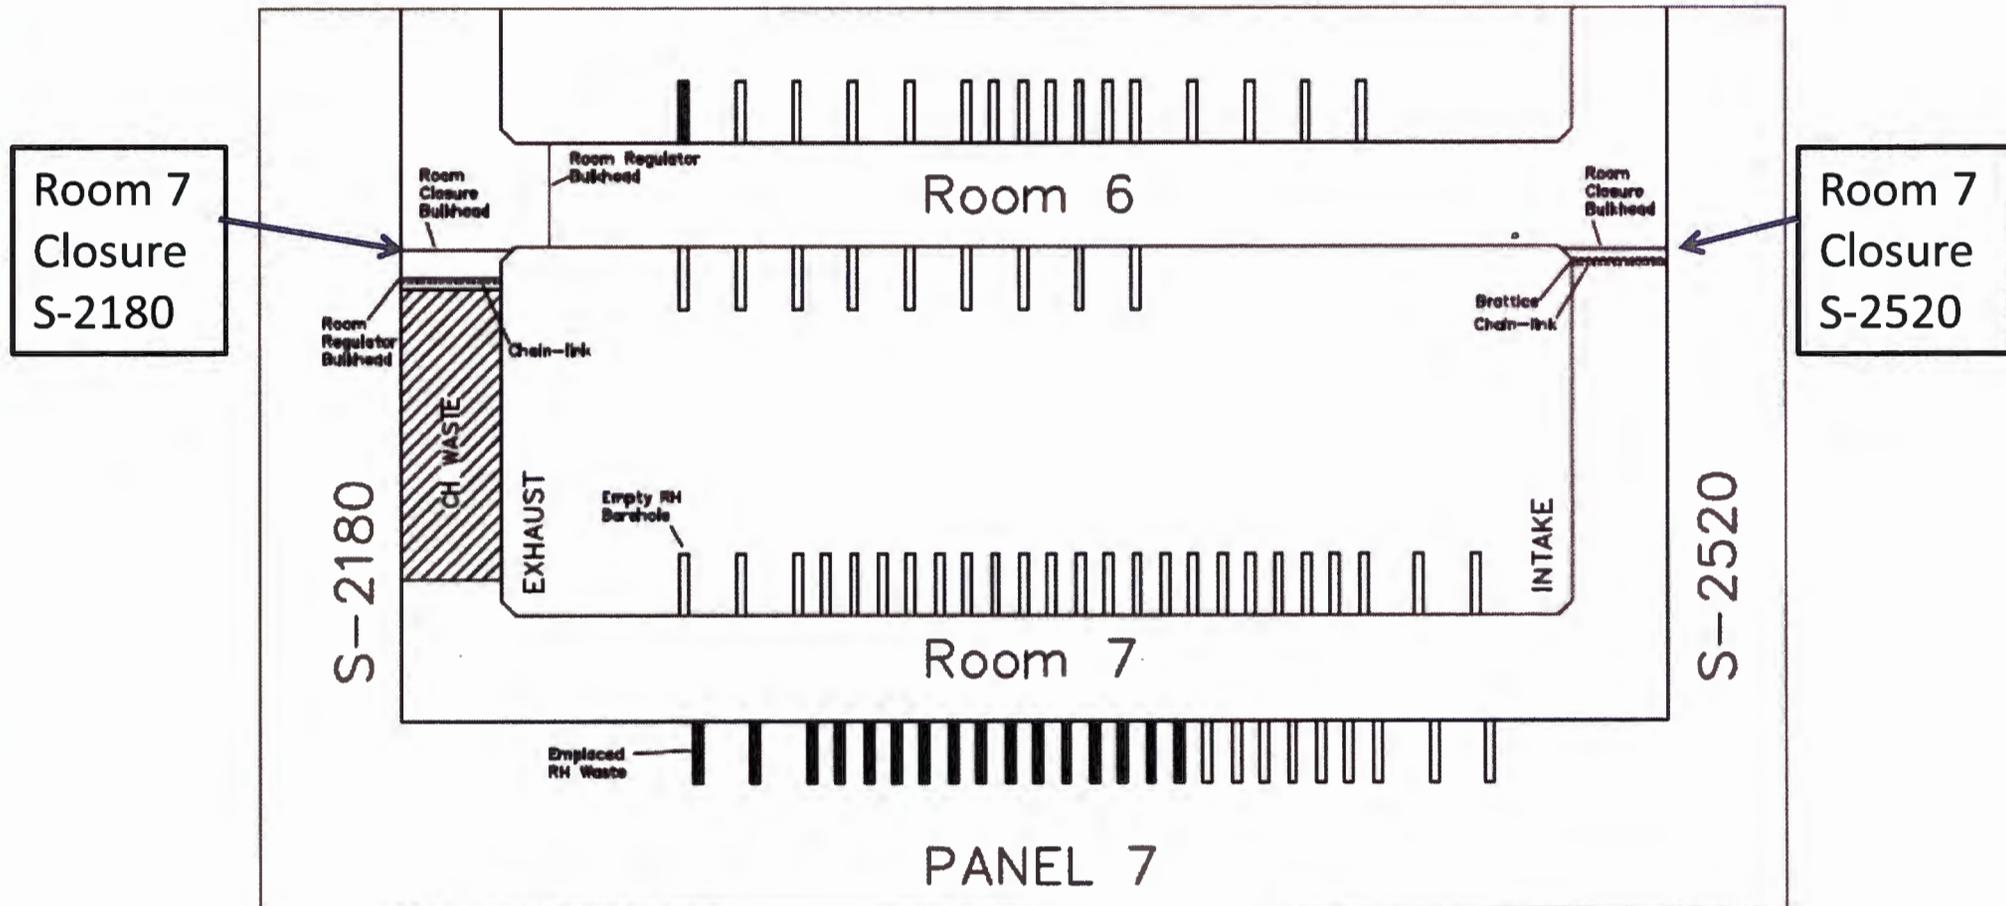
Proposed Closure of Room 7 in Panel 7

(disposal room closure – steel bulkhead)

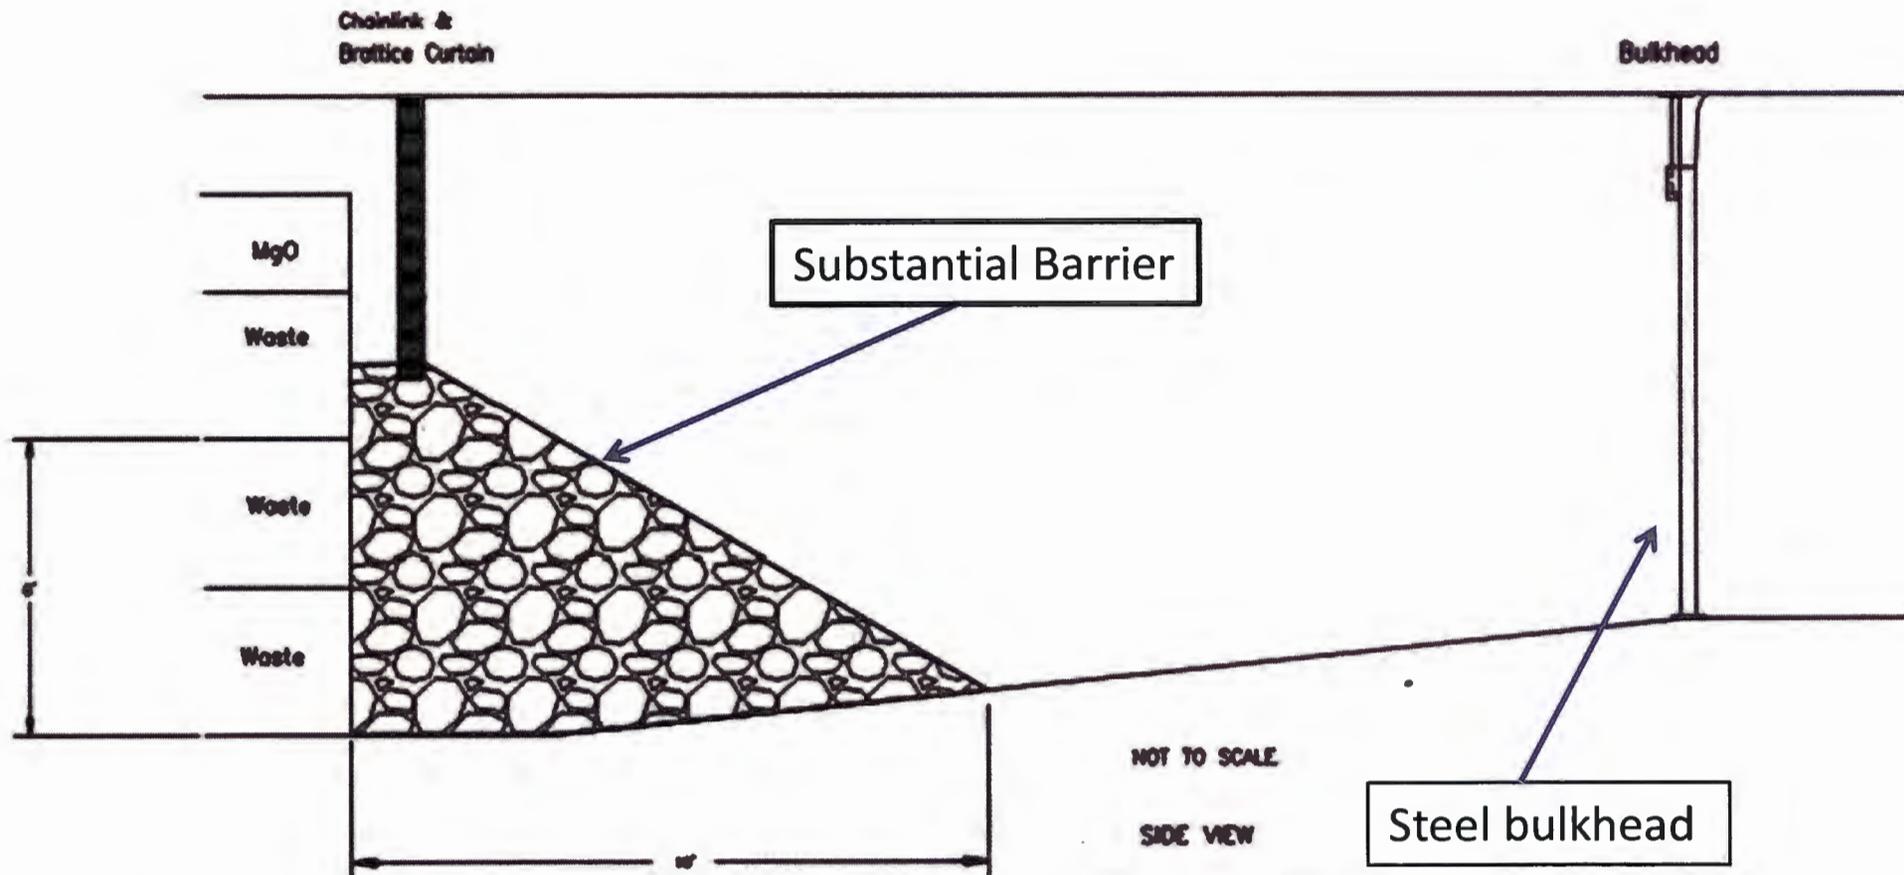
Initial Closure of Panel 6:

Consists of a Substantial Barrier & Steel Bulkhead
(cross-sectional view of access drift)

“Substantial barrier” means salt or other non-combustible material installed between the waste face and the bulkhead

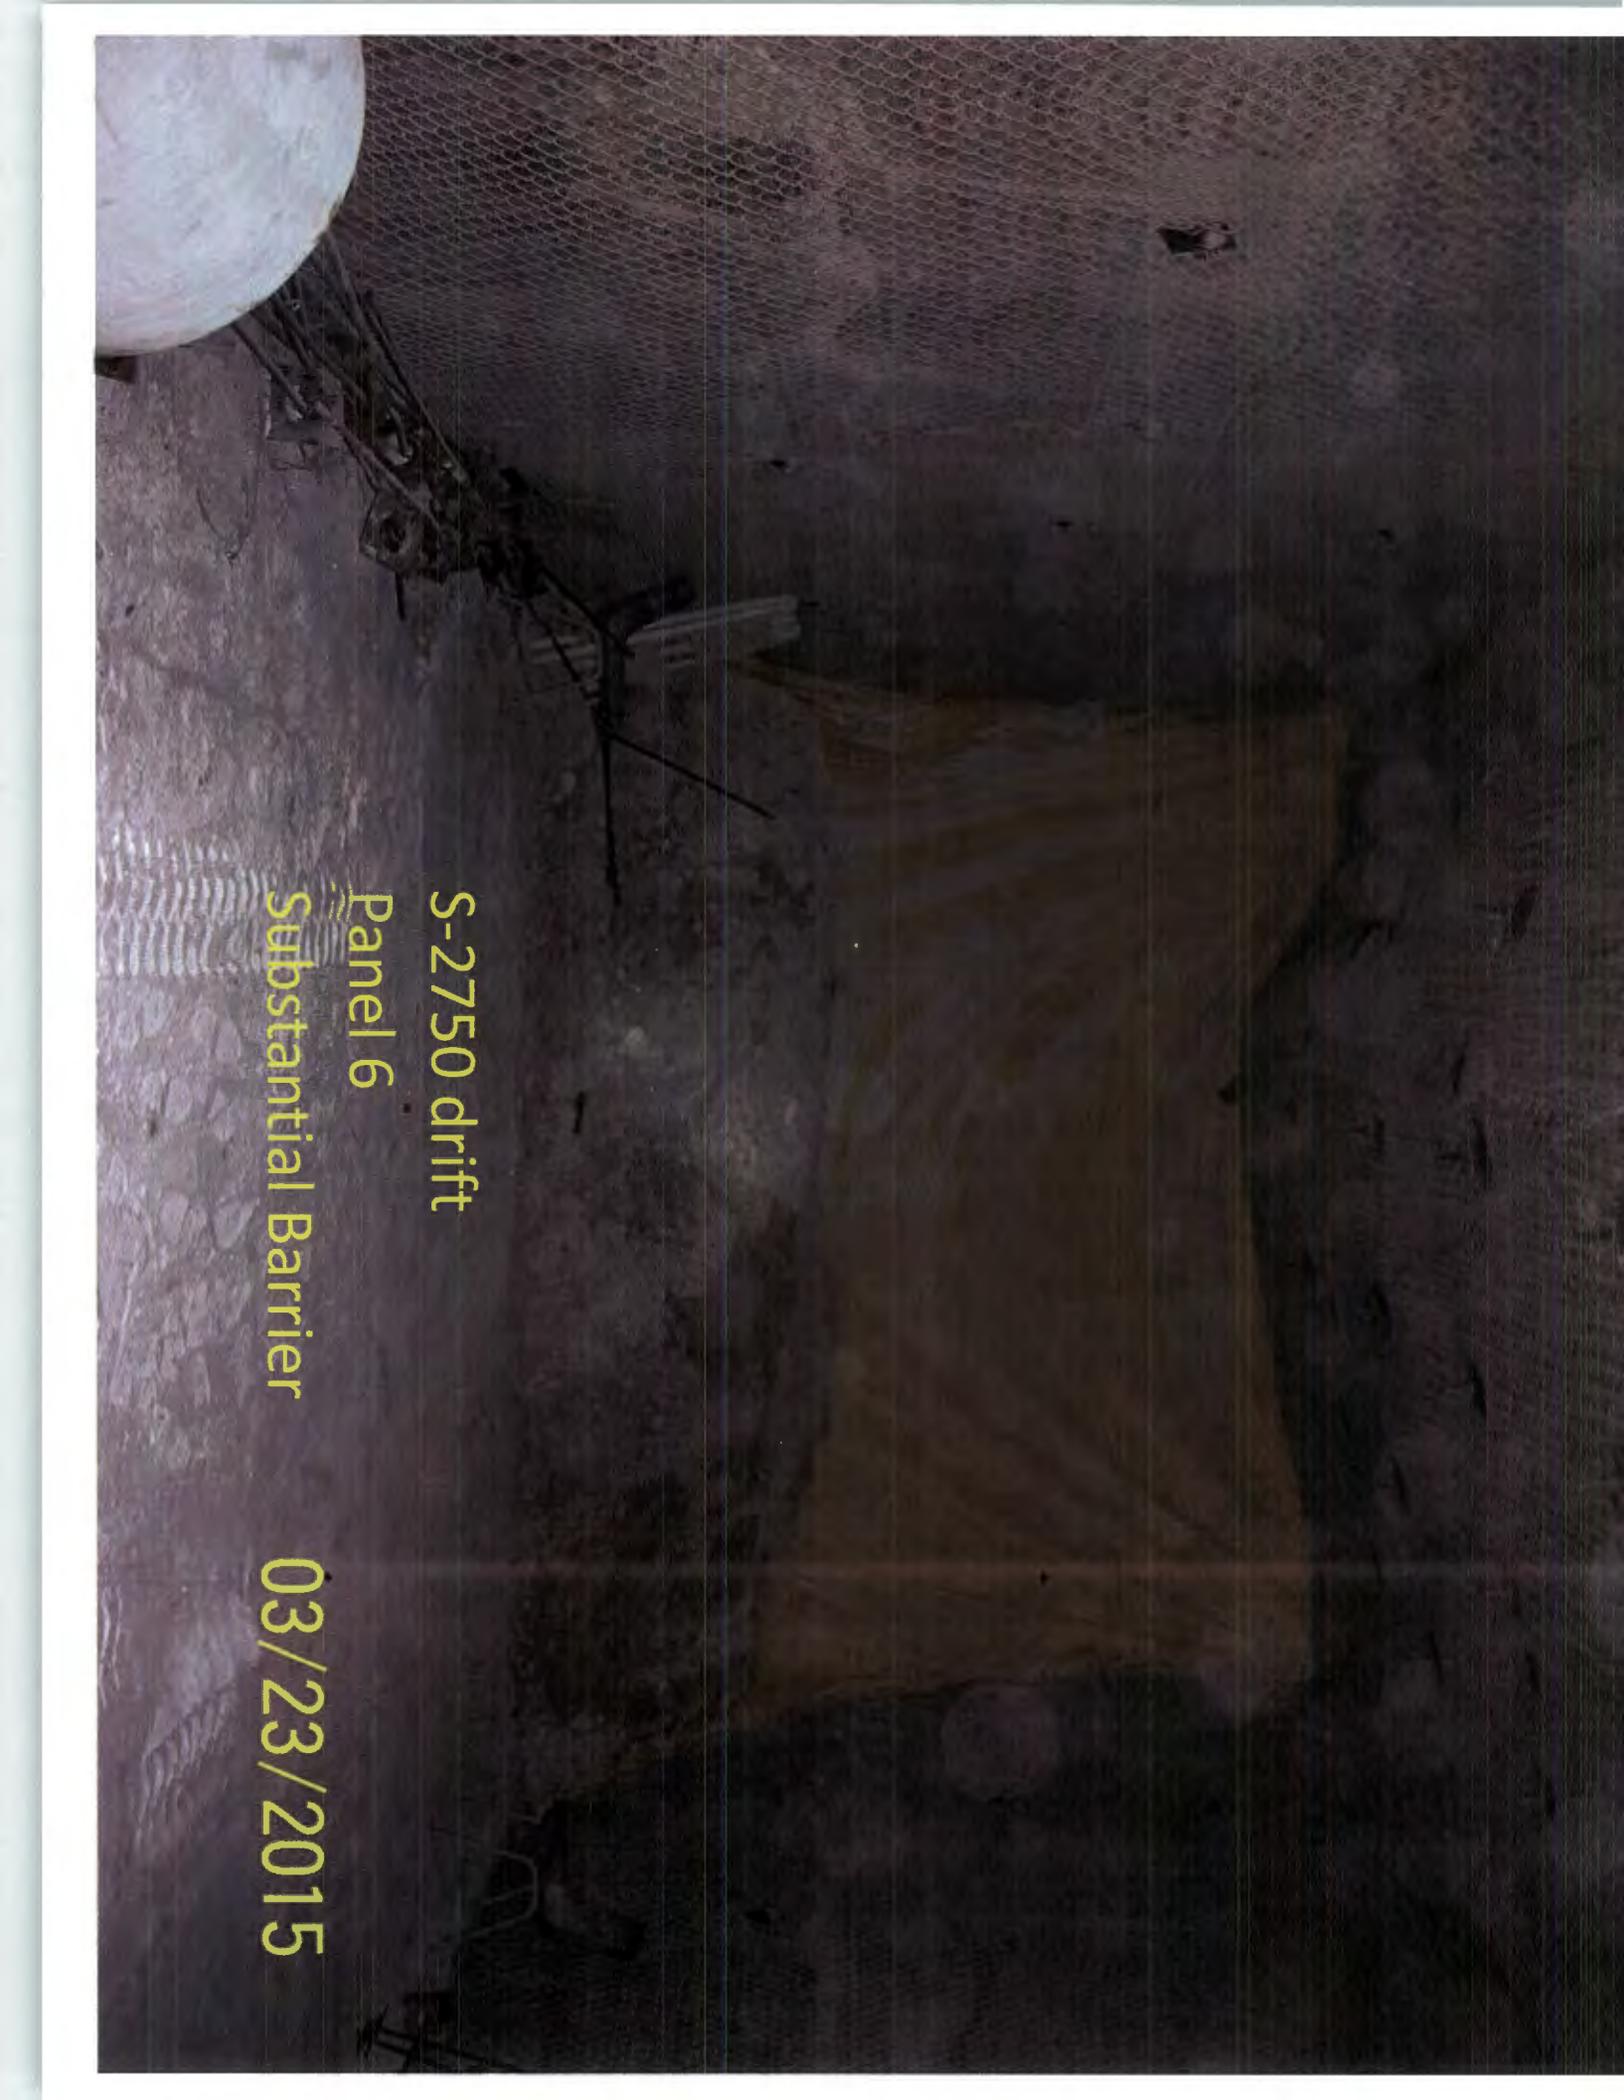
S-2750 drift

Panel 6

Substantial Barrier

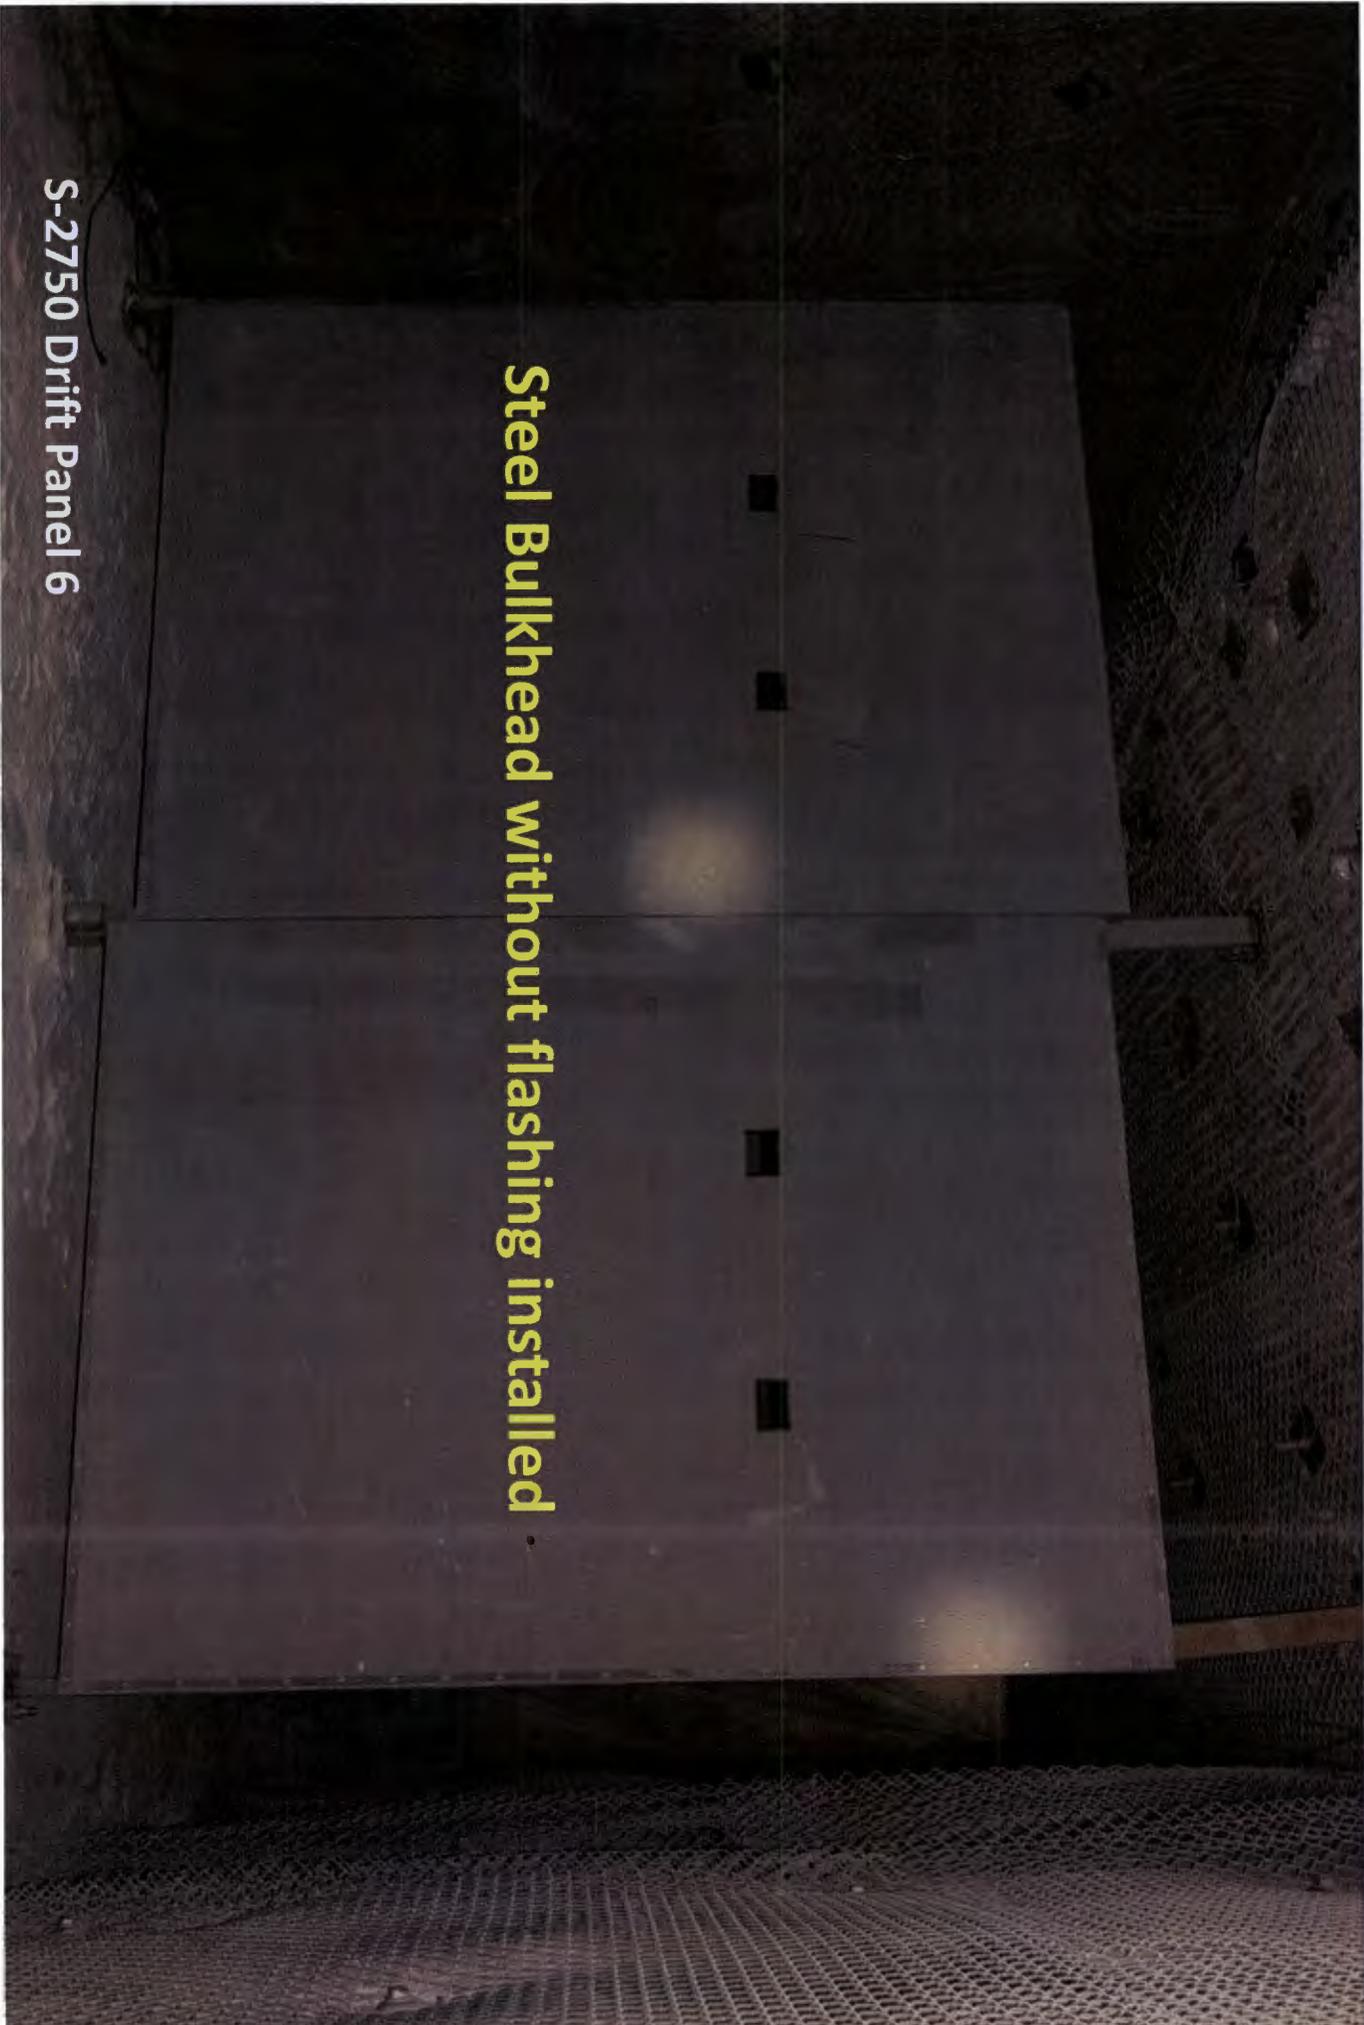
Steel Bulkhead without flashing installed

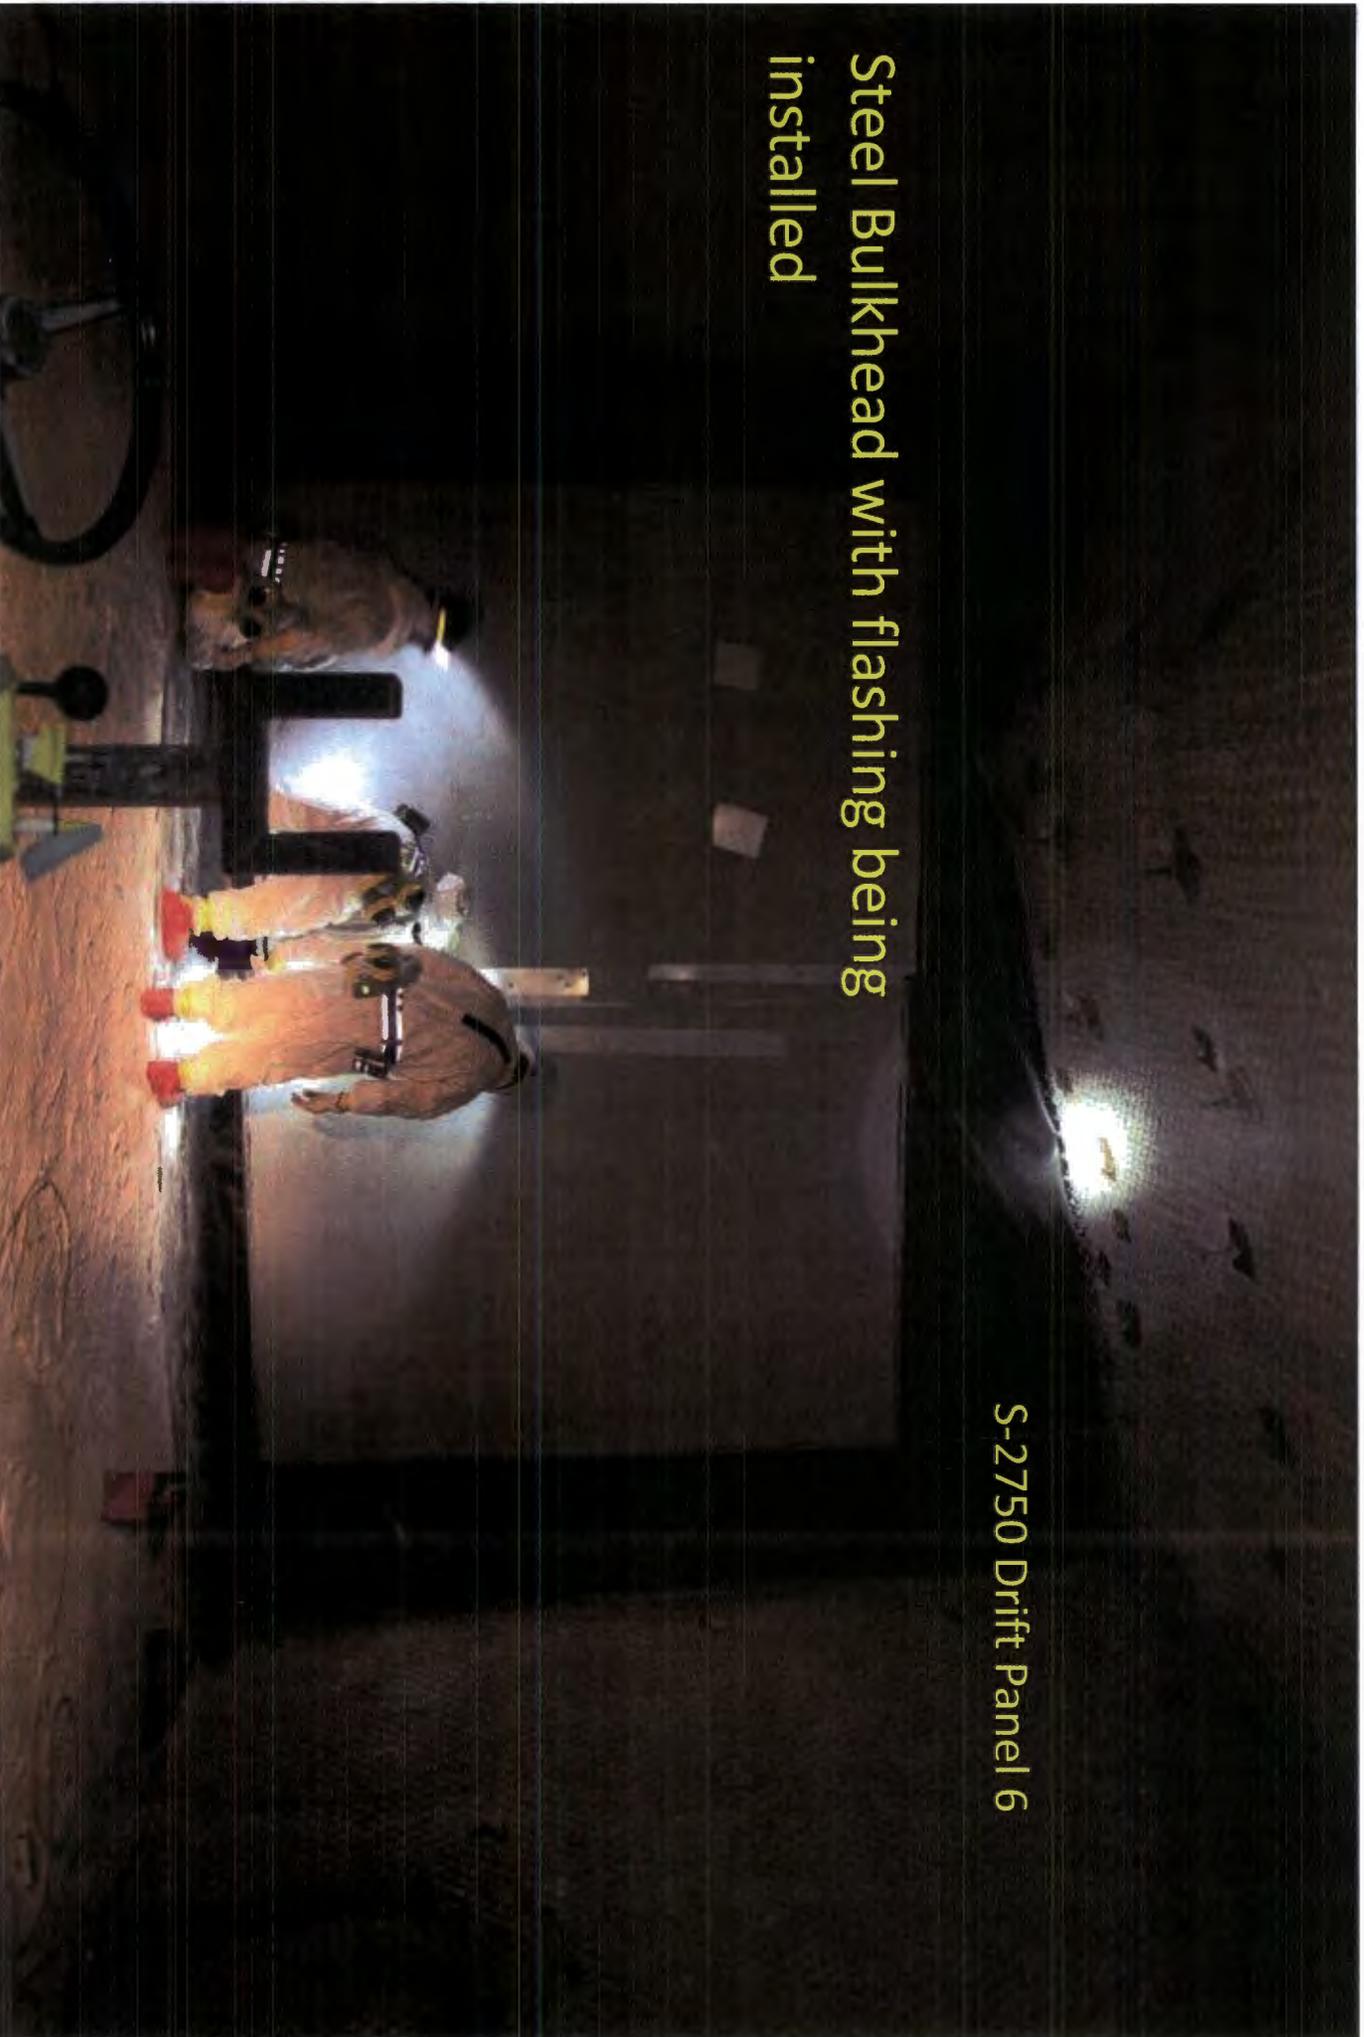
Steel Bulkhead with flashing being installed

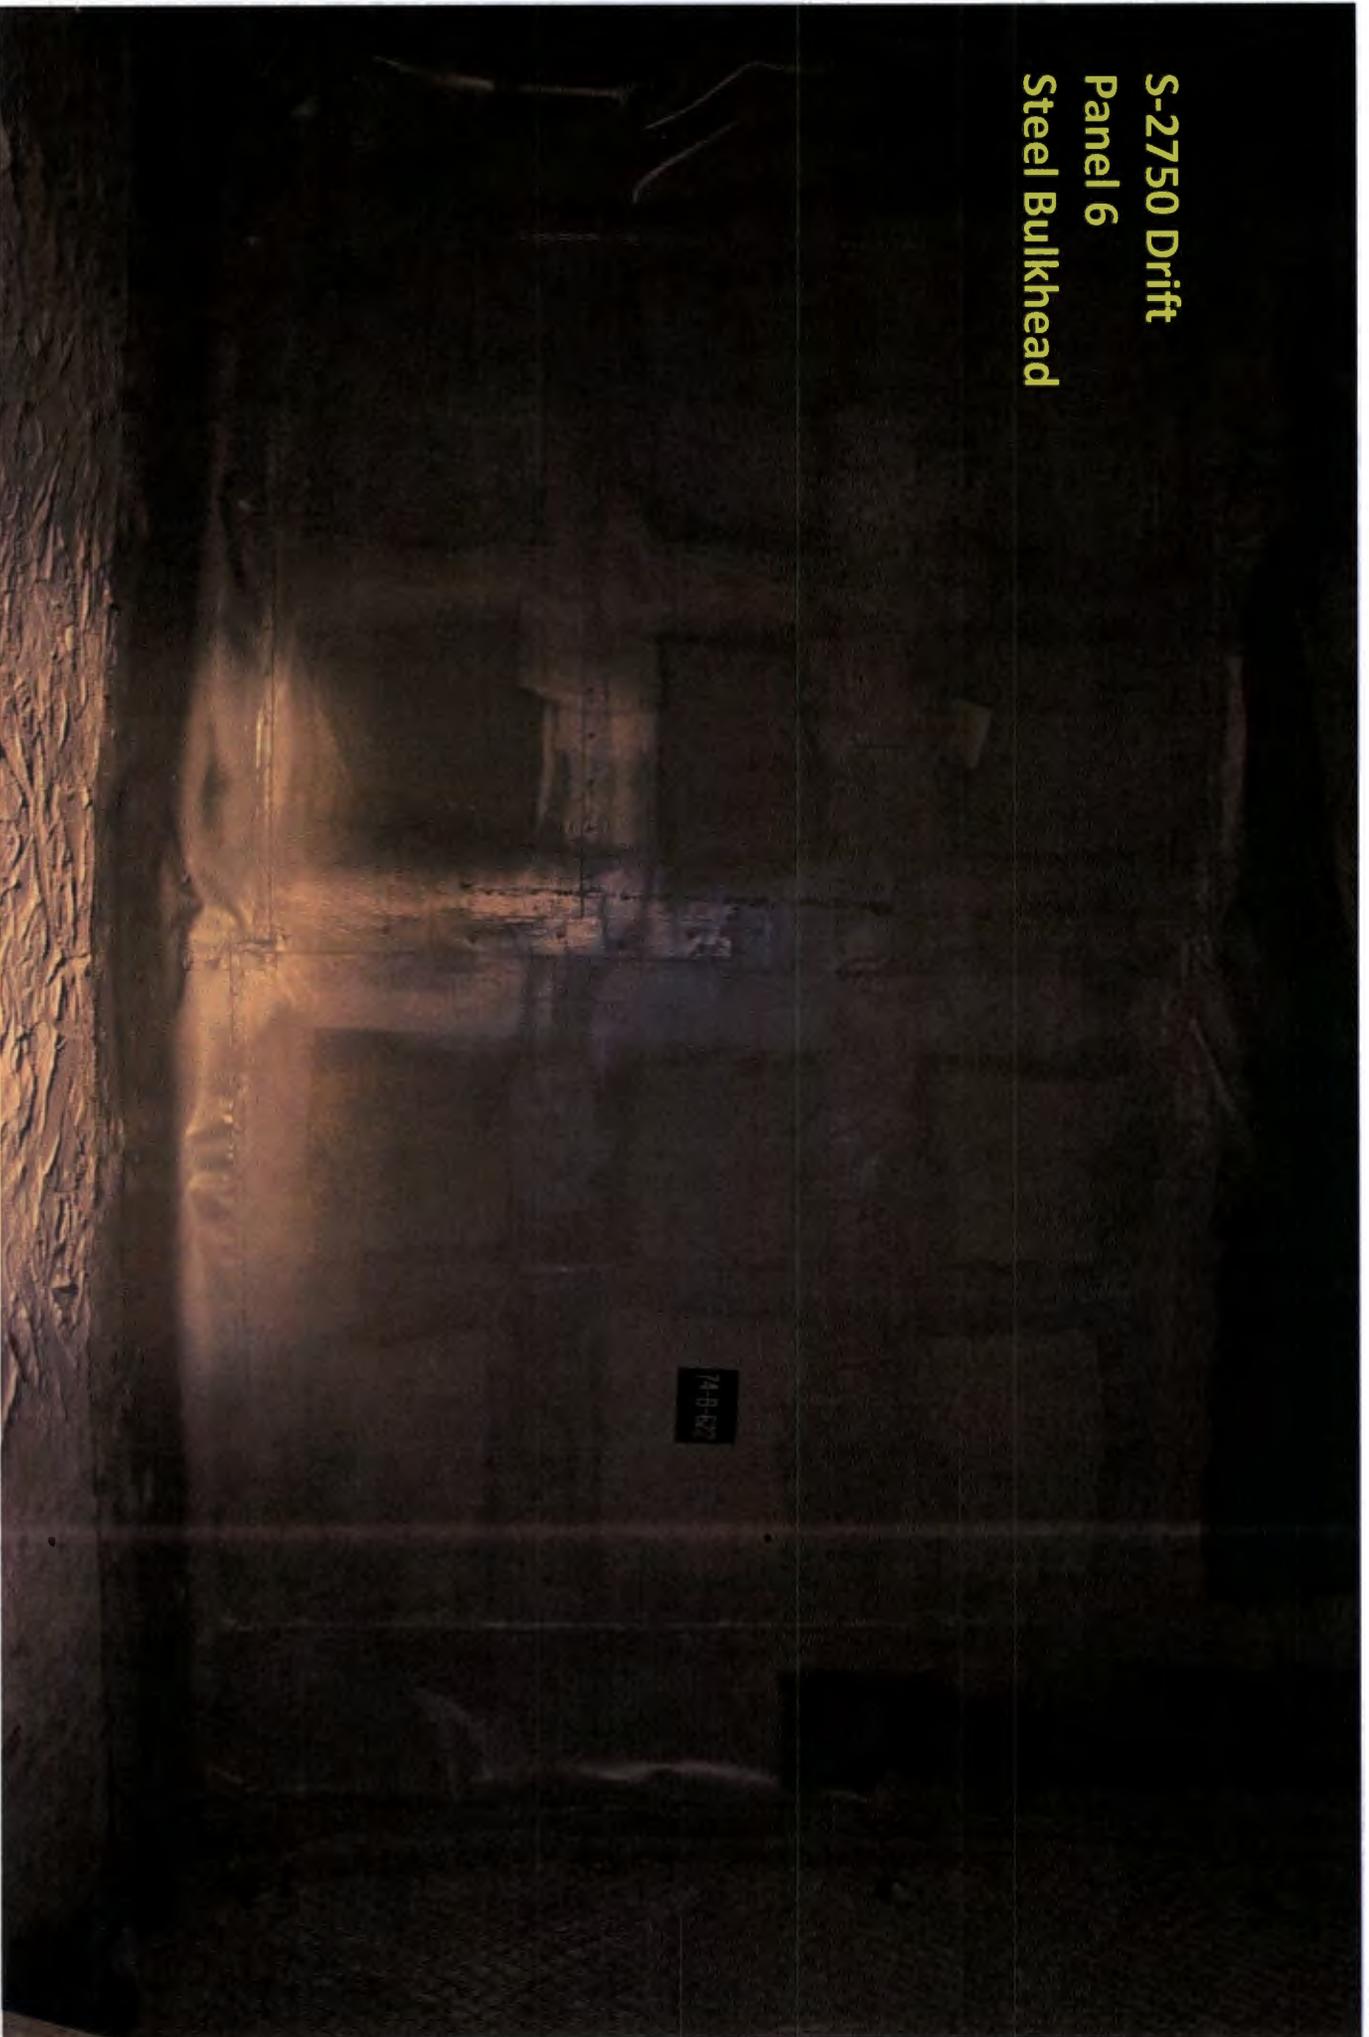
**S-2750 Drift
Panel 6
Steel Bulkhead**

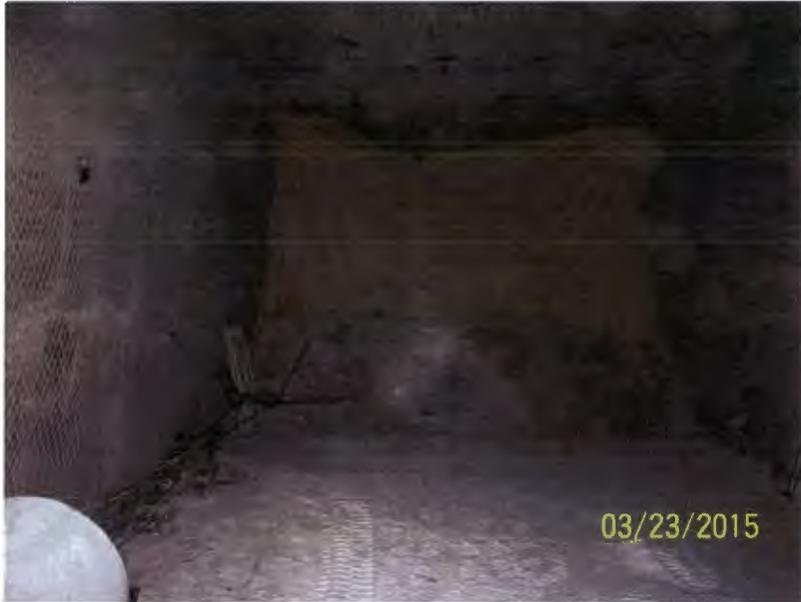
S-2750 Drift Panel 6
Substantial Barrier

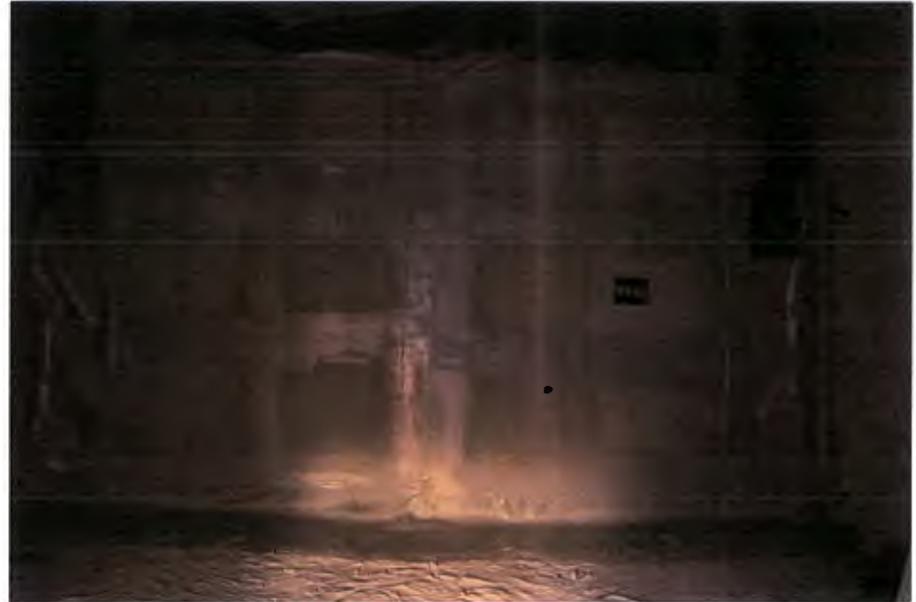
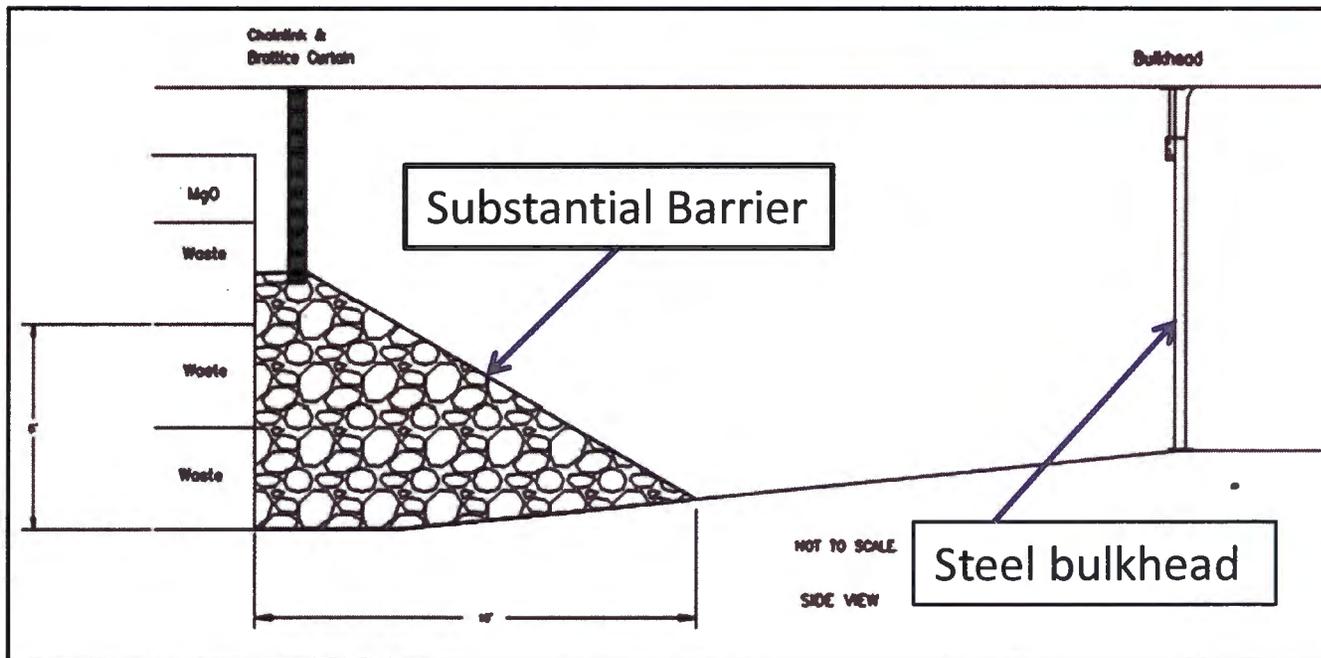
S-2750 Drift Panel 6
Steel Bulkhead & Flashing

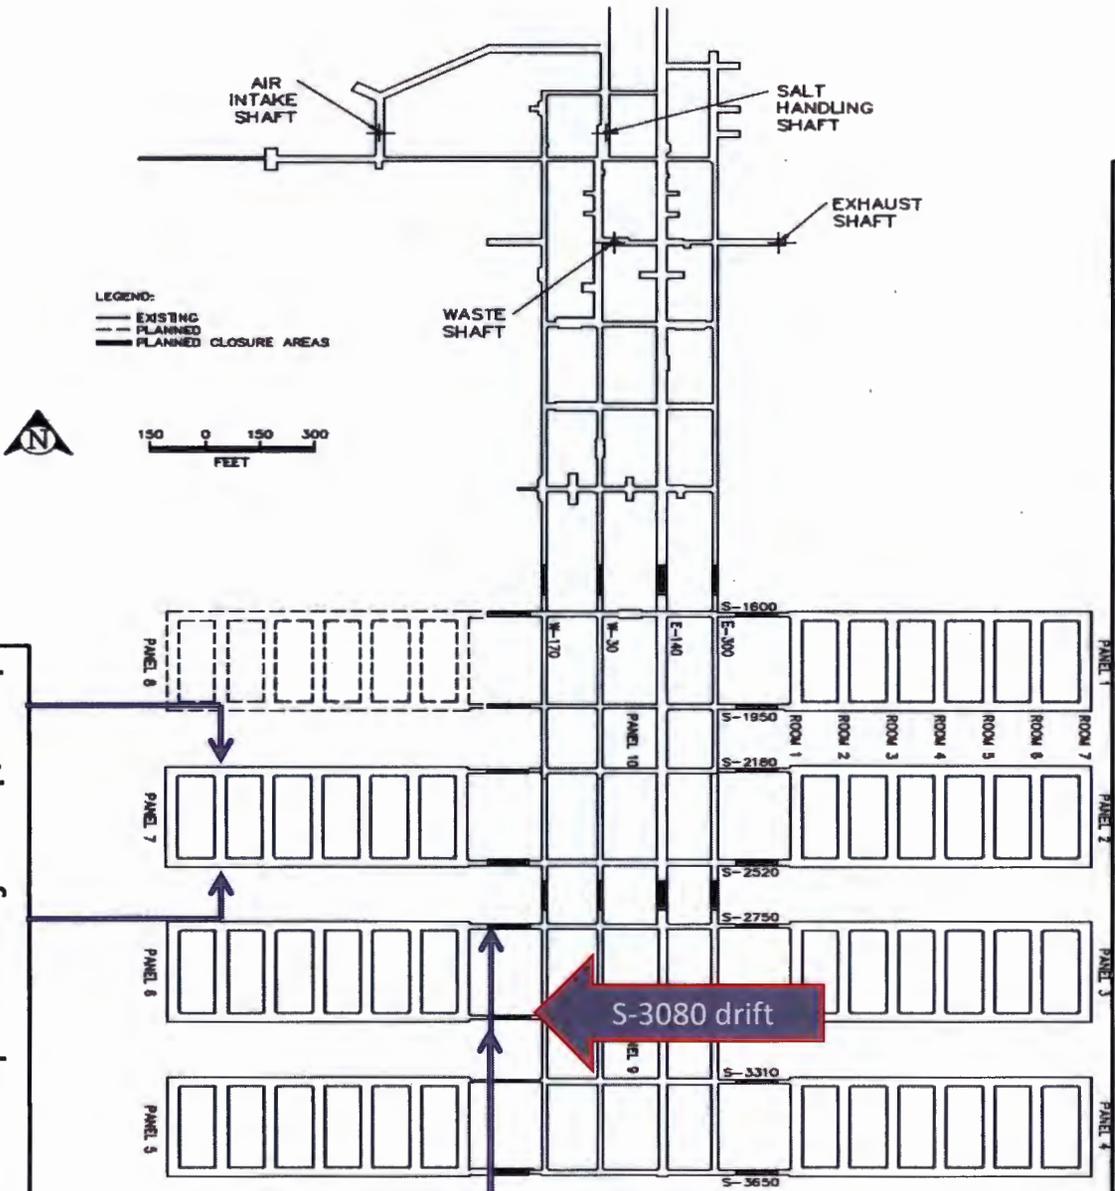
Plan View of the WIPP Underground

Location of room closures for Room 7 in Panel 7

Location of Initial & Final Panel Closure for Panel 6

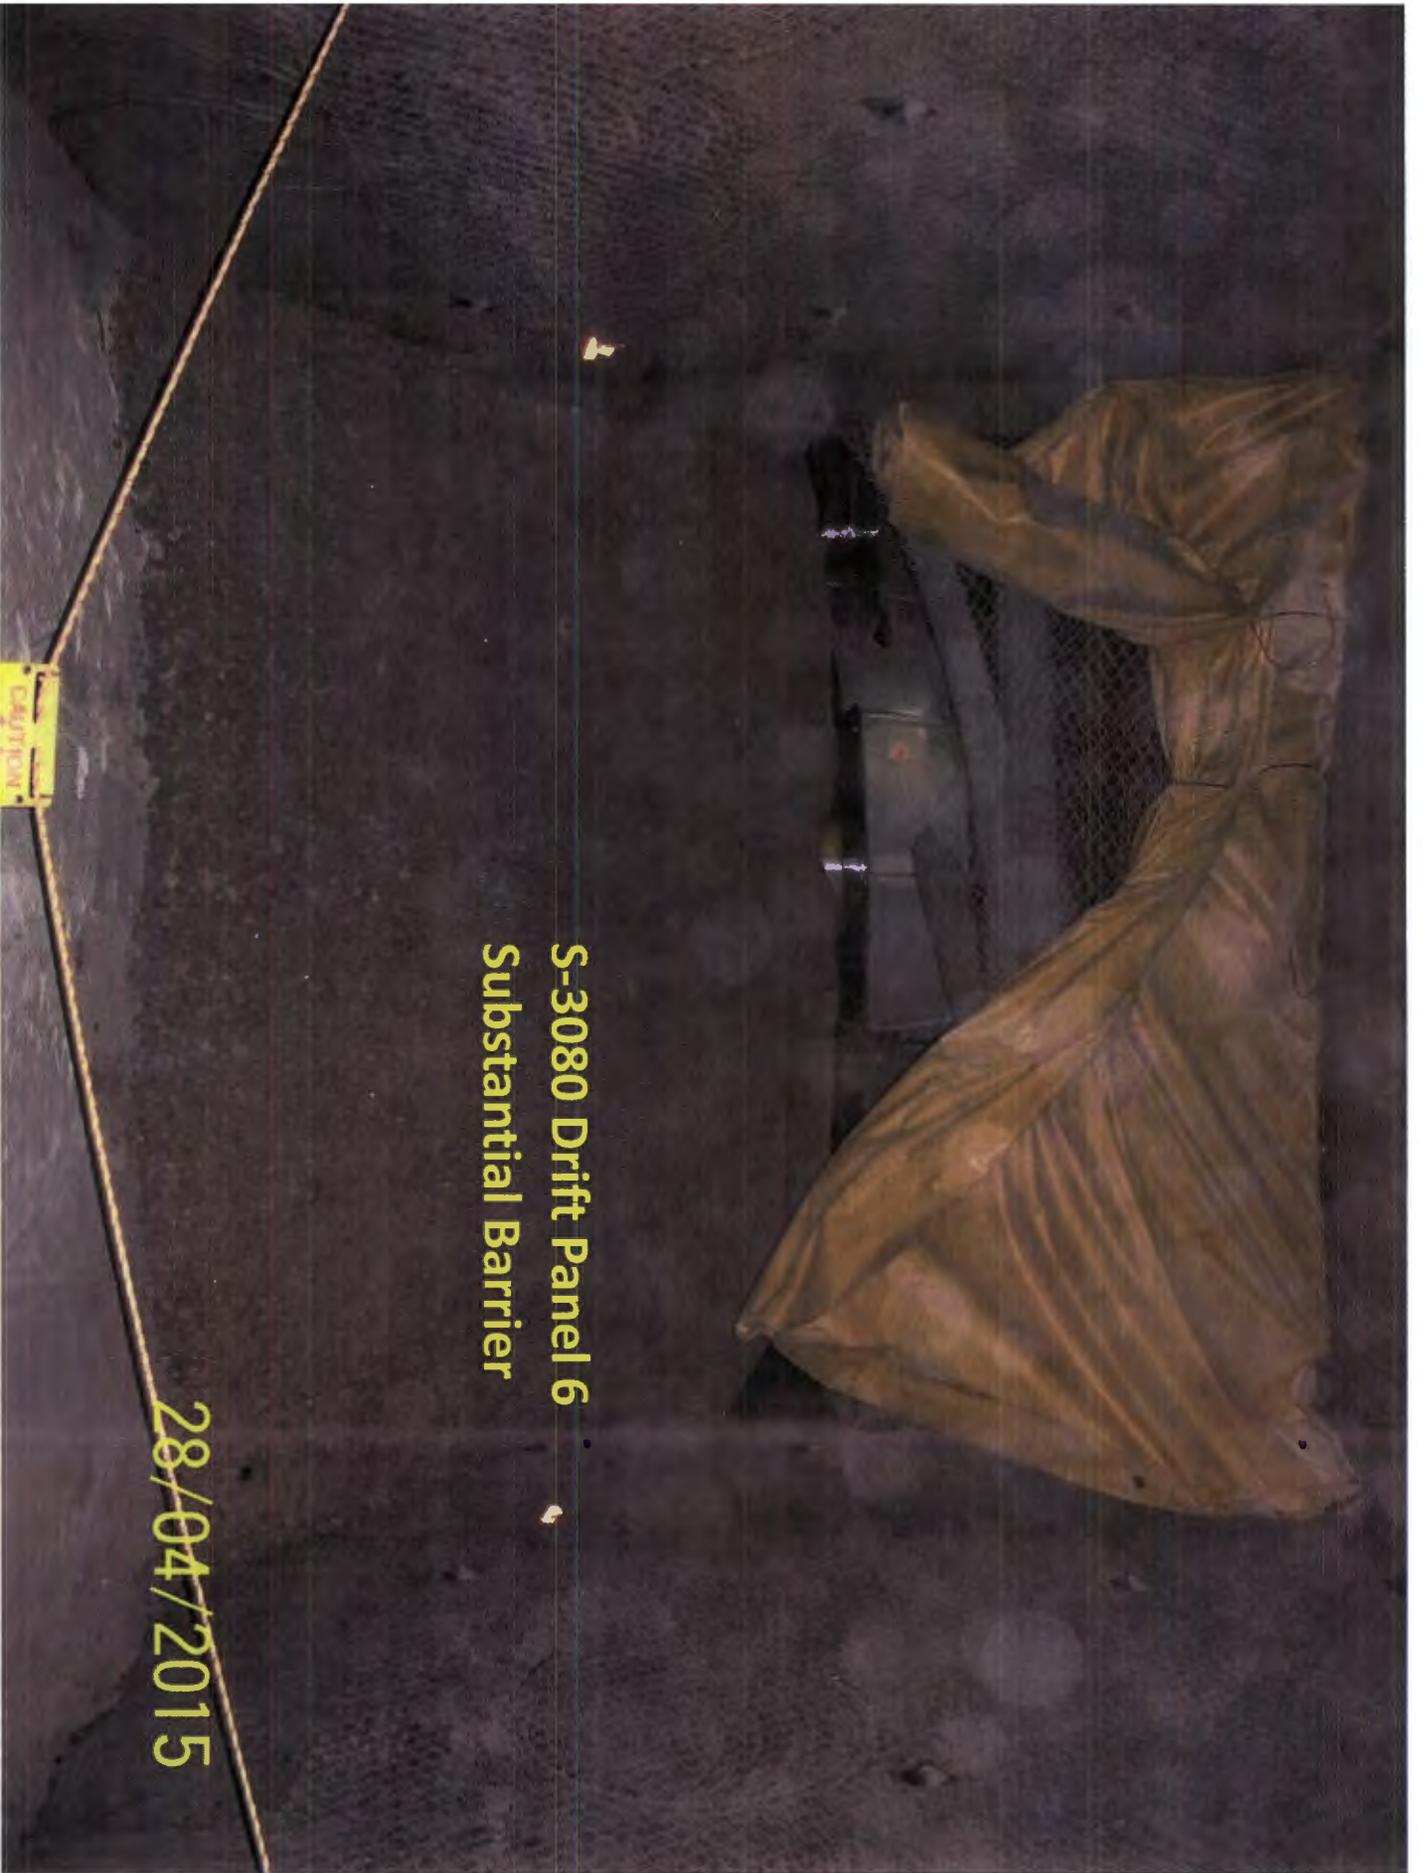
**S-3080 Drift Panel 6
Substantial Barrier**
