Initial Closure of Panel 6 & Closure of Room 7, Panel 7

Prerequisites for Initial Closure of Panel 6 and Closure of Room 7, Panel 7

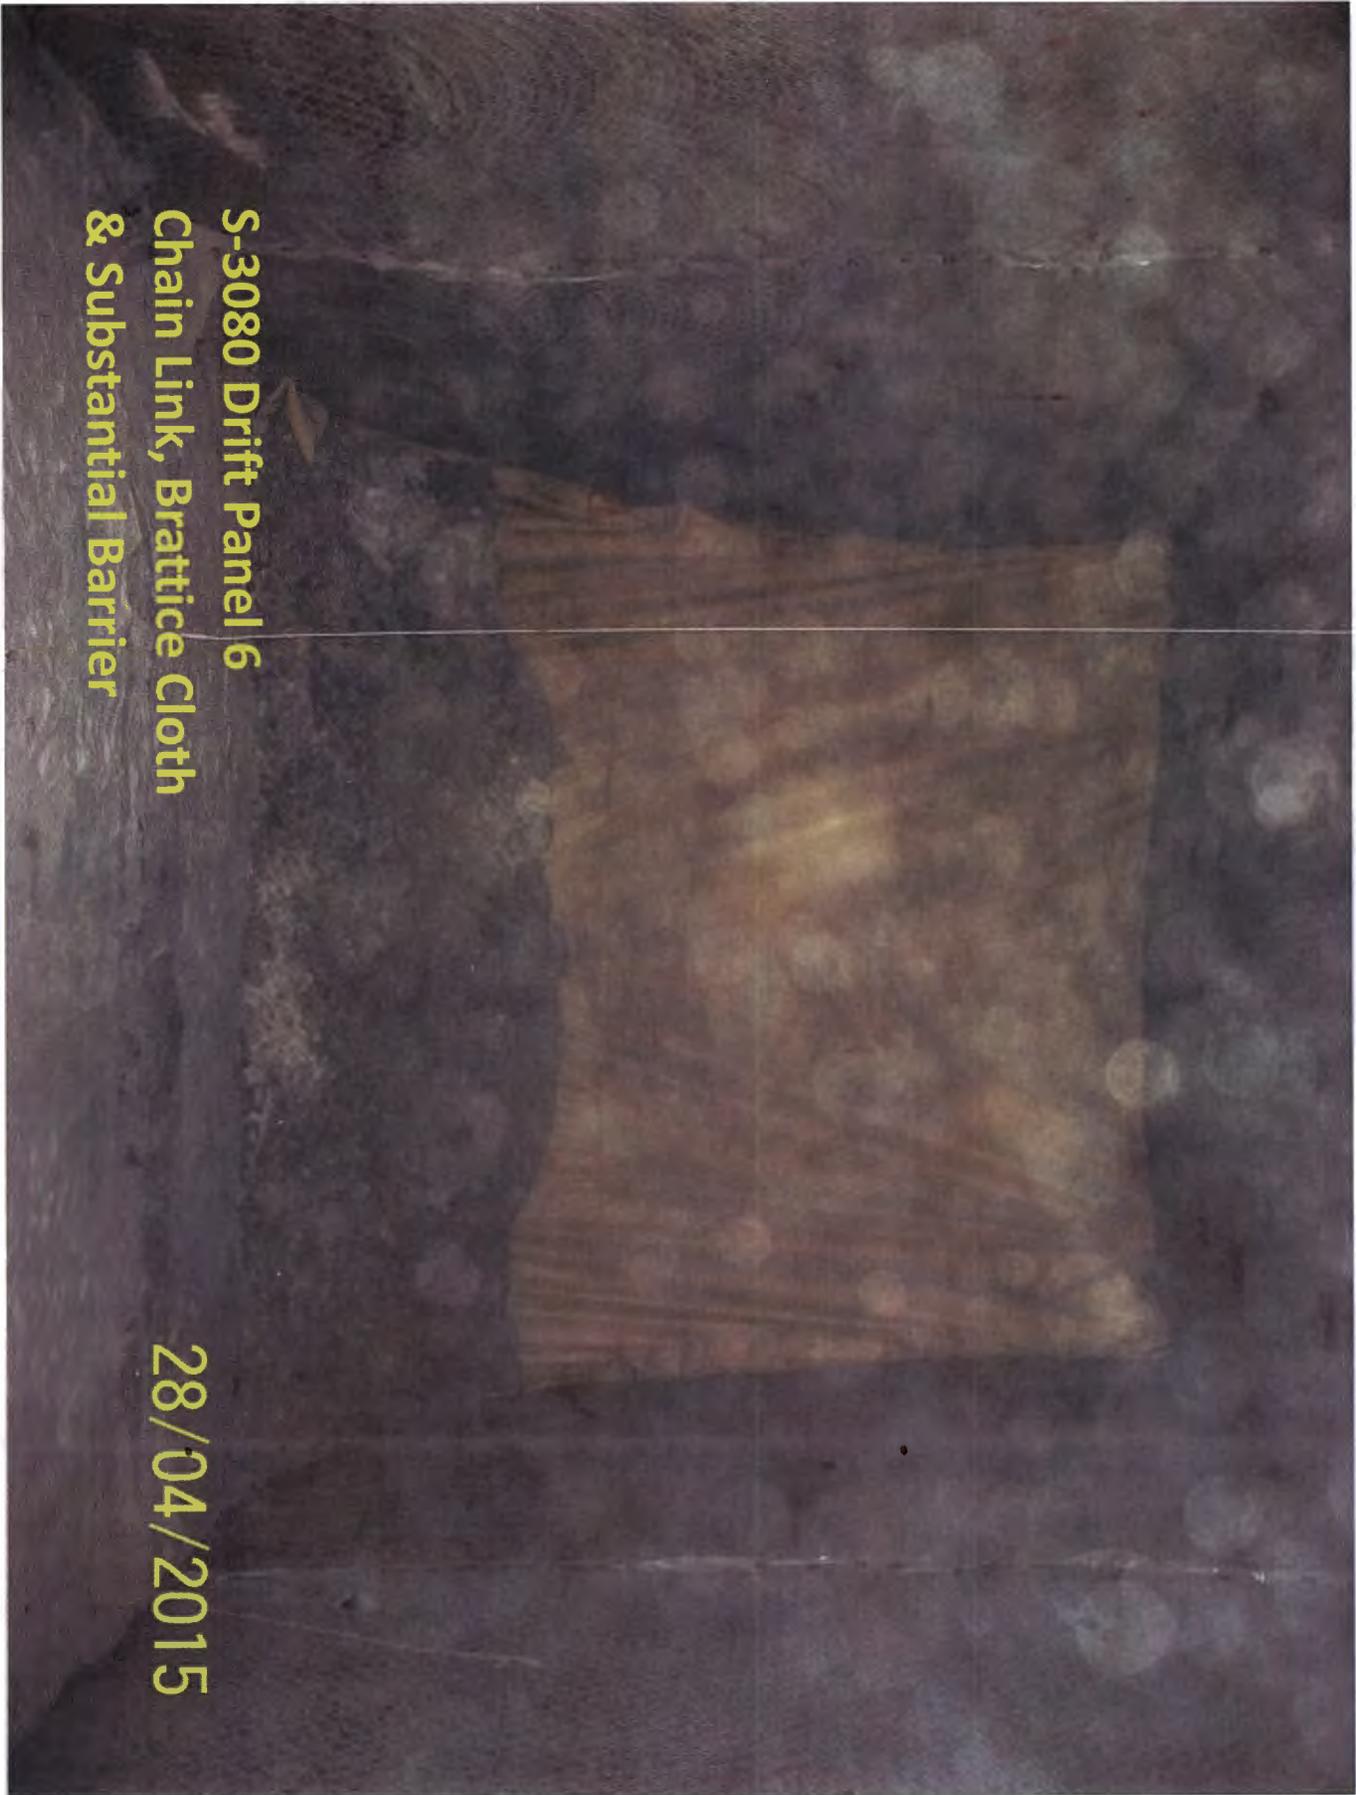
**S-3080 Drift Panel 6
Chain Link, Brattice Cloth
& Substantial Barrier**

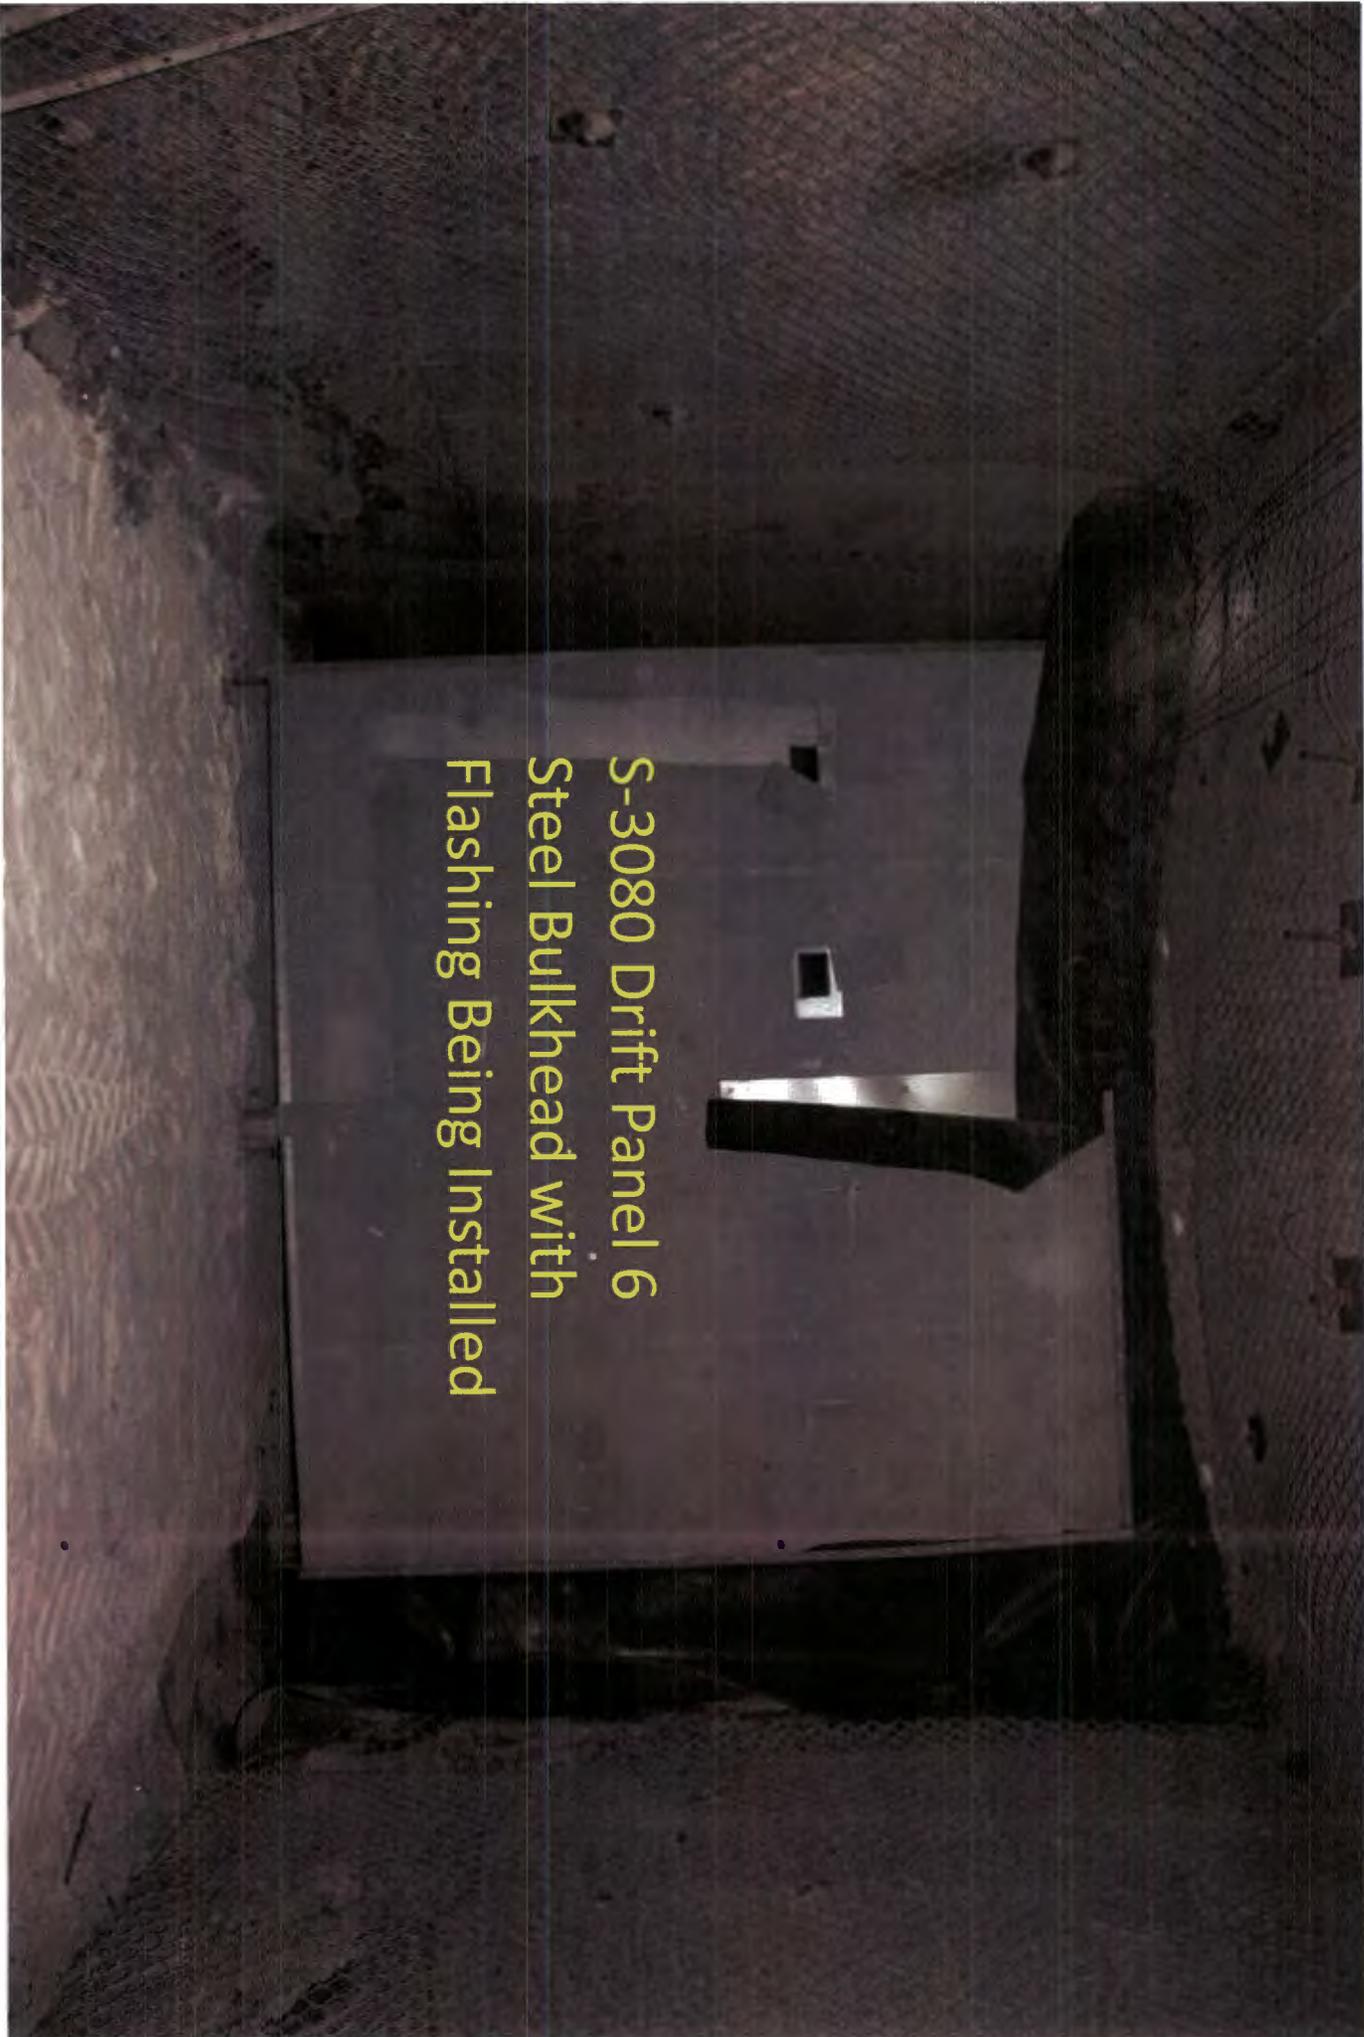
S-3080 Drift Panel 6
Steel Bulkhead with
Flashing Being Installed

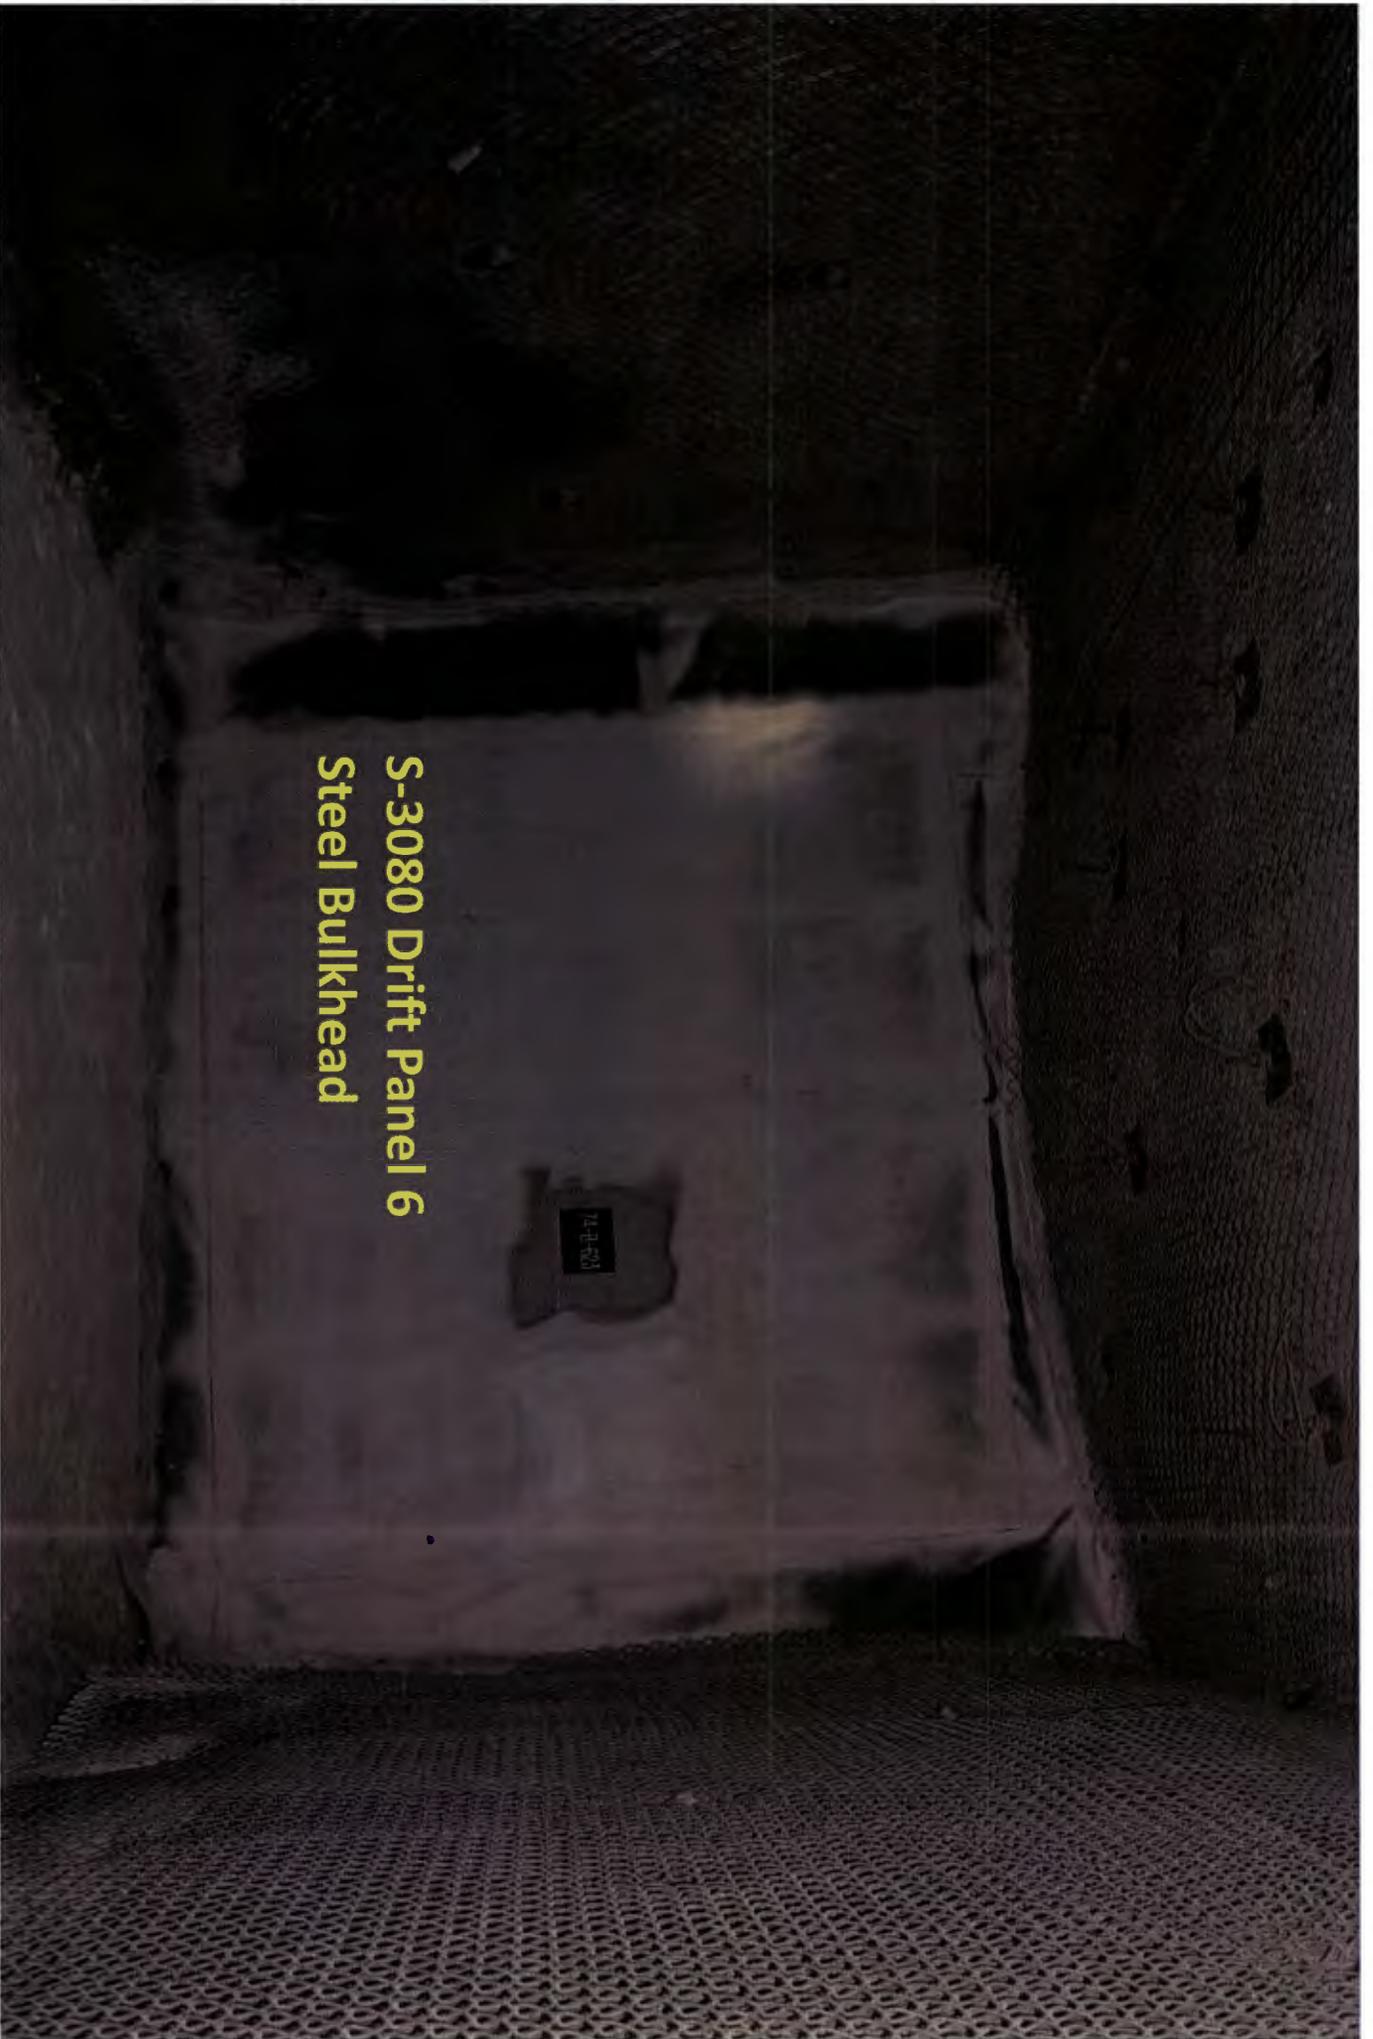
**S-3080 Drift Panel 6
Steel Bulkhead**

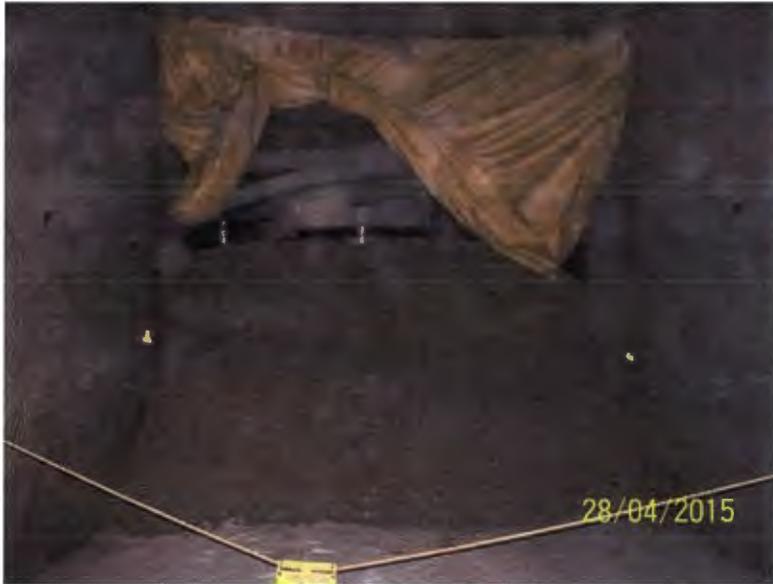
S-3080 Drift Panel 6
Substantial Barrier

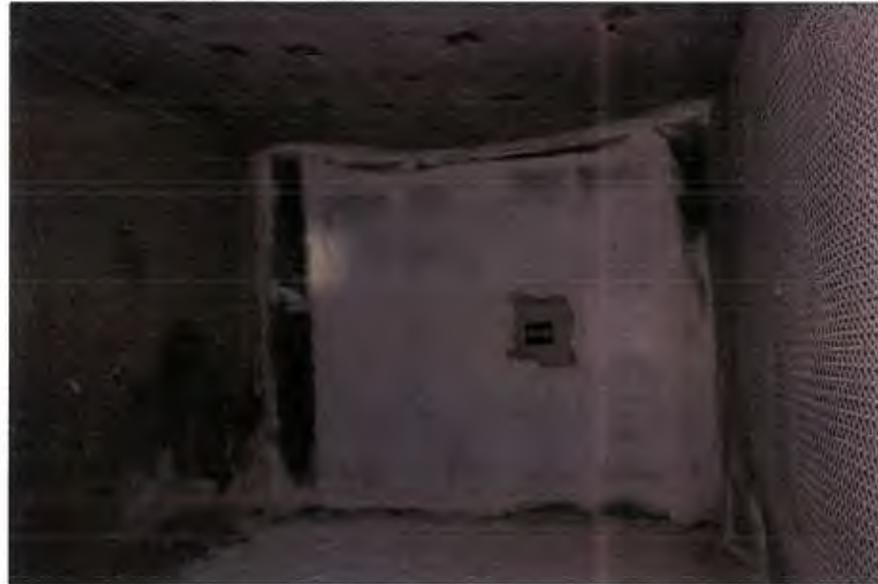
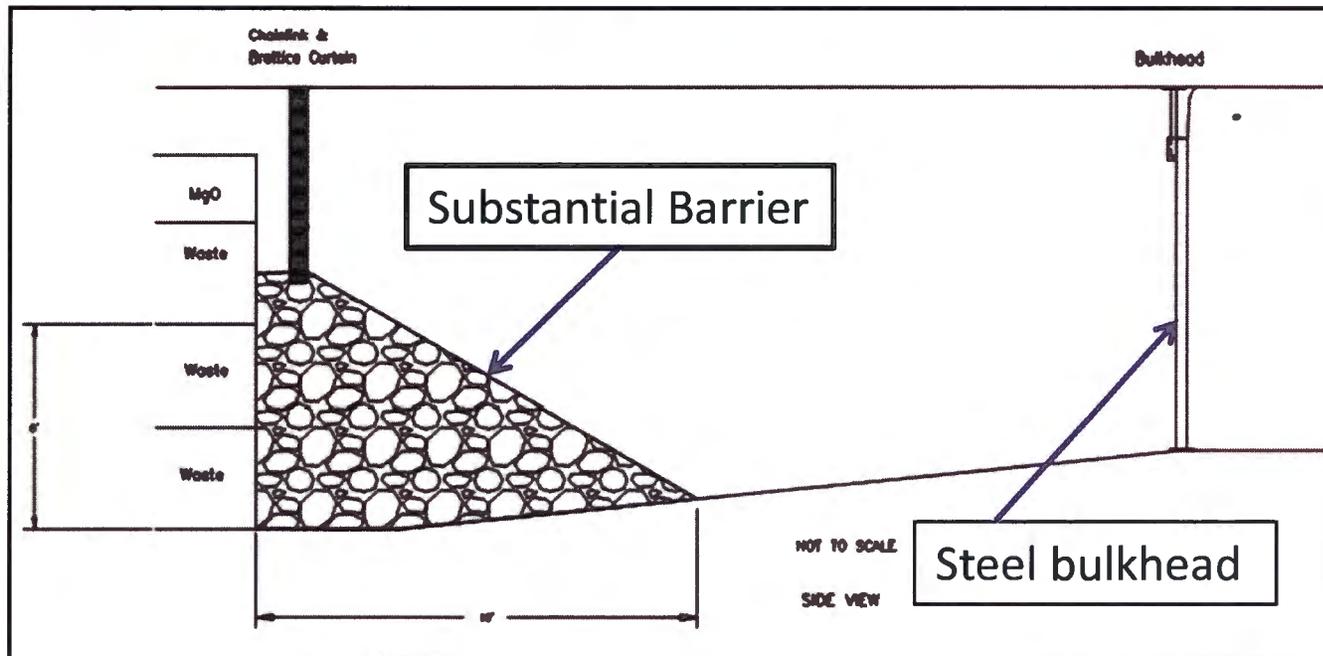
S-3080 Drift Panel 6
Steel Bulkhead & Flashing

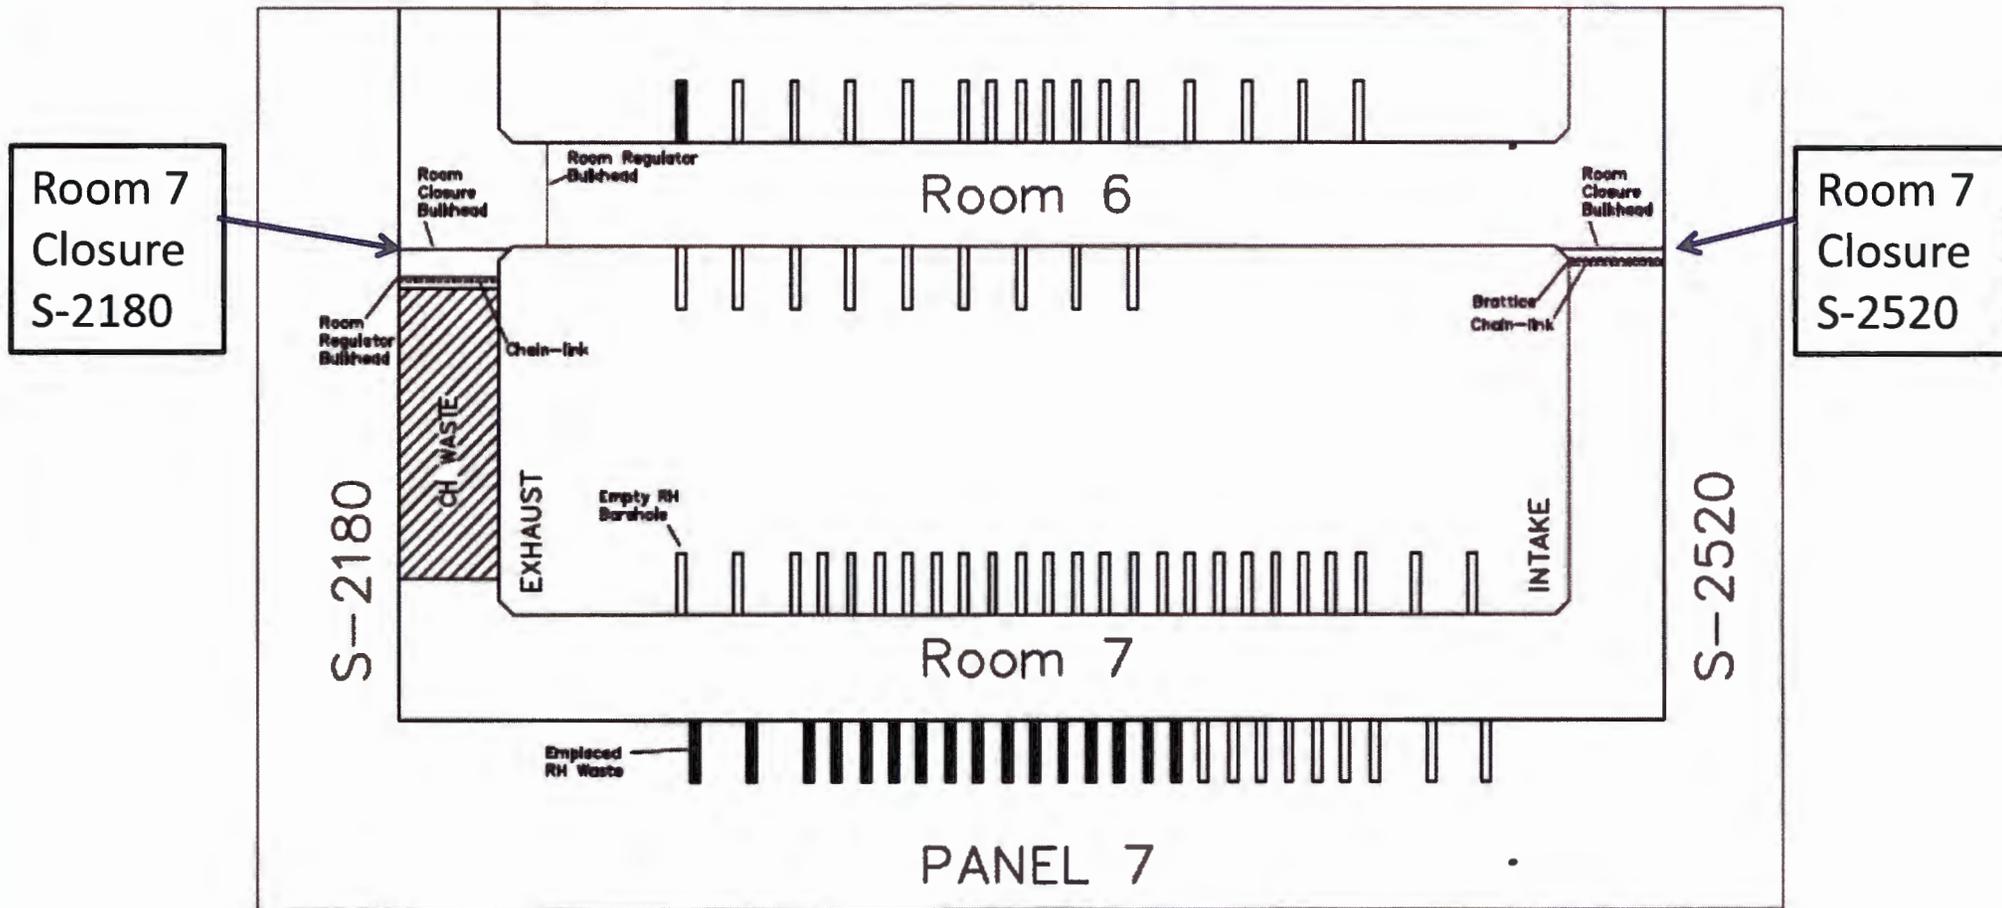
Closure of Room 7, Panel 7

(disposal room closure – steel bulkhead)

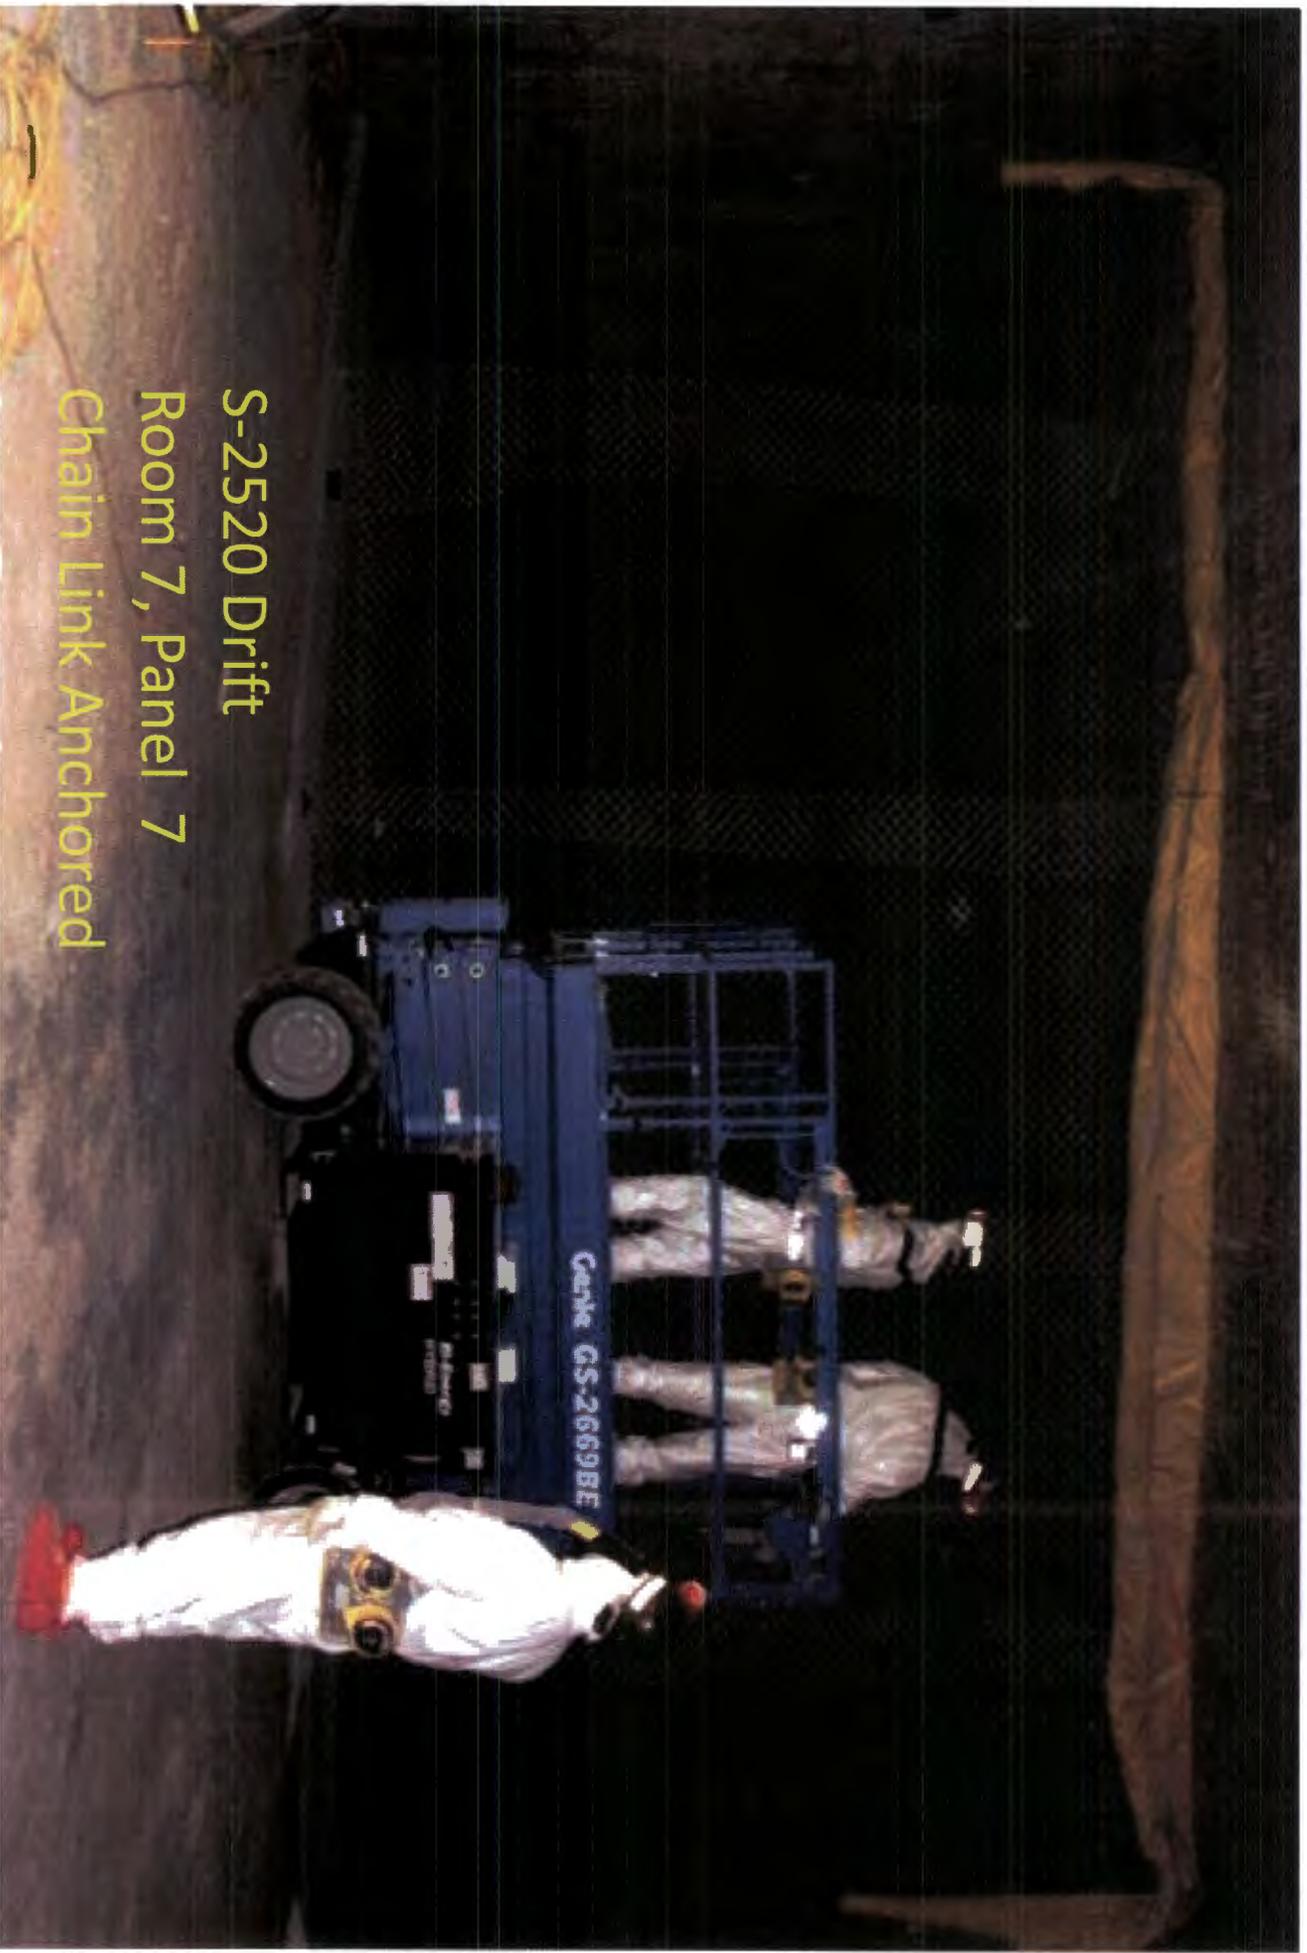
S-2520 Drift
Room 7, Panel 7
Chain Link Anchored

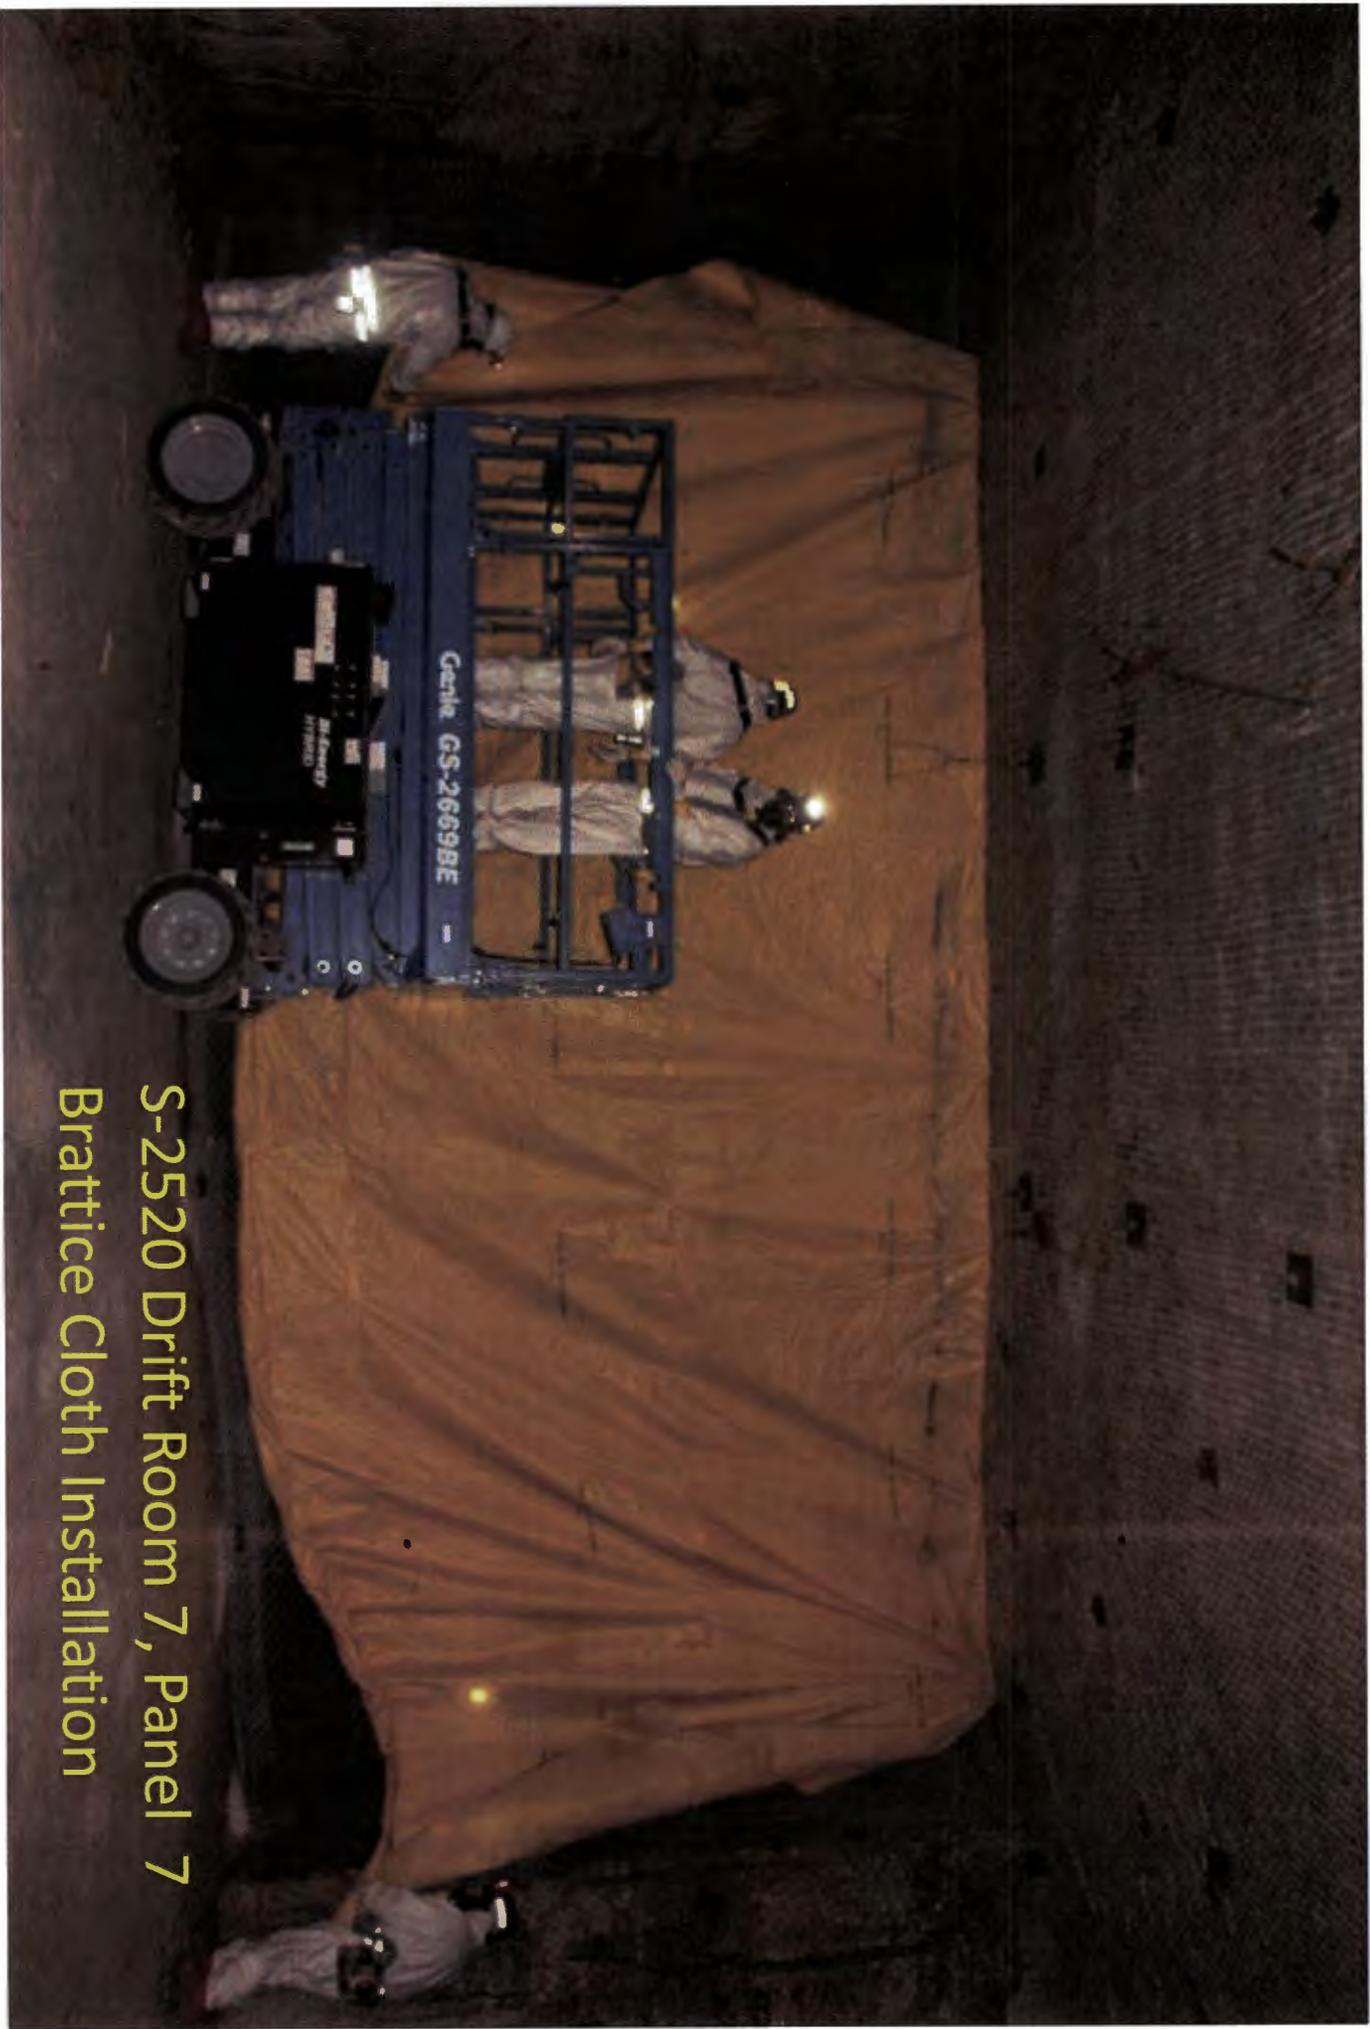
S-2520 Drift Room 7, Panel 7
Brattice Cloth Installation

**S-2520 Drift
Room 7, Panel 7
Chain Link & Brattice
Cloth Installed**

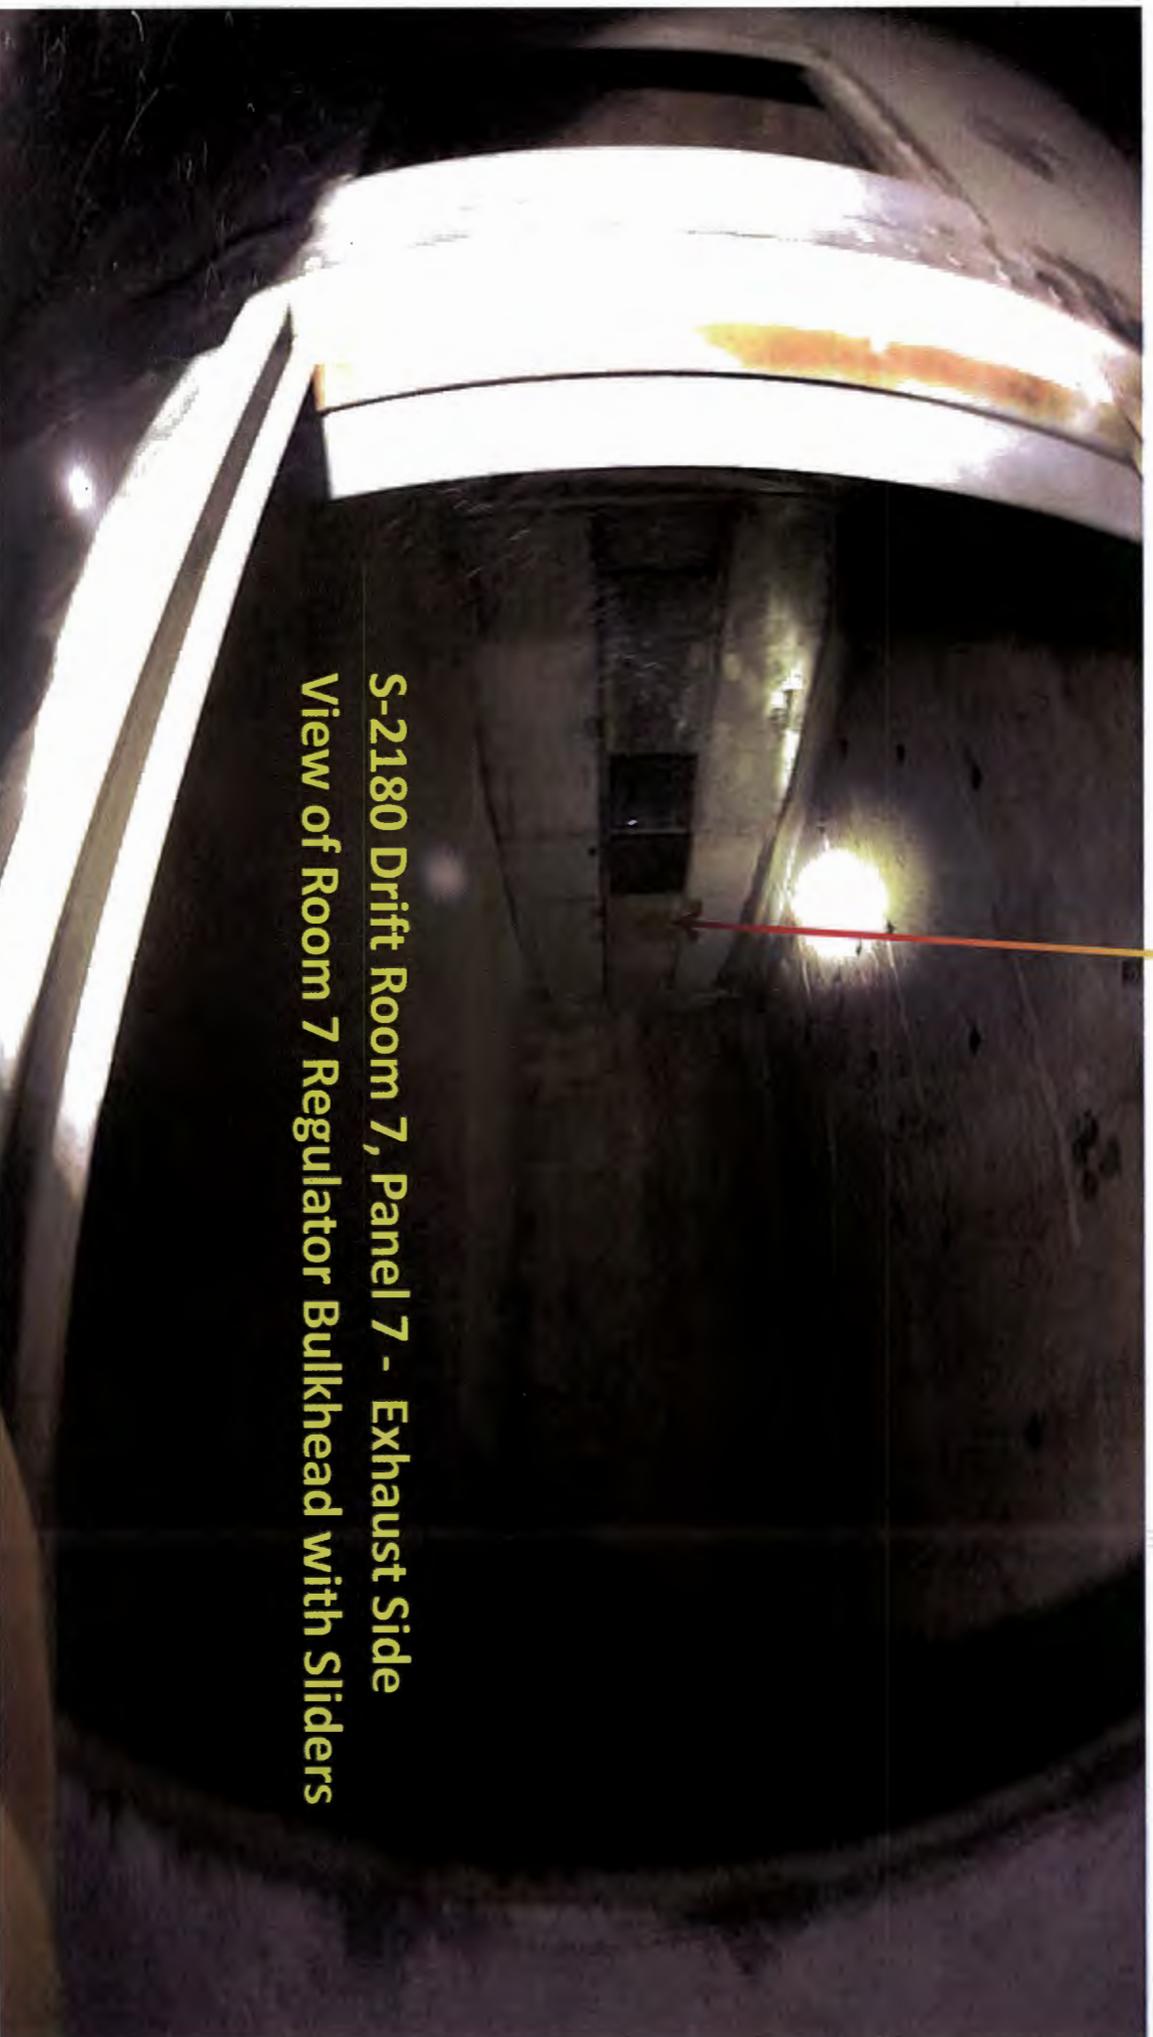
**S-2180 Drift Room 7, Panel 7 - Exhaust Side
View of Room 7 Regulator Bulkhead with Sliders**
