From: George Basabilvazo [<mailto:george.basabilvazo@cbfo.doe.gov>]
Sent: Wednesday, June 03, 2015 5:43 PM
To: Maestas, Ricardo, NMENV; Kieling, John, NMENV; Roberts, Kathryn, NMENV
Cc: Chavez, Rick - RES (Rick.Chavez@wipp.ws); rkehrman@plateautel.net; John Vandekraats - NWP; Anthony Stone
Subject: Summary of Panel 6 Initial Closure and Closure of Room 7, Panel 7

Prerequisites for Expedited Closure of Panel 6 (initial) and Closure of Room 7, Panel 7

Initial Closure of Panel 6: Consists of a Substantial Barrier & Steel Bulkhead (cross-sectional view of access drift)

Closure of Room 7, Panel 7 (disposal room closure – steel bulkhead)

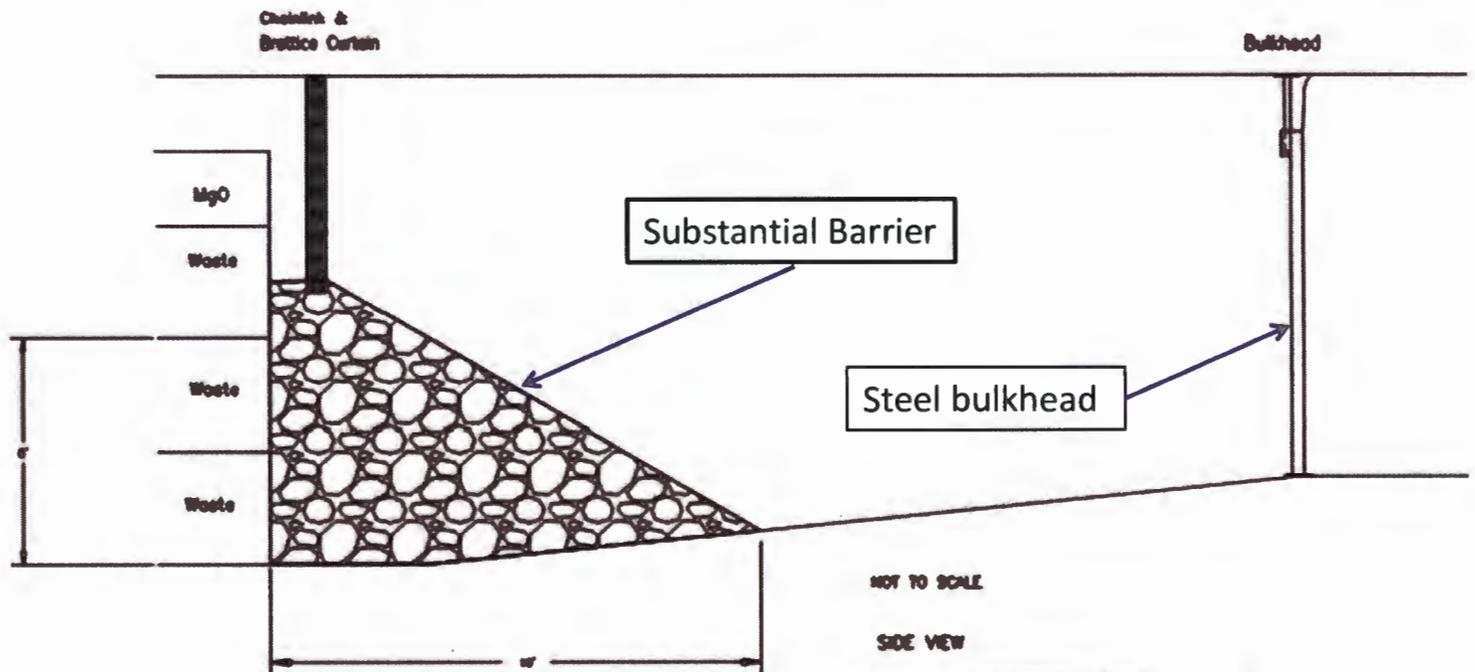
“Substantial barrier” means salt or other non-combustible material installed between the waste face and the bulkhead

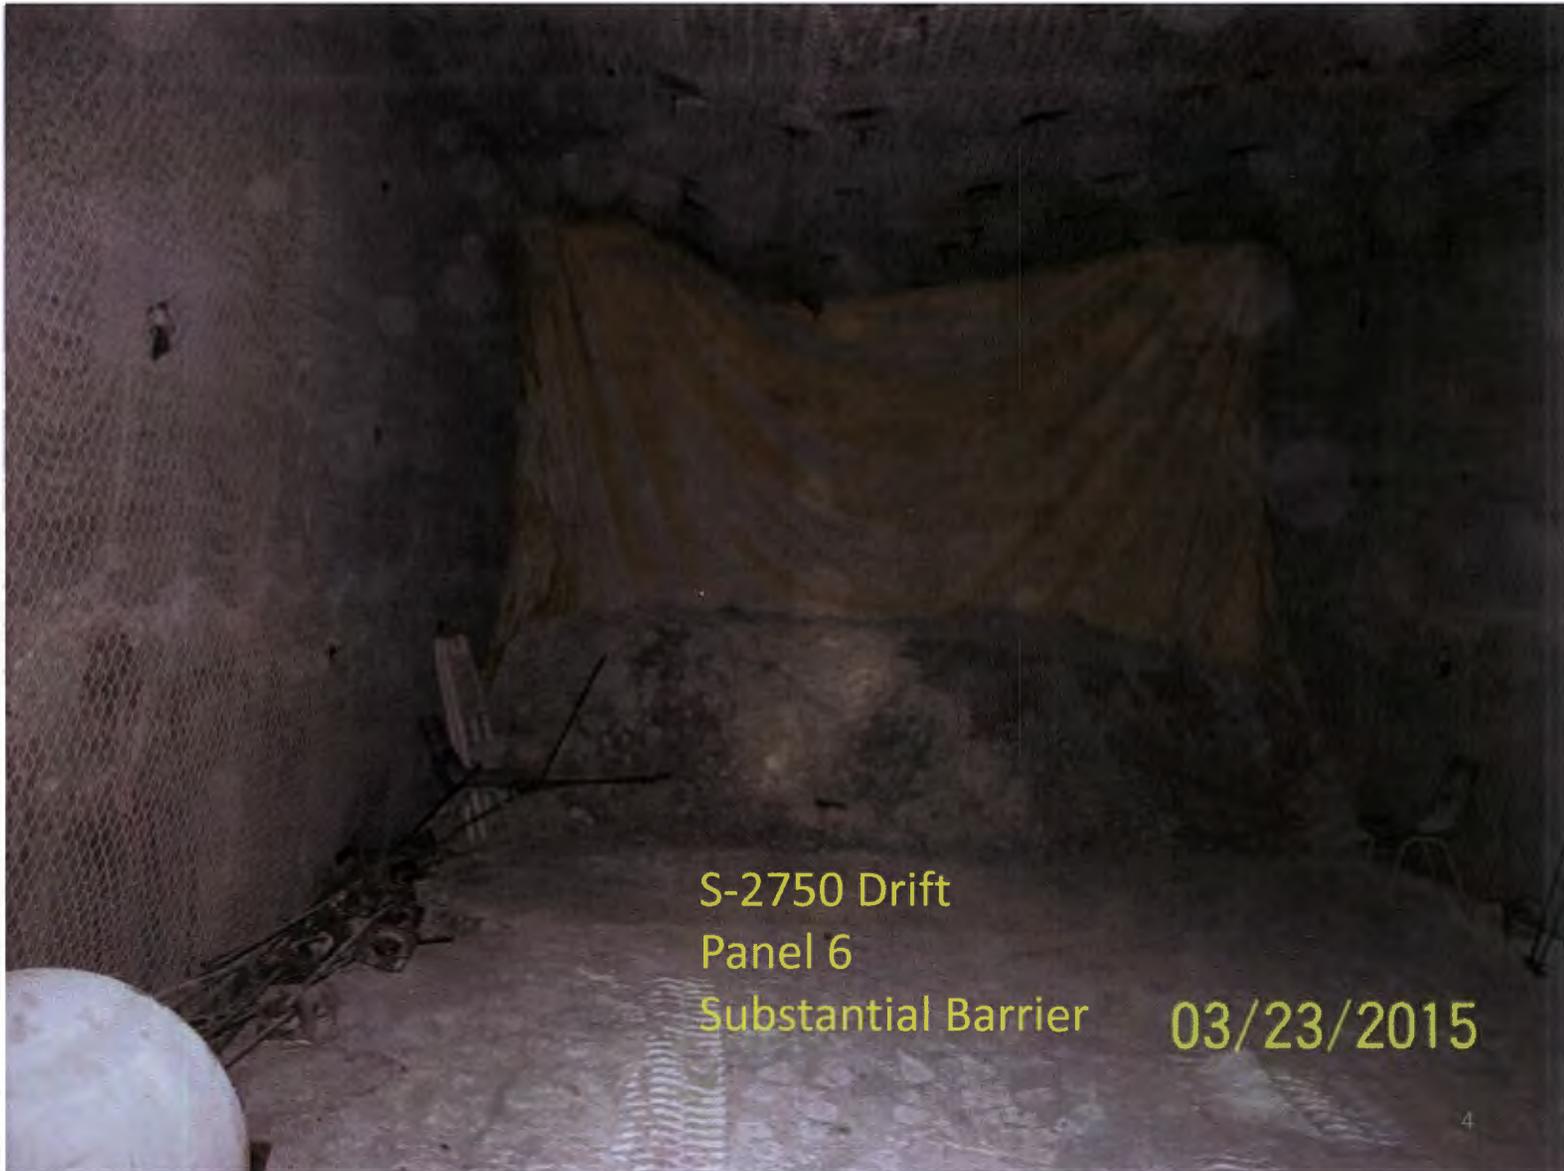
S-2750 Drift

Panel 6

Substantial Barrier

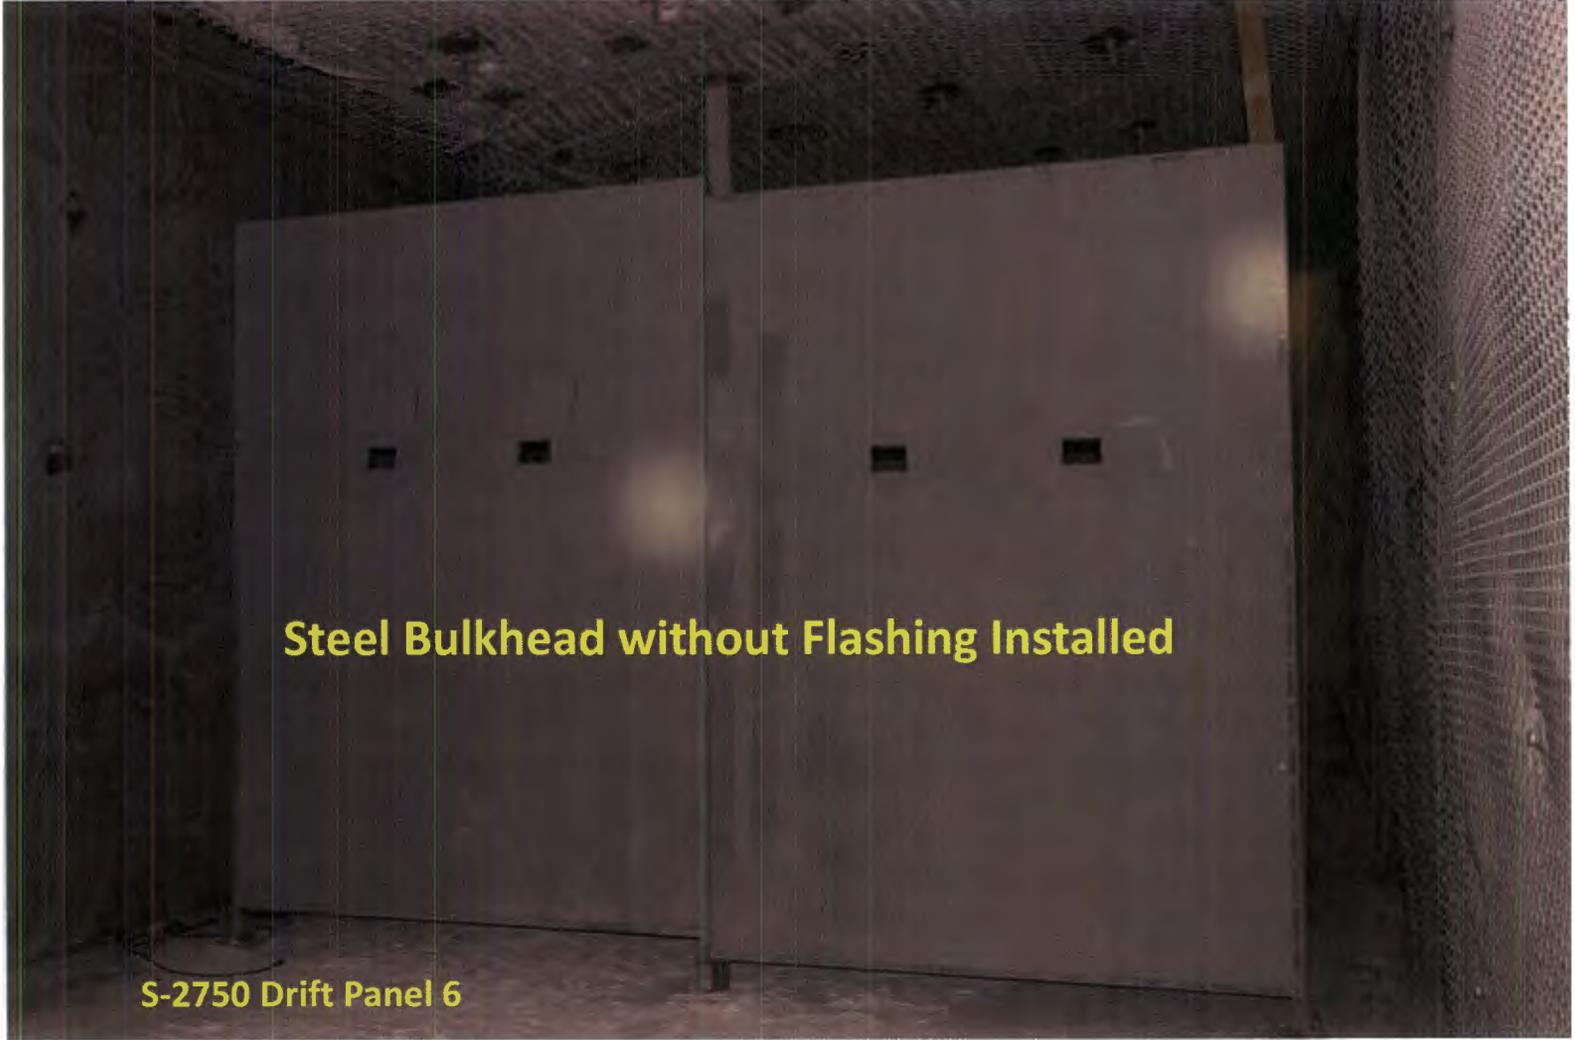
Steel Bulkhead without Flashing Installed

S-2750 Drift Panel 6

Steel Bulkhead with Flashing being
Installed

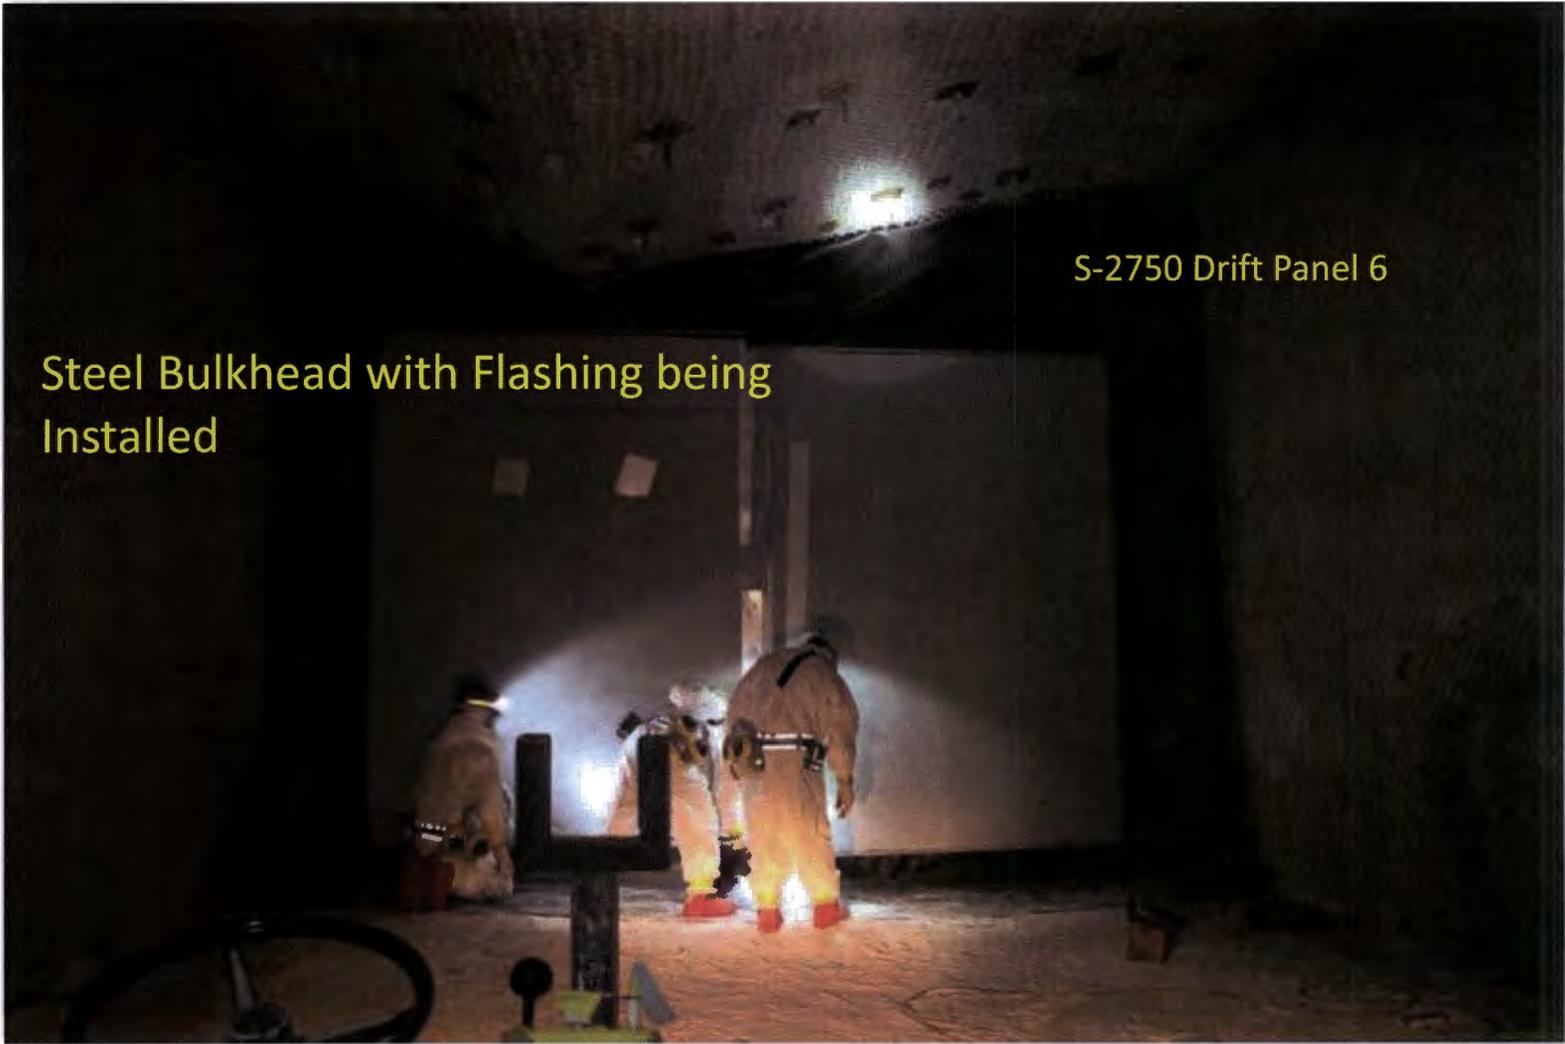
**S-2750 Drift
Panel 6
Steel Bulkhead &
Flashing Installed**

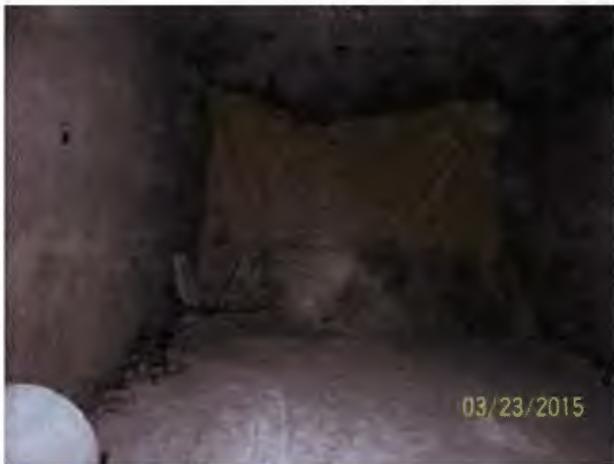
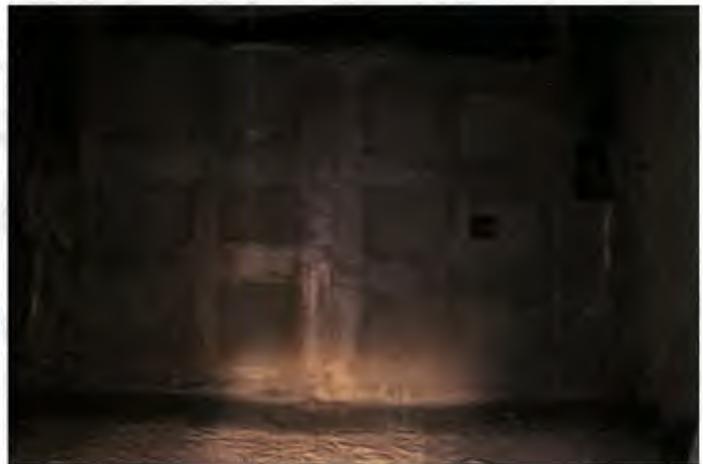
S-2750 Drift Panel 6
Steel Bulkhead & Flashing

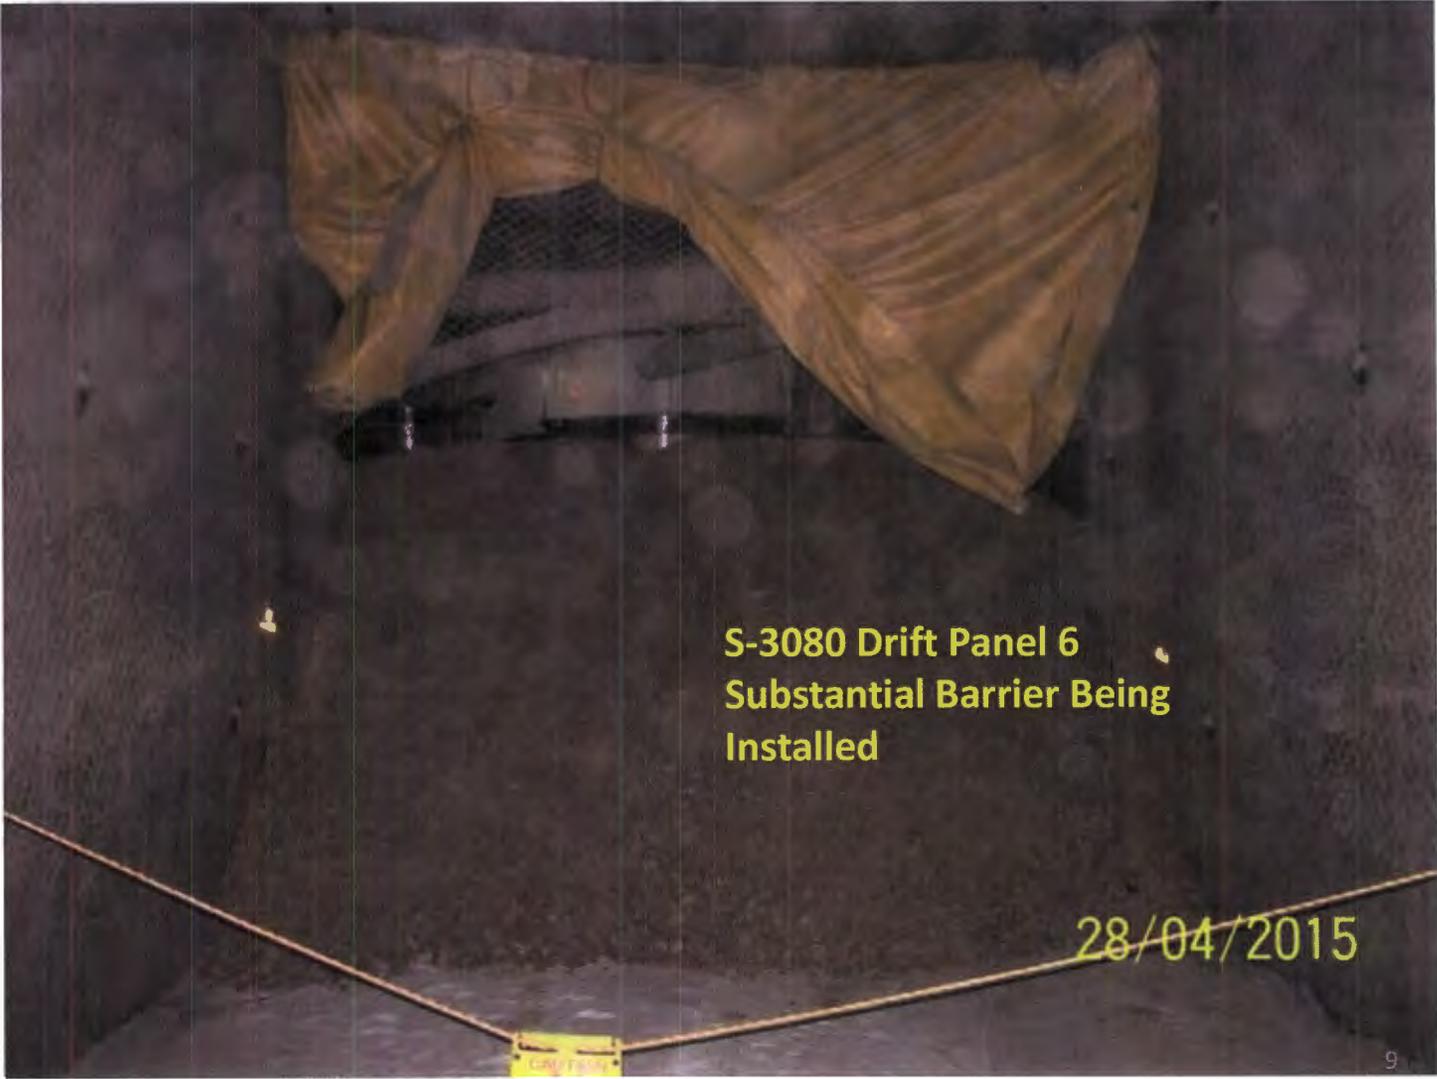
**S-3080 Drift Panel 6
Substantial Barrier Being
Installed**

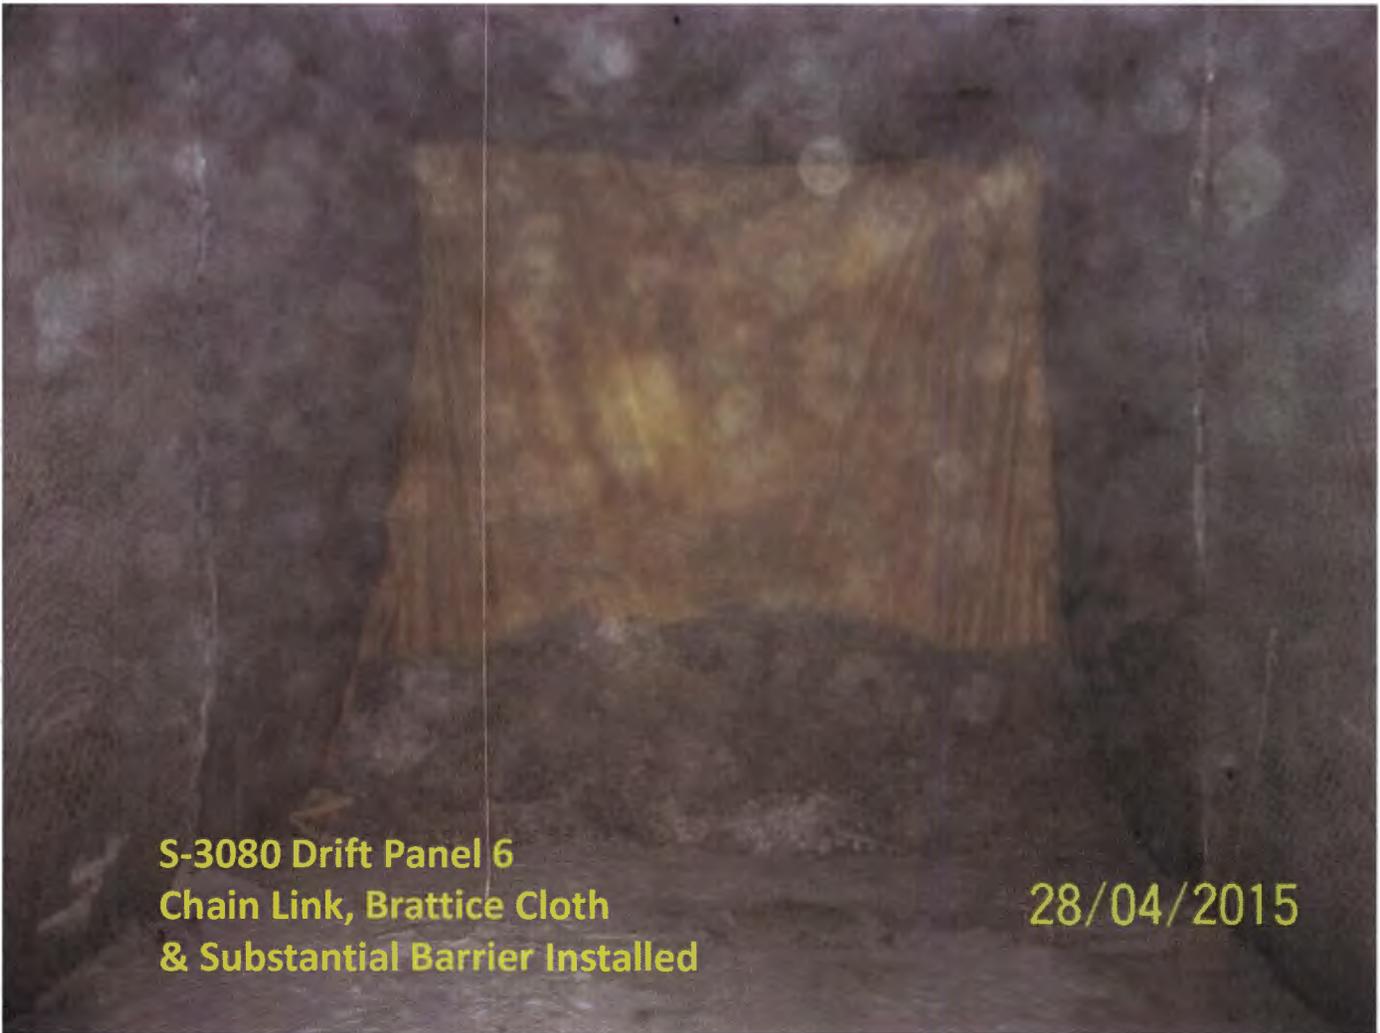
**S-3080 Drift Panel 6
Chain Link, Brattice Cloth
& Substantial Barrier Installed**

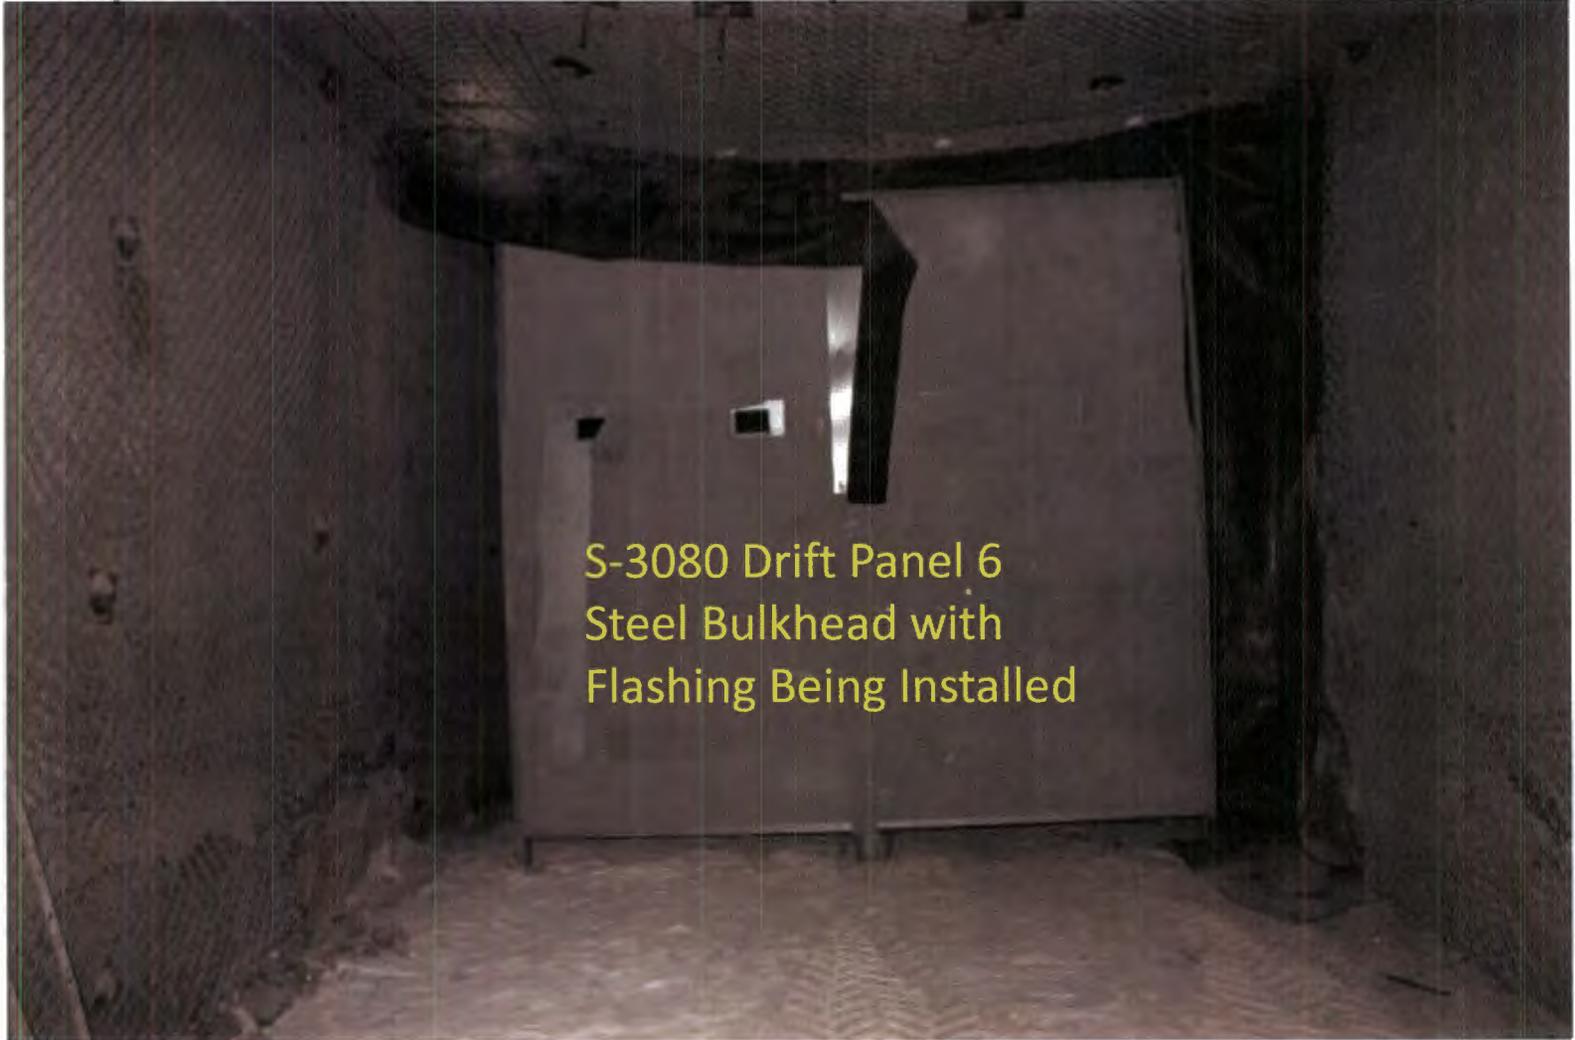
S-3080 Drift Panel 6
Steel Bulkhead with
Flashing Being Installed

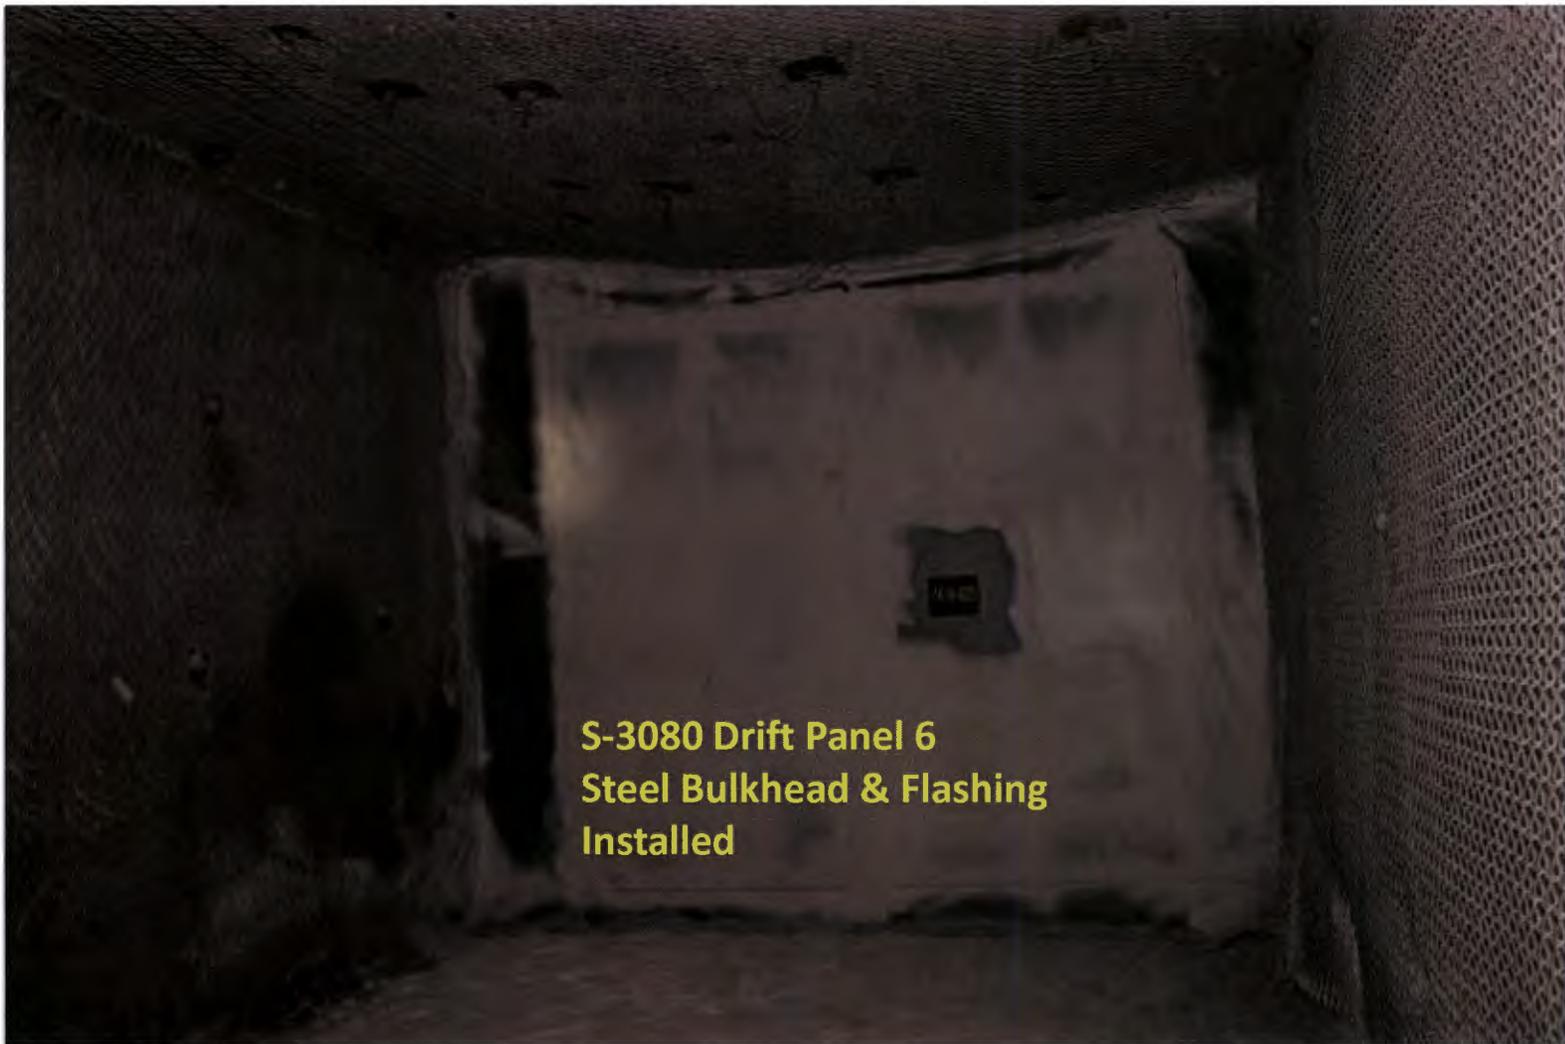
**S-3080 Drift Panel 6
Steel Bulkhead & Flashing
Installed**

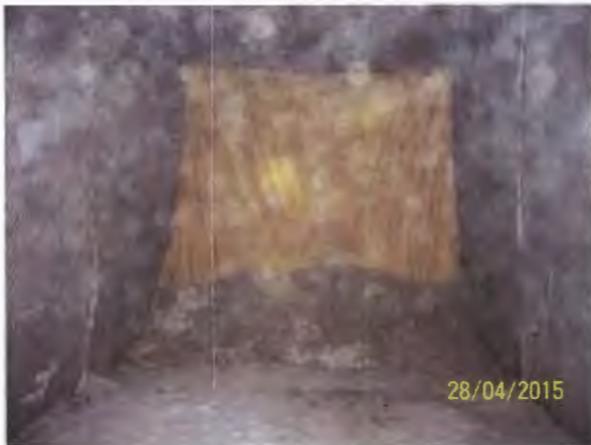
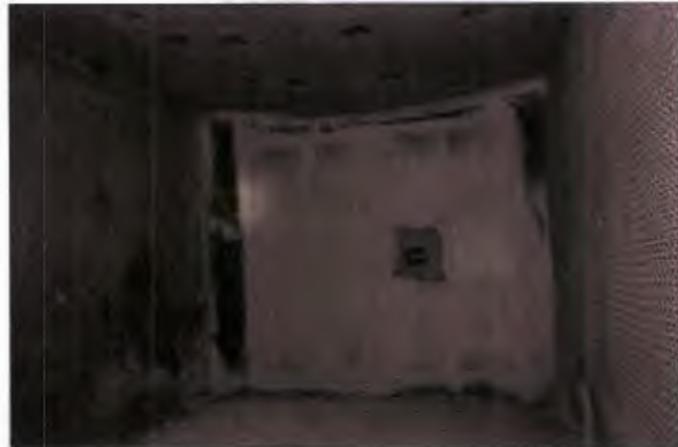
S-3080 Drift Panel 6
Substantial Barrier

S-3080 Drift Panel 6
Steel Bulkhead & Flashing

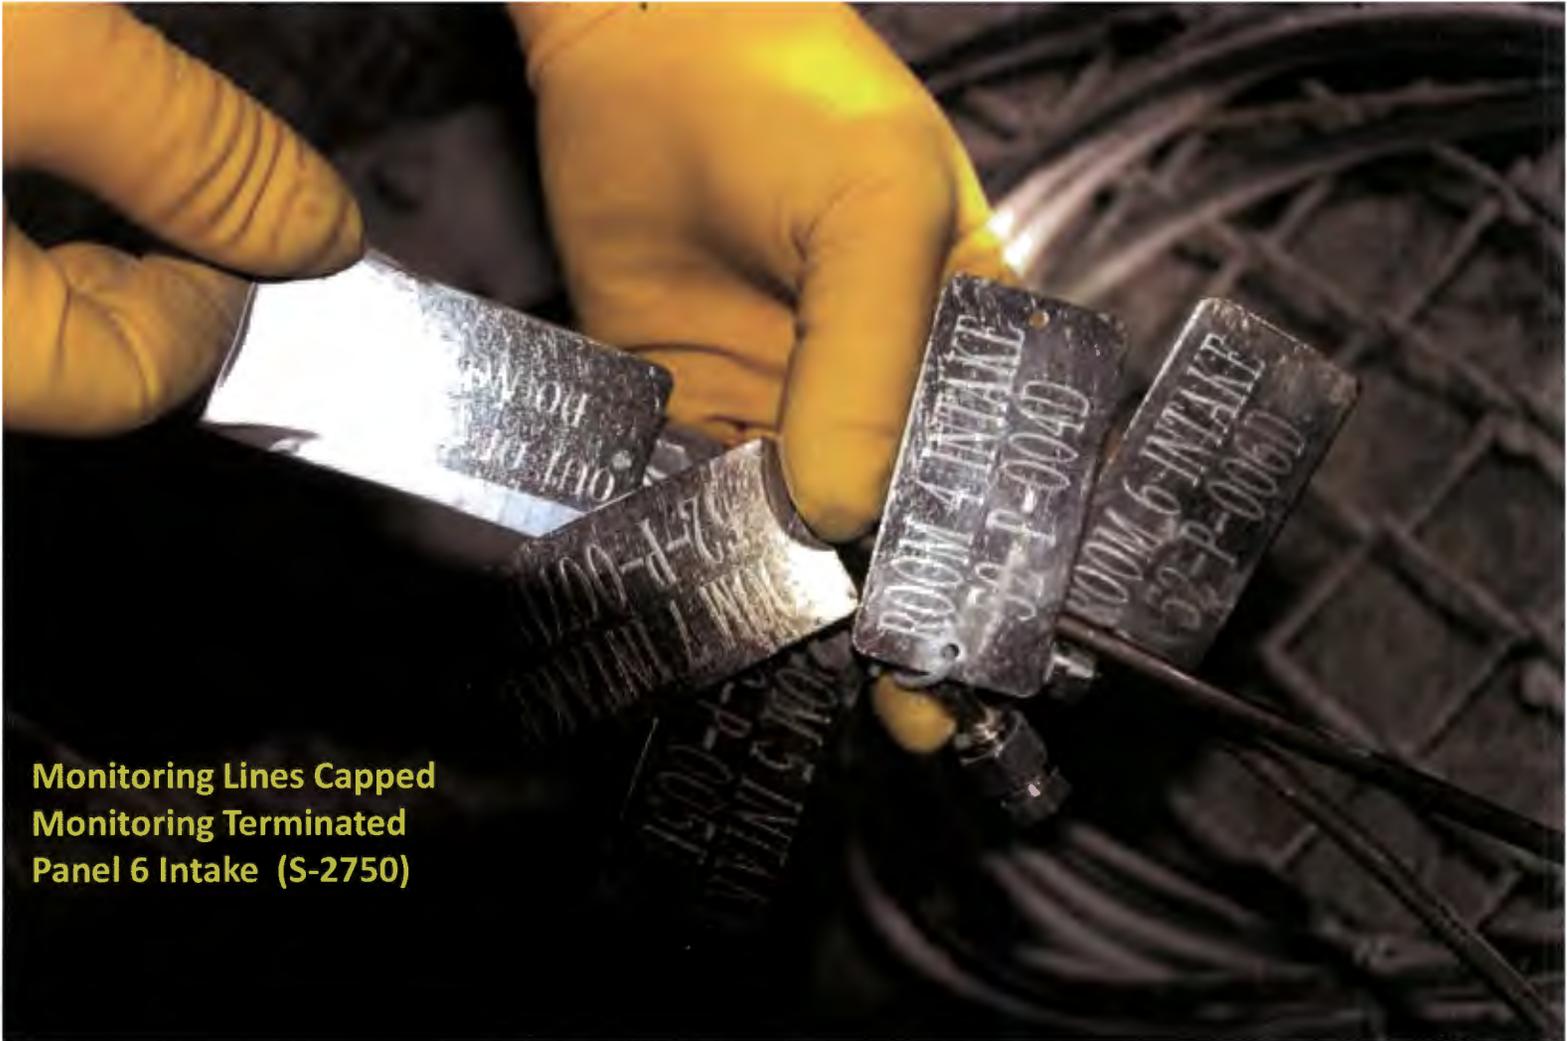
**Monitoring Lines Capped
Monitoring Terminated
Panel 6 Intake (S-2750)**

Slide 14 – monitoring lines and capped line on the intake side of Panel 6

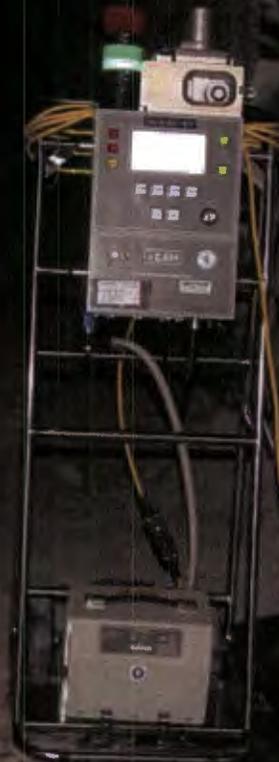
**W-170 & S-3080 Drift
Panel 6 - Radiological
Monitoring
Equipment Installed**

Slides 15 & 16 – radiological monitoring equipment for panel 6

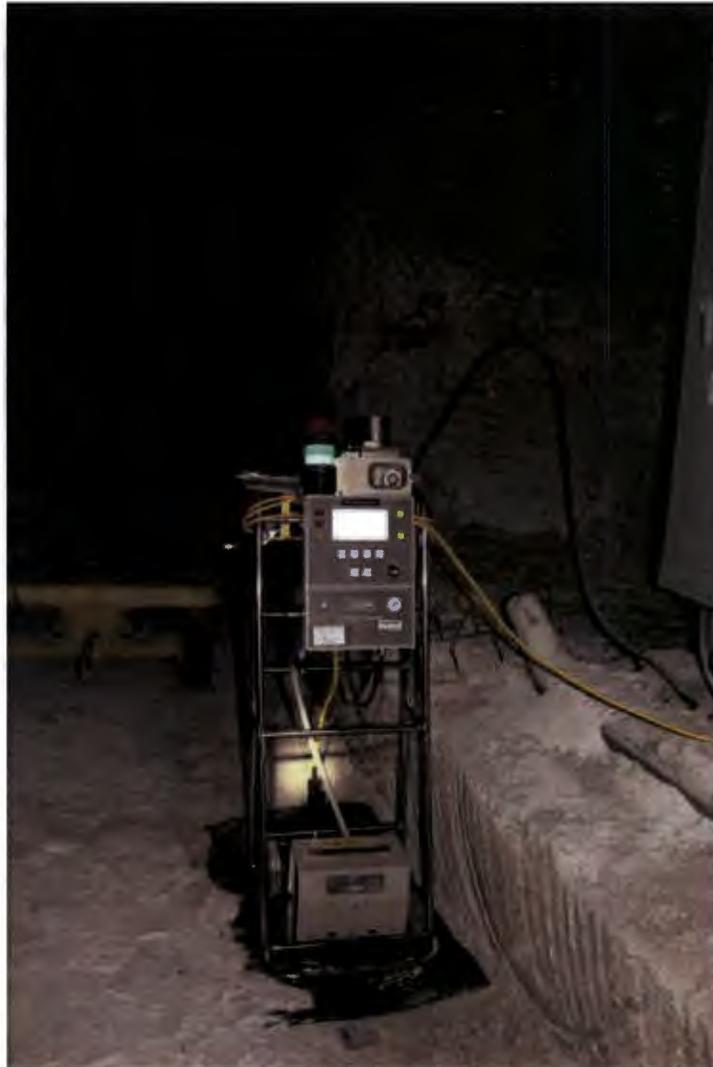
**W-170 & S-2750 Drift
Panel 6 - Radiological
Monitoring
Equipment Installed**

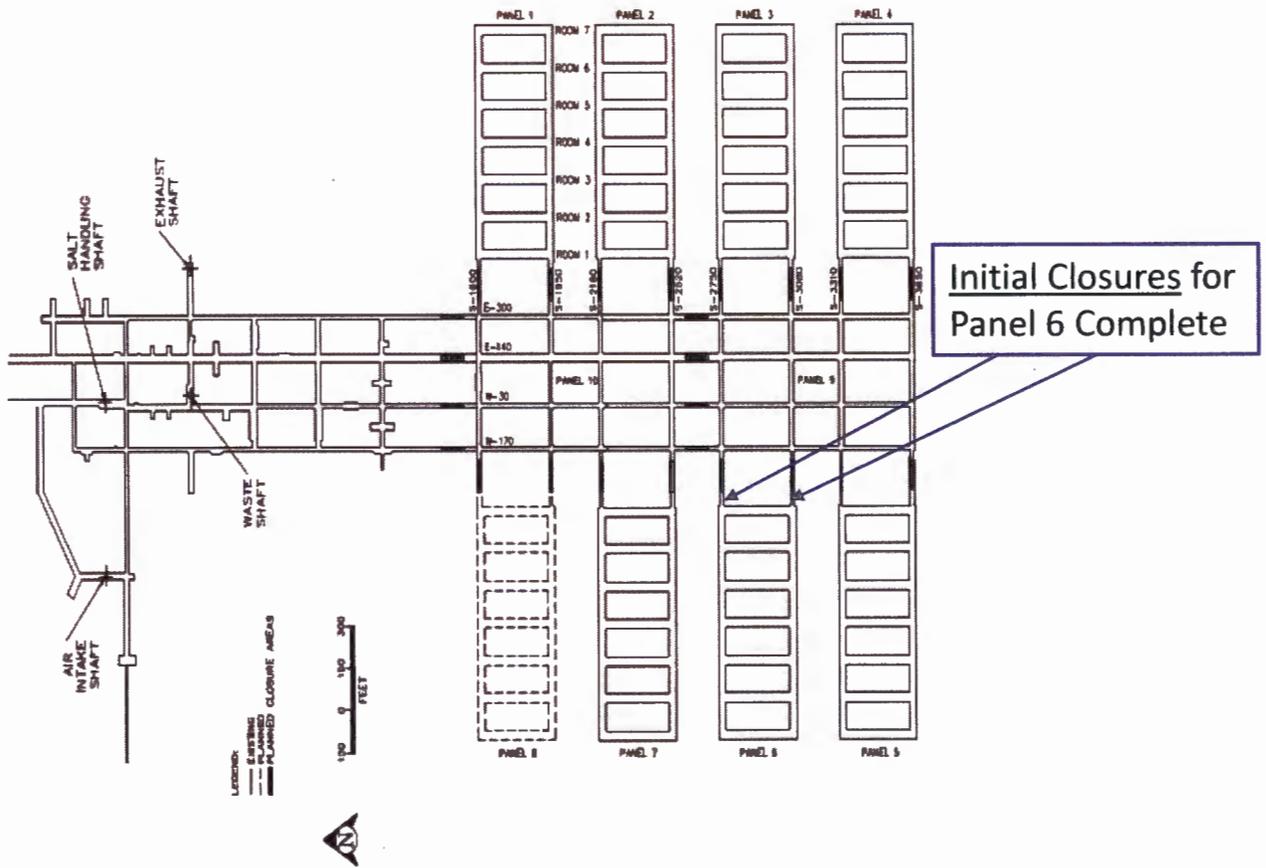
Installation of Initial Panel 6 Closures Has Been Completed

Slide 17 – figure illustrating where the Initial Closure Panel 6 work was completed

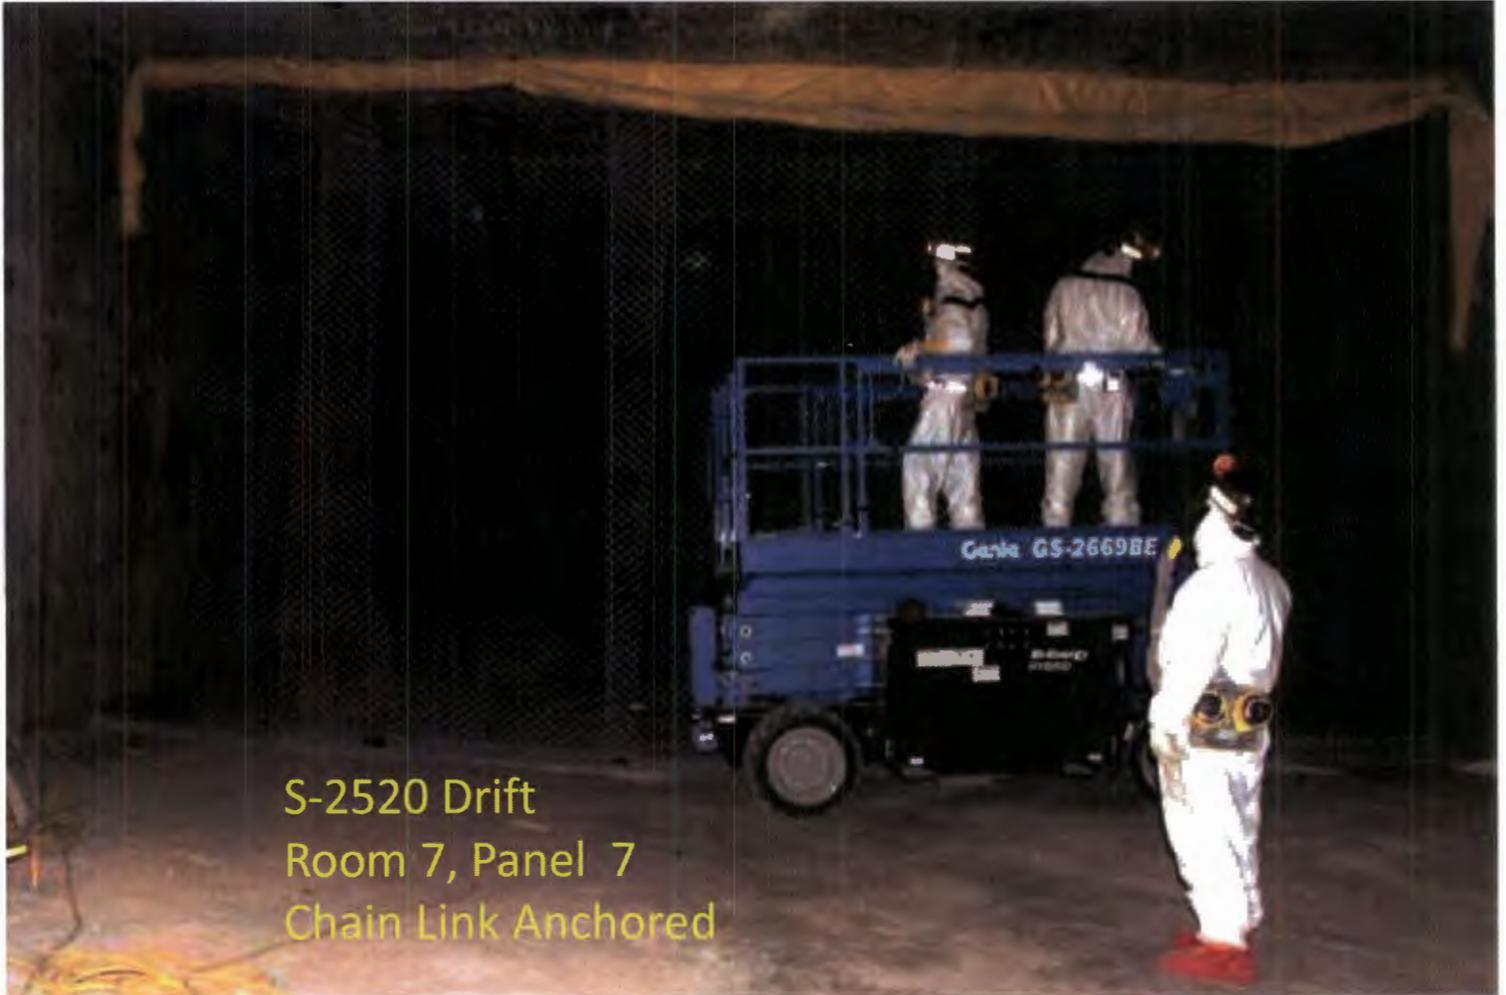
S-2520 Drift
Room 7, Panel 7
Chain Link Anchored

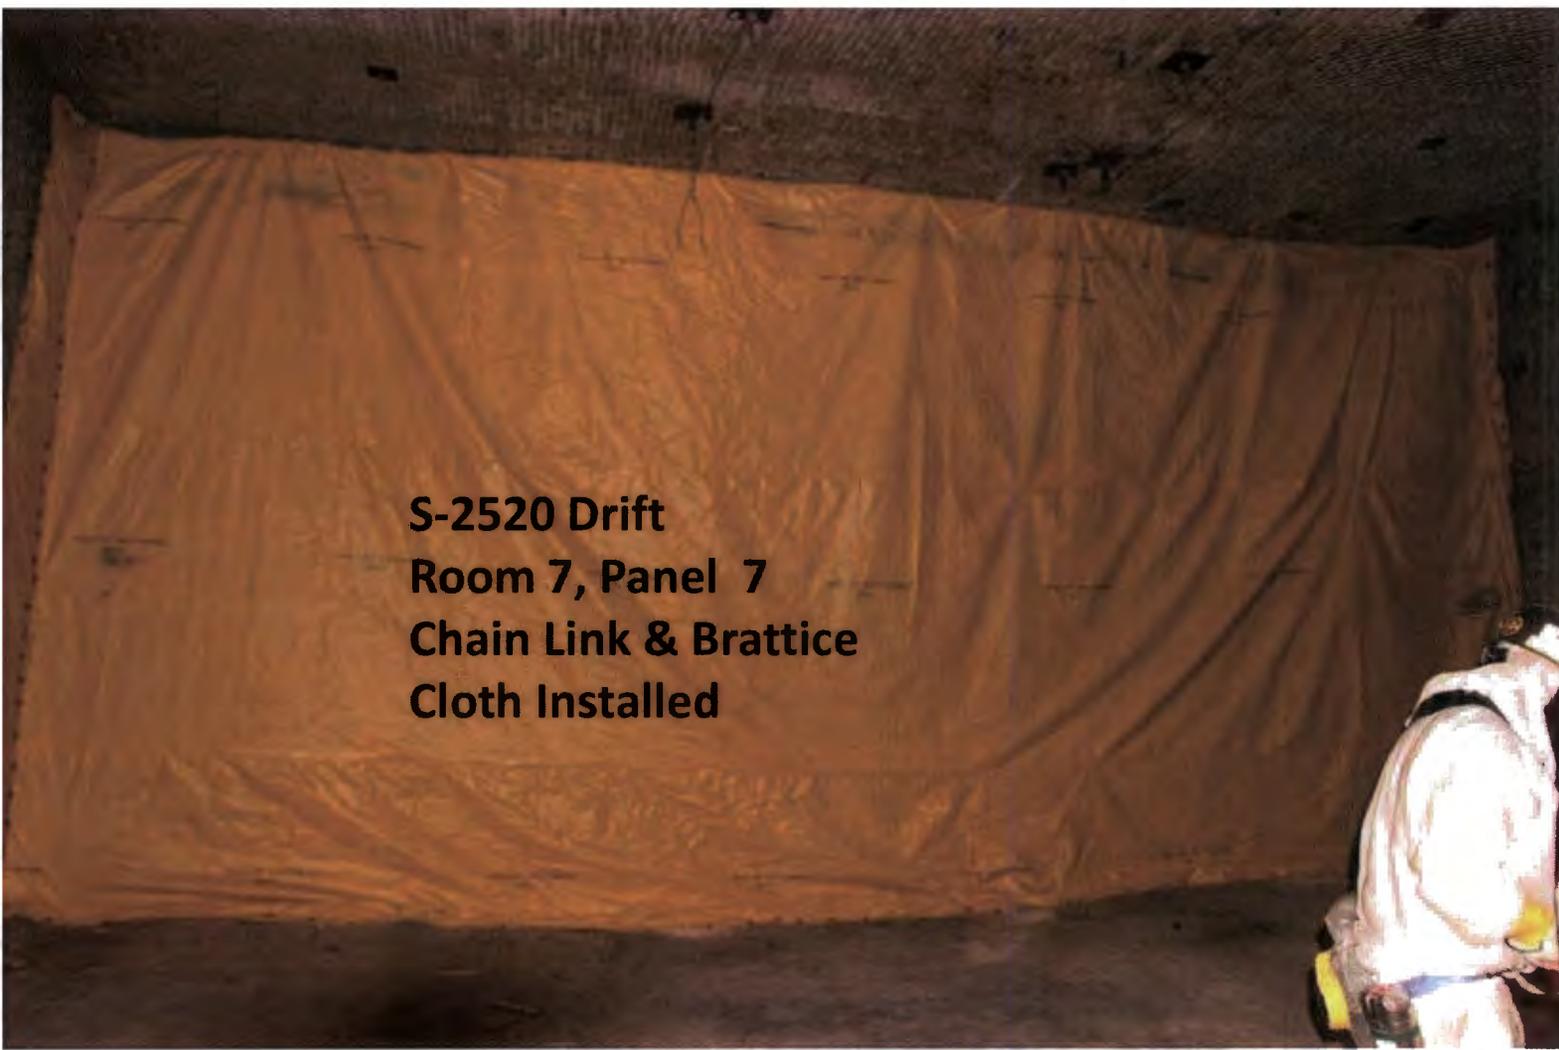
**S-2520 Drift
Room 7, Panel 7
Chain Link & Brattice
Cloth Installed**

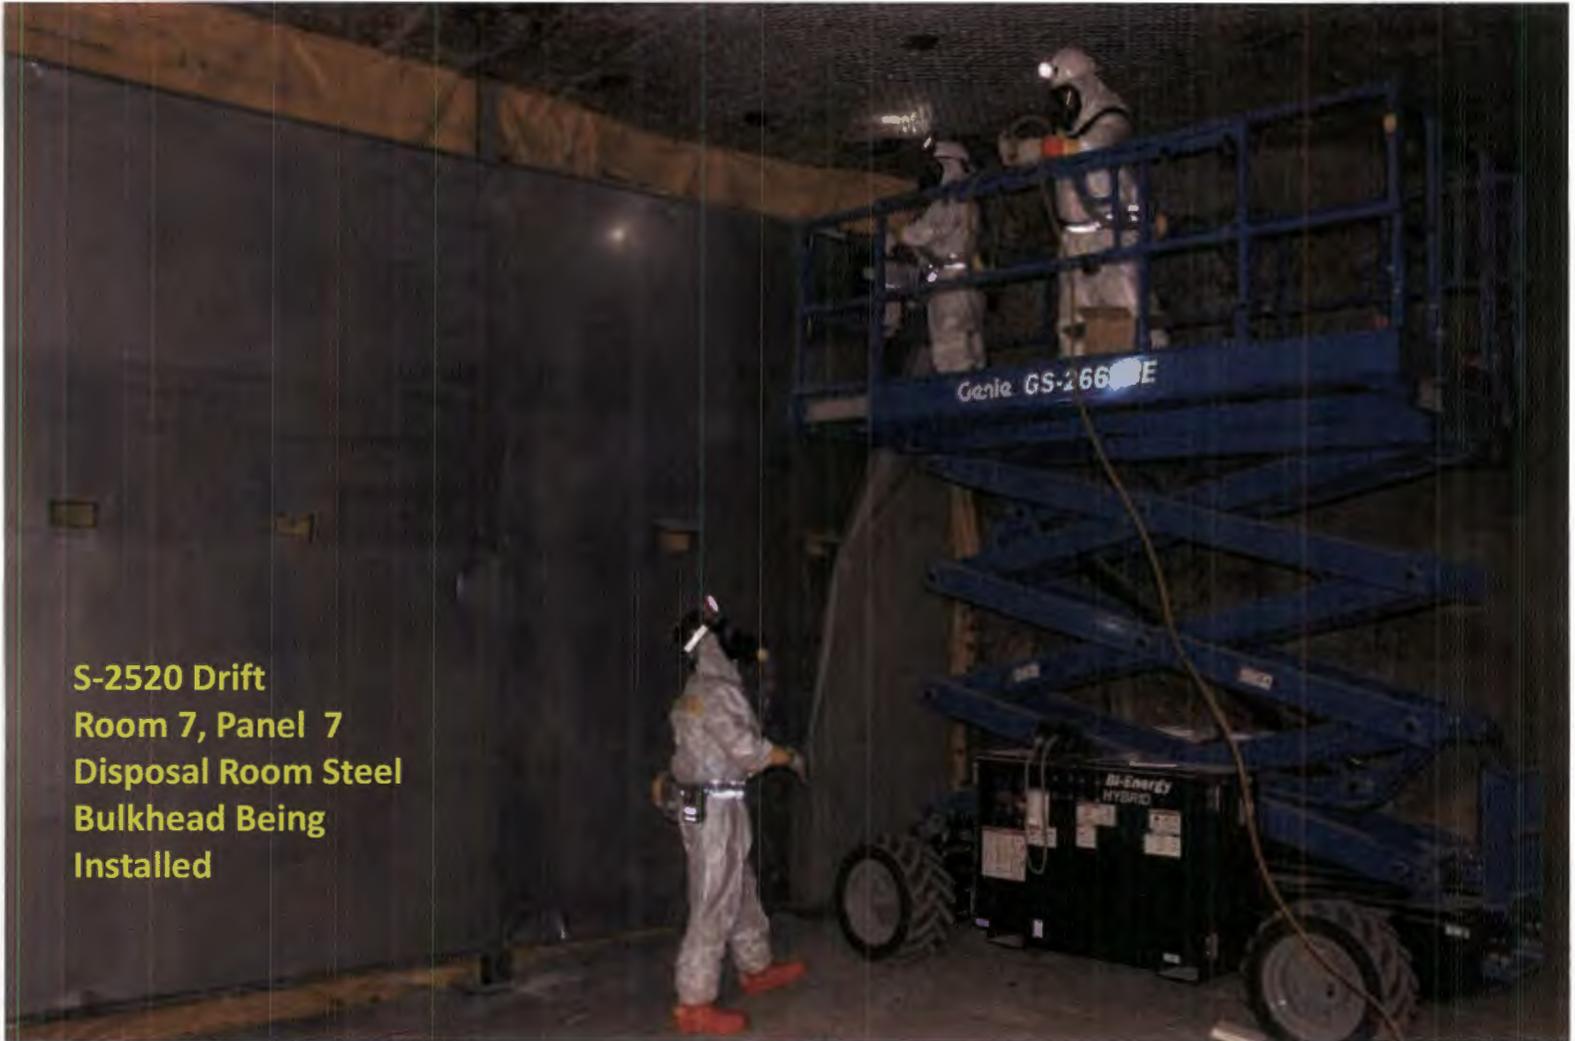
S-2520 Drift
Room 7, Panel 7
Disposal Room Steel
Bulkhead Being
Installed

Slide 22 – Installation of Room Closure Bulkhead between Room 7, Panel 7 and Room 6, Panel 7 in the S-2520 Drift (air intake side)
