From: George Basabilvazo [<mailto:george.basabilvazo@cbfo.doe.gov>]
Sent: Wednesday, June 03, 2015 5:43 PM
To: Maestas, Ricardo, NMENV; Kieling, John, NMENV; Roberts, Kathryn, NMENV
Cc: Chavez, Rick - RES (Rick.Chavez@wipp.ws); rkehrman@plateautel.net; John Vandekraats - NWP; Anthony Stone
Subject: Summary of Panel 6 Initial Closure and Closure of Room 7, Panel 7

Prerequisites for Expedited Closure of Panel 6 (initial) and Closure of Room 7, Panel 7

Initial Closure of Panel 6: Consists of a Substantial Barrier & Steel Bulkhead (cross-sectional view of access drift)

Closure of Room 7, Panel 7 (disposal room closure – steel bulkhead)

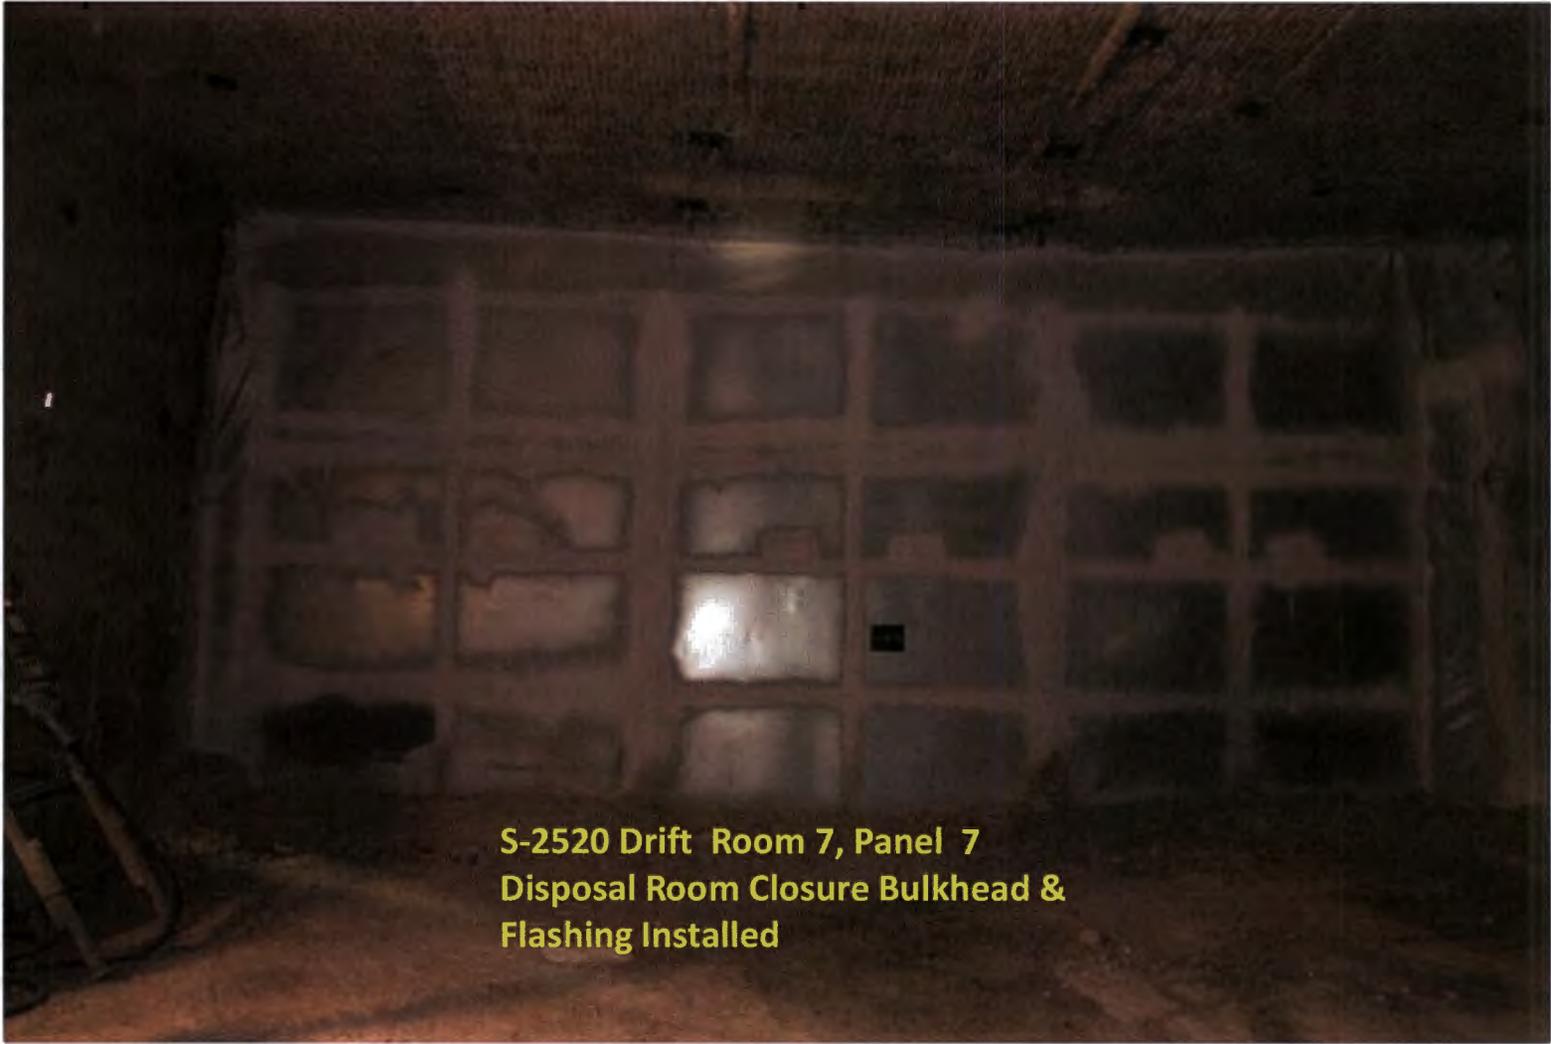
**S-2520 Drift Room 7, Panel 7
Disposal Room Closure Bulkhead &
Flashing Installed**

Slide 22 – Installation of Room Closure Bulkhead between Room 7, Panel 7 and Room 6, Panel 7 in the S-2520 Drift (air intake side)

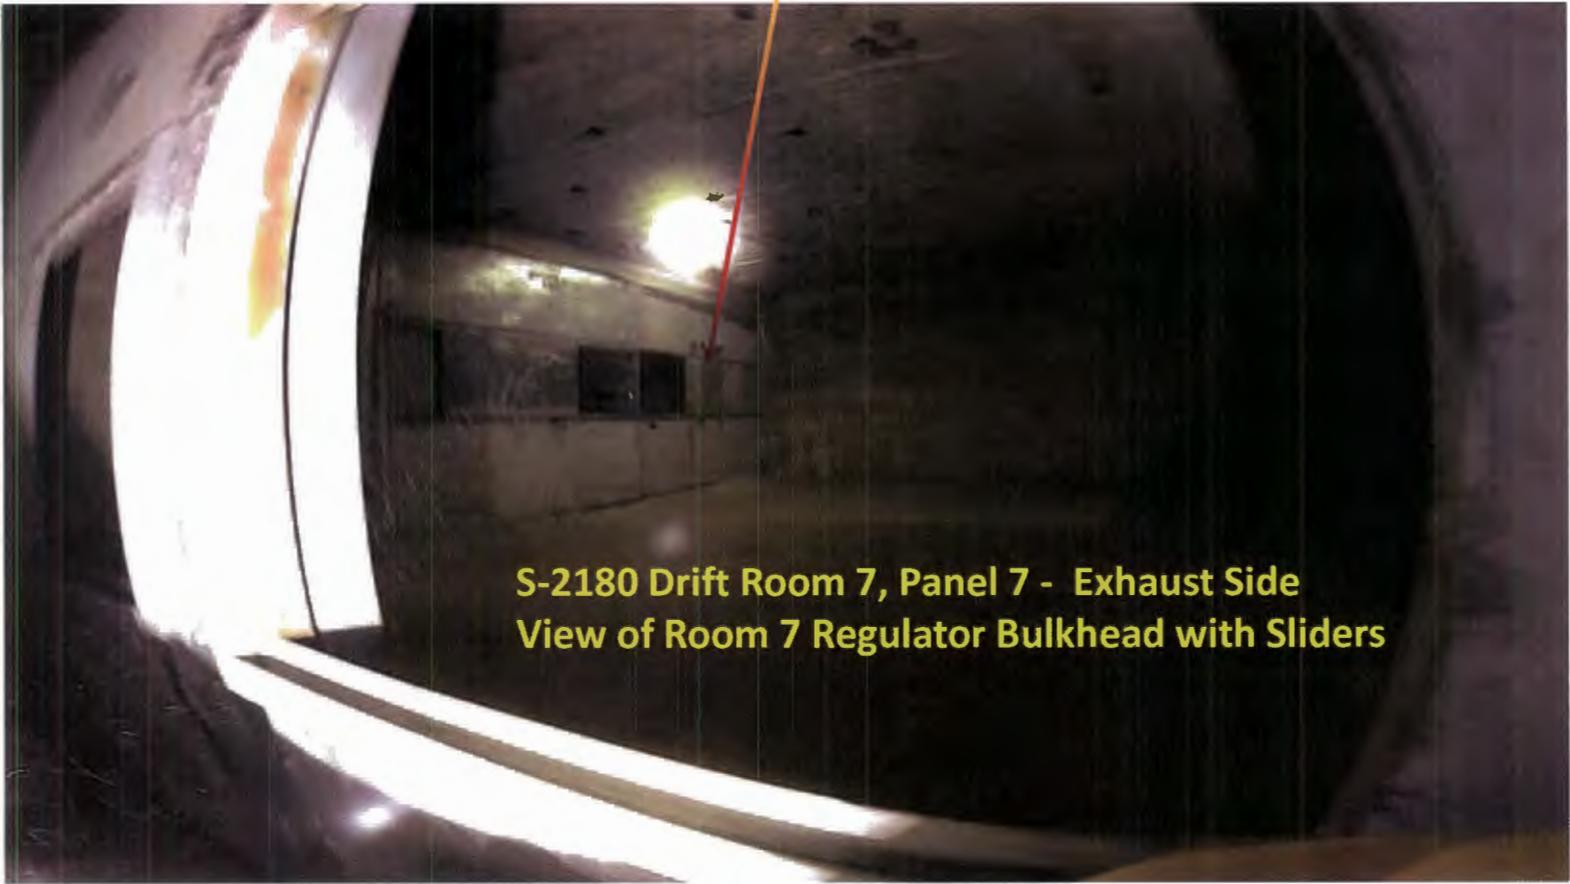
The Ventilation Sliders on the Room 7 Steel Regulator Bulkhead Have Now Been Closed

**S-2180 Drift Room 7, Panel 7 - Exhaust Side
View of Room 7 Regulator Bulkhead with Sliders**

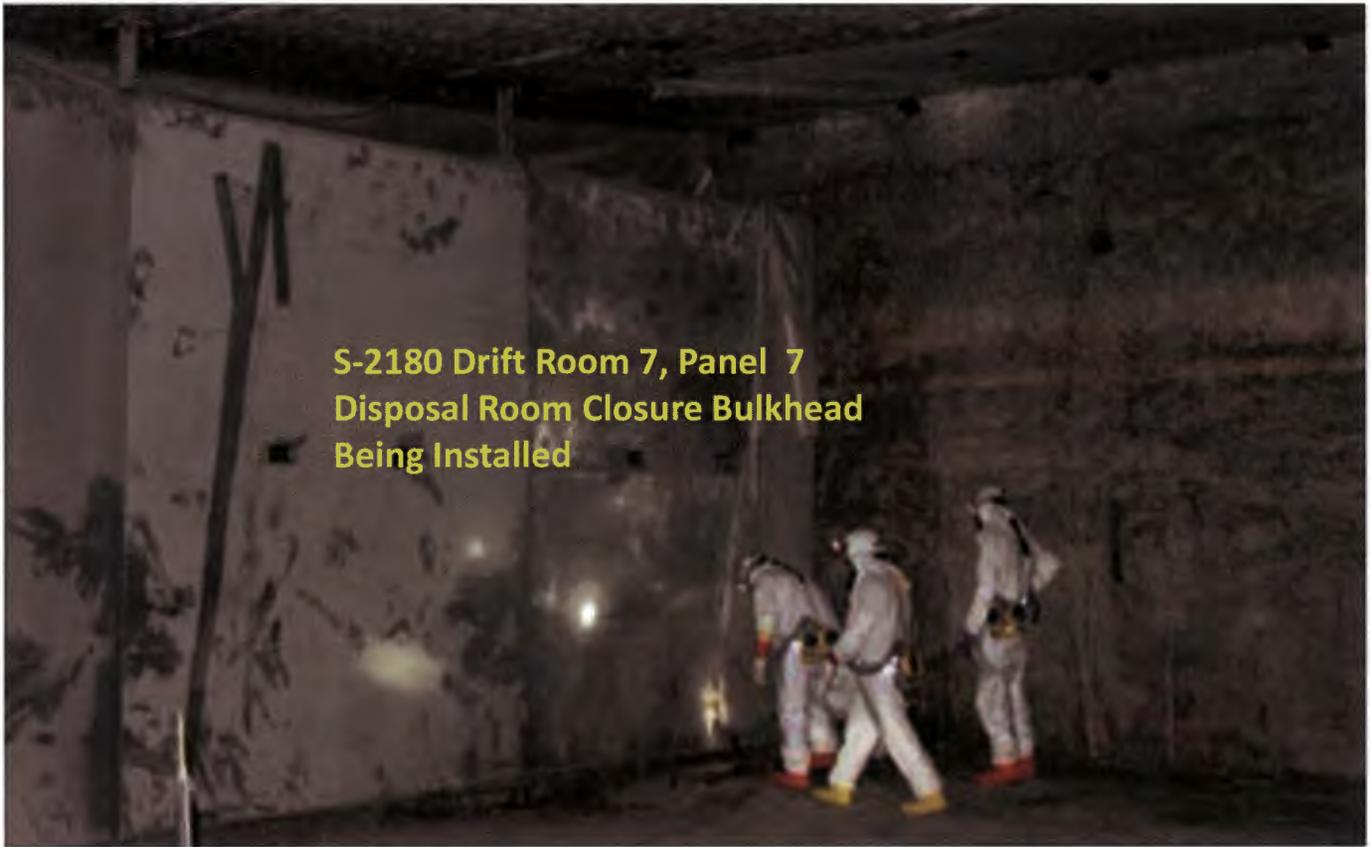
**S-2180 Drift Room 7, Panel 7
Disposal Room Closure Bulkhead
Being Installed**

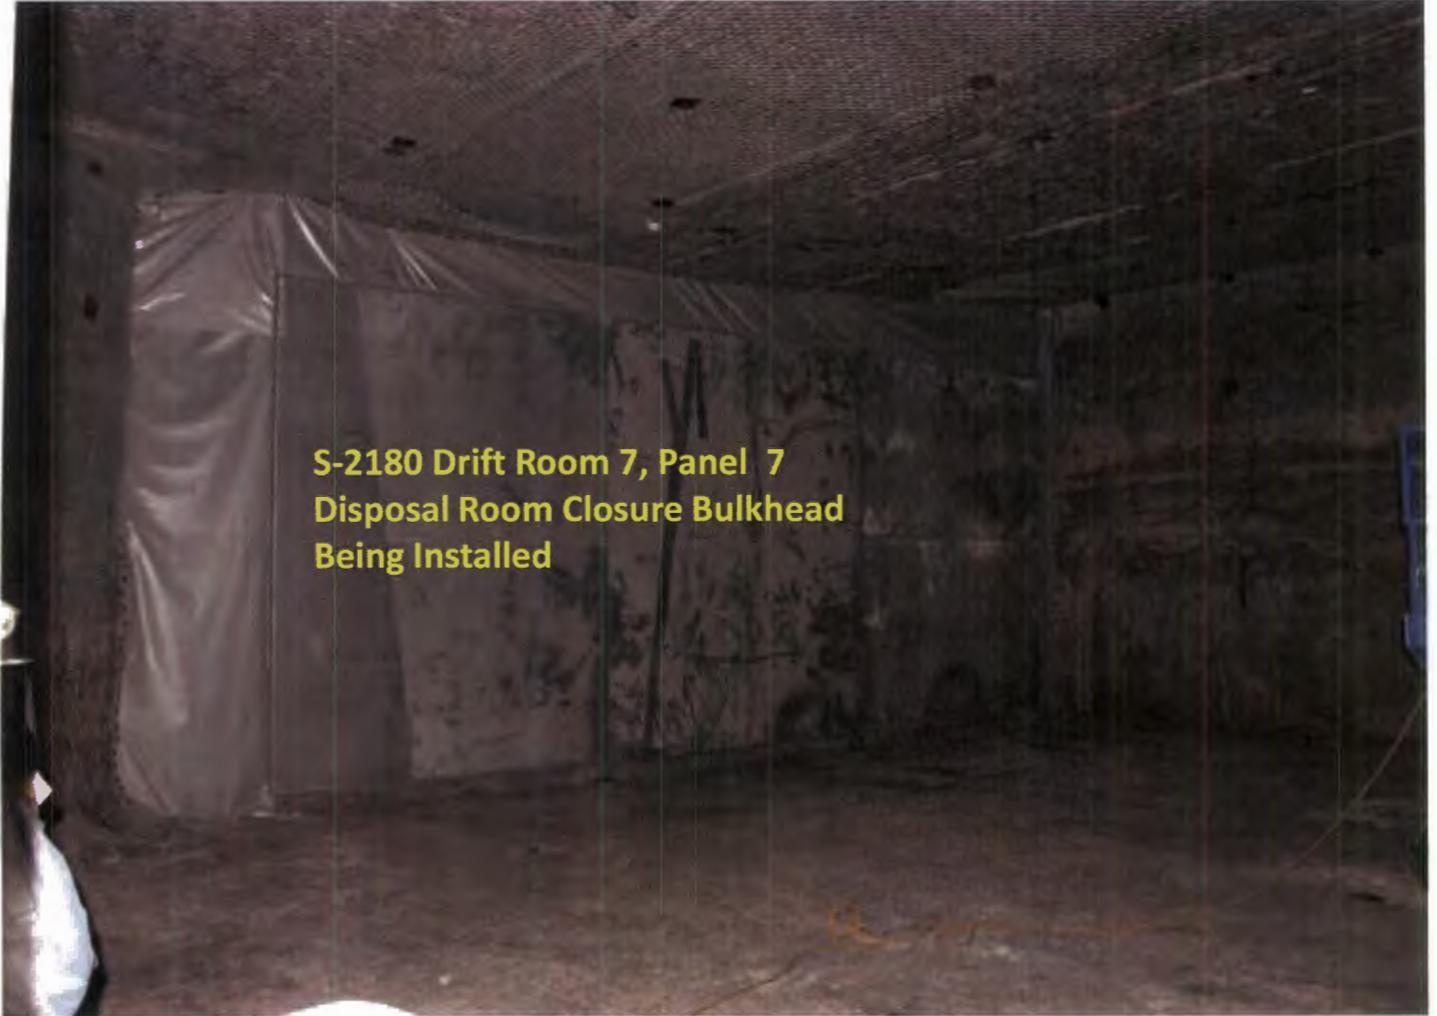
**S-2180 Drift Room 7, Panel 7
Disposal Room Closure Bulkhead
Being Installed**

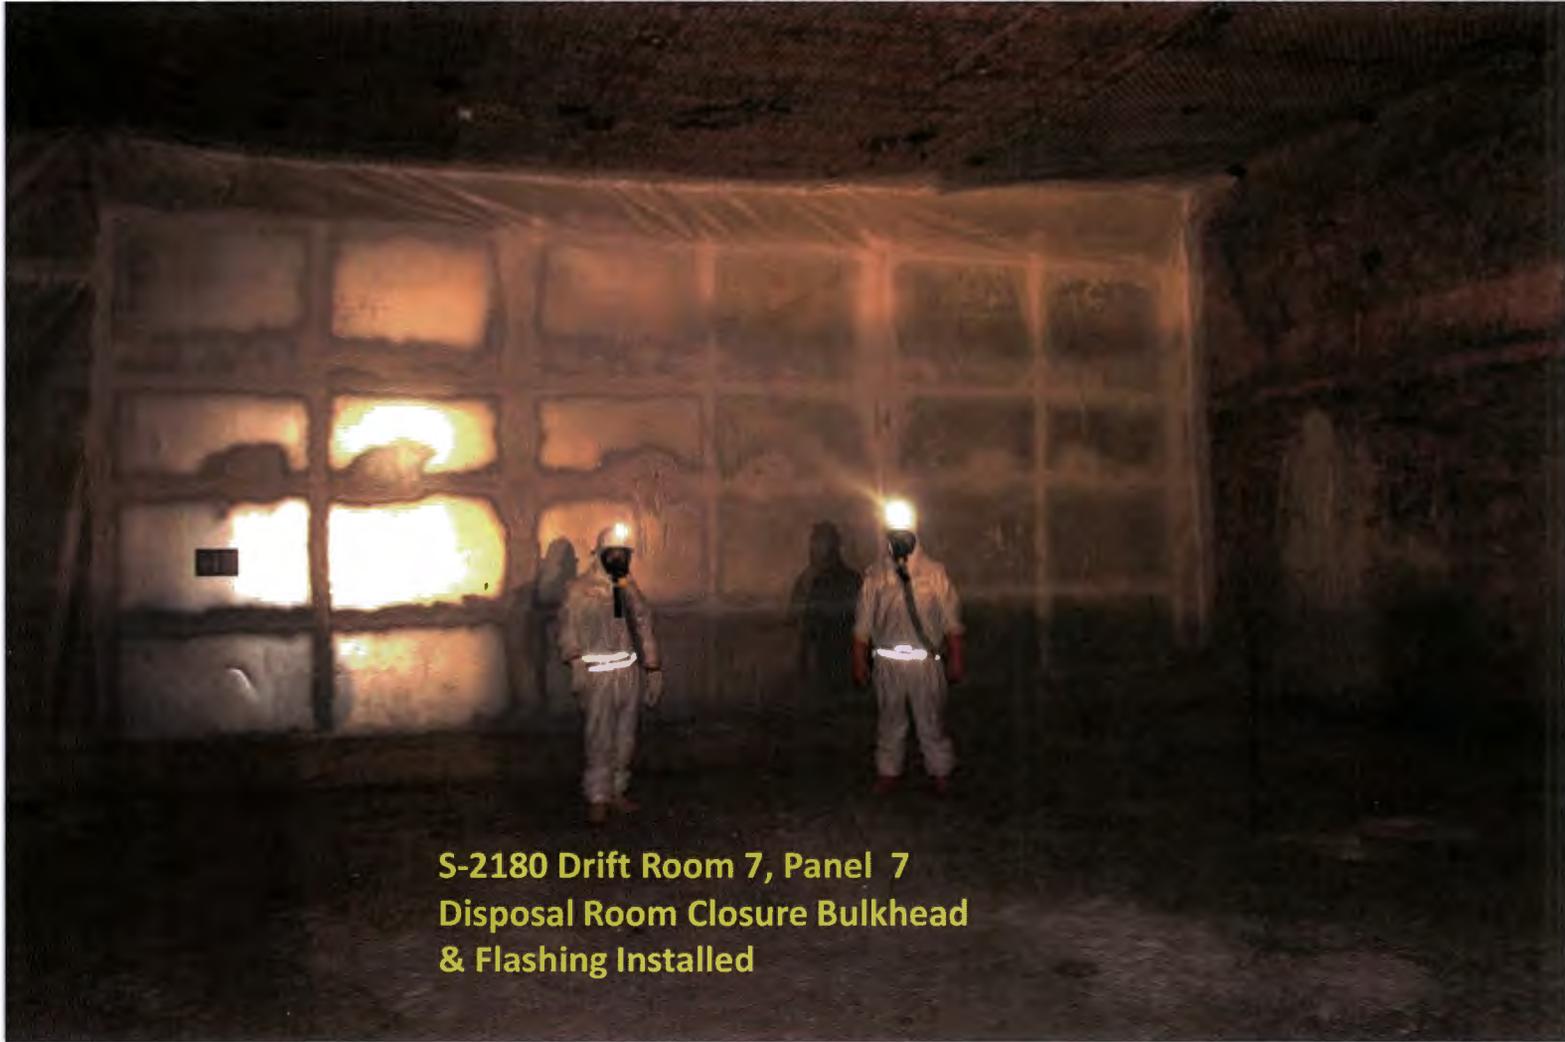
**S-2180 Drift Room 7, Panel 7
Disposal Room Closure Bulkhead
& Flashing Installed**

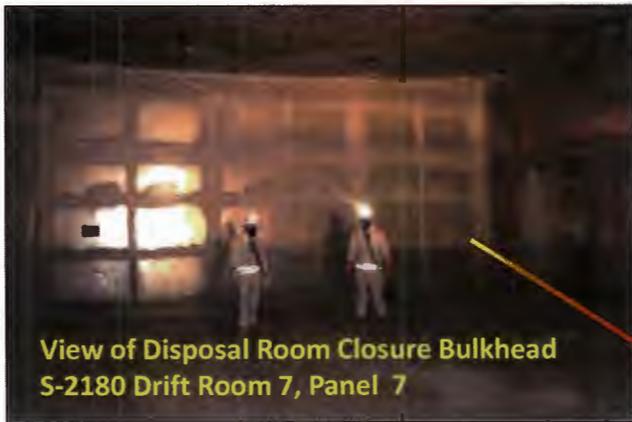
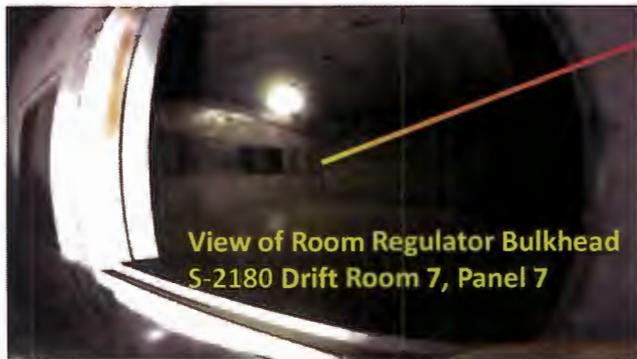
Top Left - View of Room Closure Bulkhead With Flashing, S-2180 Drift Room 7, Panel 7 – Exhaust Side

Bottom Left – View of Room Regulator Bulkhead with Sliders, S-2180 Drift Room 7, Panel 7 – Exhaust Side

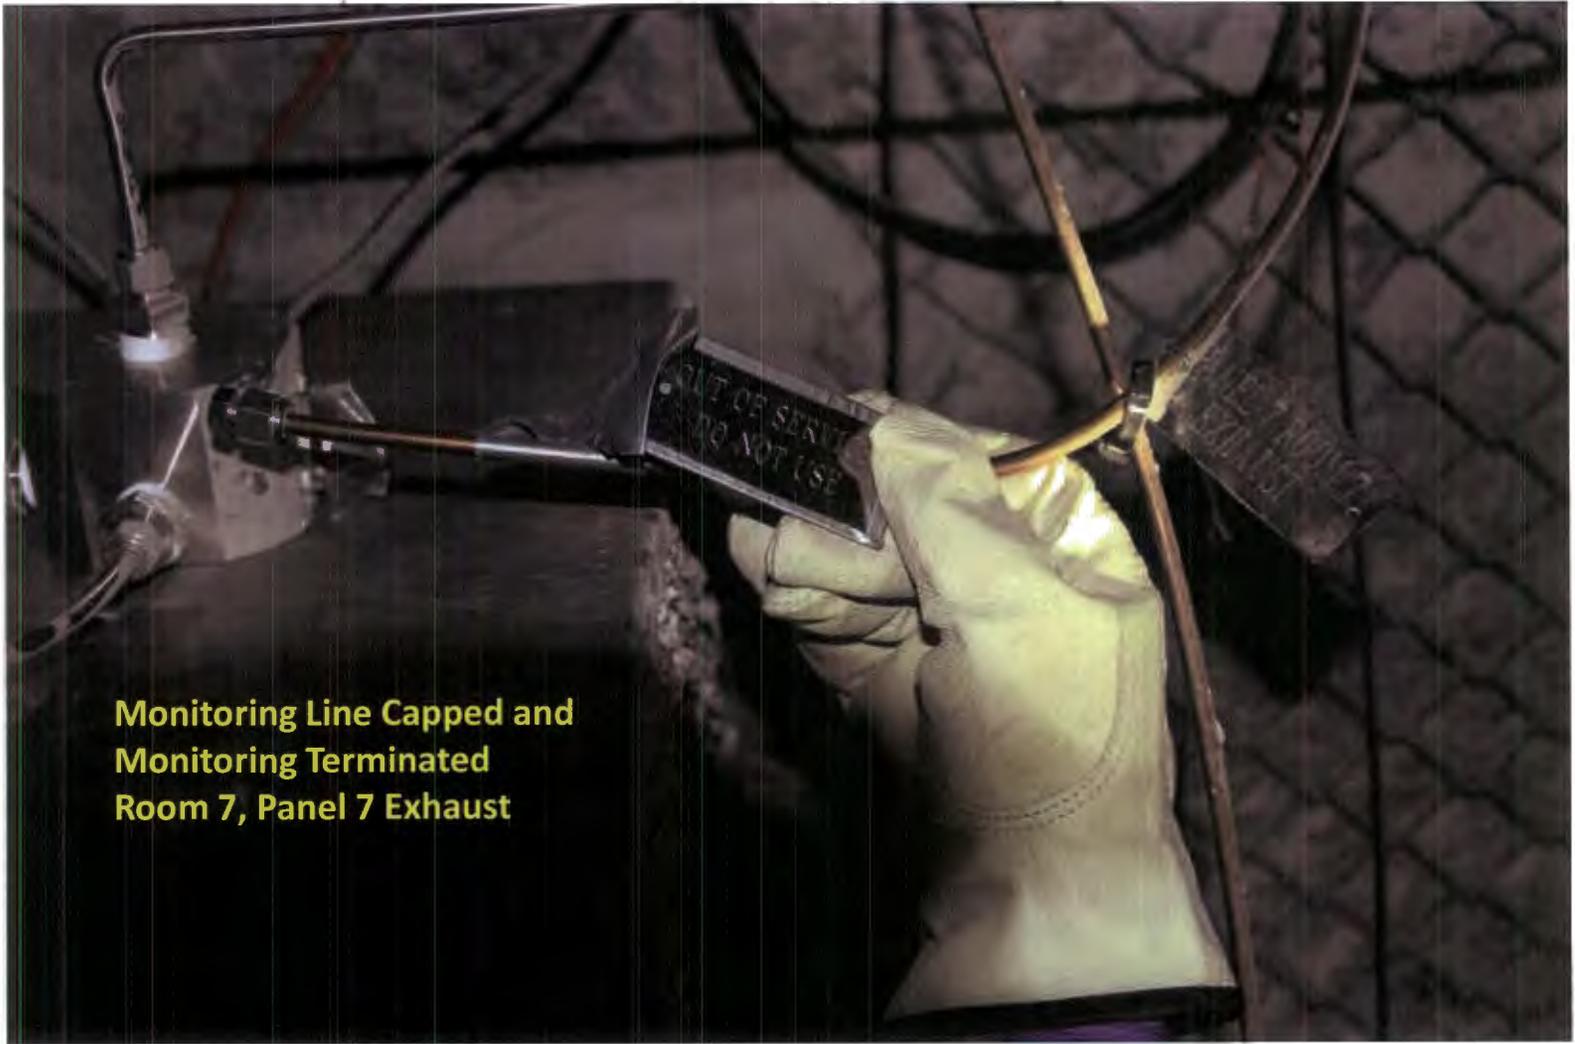
**Monitoring Line Capped and
Monitoring Terminated
Room 7, Panel 7 Exhaust**

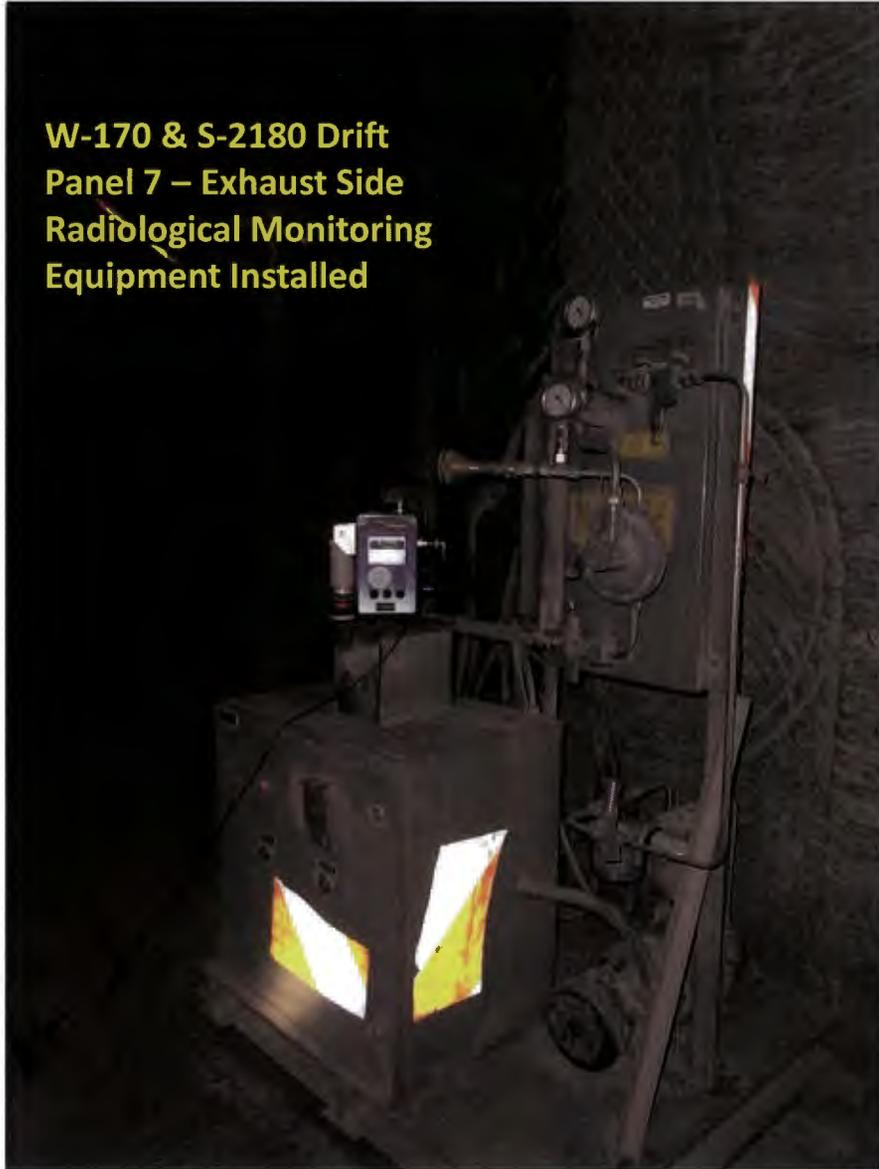
**W-170 & S-2180 Drift
Panel 7 – Exhaust Side
Radiological Monitoring
Equipment Installed**

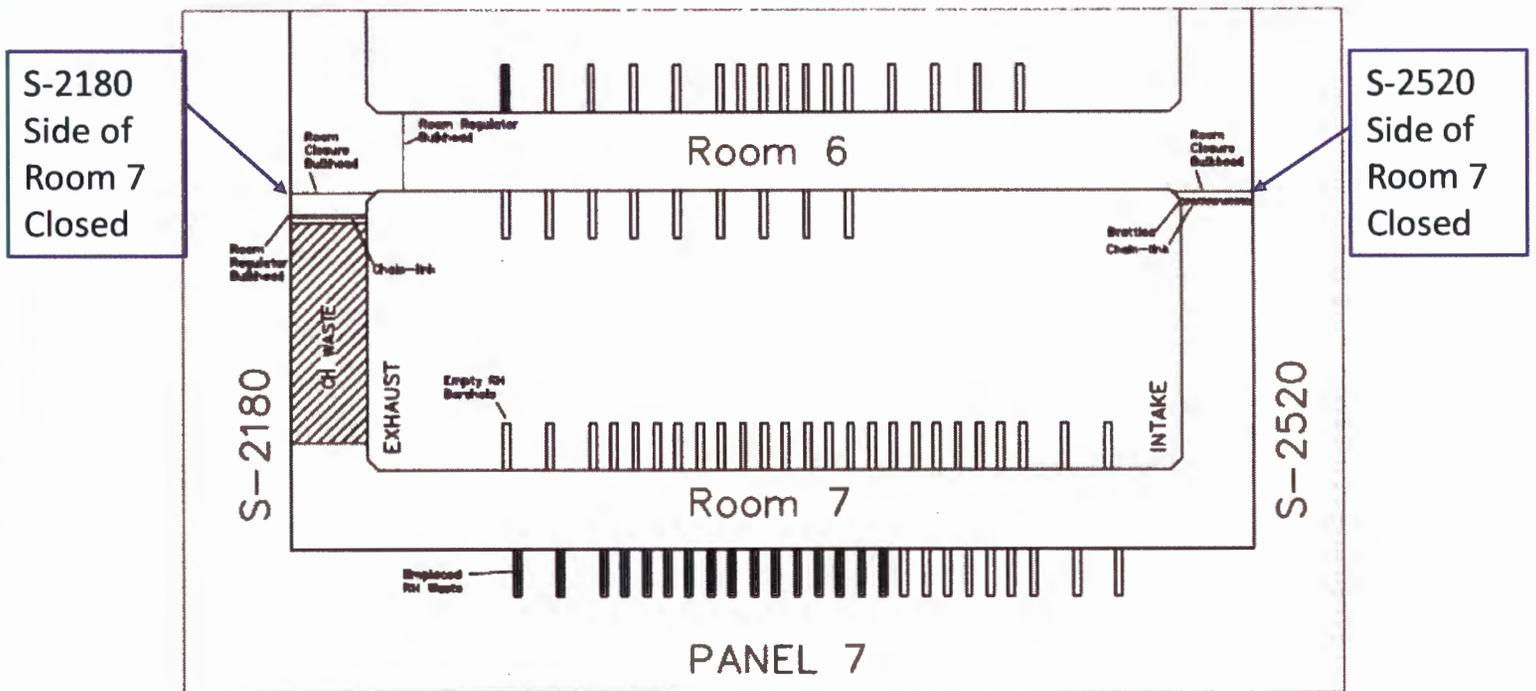
Disposal Room Closure for Room 7 in Panel 7 Has Been Completed

Slides 24-31 – room closure activities between Room 7, Panel 7 and Room 6, Panel 7 in the S-2180 Drift (air exhaust side); capping of monitoring line; Radiological Monitoring Equipment and figure illustrating where the room closure for Room 7 in Panel 7 was completed.
