Facility: Western Refining, Gallup Refinery

NMIED

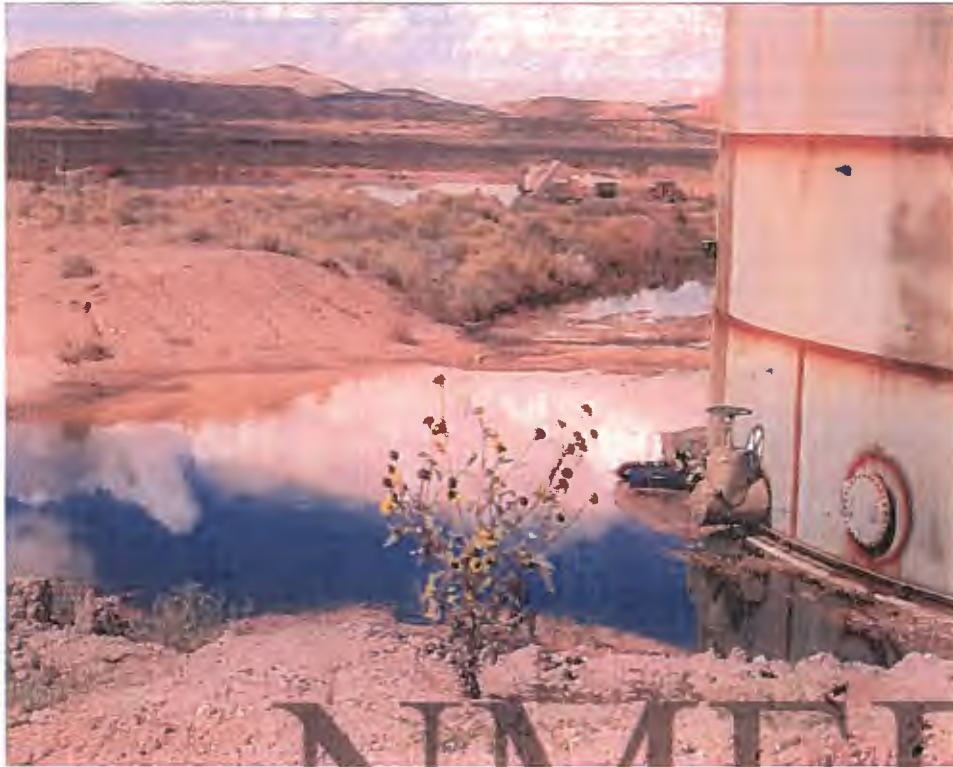
Photo #: 1

Location: Tank 35. Facing north.

Description: Photo showing the overflow of process waste water due to heavy rain event the previous night. This process waste water goes to the API Separator.

Violation(s): NONE. The facility notified the State of the occurrence.
